**Flood Control Project Maintenance
Levee Inspections**

Fall 2019 Levee Maintenance Deficiency Summary Report

**Flood Control Project Maintenance
Levee Inspections****LMA District Cover Sheet****Fall 2019 Levee Inspection Results****Levee District No. 0002 (Glenn County)**

Levee District No. 0002 (Glenn County)

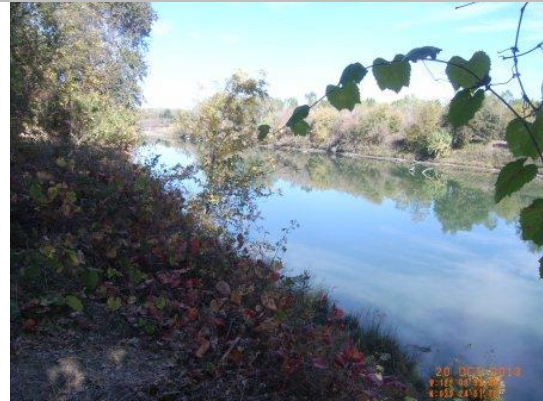
Photo 1 of 2 : FA_2019_LD0002_28_6_20190822_00003.jpg

USACE 2013 Photo #1

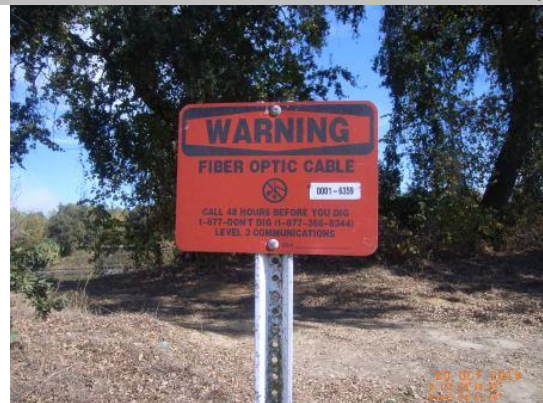
Photo 2 of 2 : FA_2019_LD0002_28_6_20190822_00004.jpg

USACE 2013 Photo #2

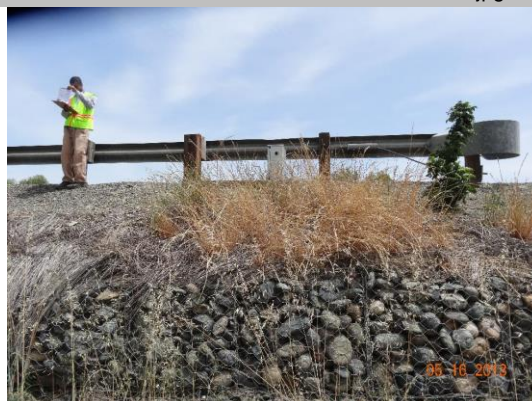
Photo 1 of 3 : UCIP_FA_2019_42083_72882.jpg

LM Start	0.59	Rating **	M	Issue No.	58
LM End	0.59	Issue Type +	En	Location *	
Category	Supplemental			GPS Latitude/Longitude	
				Start	End
Item	DRAFT DWR UCIP Field Study			39.422088 °	39.422088 °
				-122.011615 °	-122.011615 °
DWR ID	24877				
Comment Code					
Inspector Comment					
DS_ID:24877 FS_ID:42083 EP_NO: N/A Repair Type: Non-Urgent Crossing Status: Indicator Found UCIP Comments: Need to contact owner to determine if conduit goes through levee crown. If it does, will need to obtain permit number issued for encroachment. FIELD_STRUCT_DESC: Caltrans traffic control box located on the landside (LS) shoulder. FS Date: 5/16/2013

View of landward slope.

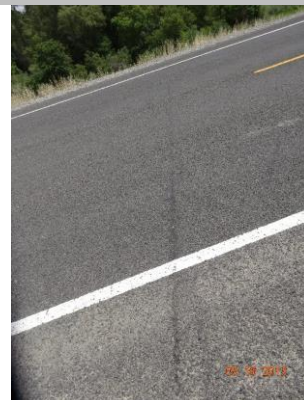
Photo 2 of 3 : UCIP_FA_2019_42083_72881.jpg

View of levee crown at crossing.

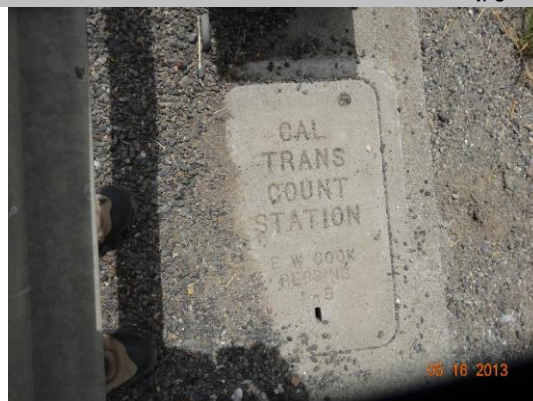
Photo 3 of 3 : UCIP_FA_2019_42083_72880.jpg

LM Start	0.59	Rating **	M	Issue No.	58 (cont)	
LM End	0.59	Issue Type +	En	Location *		
Category	Supplemental			GPS Latitude/Longitude		
				Start	End	
Item	DRAFT DWR UCIP Field Study			39.422088°	39.422088°	
				-122.011615°	-122.011615°	
DWR ID	24877					
Comment Code						
Inspector Comment						
DS_ID:24877 FS_ID:42083 EP_NO: N/A Repair Type: Non-Urgent Crossing Status: Indicator Found UCIP Comments: Need to contact owner to determine if conduit goes through levee crown. If it does, will need to obtain permit number issued for encroachment. FIELD_STRUCT_DESC: Caltrans traffic control box located on the landside (LS) shoulder. FS Date: 5/16/2013

Service box located on landward shoulder.

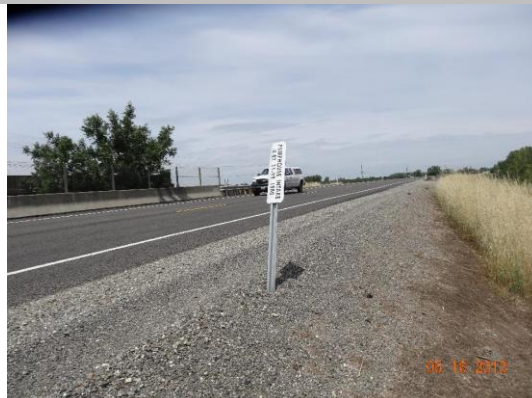
Photo 1 of 3 : UCIP_FA_2019_38165_69467.jpg

Comment Code					
Inspector Comment					
DS_ID:21185 FS_ID:38165 EP_NO: 2356 Repair Type: Non-Urgent Crossing Status: Found UCIP Comments: Three pipes found in the pump house on landward side. Pump house appears to be no longer in use. Unable to locate pipes on waterward side. Will need to contact owner to determine status. Owner will need to coordinate with CVFPB regarding proper removal per Title 23 requirements. FIELD_STRUCT_DESC: [Princeton-Cordora-Glenn Irrigation District: Schaad Pumping Plant] 1 of 3: 28-inch steel pipe sleeved through 30-inch steel pipe through the levee, 20 feet below the crown. Annular gap is grouted. Flap gate on landside (LS) end. Pump in pump house on LS slope. Rock revetment around outlet on waterside (WS) slope. (28- and 34-inch pipes sleeved through existing 30- and 36-inch pipes, permit shows three 36-inch pipes as part of Schaad Pumping Plant p. 17 of 19, authorized under Permit No. 2356, 1956, Princeton-Cordora-Glenn Irrigation District) [Additional Reference(s): DWR Levee Logs, 2005. USACE Sacramento O&M Manual Unit No. 151, November 1953, (Station 41+47), two 36-inch pipes] FS Date: 5/16/2013

View of levee crown at crossing.

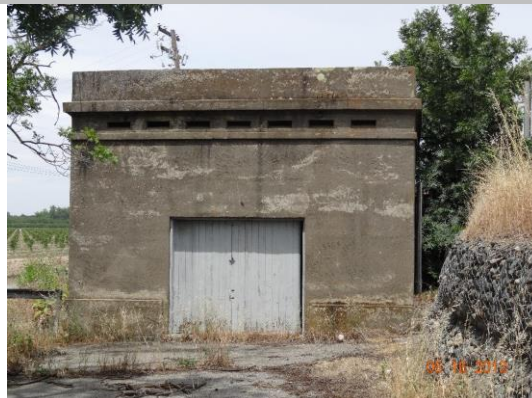
Photo 2 of 3 : UCIP_FA_2019_38165_69469.jpg

View of Princeton-Cordora-Glenn Irrigation District--Schaad Pumping Plant.

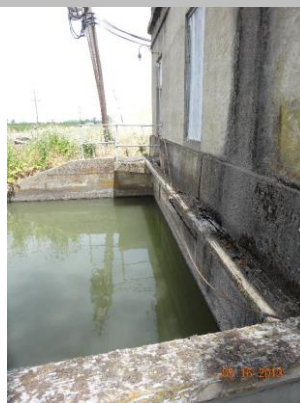
Photo 3 of 3 : UCIP_FA_2019_38165_69463.jpg

Comment Code						
Inspector Comment						
DS_ID:21185 FS_ID:38165 EP_NO: 2356 Repair Type: Non-Urgent Crossing Status: Found UCIP Comments: Three pipes found in the pump house on landward side. Pump house appears to be no longer in use. Unable to locate pipes on waterward side. Will need to contact owner to determine status. Owner will need to coordinate with CVFPB regarding proper removal per Title 23 requirements. FIELD_STRUCT_DESC: [Princeton-Cordora-Glenn Irrigation District: Schaad Pumping Plant] 1 of 3: 28-inch steel pipe sleeved through 30-inch steel pipe through the levee, 20 feet below the crown. Annular gap is grouted. Flap gate on landside (LS) end. Pump in pump house on LS slope. Rock revetment around outlet on waterside (WS) slope. (28- and 34-inch pipes sleeved through existing 30- and 36-inch pipes, permit shows three 36-inch pipes as part of Schaad Pumping Plant p. 17 of 19, authorized under Permit No. 2356, 1956, Princeton-Cordora-Glenn Irrigation District) [Additional Reference(s): DWR Levee Logs, 2005. USACE Sacramento O&M Manual Unit No. 151, November 1953, (Station 41+47), two 36-inch pipes] FS Date: 5/16/2013

View of landward side--outlet.

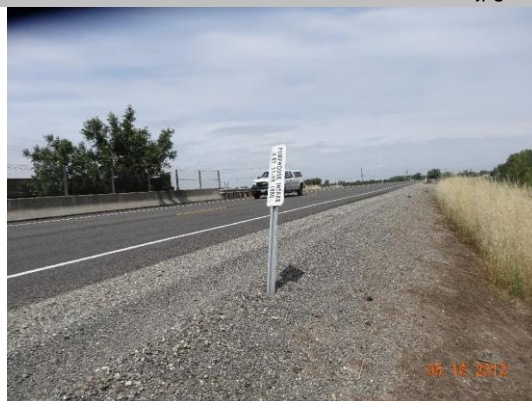
Photo 1 of 3 : UCIP_FA_2019_38166_69475.jpg

Comment Code						
Inspector Comment						
DS_ID:21184 FS_ID:38166 EP_NO: N/A Repair Type: Non-Urgent Crossing Status: Found UCIP Comments: Three pipes found in the pump house on landward side. Pump house appears to be no longer in use. Unable to locate pipes on waterward side. Will need to contact owner to determine status. Owner will need to coordinate with CVFPB regarding proper removal per Title 23 requirements. FIELD_STRUCT_DESC: [Princeton-Cordora-Glenn Irrigation District: Schaad Pumping Plant] 2 of 3: 34-inch steel pipe sleeved through 36-inch steel pipe through the levee, 20 feet below the crown. Annular gap is grouted. Flap gate on landside (LS) end. Pump in pump house on LS slope. Rock revetment around outlet on waterside (WS) slope. (28- and 34-inch pipes sleeved through existing 30- and 36-inch pipes, permit shows three 36-inch pipes as part of Schaad Pumping Plant p. 17 of 19, authorized under Permit No. 2356, 1956, Princeton-Cordora-Glenn Irrigation District) [Additional Reference(s): DWR Levee Logs, 2005. USACE Sacramento O&M Manual Unit No. 151, November 1953, (Station 41+47), two 36-inch pipes] FS Date: 5/16/2013

View of levee crown at crossing.

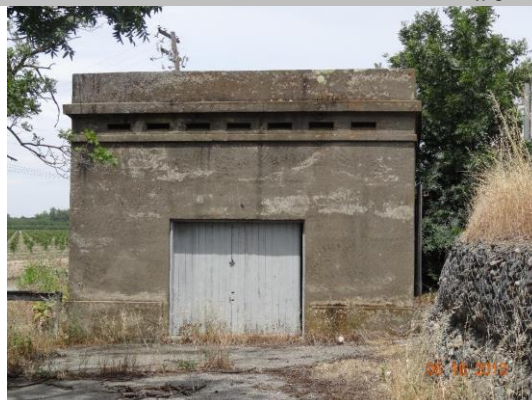
Photo 2 of 3 : UCIP_FA_2019_38166_69476.jpg

View of Princeton-Cordora-Glenn Irrigation District--Schaad Pumping Plant.

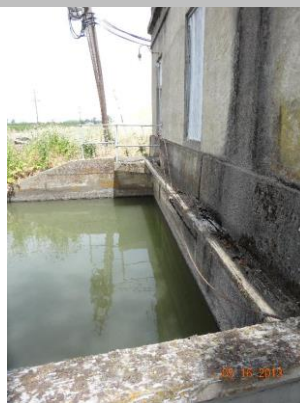
Photo 3 of 3 : UCIP_FA_2019_38166_69477.jpg

Comment Code						
Inspector Comment						
DS_ID:21184 FS_ID:38166 EP_NO: N/A Repair Type: Non-Urgent Crossing Status: Found UCIP Comments: Three pipes found in the pump house on landward side. Pump house appears to be no longer in use. Unable to locate pipes on waterward side. Will need to contact owner to determine status. Owner will need to coordinate with CVFPB regarding proper removal per Title 23 requirements. FIELD_STRUCT_DESC: [Princeton-Cordora-Glenn Irrigation District: Schaad Pumping Plant] 2 of 3: 34-inch steel pipe sleeved through 36-inch steel pipe through the levee, 20 feet below the crown. Annular gap is grouted. Flap gate on landside (LS) end. Pump in pump house on LS slope. Rock revetment around outlet on waterside (WS) slope. (28- and 34-inch pipes sleeved through existing 30- and 36-inch pipes, permit shows three 36-inch pipes as part of Schaad Pumping Plant p. 17 of 19, authorized under Permit No. 2356, 1956, Princeton-Cordora-Glenn Irrigation District) [Additional Reference(s): DWR Levee Logs, 2005. USACE Sacramento O&M Manual Unit No. 151, November 1953, (Station 41+47), two 36-inch pipes] FS Date: 5/16/2013

View of landward side--outlet.

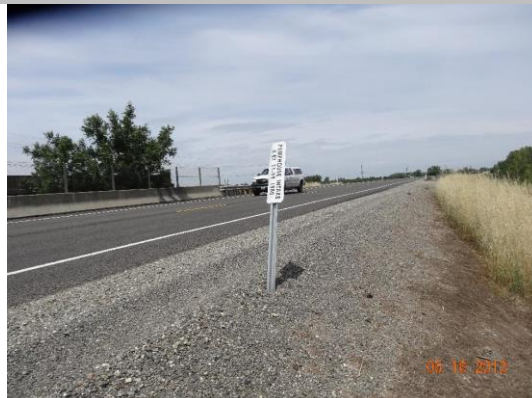
Photo 1 of 3 : UCIP_FA_2019_38167_69483.jpg

Comment Code						
Inspector Comment						
DS_ID:21171 FS_ID:38167 EP_NO: N/A Repair Type: Non-Urgent Crossing Status: Found UCIP Comments: Three pipes found in the pump house on landward side. Pump house appears to be no longer in use. Unable to locate pipes on waterward side. Will need to contact owner to determine status. Owner will need to coordinate with CVFPB regarding proper removal per Title 23 requirements. FIELD_STRUCT_DESC: [Princeton-Cordora-Glenn Irrigation District: Schaad Pumping Plant] 3 of 3: 34-inch steel pipe sleeved through 36-inch steel pipe through the levee, 20 feet below the crown. Annular gap is grouted. Flap gate on landside (LS) end. Pump in pump house on LS slope. Rock revetment around outlet on waterside (WS) slope. (28- and 34-inch pipes sleeved through existing 30- and 36-inch pipes, permit shows three 36-inch pipes as part of Schaad Pumping Plant p. 17 of 19, authorized under Permit No. 2356, 1956, Princeton-Cordora-Glenn Irrigation District) [Additional Reference(s): DWR Levee Logs, 2005. USACE Sacramento O&M Manual Unit No. 151, November 1953, (Station 41+47), two 36-inch pipes] FS Date: 5/16/2013

View of levee crown with marker on waterward side.

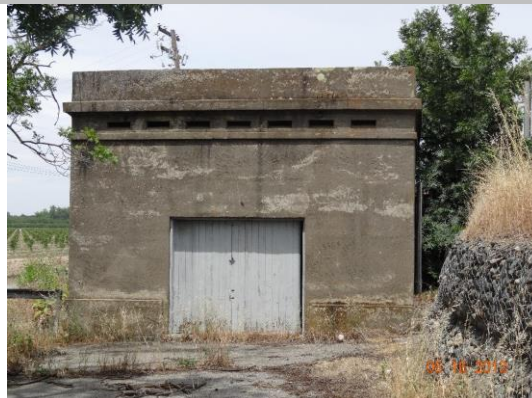
Photo 2 of 3 : UCIP_FA_2019_38167_69484.jpg

View of Princeton-Cordora-Glenn Irrigation District-Schaad Pumping Plant.

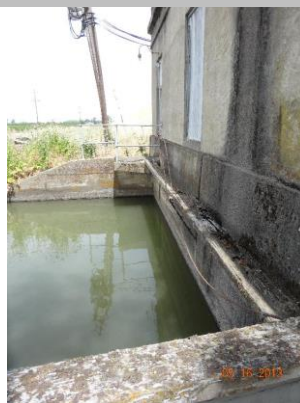
Photo 3 of 3 : UCIP_FA_2019_38167_69478.jpg

Comment Code						
Inspector Comment						
DS_ID:21171 FS_ID:38167 EP_NO: N/A Repair Type: Non-Urgent Crossing Status: Found UCIP Comments: Three pipes found in the pump house on landward side. Pump house appears to be no longer in use. Unable to locate pipes on waterward side. Will need to contact owner to determine status. Owner will need to coordinate with CVFPB regarding proper removal per Title 23 requirements. FIELD_STRUCT_DESC: [Princeton-Cordora-Glenn Irrigation District: Schaad Pumping Plant] 3 of 3: 34-inch steel pipe sleeved through 36-inch steel pipe through the levee, 20 feet below the crown. Annular gap is grouted. Flap gate on landside (LS) end. Pump in pump house on LS slope. Rock revetment around outlet on waterside (WS) slope. (28- and 34-inch pipes sleeved through existing 30- and 36-inch pipes, permit shows three 36-inch pipes as part of Schaad Pumping Plant p. 17 of 19, authorized under Permit No. 2356, 1956, Princeton-Cordora-Glenn Irrigation District) [Additional Reference(s): DWR Levee Logs, 2005. USACE Sacramento O&M Manual Unit No. 151, November 1953, (Station 41+47), two 36-inch pipes] FS Date: 5/16/2013

View of landward side--outlet.

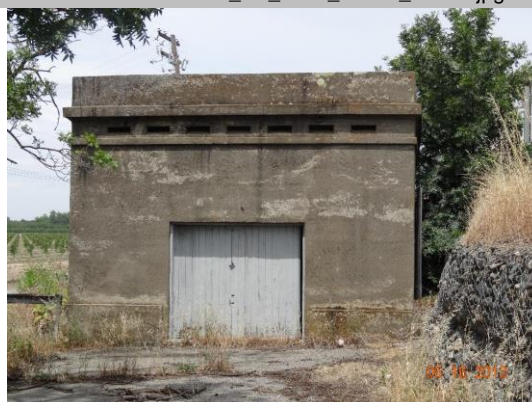
Photo 2 of 3 : UCIP_FA_2019_38168_69493.jpg

Comment Code					
Inspector Comment					
DS_ID:21182					
FS_ID:38168					
EP_NO: N/A					
Repair Type: Non-Urgent					
Crossing Status: Indicator Found					
UCIP Comments: Unable to verify if the pipes inside the existing pump house correlate to 24-inch installed in 1955. Three pipes found in the pump house on landward side. Pump house appears to be no longer in use. Unable to locate pipes on waterward side. Will need to contact owner to determine status.					
FIELD_STRUCT_DESC: [Pumping Plant] 24-inch steel pipe through the levee, 27.3 feet below the crown. Flap gate on landside (LS). Pump in pump house on LS. [Additional Reference(s): DWR Levee Logs, 2005. USACE Sacramento O&M Manual Unit No. 151, November 1953, (Station 41+47), 24-inch pipe]					
FS Date: 5/16/2013

View of Princeton-Cordora-Glenn Irrigation District-Schaad Pumping Plant.

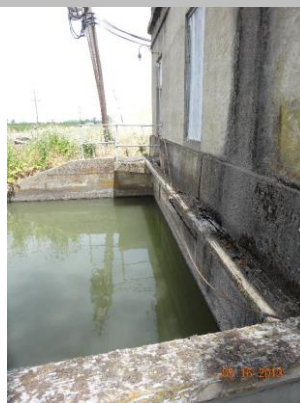
Photo 3 of 3 : UCIP_FA_2019_38168_69486.jpg

Comment Code						
Inspector Comment						
DS_ID:21182						
FS_ID:38168						
EP_NO: N/A						
Repair Type: Non-Urgent						
Crossing Status: Indicator Found						
UCIP Comments: Unable to verify if the pipes inside the existing pump house correlate to 24-inch installed in 1955. Three pipes found in the pump house on landward side. Pump house appears to be no longer in use. Unable to locate pipes on waterward side. Will need to contact owner to determine status.						
FIELD_STRUCT_DESC: [Pumping Plant] 24-inch steel pipe through the levee, 27.3 feet below the crown. Flap gate on landside (LS). Pump in pump house on LS. [Additional Reference(s): DWR Levee Logs, 2005. USACE Sacramento O&M Manual Unit No. 151, November 1953, (Station 41+47), 24-inch pipe]						
FS Date: 5/16/2013

View of landward side--outlet.

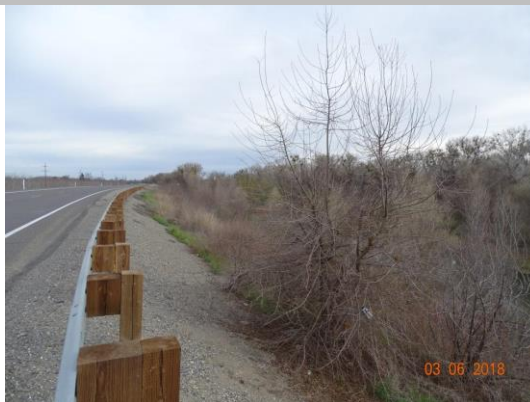
Photo 1 of 1 : FA_2019_LD0002_28_35_20190822_00018.jpg

LM Start	0.64	Rating **	M	Issue No.	35
LM End	0.77	Issue Type +	Ma	Location *	WS
Category	Earthen Levee			GPS Latitude/Longitude	
				Start	End
Item	Vegetation			39.422805°	39.424597°
				-122.011640°	-122.011527°
DWR ID	DWR_LD0002_01_s_2018_35				
Comment Code					
V2 : Remove the wild growth other than native grasses from the levee slopes.					
Inspector Comment

View of the vegetation along the waterside slope.

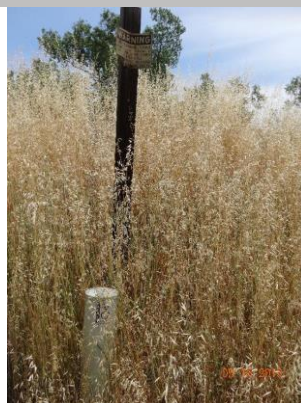
Photo 1 of 3 : UCIP_FA_2019_44170_72602.jpg

Comment Code						
Inspector Comment						
DS_ID:21177						
FS_ID:44170						
EP_NO: 9723						
Repair Type: Non-Urgent						
Crossing Status: Indicator Found						
UCIP Comments: Owner is listed as Pacific Bell however sign lists AT&T as owner, need to contact owner to determine if permit was updated or if this crossing is listed under new permit. Unable to confirm if 2 crossings are present at this site.						
FIELD_STRUCT_DESC: Buried telephone cable through the levee at unknown depth. Telephone pole and junction box on landside (LS) toe. (telephone cable authorized under Automatic Board Order (ABO) issued as Permit No. 9723-1974, Pacific Telephone Company).						
FS Date: 5/16/2013

Indicators of existing line visible on slope.

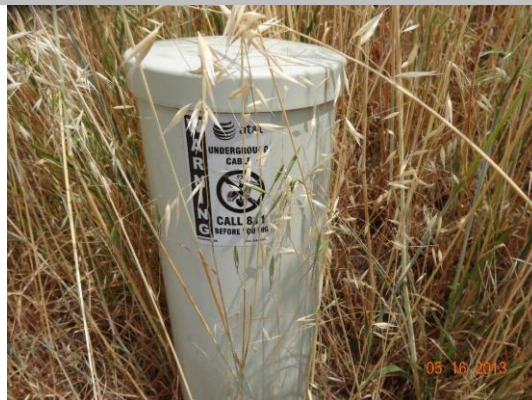
Photo 2 of 3 : UCIP_FA_2019_44170_72601.jpg

AT&T underground cable line.

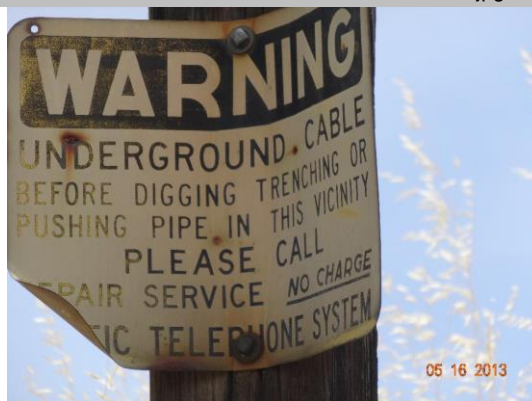
Photo 3 of 3 : UCIP_FA_2019_44170_72600.jpg

Comment Code						
Inspector Comment						
DS_ID:21177						
FS_ID:44170						
EP_NO: 9723						
Repair Type: Non-Urgent						
Crossing Status: Indicator Found						
UCIP Comments: Owner is listed as Pacific Bell however sign lists AT&T as owner, need to contact owner to determine if permit was updated or if this crossing is listed under new permit. Unable to confirm if 2 crossings are present at this site.						
FIELD_STRUCT_DESC: Buried telephone cable through the levee at unknown depth. Telephone pole and junction box on landside (LS) toe. (telephone cable authorized under Automatic Board Order (ABO) issued as Permit No. 9723-1974, Pacific Telephone Company).						
FS Date: 5/16/2013

Sign lists Pacific Telephone system.

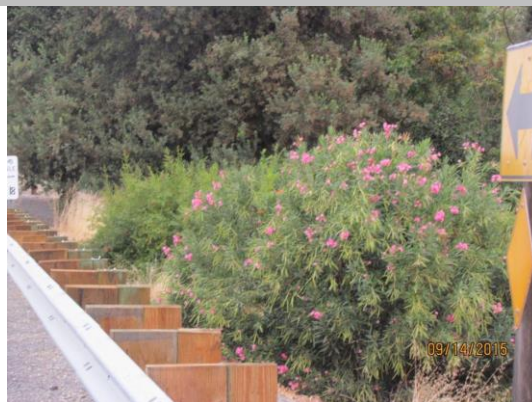
Photo 1 of 1 : FA_2019_LD0002_28_30_20190822_00015.jpg

LM Start	1.03	Rating **	M	Issue No.	30
LM End	1.03	Issue Type +	En	Location *	WS
Category	Earthen Levee			GPS Latitude/Longitude	
				Start	End
Item	Vegetation			39.428445 °	39.428445 °
				-122.010972 °	-122.010972 °
DWR ID	DWR_LD0002_01_f_2015_30				
Comment Code					
V6 : Landscaping					
Inspector Comment					
Remove the oleanders from the waterside slope.

View of the oleanders along the waterside slope.

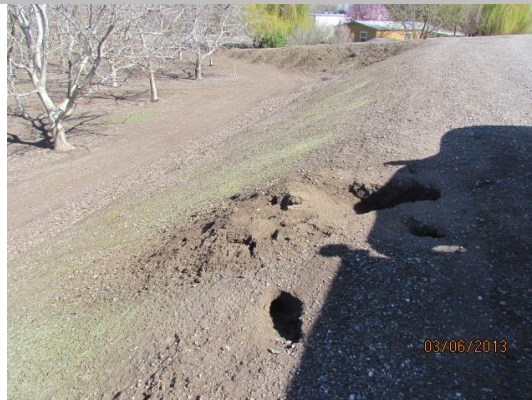
Photo 2 of 2 : FA_2019_LD0002_28_12_20190822_00005.jpg

View of the rodent activity along the landside slope.

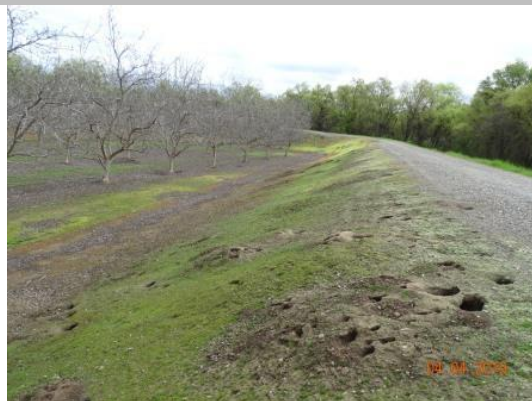
Photo 1 of 2 : FA_2019_LD0002_28_16_20190822_00010.jpg

LM Start	3.26	Rating **	U	Issue No.	16
LM End	3.30	Issue Type +	Ma	Location *	LS
Category	Earthen Levee			GPS Latitude/Longitude	
				Start	End
Item	Animal Control			39.456228 °	39.456272 °
				-122.011002 °	-122.010163 °
DWR ID	DWR_LD0002_01_f_2012_16				
Comment Code					
A3 : No rodents visible, but rodent burrows visible; need to backfill and compact or grout burrows.					
Inspector Comment

View of the rodent holes along the landside slope. Spring 2019.

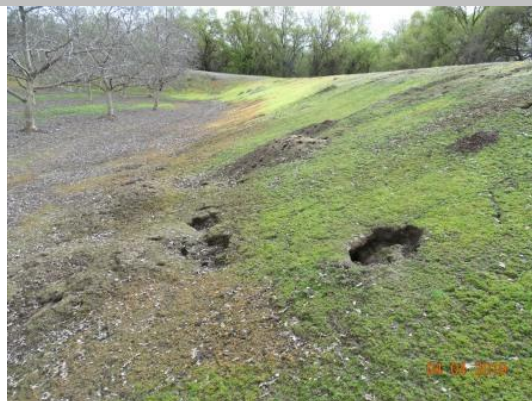
Photo 2 of 2 : FA_2019_LD0002_28_16_20190822_00011.jpg

Another view of the rodent holes along the landside slope. Spring 2019.

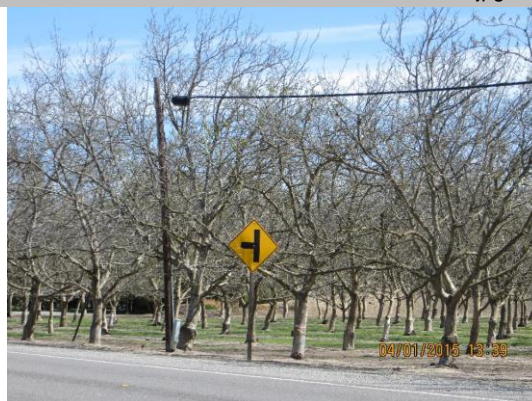
Photo 1 of 2 : UCIP_FA_2019_44186_73606.jpg

Comment Code						
Inspector Comment						
DS_ID:21188						
FS_ID:44186						
EP_NO: 12444						
Repair Type: Non-Urgent						
Crossing Status: Indicator Found						
UCIP Comments: Needs markers 10-feet off both levee toes.						
FIELD_STRUCT_DESC: Buried cable steel conduit through the levee, 2.5 feet below the crown. Conduit extends to pole on waterside (WS). Cut in pavement visible at levee crown (aerial communication cable across left bank levee and channel of the Sacramento River and buried cable across the right bank overflow and through the right bank levee authorized under Permit No. 12444, 1978-Pacific Telephone and Telegraph Company) [Additional Reference(s): DWR Levee Logs, 2005]						
FS Date: 4/1/2015

Conduit may be visible on pole about 1000-feet west of levee crown.

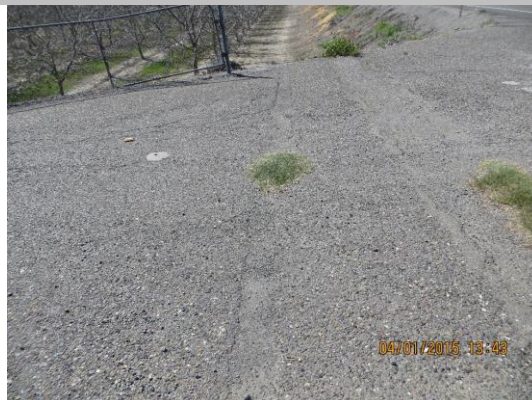
Photo 2 of 2 : UCIP_FA_2019_44186_73605.jpg

Cut in pavement at levee crown good indicator of crossing.

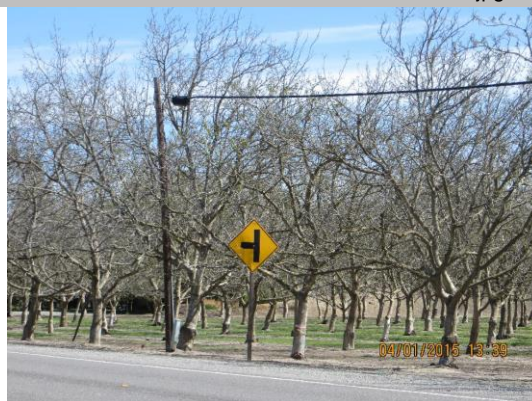
Photo 1 of 2 : UCIP_FA_2019_44185_73608.jpg

Comment Code						
Inspector Comment						
DS_ID:21175 FS_ID:44185 EP_NO: 5376 Repair Type: Non-Urgent Crossing Status: Indicator Found UCIP Comments: Conduit needs markers ten feet off both levee toes. FIELD_STRUCT_DESC: Three 3.5-inch steel cables sleeved through conduit through the levee, 3 feet below the crown. Metal cutoff wall around conduits near center of levee. Conduits are welded to the cutoff wall, extending only between the levee shoulders under the crown. Cut in pavement visible at crown. Cables extend to pole on waterside (WS). (replace existing aerial telephone cables with two buried cables authorized under Permit No. 5376, 1967-Pacific Telephone & Telegraph Co.) [Additional Reference(s): DWR Levee Logs, 2005] FS Date: 4/1/2015

Conduit may be visible at pole about 1000-feet west of crown.

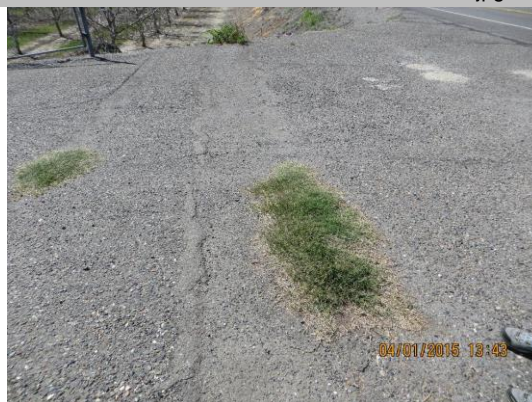
Photo 2 of 2 : UCIP_FA_2019_44185_73607.jpg

Cut in pavement visible at crown good indicator of crossing location.

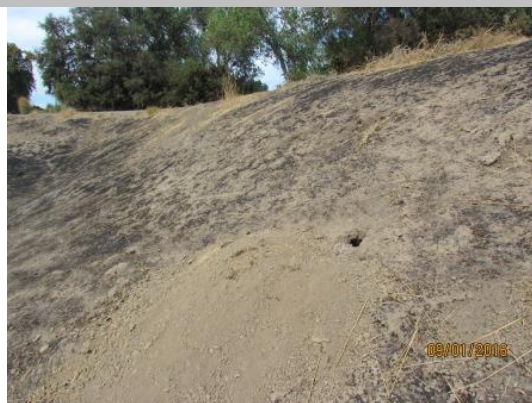
Photo 1 of 2 : FA_2019_LD0002_28_27_20190822_00013.jpg

View of the rodent holes along the landside slope.

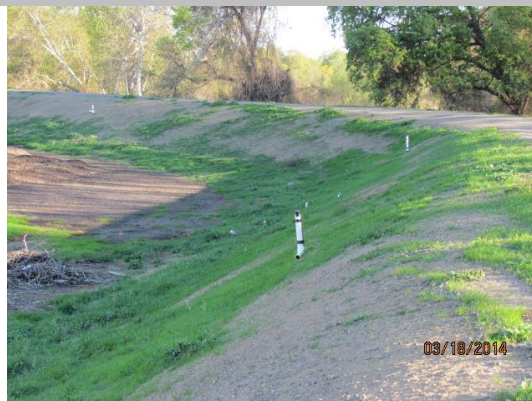
Photo 2 of 2 : FA_2019_LD0002_28_27_20190822_00012.jpg

View of the rodent activity along the landside slope.

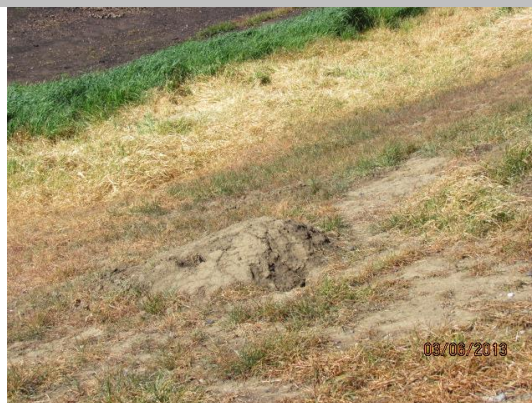
Photo 1 of 1 : FA_2019_LD0002_28_13_20190822_00006.jpg

View of the rodent activity along the landside slope.

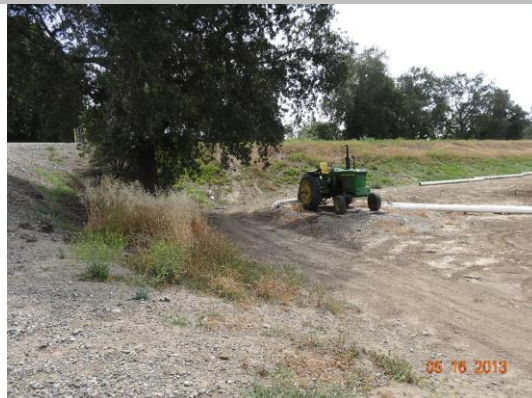
Photo 1 of 3 : UCIP_FA_2019_38178_69502.jpg

Comment Code					
Inspector Comment					
DS_ID:21178 FS_ID:38178 EP_NO: 16931 Repair Type: Non-Urgent Crossing Status: Indicator Found UCIP Comments: Inspector notes indicate that pipe was never installed through levee and application was closed. Steel pipe was not installed but detachable section was installed. The pipe section goes up and over levee. Permit 16931 file was closed in 2005 owner was unable to install pipe due to costs. Permit indicates that pipe was to be used for winter supply of irrigation water to landward side. Need to coordinate with DWR inspector--permit revised for this type of structure. FIELD_STRUCT_DESC: Crossing visible at location. Current structure differs from original request in Permit No. 16931. PVC connection visible on landside (LS) toe with cutoff valve. Pipe connects to 8-inch PVC pipe extending past LS toe. FS Date: 5/16/2013

View of pump system on landward side located behind tracker.

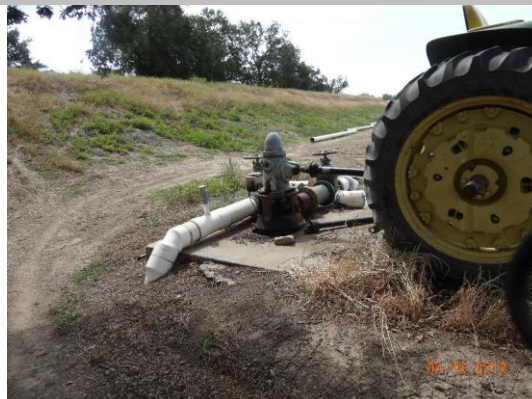
Photo 2 of 3 : UCIP_FA_2019_38178_69501.jpg

Pump system located near landward toe.

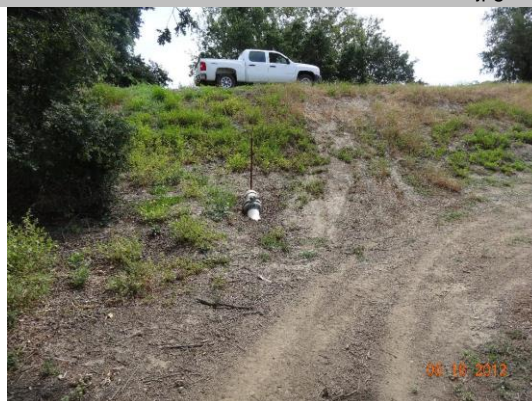
Photo 3 of 3 : UCIP_FA_2019_38178_69500.jpg

Comment Code						
Inspector Comment						
DS_ID:21178 FS_ID:38178 EP_NO: 16931 Repair Type: Non-Urgent Crossing Status: Indicator Found UCIP Comments: Inspector notes indicate that pipe was never installed through levee and application was closed. Steel pipe was not installed but detachable section was installed. The pipe section goes up and over levee. Permit 16931 file was closed in 2005 owner was unable to install pipe due to costs. Permit indicates that pipe was to be used for winter supply of irrigation water to landward side. Need to coordinate with DWR inspector--permit revised for this type of structure. FIELD_STRUCT_DESC: Crossing visible at location. Current structure differs from original request in Permit No. 16931. PVC connection visible on landside (LS) toe with cutoff valve. Pipe connects to 8-inch PVC pipe extending past LS toe. FS Date: 5/16/2013

Pipe connection capped with control valve located on landward toe.

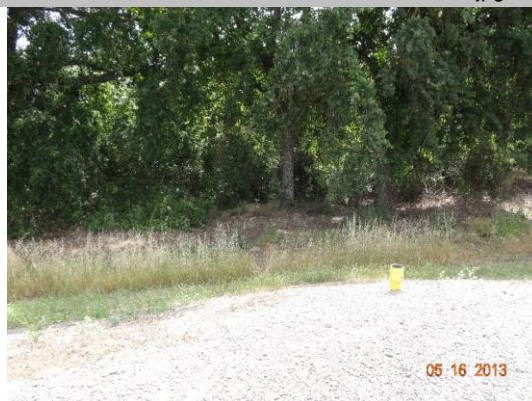
Photo 1 of 3 : UCIP_FA_2019_38182_69537.jpg

LM Start	3.74	Rating **	M	Issue No.	69
LM End	3.74	Issue Type +	En	Location *	
Category	Supplemental			GPS Latitude/Longitude	
				Start	End
Item	DRAFT DWR UCIP Field Study			39.461674 °	39.461674 °
				-122.011507 °	-122.011507 °
DWR ID	24659				
Comment Code					
Inspector Comment					
DS_ID:24659					
FS_ID:38182					
EP_NO: N/A					
Repair Type: Non-Urgent					
Crossing Status: Found					
UCIP Comments: Need to contact owner to determine status of crossing.					
FIELD_STRUCT_DESC: 24-inch steel drainage pipe through levee, 2-feet below the crown. Pipe is exposed on waterside (WS) with air vent on the WS levee shoulder. Open pump is approximately 550 feet on the landside (LS) of the levee toe and concrete distribution pipe. (electronic permit not available - Permit No. 16280-1995, Mathew J. Southam/McGowan)					
FS Date: 5/16/2013

View of waterward side.

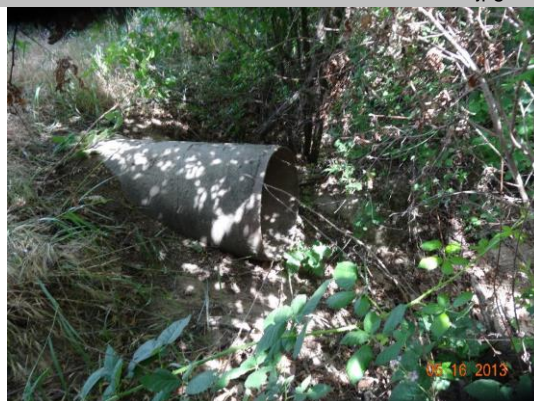
Photo 2 of 3 : UCIP_FA_2019_38182_69533.jpg

Pipe visible on waterward side.

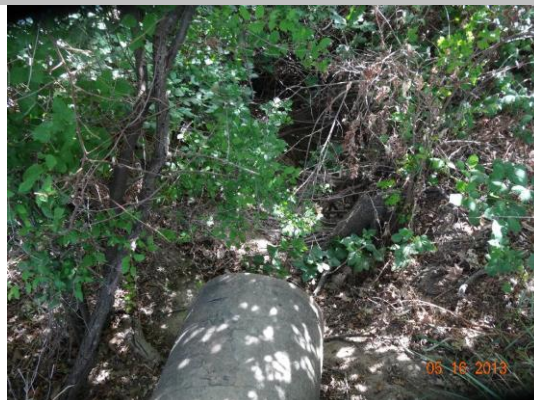
Photo 3 of 3 : UCIP_FA_2019_38182_69541.jpg

View of channel on waterward side.

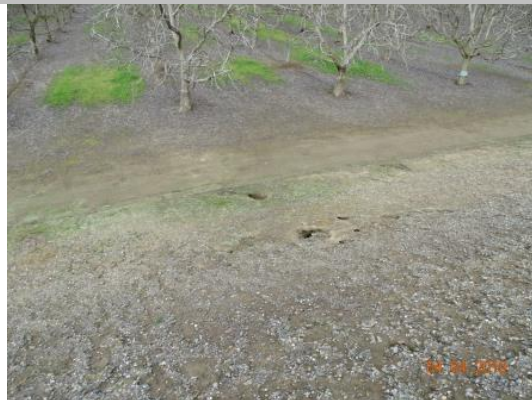
Photo 1 of 1 : FA_2019_LD0002_28_50_20190822_00019.jpg

View of the rodent holes on the landside slope. Spring 2019.

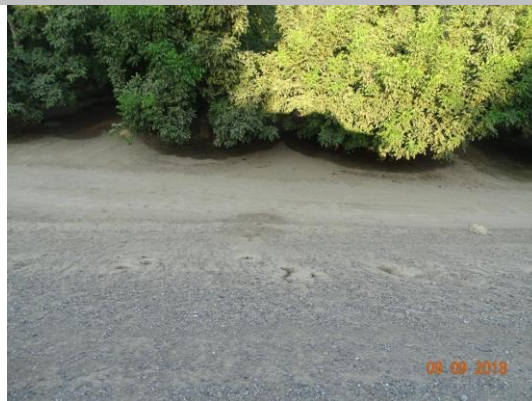
Photo 1 of 1 : FA_2019_LD0002_28_28_20190822_00014.jpg

View of the rodent holes along the landside slope.

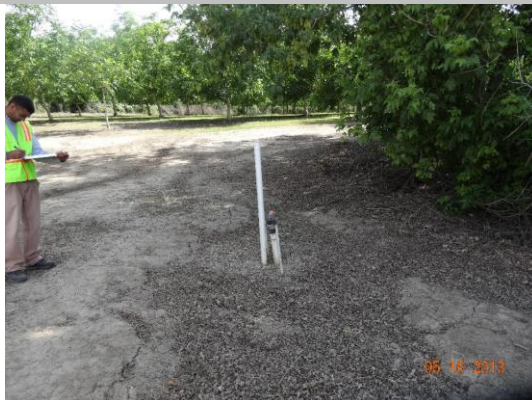
Photo 1 of 3 : UCIP_FA_2019_44188_69544.jpg

3-inch PVC pipe and vent exposed on waterward toe, likely in alignment with this crossing.

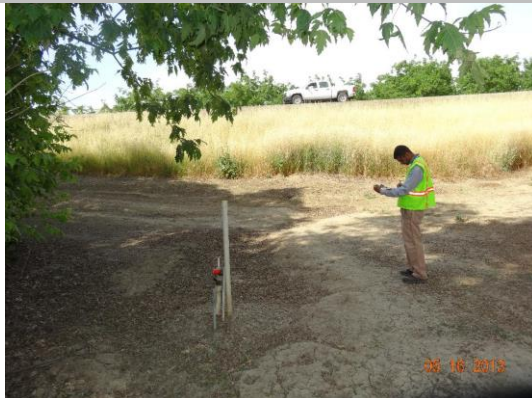
Photo 2 of 3 : UCIP_FA_2019_44188_69543.jpg

3-inch PVC pipe and vent exposed on waterward toe, likely in alignment with this crossing.

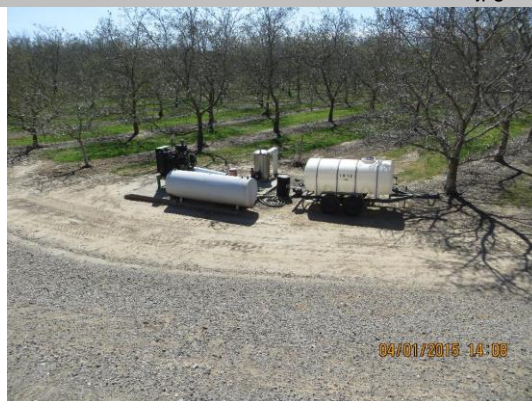
Photo 3 of 3 : UCIP_FA_2019_44188_73609.jpg

Well and pump visible on LS toe.

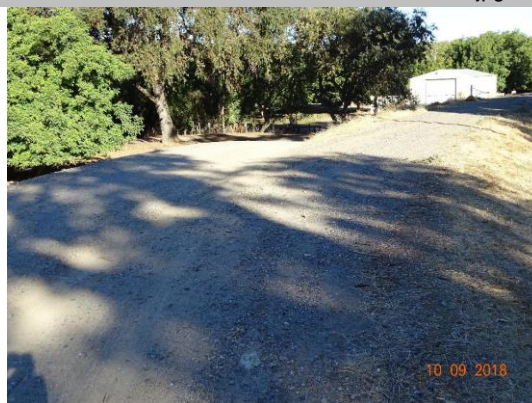
Photo 1 of 3 : UCIP_FA_2019_53005_78119.jpg

View of levee crown at the crossing.

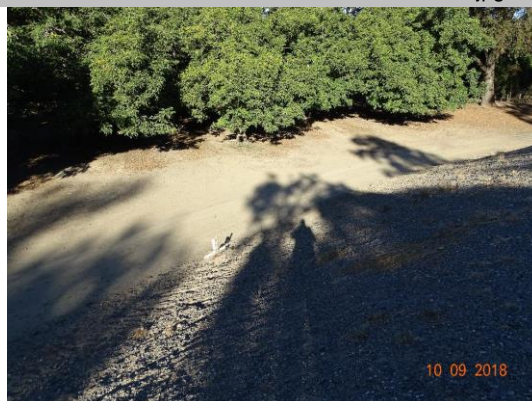
Photo 2 of 3 : UCIP_FA_2019_53005_78120.jpg

View of landside at crossing.

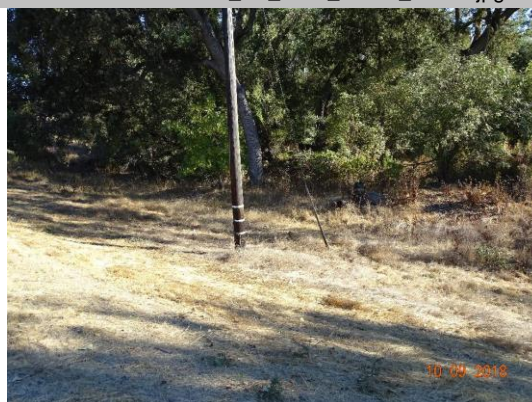
Photo 3 of 3 : UCIP_FA_2019_53005_78121.jpg

View of waterside at crossing.
