Flood Control Project Maintenance Levee Inspections

Fall 2020 Levee Maintenance Deficiency Summary Report

Sacramento River Basin

Levee District No. 0002 (Glenn County)

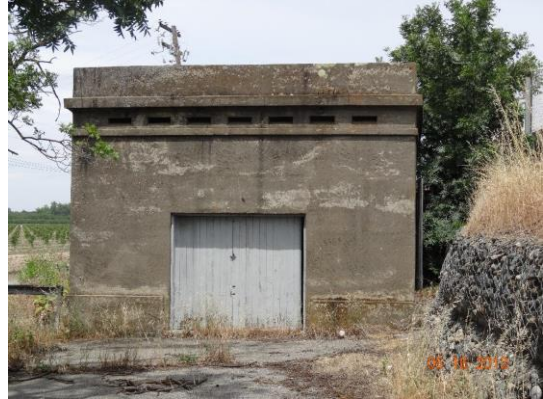
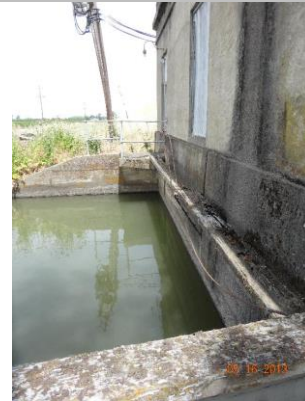
DS_ID:21185
 FS_ID:38165
 EP_NO: 2356
 Repair Type: Non-Urgent
 EVAL Issue:
 Crossing Status: Found
 UCIP Comments: Three pipes found in the pump house on landward side. Pump house appears to be no longer in use. Unable to locate pipes on waterward side. Will need to contact owner to determine status. Owner will need to coordinate with CVFPB regarding proper removal per Title 23 requirements.
 FIELD_STRUCT_DESC: [Princeton-Cordora-Glenn Irrigation District: Schaad Pumping Plant] 1 of 3: 28-inch steel pipe sleeved through 30-inch steel pipe through the levee, 20 feet below the crown. Annular gap is grouted. Flap gate on landside (LS) end. Pump in pump house on LS slope. Rock revetment around outlet on waterside (WS) slope. (28- and 34-inch pipes sleeved through existing 30- and 36-inch pipes, permit shows three 36-inch pipes as part of Schaad Pumping Plant p. 17 of 19, authorized under Permit No. 2356, 1956, Princeton-Cordora-Glenn Irrigation District) [Additional Reference(s): DWR Levee Logs, 2005. USACE Sacramento O&M Manual Unit No. 151, November 1953, (Station 41+47), two 36-inch pipes]

View of levee crown at crossing.

View of Princeton-Cordora-Glenn Irrigation District--Schaad Pumping Plant.

View of landward side--outlet.

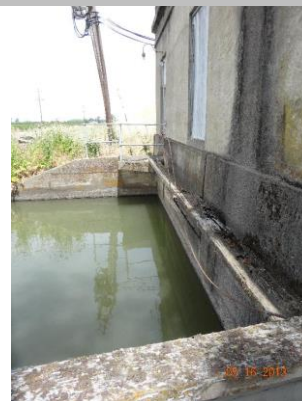
Comment Code						
Inspector Comment						
DS_ID:21184 FS_ID:38166 EP_NO: N/A Repair Type: Non-Urgent EVAL Issue: Crossing Status: Found UCIP Comments: Three pipes found in the pump house on landward side. Pump house appears to be no longer in use. Unable to locate pipes on waterward side. Will need to contact owner to determine status. Owner will need to coordinate with CVFPB regarding proper removal per Title 23 requirements. FIELD_STRUCT_DESC: [Princeton-Cordora-Glenn Irrigation District: Schaad Pumping Plant] 2 of 3: 34-inch steel pipe sleeved through 36-inch steel pipe through the levee, 20 feet below the crown. Annular gap is grouted. Flap gate on landside (LS) end. Pump in pump house on LS slope. Rock revetment around outlet on waterside (WS) slope. (28- and 34-inch pipes sleeved through existing 30- and 36-inch pipes, permit shows three 36-inch pipes as part of Schaad Pumping Plant p. 17 of 19, authorized under Permit No. 2356, 1956, Princeton-Cordora-Glenn Irrigation District) [Additional Reference(s): DWR Levee Logs, 2005. USACE Sacramento O&M Manual Unit No. 151, November 1953, (Station 41+47), two 36-inch pipes] FS Date: 5/16/2013

View of levee crown at crossing.

View of Princeton-Cordora-Glenn Irrigation District--Schaad Pumping Plant.

View of landward side-outlet.

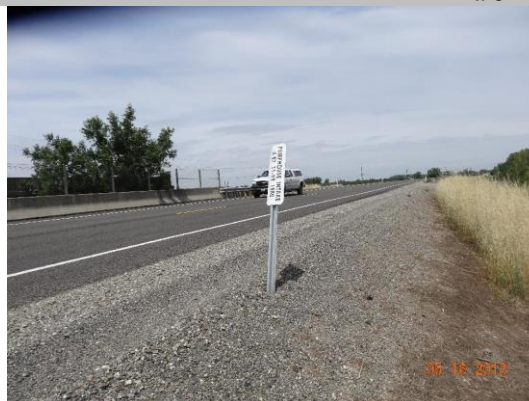
UCIP Comments: Three pipes found in the pump house on landward side. Pump house appears to be no longer in use. Unable to locate pipes on waterward side. Will need to contact owner to determine status. Owner will need to coordinate with CVFPB regarding proper removal per Title 23 requirements.

View of levee crown with marker on waterward side.

View of Princeton-Cordora-Glenn Irrigation District-Schaad Pumping Plant.

View of landward side--outlet.

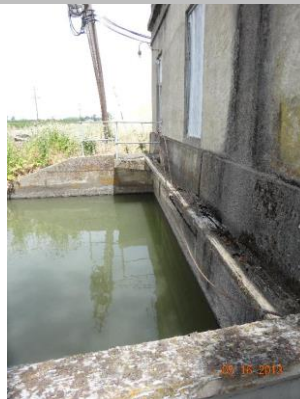
Comment Code						
Inspector Comment						
DS_ID:21182 FS_ID:38168 EP_NO: N/A Repair Type: Non-Urgent EVAL Issue: Crossing Status: Indicator Found UCIP Comments: Unable to verify if the pipes inside the existing pump house correlate to 24-inch installed in 1955. Three pipes found in the pump house on landward side. Pump house appears to be no longer in use. Unable to locate pipes on waterward side. Will need to contact owner to determine status. FIELD_STRUCT_DESC: [Pumping Plant] 24-inch steel pipe through the levee, 27.3 feet below the crown. Flap gate on landside (LS). Pump in pump house on LS. [Additional Reference(s): DWR Levee Logs, 2005. USACE Sacramento O&M Manual Unit No. 151, November 1953, (Station 41+47), 24-inch pipe] FS Date: 5/16/2013

View of levee crown with marker on waterward side.

View of Princeton-Cordora-Glenn Irrigation District-Schaad Pumping Plant.

View of landward side--outlet.

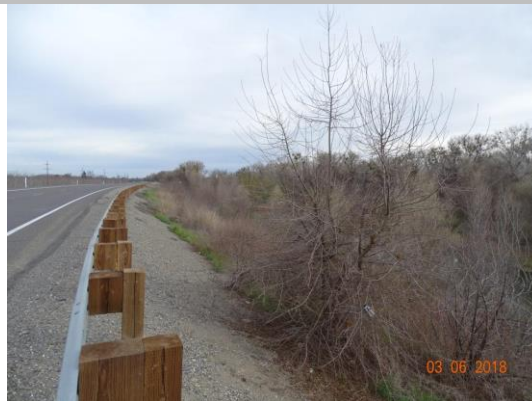
LM Start	0.64	Rating **	M	Issue No.	35
LM End	0.77	Issue Type +	Ma	Location *	WS
Category	Earthen Levee			GPS Latitude/Longitude	
				Start	End
Item	Vegetation			39.422805 °	39.424597 °
				-122.011640 °	-122.011527 °
DWR ID	DWR_LD0002_01_s_2018_35				
Comment Code					
V2 : Remove the wild growth other than native grasses from the levee slopes.					
Inspector Comment

View of the vegetation along the waterside slope.

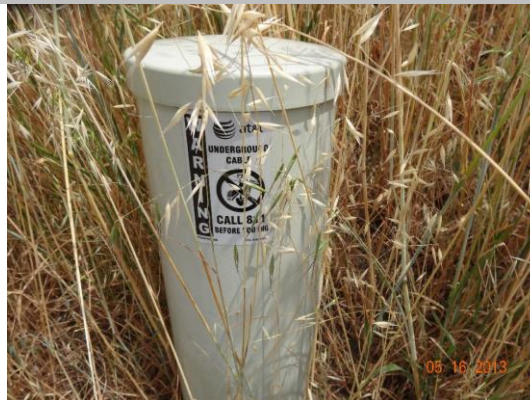
Comment Code						
Inspector Comment						
DS_ID:21177 FS_ID:44170 EP_NO: 9723 Repair Type: Non-Urgent EVAL Issue: Crossing Status: Indicator Found UCIP Comments: Owner is listed as Pacific Bell however sign lists AT&T as owner, need to contact owner to determine if permit was updated or if this crossing is listed under new permit. Unable to confirm if 2 crossings are present at this site. FIELD_STRUCT_DESC: Buried telephone cable through the levee at unknown depth. Telephone pole and junction box on landside (LS) toe. (telephone cable authorized under Automatic Board Order (ABO) issued as Permit No. 9723-1974, Pacific Telephone Company). FS Date: 5/16/2013

Indicators of existing line visible on slope.

AT&T underground cable line.

Sign lists Pacific Telephone system.

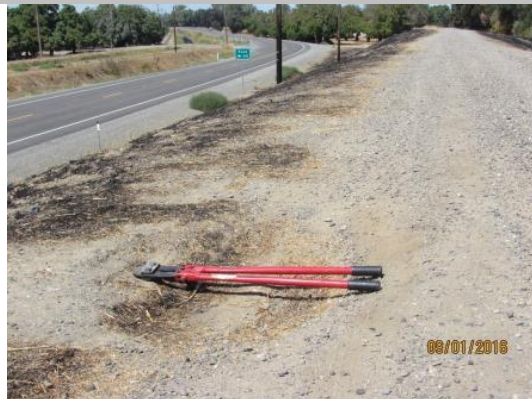
LM Start	1.40	Rating **	M	Issue No.	34
LM End	1.40	Issue Type +	Ma	Location *	CR
Category	Earthen Levee			GPS Latitude/Longitude	
				Start	End
Item	Crown Surface / Depressions / Rutting			39.433809 °	39.433809 °
				-122.010814 °	-122.010814 °
DWR ID	DWR_LD0002_01_f_2016_34				
Comment Code					
C2 : Repair depressions or ruts in the crown or slope.					
Inspector Comment

View of a depression on the levee crown looking upstream.

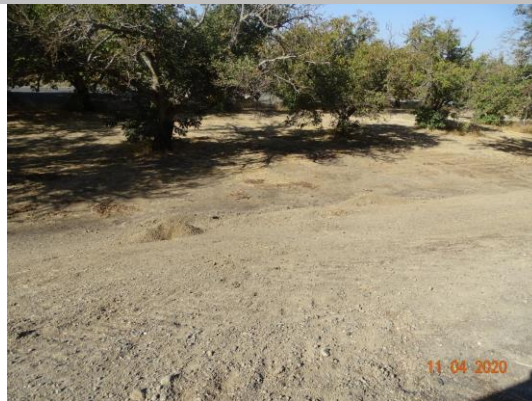
LM Start	1.56	Rating **	U	Issue No.	15
LM End	1.60	Issue Type +	Ma	Location *	LS
Category	Earthen Levee			GPS Latitude/Longitude	
				Start	End
Item	Animal Control			39.436009 °	39.436643 °
				-122.010524 °	-122.010498 °
DWR ID	DWR_LD0002_01_f_2012_15				
Comment Code					
A3 : No rodents visible, but rodent burrows visible; need to backfill and compact or grout burrows.					
Inspector Comment

View of the rodent activity along the landside slope. Fall 2020.

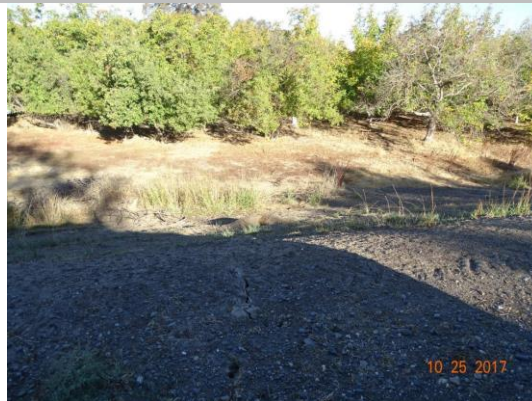
View of the rodent holes along the landside slope.

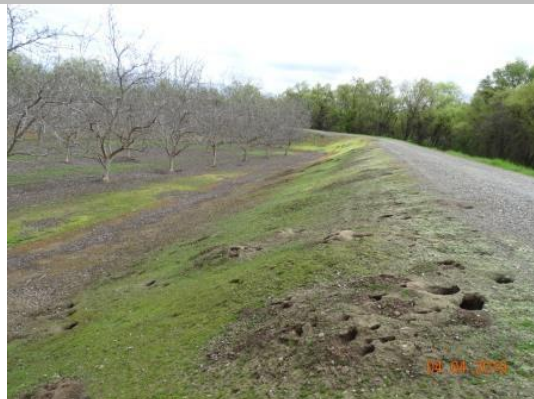
View of the rodent holes along the landside slope. Spring 2019.

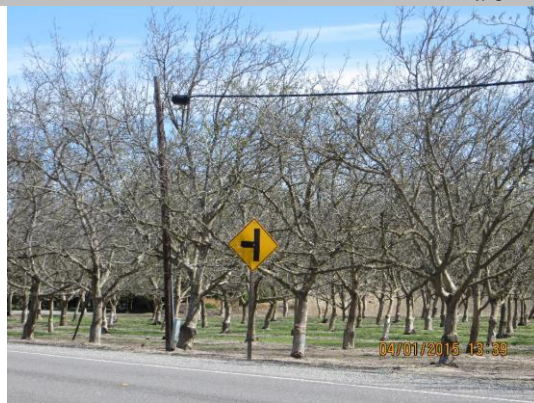
Comment Code						
Inspector Comment						
DS_ID:21188 FS_ID:44186 EP_NO: 12444 Repair Type: Non-Urgent EVAL Issue: Crossing Status: Indicator Found UCIP Comments: Needs markers 10-feet off both levee toes. FIELD_STRUCT_DESC: Buried cable steel conduit through the levee, 2.5 feet below the crown. Conduit extends to pole on waterside (WS). Cut in pavement visible at levee crown (aerial communication cable across left bank levee and channel of the Sacramento River and buried cable across the right bank overflow and through the right bank levee authorized under Permit No. 12444, 1978-Pacific Telephone and Telegraph Company) [Additional Reference(s): DWR Levee Logs, 2005] FS Date: 4/1/2015

Conduit may be visible on pole about 1000-feet west of levee crown.

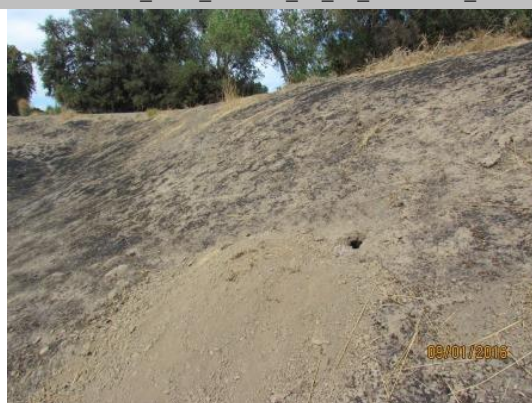
View of the rodent holes along the landside slope.

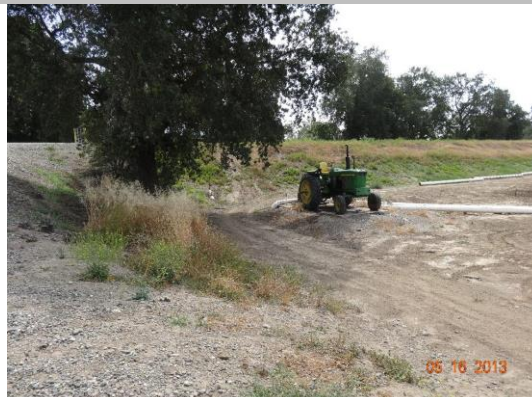
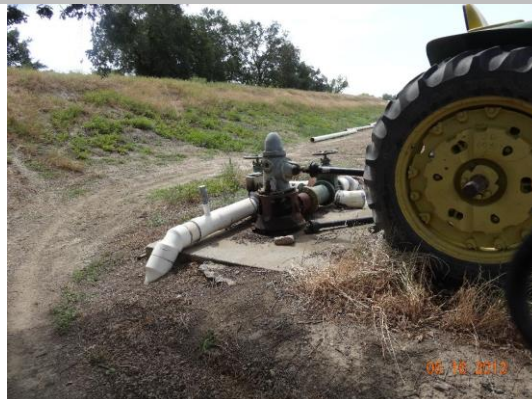
Comment Code					
Inspector Comment					
DS_ID:21178 FS_ID:38178 EP_NO: 16931 Repair Type: Non-Urgent EVAL Issue: Crossing Status: Indicator Found UCIP Comments: Inspector notes indicate that pipe was never installed through levee and application was closed. Steel pipe was not installed but detachable section was installed. The pipe section goes up and over levee. Permit 16931 file was closed in 2005 owner was unable to install pipe due to costs. Permit indicates that pipe was to be used for winter supply of irrigation water to landward side. Need to coordinate with DWR inspector--permit revised for this type of structure. FIELD_STRUCT_DESC: Crossing visible at location. Current structure differs from original request in Permit No. 16931. PVC connection visible on landside (LS) toe with cutoff valve. Pipe connects to 8-inch PVC pipe extending past LS toe. FS Date: 5/16/2013

View of pump system on landward side located behind tracker.

Pump system located near landward toe.

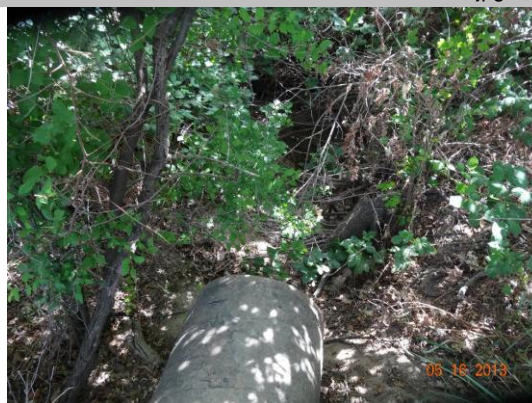
Pipe visible on waterward side.

View of channel on waterward side.

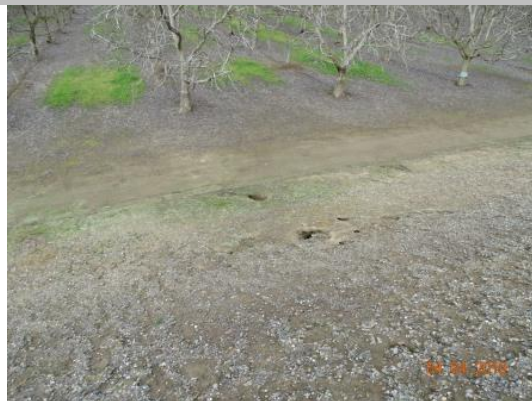
LM Start	3.79	Rating **	M	Issue No.	50
LM End	3.79	Issue Type +	Ma	Location *	LS
Category	Earthen Levee			GPS Latitude/Longitude	
				Start	End
Item	Animal Control			39.462358 °	39.462358 °
				-122.011623 °	-122.011623 °
DWR ID	DWR_LD0002_01_s _ 2019_50				
Comment Code					
A3 : No rodents visible, but rodent burrows visible; need to backfill and compact or grout burrows.					
Inspector Comment

View of the rodent holes on the landside slope. Spring 2019.

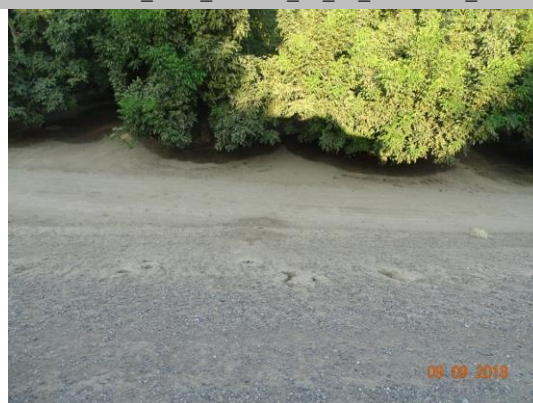
View of the rodent holes along the landside slope.

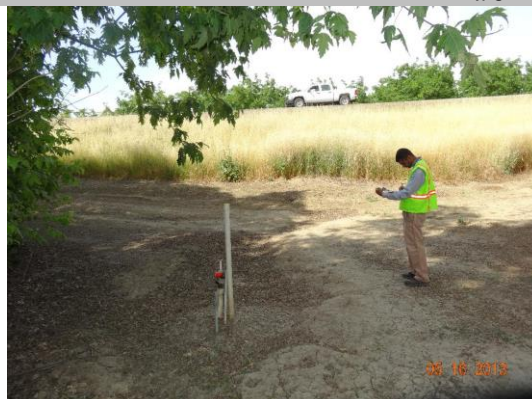
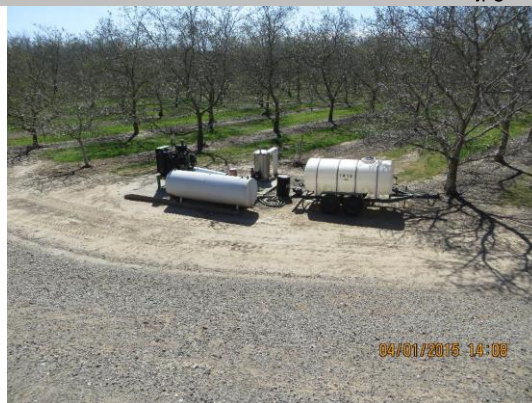
LM Start	4.32	Rating **	M	Issue No.	70
LM End	4.32	Issue Type +	En	Location *	
Category	Supplemental			GPS Latitude/Longitude	
				Start	End
Item	DWR UCIP Field Study			39.469908 °	39.469908 °
				-122.012117 °	-122.012117 °
DWR ID	21181				
Comment Code					
Inspector Comment					
DS_ID:21181 FS_ID:44188 EP_NO: 18072 Repair Type: Non-Urgent EVAL Issue: Crossing Status: Indicator Found UCIP Comments: Pipe needs better markers at pipe crossing. FIELD_STRUCT_DESC: 6-inch steel irrigation pipe through the levee, 2 feet below the levee. Well, pump, and vent visible on landside (LS) toe. Vent visible just off waterside (WS) toe. (6-inch pipe authorized under Permit No. 18072, 2006-McCowan & Southam) FS Date: 4/1/2015

3-inch PVC pipe and vent exposed on waterward toe, likely in alignment with this crossing.

Well and pump visible on LS toe.

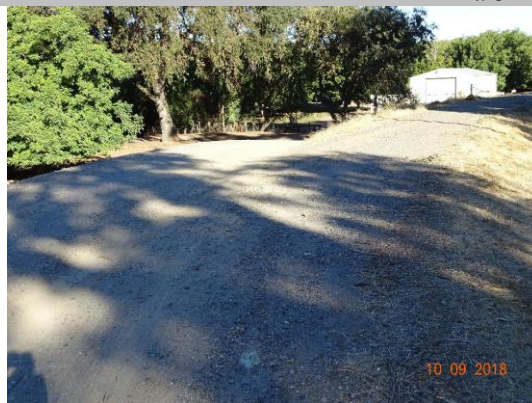
Comment Code						
Inspector Comment						
DS_ID:21176 FS_ID:53005 EP_NO: 15198 Repair Type: Non-Urgent EVAL Issue: Crossing Status: Not Found UCIP Comments: 10/9/2018 No markers found. Crossing downgraded to "Non-Urgent" due to reclassification of gas lines. (O.Yakimov - DWR UCIP)07/07/2016 same as previous inspection: No markers found. Unable to confirm crossing status. (DWR UCIP - omagana)05/16/2013 No markers found. Need to contact owner to determine if crossing is still active and to determine last inspection date. Will need copy of letter showing crossings passed inspection. (DWR UCIP - omagana) FIELD_STRUCT_DESC: 2-inch steel gas line through the levee, 2.5 feet below the crown. (2-inch gas line authorized under Permit No. 15198, 1989-Northern Michigan Exploration Company) FS Date: 10/9/2018 2:50:03 PM

View of levee crown at the crossing.
