## Flood Control Project Maintenance Levee Inspections

### Fall 2021 Levee Maintenance Deficiency Summary Report

#### Sacramento River Basin

**Levee District No. 0002 (Glenn County)**

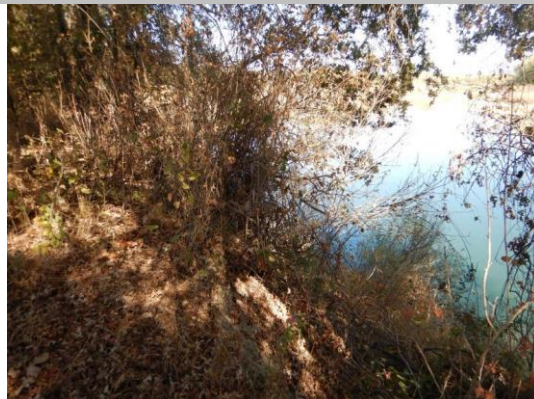
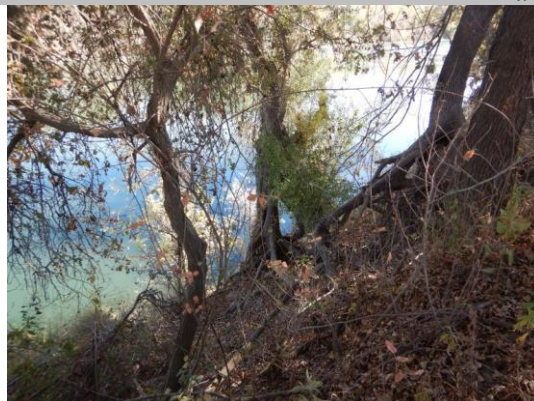
Photo 1 of 2 : FA\_2021\_LD0002\_28\_6\_20211218\_2.jpg

LM Start	0.07	Rating **	M	Issue No.	6
LM End	0.28	Issue Type +	Ma	Location *	WS
Category	Supplemental			GPS Latitude/Longitude	
				Start	End
Item	2018 USACE Erosion Survey			39.414649 °	39.417689 °
				-122.009853 °	-122.010369 °
DWR ID					
Comment Code					
Inspector Comment					
2018 Site ID: SAC 164.7 R					
Status: Eroding					
2018 Field Notes: No observed change.					
Site History: 2009 - Very slow retreat, hard toe, encroaching into the levee projection. 2010 - Slowly eroding. 2011 - Site extended downstream. 2017 - New erosion along entire site.

USACE 2018 Erosion Photo #1

USACE 2018 Erosion Photo #2

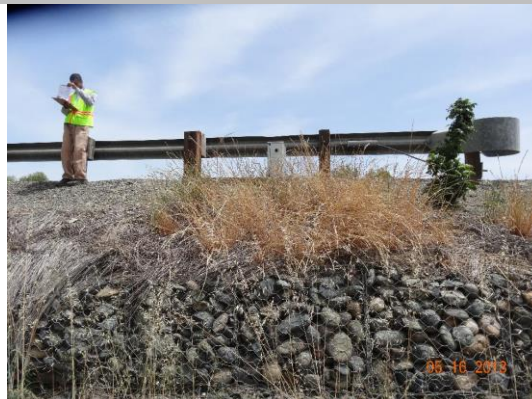
Photo 1 of 3 : UCIP\_FA\_2021\_42083\_72882.jpg

LM Start	0.59	Rating **	M	Issue No.	58	
LM End	0.59	Issue Type +	En	Location *		
Category	Supplemental			GPS Latitude/Longitude		
				Start	End	
Item	DWR UCIP Field Study			39.422088 °	39.422088 °	
				-122.011615 °	-122.011615 °	
DWR ID	24877					
Comment Code						
Inspector Comment						
DS_ID:24877						
FS_ID:42083						
EP_NO: N/A						
Repair Type: Non-Urgent						
EVAL Issue:						
Crossing Status: Indicator Found						
UCIP Comments: Need to contact owner to determine if conduit goes through levee crown. If it does, will need to obtain permit number issued for encroachment.						
FIELD_STRUCT_DESC: Caltrans traffic control box located on the landside (LS) shoulder.						
FS Date: 5/16/2013

View of landward slope.

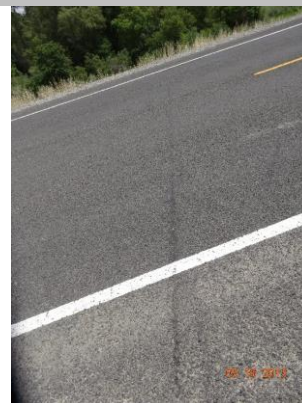
Photo 2 of 3 : UCIP\_FA\_2021\_42083\_72881.jpg

View of levee crown at crossing.

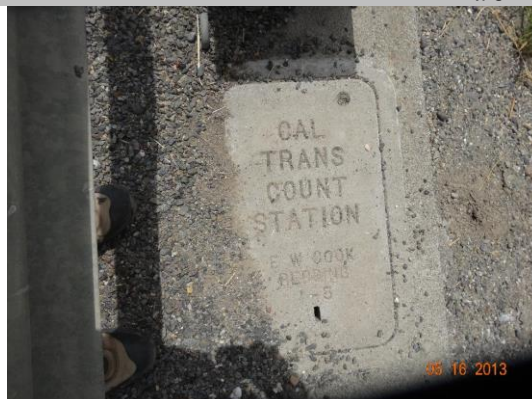
Photo 3 of 3 : UCIP\_FA\_2021\_42083\_72880.jpg

Service box located on landward shoulder.

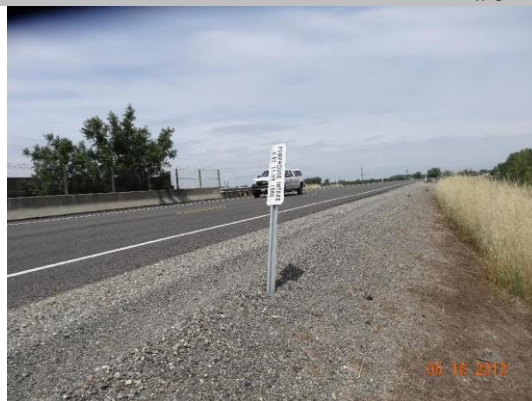
Photo 1 of 3 : UCIP\_FA\_2021\_38165\_69467.jpg

DS\_ID:21185  
 FS\_ID:38165  
 EP\_NO: 2356  
 Repair Type: Non-Urgent  
 EVAL Issue:  
 Crossing Status: Found  
 UCIP Comments: Three pipes found in the pump house on landward side. Pump house appears to be no longer in use. Unable to locate pipes on waterward side. Will need to contact owner to determine status. Owner will need to coordinate with CVFPB regarding proper removal per Title 23 requirements.  
 FIELD\_STRUCT\_DESC: [Princeton-Cordora-Glenn Irrigation District: Schaad Pumping Plant] 1 of 3: 28-inch steel pipe sleeved through 30-inch steel pipe through the levee, 20 feet below the crown. Annular gap is grouted. Flap gate on landside (LS) end. Pump in pump house on LS slope. Rock revetment around outlet on waterside (WS) slope. (28- and 34-inch pipes sleeved through existing 30- and 36-inch pipes, permit shows three 36-inch pipes as part of Schaad Pumping Plant p. 17 of 19, authorized under Permit No. 2356, 1956, Princeton-Cordora-Glenn Irrigation District) [Additional Reference(s): DWR Levee Logs, 2005. USACE Sacramento O&M Manual Unit No. 151, November 1953, (Station 41+47), two 36-inch pipes]

View of levee crown at crossing.

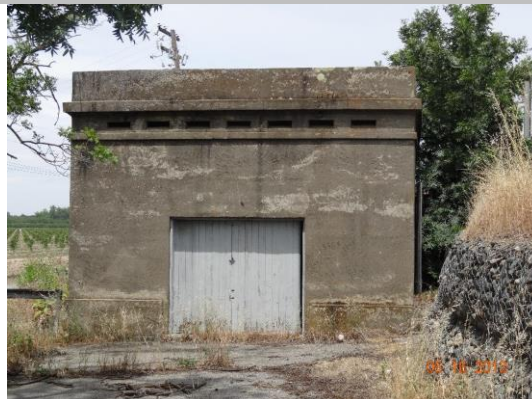
Photo 2 of 3 : UCIP\_FA\_2021\_38165\_69469.jpg

View of Princeton-Cordora-Glenn Irrigation District--Schaad Pumping Plant.

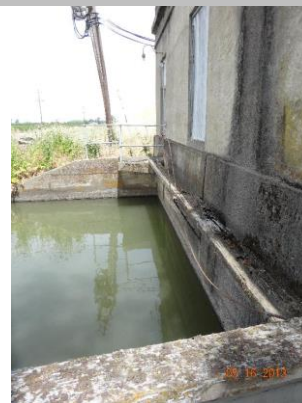
Photo 3 of 3 : UCIP\_FA\_2021\_38165\_69463.jpg

View of landward side--outlet.

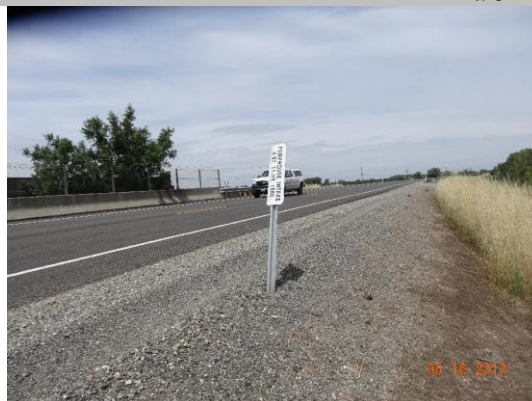
Photo 1 of 3 : UCIP\_FA\_2021\_38166\_69475.jpg

Comment Code						
Inspector Comment						
DS_ID:21184 FS_ID:38166 EP_NO: N/A Repair Type: Non-Urgent EVAL Issue: Crossing Status: Found UCIP Comments: Three pipes found in the pump house on landward side. Pump house appears to be no longer in use. Unable to locate pipes on waterward side. Will need to contact owner to determine status. Owner will need to coordinate with CVFPB regarding proper removal per Title 23 requirements. FIELD_STRUCT_DESC: [Princeton-Cordora-Glenn Irrigation District: Schaad Pumping Plant] 2 of 3: 34-inch steel pipe sleeved through 36-inch steel pipe through the levee, 20 feet below the crown. Annular gap is grouted. Flap gate on landside (LS) end. Pump in pump house on LS slope. Rock revetment around outlet on waterside (WS) slope. (28- and 34-inch pipes sleeved through existing 30- and 36-inch pipes, permit shows three 36-inch pipes as part of Schaad Pumping Plant p. 17 of 19, authorized under Permit No. 2356, 1956, Princeton-Cordora-Glenn Irrigation District) [Additional Reference(s): DWR Levee Logs, 2005. USACE Sacramento O&M Manual Unit No. 151, November 1953, (Station 41+47), two 36-inch pipes] FS Date: 5/16/2013

View of levee crown at crossing.

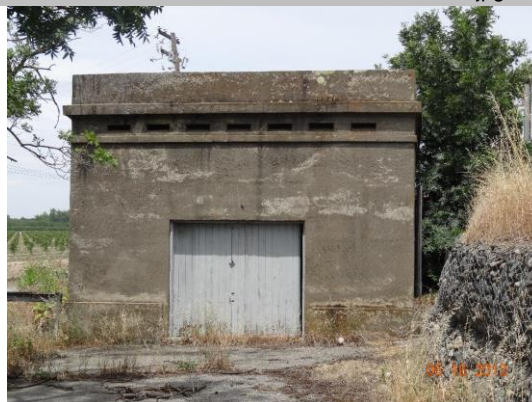
Photo 2 of 3 : UCIP\_FA\_2021\_38166\_69476.jpg

View of Princeton-Cordora-Glenn Irrigation District--Schaad Pumping Plant.

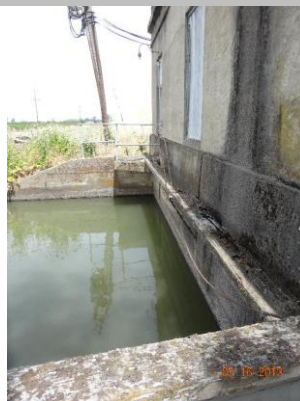
Photo 3 of 3 : UCIP\_FA\_2021\_38166\_69477.jpg

View of landward side-outlet.

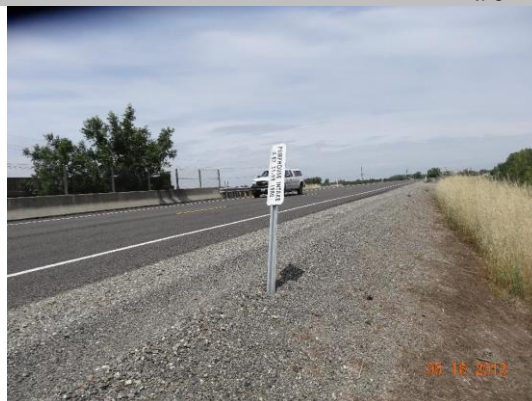
Photo 1 of 3 : UCIP\_FA\_2021\_38167\_69483.jpg

UCIP Comments: Three pipes found in the pump house on landward side. Pump house appears to be no longer in use. Unable to locate pipes on waterward side. Will need to contact owner to determine status. Owner will need to coordinate with CVFPB regarding proper removal per Title 23 requirements.

View of levee crown with marker on waterward side.

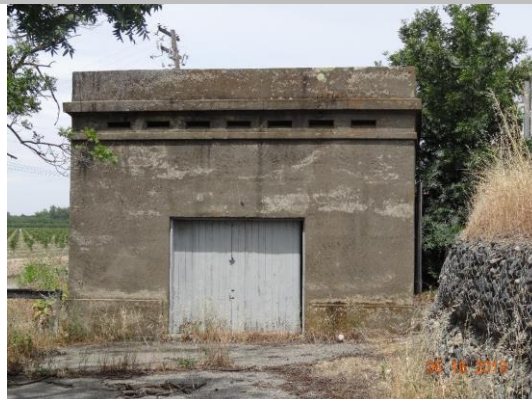
Photo 2 of 3 : UCIP\_FA\_2021\_38167\_69484.jpg

View of Princeton-Cordora-Glenn Irrigation District-Schaad Pumping Plant.

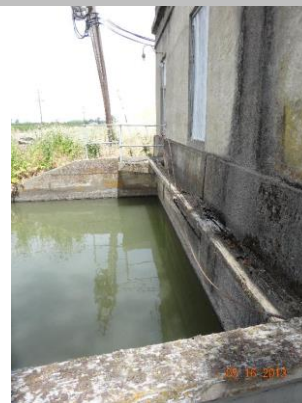
Photo 3 of 3 : UCIP\_FA\_2021\_38167\_69478.jpg

View of landward side--outlet.

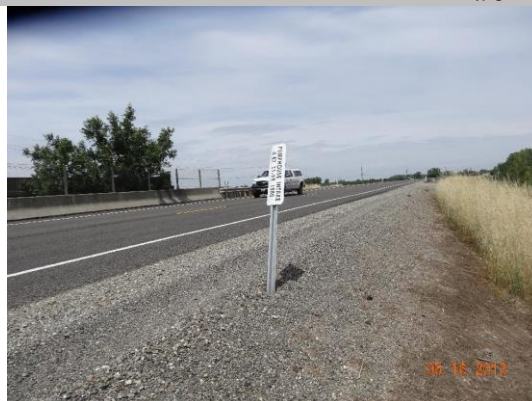
Photo 1 of 3 : UCIP\_FA\_2021\_38168\_69491.jpg

Comment Code					
Inspector Comment					
DS_ID:21182 FS_ID:38168 EP_NO: N/A Repair Type: Non-Urgent EVAL Issue: Crossing Status: Indicator Found UCIP Comments: Unable to verify if the pipes inside the existing pump house correlate to 24-inch installed in 1955. Three pipes found in the pump house on landward side. Pump house appears to be no longer in use. Unable to locate pipes on waterward side. Will need to contact owner to determine status. FIELD_STRUCT_DESC: [Pumping Plant] 24-inch steel pipe through the levee, 27.3 feet below the crown. Flap gate on landside (LS). Pump in pump house on LS. [Additional Reference(s): DWR Levee Logs, 2005. USACE Sacramento O&M Manual Unit No. 151, November 1953, (Station 41+47), 24-inch pipe] FS Date: 5/16/2013

View of levee crown with marker on waterward side.

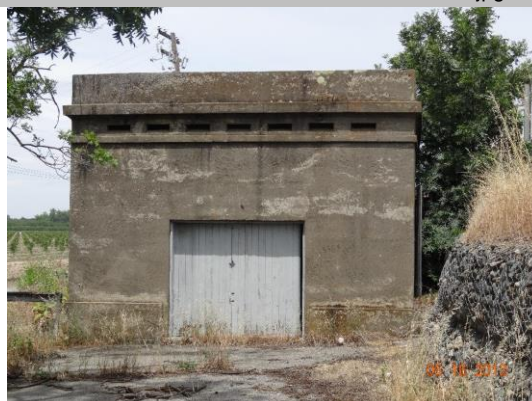
Photo 2 of 3 : UCIP\_FA\_2021\_38168\_69493.jpg

View of Princeton-Cordora-Glenn Irrigation District-Schaad Pumping Plant.

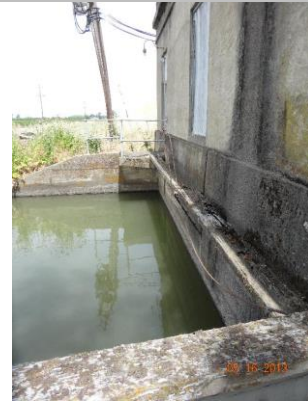
Photo 3 of 3 : UCIP\_FA\_2021\_38168\_69486.jpg

View of landward side--outlet.

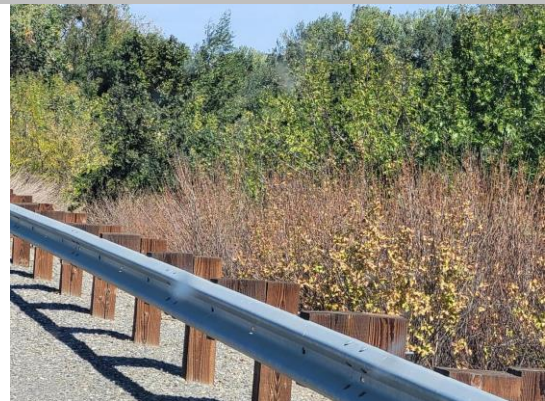
Photo 1 of 1 : FA\_2021\_LD0002\_28\_35\_20211015\_00047.jpg

LM Start	0.64	Rating **	M	Issue No.	35
LM End	0.77	Issue Type +	Ma	Location *	WS
Category	Earthen Levee			GPS Latitude/Longitude	
				Start	End
Item	Vegetation			39.422805 °	39.424597 °
				-122.011640 °	-122.011527 °
DWR ID	DWR_LD0002_01_s_2018_35				
Comment Code					
V2 : Remove the wild growth other than native grasses from the levee slopes.					
Inspector Comment

View of the vegetation along the waterside slope. Fall 2021.

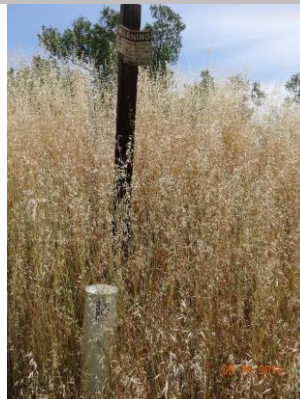
Photo 1 of 3 : UCIP\_FA\_2021\_44170\_72602.jpg

Comment Code						
Inspector Comment						
DS_ID:21177 FS_ID:44170 EP_NO: 9723 Repair Type: Non-Urgent EVAL Issue: Crossing Status: Indicator Found UCIP Comments: Owner is listed as Pacific Bell however sign lists AT&T as owner, need to contact owner to determine if permit was updated or if this crossing is listed under new permit. Unable to confirm if 2 crossings are present at this site. FIELD_STRUCT_DESC: Buried telephone cable through the levee at unknown depth. Telephone pole and junction box on landside (LS) toe. (telephone cable authorized under Automatic Board Order (ABO) issued as Permit No. 9723-1974, Pacific Telephone Company). FS Date: 5/16/2013

Indicators of existing line visible on slope.

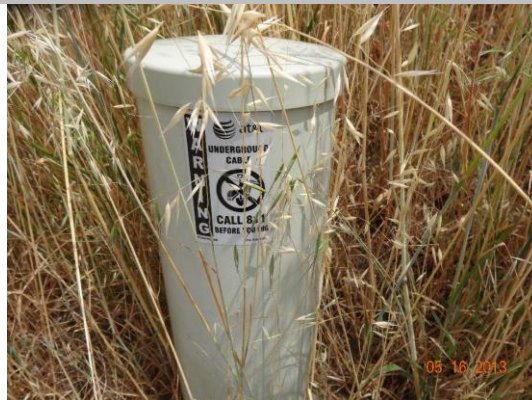
Photo 2 of 3 : UCIP\_FA\_2021\_44170\_72601.jpg

AT&amp;T underground cable line.

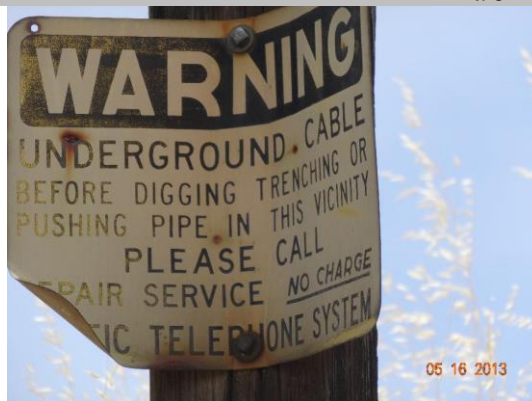
Photo 3 of 3 : UCIP\_FA\_2021\_44170\_72600.jpg

Sign lists Pacific Telephone system.

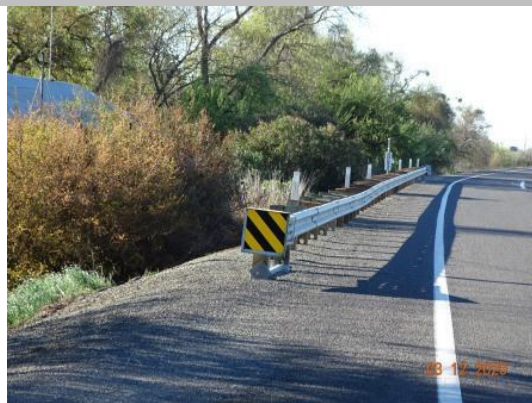
Photo 1 of 1 : FA\_2021\_LD0002\_28\_30\_20210928\_00008.jpg

LM Start	1.03	Rating **	M	Issue No.	30
LM End	1.03	Issue Type +	En	Location *	WS
Category	Earthen Levee			GPS Latitude/Longitude	
				Start	End
Item	Vegetation			39.428445 °	39.428445 °
				-122.010972 °	-122.010972 °
DWR ID	DWR_LD0002_01_f_2015_30				
Comment Code					
V6 : Landscaping					
Inspector Comment					
Remove the oleanders from the waterside slope.

View of the oleanders along the waterside slope. Spring 2020.

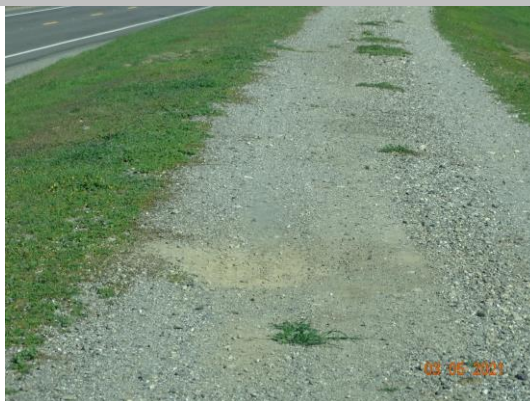
Photo 1 of 1 : FA\_2021\_LD0002\_28\_34\_20210928\_00009.jpg

LM Start	1.40	Rating **	M	Issue No.	34
LM End	1.40	Issue Type +	Ma	Location *	CR
Category	Earthen Levee			GPS Latitude/Longitude	
				Start	End
Item	Crown Surface / Depressions / Rutting			39.433809 °	39.433809 °
				-122.010814 °	-122.010814 °
DWR ID	DWR_LD0002_01_f_2016_34				
Comment Code					
C2 : Repair depressions or ruts in the crown or slope.					
Inspector Comment

View of a depression on the levee crown looking upstream. Spring 2021.

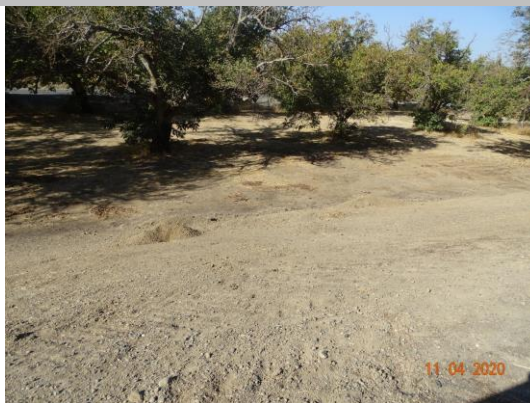
Photo 1 of 1 : FA\_2021\_LD0002\_28\_15\_20210928\_00004.jpg

LM Start	1.56	Rating **	U	Issue No.	15
LM End	1.60	Issue Type +	Ma	Location *	LS
Category	Earthen Levee			GPS Latitude/Longitude	
				Start	End
Item	Animal Control			39.436009 °	39.436643 °
				-122.010524 °	-122.010498 °
DWR ID	DWR_LD0002_01_f_2012_15				
Comment Code					
A3 : No rodents visible, but rodent burrows visible; need to backfill and compact or grout burrows.					
Inspector Comment

View of the rodent activity along the landside slope. Fall 2020.

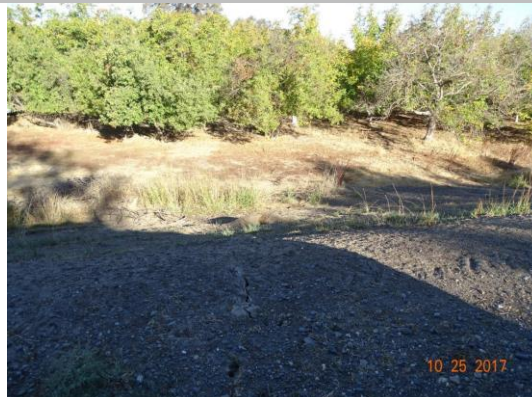
Photo 1 of 1 : FA\_2021\_LD0002\_28\_2\_20210928\_00001.jpg

View of the rodent holes along the landside slope.

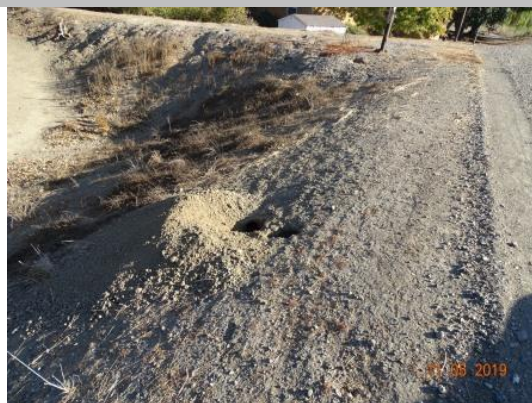
Photo 1 of 1 : FA\_2021\_LD0002\_28\_12\_20210928\_00003.jpg

LM Start	3.08	Rating **	M	Issue No.	23
LM End	3.09	Issue Type +	Ma	Location *	LS
Category	Earthen Levee			GPS Latitude/Longitude	
				Start	End
Item	Animal Control			39.455394 °	39.455501 °
				-122.013990 °	-122.013879 °
DWR ID	DWR_LD0002_01_f_2020_23				
Comment Code					
A3 : No rodents visible, but rodent burrows visible; need to backfill and compact or grout burrows.					
Inspector Comment

View of rodent activity on the landside slope. Fall 2019.

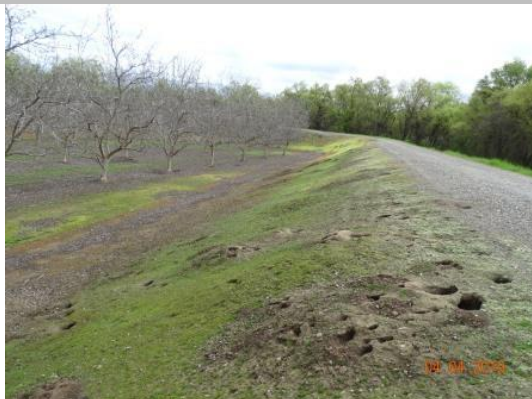
Photo 1 of 1 : FA\_2021\_LD0002\_28\_16\_20210928\_00005.jpg

View of the rodent holes along the landside slope. Spring 2019.

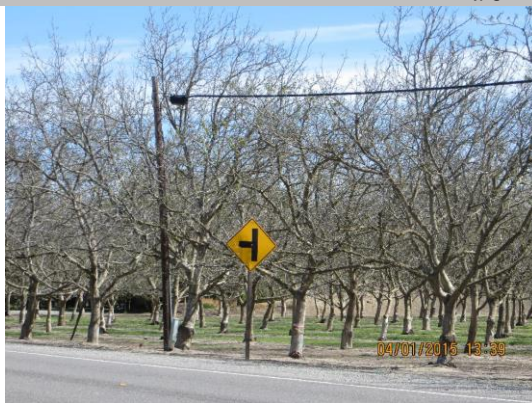
Photo 1 of 2 : UCIP\_FA\_2021\_44186\_73606.jpg

Comment Code						
Inspector Comment						
DS_ID:21188 FS_ID:44186 EP_NO: 12444 Repair Type: Non-Urgent EVAL Issue: Crossing Status: Indicator Found UCIP Comments: Needs markers 10-feet off both levee toes. FIELD_STRUCT_DESC: Buried cable steel conduit through the levee, 2.5 feet below the crown. Conduit extends to pole on waterside (WS). Cut in pavement visible at levee crown (aerial communication cable across left bank levee and channel of the Sacramento River and buried cable across the right bank overflow and through the right bank levee authorized under Permit No. 12444, 1978-Pacific Telephone and Telegraph Company) [Additional Reference(s): DWR Levee Logs, 2005] FS Date: 4/1/2015

Conduit may be visible on pole about 1000-feet west of levee crown.

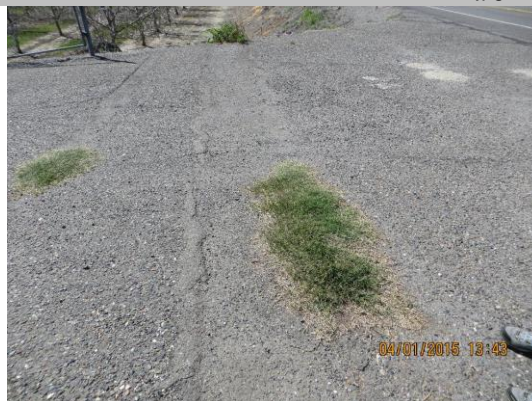
Photo 2 of 2 : UCIP\_FA\_2021\_44185\_73607.jpg

Cut in pavement visible at crown good indicator of crossing location.

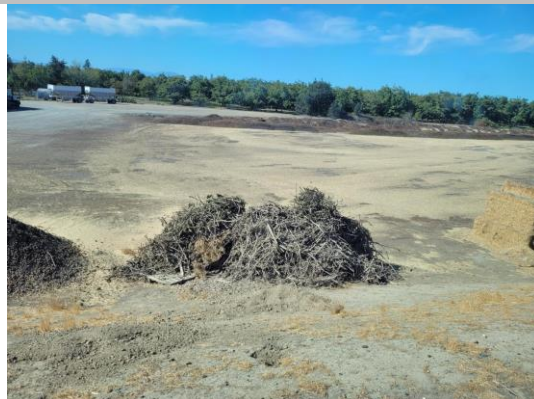
Photo 1 of 1 : FA\_2021\_LD0002\_28\_33\_20211015\_00048.jpg

View of the pile of prunings at the landside toe. Fall 2021.

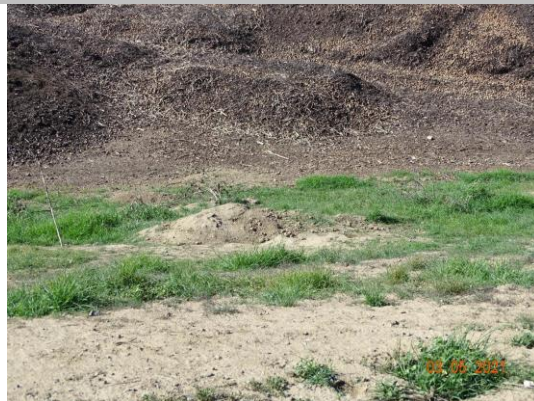
Photo 1 of 1 : FA\_2021\_LD0002\_28\_27\_20210928\_00006.jpg

LM Start	3.53	Rating **	M	Issue No.	27
LM End	3.59	Issue Type +	Ma	Location *	LS
Category	Earthen Levee			GPS Latitude/Longitude	
				Start	End
Item	Animal Control			39.458807 °	39.459614 °
				-122.009990 °	-122.010741 °
DWR ID	DWR_LD0002_01_s _ 2014_27				
Comment Code					
A3 : No rodents visible, but rodent burrows visible; need to backfill and compact or grout burrows.					
Inspector Comment

View of the rodent holes along the landside slope. Spring 2021.

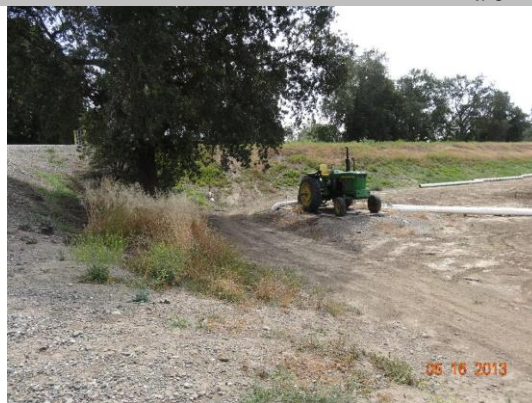
Photo 1 of 3 : UCIP\_FA\_2021\_38178\_69502.jpg

Comment Code						
Inspector Comment						
DS_ID:21178 FS_ID:38178 EP_NO: 16931 Repair Type: Non-Urgent EVAL Issue: Crossing Status: Indicator Found UCIP Comments: Inspector notes indicate that pipe was never installed through levee and application was closed. Steel pipe was not installed but detachable section was installed. The pipe section goes up and over levee. Permit 16931 file was closed in 2005 owner was unable to install pipe due to costs. Permit indicates that pipe was to be used for winter supply of irrigation water to landward side. Need to coordinate with DWR inspector--permit revised for this type of structure. FIELD_STRUCT_DESC: Crossing visible at location. Current structure differs from original request in Permit No. 16931. PVC connection visible on landside (LS) toe with cutoff valve. Pipe connects to 8-inch PVC pipe extending past LS toe. FS Date: 5/16/2013

View of pump system on landward side located behind tracker.

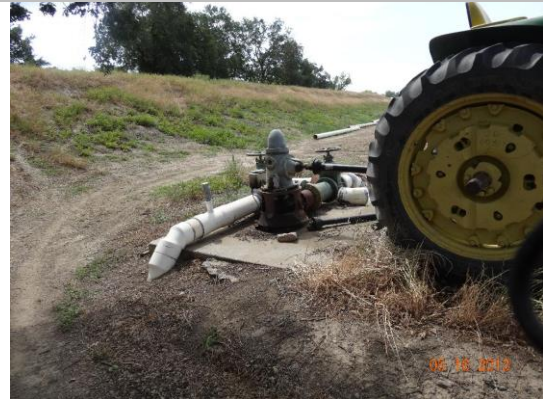
Photo 2 of 3 : UCIP\_FA\_2021\_38178\_69501.jpg

Pump system located near landward toe.

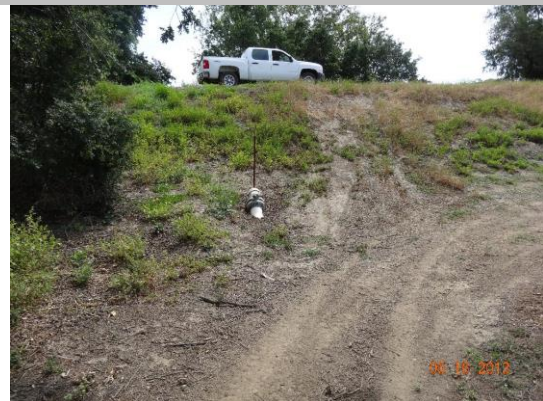
Photo 3 of 3 : UCIP\_FA\_2021\_38178\_69500.jpg

Pipe connection capped with control valve located on landward toe.

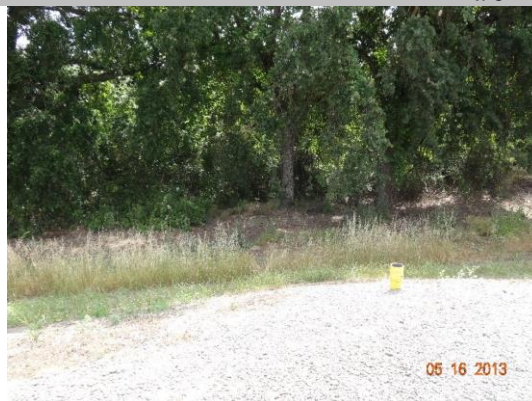
Photo 1 of 3 : UCIP\_FA\_2021\_38182\_69537.jpg

LM Start	3.74	Rating **	M	Issue No.	69	
LM End	3.74	Issue Type +	En	Location *		
Category	Supplemental			GPS Latitude/Longitude		
				Start		End
Item	DWR UCIP Field Study			39.461674 °		39.461674 °
				-122.011507 °		-122.011507 °
DWR ID	24659					
Comment Code						
Inspector Comment						
DS_ID:24659						
FS_ID:38182						
EP_NO: N/A						
Repair Type: Non-Urgent						
EVAL Issue:						
Crossing Status: Found						
UCIP Comments: Need to contact owner to determine status of crossing.						
FIELD_STRUCT_DESC: 24-inch steel drainage pipe through levee, 2-feet below the crown. Pipe is exposed on waterside (WS) with air vent on the WS levee shoulder. Open pump is approximately 550 feet on the landside (LS) of the levee toe and concrete distribution pipe. (electronic permit not available - Permit No. 16280-1995, Mathew J. Southam/McGowan)						
FS Date: 5/16/2013

View of waterward side.

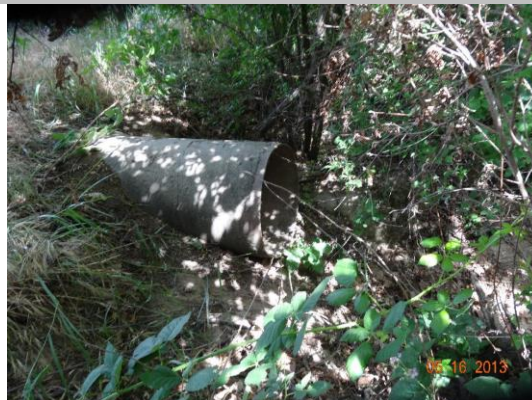
Photo 2 of 3 : UCIP\_FA\_2021\_38182\_69533.jpg

Pipe visible on waterward side.

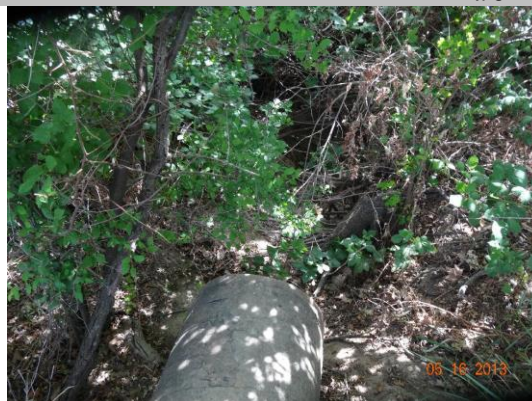
Photo 3 of 3 : UCIP\_FA\_2021\_38182\_69541.jpg

View of channel on waterward side.

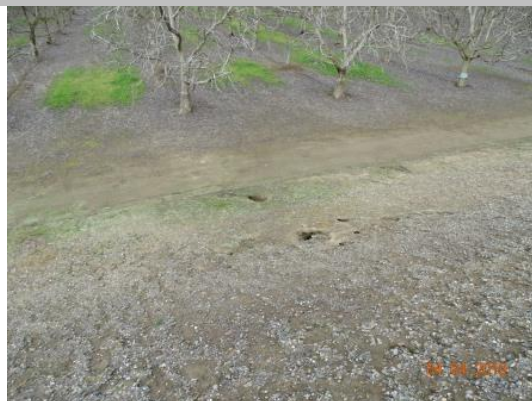
Photo 1 of 1 : FA\_2021\_LD0002\_28\_50\_20210928\_00011.jpg

View of the rodent holes on the landside slope. Spring 2019.

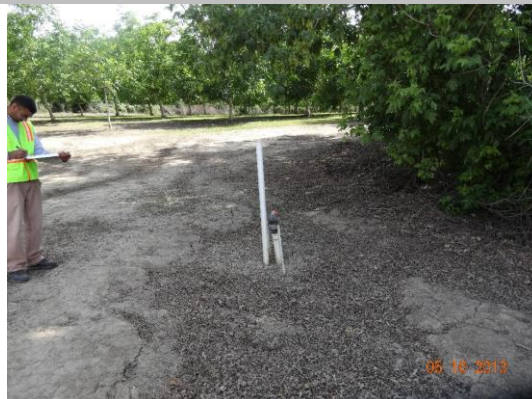
Photo 1 of 3 : UCIP\_FA\_2021\_44188\_69544.jpg

LM Start	4.32	Rating **	M	Issue No.	70
LM End	4.32	Issue Type +	En	Location *	
Category	Supplemental			GPS Latitude/Longitude	
				Start	End
Item	DWR UCIP Field Study			39.469908 °	39.469908 °
				-122.012117 °	-122.012117 °
DWR ID	21181				
Comment Code					
Inspector Comment					
DS_ID:21181					
FS_ID:44188					
EP_NO: 18072					
Repair Type: Non-Urgent					
EVAL Issue:					
Crossing Status: Indicator Found					
UCIP Comments: Pipe needs better markers at pipe crossing.					
FIELD_STRUCT_DESC: 6-inch steel irrigation pipe through the levee, 2 feet below the levee. Well, pump, and vent visible on landside (LS) toe. Vent visible just off waterside (WS) toe. (6-inch pipe authorized under Permit No. 18072, 2006-McCowan & Southam)					
FS Date: 4/1/2015

3-inch PVC pipe and vent exposed on waterward toe, likely in alignment with this crossing.

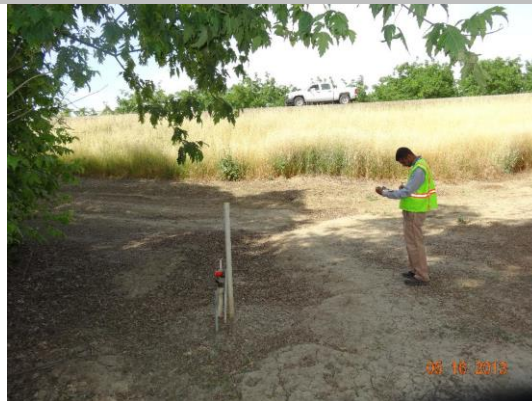
Photo 2 of 3 : UCIP\_FA\_2021\_44188\_69543.jpg

3-inch PVC pipe and vent exposed on waterward toe, likely in alignment with this crossing.

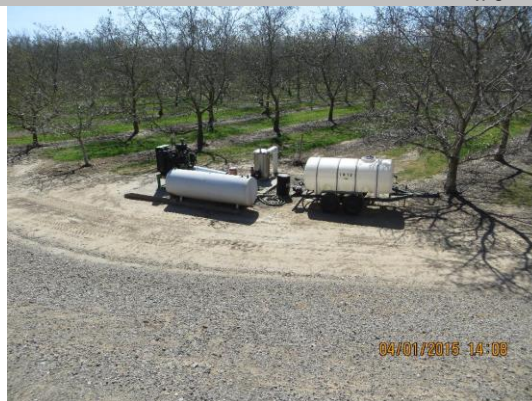
Photo 3 of 3 : UCIP\_FA\_2021\_44188\_73609.jpg

Well and pump visible on LS toe.

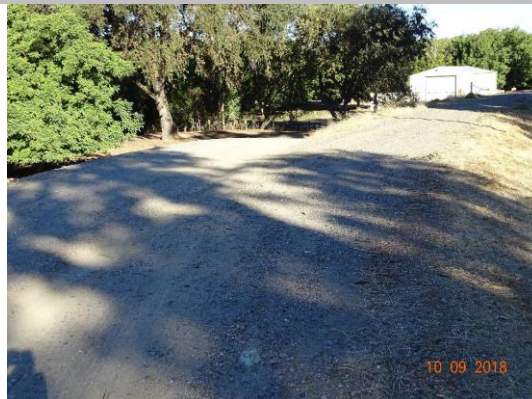
Photo 1 of 3 : UCIP\_FA\_2021\_53005\_78119.jpg

Comment Code						
Inspector Comment						
DS_ID:21176 FS_ID:53005 EP_NO: 15198 Repair Type: Non-Urgent EVAL Issue: Crossing Status: Not Found UCIP Comments: 10/9/2018 No markers found. Crossing downgraded to "Non-Urgent" due to reclassification of gas lines. (O.Yakimov - DWR UCIP)07/07/2016 same as previous inspection: No markers found. Unable to confirm crossing status. (DWR UCIP - omagana)05/16/2013 No markers found. Need to contact owner to determine if crossing is still active and to determine last inspection date. Will need copy of letter showing crossings passed inspection. (DWR UCIP - omagana) FIELD_STRUCT_DESC: 2-inch steel gas line through the levee, 2.5 feet below the crown. (2-inch gas line authorized under Permit No. 15198, 1989-Northern Michigan Exploration Company) FS Date: 10/9/2018 2:50:03 PM

View of levee crown at the crossing.

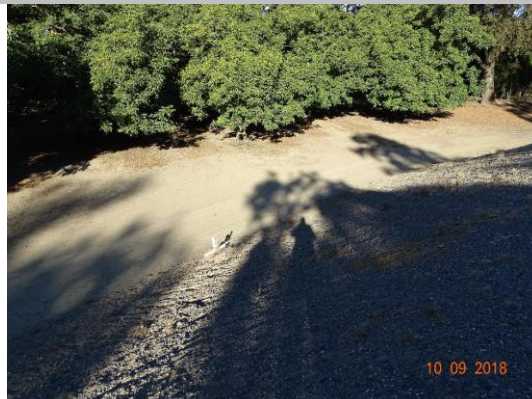
Photo 2 of 3 : UCIP\_FA\_2021\_53005\_78120.jpg

View of landside at crossing.

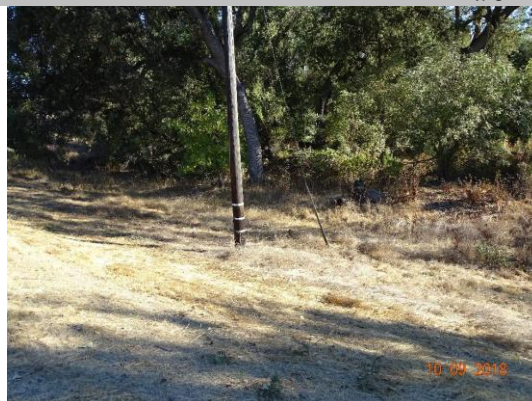
Photo 3 of 3 : UCIP\_FA\_2021\_53005\_78121.jpg

View of waterside at crossing.

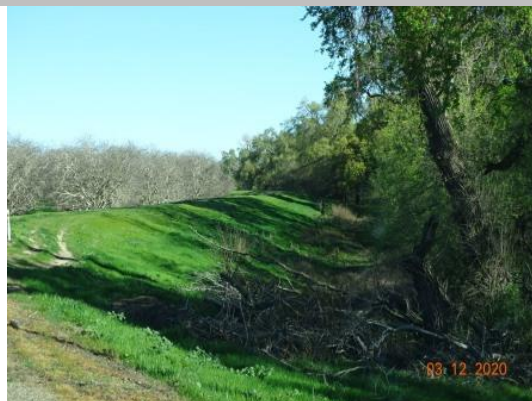
Photo 1 of 1 : FA\_2021\_LD0002\_28\_57\_20210928\_00012.jpg

View of the tree and branches on the waterside slope. Spring 2020.
