## Flood Control Project Maintenance Levee Inspections

### Fall 2022 Levee Maintenance Deficiency Summary Report

#### Sacramento River Basin

**Levee District No. 0002 (Glenn County)**

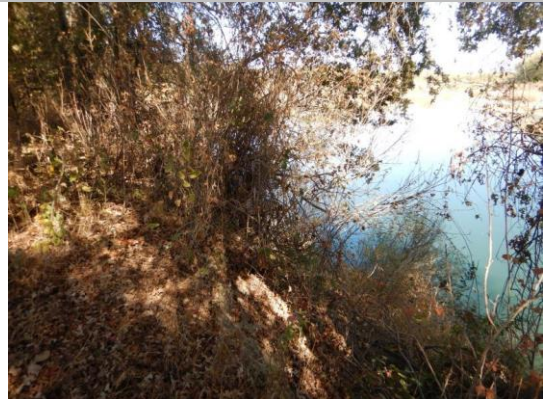
Photo 1 of 2 : FA\_2022\_LD0002\_28\_6\_20220906\_00002.jpg

LM Start	0.07	Rating **	M	Issue No.	6
LM End	0.28	Issue Type +	Ma	Location *	WS
Category	Supplemental			GPS Latitude/Longitude	
				Start	End
Item	2018 USACE Erosion Survey			39.414649 °	39.417689 °
				-122.009853 °	-122.010369 °
DWR ID	DWR_LD0002_01_s _ 2022_6				
Comment Code					
Inspector Comment					
2018 Site ID: SAC 164.7 R					
Status: Eroding					
2018 Field Notes: No observed change.					
Site History: 2009 - Very slow retreat, hard toe, encroaching into the levee projection. 2010 - Slowly eroding. 2011 - Site extended downstream. 2017 - New erosion along entire site.

USACE 2018 Erosion Photo #1

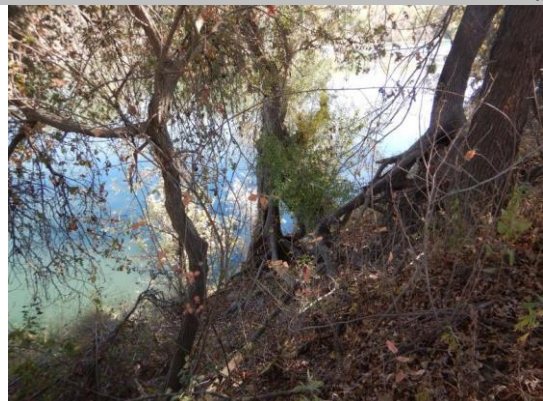
Photo 2 of 2 : FA\_2022\_LD0002\_28\_6\_20220906\_00003.jpg

USACE 2018 Erosion Photo #2

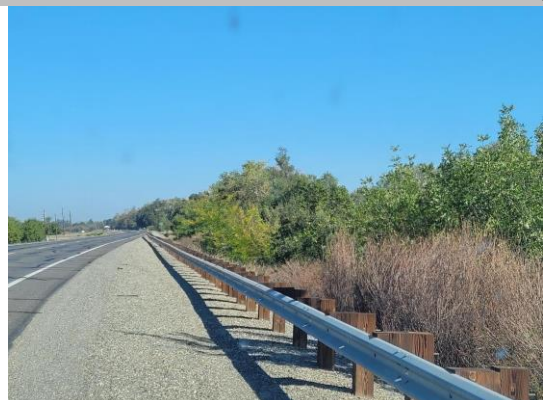
Photo 1 of 1 : FA\_2022\_LD0002\_28\_35\_20221024\_00016.jpg

LM Start	0.64	Rating **	M	Issue No.	35
LM End	0.77	Issue Type +	Ma	Location *	WS
Category	Earthen Levee			GPS Latitude/Longitude	
				Start	End
Item	Vegetation			39.422805 °	39.424597 °
				-122.011640 °	-122.011527 °
DWR ID	DWR_LD0002_01_s _ 2018_35				
Comment Code					
V2 : Remove the wild growth and woody vegetation other than native grasses from the levee slopes.					
Inspector Comment

View of the wild growth along the waterside slope. Fall 2022.

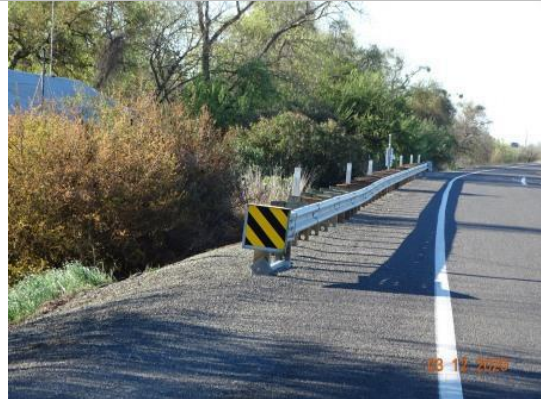
Photo 1 of 1 : FA\_2022\_LD0002\_28\_30\_20220906\_00008.jpg

LM Start	1.03	Rating **	M	Issue No.	30
LM End	1.03	Issue Type +	En	Location *	WS
Category	Earthen Levee			GPS Latitude/Longitude	
				Start	End
Item	Vegetation			39.428445 °	39.428445 °
				-122.010972 °	-122.010972 °
DWR ID	DWR_LD0002_01_f _ 2015_30				
Comment Code					
V6 : Landscaping					
Inspector Comment					
Remove the oleanders from the waterside slope.

View of the oleanders along the waterside slope. Spring 2020.

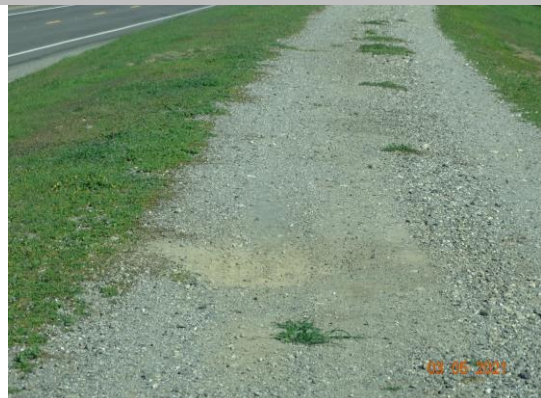
Photo 1 of 1 : FA\_2022\_LD0002\_28\_34\_20220906\_00010.jpg

LM Start	1.40	Rating **	M	Issue No.	34
LM End	1.40	Issue Type +	Ma	Location *	CR
Category	Earthen Levee			GPS Latitude/Longitude	
				Start	End
Item	Crown Surface / Depressions / Rutting			39.433809 °	39.433809 °
				-122.010814 °	-122.010814 °
DWR ID	DWR_LD0002_01_f_2016_34				
Comment Code					
C2 : Repair depressions or ruts in the crown or slope.					
Inspector Comment

View of a depression on the levee crown looking upstream. Spring 2021.

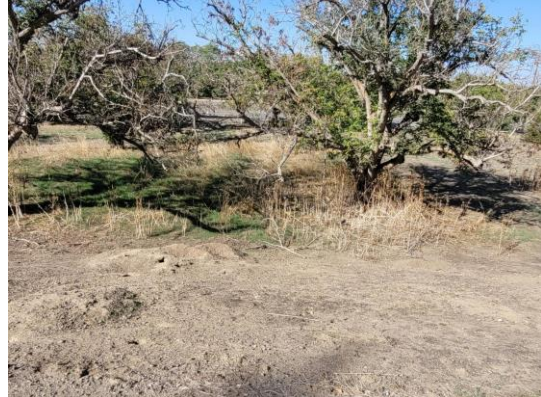
Photo 1 of 1 : FA\_2022\_LD0002\_28\_15\_20221024\_00017.jpg

LM Start	1.54	Rating **	U	Issue No.	15
LM End	1.60	Issue Type +	Ma	Location *	LS
Category	Earthen Levee			GPS Latitude/Longitude	
				Start	End
Item	Animal Control			39.435730 °	39.436643 °
				-122.010565 °	-122.010498 °
DWR ID	DWR_LD0002_01_f_2012_15				
Comment Code					
A3 : No rodents visible, but rodent burrows visible; need to backfill and compact or grout burrows.					
Inspector Comment

View of the rodent activity along the landside slope. Fall 2022.

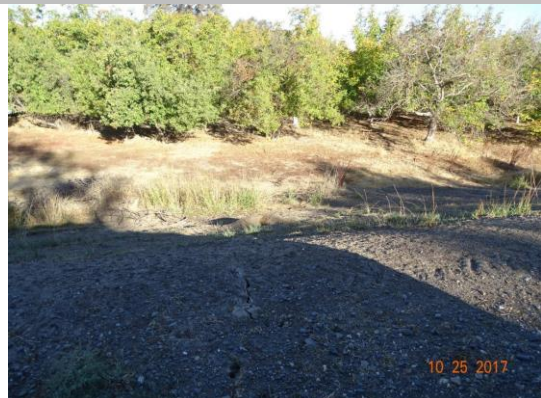
Photo 1 of 1 : FA\_2022\_LD0002\_28\_2\_20220906\_00001.jpg

LM Start	2.94	Rating **	M	Issue No.	2
LM End	2.94	Issue Type +	Ma	Location *	LS
Category	Earthen Levee			GPS Latitude/Longitude	
				Start	End
Item	Animal Control			39.453947 °	39.453947 °
				-122.015764 °	-122.015764 °
DWR ID	DWR_LD0002_01_f_2015_2				
Comment Code					
A3 : No rodents visible, but rodent burrows visible; need to backfill and compact or grout burrows.					
Inspector Comment

View of the rodent holes along the landside slope.

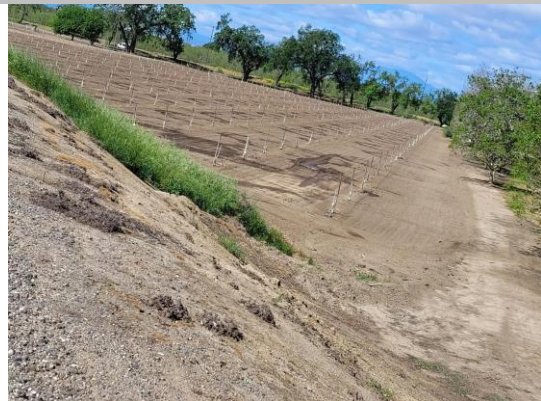
Photo 1 of 1 : FA\_2022\_LD0002\_28\_12\_20220906\_00004.jpg

LM Start	3.11	Rating **	U	Issue No.	12
LM End	3.13	Issue Type +	Ma	Location *	LS
Category	Earthen Levee			GPS Latitude/Longitude	
				Start	End
Item	Animal Control			39.455647 °	39.455805 °
				-122.013623 °	-122.013286 °
DWR ID	DWR_LD0002_01_s_2013_12				
Comment Code					
A1 : Exterminate rodents and backfill and compact or grout burrows.					
Inspector Comment

View of rodent activity on the landside slope. Spring 2022.

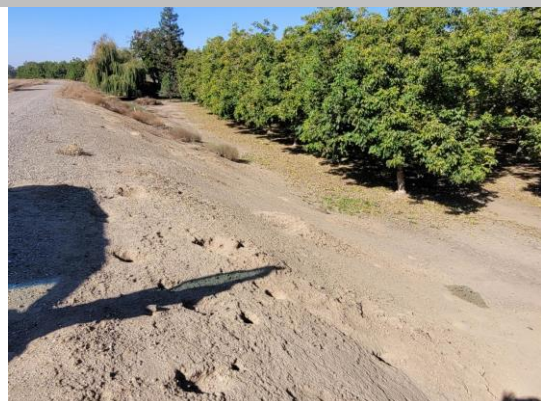
Photo 1 of 1 : FA\_2022\_LD0002\_28\_16\_20221024\_00018.jpg

LM Start	3.23	Rating **	U	Issue No.	16
LM End	3.32	Issue Type +	Ma	Location *	LS
Category	Earthen Levee			GPS Latitude/Longitude	
				Start	End
Item	Animal Control			39.456234 °	39.456302 °
				-122.011413 °	-122.009772 °
DWR ID	DWR_LD0002_01_f_2012_16				
Comment Code					
A3 : No rodents visible, but rodent burrows visible; need to backfill and compact or grout burrows.					
Inspector Comment

View of the rodent holes along the landside slope. Fall 2022.

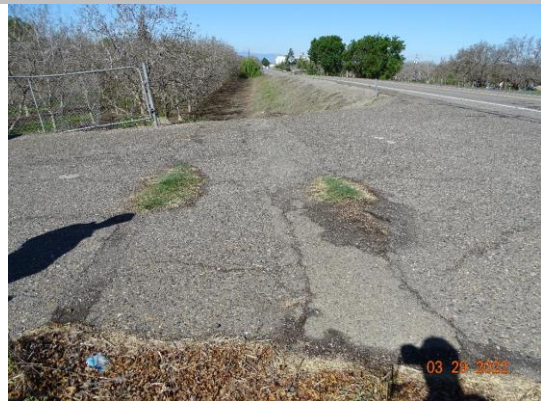
Photo 1 of 3 : UCIP\_FA\_2022\_75855\_113913.jpg

Comment Code						
Inspector Comment						
DS_ID:21188 FS_ID:75855 EP_NO: 12444 Repair Type: Non-Urgent EVAL Issue: 11, Maintenance Compliance Issue Crossing Status: Indicator Found UCIP Comments: 03/29/2022 Record remains Non-Urgent. Communication line markers are not installed on any side of levee. Bridge will be reconstructed. (O.Yakimov - DWR UCIP) 04/01/2015 Needs markers 10-feet off both levee toes. (W.Wylie - DWR UCIP) FIELD_STRUCT_DESC: Buried cable steel conduit through the levee, 2.5 feet below the crown. Conduit extends to pole on waterside (WS). Cut in pavement visible at levee crown (aerial communication cable across left bank levee and channel of the Sacramento River and buried cable across the right bank overflow and through the right bank levee authorized under Permit No. 12444, 1978-Pacific Telephone and Telegraph Company) [Additional Reference(s): DWR Levee Logs, 2005] FS Date: 3/29/2022 7:16:30 AM

Top of Levee: View of levee crown looking from waterside. Cut in levee crown visible

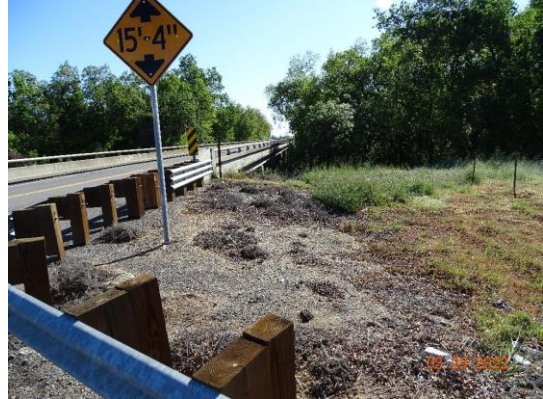
Photo 2 of 3 : UCIP\_FA\_2022\_75855\_113912.jpg

Water-Side: View of levee slope looking from crown. Conduit not found

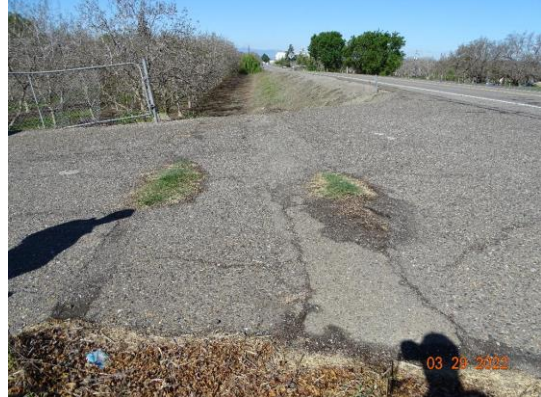
Photo 1 of 3 : UCIP\_FA\_2022\_75856\_113915.jpg

Comment Code					
Inspector Comment					
DS_ID:21175 FS_ID:75856 EP_NO: 5376 Repair Type: Non-Urgent EVAL Issue: 11, Maintenance Compliance Issue Crossing Status: Indicator Found UCIP Comments: 03/29/2022 Record remains Non-Urgent. Communication line markers are not installed on any side of levee. (O.Yakimov - DWR UCIP) 04/01/2015 Conduit needs markers ten feet off both levee toes. (W.Wylie - DWR UCIP) FIELD_STRUCT_DESC: Three 3.5-inch steel cables sleeved through conduit through the levee, 3 feet below the crown. Metal cutoff wall around conduits near center of levee. Conduits are welded to the cutoff wall, extending only between the levee shoulders under the crown. Cut in pavement visible at crown. Cables extend to pole on waterside (WS). (replace existing aerial telephone cables with two buried cables authorized under Permit No. 5376, 1967-Pacific Telephone & Telegraph Co.) [Additional Reference(s): DWR Levee Logs, 2005] FS Date: 3/29/2022 7:25:51 AM

Top of Levee: View of levee crown looking from waterside. Cut in pavement still visible

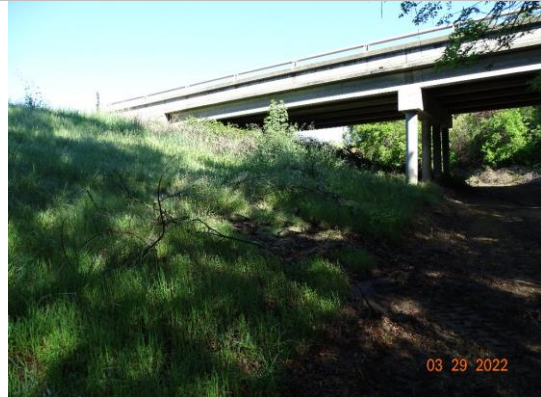
Photo 2 of 3 : UCIP\_FA\_2022\_75856\_113917.jpg

Water-Side: View of levee slope looking from toe. Conduit not found

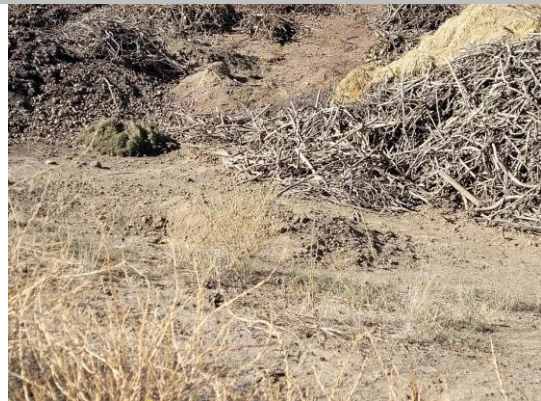
Photo 1 of 1 : FA\_2022\_LD0002\_28\_24\_20221024\_00019.jpg

LM Start	3.48	Rating **	U	Issue No.	24
LM End	3.48	Issue Type +	Ma	Location *	LS
Category	Earthen Levee			GPS Latitude/Longitude	
				Start	End
Item	Animal Control			39.458193 °	39.458193 °
				-122.009550 °	-122.009550 °
DWR ID	DWR_LD0002_01_f_2021_24				
Comment Code					
A3 : No rodents visible, but rodent burrows visible; need to backfill and compact or grout burrows.					
Inspector Comment

View of rodent activity along the landside slope. Fall 2022.

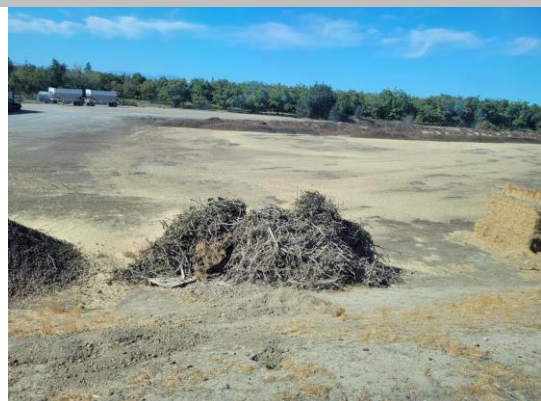
Photo 1 of 1 : FA\_2022\_LD0002\_28\_33\_20220906\_00009.jpg

LM Start	3.48	Rating **	M	Issue No.	33
LM End	3.48	Issue Type +	En	Location *	LS
Category	Earthen Levee			GPS Latitude/Longitude	
				Start	End
Item	Encroachments			39.458199 °	39.458199 °
				-122.009549 °	-122.009549 °
DWR ID	DWR_LD0002_01_f_2021_33				
Comment Code					
PR : Prunings					
Inspector Comment

View of the pile of prunings at the landside toe. Fall 2021.

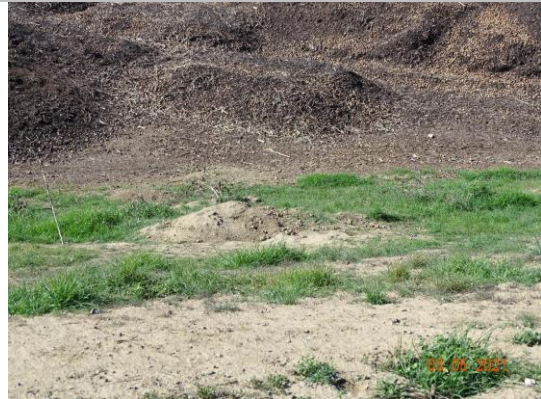
Photo 1 of 1 : FA\_2022\_LD0002\_28\_27\_20220906\_00007.jpg

LM Start	3.53	Rating **	M	Issue No.	27
LM End	3.59	Issue Type +	Ma	Location *	LS
Category	Earthen Levee			GPS Latitude/Longitude	
				Start	End
Item	Animal Control			39.458807 °	39.459614 °
				-122.009990 °	-122.010741 °
DWR ID	DWR_LD0002_01_s_2014_27				
Comment Code					
A3 : No rodents visible, but rodent burrows visible; need to backfill and compact or grout burrows.					
Inspector Comment

View of the rodent holes along the landside slope. Spring 2021.

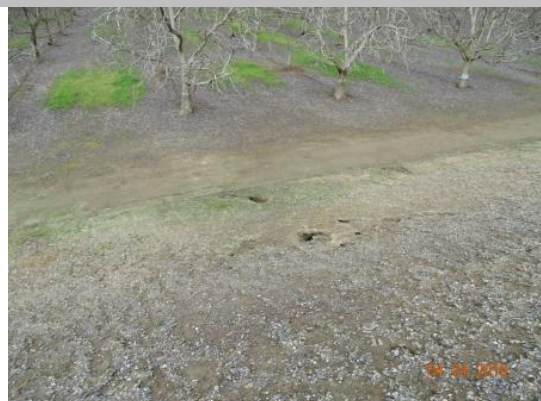
Photo 1 of 1 : FA\_2022\_LD0002\_28\_50\_20220906\_00012.jpg

LM Start	3.79	Rating **	M	Issue No.	50
LM End	3.79	Issue Type +	Ma	Location *	LS
Category	Earthen Levee			GPS Latitude/Longitude	
				Start	End
Item	Animal Control			39.462358 °	39.462358 °
				-122.011623 °	-122.011623 °
DWR ID	DWR_LD0002_01_s_2019_50				
Comment Code					
A3 : No rodents visible, but rodent burrows visible; need to backfill and compact or grout burrows.					
Inspector Comment

View of the rodent holes on the landside slope. Spring 2019.
