**Flood Control Project Maintenance
Levee Inspections
Fall 2023 Levee Maintenance Deficiency Summary Report**

Sacramento River Basin

Levee Inspection Report By Mile - Fall 2023

Waterway	Bank	Unit Miles	Inspection Start/End	Inspector
Unit No. 01 Glenn County Sacramento River	Right	4.90	10/30/2023 10/30/2023	Makar Sokol

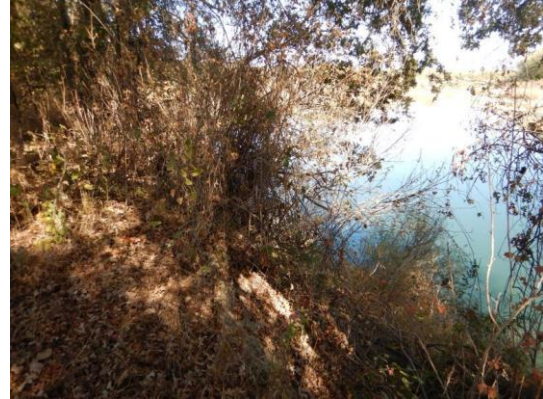
Photo 1 of 2 : FA_2023_LD0002_28_6_20231002_00002.jpg

LM Start	0.07	Rating **	M	Issue No.	6
LM End	0.28	Issue Type +	Ma	Location *	WS
Category	Supplemental			GPS Latitude/Longitude	
				Start	End
Item	2018 USACE Erosion Survey			39.414649 °	39.417689 °
				-122.009853 °	-122.010369 °
DWR ID	DWR_LD0002_01_s _ 2022_6				
Comment Code					
Inspector Comment					
2018 Site ID: SAC 164.7 R					
Status: Eroding					
2018 Field Notes: No observed change.					
Site History: 2009 - Very slow retreat, hard toe, encroaching into the levee projection. 2010 - Slowly eroding. 2011 - Site extended downstream. 2017 - New erosion along entire site.

USACE 2018 Erosion Photo #1

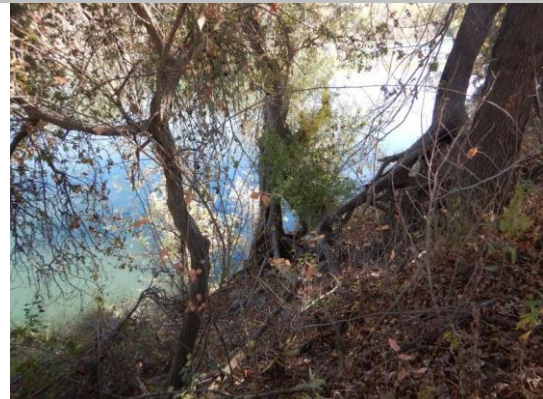
Photo 2 of 2 : FA_2023_LD0002_28_6_20231002_00003.jpg

LM Start	0.07	Rating **	M	Issue No.	6 (cont)
LM End	0.28	Issue Type +	Ma	Location *	WS

USACE 2018 Erosion Photo #2

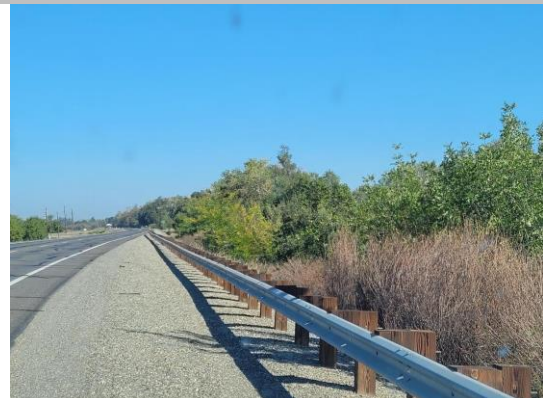
Photo 1 of 1 : FA_2023_LD0002_28_35_20231002_00012.jpg

LM Start	0.64	Rating **	M	Issue No.	35
LM End	0.77	Issue Type +	Ma	Location *	WS
Category	Earthen Levee			GPS Latitude/Longitude	
				Start	End
Item	Vegetation			39.422805°	39.424597°
				-122.011640°	-122.011527°
DWR ID	DWR_LD0002_01_s _ 2018_35				
Comment Code					
V2 : Remove the wild growth and woody vegetation other than native grasses from the levee slopes.					
Inspector Comment

View of the wild growth along the waterside slope. Fall 2022.

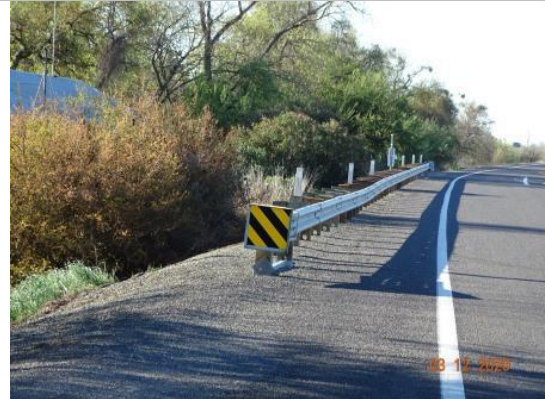
Photo 1 of 1 : FA_2023_LD0002_28_30_20231002_00009.jpg

LM Start	1.03	Rating **	M	Issue No.	30
LM End	1.03	Issue Type +	En	Location *	WS
Category	Earthen Levee			GPS Latitude/Longitude	
				Start	End
Item	Vegetation			39.428445°	39.428445°
				-122.010972°	-122.010972°
DWR ID	DWR_LD0002_01_f_2015_30				
Comment Code					
V6 : Landscaping					
Inspector Comment					
Remove the oleanders from the waterside slope.

View of the oleanders along the waterside slope. Spring 2020.

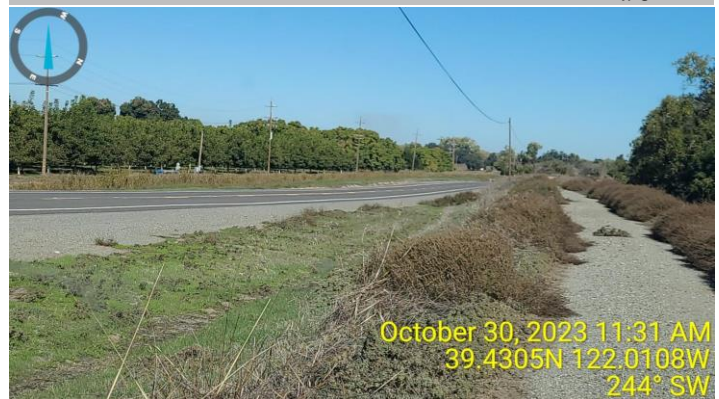
Photo 1 of 1 : FA_2023_LD0002_28_4_20231030_00020.jpg

LM Start	1.16	Rating **	U	Issue No.	4
LM End	2.00	Issue Type +	Ma	Location *	LS
Category	Earthen Levee			GPS Latitude/Longitude	
				Start	End
Item	Vegetation			39.430309°	39.441575°
				-122.010800°	-122.012650°
DWR ID	DWR_LD0002_01_f_2023_4				
Comment Code					
V1 : Control annual grass and weeds on the levee slopes and easements.					
Inspector Comment

View of the vegetation along the landside slope. Fall 2023.

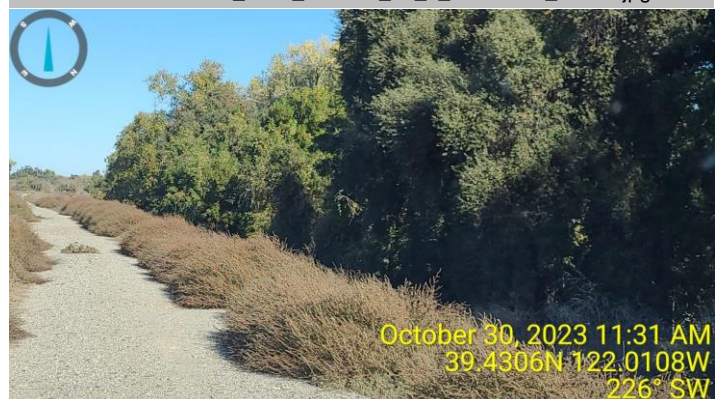
Photo 1 of 1 : FA_2023_LD0002_28_5_20231030_00021.jpg

LM Start	1.16	Rating **	U	Issue No.	5
LM End	2.01	Issue Type +	Ma	Location *	WS
Category	Earthen Levee			GPS Latitude/Longitude	
				Start	End
Item	Vegetation			39.430310°	39.441725°
				-122.010800°	-122.012877°
DWR ID	DWR_LD0002_01_f_2023_5				
Comment Code					
V1 : Control annual grass and weeds on the levee slopes and easements.					
Inspector Comment

View of the vegetation along the waterside slope. Fall 2023.

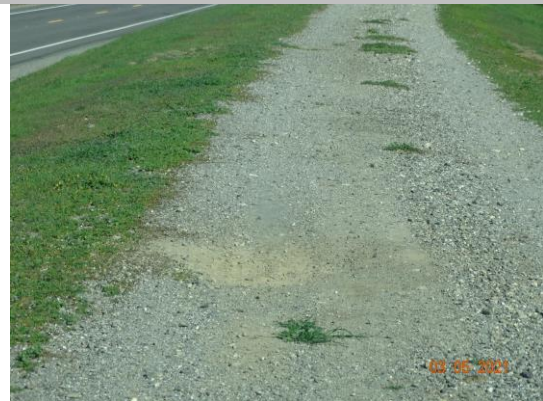
Photo 1 of 1 : FA_2023_LD0002_28_34_20231002_00011.jpg

LM Start	1.40	Rating **	M	Issue No.	34
LM End	1.40	Issue Type +	Ma	Location *	CR
Category	Earthen Levee			GPS Latitude/Longitude	
				Start	End
Item	Crown Surface / Depressions / Rutting			39.433809°	39.433809°
				-122.010814°	-122.010814°
DWR ID	DWR_LD0002_01_f_2016_34				
Comment Code					
C2 : Repair depressions or ruts in the crown or slope.					
Inspector Comment

View of a depression on the levee crown looking upstream. Spring 2021.

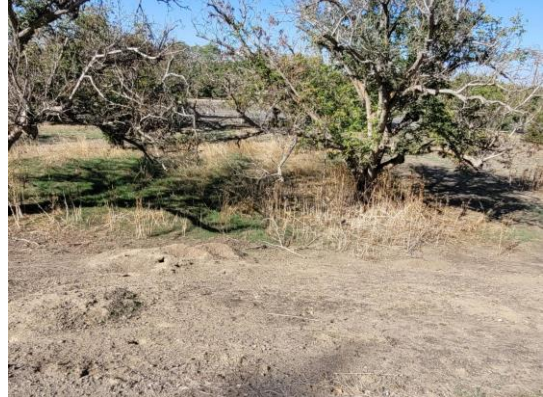
Photo 1 of 1 : FA_2023_LD0002_28_15_20231002_00005.jpg

LM Start	1.54	Rating **	U	Issue No.	15
LM End	1.60	Issue Type +	Ma	Location *	LS
Category	Earthen Levee			GPS Latitude/Longitude	
				Start	End
Item	Animal Control			39.435730°	39.436643°
				-122.010565°	-122.010498°
DWR ID	DWR_LD0002_01_f_2012_15				
Comment Code					
A3 : No rodents visible, but rodent burrows visible; need to backfill and compact or grout burrows.					
Inspector Comment

View of the rodent activity along the landside slope. Fall 2022.

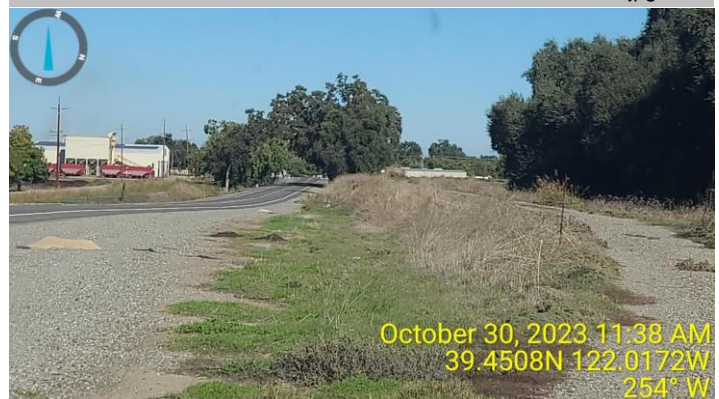
Photo 1 of 1 : FA_2023_LD0002_28_10_20231030_00022.jpg

LM Start	2.70	Rating **	U	Issue No.	10
LM End	3.33	Issue Type +	Ma	Location *	LS
Category	Earthen Levee			GPS Latitude/Longitude	
				Start	End
Item	Vegetation			39.450897°	39.456286°
				-122.017225°	-122.009681°
DWR ID	DWR_LD0002_01_f_2023_10				
Comment Code					
V1 : Control annual grass and weeds on the levee slopes and easements.					
Inspector Comment

View of the vegetation along the landside slope. Fall 2023.

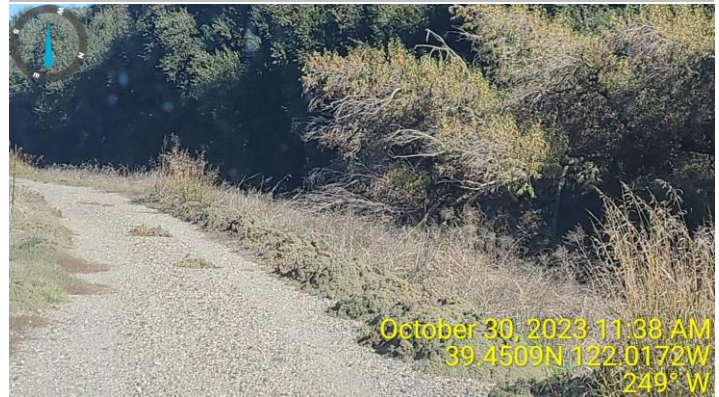
Photo 1 of 1 : FA_2023_LD0002_28_9_20231030_00023.jpg

LM Start	2.70	Rating **	U	Issue No.	9
LM End	3.12	Issue Type +	Ma	Location *	WS
Category	Earthen Levee			GPS Latitude/Longitude	
				Start	End
Item	Vegetation			39.450904°	39.455728°
				-122.017229°	-122.013429°
DWR ID	DWR_LD0002_01_f_2023_9				
Comment Code					
V1 : Control annual grass and weeds on the levee slopes and easements.					
Inspector Comment

View of the vegetation along the waterside slope. Fall 2023.

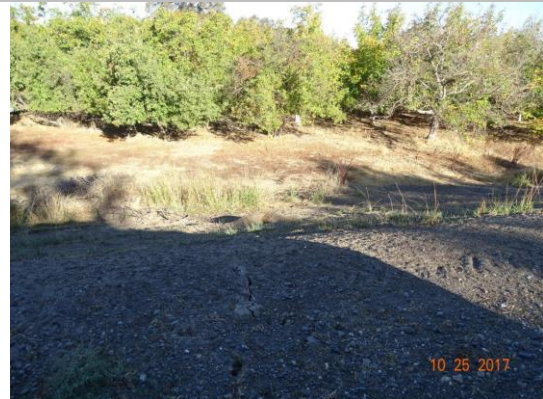
Photo 1 of 1 : FA_2023_LD0002_28_2_20231002_00001.jpg

LM Start	2.94	Rating **	M	Issue No.	2
LM End	2.94	Issue Type +	Ma	Location *	LS
Category	Earthen Levee			GPS Latitude/Longitude	
				Start	End
Item	Animal Control			39.453947°	39.453947°
				-122.015764°	-122.015764°
DWR ID	DWR_LD0002_01_f_2015_2				
Comment Code					
A3 : No rodents visible, but rodent burrows visible; need to backfill and compact or grout burrows.					
Inspector Comment

View of the rodent holes along the landside slope.

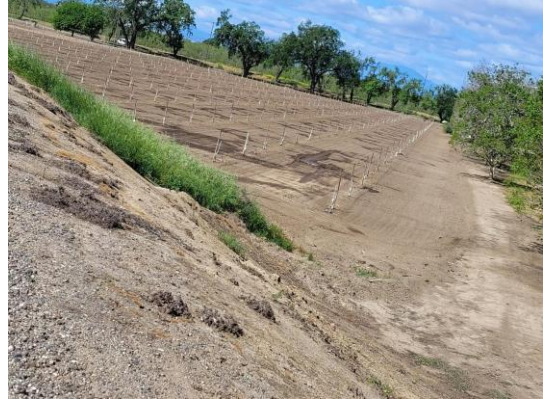
Photo 1 of 1 : FA_2023_LD0002_28_12_20231002_00004.jpg

LM Start	3.11	Rating **	U	Issue No.	12
LM End	3.13	Issue Type +	Ma	Location *	LS
Category	Earthen Levee			GPS Latitude/Longitude	
				Start	End
Item	Animal Control			39.455647°	39.455805°
				-122.013623°	-122.013286°
DWR ID	DWR_LD0002_01_s_2013_12				
Comment Code					
A1 : Exterminate rodents and backfill and compact or grout burrows.					
Inspector Comment

View of rodent activity on the landside slope. Spring 2022.

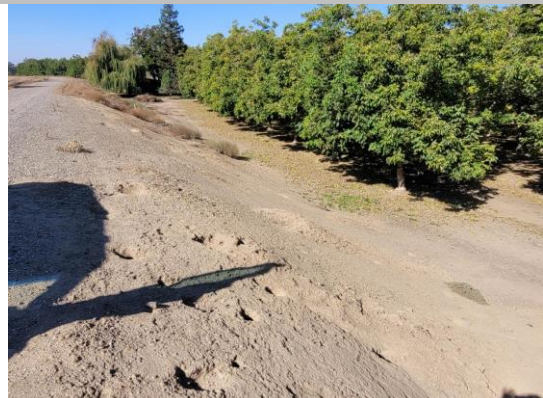
Photo 1 of 1 : FA_2023_LD0002_28_16_20231002_00006.jpg

LM Start	3.23	Rating **	U	Issue No.	16
LM End	3.32	Issue Type +	Ma	Location *	LS
Category	Earthen Levee			GPS Latitude/Longitude	
				Start	End
Item	Animal Control			39.456234°	39.456302°
				-122.011413°	-122.009772°
DWR ID	DWR_LD0002_01_f_2012_16				
Comment Code					
A3 : No rodents visible, but rodent burrows visible; need to backfill and compact or grout burrows.					
Inspector Comment

View of the rodent holes along the landside slope. Fall 2022.

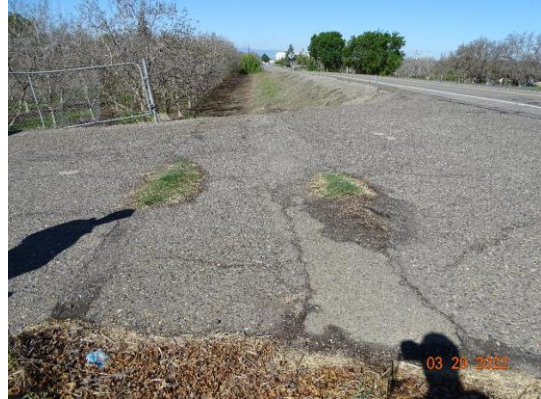
Photo 1 of 3 : UCIP_FA_2023_75855_113913.jpg

LM Start	3.37	Rating **	M	Issue No.	56
LM End	3.37	Issue Type +	En	Location *	
Category	Supplemental			GPS Latitude/Longitude	
				Start	End
Item	DWR UCIP Field Study			39.456704°	39.456704°
				-122.009621°	-122.009621°
DWR ID	21188

Comment Code					
Inspector Comment					
DS_ID:21188 FS_ID:75855 EP_NO: 12444 Repair Type: Non-Urgent EVAL Issue: 11, Maintenance Compliance Issue Crossing Status: Indicator Found UCIP Comments: 03/29/2022 Record remains Non-Urgent. Communication line markers are not installed on any side of levee. Bridge will be reconstructed. (O.Yakimov - DWR UCIP) 04/01/2015 Needs markers 10-feet off both levee toes. (W.Wylie - DWR UCIP) FIELD_STRUCT_DESC: Buried cable steel conduit through the levee, 2.5 feet below the crown. Conduit extends to pole on waterside (WS). Cut in pavement visible at levee crown (aerial communication cable across left bank levee and channel of the Sacramento River and buried cable across the right bank overflow and through the right bank levee authorized under Permit No. 12444, 1978-Pacific Telephone and Telegraph Company) [Additional Reference(s): DWR Levee Logs, 2005] FS Date: 3/29/2022 7:16:30 AM

Top of Levee: View of levee crown looking from waterside. Cut in levee crown visible

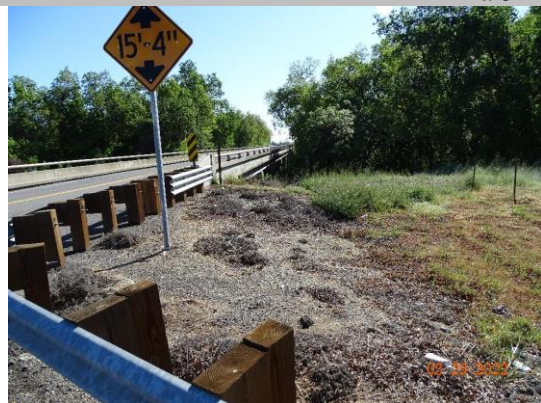
Photo 2 of 3 : UCIP_FA_2023_75855_113912.jpg

Water-Side: View of levee slope looking from crown. Conduit not found

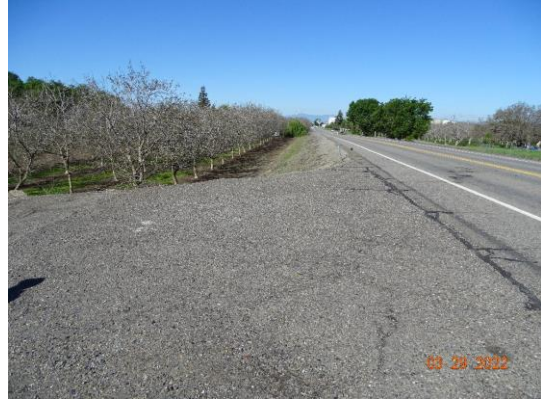
Photo 3 of 3 : UCIP_FA_2023_75855_113914.jpg

Land-Side: View of levee slope looking from crown

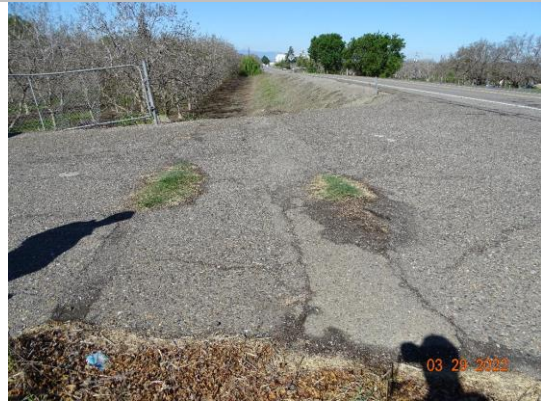
Photo 1 of 3 : UCIP_FA_2023_75856_113915.jpg

LM Start	3.37	Rating **	M	Issue No.	57
LM End	3.37	Issue Type +	En	Location *	
Category	Supplemental		GPS Latitude/Longitude		
			Start	End	
Item	DWR UCIP Field Study		39.456720 °	39.456720 °	
			-122.009630 °	-122.009630 °	
DWR ID	21175

DS_ID:21175
 FS_ID:75856
 EP_NO: 5376
 Repair Type: Non-Urgent
 EVAL Issue: 11, Maintenance Compliance Issue
 Crossing Status: Indicator Found
 UCIP Comments: 03/29/2022 Record remains Non-Urgent.
 Communication line markers are not installed on any side of levee.
 (O.Yakimov - DWR UCIP)
 04/01/2015 Conduit needs markers ten feet off both levee toes.
 (W.Wylie - DWR UCIP)
 FIELD_STRUCT_DESC: Three 3.5-inch steel cables sleeved through conduit through the levee, 3 feet below the crown. Metal cutoff wall around conduits near center of levee. Conduits are welded to the cutoff wall, extending only between the levee shoulders under the crown. Cut in pavement visible at crown. Cables extend to pole on waterside (WS). (replace existing aerial telephone cables with two buried cables authorized under Permit No. 5376, 1967-Pacific Telephone & Telegraph Co.) [Additional Reference(s): DWR Levee Logs, 2005]
 FS Date: 3/29/2022 7:25:51 AM

Top of Levee: View of levee crown looking from waterside. Cut in pavement still visible

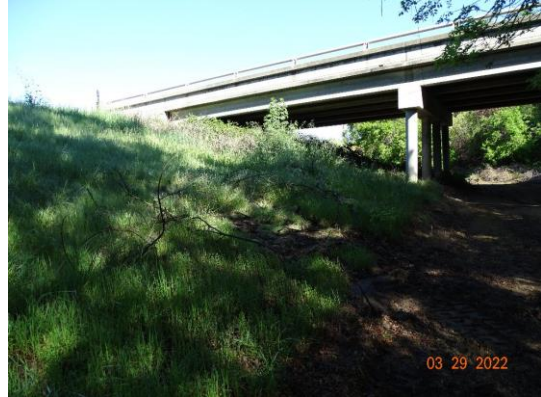
Photo 2 of 3 : UCIP_FA_2023_75856_113917.jpg

Water-Side: View of levee slope looking from toe. Conduit not found

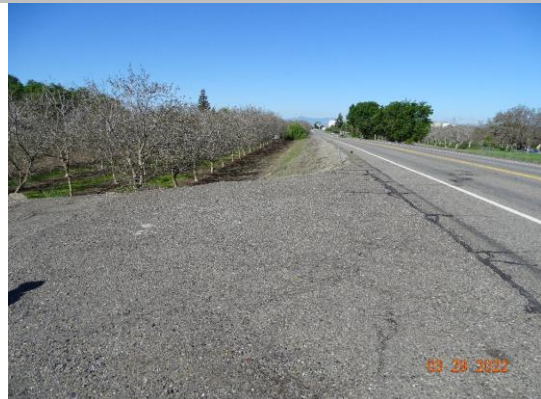
Photo 3 of 3 : UCIP_FA_2023_75856_113916.jpg

Land-Side: View of levee slope looking from crown

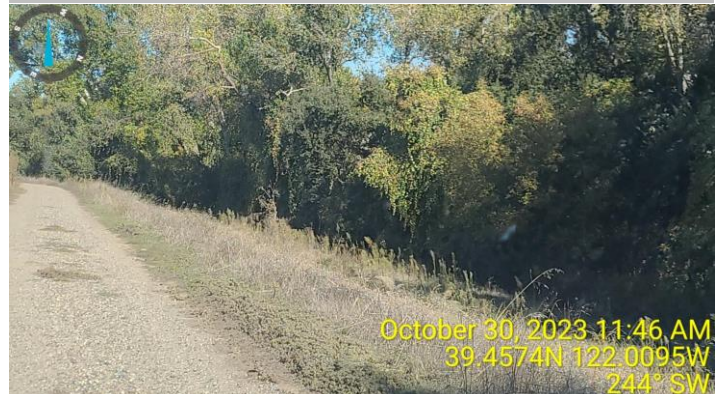
Photo 1 of 1 : FA_2023_LD0002_28_13_20231030_00024.jpg

LM Start	3.42	Rating **	U	Issue No.	13
LM End	4.16	Issue Type +	Ma	Location *	WS
Category	Earthen Levee			GPS Latitude/Longitude	
				Start	End
Item	Vegetation			39.457403°	39.467608°
				-122.009471°	-122.011616°
DWR ID	DWR_LD0002_01_f_2023_13				
Comment Code					
V1 : Control annual grass and weeds on the levee slopes and easements.					
Inspector Comment

View of the vegetation along the waterside slope. Fall 2023.

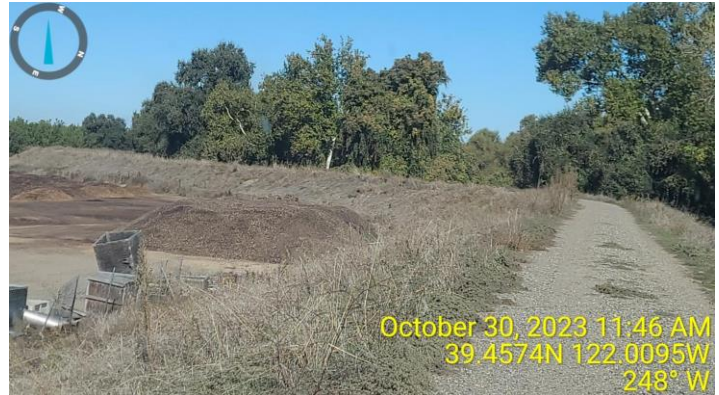
Photo 1 of 1 : FA_2023_LD0002_28_11_20231030_00025.jpg

LM Start	3.42	Rating **	U	Issue No.	11
LM End	3.74	Issue Type +	Ma	Location *	LS
Category	Earthen Levee			GPS Latitude/Longitude	
				Start	End
Item	Vegetation			39.457409°	39.461675°
				-122.009477°	-122.011557°
DWR ID	DWR_LD0002_01_f_2023_11				
Comment Code					
V1 : Control annual grass and weeds on the levee slopes and easements.					
Inspector Comment

View of the vegetation along the landside slope. Fall 2023.

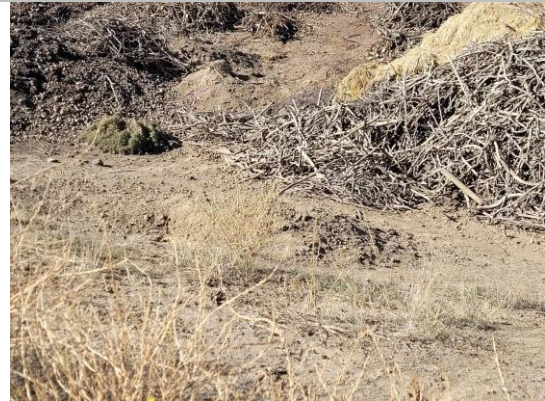
Photo 1 of 1 : FA_2023_LD0002_28_24_20231002_00007.jpg

LM Start	3.48	Rating **	U	Issue No.	24
LM End	3.48	Issue Type +	Ma	Location *	LS
Category	Earthen Levee			GPS Latitude/Longitude	
				Start	End
Item	Animal Control			39.458193°	39.458193°
				-122.009550°	-122.009550°
DWR ID	DWR_LD0002_01_f_2021_24				
Comment Code					
A3 : No rodents visible, but rodent burrows visible; need to backfill and compact or grout burrows.					
Inspector Comment

View of rodent activity along the landside slope. Fall 2022.

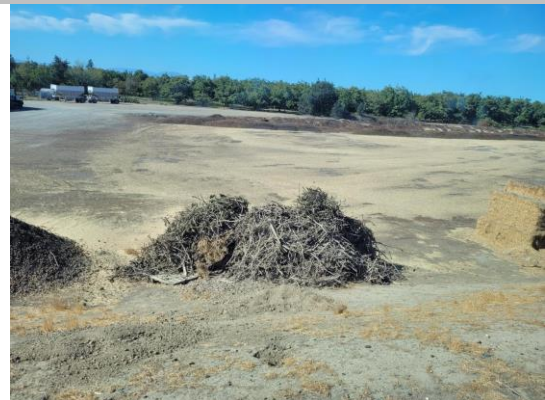
Photo 1 of 1 : FA_2023_LD0002_28_33_20231002_00010.jpg

LM Start	3.48	Rating **	M	Issue No.	33
LM End	3.48	Issue Type +	En	Location *	LS
Category	Earthen Levee			GPS Latitude/Longitude	
				Start	End
Item	Encroachments			39.458199°	39.458199°
				-122.009549°	-122.009549°
DWR ID	DWR_LD0002_01_f_2021_33				
Comment Code					
PR : Prunings					
Inspector Comment

View of the pile of prunings at the landside toe. Fall 2021.

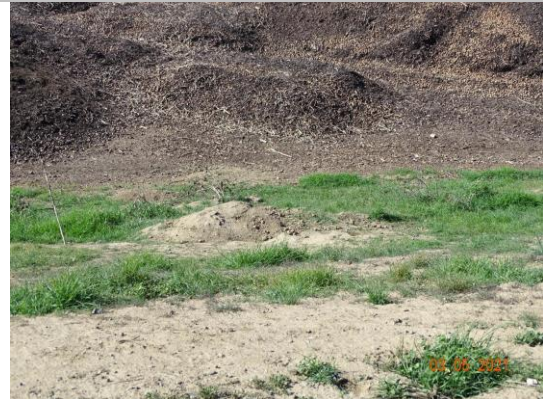
Photo 1 of 1 : FA_2023_LD0002_28_27_20231002_00008.jpg

LM Start	3.53	Rating **	M	Issue No.	27
LM End	3.59	Issue Type +	Ma	Location *	LS
Category	Earthen Levee			GPS Latitude/Longitude	
				Start	End
Item	Animal Control			39.458807°	39.459614°
				-122.009990°	-122.010741°
DWR ID	DWR_LD0002_01_s_2014_27				
Comment Code					
A3 : No rodents visible, but rodent burrows visible; need to backfill and compact or grout burrows.					
Inspector Comment

View of the rodent holes along the landside slope. Spring 2021.

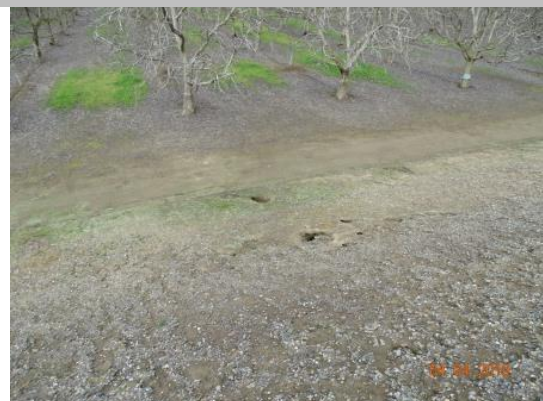
Photo 1 of 1 : FA_2023_LD0002_28_50_20231002_00013.jpg

LM Start	3.79	Rating **	M	Issue No.	50
LM End	3.79	Issue Type +	Ma	Location *	LS
Category	Earthen Levee			GPS Latitude/Longitude	
				Start	End
Item	Animal Control			39.462358°	39.462358°
				-122.011623°	-122.011623°
DWR ID	DWR_LD0002_01_s_2019_50				
Comment Code					
A3 : No rodents visible, but rodent burrows visible; need to backfill and compact or grout burrows.					
Inspector Comment

View of the rodent holes on the landside slope. Spring 2019.
