## Flood Control Project Maintenance Levee Inspections

### Fall 2024 Levee Maintenance Deficiency Summary Report

**Levee District No. 0002 (Glenn County)**

Waterway			Bank	Unit Miles
Unit No. 01 Glenn County Sacramento River			Right	4.90
	Spring (March - May)	Summer (June - August)	(September - November) Fall	Winter (December - February)
Unit Maintenance Rating (Fall Only)			U	
Date of Inspection	5/6/2024 - 5/6/2024		9/25/2024 - 9/25/2024	
DWR Inspector	Makar Sokol		Makar Sokol	
Accompanied By

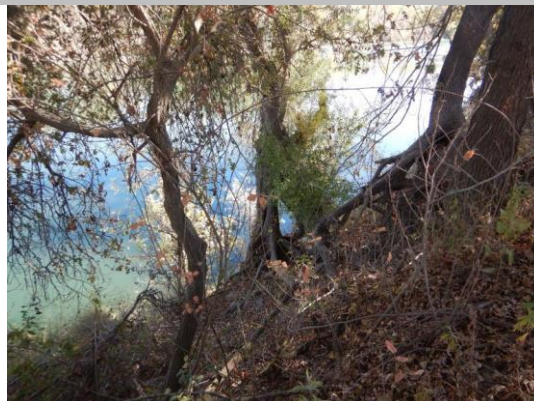
Photo 1 of 2 : FA\_2024\_LD0002\_28\_6\_20240924\_00002.jpg

LM Start	0.07	Rating **	M	Issue No.	6
LM End	0.28	Issue Type +	Ma	Location *	WS
Category	Supplemental			GPS Latitude/Longitude	
				Start	End
Item	2018 USACE Erosion Survey			39.414649 °	39.417689 °
				-122.009853 °	-122.010369 °
DWR ID	DWR_LD0002_01_s _ 2022_6				
Comment Code					
Inspector Comment					
2018 Site ID: SAC 164.7 R					
Status: Eroding					
2018 Field Notes: No observed change.					
Site History: 2009 - Very slow retreat, hard toe, encroaching into the levee projection. 2010 - Slowly eroding. 2011 - Site extended downstream. 2017 - New erosion along entire site.

USACE 2018 Erosion Photo #1

USACE 2018 Erosion Photo #2

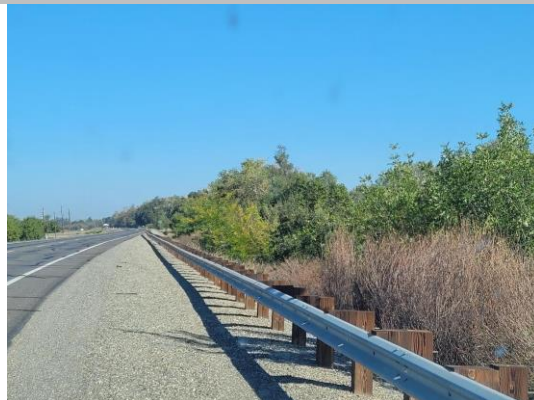
Photo 1 of 1 : FA\_2024\_LD0002\_28\_35\_20240924\_00012.jpg

LM Start	0.64	Rating **	M	Issue No.	35
LM End	0.77	Issue Type +	Ma	Location *	WS
Category	Earthen Levee			GPS Latitude/Longitude	
				Start	End
Item	Vegetation			39.422805 °	39.424597 °
				-122.011640 °	-122.011527 °
DWR ID	DWR_LD0002_01_s _ 2018_35				
Comment Code					
V2 : Remove the wild growth and woody vegetation other than native grasses from the levee slopes.					
Inspector Comment

View of the wild growth along the waterside slope. Fall 2022.

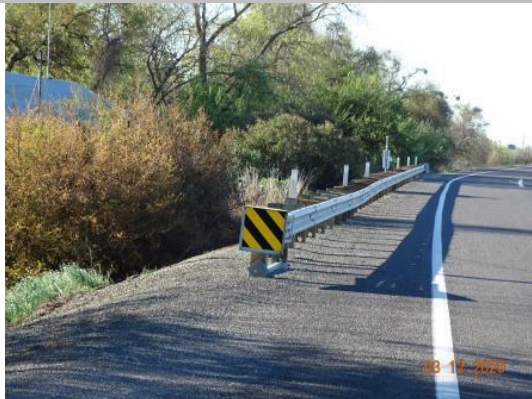
Photo 1 of 1 : FA\_2024\_LD0002\_28\_30\_20240924\_00009.jpg

LM Start	1.03	Rating **	M	Issue No.	30
LM End	1.03	Issue Type +	En	Location *	WS
Category	Earthen Levee			GPS Latitude/Longitude	
				Start	End
Item	Vegetation			39.428445 °	39.428445 °
				-122.010972 °	-122.010972 °
DWR ID	DWR_LD0002_01_f_2015_30				
Comment Code					
V6 : Landscaping					
Inspector Comment					
Remove the oleanders from the waterside slope.

View of the oleanders along the waterside slope. Spring 2020.

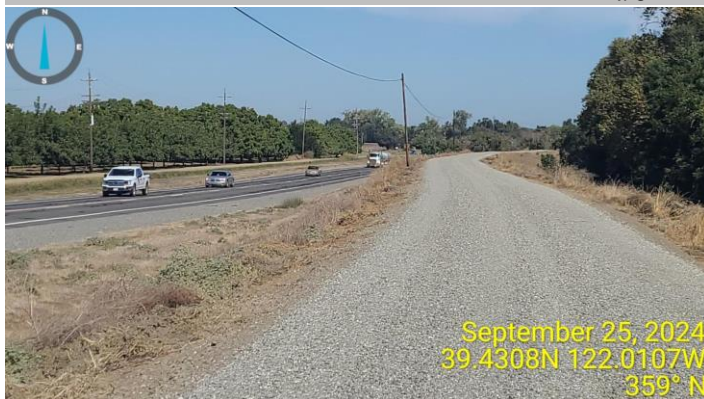
Photo 1 of 1 : FA\_2024\_LD0002\_28\_9\_20241001\_00027.jpg

LM Start	1.19	Rating **	M	Issue No.	9
LM End	1.97	Issue Type +	Ma	Location *	LS
Category	Earthen Levee			GPS Latitude/Longitude	
				Start	End
Item	Vegetation			39.430783°	39.441432°
				-122.010747°	-122.012150°
DWR ID	DWR_LD0002_01_f_2024_9				
Comment Code					
V1 : Control annual grass and weeds on the levee slopes and easements.					
Inspector Comment

View of the vegetation along the landside slope. Fall 2024.

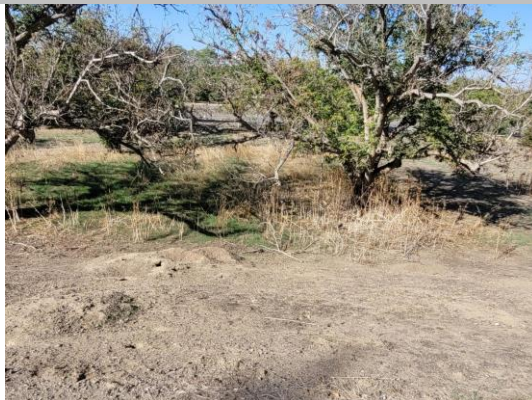
Photo 1 of 1 : FA\_2024\_LD0002\_28\_15\_20240924\_00005.jpg

LM Start	1.54	Rating **	U	Issue No.	15
LM End	1.60	Issue Type +	Ma	Location *	LS
Category	Earthen Levee			GPS Latitude/Longitude	
				Start	End
Item	Animal Control			39.435730 °	39.436643 °
				-122.010565 °	-122.010498 °
DWR ID	DWR_LD0002_01_f_2012_15				
Comment Code					
A3 : No rodents visible, but rodent burrows visible; need to backfill and compact or grout burrows.					
Inspector Comment

View of the rodent activity along the landside slope. Fall 2022.

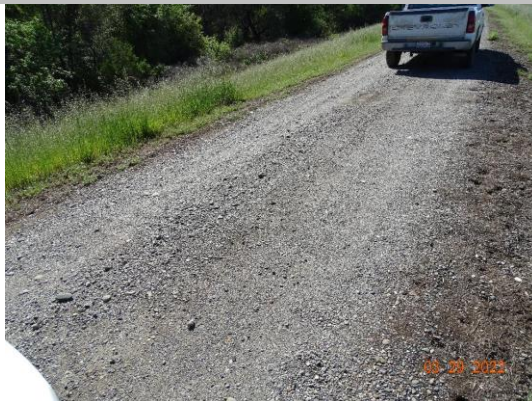
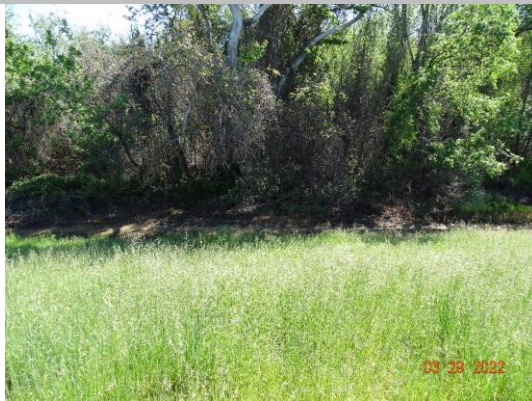
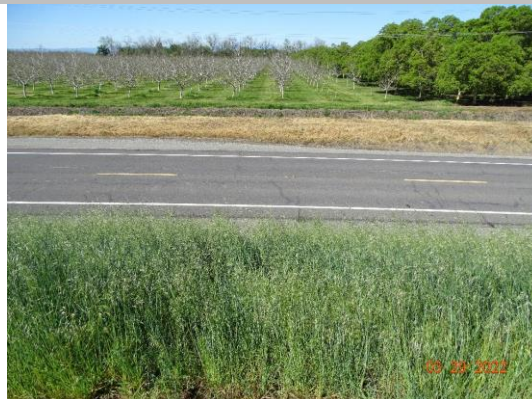
DS\_ID:21172  
FS\_ID:82099  
EP\_NO: N/A  
Repair Type: Non-Urgent  
EVAL Issue:  
Crossing Status: Not Found  
UCIP Comments: 01/11/2024 After detail review updated crossing location according to the Levee Log. Geophysical study of pipe DSID 21173 indicates possible presence of pipe through levee at this location, coordinates updated. Owner needs to coordinate with the CVFPB to remove or abandon crossing according to Title 23 requirements. Photos were taken at incorrect location. (O. Yakimov - DWR UCIP)  
03/29/2022 Record updated from No Action Needed to Non-Urgent. Crossing not found. Unauthorized encroachment recorded in Levee Log. (O.Yakimov - DWR UCIP)  
FIELD\_STRUCT\_DESC: 4-inch steel drainage pipe through the levee, 5.3 feet below the crown. No control valves. Pipe open on waterside (WS) end. Pump and pipe in concrete box (1x10-foot) and pit at the landside (LS) toe. [Additional Reference(s): DWR Levee Log, 2005 (HLM 1.86), listed as abandoned 4-inch pipe. USACE Sacramento O&M Manual, Unit 139, May 1955, Revised 29 December 2016, (STA 82+50), listed as 4-inch pipe].

Top of Levee: View of levee crown looking downstream

Water-Side: View of levee slope looking from crown

Land-Side: View of levee slope looking from crown

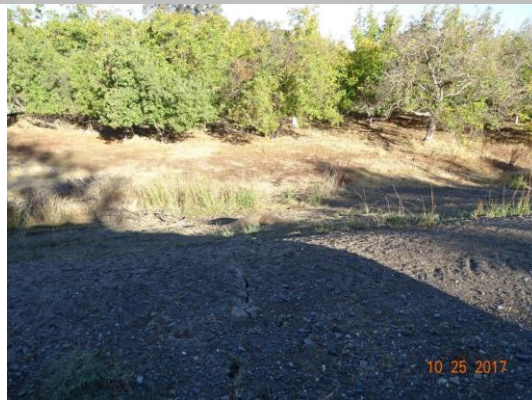
Photo 1 of 1 : FA\_2024\_LD0002\_28\_2\_20240924\_00001.jpg

LM Start	2.94	Rating **	M	Issue No.	2
LM End	2.94	Issue Type +	Ma	Location *	LS
Category	Earthen Levee			GPS Latitude/Longitude	
				Start	End
Item	Animal Control			39.453947 °	39.453947 °
				-122.015764 °	-122.015764 °
DWR ID	DWR_LD0002_01_f_2015_2				
Comment Code					
A3 : No rodents visible, but rodent burrows visible; need to backfill and compact or grout burrows.					
Inspector Comment

View of the rodent holes along the landside slope.

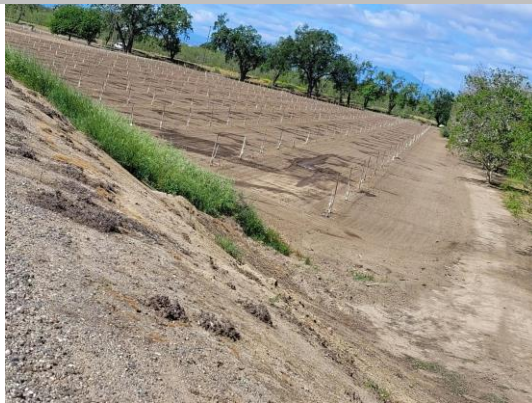
Photo 1 of 1 : FA\_2024\_LD0002\_28\_12\_20240924\_00004.jpg

LM Start	3.11	Rating **	U	Issue No.	12
LM End	3.13	Issue Type +	Ma	Location *	LS
Category	Earthen Levee			GPS Latitude/Longitude	
				Start	End
Item	Animal Control			39.455647 °	39.455805 °
				-122.013623 °	-122.013286 °
DWR ID	DWR_LD0002_01_s_2013_12				
Comment Code					
A1 : Exterminate rodents and backfill and compact or grout burrows.					
Inspector Comment

View of rodent activity on the landside slope. Spring 2022.

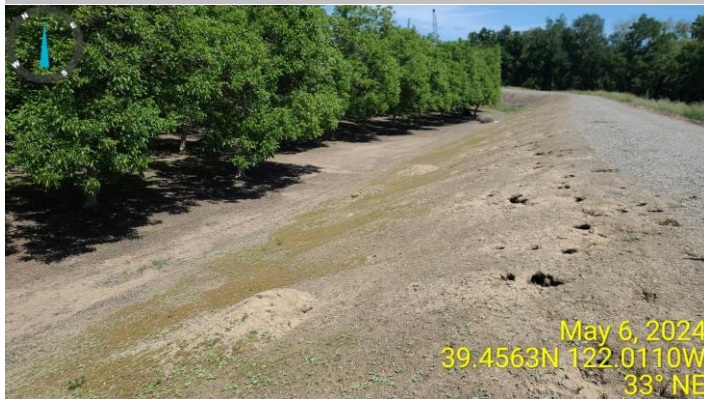
Photo 1 of 1 : FA\_2024\_LD0002\_28\_16\_20240924\_00006.jpg

LM Start	3.23	Rating **	U	Issue No.	16
LM End	3.32	Issue Type +	Ma	Location *	LS
Category	Earthen Levee			GPS Latitude/Longitude	
				Start	End
Item	Animal Control			39.456234 °	39.456302 °
				-122.011413 °	-122.009772 °
DWR ID	DWR_LD0002_01_f_2012_16				
Comment Code					
A3 : No rodents visible, but rodent burrows visible; need to backfill and compact or grout burrows.					
Inspector Comment

View of the rodent holes along the landside slope. Spring 2024.

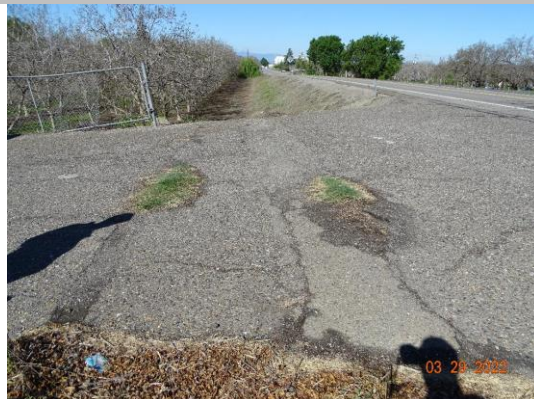
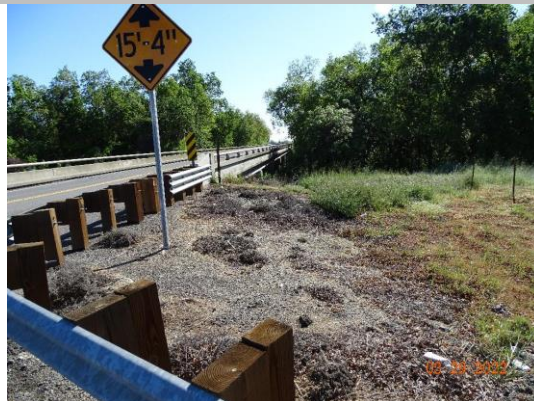
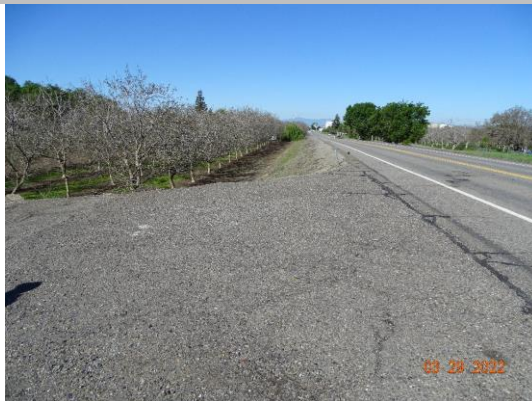
DS\_ID:21188  
 FS\_ID:75855  
 EP\_NO: 12444  
 Repair Type: Non-Urgent  
 EVAL Issue: 11, Maintenance Compliance Issue  
 Crossing Status: Indicator Found  
 UCIP Comments: 03/29/2022 Record remains Non-Urgent.  
 Communication line markers are not installed on any side of levee.  
 Bridge will be reconstructed. (O.Yakimov - DWR UCIP)  
 04/01/2015 Needs markers 10-feet off both levee toes. (W.Wylie - DWR UCIP)  
 FIELD\_STRUCT\_DESC: Buried cable steel conduit of unknown diameter through the levee, 2.5 feet below the crown. Conduit extends to pole on waterside (WS). Cut in pavement visible at levee crown.  
 (Buried cable authorized under Permit No. 12444, 1978 - Pacific Telephone and Telegraph Company). [Additional Reference(s): DWR Levee Log, 2005 (HLM 3.40), listed as fourth conduit].  
 FS Date: 3/29/2022 7:16:30 AM

Top of Levee: View of levee crown looking from waterside. Cut in levee crown visible

Water-Side: View of levee slope looking from crown. Conduit not found

Land-Side: View of levee slope looking from crown

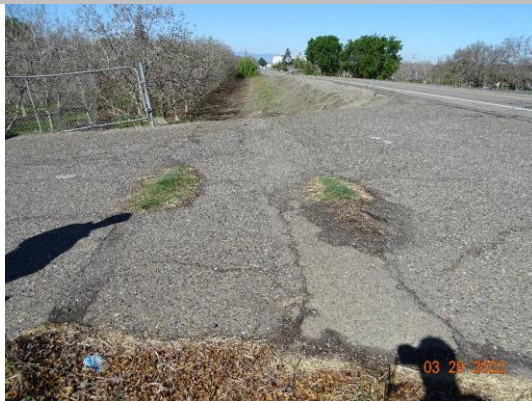
DS\_ID:21175  
FS\_ID:75856  
EP\_NO: 5376  
Repair Type: Non-Urgent  
EVAL Issue: 11, Maintenance Compliance Issue  
Crossing Status: Indicator Found  
UCIP Comments: 03/29/2022 Record remains Non-Urgent.  
Communication line markers are not installed on any side of levee.  
(O.Yakimov - DWR UCIP)  
04/01/2015 Conduit needs markers ten feet off both levee toes.  
(W.Wylie - DWR UCIP)  
FIELD\_STRUCT\_DESC: Three 3.5-inch steel cables sleeved through conduit through the levee, 3 feet below the crown. Metal cutoff wall around conduits near center of levee. Conduits are welded to the cutoff wall, extending only between the levee shoulders under the crown. Cut in pavement visible at crown. Cables extend to pole on waterside (WS). (Replacement of existing aerial telephone cables with two buried cables authorized under Permit No. 5376, 1967-Pacific Telephone & Telegraph Co). [Additional Reference(s): DWR Levee Log, 2005 (HLM 3.40), listed as three 3.5-inch conduits].

Top of Levee: View of levee crown looking from waterside. Cut in pavement still visible

Water-Side: View of levee slope looking from toe. Conduit not found

Land-Side: View of levee slope looking from crown

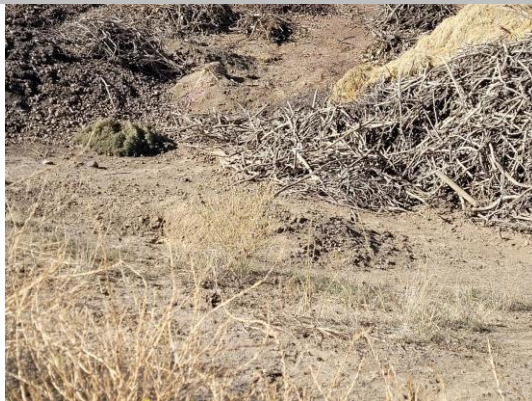
Photo 1 of 1 : FA\_2024\_LD0002\_28\_24\_20240924\_00007.jpg

LM Start	3.48	Rating **	U	Issue No.	24
LM End	3.48	Issue Type +	Ma	Location *	LS
Category	Earthen Levee			GPS Latitude/Longitude	
				Start	End
Item	Animal Control			39.458193 °	39.458193 °
				-122.009550 °	-122.009550 °
DWR ID	DWR_LD0002_01_f_2021_24				
Comment Code					
A3 : No rodents visible, but rodent burrows visible; need to backfill and compact or grout burrows.					
Inspector Comment

View of rodent activity along the landside slope. Fall 2022.

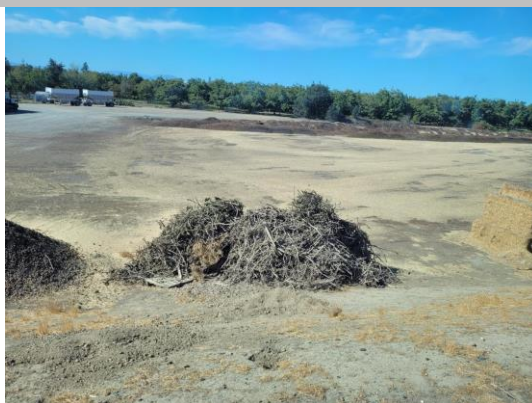
Photo 1 of 1 : FA\_2024\_LD0002\_28\_33\_20240924\_00010.jpg

LM Start	3.48	Rating **	M	Issue No.	33
LM End	3.48	Issue Type +	En	Location *	LS
Category	Earthen Levee			GPS Latitude/Longitude	
				Start	End
Item	Encroachments			39.458199 °	39.458199 °
				-122.009549 °	-122.009549 °
DWR ID	DWR_LD0002_01_f_2021_33				
Comment Code					
PR : Prunings					
Inspector Comment

View of the pile of prunings at the landside toe. Fall 2021.

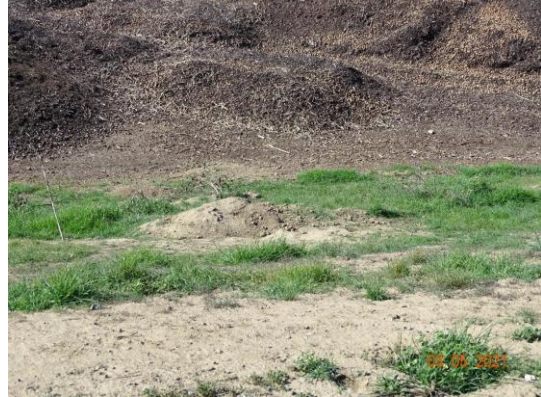
Photo 1 of 1 : FA\_2024\_LD0002\_28\_27\_20240924\_00008.jpg

LM Start	3.53	Rating **	M	Issue No.	27
LM End	3.59	Issue Type +	Ma	Location *	LS
Category	Earthen Levee			GPS Latitude/Longitude	
				Start	End
Item	Animal Control			39.458807°	39.459614°
				-122.009990°	-122.010741°
DWR ID	DWR_LD0002_01_s_ 2014_27				
Comment Code					
A3 : No rodents visible, but rodent burrows visible; need to backfill and compact or grout burrows.					
Inspector Comment

View of the rodent holes along the landside slope. Spring 2021.

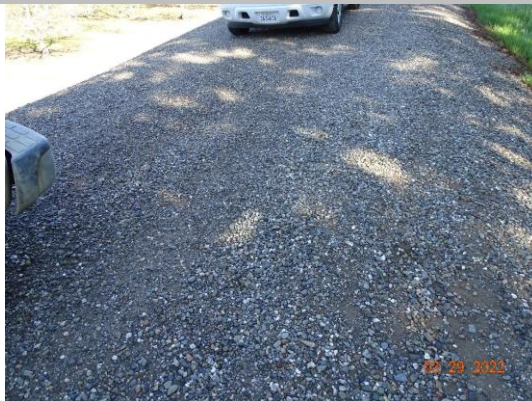
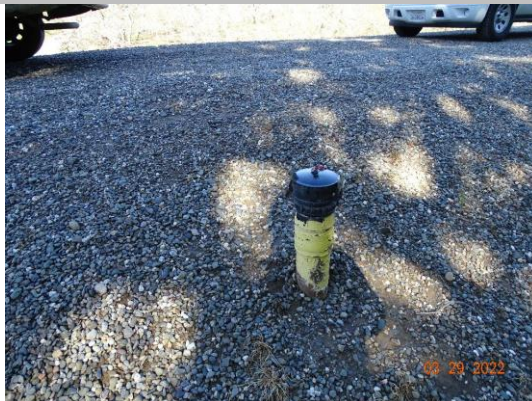
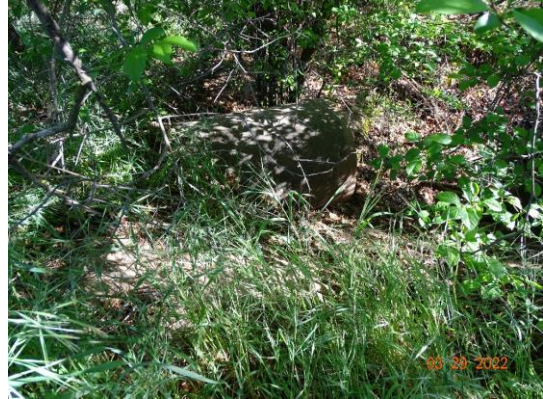
DS\_ID:24659  
FS\_ID:75859  
EP\_NO: 16280  
Repair Type: Non-Urgent  
EVAL Issue: 10, Unauthorized Modification or Non-Compliant Permit  
Crossing Status: Found  
UCIP Comments: 03/29/2022 Record remains Non-Urgent. Permit file not available, only USACE no objection letter authorizing 10-inch pipe. No other issues observed during inspection. (O.Yakimov - DWR UCIP)  
05/16/2013 Need to contact owner to determine status of crossing. (O.Magana - DWR UCIP)  
FIELD\_STRUCT\_DESC: 24-inch steel drainage pipe through levee, 2-feet below the crown. Pipe is exposed on waterside (WS) with air vent on the WS levee shoulder. Intake point in drainage ditch and diesel pump are located approximately 500 feet on the landside (LS) off the levee toe. (10-inch pipe authorized under Permit No. 16280, 1995 - Mathew J. Southam/McGowan).  
FS Date: 3/29/2022 8:12:59 AM

Top of Levee: View of levee crown looking upstream

Water-Side: Capped air vent on levee slope

Water-Side: View of pipe on levee berm

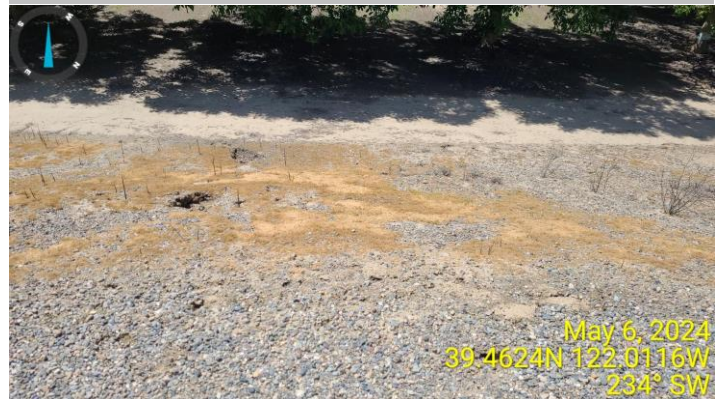
Photo 1 of 1 : FA\_2024\_LD0002\_28\_50\_20240924\_00014.jpg

LM Start	3.79	Rating **	M	Issue No.	50
LM End	3.79	Issue Type +	Ma	Location *	LS
Category	Earthen Levee			GPS Latitude/Longitude	
				Start	End
Item	Animal Control			39.462358 °	39.462358 °
				-122.011623 °	-122.011623 °
DWR ID	DWR_LD0002_01_s_2019_50				
Comment Code					
A3 : No rodents visible, but rodent burrows visible; need to backfill and compact or grout burrows.					
Inspector Comment

View of the rodent holes on the landside slope. Spring 2024.
