**Flood Control Project Maintenance  
Levee Inspections**  
**LMA District Cover Sheet**  
**Spring 2015 Levee Inspection Results**

**Levee District No. 0002 (Glenn County)**

**Levee Inspection Report By Mile - Spring 2015**

Waterway	Bank	Unit Miles	Inspection Start/End	Inspector
Unit No. 01 Glenn County Sacramento River	Right	4.90	04/07/2015 04/07/2015	Bob Duffey

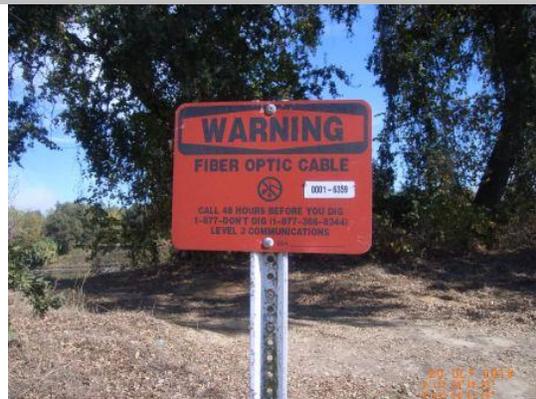
Photo 2 of 2 : SP\_2015\_LD0002\_28\_6\_20150310\_00005.jpg

LM Start	<b>0.07</b>	Rating **	M	Issue No.	<b>6 (cont)</b>
LM End	<b>0.28</b>	Issue Type +	Ma	Location *	WS

USACE 2013 Photo #2

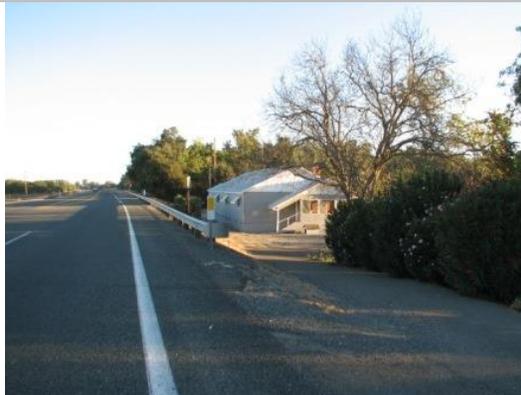
Photo 1 of 1 : SP\_2015\_LD0002\_28\_8\_20150310\_00006.jpg

LM Start	<b>1.02</b>	Rating **	M	Issue No.	<b>8</b>
LM End	<b>1.02</b>	Issue Type +	En	Location *	WS
Category	Earthen Levee		GPS Latitude/Longitude		
			Start	End	
Item	Encroachments		39.428322 °	39.428322 °	
			-122.010973 °	-122.010973 °	
DWR ID	DWR_LD0002_01_s_2012_8				
Action/Comments					
Building

View of a house along the waterside toe.

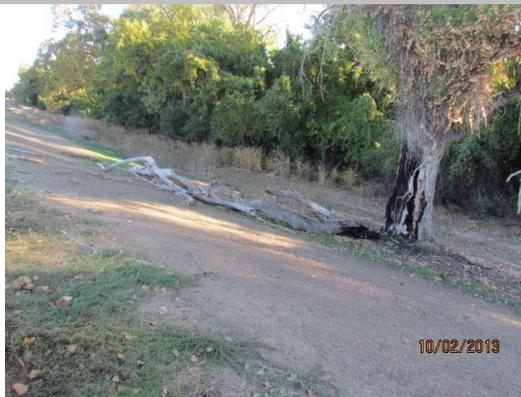
Photo 1 of 1 : SP\_2015\_LD0002\_28\_40\_20150310\_00013.jpg

LM Start	<b>1.24</b>	Rating **	M	Issue No.	<b>40</b>
LM End	<b>1.24</b>	Issue Type +	En	Location *	WS
Category	Earthen Levee			GPS Latitude/Longitude	
				Start	End
Item	Encroachments			39.431499 °	39.431499 °
				-122.010803 °	-122.010803 °
DWR ID	DWR_LD0002_01_f_2013_40				
Action/Comments					
Tree or limb

View of the downed tree limb along the slope of the levee.

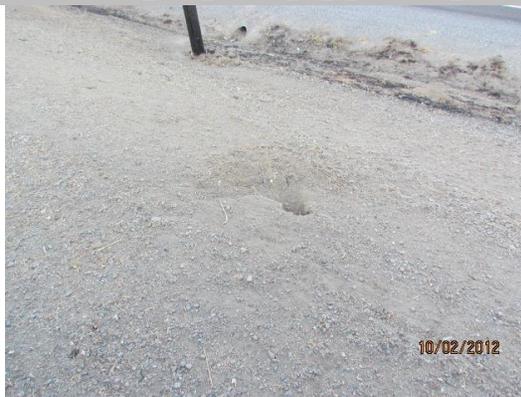
Photo 1 of 1 : SP\_2015\_LD0002\_28\_4\_20150310\_00002.jpg

LM Start	<b>1.43</b>	Rating **	M	Issue No.	<b>4</b>
LM End	<b>1.43</b>	Issue Type +	Ma	Location *	LS
Category	Earthen Levee			GPS Latitude/Longitude	
				Start	End
Item	Animal Control			39.434157 °	39.434157 °
				-122.010760 °	-122.010760 °
DWR ID	DWR_LD0002_01_f_2012_4				
Action/Comments					
No rodents visible, but rodent burrows visible; need to backfill and compact or grout burrows.

View of the rodent holes along the landside slope.

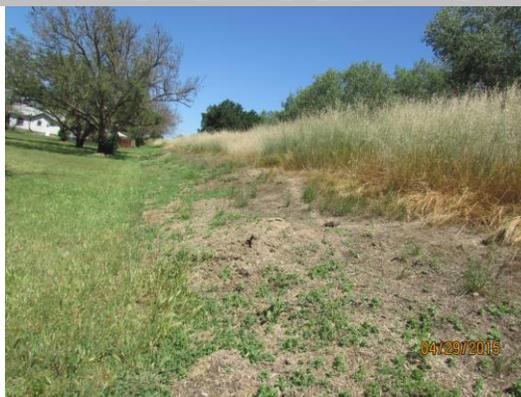
Photo 1 of 1 : SP\_2015\_LD0002\_28\_15\_20150504\_00018.jpg

LM Start	<b>1.52</b>	Rating **	M	Issue No.	<b>15</b>
LM End	<b>1.60</b>	Issue Type +	Ma	Location *	LS
Category	Earthen Levee			GPS Latitude/Longitude	
				Start	End
Item	Animal Control			39.435485 °	39.436643 °
				-122.010640 °	-122.010498 °
DWR ID	DWR_LD0002_01_f_2012_15				
Action/Comments					
No rodents visible, but rodent burrows visible; need to backfill and compact or grout burrows. Inspector Comments: LMA needs to repair the rodent holes.

View of the rodent holes along the landside slope.

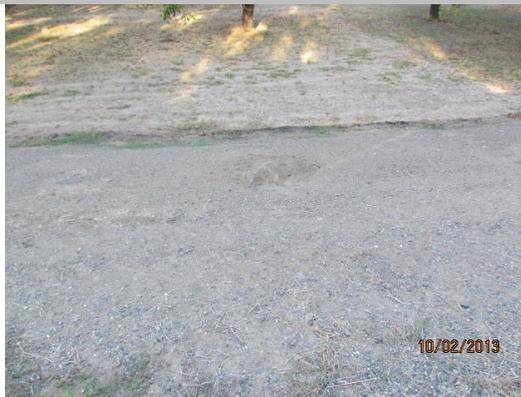
Photo 1 of 1 : SP\_2015\_LD0002\_28\_41\_20150310\_00014.jpg

LM Start	<b>1.57</b>	Rating **	A/W	Issue No.	<b>41</b>
LM End	<b>1.57</b>	Issue Type +	Ma	Location *	LS
Category	Earthen Levee			GPS Latitude/Longitude	
				Start	End
Item	Animal Control			39.436149 °	39.436149 °
				-122.010525 °	-122.010525 °
DWR ID	DWR_LD0002_01_f_2013_41				
Action/Comments					
No rodents visible, but rodent burrows visible; need to backfill and compact or grout burrows.

View of the rodent holes along the slope of the levee.

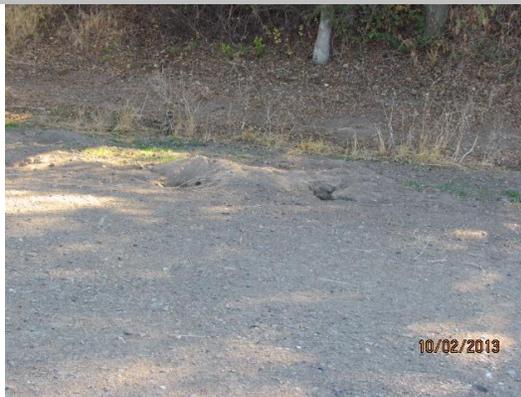
Photo 1 of 1 : SP\_2015\_LD0002\_28\_42\_20150310\_00015.jpg

LM Start	<b>2.77</b>	Rating **	A/W	Issue No.	<b>42</b>
LM End	<b>2.77</b>	Issue Type +	Ma	Location *	WS
Category	Earthen Levee			GPS Latitude/Longitude	
				Start	End
Item	Animal Control			39.451841 °	39.451841 °
				-122.017120 °	-122.017120 °
DWR ID	DWR_LD0002_01_f_2013_42				
Action/Comments					
No rodents visible, but rodent burrows visible; need to backfill and compact or grout burrows.

View of the rodent holes along the slope of the levee.

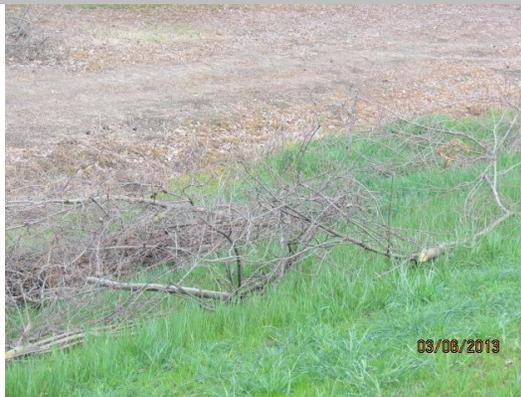
Photo 1 of 1 : SP\_2015\_LD0002\_28\_5\_20150310\_00003.jpg

LM Start	<b>2.89</b>	Rating **	M	Issue No.	<b>5</b>
LM End	<b>2.89</b>	Issue Type +	En	Location *	LS
Category	Earthen Levee		GPS Latitude/Longitude		
			Start	End	
Item	Encroachments		39.453490 °	39.453490 °	
			-122.016457 °	-122.016457 °	
DWR ID	DWR_LD0002_01_s_2013_5				
Action/Comments					
Prunings

View of the prunings along the landside toe.

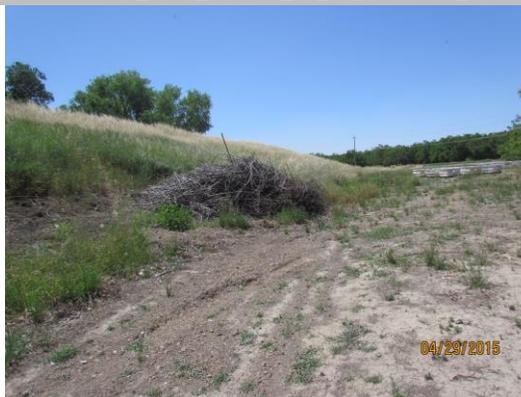
Photo 1 of 1 : SP\_2015\_LD0002\_28\_29\_20150504\_00019.jpg

LM Start	<b>2.91</b>	Rating **	M	Issue No.	<b>29</b>
LM End	<b>2.91</b>	Issue Type +	En	Location *	LS
Category	Earthen Levee		GPS Latitude/Longitude		
			Start	End	
Item	Encroachments		39.453737 °	39.453737 °	
			-122.016413 °	-122.016413 °	
DWR ID	DWR_LD0002_01_s_2015_29				
Action/Comments					
Prunings

View of the prunings along the landside toe.

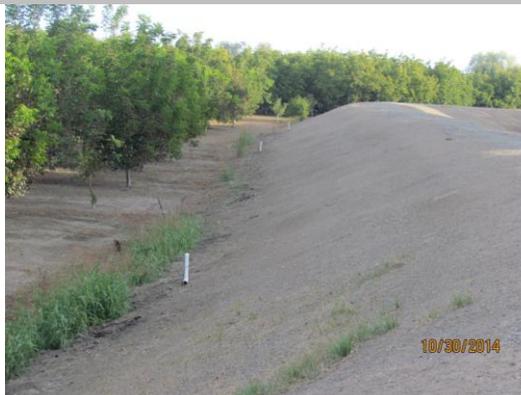
Photo 1 of 1 : SP\_2015\_LD0002\_28\_2\_20150310\_00001.jpg

LM Start	<b>2.91</b>	Rating **	A/W	Issue No.	<b>2</b>
LM End	<b>2.96</b>	Issue Type +	Ma	Location *	LS
Category	Earthen Levee		GPS Latitude/Longitude		
			Start	End	
Item	Animal Control		39.453595 °	39.454003 °	
			-122.016273 °	-122.015503 °	
DWR ID	DWR_LD0002_01_s_2012_2				
Action/Comments					
No rodents visible, but rodent burrows visible; need to backfill and compact or grout burrows.

View of the rodent holes and bait station along the landside slope.

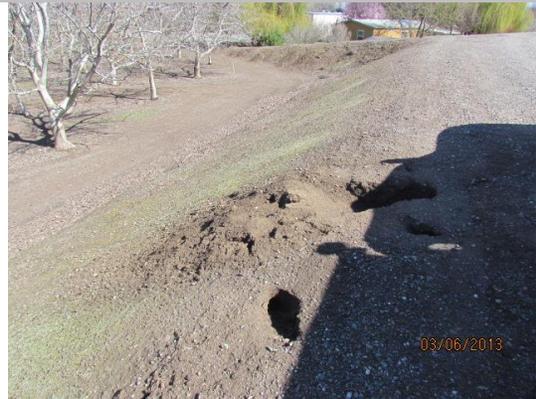
Photo 1 of 1 : SP\_2015\_LD0002\_28\_12\_20150310\_00009.jpg

LM Start	<b>3.16</b>	Rating **	M	Issue No.	<b>12</b>
LM End	<b>3.16</b>	Issue Type +	Ma	Location *	WS
Category	Earthen Levee		GPS Latitude/Longitude		
			Start	End	
Item	Animal Control		39.455992 °	39.455992 °	
			-122.012809 °	-122.012809 °	
DWR ID	DWR_LD0002_01_s_2013_12				
Action/Comments					
Exterminate rodents and backfill and compact or grout burrows.

View of the rodent activity along the landside slope.

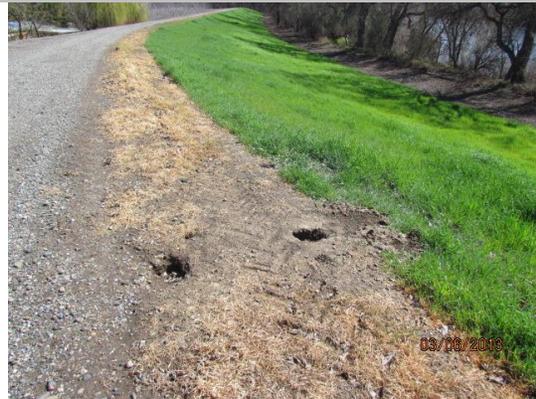
Photo 1 of 1 : SP\_2015\_LD0002\_28\_9\_20150310\_00007.jpg

LM Start	<b>3.16</b>	Rating **	M	Issue No.	<b>9</b>
LM End	<b>3.16</b>	Issue Type +	Ma	Location *	LS
Category	Earthen Levee		GPS Latitude/Longitude		
			Start	End	
Item	Animal Control		39.455992 °	39.455992 °	
			-122.012808 °	-122.012808 °	
DWR ID	DWR_LD0002_01_s_2013_9				
Action/Comments					
No rodents visible, but rodent burrows visible; need to backfill and compact or grout burrows.

View of the rodent activity along the waterside slope.

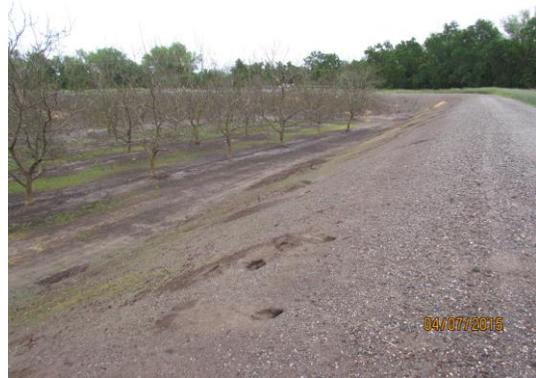
Photo 1 of 1 : SP\_2015\_LD0002\_28\_16\_20150420\_00016.jpg

LM Start	<b>3.27</b>	Rating **	M	Issue No.	<b>16</b>
LM End	<b>3.30</b>	Issue Type +	Ma	Location *	LS
Category	Earthen Levee			GPS Latitude/Longitude	
				Start	End
Item	Animal Control			39.456237 °	39.456272 °
				-122.010640 °	-122.010163 °
DWR ID	DWR_LD0002_01_f_2012_16				
Action/Comments					
No rodents visible, but rodent burrows visible; need to backfill and compact or grout burrows. Inspector Comments: Grout or fill the rodent holes.

View of the rodent holes along the landside slope.

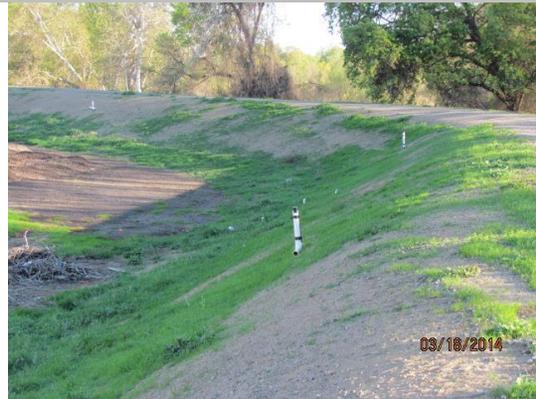
Photo 1 of 1 : SP\_2015\_LD0002\_28\_27\_20150310\_00012.jpg

LM Start	<b>3.44</b>	Rating **	A/W	Issue No.	<b>27</b>
LM End	<b>3.52</b>	Issue Type +	Ma	Location *	LS
Category	Earthen Levee			GPS Latitude/Longitude	
				Start	End
Item	Animal Control			39.457692 °	39.458705 °
				-122.009517 °	-122.009872 °
DWR ID	DWR_LD0002_01_s_2014_27				
Action/Comments					
No rodents visible, but rodent burrows visible; need to backfill and compact or grout burrows.

View of the rodent activity along the l/s slope.

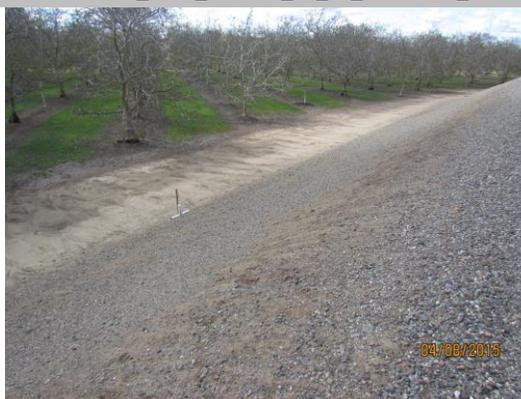
Photo 1 of 1 : SP\_2015\_LD0002\_28\_11\_20150420\_00017.jpg

LM Start	<b>4.87</b>	Rating **	A/W	Issue No.	<b>11</b>
LM End	<b>4.87</b>	Issue Type +	Ma	Location *	LS
Category	Earthen Levee		GPS Latitude/Longitude		
			Start	End	
Item	Animal Control		39.476676 °	39.476676 °	
			-122.017439 °	-122.017439 °	
DWR ID	DWR_LD0002_01_s_2012_11				
Action/Comments					
No rodents visible, but rodent burrows visible; need to backfill and compact or grout burrows. Inspector Comments: The rodent holes have been filled with dirt.

View of the removed rodent holes and bait station.
