**Flood Control Project Maintenance  
Levee Inspections**  
**LMA District Cover Sheet**  
**Spring 2016 Levee Inspection Results**

**Levee District No. 0002 (Glenn County)**

**Levee Inspection Report By Mile - Spring 2016**

Waterway	Bank	Unit Miles	Inspection Start/End	Inspector
Unit No. 01 Glenn County Sacramento River	Right	4.90	04/22/2016 04/22/2016	Keith Millard

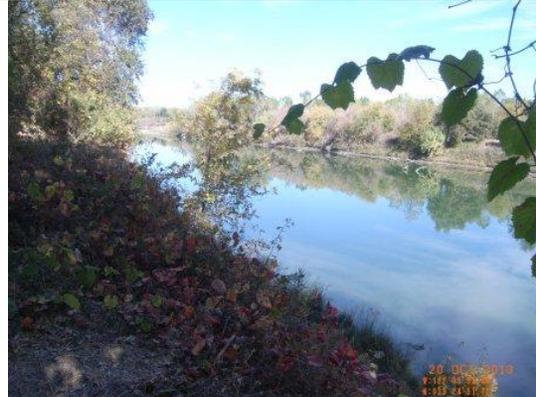
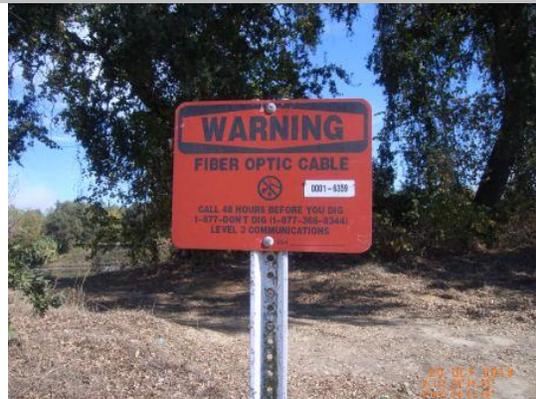
LM Start	<b>0.07</b>	Rating **	M	Issue No.	<b>6</b>
LM End	<b>0.28</b>	Issue Type +	Ma	Location *	WS
Category	Supplemental			GPS Latitude/Longitude	
				Start	End
Item	2015 USACE Erosion Survey, DRAFT			39.414649 °	39.417689 °
				-122.009853 °	-122.010369 °
DWR ID	DWR_LD0002_01_s_2016_6				
Comment Code					
Inspector Comment					
2009 - Very slow retreat, hard toe, encroaching into the levee projection. 2010 - Slowly eroding. 2011 - Site extended downstream. 2015: Last observed in 2013. [2015 Site ID: SAC_164-7_R]

USACE 2013 Photo #1

USACE 2013 Photo #2

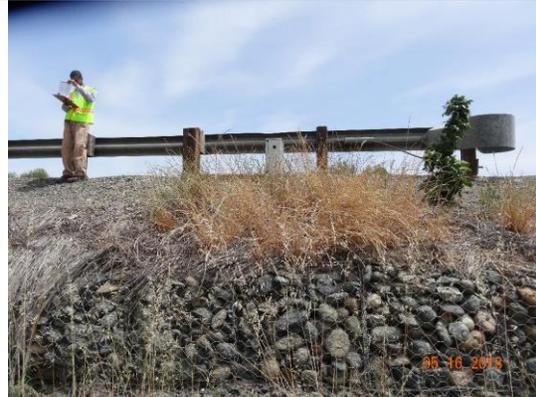
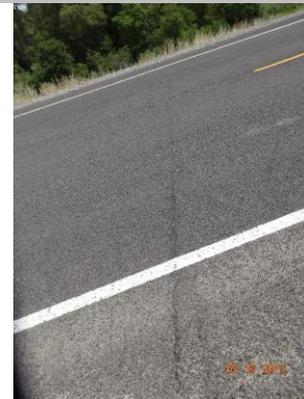
LM Start	<b>0.59</b>	Rating **	M	Issue No.	<b>53</b>
LM End	<b>0.59</b>	Issue Type +	En	Location *	WS
Category	Supplemental			GPS Latitude/Longitude	
				Start	End
Item	DWR UCIP Field Study			39.422088 °	39.422088 °
				-122.011615 °	-122.011615 °
DWR ID					
Comment Code					
Inspector Comment					
FS_ID:42083 DS_ID:24877 EP_NO: N/A Repair Type: Non-Urgent Crossing Status: Indicator Found UCIP Comments: Need to contact owner to determine if conduit goes through levee crown. If it does, will need to obtain permit number issued for encroachment. FIELD_STRUCT_DESC: Caltrans traffic control box located on the landside (LS) shoulder. Unable to determine if crossing goes through levee. FS Date: 5/16/2013

View of landward slope.

View of levee crown at crossing.

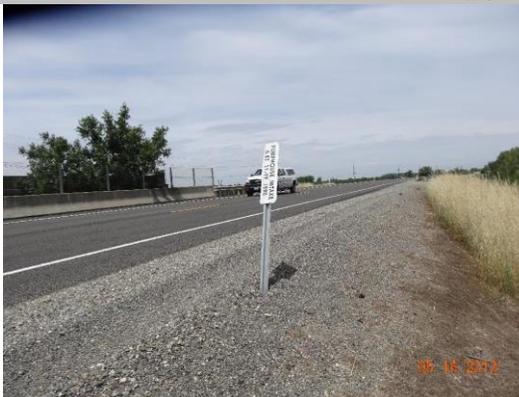
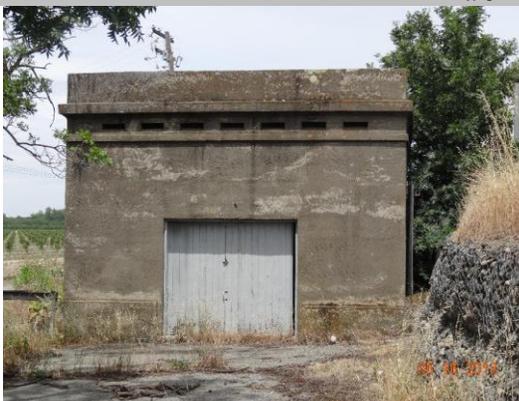
FS\_ID:38166  
 DS\_ID:21184  
 EP\_NO: N/A  
 Repair Type: Non-Urgent  
 Crossing Status: Found  
 UCIP Comments: Three pipes found in the pump house on landward side. Pump house appears to be no longer in use. Unable to locate pipes on waterward side. Will need to contact owner to determine status. Owner will need to coordinate with CVFPB regarding proper removal per Title 23 requirements.  
 FIELD\_STRUCT\_DESC: [Princeton-Cordora-Glenn Irrigation District: Schaad Pumping Plant] 2 of 3: 34-inch steel pipe sleeved through 36-inch steel pipe through the levee, 20.0 feet below the crown. Annular gap is grouted. Flap gate on landside (LS) end. Pump in pump house on LS slope. Rock revetment around outlet on waterside (WS) slope. (USACE-1955). This entry matches the Drainage or Irrigation Structure referenced in O&M manual (Station 41+47). Pipes sleeved through pre-existing pipes installed under Permit No. 2356 (1956). (Permit No. 2356-1956, Princetan-Codora-Glenn Irrigation District)

View of levee crown at crossing.

View of Princeton-Cordora-Glenn Irrigation District--Schaad Pumping Plant.

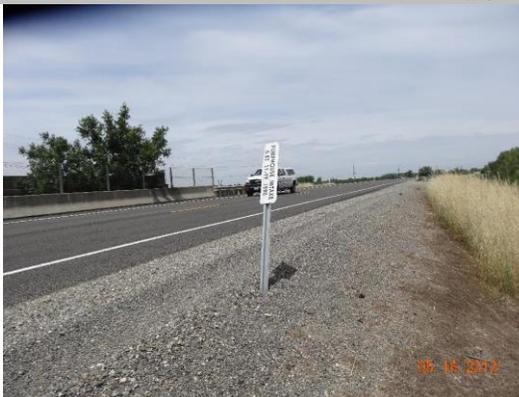
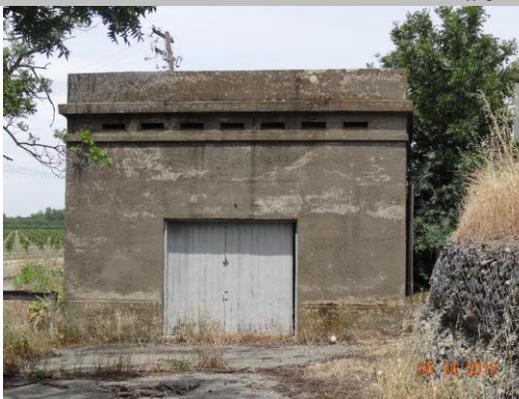
FS\_ID:38167  
 DS\_ID:21171  
 EP\_NO: N/A  
 Repair Type: Non-Urgent  
 Crossing Status: Found  
 UCIP Comments: Three pipes found in the pump house on landward side. Pump house appears to be no longer in use. Unable to locate pipes on waterward side. Will need to contact owner to determine status. Owner will need to coordinate with CVFPB regarding proper removal per Title 23 requirements.  
 FIELD\_STRUCT\_DESC: [Princeton-Cordora-Glenn Irrigation District: Schaad Pumping Plant] 3 of 3: 34-inch steel pipe sleeved through 36-inch steel pipe through the levee, 20.0 feet below the crown. Annular gap is grouted. Flap gate on landside (LS) end. Pump in pump house on LS slope. Rock revetment around outlet on waterside (WS) slope. (USACE-1955). This entry matches the Drainage or Irrigation Structure referenced in O&M manual (Station 41+47). Pipes sleeved through pre-existing pipes installed under Permit No. 2356 (1956). (Permit No. 2356-1956, Princetan-Codora-Glenn Irrigation District)

View of levee crown with marker on waterward side.

View of Princeton-Cordora-Glenn Irrigation District-Schaad Pumping Plant.

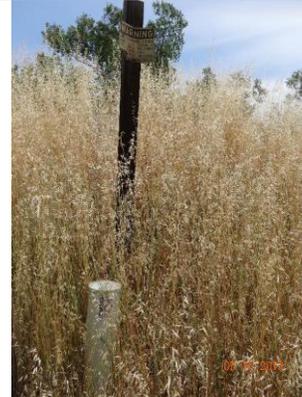
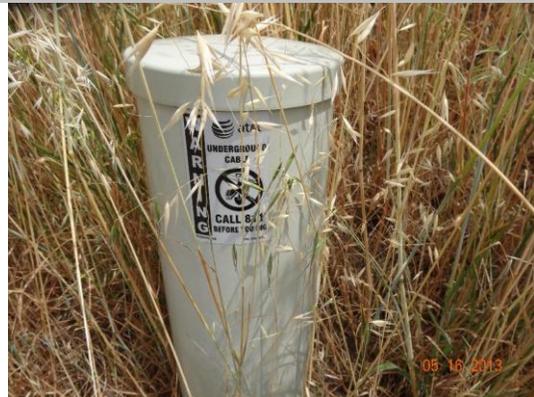
Item	DWR UCIP Field Study			39.428441 °	39.428441 °
				-122.011032 °	-122.011032 °
DWR ID					
Comment Code					
Inspector Comment					
FS_ID:44170 DS_ID:21177 EP_NO: 9723 Repair Type: Non-Urgent Crossing Status: Indicator Found UCIP Comments: Owner is listed as Pacific Bell however sign lists AT&T as owner, need to contact owner to determine if permit was updated or if this crossing is listed under new permit. Unable to confirm if 2 crossings are present at this site. FIELD_STRUCT_DESC: Buried telephone cable through the levee at unknown depth. Telephone pole and junction box on landside (LS) toe. This line was retained under an automatic board order (ABO) (Permit No. 9723-1974, Pacific Telephone Company). FS Date: 5/16/2013

Indicators of existing line visible on slope.

AT&T underground cable line.

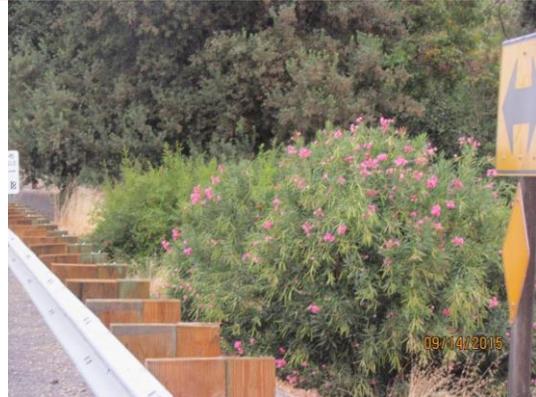
View of the oleanders along the waterside slope.

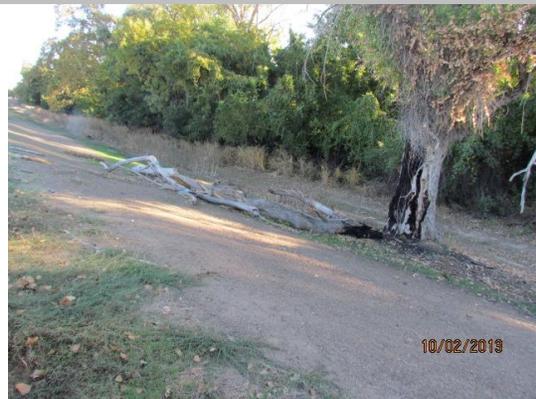
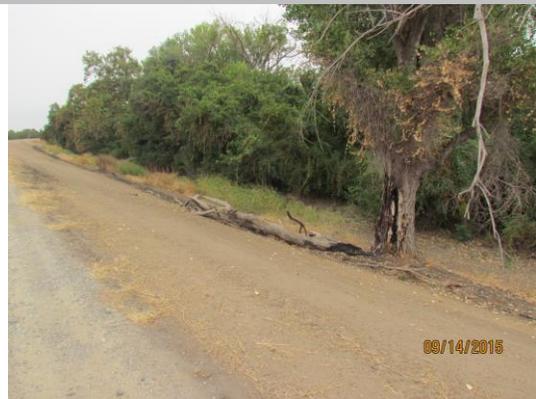
View of the downed tree limb along the slope of the levee.

View of the tree limbs along the waterside slope.

LM Start	<b>1.24</b>	Rating **	M	Issue No.	<b>40</b>
LM End	<b>1.24</b>	Issue Type +	Ma	Location *	WS
Category	Earthen Levee		GPS Latitude/Longitude		
			Start	End	
Item	Encroachments		39.431499 °	39.431499 °	
			-122.010803 °	-122.010803 °	
DWR ID	DWR_LD0002_01_f_2013_40				
Comment Code					
TR : Tree or limb					
Inspector Comment					
Remove the tree limbs from the waterside slope.

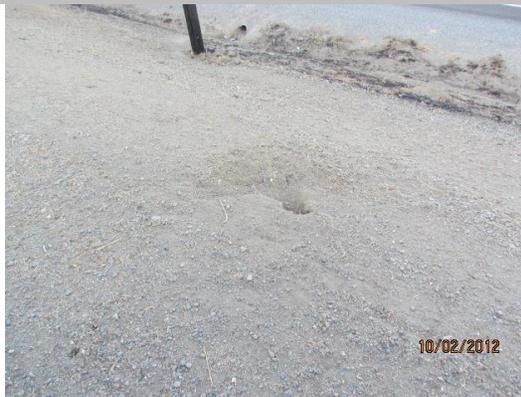
View of the rodent holes along the landside slope.

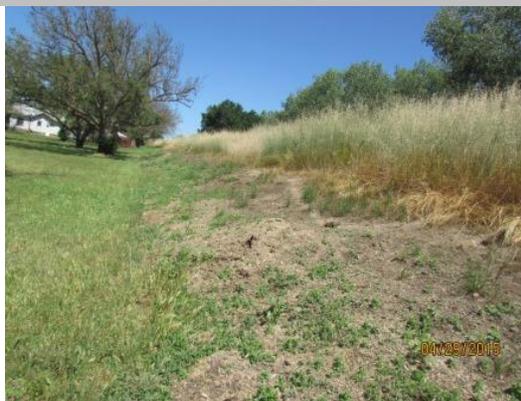
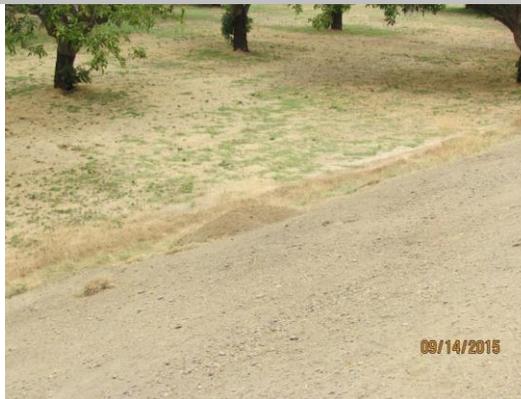
View of the rodent holes along the landside slope.

LM Start	<b>1.52</b>	Rating **	M	Issue No.	<b>15</b>
LM End	<b>1.60</b>	Issue Type +	Ma	Location *	LS
Category	Earthen Levee		GPS Latitude/Longitude		
			Start	End	
Item	Animal Control		39.435485 °	39.436643 °	
			-122.010640 °	-122.010498 °	
DWR ID	DWR_LD0002_01_f_2012_15				
Comment Code					
A3 : No rodents visible, but rodent burrows visible; need to backfill and compact or grout burrows.					
Inspector Comment					
LMA needs to repair the rodent holes.

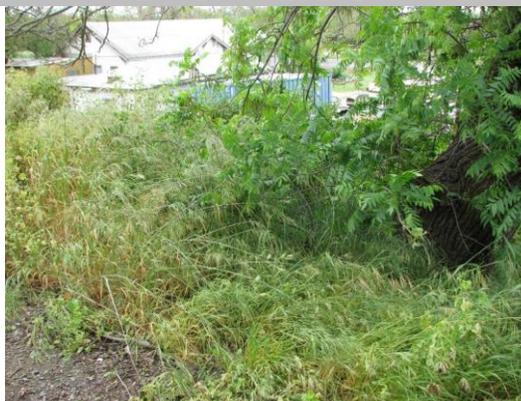
04/22/2016: Vegetation on L/S slope

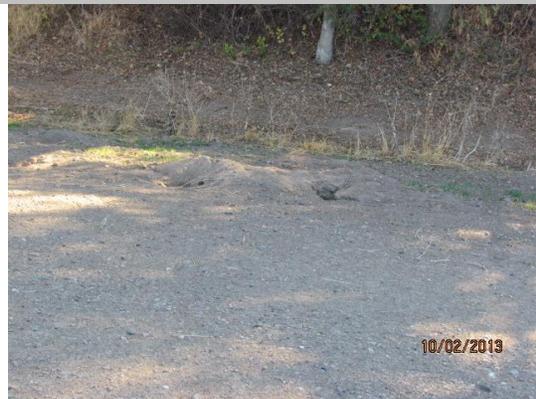
View of the rodent holes along the slope of the levee.

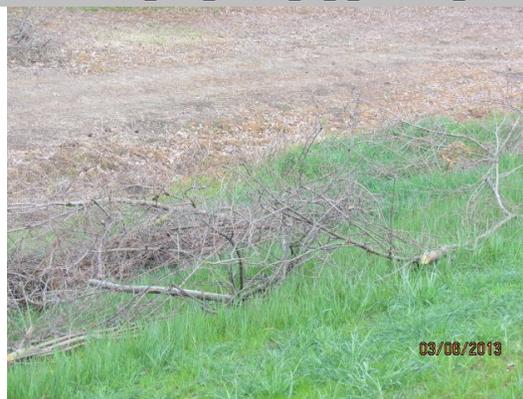
View of the prunings along the landside toe.

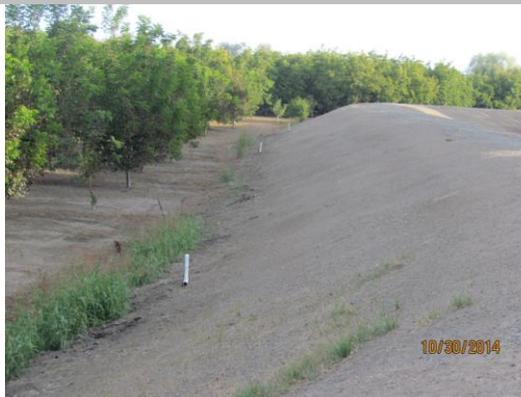
View of the rodent holes and bait station along the landside slope.

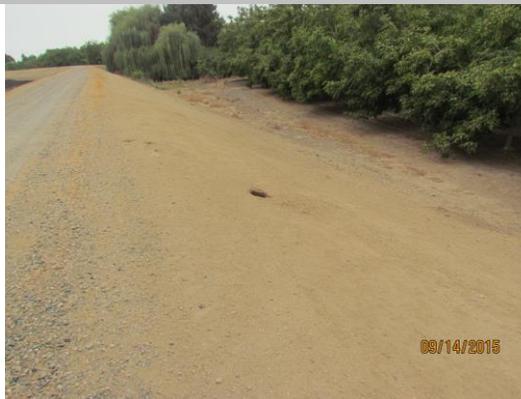
View of the rodent holes along the waterside slope.

LM Start	<b>3.06</b>	Rating **	M	Issue No.	<b>3</b>
LM End	<b>3.13</b>	Issue Type +	Ma	Location *	WS
Category	Earthen Levee		GPS Latitude/Longitude		
			Start	End	
Item	Animal Control		39.455145 °	39.455813 °	
			-122.014287 °	-122.013205 °	
DWR ID	DWR_LD0002_01_s_2012_3				
Comment Code					
A3 : No rodents visible, but rodent burrows visible; need to backfill and compact or grout burrows.					
Inspector Comment					
Repair the rodent holes along the waterside slope.

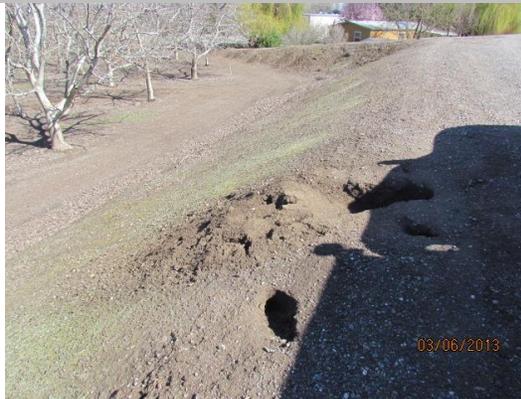
View of the rodent activity along the landside slope.

LM Start	<b>3.12</b>	Rating **	U	Issue No.	<b>12</b>
LM End	<b>3.17</b>	Issue Type +	Ma	Location *	LS
Category	Earthen Levee		GPS Latitude/Longitude		
			Start	End	
Item	Animal Control		39.455752 °	39.456108 °	
			-122.013387 °	-122.012511 °	
DWR ID	DWR_LD0002_01_s_2013_12				
Comment Code					
A1 : Exterminate rodents and backfill and compact or grout burrows.					
Inspector Comment					
Repair the rodent holes along landside slope.

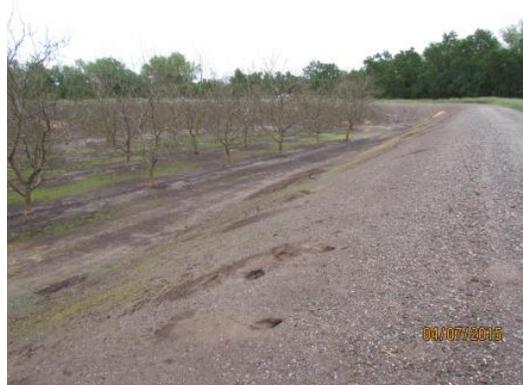
View of the rodent holes along the landside slope.

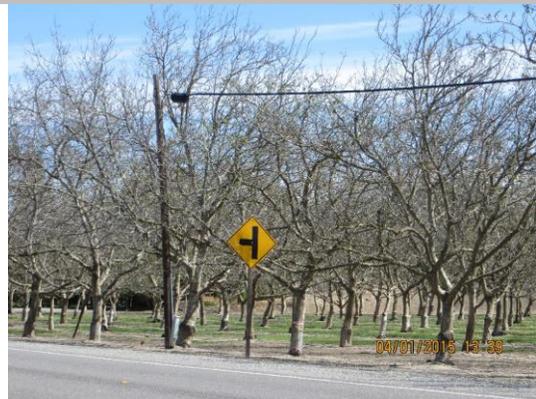
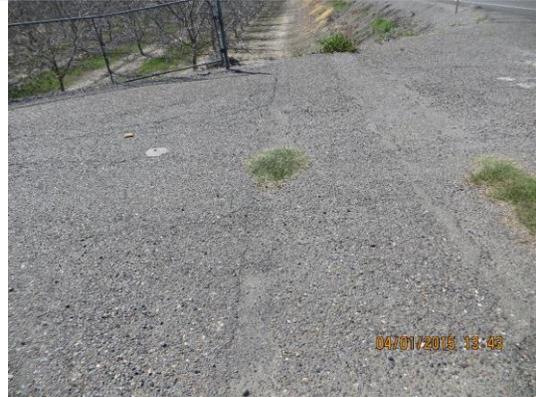
LM Start	<b>3.37</b>	Rating **	M	Issue No.	<b>56</b>
LM End	<b>3.37</b>	Issue Type +	En	Location *	LS
Category	Supplemental			GPS Latitude/Longitude	
				Start	End
Item	DWR UCIP Field Study			39.456704 °	39.456704 °
				-122.009621 °	-122.009621 °
DWR ID					
Comment Code					
Inspector Comment					
FS_ID:44186 DS_ID:21188 EP_NO: 12444 Repair Type: Non-Urgent Crossing Status: Indicator Found UCIP Comments: Needs markers 10-feet off both levee toes. FIELD_STRUCT_DESC: Steel conduit through the levee, 2.5 feet below the crown. Conduit extends to pole on waterside (WS). Cut in pavement visible at levee crown (Permit No. 12444-1978) FS Date: 4/1/2015

Conduit may be visible on pole about 1000-feet west of levee crown.

Cut in pavement at levee crown good indicator of crossing.

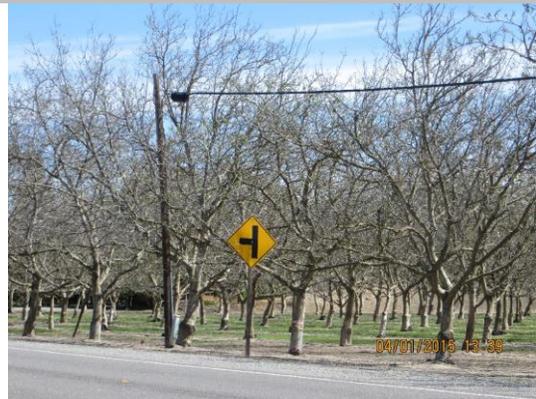
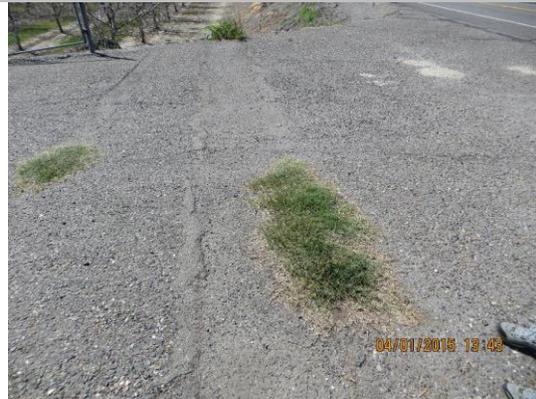
LM Start	3.37	Rating **	M	Issue No.	55
LM End	3.37	Issue Type +	En	Location *	LS
Category	Supplemental			GPS Latitude/Longitude	
			Start	End	
Item	DWR UCIP Field Study			39.456720 °	39.456720 °
				-122.009630 °	-122.009630 °
DWR ID					
Comment Code					
Inspector Comment					
FS_ID:44185 DS_ID:21175 EP_NO: 5376 Repair Type: Non-Urgent Crossing Status: Indicator Found UCIP Comments: Conduit needs markers ten feet off both levee toes. FIELD_STRUCT_DESC: Three 3.5-inch steel conduits through the levee, 3.0 feet below the crown. Metal cutoff wall around conduits near center of levee. Conduits are welded to the cutoff wall, extending only between the levee shoulders under the crown. Cut in pavement visible at crown. Cables extend to pole on waterside (WS). (Permit No. 5376-1967, Pacific Telephone & Telegraph Co.) FS Date: 4/1/2015

Conduit may be visible at pole about 1000-feet west of crown.

Cut in pavement visible at crown good indicator of crossing location.

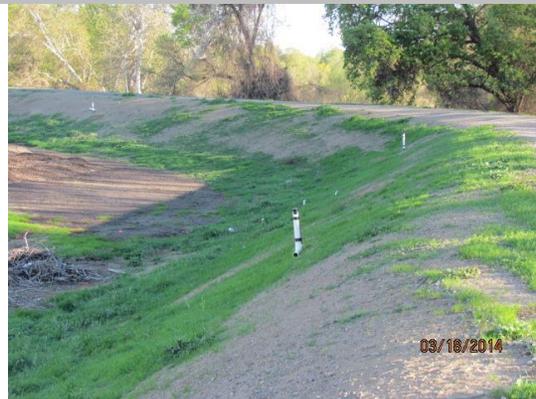
View of the rodent activity along the l/s slope.

LM Start	<b>3.44</b>	Rating **	U	Issue No.	<b>27</b>
LM End	<b>3.52</b>	Issue Type +	Ma	Location *	LS
Category	Earthen Levee			GPS Latitude/Longitude	
				Start	End
Item	Animal Control			39.457692 °	39.458705 °
				-122.009517 °	-122.009872 °
DWR ID	DWR_LD0002_01_s_2014_27				
Comment Code					
A3 : No rodents visible, but rodent burrows visible; need to backfill and compact or grout burrows.					
Inspector Comment					
Repair the rodent holes on landside slope.

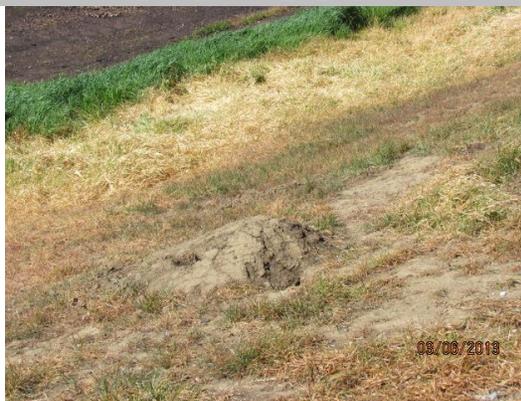
View of the rodent activity along the landside slope.

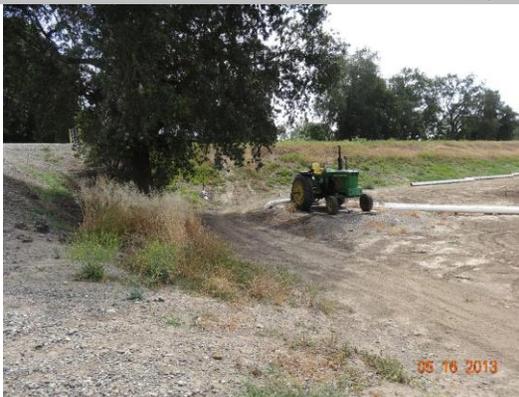
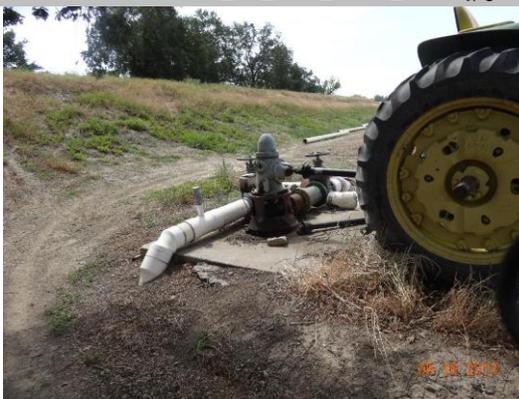
Item	DWR UCIP Field Study		39.461509 °	39.461509 °	
			-122.011493 °	-122.011493 °	
DWR ID					
Comment Code					
Inspector Comment					
FS_ID:38178 DS_ID:21178 EP_NO: 16931 Repair Type: Non-Urgent Crossing Status: Indicator Found UCIP Comments: Inspector notes indicate that pipe was never installed through levee and application was closed. Steel pipe was not installed but detachable section was installed. The pipe section goes up and over levee. Permit 16931 file was closed in 2005 owner was unable to install pipe due to costs. Permit indicates that pipe was to be used for winter supply of irrigation water to landward side. Need to coordinate with DWR inspector--permit revised for this type of structure. FIELD_STRUCT_DESC: Crossing visible at location. Current structure differs from original request in Permit No. 16931. PVC connection visible on landside (LS) toe with cutoff valve. Pipe connects to 8-inch PVC pipe extending past LS toe. FS Date: 5/16/2013

View of pump system on landward side located behind tracker.

Pump system located near landward toe.

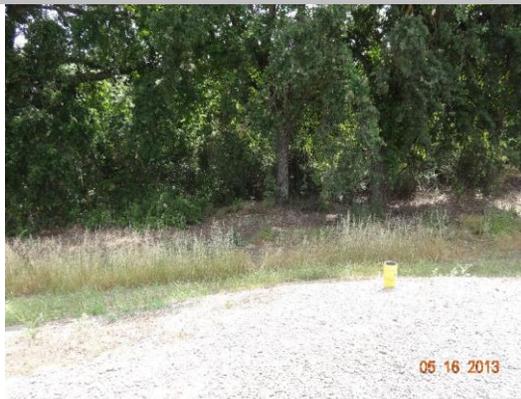
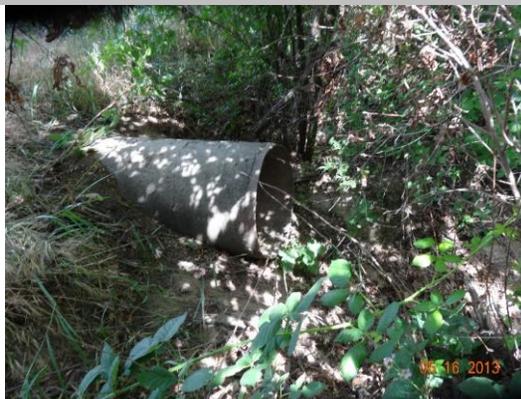
LM Start	<b>3.74</b>	Rating **	M	Issue No.	<b>49</b>
LM End	<b>3.74</b>	Issue Type +	En	Location *	LS
Category	Supplemental			GPS Latitude/Longitude	
				Start	End
Item	DWR UCIP Field Study			39.461674 °	39.461674 °
				-122.011507 °	-122.011507 °
DWR ID					
Comment Code					
Inspector Comment					
FS_ID:38182 DS_ID:24659 EP_NO: N/A Repair Type: Non-Urgent Crossing Status: Found UCIP Comments: Need to contact owner to determine status of crossing. FIELD_STRUCT_DESC: 24-inch steel drainage pipe through levee at 2-feet below the crown. Pipe is exposed on waterside (WS) with air vent on the WS levee shoulder. Open pump is approximately 550 feet on the landside (LS) of the levee toe and concrete distribution pipe. (Permit No. 16280-1995, Mathew J. Southam/McGowan) FS Date: 5/16/2013

View of waterward side.

Pipe visible on waterward side.

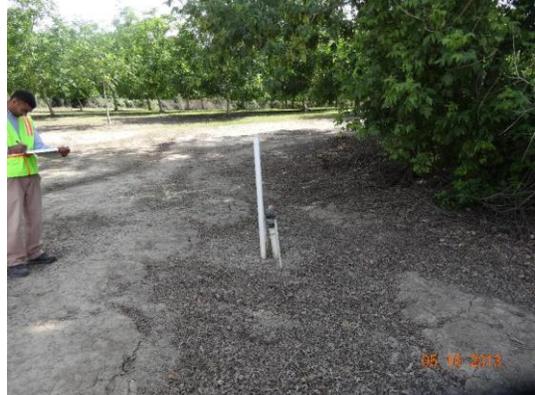
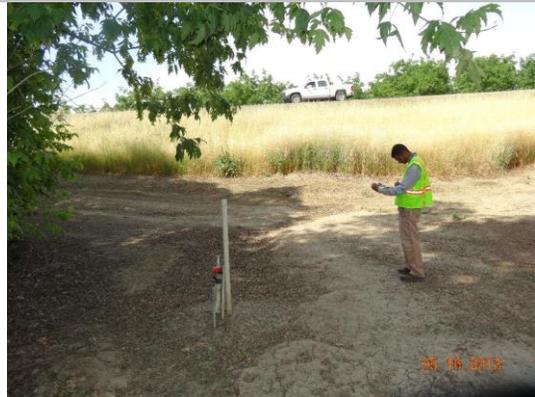
LM Start	<b>4.32</b>	Rating **	M	Issue No.	<b>57</b>
LM End	<b>4.32</b>	Issue Type +	En	Location *	LS
Category	Supplemental			GPS Latitude/Longitude	
				Start	End
Item	DWR UCIP Field Study			39.469908 °	39.469908 °
				-122.012117 °	-122.012117 °
DWR ID					
Comment Code					
Inspector Comment					
FS_ID:44188 DS_ID:21181 EP_NO: 18072 Repair Type: Non-Urgent Crossing Status: Indicator Found UCIP Comments: Pipe needs better markers at pipe crossing. FIELD_STRUCT_DESC: 6-inch steel irrigation pipe through the levee, 2.0 feet below the levee. Well, pump, and vent visible on landside (LS) toe. Vent visible just off waterside (WS) toe. (Permit No. 18072-2006, McCowan & Southam) FS Date: 4/1/2015

3-inch PVC pipe and vent exposed on waterward toe, likely in alignment with this crossing.

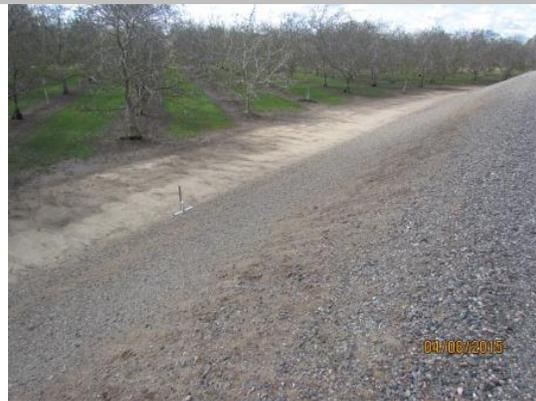
View of the removed rodent holes and bait station.
