**Flood Control Project Maintenance  
Levee Inspections**

**Maintenance Issue Types Only, Levee Inspection Report By Mile - Fall 2014**

**Levee District No. 0002 (Glenn County)**

Waterway	Bank	Unit Miles	Inspection Start/End	Inspector
Unit No. 01 Glenn County Sacramento River	Right	4.90	10/30/2014 10/30/2014	Bob Duffey

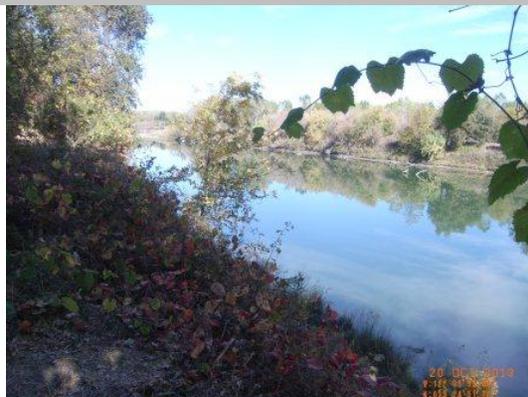
Photo 1 of 2 : FA\_2014\_LD0002\_28\_6\_20141013\_00003.jpg

LM Start	<b>0.02</b>	Rating **	M	Issue No.	<b>6</b>
LM End	<b>0.02</b>	Issue Type +	Ma	Location *	WS
Category	Supplemental		GPS Latitude/Longitude		
			Start	End	
Item	USACE Erosion Survey		39.414649 °	39.417689 °	
			-122.009853 °	-122.010369 °	
DWR ID	DWR_LD0002_01_f_2014_6				
Action/Comments					
Inspector Comments: 2009 - Very slow retreat, hard toe, encroaching into the levee projection. 2010 - Slowly eroding. 2011 - Site extended downstream. 2013: No observed changes. [2013 Site ID: SAC_164-7_R]

USACE 2013 Photo #1

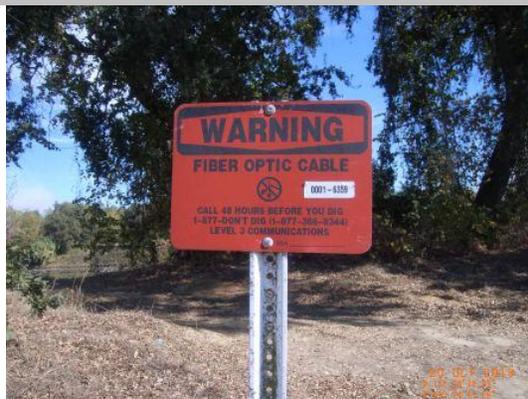
Photo 2 of 2 : FA\_2014\_LD0002\_28\_6\_20141013\_00004.jpg

USACE 2013 Photo #2

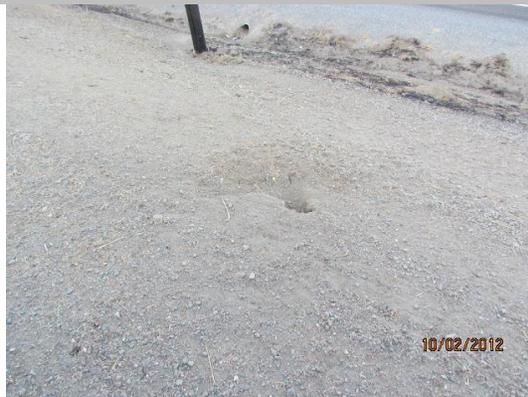
Photo 1 of 1 : FA\_2014\_LD0002\_28\_4\_20141013\_00001.jpg

LM Start	<b>1.45</b>	Rating **	M	Issue No.	<b>4</b>
LM End	<b>1.45</b>	Issue Type +	Ma	Location *	LS
Category	Earthen Levee		GPS Latitude/Longitude		
			Start	End	
Item	Animal Control		39.434157 °	39.434157 °	
			-122.010760 °	-122.010760 °	
DWR ID	DWR_LD0002_01_f_2012_4				
Action/Comments					
No rodents visible, but rodent burrows visible; need to backfill and compact or gROUT burrows.

View of the rodent holes along the landside slope.

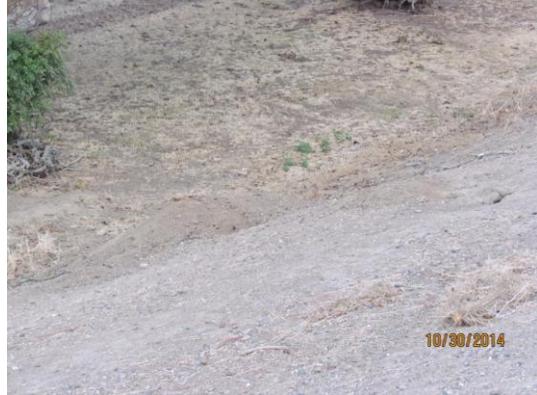
Photo 1 of 1 : FA\_2014\_LD0002\_28\_15\_20141121\_00015.jpg

LM Start	<b>1.54</b>	Rating **	M	Issue No.	<b>15</b>
LM End	<b>1.62</b>	Issue Type +	Ma	Location *	LS
Category	Earthen Levee		GPS Latitude/Longitude		
			Start	End	
Item	Animal Control		39.435485 °	39.436643 °	
			-122.010640 °	-122.010498 °	
DWR ID	DWR_LD0002_01_f_2012_15				
Action/Comments					
No rodents visible, but rodent burrows visible; need to backfill and compact or grout burrows.

View of the rodent holes along the landside slope.

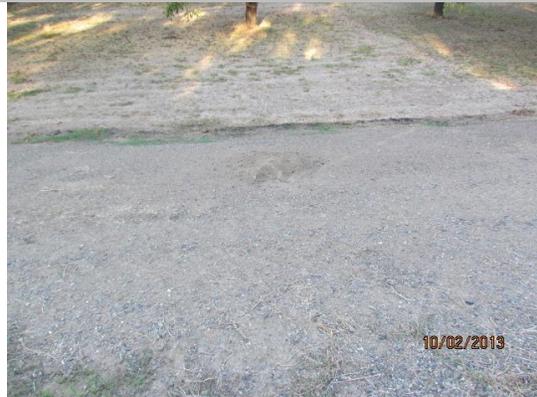
Photo 1 of 1 : FA\_2014\_LD0002\_28\_41\_20141013\_00013.jpg

LM Start	<b>1.58</b>	Rating **	A/W	Issue No.	<b>41</b>
LM End	<b>1.58</b>	Issue Type +	Ma	Location *	LS
Category	Earthen Levee		GPS Latitude/Longitude		
			Start	End	
Item	Animal Control		39.436149 °	39.436149 °	
			-122.010525 °	-122.010525 °	
DWR ID	DWR_LD0002_01_f_2013_41				
Action/Comments					
No rodents visible, but rodent burrows visible; need to backfill and compact or grout burrows.

View of the rodent holes along the slope of the levee.

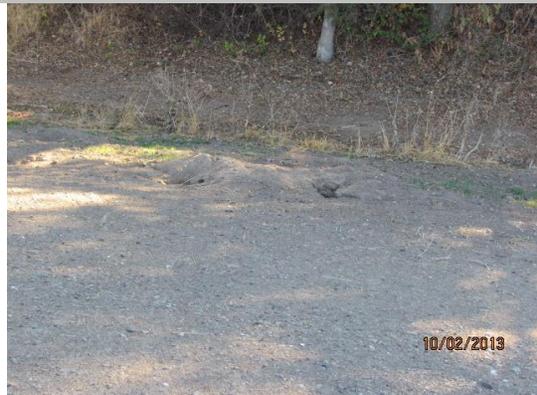
Photo 1 of 1 : FA\_2014\_LD0002\_28\_42\_20141013\_00014.jpg

LM Start	<b>2.81</b>	Rating **	A/W	Issue No.	<b>42</b>
LM End	<b>2.81</b>	Issue Type +	Ma	Location *	WS
Category	Earthen Levee		GPS Latitude/Longitude		
			Start	End	
Item	Animal Control		39.451841 °	39.451841 °	
			-122.017120 °	-122.017120 °	
DWR ID	DWR_LD0002_01_f_2013_42				
Action/Comments					
No rodents visible, but rodent burrows visible; need to backfill and compact or grout burrows.

View of the rodent holes along the slope of the levee.

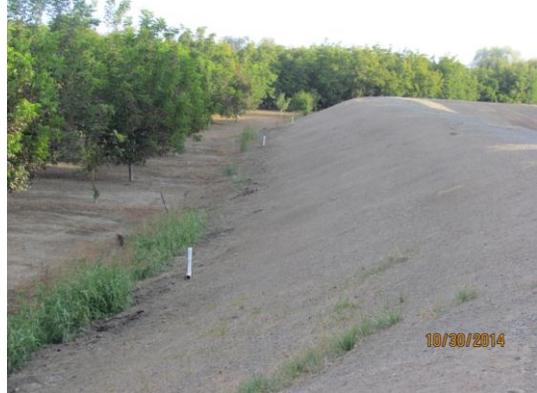
Photo 1 of 1 : FA\_2014\_LD0002\_28\_2\_20141121\_00016.jpg

LM Start	<b>2.95</b>	Rating **	A/W	Issue No.	<b>2</b>
LM End	<b>3.00</b>	Issue Type +	Ma	Location *	LS
Category	Earthen Levee		GPS Latitude/Longitude		
			Start	End	
Item	Animal Control		39.453595 °	39.454003 °	
			-122.016273 °	-122.015503 °	
DWR ID	DWR_LD0002_01_s_2012_2				
Action/Comments					
No rodents visible, but rodent burrows visible; need to backfill and compact or grout burrows.

View of the rodent holes and bait station along the landside slope.

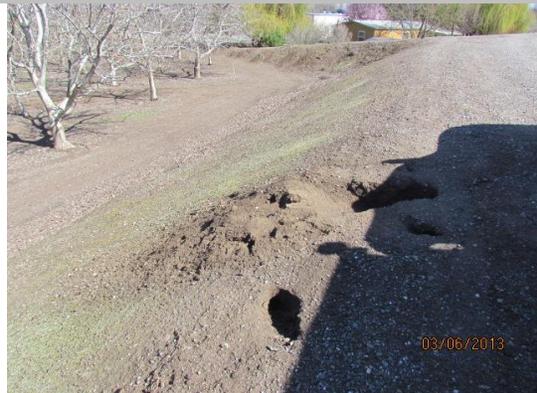
Photo 1 of 1 : FA\_2014\_LD0002\_28\_12\_20141013\_00008.jpg

LM Start	<b>3.20</b>	Rating **	M	Issue No.	<b>12</b>
LM End	<b>3.20</b>	Issue Type +	Ma	Location *	WS
Category	Earthen Levee		GPS Latitude/Longitude		
			Start	End	
Item	Animal Control		39.455992 °	39.455992 °	
			-122.012809 °	-122.012809 °	
DWR ID	DWR_LD0002_01_s_2013_12				
Action/Comments					
Exterminate rodents and backfill and compact or grout burrows.

View of the rodent activity along the landside slope.

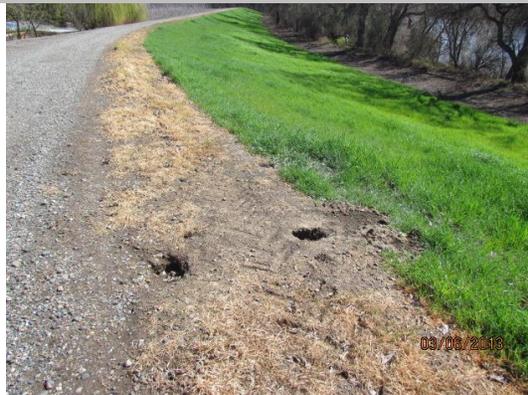
Photo 1 of 1 : FA\_2014\_LD0002\_28\_9\_20141013\_00006.jpg

LM Start	<b>3.20</b>	Rating **	M	Issue No.	<b>9</b>
LM End	<b>3.20</b>	Issue Type +	Ma	Location *	LS
Category	Earthen Levee		GPS Latitude/Longitude		
			Start	End	
Item	Animal Control		39.455992 °	39.455992 °	
			-122.012808 °	-122.012808 °	
DWR ID	DWR_LD0002_01_s_2013_9				
Action/Comments					
No rodents visible, but rodent burrows visible; need to backfill and compact or grout burrows.

View of the rodent activity along the waterside slope.

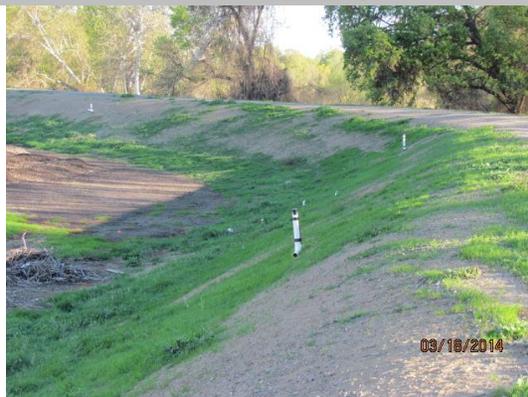
Photo 1 of 1 : FA\_2014\_LD0002\_28\_27\_20141013\_00011.jpg

LM Start	<b>3.48</b>	Rating **	A/W	Issue No.	<b>27</b>
LM End	<b>3.56</b>	Issue Type +	Ma	Location *	LS
Category	Earthen Levee		GPS Latitude/Longitude		
			Start	End	
Item	Animal Control		39.457692 °	39.458705 °	
			-122.009517 °	-122.009872 °	
DWR ID	DWR_LD0002_01_s_2014_27				
Action/Comments					
No rodents visible, but rodent burrows visible; need to backfill and compact or grout burrows.

View of the rodent activity along the I/s slope.

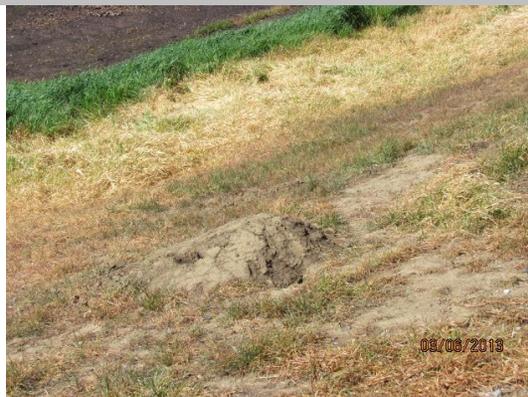
Photo 1 of 1 : FA\_2014\_LD0002\_28\_13\_20141013\_00009.jpg

LM Start	<b>3.56</b>	Rating **	M	Issue No.	<b>13</b>
LM End	<b>3.61</b>	Issue Type +	Ma	Location *	LS
Category	Earthen Levee		GPS Latitude/Longitude		
			Start	End	
Item	Animal Control		39.458803 °	39.459305 °	
			-122.009980 °	-122.010511 °	
DWR ID	DWR_LD0002_01_s_ 2013_13				
Action/Comments					
Exterminate rodents and backfill and compact or grout burrows.

View of the rodent activity along the landside slope.

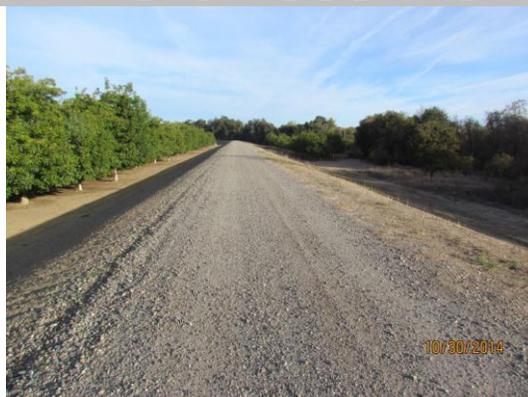
Photo 1 of 1 : FA\_2014\_LD0002\_28\_28\_20141121\_00017.jpg

LM Start	<b>4.13</b>	Rating **	A	Issue No.	<b>28</b>
LM End	<b>4.13</b>	Issue Type +	Ma	Location *	LS
Category	Earthen Levee		GPS Latitude/Longitude		
			Start	End	
Item	Vegetation		39.466840 °	39.466840 °	
			-122.011457 °	-122.011457 °	
DWR ID	DWR_LD0002_01_f_ 2014_28				
Action/Comments					
Control annual grass and weeds on the levee slopes and easements.

View of the controlled vegetation on both slopes.

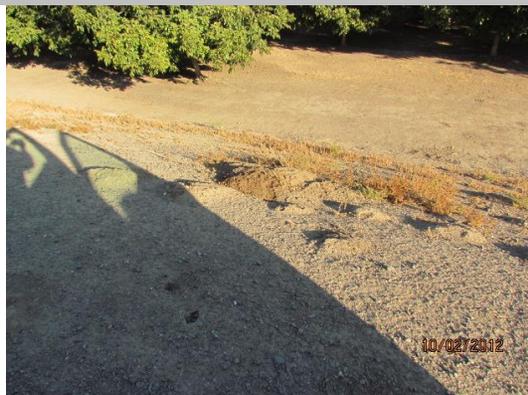
Photo 1 of 1 : FA\_2014\_LD0002\_28\_11\_20141013\_00007.jpg

LM Start	<b>4.87</b>	Rating **	M	Issue No.	<b>11</b>
LM End	<b>4.87</b>	Issue Type +	Ma	Location *	LS
Category	Earthen Levee		GPS Latitude/Longitude		
			Start	End	
Item	Animal Control		39.476676 °	39.476676 °	
			-122.017439 °	-122.017439 °	
DWR ID	DWR_LD0002_01_s_ 2012_11				
Action/Comments					
No rodents visible, but rodent burrows visible; need to backfill and compact or grout burrows.

View of the rodent holes along the levee slope.
