**Flood Control Project Maintenance
Levee Inspections**

Maintenance Issue Types Only, Levee Inspection Report By Mile - Fall 2015

Levee District No. 0002 (Glenn County)

Waterway	Bank	Unit Miles	Inspection Start/End	Inspector
Unit No. 01 Glenn County Sacramento River	Right	4.90	09/14/2015 09/14/2015	Bob Duffey

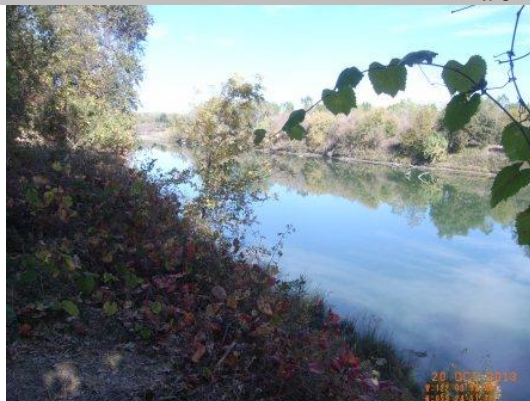
Photo 1 of 2 : USACE2013A_SAC_164-7_R_1.jpg

LM Start	0.07	Rating **	M	Issue No.	6
LM End	0.28	Issue Type +	Ma	Location *	WS
Category	Supplemental			GPS Latitude/Longitude	
				Start	End
Item	2015 USACE Erosion Survey, DRAFT			39.414649 °	39.417689 °
				-122.009853 °	-122.010369 °
DWR ID					
Action/Comments					
Inspector Comments: 2009 - Very slow retreat, hard toe, encroaching into the levee projection. 2010 - Slowly eroding. 2011 - Site extended downstream. 2015: Last observed in 2013. [2015 Site ID: SAC_164-7_R]

USACE 2013 Photo #1

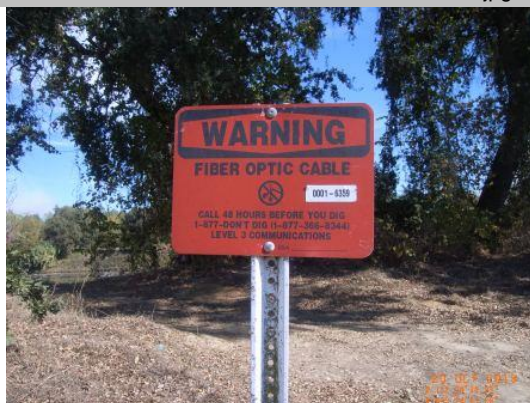
Photo 2 of 2 : USACE2013A_SAC_164-7_R_3.jpg

USACE 2013 Photo #2

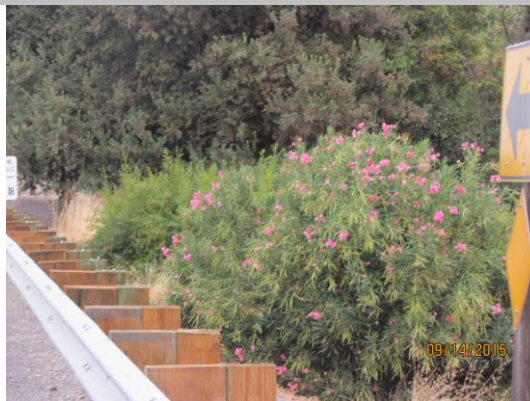
Photo 1 of 1 : FA_2015_LD0002_28_30_20151013_00019.jpg

View of the oleanders along the waterside slope.

LM Start	1.03	Rating **	M	Issue No.	30
LM End	1.03	Issue Type +	Ma	Location *	WS
Category	Earthen Levee			GPS Latitude/Longitude	
				Start	End
Item	Trim / Thin Trees			39.428445 °	39.428445 °
				-122.010972 °	-122.010972 °
DWR ID	DWR_LD0002_01_f_2015_30				
Action/Comments					
Thin trees to allow visibility of the ground and room to flood fight. Inspector Comments: Remove the oleanders from the waterside slope.

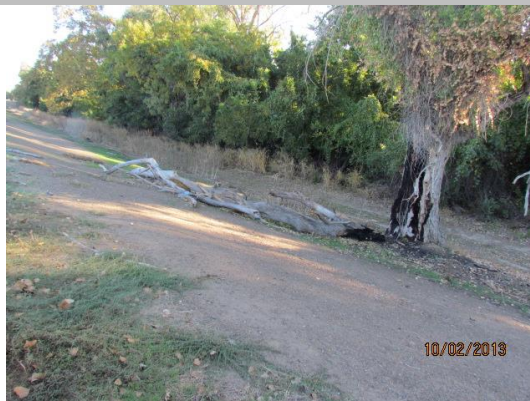
Photo 1 of 2 : FA_2015_LD0002_28_40_20150910_00015.jpg

View of the downed tree limb along the slope of the levee.

LM Start	1.24	Rating **	M	Issue No.	40
LM End	1.24	Issue Type +	Ma	Location *	WS
Category	Earthen Levee			GPS Latitude/Longitude	
				Start	End
Item	Encroachments			39.431499 °	39.431499 °
				-122.010803 °	-122.010803 °
DWR ID	DWR_LD0002_01_f_2013_40				
Action/Comments					
Tree or limb					
Inspector Comments: Remove the tree limbs from the waterside slope.

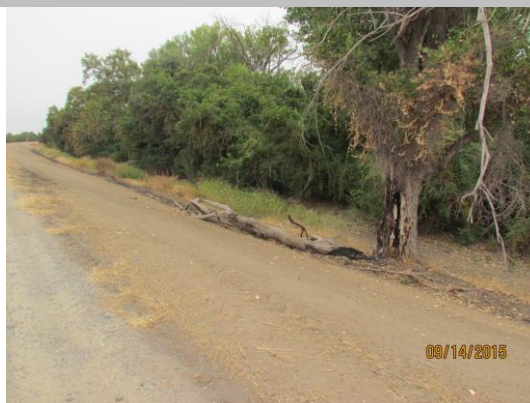
Photo 2 of 2 : FA_2015_LD0002_28_40_20151013_00020.jpg

View of the tree limbs along the waterside slope.

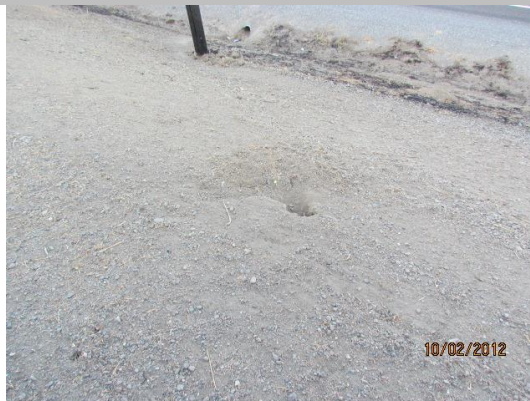
Photo 1 of 1 : FA_2015_LD0002_28_4_20150910_00002.jpg

View of the rodent holes along the landside slope.

LM Start	1.43	Rating **	M	Issue No.	4
LM End	1.43	Issue Type +	Ma	Location *	LS
Category	Earthen Levee			GPS Latitude/Longitude	
				Start	End
Item	Animal Control			39.434157 °	39.434157 °
				-122.010760 °	-122.010760 °
DWR ID	DWR_LD0002_01_f_2012_4				
Action/Comments					
No rodents visible, but rodent burrows visible; need to backfill and compact or grout burrows.

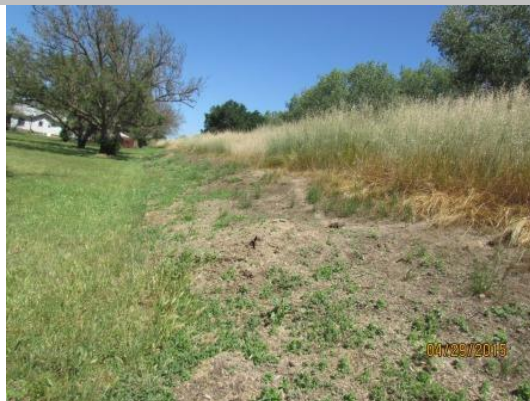
Photo 1 of 2 : FA_2015_LD0002_28_15_20150910_00011.jpg

View of the rodent holes along the landside slope.

LM Start	1.52	Rating **	M	Issue No.	15
LM End	1.60	Issue Type +	Ma	Location *	LS
Category	Earthen Levee			GPS Latitude/Longitude	
				Start	End
Item	Animal Control			39.435485 °	39.436643 °
				-122.010640 °	-122.010498 °
DWR ID	DWR_LD0002_01_f_2012_15				
Action/Comments					
No rodents visible, but rodent burrows visible; need to backfill and compact or grout burrows. Inspector Comments: LMA needs to repair the rodent holes.

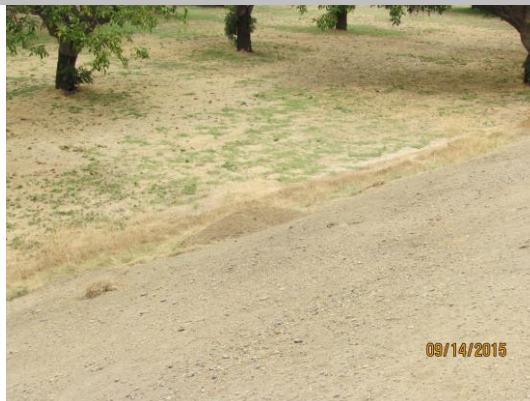
Photo 2 of 2 : FA_2015_LD0002_28_15_20151013_00021.jpg

View of the rodent holes along the landside slope.

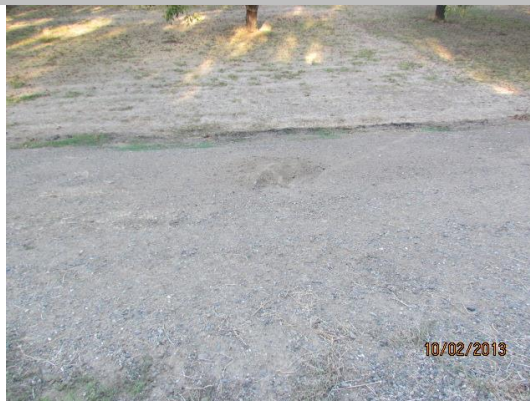
Photo 1 of 1 : FA_2015_LD0002_28_41_20150910_00016.jpg

View of the rodent holes along the slope of the levee.

LM Start	1.57	Rating **	M	Issue No.	41
LM End	1.57	Issue Type +	Ma	Location *	LS
Category	Earthen Levee			GPS Latitude/Longitude	
				Start	End
Item	Animal Control			39.436149 °	39.436149 °
				-122.010525 °	-122.010525 °
DWR ID	DWR_LD0002_01_f_2013_41				
Action/Comments					
No rodents visible, but rodent burrows visible; need to backfill and compact or grout burrows.

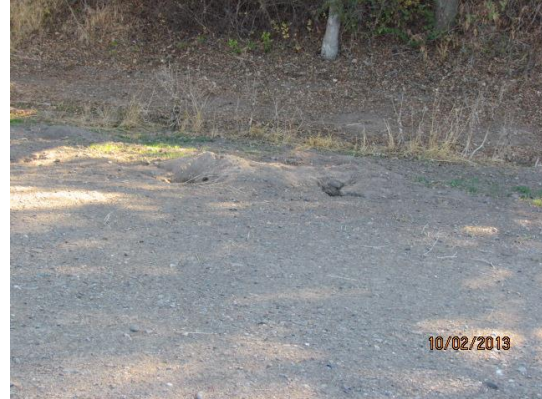
Photo 1 of 1 : FA_2015_LD0002_28_42_20150910_00017.jpg

View of the rodent holes along the slope of the levee.

LM Start	2.77	Rating **	M	Issue No.	42
LM End	2.77	Issue Type +	Ma	Location *	WS
Category	Earthen Levee			GPS Latitude/Longitude	
				Start	End
Item	Animal Control			39.451841 °	39.451841 °
				-122.017120 °	-122.017120 °
DWR ID	DWR_LD0002_01_f_2013_42				
Action/Comments					
No rodents visible, but rodent burrows visible; need to backfill and compact or grout burrows.

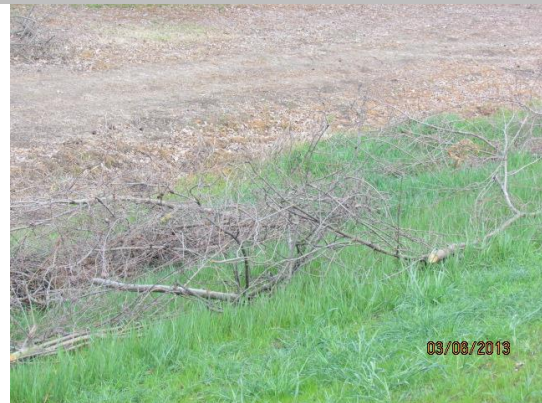
Photo 1 of 1 : FA_2015_LD0002_28_5_20150910_00003.jpg

View of the prunings along the landside toe.

LM Start	2.89	Rating **	M	Issue No.	5
LM End	2.89	Issue Type +	Ma	Location *	LS
Category	Earthen Levee			GPS Latitude/Longitude	
				Start	End
Item	Encroachments			39.453490 °	39.453490 °
				-122.016457 °	-122.016457 °
DWR ID	DWR_LD0002_01_f_2015_5				
Action/Comments					
Prunings

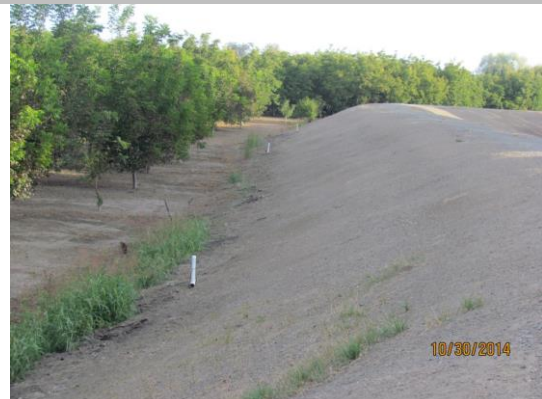
Photo 1 of 1 : FA_2015_LD0002_28_2_20150910_00001.jpg

View of the rodent holes and bait station along the landside slope.

LM Start	2.91	Rating **	M	Issue No.	2
LM End	2.96	Issue Type +	Ma	Location *	LS
Category	Earthen Levee			GPS Latitude/Longitude	
				Start	End
Item	Animal Control			39.453595 °	39.454003 °
				-122.016273 °	-122.015503 °
DWR ID	DWR_LD0002_01_f_2015_2				
Action/Comments					
No rodents visible, but rodent burrows visible; need to backfill and compact or grout burrows.

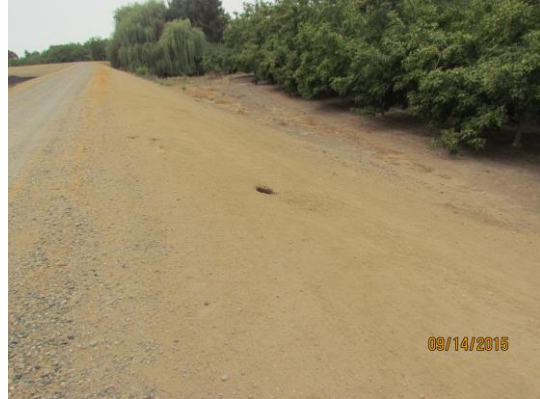
Photo 1 of 1 : FA_2015_LD0002_28_3_20151013_00024.jpg

View of the rodent holes along the waterside slope.

LM Start	3.06	Rating **	M	Issue No.	3
LM End	3.13	Issue Type +	Ma	Location *	WS
Category	Earthen Levee	GPS Latitude/Longitude			
		Start		End	
Item	Animal Control	39.455145 °		39.455813 °	
		-122.014287 °		-122.013205 °	
DWR ID	DWR_LD0002_01_s _ 2012_3				
Action/Comments					
No rodents visible, but rodent burrows visible; need to backfill and compact or grout burrows.					
Inspector Comments: Repair the rodent holes along the waterside slope.

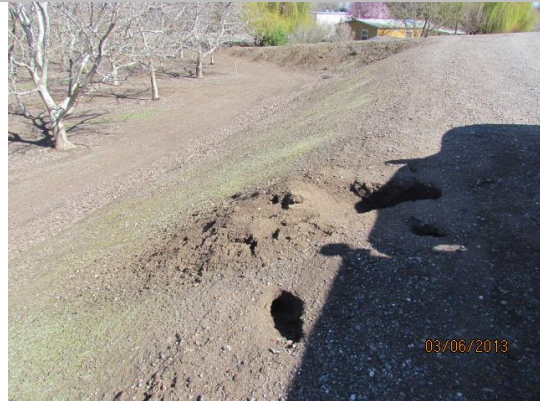
Photo 1 of 1 : FA_2015_LD0002_28_12_20150910_00009.jpg

View of the rodent activity along the landside slope.

LM Start	3.16	Rating **	U	Issue No.	12
LM End	3.16	Issue Type +	Ma	Location *	LS
Category	Earthen Levee			GPS Latitude/Longitude	
				Start	End
Item	Animal Control			39.455992 °	39.455992 °
				-122.012809 °	-122.012809 °
DWR ID	DWR_LD0002_01_s _ 2013_12				
Action/Comments					
Exterminate rodents and backfill and compact or grout burrows. Inspector Comments: Repair the rodent holes along landside slope.

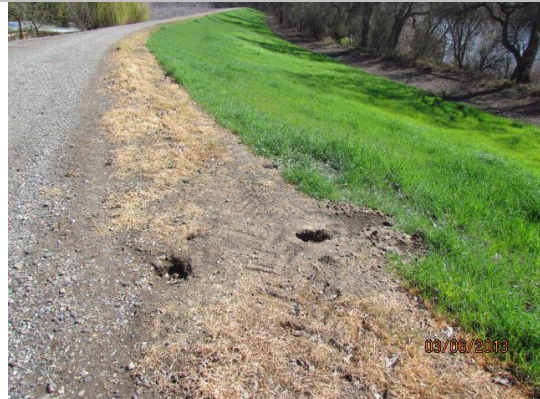
Photo 1 of 1 : FA_2015_LD0002_28_9_20150910_00007.jpg

View of the rodent activity along the waterside slope.

LM Start	3.16	Rating **	M	Issue No.	9
LM End	3.16	Issue Type +	Ma	Location *	LS
Category	Earthen Levee			GPS Latitude/Longitude	
				Start	End
Item	Animal Control			39.455992 °	39.455992 °
				-122.012808 °	-122.012808 °
DWR ID	DWR_LD0002_01_s _ 2013_9				
Action/Comments					
No rodents visible, but rodent burrows visible; need to backfill and compact or grout burrows.

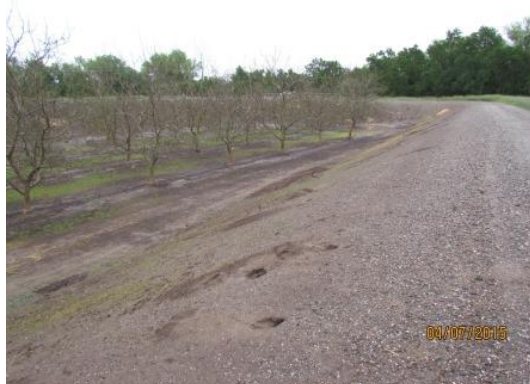
Photo 1 of 1 : FA_2015_LD0002_28_16_20150910_00012.jpg

View of the rodent holes along the landside slope.

LM Start	3.27	Rating **	M	Issue No.	16
LM End	3.30	Issue Type +	Ma	Location *	LS
Category	Earthen Levee			GPS Latitude/Longitude	
				Start	End
Item	Animal Control			39.456237 °	39.456272 °
				-122.010640 °	-122.010163 °
DWR ID	DWR_LD0002_01_f_2012_16				
Action/Comments					
No rodents visible, but rodent burrows visible; need to backfill and compact or grout burrows.					
Inspector Comments: Grout or fill the rodent holes.

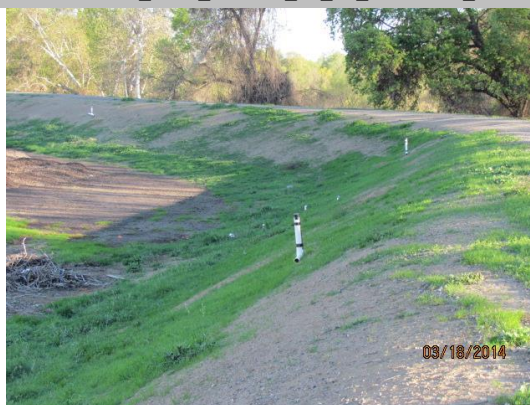
Photo 1 of 1 : FA_2015_LD0002_28_27_20150910_00013.jpg

View of the rodent activity along the l/s slope.

LM Start	3.44	Rating **	U	Issue No.	27
LM End	3.52	Issue Type +	Ma	Location *	LS
Category	Earthen Levee			GPS Latitude/Longitude	
				Start	End
Item	Animal Control			39.457692 °	39.458705 °
				-122.009517 °	-122.009872 °
DWR ID	DWR_LD0002_01_s_2014_27				
Action/Comments					
No rodents visible, but rodent burrows visible; need to backfill and compact or grout burrows.					
Inspector Comments: Repair the rodent holes on landside slope.

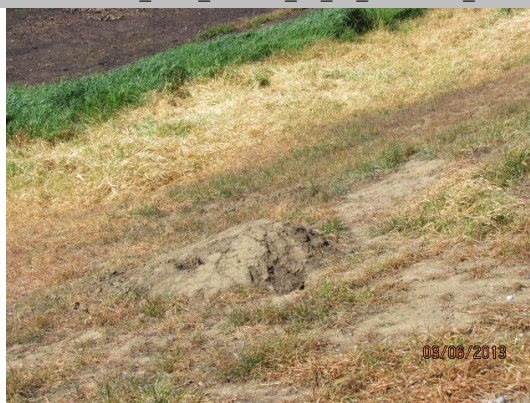
Photo 1 of 1 : FA_2015_LD0002_28_13_20150910_00010.jpg

View of the rodent activity along the landside slope.

LM Start	3.53	Rating **	M	Issue No.	13
LM End	3.57	Issue Type +	Ma	Location *	LS
Category	Earthen Levee			GPS Latitude/Longitude	
				Start	End
Item	Animal Control			39.458803 °	39.459305 °
				-122.009980 °	-122.010511 °
DWR ID	DWR_LD0002_01_s_2013_13				
Action/Comments					
Exterminate rodents and backfill and compact or grout burrows.

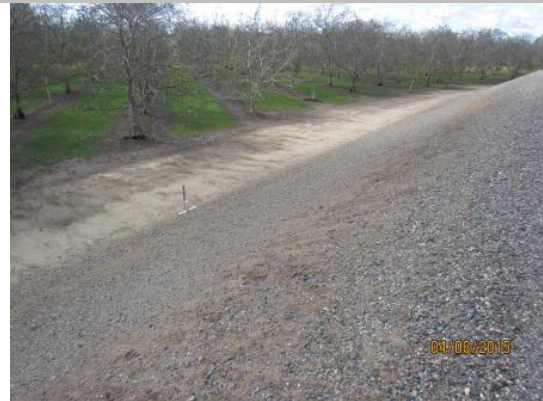
Photo 1 of 1 : FA_2015_LD0002_28_11_20150910_00008.jpg

LM Start	4.87	Rating **	A/W	Issue No.	11
LM End	4.87	Issue Type +	Ma	Location *	LS
Category	Earthen Levee			GPS Latitude/Longitude	
				Start	End
Item	Animal Control			39.476676 °	39.476676 °
				-122.017439 °	-122.017439 °
DWR ID	DWR_LD0002_01_s __ 2012_11				
Action/Comments					
No rodents visible, but rodent burrows visible; need to backfill and compact or grout burrows.					
Inspector Comments: The rodent holes have been filled with dirt.

View of the removed rodent holes and bait station.
