**Flood Control Project Maintenance  
Levee Inspections**

**Maintenance Issue Types Only, Levee Inspection Report By Mile - Fall 2016**

**Levee District No. 0002 (Glenn County)**

Waterway	Bank	Unit Miles	Inspection Start/End	Inspector
Unit No. 01 Glenn County Sacramento River	Right	4.90	09/01/2016 09/01/2016	Tariq Chechi

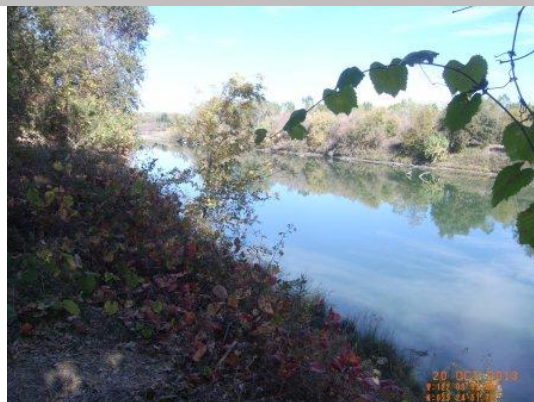
Photo 1 of 2 : FA\_2016\_LD0002\_28\_6\_20160823\_00005.jpg

LM Start	0.07	Rating **	M	Issue No.	6
LM End	0.28	Issue Type +	Ma	Location *	WS
Category	Supplemental			GPS Latitude/Longitude	
				Start	End
Item	2015 USACE Erosion Survey, DRAFT			39.414649 °	39.417689 °
				-122.009853 °	-122.010369 °
DWR ID	DWR_LD0002_01_s_2016_6				
Comment Code					
Inspector Comment					
2009 - Very slow retreat, hard toe, encroaching into the levee projection. 2010 - Slowly eroding. 2011 - Site extended downstream. 2015: Last observed in 2013. [2015 Site ID: SAC_164-7_R]

USACE 2013 Photo #1

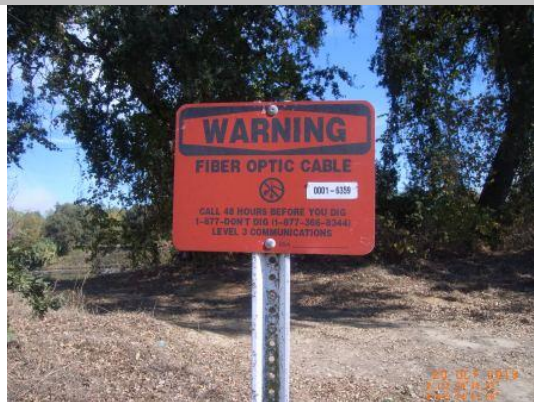
Photo 2 of 2 : FA\_2016\_LD0002\_28\_6\_20160823\_00006.jpg

USACE 2013 Photo #2

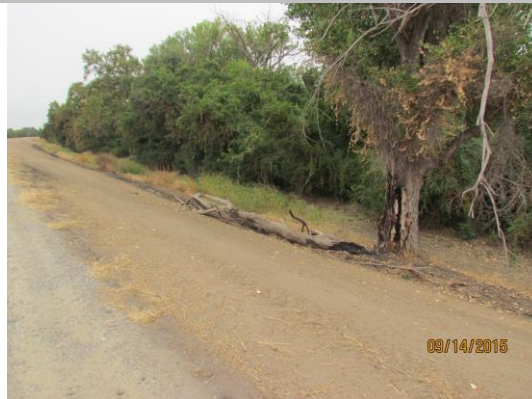
Photo 2 of 2 : FA\_2016\_LD0002\_28\_40\_20160823\_00016.jpg

View of the tree limbs along the waterside slope.

LM Start	1.24	Rating **	M	Issue No.	40 (cont)	
LM End	1.24	Issue Type +	Ma	Location *	WS	
Category	Earthen Levee			GPS Latitude/Longitude		
				Start		End
Item	Encroachments			39.431499 °		39.431499 °
				-122.010803 °		-122.010803 °
DWR ID	DWR_LD0002_01_f_2013_40					
Comment Code						
TR : Tree or limb						
Inspector Comment						
Remove the tree limbs from the waterside slope.

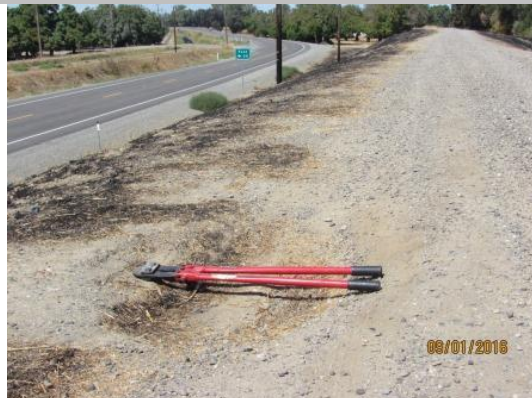
Photo 1 of 1 : FA\_2016\_LD0002\_28\_34\_20160906\_00051.jpg

LM Start	1.40	Rating **	M	Issue No.	34
LM End	1.40	Issue Type +	Ma	Location *	CR
Category	Earthen Levee			GPS Latitude/Longitude	
				Start	End
Item	Crown Surface / Depressions / Rutting			39.433809 °	39.433809 °
				-122.010814 °	-122.010814 °
DWR ID	DWR_LD0002_01_f_2016_34				
Comment Code					
C2 : Repair depressions or ruts in the crown or slope.					
Inspector Comment

View of a depression on the levee crown looking upstream.

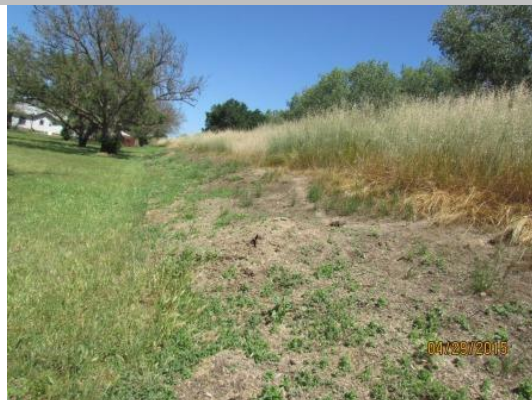
Photo 1 of 2 : FA\_2016\_LD0002\_28\_15\_20160823\_00010.jpg

View of the rodent holes along the landside slope.

LM Start	1.52	Rating **	M	Issue No.	15
LM End	1.60	Issue Type +	Ma	Location *	LS
Category	Earthen Levee			GPS Latitude/Longitude	
				Start	End
Item	Animal Control			39.435485 °	39.436643 °
				-122.010640 °	-122.010498 °
DWR ID	DWR_LD0002_01_f_2012_15				
Comment Code					
A3 : No rodents visible, but rodent burrows visible; need to backfill and compact or grout burrows.					
Inspector Comment					
LMA needs to repair the rodent holes.

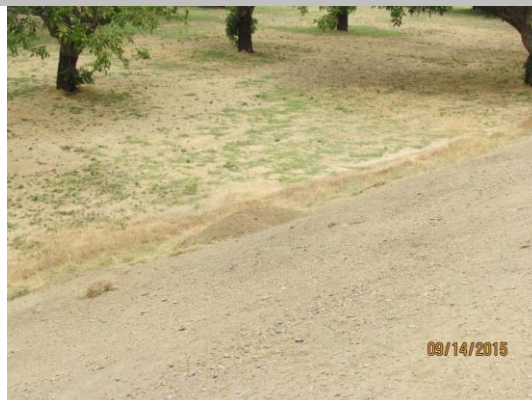
Photo 2 of 2 : FA\_2016\_LD0002\_28\_15\_20160823\_00011.jpg

View of the rodent holes along the landside slope.

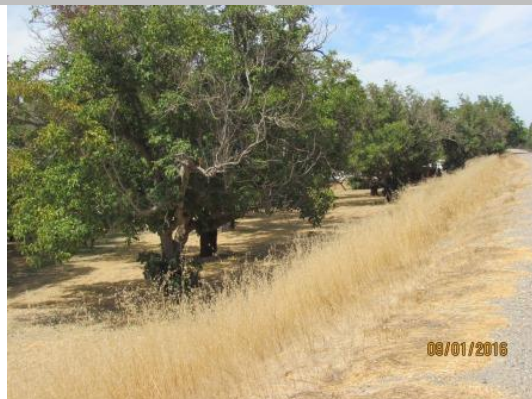
Photo 1 of 1 : FA\_2016\_LD0002\_28\_35\_20160906\_00052.jpg

LM Start	1.52	Rating **	M	Issue No.	35
LM End	1.65	Issue Type +	Ma	Location *	LS
Category	Earthen Levee			GPS Latitude/Longitude	
				Start	End
Item	Vegetation			39.435522 °	39.437441 °
				-122.010582 °	-122.010438 °
DWR ID	DWR_LD0002_01_f_2016_35				
Comment Code					
V1 : Control annual grass and weeds on the levee slopes and easements.					
Inspector Comment

View of the landside vegetation looking upstream.

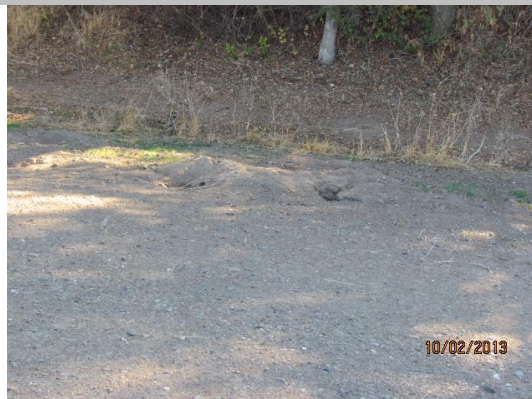
Photo 1 of 1 : FA\_2016\_LD0002\_28\_42\_20160823\_00017.jpg

LM Start	2.77	Rating **	A/W	Issue No.	42
LM End	2.77	Issue Type +	Ma	Location *	WS
Category	Earthen Levee			GPS Latitude/Longitude	
				Start	End
Item	Animal Control			39.451841 °	39.451841 °
				-122.017120 °	-122.017120 °
DWR ID	DWR_LD0002_01_f_2013_42				
Comment Code					
A3 : No rodents visible, but rodent burrows visible; need to backfill and compact or grout burrows.					
Inspector Comment

View of the rodent holes along the slope of the levee.

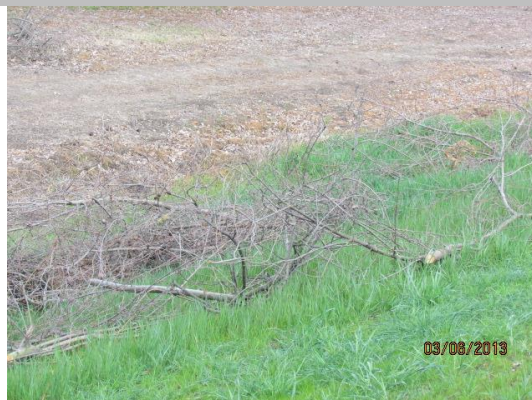
Photo 1 of 1 : FA\_2016\_LD0002\_28\_5\_20160823\_00004.jpg

LM Start	2.89	Rating **	M	Issue No.	5
LM End	2.89	Issue Type +	Ma	Location *	LS
Category	Earthen Levee			GPS Latitude/Longitude	
				Start	End
Item	Encroachments			39.453490 °	39.453490 °
				-122.016457 °	-122.016457 °
DWR ID	DWR_LD0002_01_f_2015_5				
Comment Code					
PR : Prunings					
Inspector Comment

View of the prunings along the landside toe.

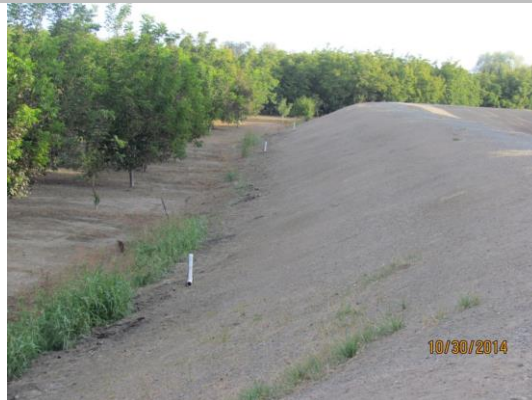
Photo 1 of 1 : FA\_2016\_LD0002\_28\_2\_20160823\_00001.jpg

LM Start	2.91	Rating **	M	Issue No.	2
LM End	2.96	Issue Type +	Ma	Location *	LS
Category	Earthen Levee			GPS Latitude/Longitude	
				Start	End
Item	Animal Control			39.453595 °	39.454003 °
				-122.016273 °	-122.015503 °
DWR ID	DWR_LD0002_01_f_2015_2				
Comment Code					
A3 : No rodents visible, but rodent burrows visible; need to backfill and compact or grout burrows.					
Inspector Comment

View of the rodent holes and bait station along the landside slope.

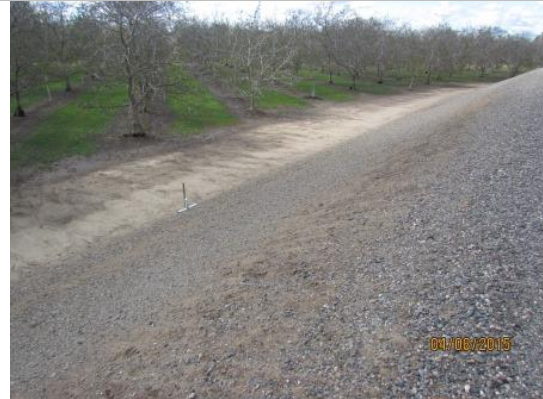
Photo 1 of 1 : FA\_2016\_LD0002\_28\_11\_20160823\_00007.jpg

LM Start	4.87	Rating **	A/W	Issue No.	11
LM End	4.87	Issue Type +	Ma	Location *	LS
Category	Earthen Levee			GPS Latitude/Longitude	
				Start	End
Item	Animal Control			39.476676°	39.476676°
				-122.017439°	-122.017439°
DWR ID	DWR_LD0002_01_s_2012_11				
Comment Code					
A3 : No rodents visible, but rodent burrows visible; need to backfill and compact or grout burrows.					
Inspector Comment					
The rodent holes have been filled with dirt.

View of the removed rodent holes and bait station.
