**Flood Control Project Maintenance
Levee Inspections**

Maintenance Issue Types Only, Levee Inspection Report By Mile - Fall 2017

Levee District No. 0002 (Glenn County)

Waterway	Bank	Unit Miles	Inspection Start/End	Inspector
Unit No. 01 Glenn County Sacramento River	Right	4.90	10/26/2017 10/26/2017	Bob Duffey

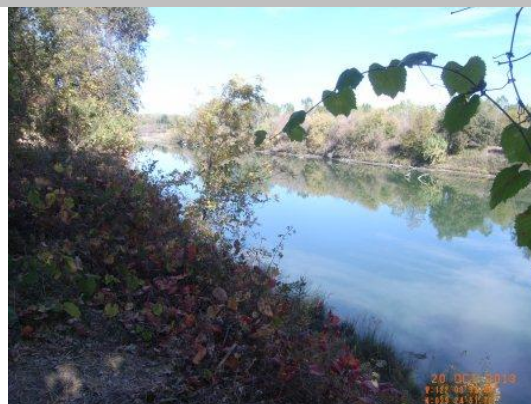
Photo 1 of 2 : FA_2017_LD0002_28_6_20170911_00003.jpg

LM Start	0.07	Rating **	M	Issue No.	6
LM End	0.28	Issue Type +	Ma	Location *	WS
Category	Supplemental			GPS Latitude/Longitude	
				Start	End
Item	2015 USACE Erosion Survey, DRAFT			39.414649 °	39.417689 °
				-122.009853 °	-122.010369 °
DWR ID	DWR_LD0002_01_s_2016_6				
Comment Code					
Inspector Comment					
2009 - Very slow retreat, hard toe, encroaching into the levee projection. 2010 - Slowly eroding. 2011 - Site extended downstream. 2015: Last observed in 2013. [2015 Site ID: SAC_164-7_R]

USACE 2013 Photo #1

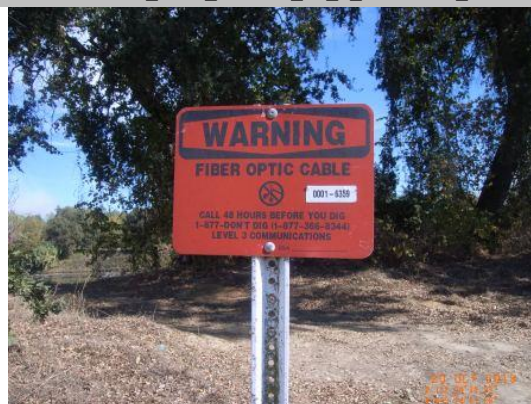
Photo 2 of 2 : FA_2017_LD0002_28_6_20170911_00004.jpg

USACE 2013 Photo #2

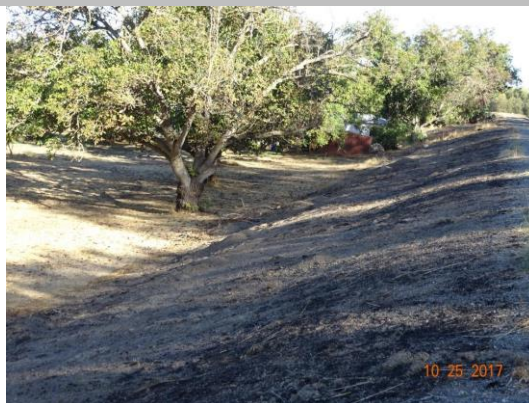
Photo 1 of 2 : FA_2017_LD0002_28_15_20171030_00055.jpg

LM Start	1.52	Rating **	U	Issue No.	15
LM End	1.60	Issue Type +	Ma	Location *	LS
Category	Earthen Levee			GPS Latitude/Longitude	
				Start	End
Item	Animal Control			39.435485 °	39.436643 °
				-122.010640 °	-122.010498 °
DWR ID	DWR_LD0002_01_f_2012_15				
Comment Code					
A3 : No rodents visible, but rodent burrows visible; need to backfill and compact or grout burrows.					
Inspector Comment					
Repair the rodent holes along the landside slope.

View of the rodent holes along the landside slope.

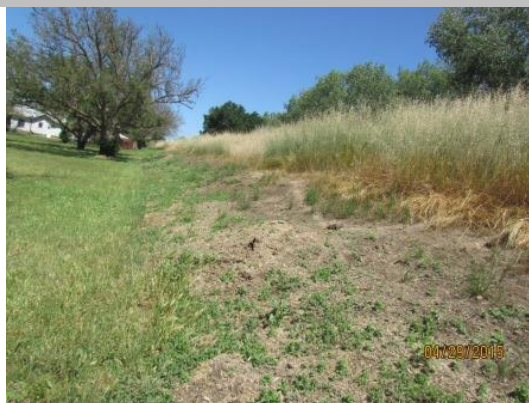
Photo 2 of 2 : FA_2017_LD0002_28_15_20170911_00008.jpg

View of the rodent holes along the landside slope.

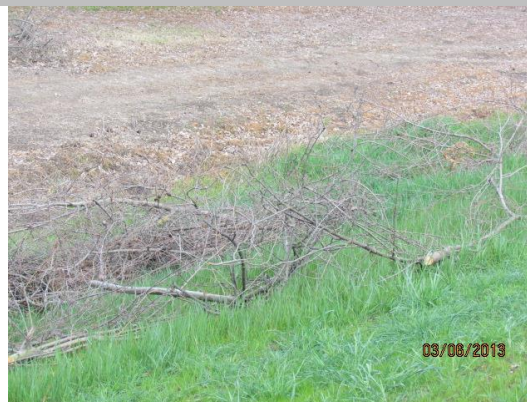
Photo 1 of 1 : FA_2017_LD0002_28_5_20170911_00002.jpg

LM Start	2.89	Rating **	M	Issue No.	5
LM End	2.89	Issue Type +	Ma	Location *	LS
Category	Earthen Levee			GPS Latitude/Longitude	
				Start	End
Item	Encroachments			39.453490 °	39.453490 °
				-122.016457 °	-122.016457 °
DWR ID	DWR_LD0002_01_f_2015_5				
Comment Code					
PR : Prunings					
Inspector Comment

View of the prunings along the landside toe.

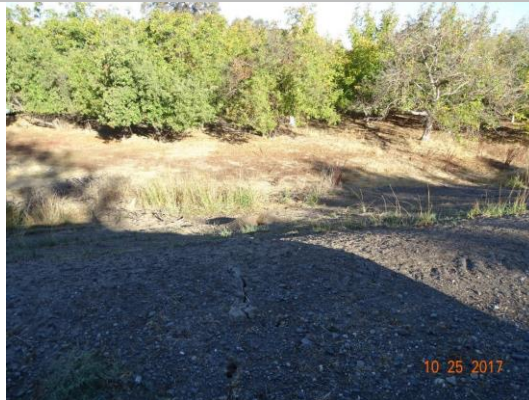
Photo 1 of 2 : FA_2017_LD0002_28_2_20171030_00058.jpg

LM Start	2.91	Rating **	U	Issue No.	2
LM End	2.96	Issue Type +	Ma	Location *	LS
Category	Earthen Levee			GPS Latitude/Longitude	
				Start	End
Item	Animal Control			39.453595 °	39.454003 °
				-122.016273 °	-122.015503 °
DWR ID	DWR_LD0002_01_f_2015_2				
Comment Code					
A3 : No rodents visible, but rodent burrows visible; need to backfill and compact or grout burrows.					
Inspector Comment					
Repair the rodent holes along the landside slope.

View of the rodent holes along the landside slope.

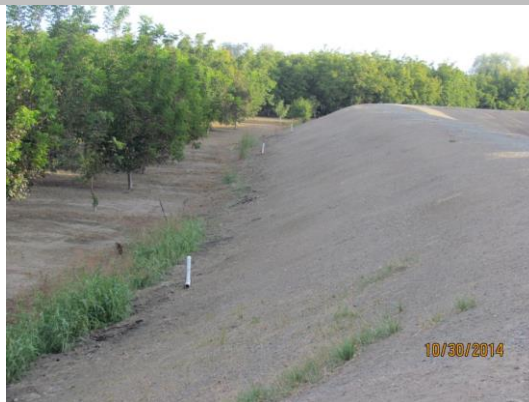
Photo 2 of 2 : FA_2017_LD0002_28_2_20170911_00001.jpg

View of the rodent holes and bait station along the landside slope.

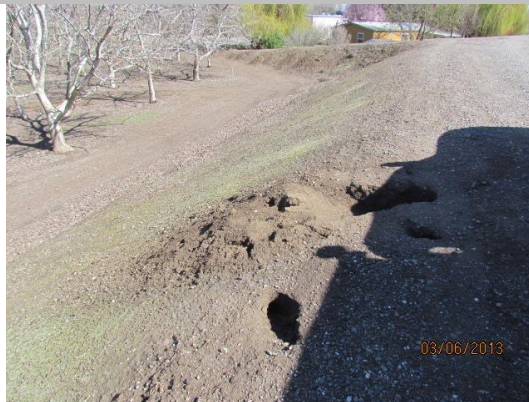
Photo 1 of 1 : FA_2017_LD0002_28_12_20170911_00006.jpg

LM Start	3.16	Rating **	U	Issue No.	12
LM End	3.16	Issue Type +	Ma	Location *	LS
Category	Earthen Levee			GPS Latitude/Longitude	
				Start	End
Item	Animal Control			39.456004 °	39.456004 °
				-122.012776 °	-122.012776 °
DWR ID	DWR_LD0002_01_s_2013_12				
Comment Code					
A1 : Exterminate rodents and backfill and compact or grout burrows.					
Inspector Comment					
Repair the rodent holes along landside slope.

View of the rodent activity along the landside slope.

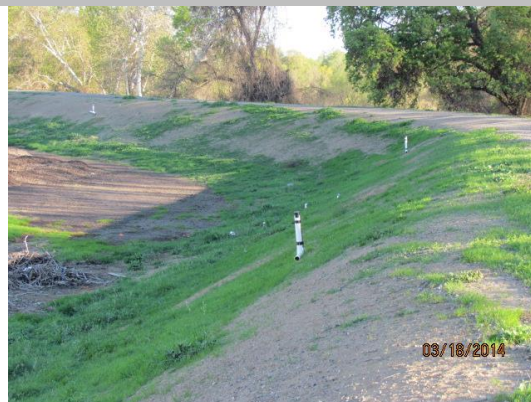
Photo 1 of 2 : FA_2017_LD0002_28_27_20170911_00012.jpg

LM Start	3.44	Rating **	U	Issue No.	27
LM End	3.52	Issue Type +	Ma	Location *	LS
Category	Earthen Levee			GPS Latitude/Longitude	
				Start	End
Item	Animal Control			39.457692 °	39.458705 °
				-122.009517 °	-122.009872 °
DWR ID	DWR_LD0002_01_s _ 2014_27				
Comment Code					
A3 : No rodents visible, but rodent burrows visible; need to backfill and compact or grout burrows.					
Inspector Comment					
Repair the rodent holes on landside slope.

View of the rodent activity along the landside slope.

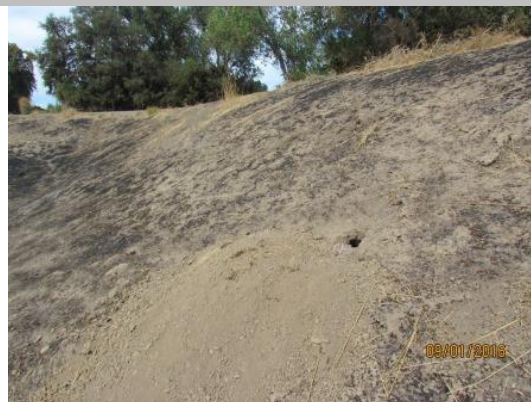
Photo 2 of 2 : FA_2017_LD0002_28_27_20170911_00013.jpg

View of the rodent holes along the landside slope.

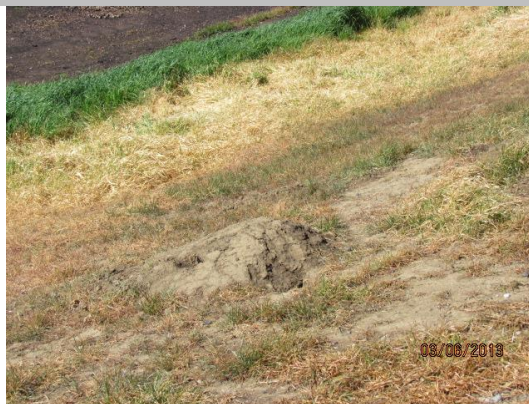
Photo 1 of 1 : FA_2017_LD0002_28_13_20170911_00007.jpg

LM Start	3.53	Rating **	U	Issue No.	13
LM End	3.57	Issue Type +	Ma	Location *	LS
Category	Earthen Levee			GPS Latitude/Longitude	
				Start	End
Item	Animal Control			39.458803 °	39.459305 °
				-122.009980 °	-122.010511 °
DWR ID	DWR_LD0002_01_s_2013_13				
Comment Code					
A3 : No rodents visible, but rodent burrows visible; need to backfill and compact or grout burrows.					
Inspector Comment

View of the rodent activity along the landside slope.

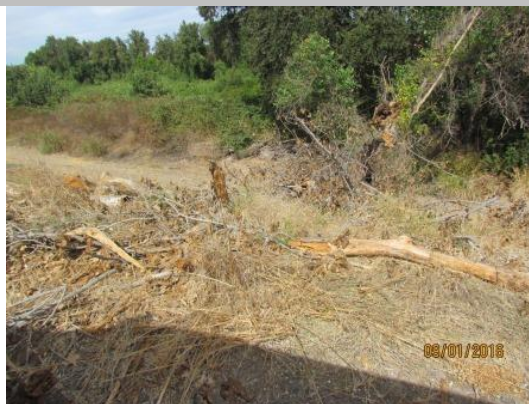
Photo 1 of 2 : FA_2017_LD0002_28_46_20170911_00021.jpg

LM Start	3.60	Rating **	M	Issue No.	46
LM End	3.60	Issue Type +	Ma	Location *	WS
Category	Earthen Levee			GPS Latitude/Longitude	
				Start	End
Item	Encroachments			39.459678 °	39.459678 °
				-122.010785 °	-122.010785 °
DWR ID	DWR_LD0002_01_f_2016_46				
Comment Code					
PR : Prunings					
Inspector Comment					
Remove the tree from the waterside slope and toe.

View of a fallen tree along the waterside slope.

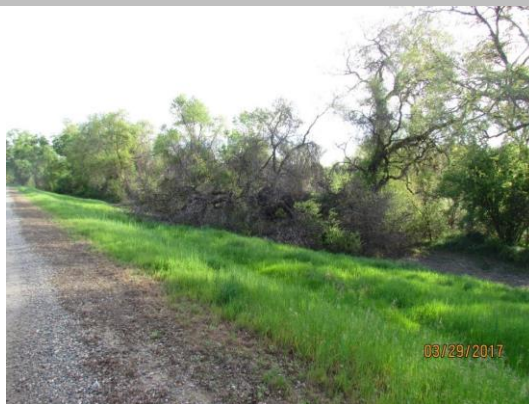
Photo 2 of 2 : FA_2017_LD0002_28_46_20170911_00022.jpg

View of the tree along the waterside slope and toe.

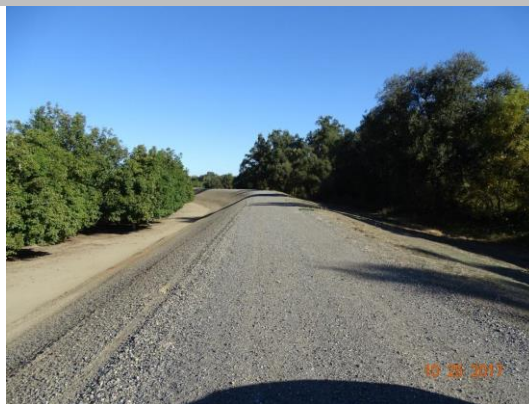
Photo 1 of 1 : FA_2017_LD0002_28_35_20171030_00060.jpg

LM Start	3.95	Rating **	A	Issue No.	35
LM End	3.95	Issue Type +	Ma	Location *	LS
Category	Earthen Levee			GPS Latitude/Longitude	
				Start	End
Item	Vegetation			39.464675 °	39.464675 °
				-122.011385 °	-122.011385 °
DWR ID	DWR_LD0002_01_f_2017_35				
Comment Code					
V1 : Control annual grass and weeds on the levee slopes and easements.					
Inspector Comment					
The vegetation was removed from both slopes.

View of no vegetation on both slopes.

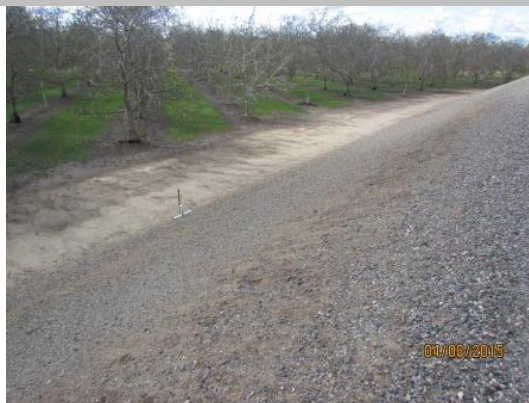
Photo 1 of 1 : FA_2017_LD0002_28_11_20170911_00005.jpg

LM Start	4.87	Rating **	A/W	Issue No.	11
LM End	4.87	Issue Type +	Ma	Location *	LS
Category	Earthen Levee			GPS Latitude/Longitude	
				Start	End
Item	Animal Control			39.476676 °	39.476676 °
				-122.017439 °	-122.017439 °
DWR ID	DWR_LD0002_01_s_2012_11				
Comment Code					
A3 : No rodents visible, but rodent burrows visible; need to backfill and compact or grout burrows.					
Inspector Comment					
The rodent holes have been filled with dirt.

View of the removed rodent holes and bait station.
