**Flood Control Project Maintenance
Levee Inspections**

Maintenance Issue Types Only, Levee Inspection Report By Mile - Fall 2018

Levee District No. 0002 (Glenn County)

Waterway	Bank	Unit Miles	Inspection Start/End	Inspector
Unit No. 01 Glenn County Sacramento River	Right	4.90	09/10/2018 09/10/2018	Bob Duffey

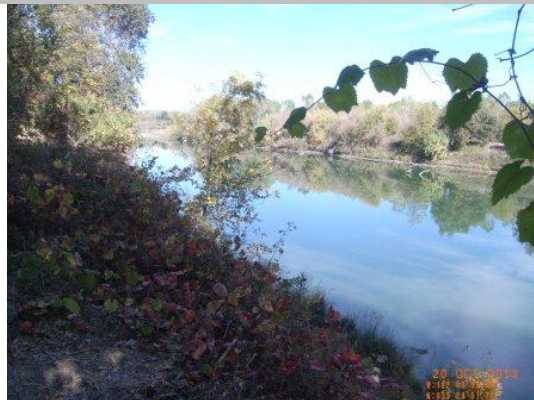
Photo 1 of 2 : FA_2018_LD0002_28_6_20180905_00003.jpg

LM Start	0.07	Rating **	M	Issue No.	6
LM End	0.28	Issue Type +	Ma	Location *	WS
Category	Supplemental			GPS Latitude/Longitude	
				Start	End
Item	2017 USACE Erosion Survey, DRAFT			39.414649 °	39.417689 °
				-122.009853 °	-122.010369 °
DWR ID	DWR_ST0010_02_f_2022_4				
Comment Code					
Inspector Comment					
2017 Site ID: SAC 164.7 R					
Status: Eroding					
2017 Field Notes: New erosion along entire site.					
Site History: 2009 - Very slow retreat, hard toe, encroaching into the levee projection. 2010 - Slowly eroding. 2011 - Site extended downstream.

USACE 2013 Photo #1

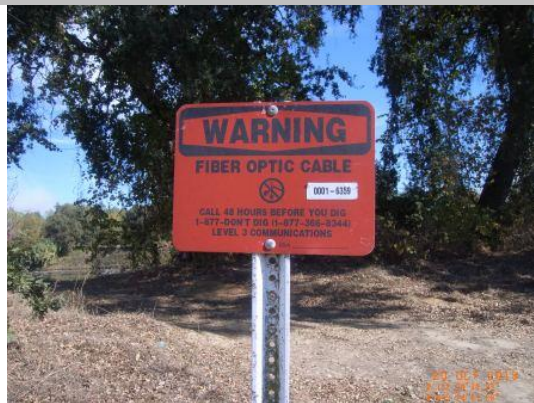
Photo 2 of 2 : FA_2018_LD0002_28_6_20180905_00004.jpg

USACE 2013 Photo #2

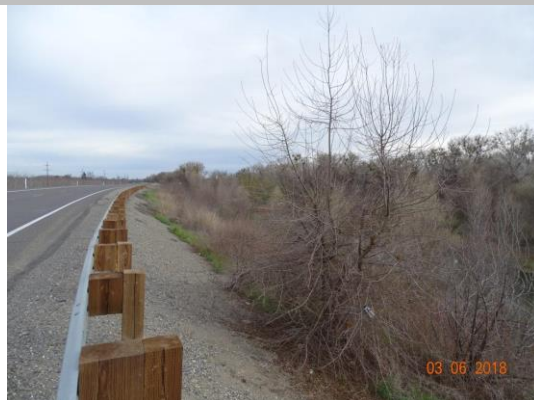
Photo 1 of 1 : FA_2018_LD0002_28_35_20180905_00018.jpg

View of the vegetation along the waterside slope.

LM Start	0.64	Rating **	M	Issue No.	35
LM End	0.77	Issue Type +	Ma	Location *	WS
Category	Earthen Levee			GPS Latitude/Longitude	
				Start	End
Item	Vegetation			39.422805 °	39.424597 °
				-122.011640 °	-122.011527 °
DWR ID	DWR_LD0002_01_s_2018_35				
Comment Code					
V2 : Remove the wild growth other than native grasses from the levee slopes.					
Inspector Comment					
Remove the vegetation from the waterside slope.

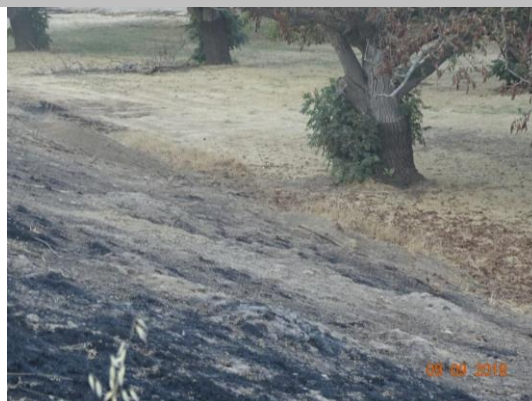
Photo 1 of 1 : FA_2018_LD0002_28_15_20181001_00057.jpg

View of the rodent holes along the landside slope.

LM Start	1.52	Rating **	U	Issue No.	15
LM End	1.60	Issue Type +	Ma	Location *	LS
Category	Earthen Levee			GPS Latitude/Longitude	
				Start	End
Item	Animal Control			39.435485 °	39.436643 °
				-122.010640 °	-122.010498 °
DWR ID	DWR_LD0002_01_f_2012_15				
Comment Code					
A3 : No rodents visible, but rodent burrows visible; need to backfill and compact or grout burrows.					
Inspector Comment					
Repair the rodent holes along the landside slope.

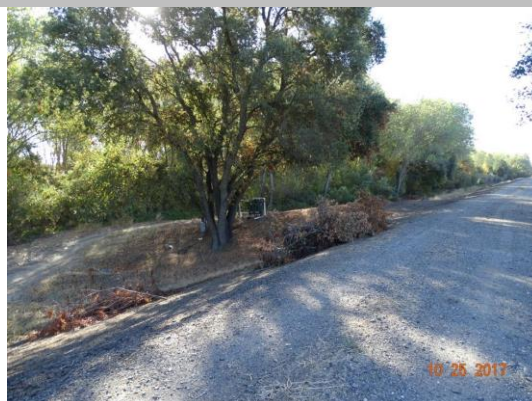
Photo 1 of 1 : FA_2018_LD0002_28_32_20180905_00016.jpg

View of the prunings along the waterside slope.

LM Start	1.63	Rating **	M	Issue No.	32
LM End	1.63	Issue Type +	Ma	Location *	WS
Category	Earthen Levee			GPS Latitude/Longitude	
				Start	End
Item	Encroachments			39.437148 °	39.437148 °
				-122.010475 °	-122.010475 °
DWR ID	DWR_LD0002_01_f_2017_32				
Comment Code					
PR : Prunings					
Inspector Comment					
Remove the prunings from the waterside slope.

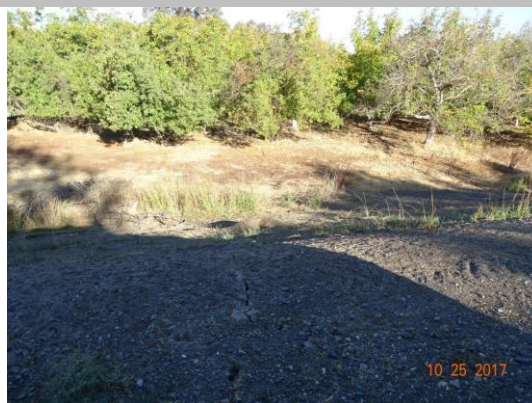
Photo 1 of 2 : FA_2018_LD0002_28_2_20180905_00001.jpg

View of the rodent holes along the landside slope.

LM Start	2.91	Rating **	U	Issue No.	2
LM End	2.96	Issue Type +	Ma	Location *	LS
Category	Earthen Levee			GPS Latitude/Longitude	
				Start	End
Item	Animal Control			39.453595 °	39.454003 °
				-122.016273 °	-122.015503 °
DWR ID	DWR_LD0002_01_f_2015_2				
Comment Code					
A3 : No rodents visible, but rodent burrows visible; need to backfill and compact or grout burrows.					
Inspector Comment					
Repair the rodent holes along the landside slope.

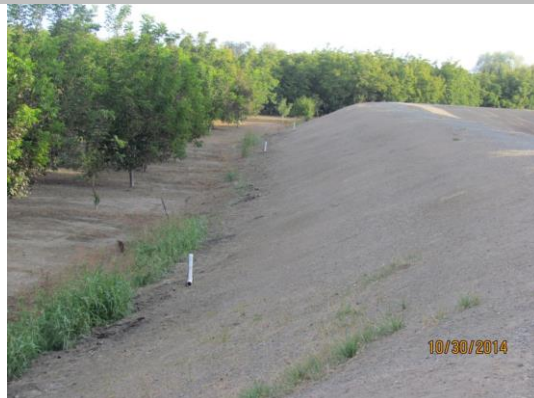
Photo 2 of 2 : FA_2018_LD0002_28_2_20180905_00002.jpg

View of the rodent holes and bait station along the landside slope.

LM Start	2.91	Rating **	U	Issue No.	2 (cont)	
LM End	2.96	Issue Type +	Ma	Location *	LS	
Category	Earthen Levee			GPS Latitude/Longitude		
				Start		End
Item	Animal Control			39.453595 °		39.454003 °
				-122.016273 °		-122.015503 °
DWR ID	DWR_LD0002_01_f_2015_2					
Comment Code						
A3 : No rodents visible, but rodent burrows visible; need to backfill and compact or grout burrows.						
Inspector Comment						
Repair the rodent holes along the landside slope.

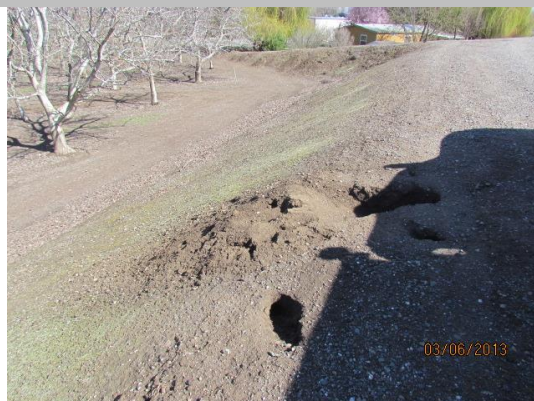
Photo 1 of 1 : FA_2018_LD0002_28_12_20180905_00005.jpg

View of the rodent activity along the landside slope.

LM Start	3.11	Rating **	U	Issue No.	12
LM End	3.16	Issue Type +	Ma	Location *	LS
Category	Earthen Levee			GPS Latitude/Longitude	
				Start	End
Item	Animal Control			39.455647 °	39.456004 °
				-122.013623 °	-122.012776 °
DWR ID	DWR_LD0002_01_s_2013_12				
Comment Code					
A1 : Exterminate rodents and backfill and compact or grout burrows.					
Inspector Comment					
Repair the rodent holes along landside slope.

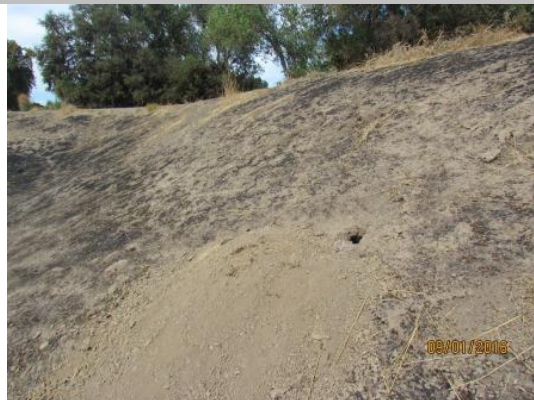
Photo 2 of 2 : FA_2018_LD0002_28_27_20180905_00012.jpg

View of the rodent holes along the landside slope.

LM Start	3.44	Rating **	U	Issue No.	27 (cont)	
LM End	3.52	Issue Type +	Ma	Location *	LS	
Category	Earthen Levee			GPS Latitude/Longitude		
				Start		End
Item	Animal Control			39.457692 °		39.458705 °
				-122.009517 °		-122.009872 °
DWR ID	DWR_LD0002_01_s_2014_27					
Comment Code						
A3 : No rodents visible, but rodent burrows visible; need to backfill and compact or grout burrows.						
Inspector Comment						
Repair the rodent holes on landside slope.

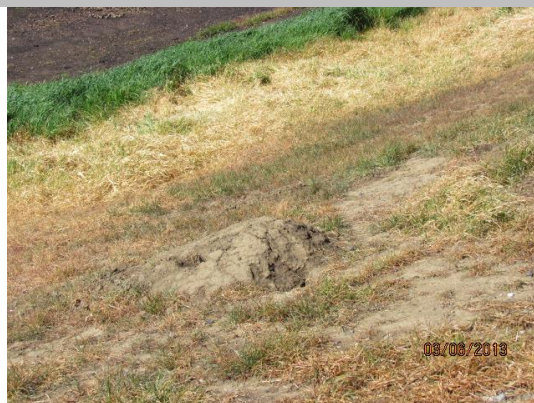
Photo 1 of 1 : FA_2018_LD0002_28_13_20180905_00006.jpg

View of the rodent activity along the landside slope.

LM Start	3.53	Rating **	U	Issue No.	13
LM End	3.57	Issue Type +	Ma	Location *	LS
Category	Earthen Levee			GPS Latitude/Longitude	
				Start	End
Item	Animal Control			39.458803 °	39.459305 °
				-122.009980 °	-122.010511 °
DWR ID	DWR_LD0002_01_s_2013_13				
Comment Code					
A3 : No rodents visible, but rodent burrows visible; need to backfill and compact or grout burrows.					
Inspector Comment

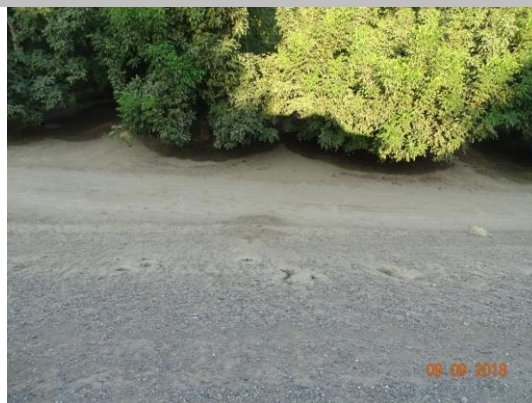
Photo 1 of 1 : FA_2018_LD0002_28_28_20181001_00068.jpg

View of the rodent holes along the landside slope.

LM Start	4.02	Rating **	M	Issue No.	28
LM End	4.02	Issue Type +	Ma	Location *	LS
Category	Earthen Levee			GPS Latitude/Longitude	
				Start	End
Item	Animal Control			39.465657 °	39.465657 °
				-122.011237 °	-122.011237 °
DWR ID	DWR_LD0002_01_f_2018_28				
Comment Code					
A3 : No rodents visible, but rodent burrows visible; need to backfill and compact or grout burrows.					
Inspector Comment					
Repair the rodent holes along the landside slope.
