**Flood Control Project Maintenance
Levee Inspections**

Maintenance Issue Types Only, Levee Inspection Report By Mile - Fall 2019

Levee District No. 0002 (Glenn County)

Waterway	Bank	Unit Miles	Inspection Start/End	Inspector
Unit No. 01 Glenn County Sacramento River	Right	4.90	11/05/2019 11/05/2019	Makar Sokol

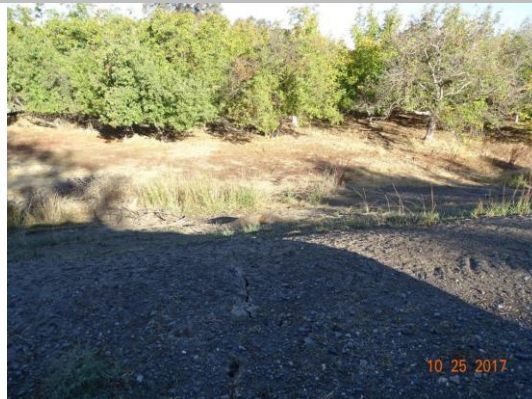
Photo 1 of 2 : FA_2019_LD0002_28_2_20190822_00001.jpg

View of the rodent holes along the landside slope.

LM Start	2.91	Rating **	U	Issue No.	2
LM End	2.96	Issue Type +	Ma	Location *	LS
Category	Earthen Levee		GPS Latitude/Longitude		
			Start	End	
Item	Animal Control		39.453595 °	39.454003 °	
			-122.016273 °	-122.015503 °	
DWR ID	DWR_LD0002_01_f_2015_2				
Comment Code					
A3 : No rodents visible, but rodent burrows visible; need to backfill and compact or grout burrows.					
Inspector Comment

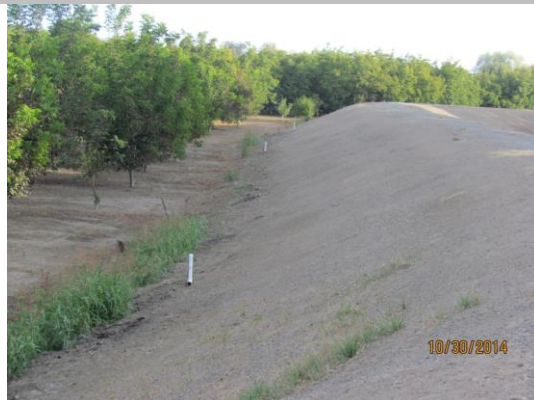
Photo 2 of 2 : FA_2019_LD0002_28_2_20190822_00002.jpg

View of the rodent holes and bait station along the landside slope.

LM Start	2.91	Rating **	U	Issue No.	2 (cont)	
LM End	2.96	Issue Type +	Ma	Location *	LS	
Category	Earthen Levee			GPS Latitude/Longitude		
				Start		End
Item	Animal Control			39.453595 °		39.454003 °
				-122.016273 °		-122.015503 °
DWR ID	DWR_LD0002_01_f_2015_2					
Comment Code						
A3 : No rodents visible, but rodent burrows visible; need to backfill and compact or grout burrows.						
Inspector Comment

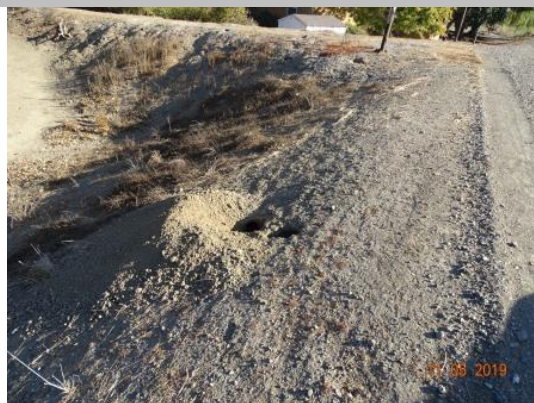
Photo 1 of 2 : FA_2019_LD0002_28_12_20191107_00054.jpg

View of new rodent activity on the landside slope. Fall 2019.

LM Start	3.11	Rating **	U	Issue No.	12
LM End	3.17	Issue Type +	Ma	Location *	LS
Category	Earthen Levee			GPS Latitude/Longitude	
				Start	End
Item	Animal Control			39.455647 °	39.456077 °
				-122.013623 °	-122.012561 °
DWR ID	DWR_LD0002_01_s_2013_12				
Comment Code					
A1 : Exterminate rodents and backfill and compact or grout burrows.					
Inspector Comment

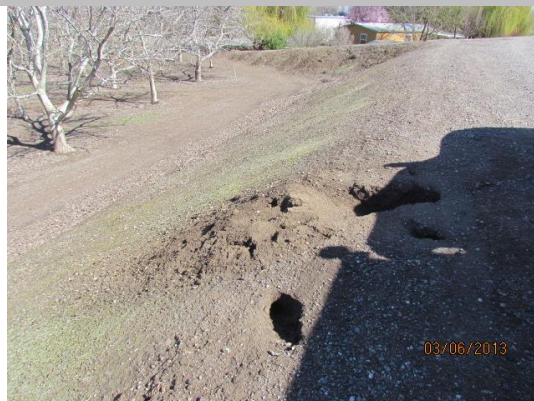
Photo 2 of 2 : FA_2019_LD0002_28_12_20190822_00005.jpg

View of the rodent activity along the landside slope.

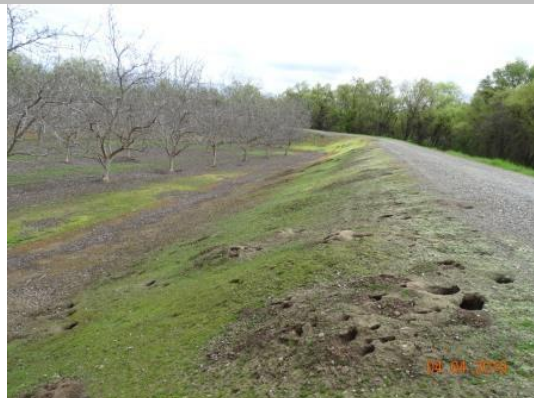
Photo 1 of 2 : FA_2019_LD0002_28_16_20190822_00010.jpg

View of the rodent holes along the landside slope. Spring 2019.

LM Start	3.26	Rating **	U	Issue No.	16
LM End	3.30	Issue Type +	Ma	Location *	LS
Category	Earthen Levee			GPS Latitude/Longitude	
				Start	End
Item	Animal Control			39.456228 °	39.456272 °
				-122.011002 °	-122.010163 °
DWR ID	DWR_LD0002_01_f _ 2012_16				
Comment Code					
A3 : No rodents visible, but rodent burrows visible; need to backfill and compact or grout burrows.					
Inspector Comment

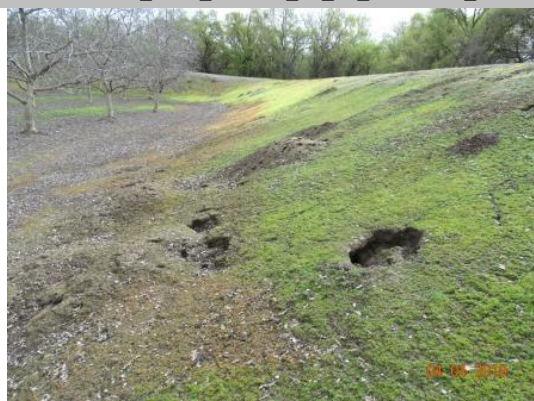
Photo 2 of 2 : FA_2019_LD0002_28_16_20190822_00011.jpg

Another view of the rodent holes along the landside slope. Spring 2019.

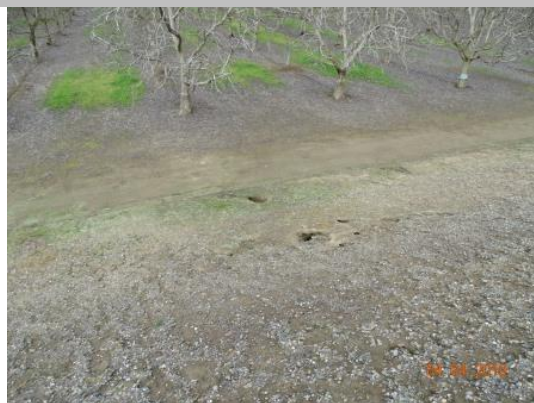
Photo 1 of 1 : FA_2019_LD0002_28_50_20190822_00019.jpg

View of the rodent holes on the landside slope. Spring 2019.

LM Start	3.79	Rating **	M	Issue No.	50							
LM End	3.79	Issue Type +	Ma	Location *	LS							
Category	Earthen Levee		GPS Latitude/Longitude									
			Start	End								
Item	Animal Control		39.462358 °	39.462358 °								
			-122.011623 °	-122.011623 °								
DWR ID	DWR_LD0002_01_s_2019_50											
Comment Code												
A3 : No rodents visible, but rodent burrows visible; need to backfill and compact or grout burrows.												
Inspector Comment
