**Flood Control Project Maintenance
Levee Inspections**

Maintenance Issue Types Only, Levee Inspection Report By Mile - Fall 2020

Levee District No. 0002 (Glenn County)

| Waterway | Bank | Unit Miles | Inspection Start/End | Inspector |
|---|---|---|---|---|
| Unit No. 01 Glenn County Sacramento River | Right | 4.90 | 11/04/2020 11/04/2020 | Makar Sokol |

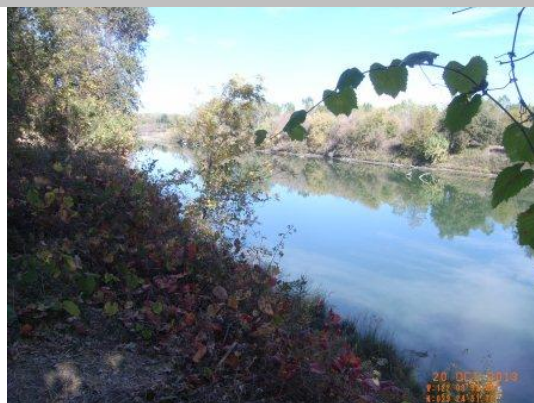
Photo 1 of 2 : FA_2020_LD0002_28_6_20200915_00002.jpg

| 2017 Site ID: SAC 164.7 R | | | | | |
| Status: Eroding | | | | | |
| 2017 Field Notes: New erosion along entire site. | | | | | |
| Site History: 2009 - Very slow retreat, hard toe, encroaching into the levee projection. 2010 - Slowly eroding. 2011 - Site extended downstream. | | | | | |

USACE 2013 Photo #1

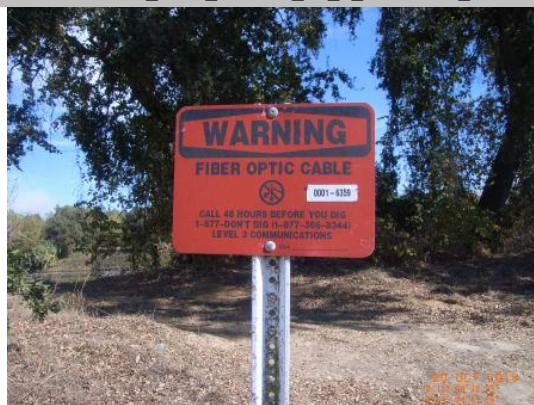
Photo 2 of 2 : FA_2020_LD0002_28_6_20200915_00003.jpg

USACE 2013 Photo #2

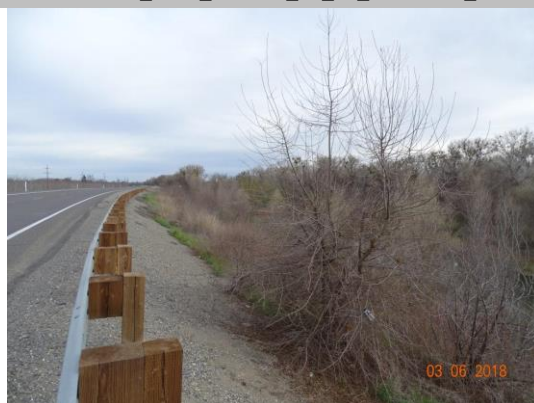
Photo 1 of 1 : FA_2020_LD0002_28_35_20200915_00013.jpg

View of the vegetation along the waterside slope.

| V2 : Remove the wild growth other than native grasses from the levee slopes. | | | | | |

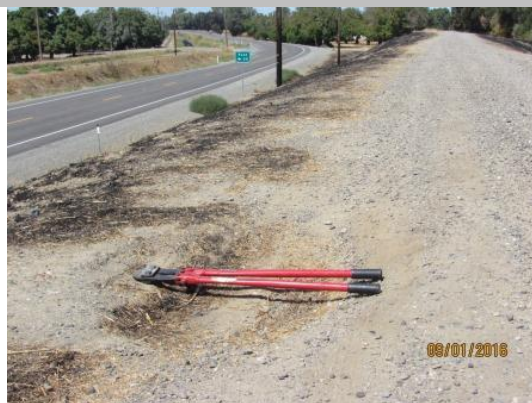
Photo 1 of 1 : FA_2020_LD0002_28_34_20200915_00012.jpg

View of a depression on the levee crown looking upstream.

| C2 : Repair depressions or ruts in the crown or slope. | | | | | |

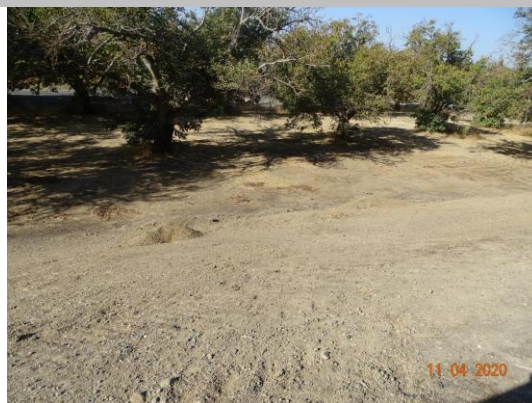
Photo 1 of 1 : FA_2020_LD0002_28_15_20201105_00050.jpg

View of the rodent activity along the landside slope. Fall 2020.

| A3 : No rodents visible, but rodent burrows visible; need to backfill and compact or grout burrows. | | | | | |

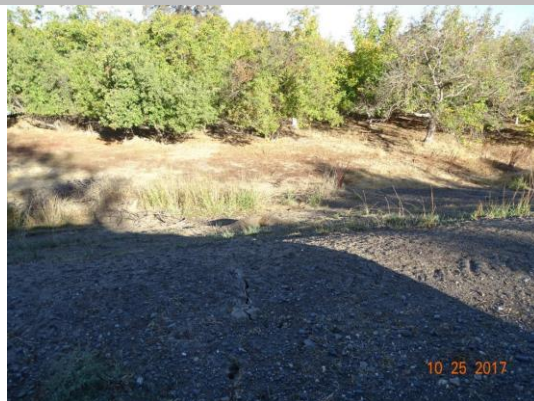
Photo 1 of 1 : FA_2020_LD0002_28_2_20200915_00001.jpg

View of the rodent holes along the landside slope.

| A3 : No rodents visible, but rodent burrows visible; need to backfill and compact or grout burrows. | | | | | |

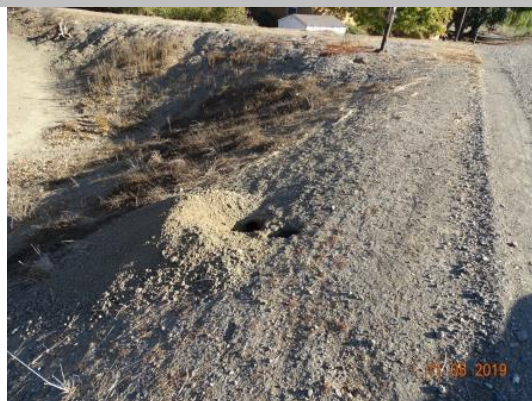
Photo 1 of 1 : FA_2020_LD0002_28_12_20200915_00004.jpg

View of rodent activity on the landside slope. Fall 2019.

| A1 : Exterminate rodents and backfill and compact or grout burrows. | | | | | |

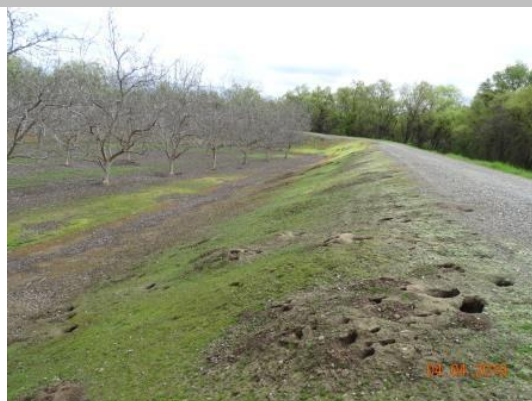
Photo 1 of 1 : FA_2020_LD0002_28_16_20200915_00006.jpg

View of the rodent holes along the landside slope. Spring 2019.

| A3 : No rodents visible, but rodent burrows visible; need to backfill and compact or grout burrows. | | | | | |

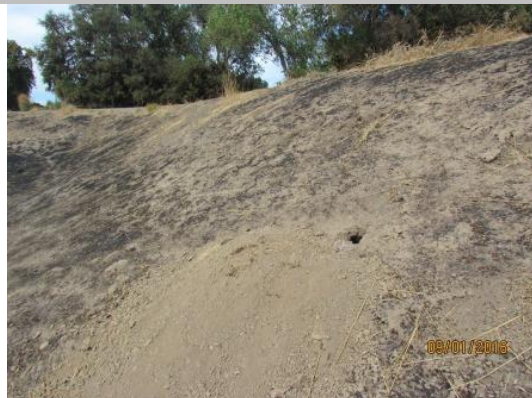
Photo 1 of 1 : FA_2020_LD0002_28_27_20200915_00008.jpg

View of the rodent holes along the landside slope.

| A3 : No rodents visible, but rodent burrows visible; need to backfill and compact or grout burrows. | | | | | |

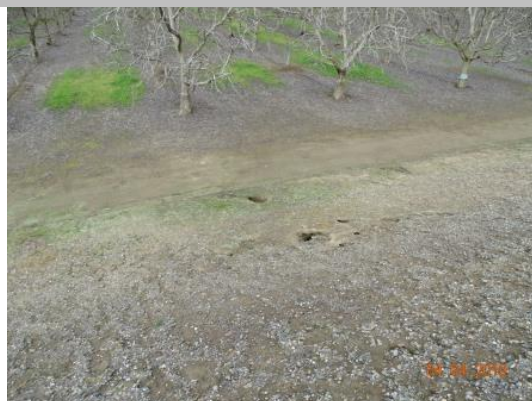
Photo 1 of 1 : FA_2020_LD0002_28_50_20200915_00014.jpg

View of the rodent holes on the landside slope. Spring 2019.

| A3 : No rodents visible, but rodent burrows visible; need to backfill and compact or grout burrows. | | | | | |

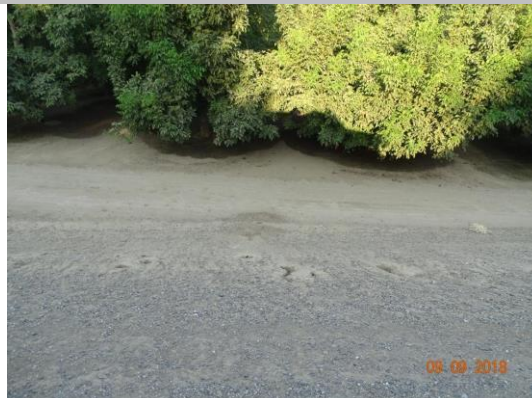
Photo 1 of 1 : FA_2020_LD0002_28_28_20200915_00010.jpg

View of the rodent holes along the landside slope.

| A3 : No rodents visible, but rodent burrows visible; need to backfill and compact or grout burrows. | | | | | | | | | | | | |

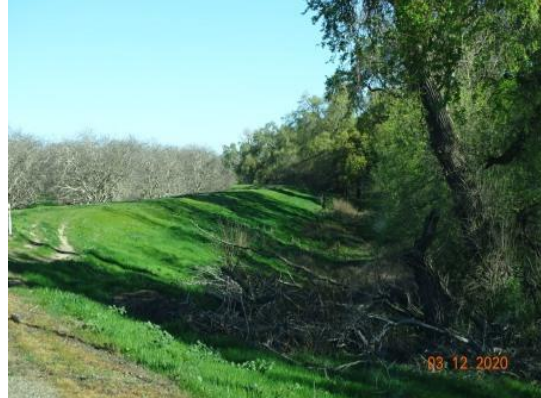
Photo 1 of 1 : FA_2020_LD0002_28_57_20200915_00015.jpg

| TR : Tree or limb | | | | | |

View of the tree and branches on the waterside slope. Spring 2020.
