**Flood Control Project Maintenance
Levee Inspections**

Maintenance Issue Types Only, Levee Inspection Report By Mile - Fall 2021

Levee District No. 0002 (Glenn County)

Waterway	Bank	Unit Miles	Inspection Start/End	Inspector
Unit No. 01 Glenn County Sacramento River	Right	4.90	10/12/2021 10/12/2021	Makar Sokol

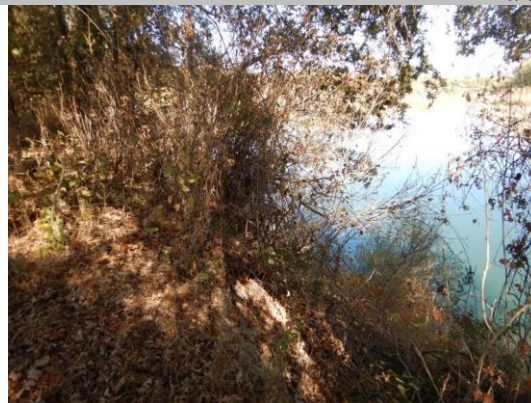
Photo 1 of 2 : FA_2021_LD0002_28_6_20211218_2.jpg

LM Start	0.07	Rating **	M	Issue No.	6
LM End	0.28	Issue Type +	Ma	Location *	WS
Category	Supplemental			GPS Latitude/Longitude	
				Start	End
Item	2018 USACE Erosion Survey			39.414649 °	39.417689 °
				-122.009853 °	-122.010369 °
DWR ID					
Comment Code					
Inspector Comment					
2018 Site ID: SAC 164.7 R					
Status: Eroding					
2018 Field Notes: No observed change.					
Site History: 2009 - Very slow retreat, hard toe, encroaching into the levee projection. 2010 - Slowly eroding. 2011 - Site extended downstream. 2017 - New erosion along entire site.

USACE 2018 Erosion Photo #1

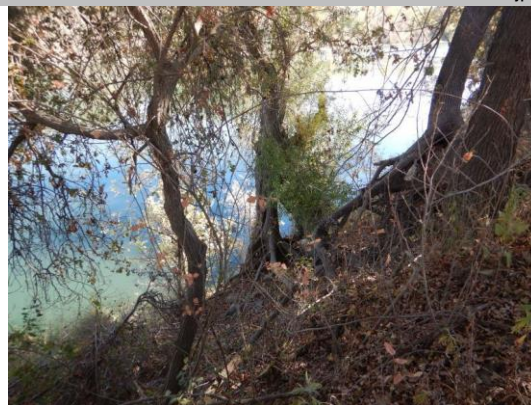
Photo 2 of 2 : FA_2021_LD0002_28_6_20211218_10.jpg

LM Start	0.07	Rating **	M	Issue No.	6 (cont)
LM End	0.28	Issue Type +	Ma	Location *	WS

USACE 2018 Erosion Photo #2

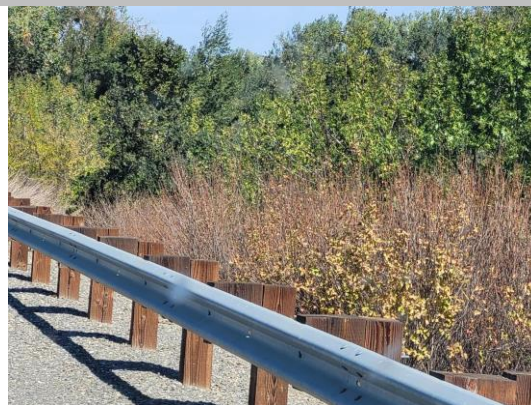
Photo 1 of 1 : FA_2021_LD0002_28_35_20211015_00047.jpg

LM Start	0.64	Rating **	M	Issue No.	35
LM End	0.77	Issue Type +	Ma	Location *	WS
Category	Earthen Levee			GPS Latitude/Longitude	
				Start	End
Item	Vegetation			39.422805 °	39.424597 °
				-122.011640 °	-122.011527 °
DWR ID	DWR_LD0002_01_s_2018_35				
Comment Code					
V2 : Remove the wild growth other than native grasses from the levee slopes.					
Inspector Comment

View of the vegetation along the waterside slope. Fall 2021.

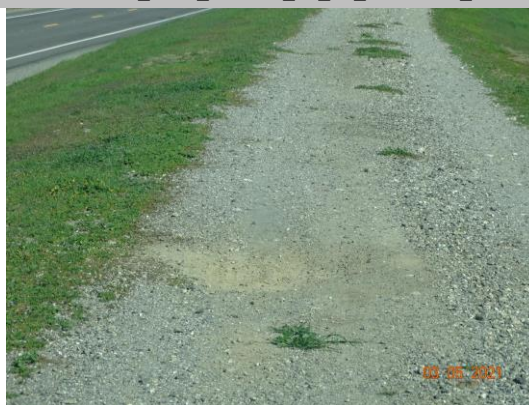
Photo 1 of 1 : FA_2021_LD0002_28_34_20210928_00009.jpg

LM Start	1.40	Rating **	M	Issue No.	34
LM End	1.40	Issue Type +	Ma	Location *	CR
Category	Earthen Levee			GPS Latitude/Longitude	
				Start	End
Item	Crown Surface / Depressions / Rutting			39.433809 °	39.433809 °
				-122.010814 °	-122.010814 °
DWR ID	DWR_LD0002_01_f_2016_34				
Comment Code					
C2 : Repair depressions or ruts in the crown or slope.					
Inspector Comment

View of a depression on the levee crown looking upstream. Spring 2021.

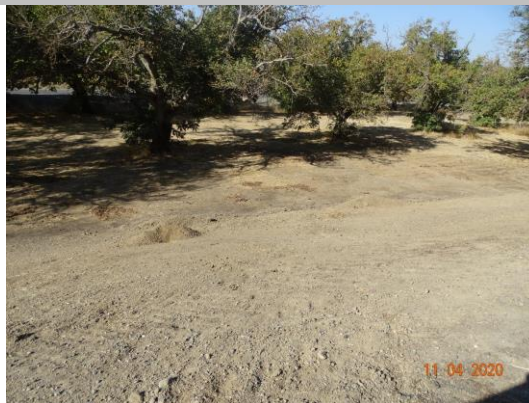
Photo 1 of 1 : FA_2021_LD0002_28_15_20210928_00004.jpg

LM Start	1.56	Rating **	U	Issue No.	15
LM End	1.60	Issue Type +	Ma	Location *	LS
Category	Earthen Levee			GPS Latitude/Longitude	
				Start	End
Item	Animal Control			39.436009 °	39.436643 °
				-122.010524 °	-122.010498 °
DWR ID	DWR_LD0002_01_f_2012_15				
Comment Code					
A3 : No rodents visible, but rodent burrows visible; need to backfill and compact or grout burrows.					
Inspector Comment

View of the rodent activity along the landside slope. Fall 2020.

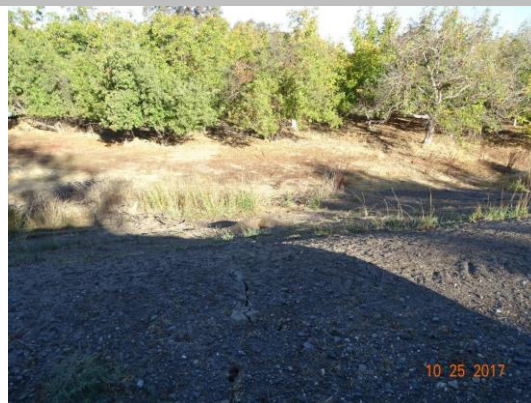
Photo 1 of 1 : FA_2021_LD0002_28_2_20210928_00001.jpg

LM Start	2.91	Rating **	M	Issue No.	2
LM End	2.96	Issue Type +	Ma	Location *	LS
Category	Earthen Levee			GPS Latitude/Longitude	
				Start	End
Item	Animal Control			39.453595 °	39.454003 °
				-122.016273 °	-122.015503 °
DWR ID	DWR_LD0002_01_f_2015_2				
Comment Code					
A3 : No rodents visible, but rodent burrows visible; need to backfill and compact or grout burrows.					
Inspector Comment

View of the rodent holes along the landside slope.

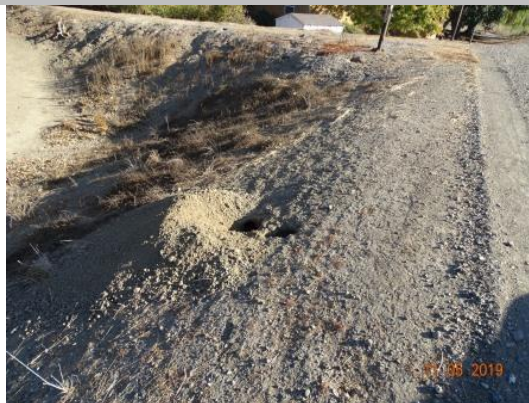
Photo 1 of 1 : FA_2021_LD0002_28_12_20210928_00003.jpg

LM Start	3.11	Rating **	U	Issue No.	12
LM End	3.13	Issue Type +	Ma	Location *	LS
Category	Earthen Levee			GPS Latitude/Longitude	
				Start	End
Item	Animal Control			39.455647 °	39.455805 °
				-122.013623 °	-122.013286 °
DWR ID	DWR_LD0002_01_s_2013_12				
Comment Code					
A1 : Exterminate rodents and backfill and compact or grout burrows.					
Inspector Comment

View of rodent activity on the landside slope. Fall 2019.

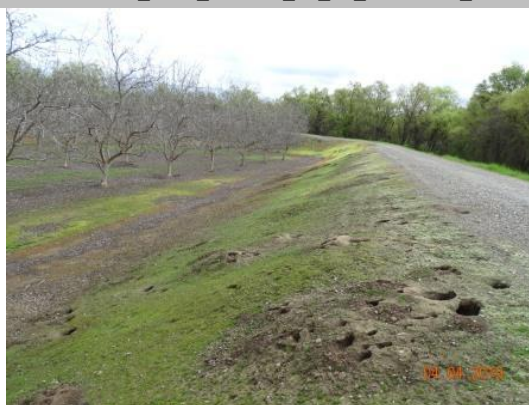
Photo 1 of 1 : FA_2021_LD0002_28_16_20210928_00005.jpg

LM Start	3.24	Rating **	U	Issue No.	16
LM End	3.32	Issue Type +	Ma	Location *	LS
Category	Earthen Levee			GPS Latitude/Longitude	
				Start	End
Item	Animal Control			39.456222 °	39.456268 °
				-122.011266 °	-122.009873 °
DWR ID	DWR_LD0002_01_f_2012_16				
Comment Code					
A3 : No rodents visible, but rodent burrows visible; need to backfill and compact or grout burrows.					
Inspector Comment

View of the rodent holes along the landside slope. Spring 2019.

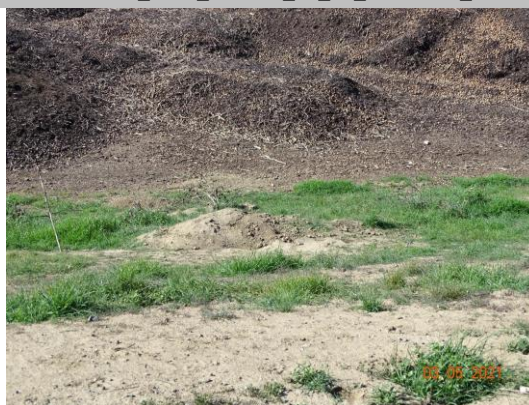
Photo 1 of 1 : FA_2021_LD0002_28_27_20210928_00006.jpg

LM Start	3.53	Rating **	M	Issue No.	27
LM End	3.59	Issue Type +	Ma	Location *	LS
Category	Earthen Levee			GPS Latitude/Longitude	
				Start	End
Item	Animal Control			39.458807 °	39.459614 °
				-122.009990 °	-122.010741 °
DWR ID	DWR_LD0002_01_s_2014_27				
Comment Code					
A3 : No rodents visible, but rodent burrows visible; need to backfill and compact or grout burrows.					
Inspector Comment

View of the rodent holes along the landside slope. Spring 2021.

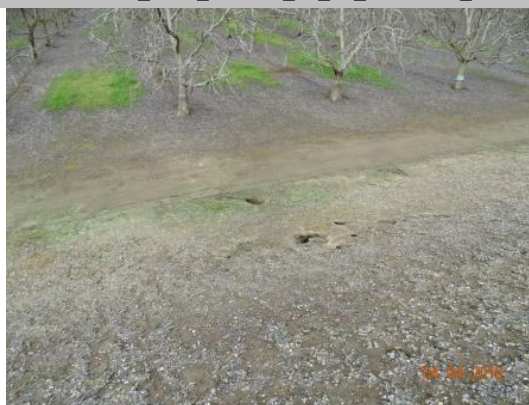
Photo 1 of 1 : FA_2021_LD0002_28_50_20210928_00011.jpg

LM Start	3.79	Rating **	M	Issue No.	50
LM End	3.79	Issue Type +	Ma	Location *	LS
Category	Earthen Levee		GPS Latitude/Longitude		
			Start	End	
Item	Animal Control		39.462358 °	39.462358 °	
			-122.011623 °	-122.011623 °	
DWR ID	DWR_LD0002_01_s_2019_50				
Comment Code					
A3 : No rodents visible, but rodent burrows visible; need to backfill and compact or grout burrows.					
Inspector Comment

View of the rodent holes on the landside slope. Spring 2019.

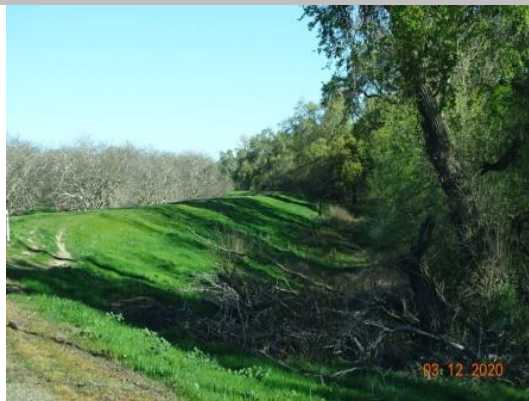
Photo 1 of 1 : FA_2021_LD0002_28_57_20210928_00012.jpg

LM Start	4.90	Rating **	M	Issue No.	57
LM End	4.90	Issue Type +	Ma	Location *	WS
Category	Earthen Levee			GPS Latitude/Longitude	
				Start	End
Item	Encroachments			39.477096 °	39.477096 °
				-122.017607 °	-122.017607 °
DWR ID	DWR_LD0002_01_s _ 2019_57				
Comment Code					
TR : Tree or limb					
Inspector Comment

View of the tree and branches on the waterside slope. Spring 2020.
