**Flood Control Project Maintenance  
Levee Inspections**

**Maintenance Issue Types Only, Levee Inspection Report By Mile - Fall 2022**

**Levee District No. 0002 (Glenn County)**

Waterway	Bank	Unit Miles	Inspection Start/End	Inspector
Unit No. 01 Glenn County Sacramento River	Right	4.90	10/14/2022 10/14/2022	Makar Sokol

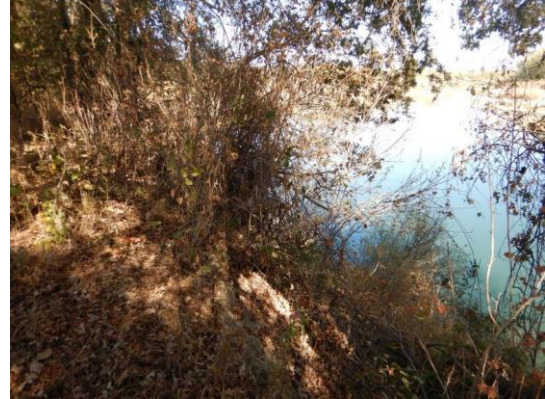
Photo 1 of 2 : FA\_2022\_LD0002\_28\_6\_20220906\_00002.jpg

LM Start	0.07	Rating **	M	Issue No.	6
LM End	0.28	Issue Type +	Ma	Location *	WS
Category	Supplemental			GPS Latitude/Longitude	
				Start	End
Item	2018 USACE Erosion Survey			39.414649 °	39.417689 °
				-122.009853 °	-122.010369 °
DWR ID	DWR_LD0002_01_s_2022_6				
Comment Code					
Inspector Comment					
2018 Site ID: SAC 164.7 R					
Status: Eroding					
2018 Field Notes: No observed change.					
Site History: 2009 - Very slow retreat, hard toe, encroaching into the levee projection. 2010 - Slowly eroding. 2011 - Site extended downstream. 2017 - New erosion along entire site.

USACE 2018 Erosion Photo #1

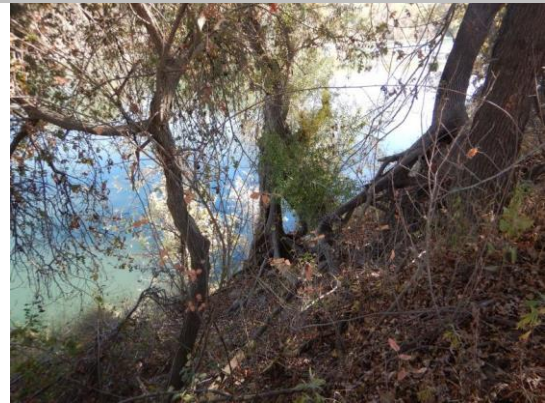
Photo 2 of 2 : FA\_2022\_LD0002\_28\_6\_20220906\_00003.jpg

USACE 2018 Erosion Photo #2

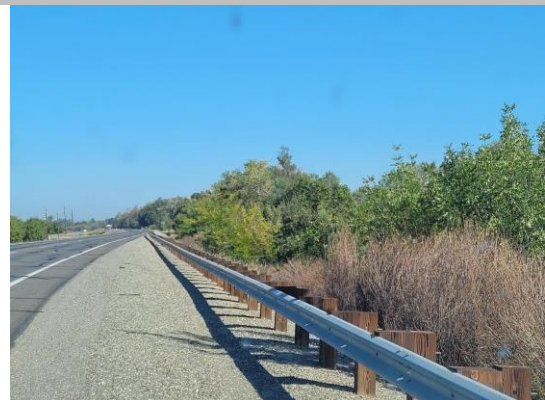
Photo 1 of 1 : FA\_2022\_LD0002\_28\_35\_20221024\_00016.jpg

LM Start	0.64	Rating **	M	Issue No.	35
LM End	0.77	Issue Type +	Ma	Location *	WS
Category	Earthen Levee			GPS Latitude/Longitude	
				Start	End
Item	Vegetation			39.422805 °	39.424597 °
				-122.011640 °	-122.011527 °
DWR ID	DWR_LD0002_01_s_2018_35				
Comment Code					
V2 : Remove the wild growth and woody vegetation other than native grasses from the levee slopes.					
Inspector Comment

View of the wild growth along the waterside slope. Fall 2022.

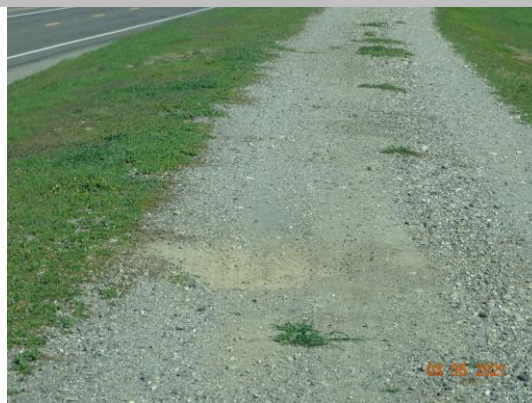
Photo 1 of 1 : FA\_2022\_LD0002\_28\_34\_20220906\_00010.jpg

LM Start	1.40	Rating **	M	Issue No.	34
LM End	1.40	Issue Type +	Ma	Location *	CR
Category	Earthen Levee			GPS Latitude/Longitude	
				Start	End
Item	Crown Surface / Depressions / Rutting			39.433809 °	39.433809 °
				-122.010814 °	-122.010814 °
DWR ID	DWR_LD0002_01_f_2016_34				
Comment Code					
C2 : Repair depressions or ruts in the crown or slope.					
Inspector Comment

View of a depression on the levee crown looking upstream. Spring 2021.

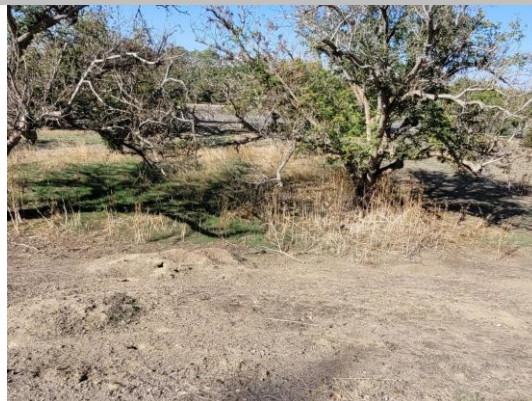
Photo 1 of 1 : FA\_2022\_LD0002\_28\_15\_20221024\_00017.jpg

LM Start	1.54	Rating **	U	Issue No.	15
LM End	1.60	Issue Type +	Ma	Location *	LS
Category	Earthen Levee			GPS Latitude/Longitude	
				Start	End
Item	Animal Control			39.435730 °	39.436643 °
				-122.010565 °	-122.010498 °
DWR ID	DWR_LD0002_01_f_2012_15				
Comment Code					
A3 : No rodents visible, but rodent burrows visible; need to backfill and compact or grout burrows.					
Inspector Comment

View of the rodent activity along the landside slope. Fall 2022.

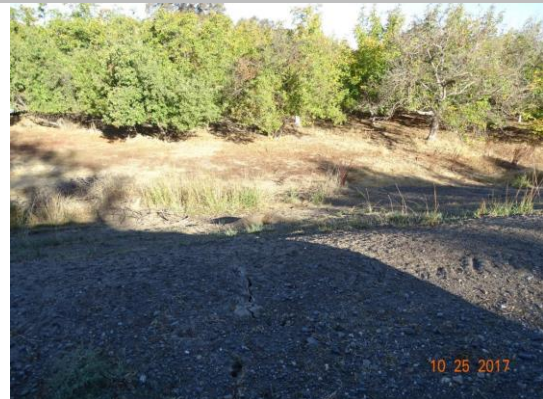
Photo 1 of 1 : FA\_2022\_LD0002\_28\_2\_20220906\_00001.jpg

LM Start	2.94	Rating **	M	Issue No.	2
LM End	2.94	Issue Type +	Ma	Location *	LS
Category	Earthen Levee			GPS Latitude/Longitude	
				Start	End
Item	Animal Control			39.453947 °	39.453947 °
				-122.015764 °	-122.015764 °
DWR ID	DWR_LD0002_01_f_2015_2				
Comment Code					
A3 : No rodents visible, but rodent burrows visible; need to backfill and compact or grout burrows.					
Inspector Comment

View of the rodent holes along the landside slope.

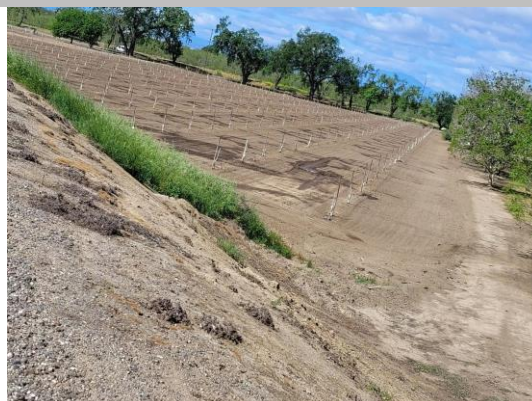
Photo 1 of 1 : FA\_2022\_LD0002\_28\_12\_20220906\_00004.jpg

LM Start	3.11	Rating **	U	Issue No.	12
LM End	3.13	Issue Type +	Ma	Location *	LS
Category	Earthen Levee			GPS Latitude/Longitude	
				Start	End
Item	Animal Control			39.455647 °	39.455805 °
				-122.013623 °	-122.013286 °
DWR ID	DWR_LD0002_01_s_2013_12				
Comment Code					
A1 : Exterminate rodents and backfill and compact or grout burrows.					
Inspector Comment

View of rodent activity on the landside slope. Spring 2022.

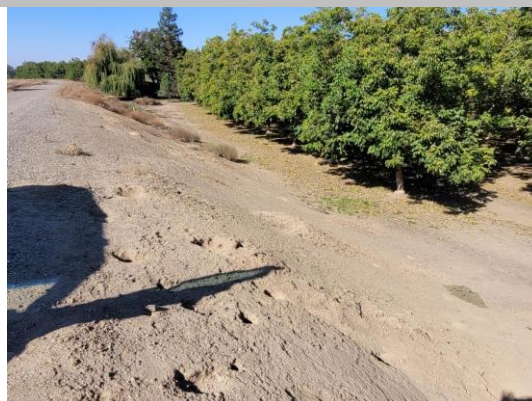
Photo 1 of 1 : FA\_2022\_LD0002\_28\_16\_20221024\_00018.jpg

LM Start	3.23	Rating **	U	Issue No.	16
LM End	3.32	Issue Type +	Ma	Location *	LS
Category	Earthen Levee			GPS Latitude/Longitude	
				Start	End
Item	Animal Control			39.456234 °	39.456302 °
				-122.011413 °	-122.009772 °
DWR ID	DWR_LD0002_01_f_2012_16				
Comment Code					
A3 : No rodents visible, but rodent burrows visible; need to backfill and compact or grout burrows.					
Inspector Comment

View of the rodent holes along the landside slope. Fall 2022.

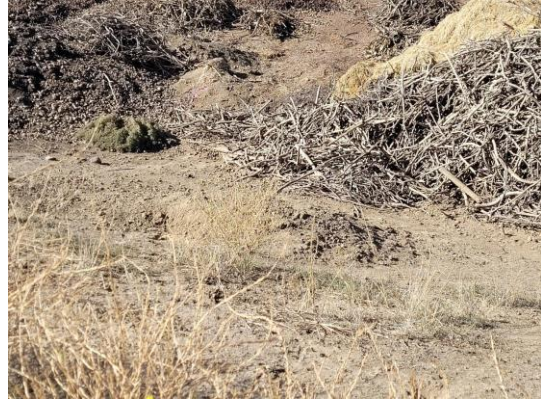
Photo 1 of 1 : FA\_2022\_LD0002\_28\_24\_20221024\_00019.jpg

LM Start	3.48	Rating **	U	Issue No.	24
LM End	3.48	Issue Type +	Ma	Location *	LS
Category	Earthen Levee			GPS Latitude/Longitude	
				Start	End
Item	Animal Control			39.458193 °	39.458193 °
				-122.009550 °	-122.009550 °
DWR ID	DWR_LD0002_01_f_2021_24				
Comment Code					
A3 : No rodents visible, but rodent burrows visible; need to backfill and compact or grout burrows.					
Inspector Comment

View of rodent activity along the landside slope. Fall 2022.

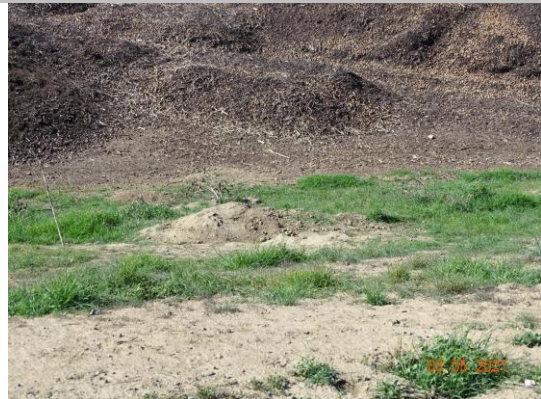
Photo 1 of 1 : FA\_2022\_LD0002\_28\_27\_20220906\_00007.jpg

LM Start	3.53	Rating **	M	Issue No.	27
LM End	3.59	Issue Type +	Ma	Location *	LS
Category	Earthen Levee			GPS Latitude/Longitude	
				Start	End
Item	Animal Control			39.458807 °	39.459614 °
				-122.009990 °	-122.010741 °
DWR ID	DWR_LD0002_01_s_2014_27				
Comment Code					
A3 : No rodents visible, but rodent burrows visible; need to backfill and compact or grout burrows.					
Inspector Comment

View of the rodent holes along the landside slope. Spring 2021.

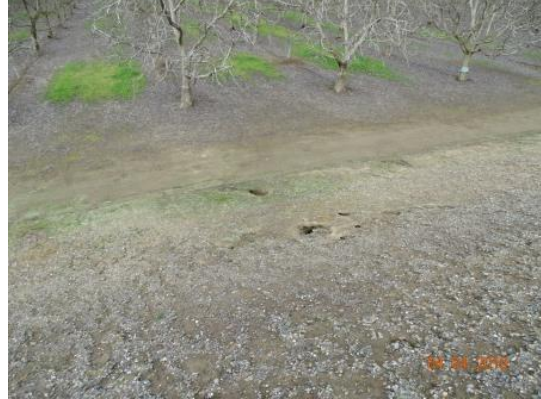
Photo 1 of 1 : FA\_2022\_LD0002\_28\_50\_20220906\_00012.jpg

LM Start	3.79	Rating **	M	Issue No.	50
LM End	3.79	Issue Type +	Ma	Location *	LS
Category	Earthen Levee			GPS Latitude/Longitude	
				Start	End
Item	Animal Control			39.462358 °	39.462358 °
				-122.011623 °	-122.011623 °
DWR ID	DWR_LD0002_01_s_2019_50				
Comment Code					
A3 : No rodents visible, but rodent burrows visible; need to backfill and compact or grout burrows.					
Inspector Comment

View of the rodent holes on the landside slope. Spring 2019.
