**Flood Control Project Maintenance
Levee Inspections**

Maintenance Issue Types Only, Levee Inspection Report By Mile - Fall 2023

Levee District No. 0002 (Glenn County)

Waterway	Bank	Unit Miles	Inspection Start/End	Inspector
Unit No. 01 Glenn County Sacramento River	Right	4.90	10/30/2023 10/30/2023	Makar Sokol

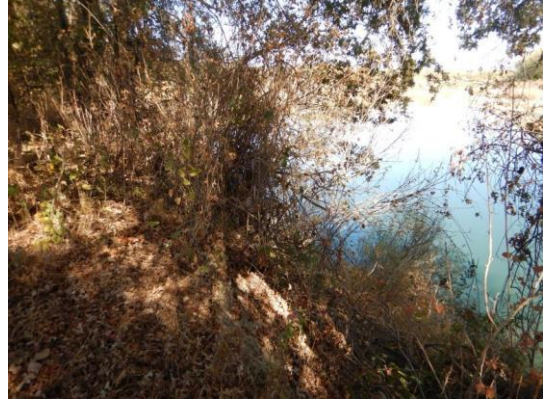
Photo 1 of 2 : FA_2023_LD0002_28_6_20231002_00002.jpg

LM Start	0.07	Rating **	M	Issue No.	6
LM End	0.28	Issue Type +	Ma	Location *	WS
Category	Supplemental			GPS Latitude/Longitude	
				Start	End
Item	2018 USACE Erosion Survey			39.414649°	39.417689°
				-122.009853°	-122.010369°
DWR ID	DWR_LD0002_01_s_2022_6				
Comment Code					
Inspector Comment					
2018 Site ID: SAC 164.7 R					
Status: Eroding					
2018 Field Notes: No observed change.					
Site History: 2009 - Very slow retreat, hard toe, encroaching into the levee projection. 2010 - Slowly eroding. 2011 - Site extended downstream. 2017 - New erosion along entire site.

USACE 2018 Erosion Photo #1

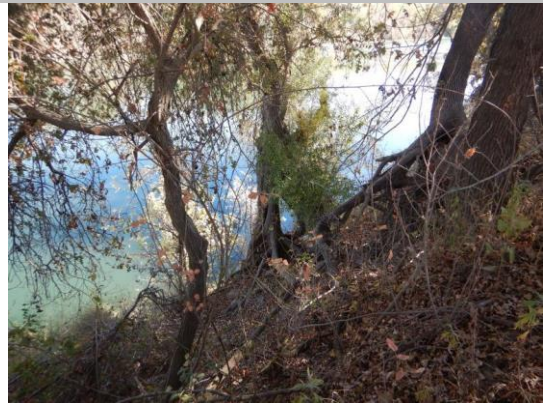
Photo 2 of 2 : FA_2023_LD0002_28_6_20231002_00003.jpg

LM Start	0.07	Rating **	M	Issue No.	6 (cont)
LM End	0.28	Issue Type +	Ma	Location *	WS

USACE 2018 Erosion Photo #2

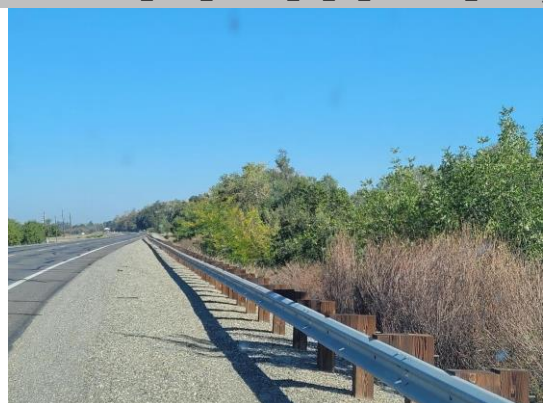
Photo 1 of 1 : FA_2023_LD0002_28_35_20231002_00012.jpg

View of the wild growth along the waterside slope. Fall 2022.

LM Start	0.64	Rating **	M	Issue No.	35
LM End	0.77	Issue Type +	Ma	Location *	WS
Category	Earthen Levee			GPS Latitude/Longitude	
				Start	End
Item	Vegetation			39.422805°	39.424597°
				-122.011640°	-122.011527°
DWR ID	DWR_LD0002_01_s_2018_35				
Comment Code					
V2 : Remove the wild growth and woody vegetation other than native grasses from the levee slopes.					
Inspector Comment

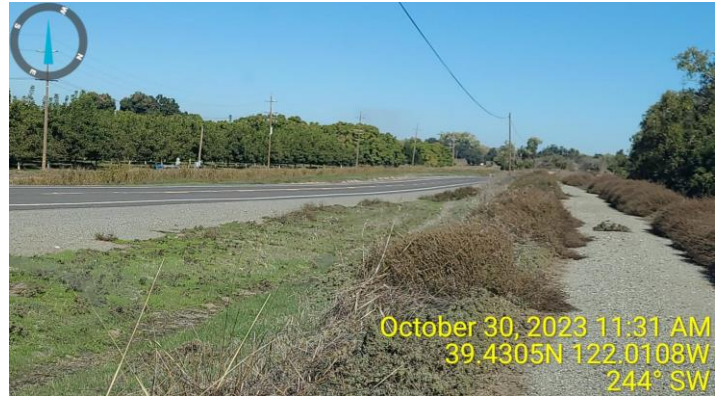
Photo 1 of 1 : FA_2023_LD0002_28_4_20231030_00020.jpg

View of the vegetation along the landside slope. Fall 2023.

LM Start	1.16	Rating **	U	Issue No.	4
LM End	2.00	Issue Type +	Ma	Location *	LS
Category	Earthen Levee			GPS Latitude/Longitude	
				Start	End
Item	Vegetation			39.430309°	39.441575°
				-122.010800°	-122.012650°
DWR ID	DWR_LD0002_01_f_2023_4				
Comment Code					
V1 : Control annual grass and weeds on the levee slopes and easements.					
Inspector Comment

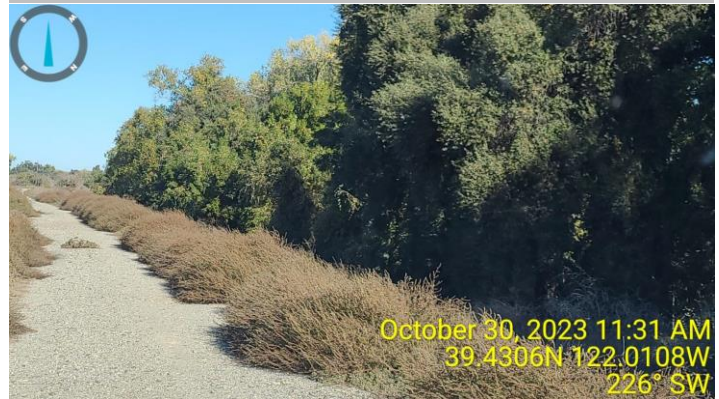
Photo 1 of 1 : FA_2023_LD0002_28_5_20231030_00021.jpg

View of the vegetation along the waterside slope. Fall 2023.

LM Start	1.16	Rating **	U	Issue No.	5
LM End	2.01	Issue Type +	Ma	Location *	WS
Category	Earthen Levee			GPS Latitude/Longitude	
				Start	End
Item	Vegetation			39.430310°	39.441725°
				-122.010800°	-122.012877°
DWR ID	DWR_LD0002_01_f_2023_5				
Comment Code					
V1 : Control annual grass and weeds on the levee slopes and easements.					
Inspector Comment

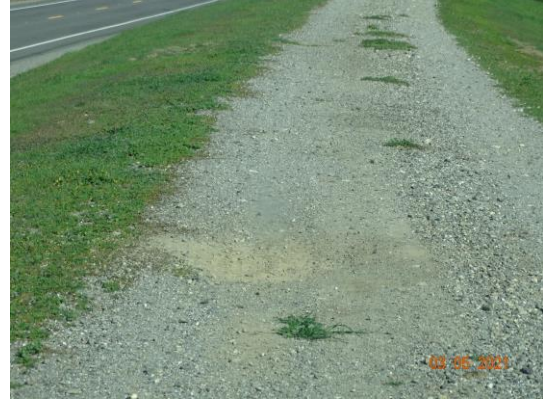
Photo 1 of 1 : FA_2023_LD0002_28_34_20231002_00011.jpg

View of a depression on the levee crown looking upstream. Spring 2021.

LM Start	1.40	Rating **	M	Issue No.	34
LM End	1.40	Issue Type +	Ma	Location *	CR
Category	Earthen Levee			GPS Latitude/Longitude	
				Start	End
Item	Crown Surface / Depressions / Rutting			39.433809°	39.433809°
				-122.010814°	-122.010814°
DWR ID	DWR_LD0002_01_f_2016_34				
Comment Code					
C2 : Repair depressions or ruts in the crown or slope.					
Inspector Comment

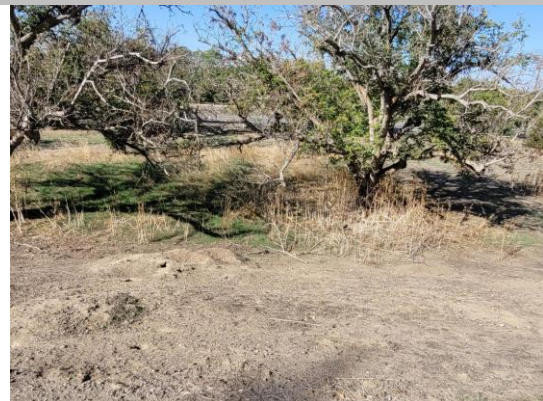
Photo 1 of 1 : FA_2023_LD0002_28_15_20231002_00005.jpg

View of the rodent activity along the landside slope. Fall 2022.

LM Start	1.54	Rating **	U	Issue No.	15
LM End	1.60	Issue Type +	Ma	Location *	LS
Category	Earthen Levee			GPS Latitude/Longitude	
				Start	End
Item	Animal Control			39.435730°	39.436643°
				-122.010565°	-122.010498°
DWR ID	DWR_LD0002_01_f_2012_15				
Comment Code					
A3 : No rodents visible, but rodent burrows visible; need to backfill and compact or grout burrows.					
Inspector Comment

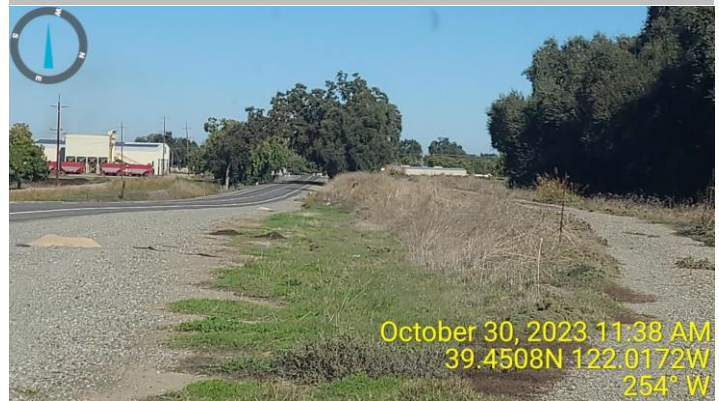
Photo 1 of 1 : FA_2023_LD0002_28_10_20231030_00022.jpg

View of the vegetation along the landside slope. Fall 2023.

LM Start	2.70	Rating **	U	Issue No.	10
LM End	3.33	Issue Type +	Ma	Location *	LS
Category	Earthen Levee			GPS Latitude/Longitude	
				Start	End
Item	Vegetation			39.450897°	39.456286°
				-122.017225°	-122.009681°
DWR ID	DWR_LD0002_01_f_2023_10				
Comment Code					
V1 : Control annual grass and weeds on the levee slopes and easements.					
Inspector Comment

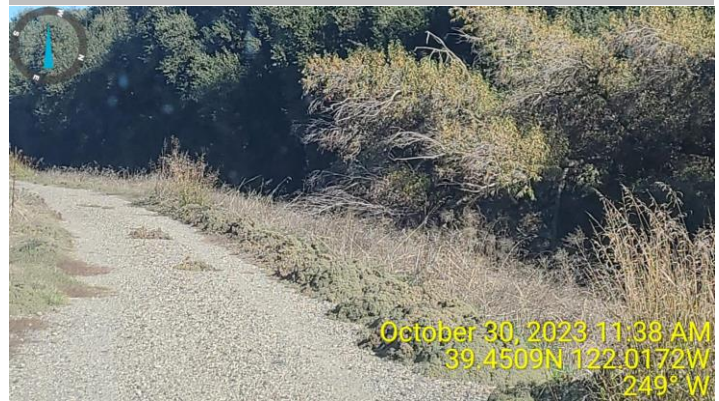
Photo 1 of 1 : FA_2023_LD0002_28_9_20231030_00023.jpg

View of the vegetation along the waterside slope. Fall 2023.

LM Start	2.70	Rating **	U	Issue No.	9
LM End	3.12	Issue Type +	Ma	Location *	WS
Category	Earthen Levee			GPS Latitude/Longitude	
				Start	End
Item	Vegetation			39.450904°	39.455728°
				-122.017229°	-122.013429°
DWR ID	DWR_LD0002_01_f_2023_9				
Comment Code					
V1 : Control annual grass and weeds on the levee slopes and easements.					
Inspector Comment

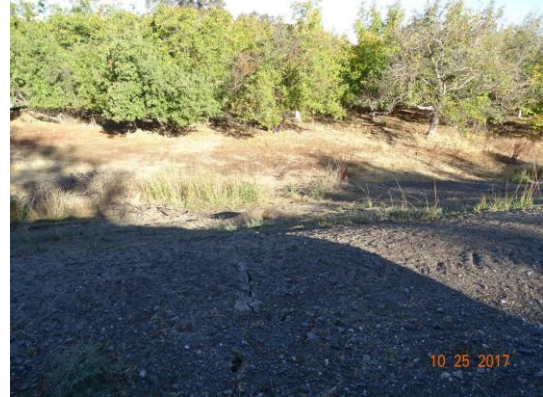
Photo 1 of 1 : FA_2023_LD0002_28_2_20231002_00001.jpg

View of the rodent holes along the landside slope.

LM Start	2.94	Rating **	M	Issue No.	2
LM End	2.94	Issue Type +	Ma	Location *	LS
Category	Earthen Levee			GPS Latitude/Longitude	
				Start	End
Item	Animal Control			39.453947°	39.453947°
				-122.015764°	-122.015764°
DWR ID	DWR_LD0002_01_f_2015_2				
Comment Code					
A3 : No rodents visible, but rodent burrows visible; need to backfill and compact or grout burrows.					
Inspector Comment

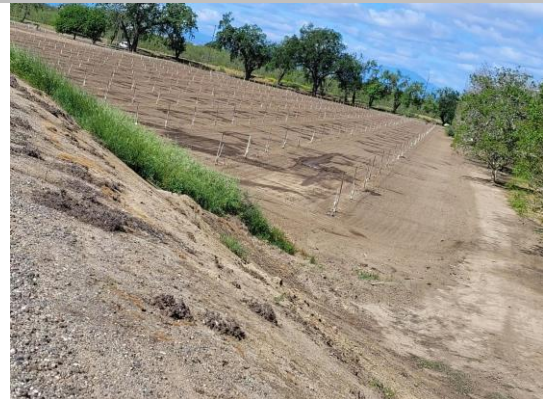
Photo 1 of 1 : FA_2023_LD0002_28_12_20231002_00004.jpg

View of rodent activity on the landside slope. Spring 2022.

LM Start	3.11	Rating **	U	Issue No.	12
LM End	3.13	Issue Type +	Ma	Location *	LS
Category	Earthen Levee			GPS Latitude/Longitude	
				Start	End
Item	Animal Control			39.455647°	39.455805°
				-122.013623°	-122.013286°
DWR ID	DWR_LD0002_01_s_2013_12				
Comment Code					
A1 : Exterminate rodents and backfill and compact or grout burrows.					
Inspector Comment

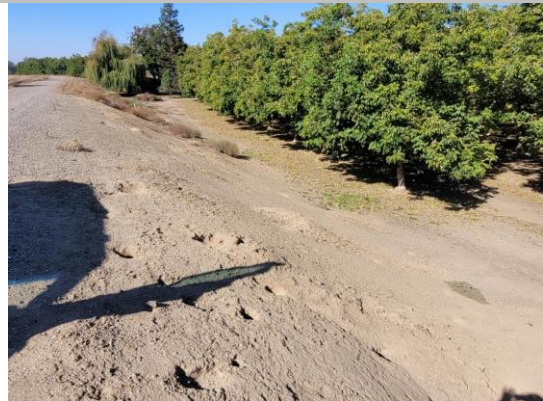
Photo 1 of 1 : FA_2023_LD0002_28_16_20231002_00006.jpg

View of the rodent holes along the landside slope. Fall 2022.

LM Start	3.23	Rating **	U	Issue No.	16
LM End	3.32	Issue Type +	Ma	Location *	LS
Category	Earthen Levee			GPS Latitude/Longitude	
				Start	End
Item	Animal Control			39.456234°	39.456302°
				-122.011413°	-122.009772°
DWR ID	DWR_LD0002_01_f_2012_16				
Comment Code					
A3 : No rodents visible, but rodent burrows visible; need to backfill and compact or grout burrows.					
Inspector Comment

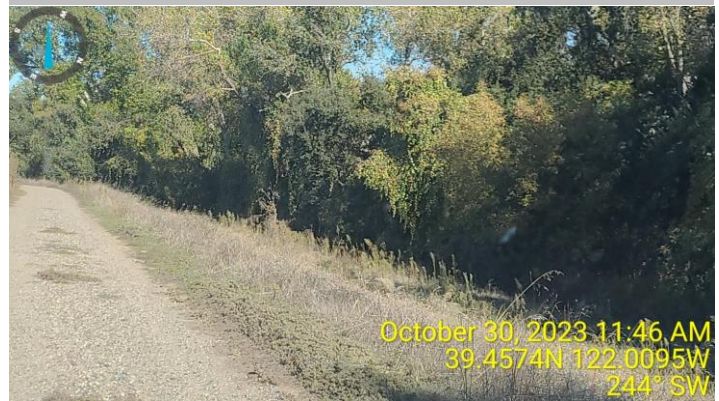
Photo 1 of 1 : FA_2023_LD0002_28_13_20231030_00024.jpg

View of the vegetation along the waterside slope. Fall 2023.

LM Start	3.42	Rating **	U	Issue No.	13
LM End	4.16	Issue Type +	Ma	Location *	WS
Category	Earthen Levee			GPS Latitude/Longitude	
				Start	End
Item	Vegetation			39.457403°	39.467608°
				-122.009471°	-122.011616°
DWR ID	DWR_LD0002_01_f_2023_13				
Comment Code					
V1 : Control annual grass and weeds on the levee slopes and easements.					
Inspector Comment

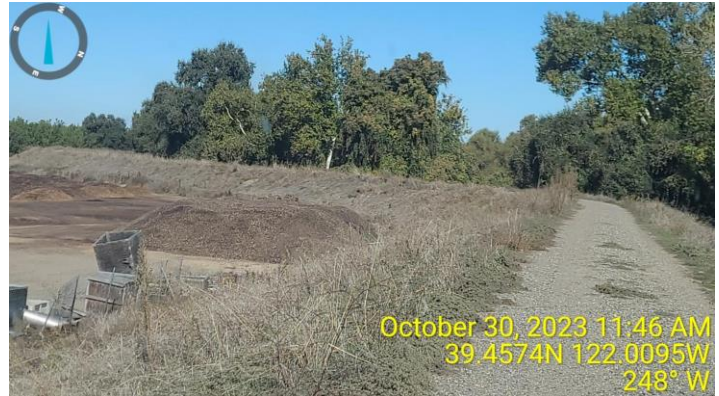
Photo 1 of 1 : FA_2023_LD0002_28_11_20231030_00025.jpg

View of the vegetation along the landside slope. Fall 2023.

LM Start	3.42	Rating **	U	Issue No.	11
LM End	3.74	Issue Type +	Ma	Location *	LS
Category	Earthen Levee			GPS Latitude/Longitude	
				Start	End
Item	Vegetation			39.457409°	39.461675°
				-122.009477°	-122.011557°
DWR ID	DWR_LD0002_01_f_2023_11				
Comment Code					
V1 : Control annual grass and weeds on the levee slopes and easements.					
Inspector Comment

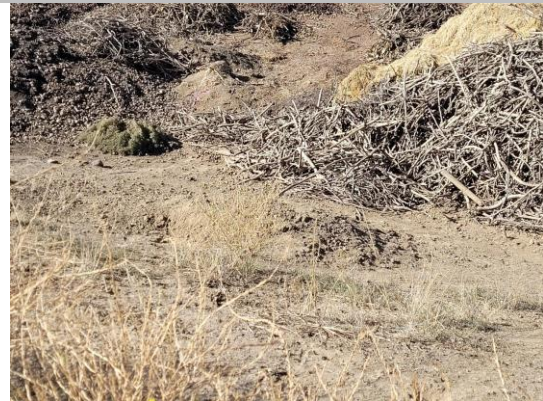
Photo 1 of 1 : FA_2023_LD0002_28_24_20231002_00007.jpg

View of rodent activity along the landside slope. Fall 2022.

LM Start	3.48	Rating **	U	Issue No.	24
LM End	3.48	Issue Type +	Ma	Location *	LS
Category	Earthen Levee			GPS Latitude/Longitude	
				Start	End
Item	Animal Control			39.458193°	39.458193°
				-122.009550°	-122.009550°
DWR ID	DWR_LD0002_01_f_2021_24				
Comment Code					
A3 : No rodents visible, but rodent burrows visible; need to backfill and compact or grout burrows.					
Inspector Comment

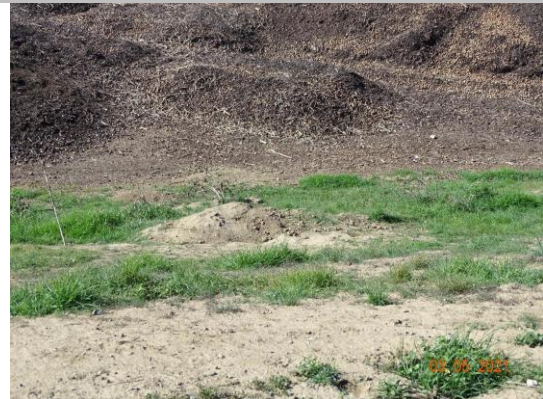
Photo 1 of 1 : FA_2023_LD0002_28_27_20231002_00008.jpg

View of the rodent holes along the landside slope. Spring 2021.

LM Start	3.53	Rating **	M	Issue No.	27
LM End	3.59	Issue Type +	Ma	Location *	LS
Category	Earthen Levee			GPS Latitude/Longitude	
				Start	End
Item	Animal Control			39.458807°	39.459614°
				-122.009990°	-122.010741°
DWR ID	DWR_LD0002_01_s_2014_27				
Comment Code					
A3 : No rodents visible, but rodent burrows visible; need to backfill and compact or grout burrows.					
Inspector Comment

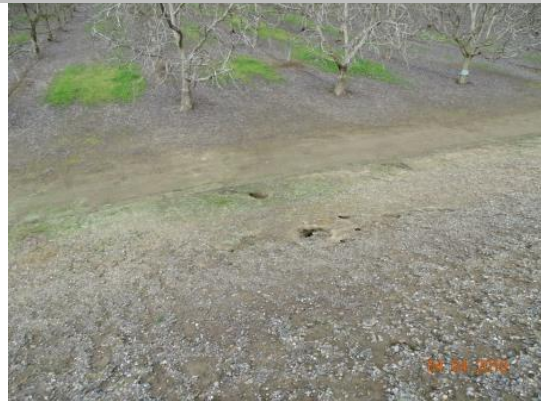
Photo 1 of 1 : FA_2023_LD0002_28_50_20231002_00013.jpg

View of the rodent holes on the landside slope. Spring 2019.

LM Start	3.79	Rating **	M	Issue No.	50
LM End	3.79	Issue Type +	Ma	Location *	LS
Category	Earthen Levee			GPS Latitude/Longitude	
				Start	End
Item	Animal Control			39.462358°	39.462358°
				-122.011623°	-122.011623°
DWR ID	DWR_LD0002_01_s_2019_50				
Comment Code					
A3 : No rodents visible, but rodent burrows visible; need to backfill and compact or grout burrows.					
Inspector Comment
