**Flood Control Project Maintenance
Levee Inspections**

Maintenance Issue Types Only, Levee Inspection Report By Mile - Fall 2024

Levee District No. 0002 (Glenn County)

Waterway	Bank	Unit Miles	Inspection Start/End	Inspector
Unit No. 01 Glenn County Sacramento River	Right	4.90	09/25/2024 09/25/2024	Makar Sokol

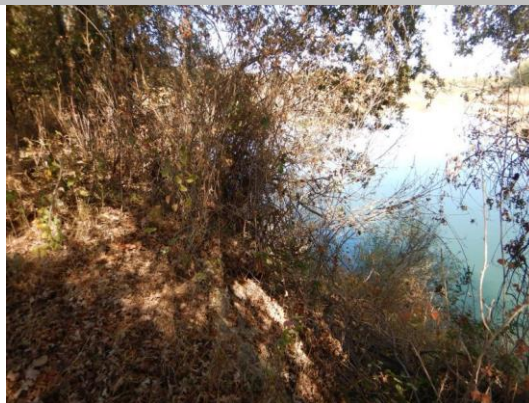
Photo 1 of 2 : FA_2024_LD0002_28_6_20240924_00002.jpg

LM Start	0.07	Rating **	M	Issue No.	6
LM End	0.28	Issue Type +	Ma	Location *	WS
Category	Supplemental			GPS Latitude/Longitude	
				Start	End
Item	2018 USACE Erosion Survey			39.414649°	39.417689°
				-122.009853°	-122.010369°
DWR ID	DWR_LD0002_01_s_2022_6				
Comment Code					
Inspector Comment					
2018 Site ID: SAC 164.7 R					
Status: Eroding					
2018 Field Notes: No observed change.					
Site History: 2009 - Very slow retreat, hard toe, encroaching into the levee projection. 2010 - Slowly eroding. 2011 - Site extended downstream. 2017 - New erosion along entire site.

USACE 2018 Erosion Photo #1

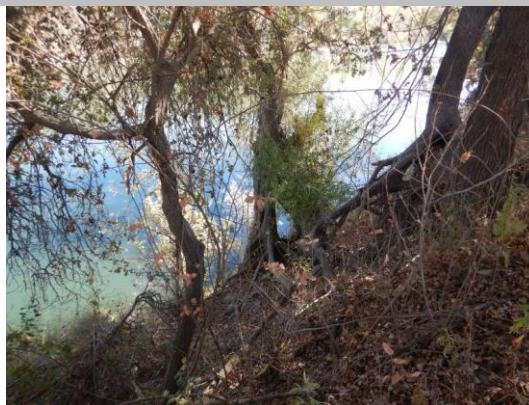
Photo 2 of 2 : FA_2024_LD0002_28_6_20240924_00003.jpg

LM Start	0.07	Rating **	M	Issue No.	6 (cont)
LM End	0.28	Issue Type +	Ma	Location *	WS

USACE 2018 Erosion Photo #2

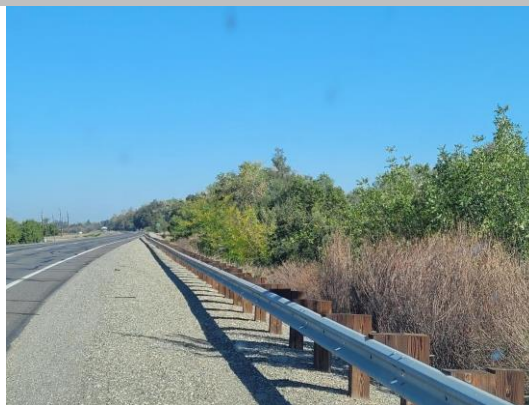
Photo 1 of 1 : FA_2024_LD0002_28_35_20240924_00012.jpg

LM Start	0.64	Rating **	M	Issue No.	35
LM End	0.77	Issue Type +	Ma	Location *	WS
Category	Earthen Levee			GPS Latitude/Longitude	
				Start	End
Item	Vegetation			39.422805°	39.424597°
				-122.011640°	-122.011527°
DWR ID	DWR_LD0002_01_s_2018_35				
Comment Code					
V2 : Remove the wild growth and woody vegetation other than native grasses from the levee slopes.					
Inspector Comment

View of the wild growth along the waterside slope. Fall 2022.

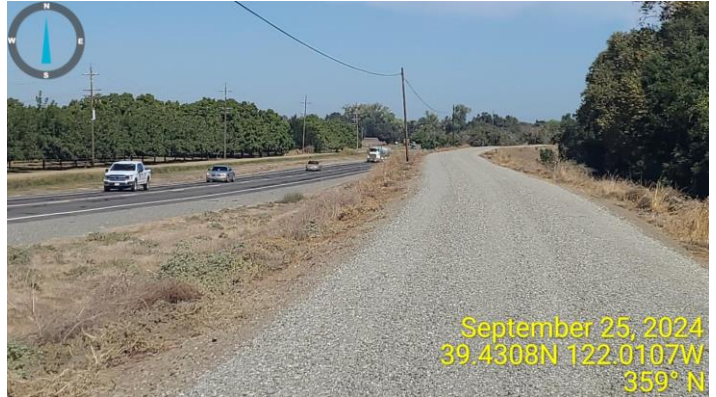
Photo 1 of 1 : FA_2024_LD0002_28_9_20241001_00027.jpg

LM Start	1.19	Rating **	M	Issue No.	9
LM End	1.97	Issue Type +	Ma	Location *	LS
Category	Earthen Levee			GPS Latitude/Longitude	
				Start	End
Item	Vegetation			39.430783°	39.441432°
				-122.010747°	-122.012150°
DWR ID	DWR_LD0002_01_f_2024_9				
Comment Code					
V1 : Control annual grass and weeds on the levee slopes and easements.					
Inspector Comment

View of the vegetation along the landside slope. Fall 2024.

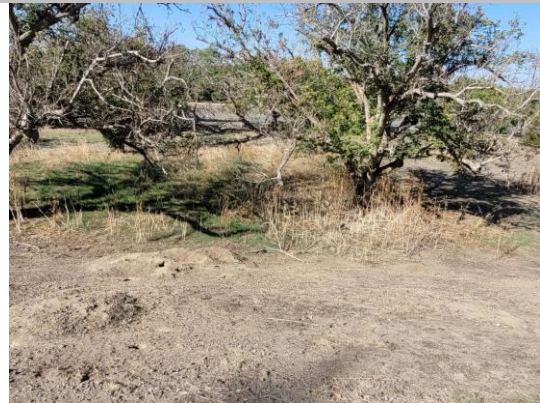
Photo 1 of 1 : FA_2024_LD0002_28_15_20240924_00005.jpg

LM Start	1.54	Rating **	U	Issue No.	15							
LM End	1.60	Issue Type +	Ma	Location *	LS							
Category	Earthen Levee		GPS Latitude/Longitude									
			Start	End								
Item	Animal Control		39.435730°	39.436643°								
			-122.010565°	-122.010498°								
DWR ID	DWR_LD0002_01_f_2012_15											
Comment Code												
A3 : No rodents visible, but rodent burrows visible; need to backfill and compact or grout burrows.												
Inspector Comment

View of the rodent activity along the landside slope. Fall 2022.

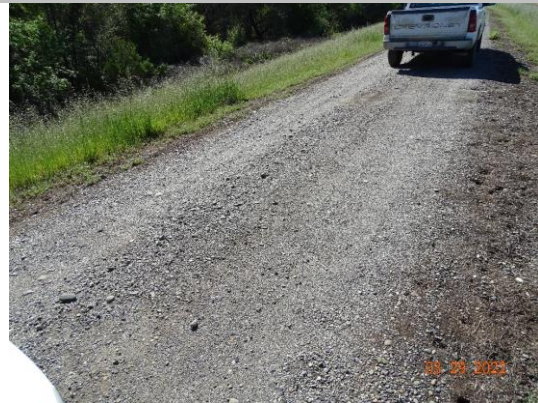
Photo 1 of 3 : UCIP_FA_2024_82099_113805.jpg

LM Start	1.84	Rating **	M	Issue No.	56	
LM End	1.84	Issue Type +	Ma	Location *		
Category	Supplemental			GPS Latitude/Longitude		
				Start		End
Item	DWR UCIP LMA Responsibility			39.440041°		39.440041°
				-122.010524°		-122.010524°
DWR ID	21172

Comment Code						
Inspector Comment						
DS_ID:21172 FS_ID:82099 EP_NO: N/A Repair Type: Non-Urgent EVAL Issue: Crossing Status: Not Found UCIP Comments: 01/11/2024 After detail review updated crossing location according to the Levee Log. Geophysical study of pipe DSID 21173 indicates possible presence of pipe through levee at this location, coordinates updated. Owner needs to coordinate with the CVFPB to remove or abandon crossing according to Title 23 requirements. Photos were taken at incorrect location. (O. Yakimov - DWR UCIP) 03/29/2022 Record updated from No Action Needed to Non-Urgent. Crossing not found. Unauthorized encroachment recorded in Levee Log. (O.Yakimov - DWR UCIP) FIELD_STRUCT_DESC: 4-inch steel drainage pipe through the levee, 5.3 feet below the crown. No control valves. Pipe open on waterside (WS) end. Pump and pipe in concrete box (1x10-foot) and pit at the landside (LS) toe. [Additional Reference(s): DWR Levee Log, 2005 (HLM 1.86), listed as abandoned 4-inch pipe. USACE Sacramento O&M Manual, Unit 139, May 1955, Revised 29 December 2016, (STA 82+50), listed as 4-inch pipe]. FS Date: 3/29/2022 3:00:18 PM

Top of Levee: View of levee crown looking downstream

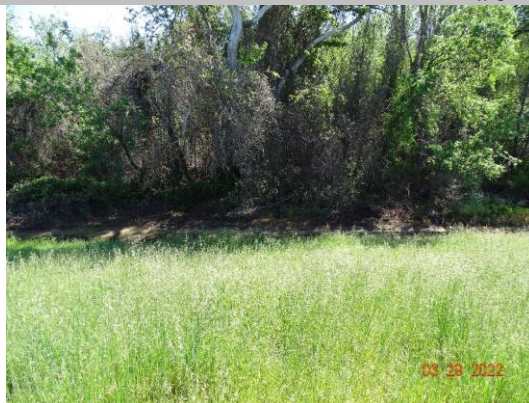
Photo 2 of 3 : UCIP_FA_2024_82099_113804.jpg

Water-Side: View of levee slope looking from crown

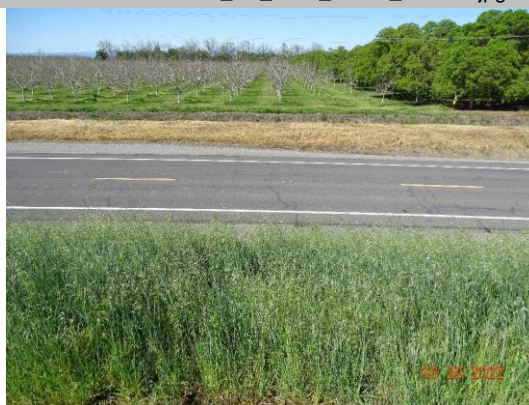
Photo 3 of 3 : UCIP_FA_2024_82099_113803.jpg

Land-Side: View of levee slope looking from crown

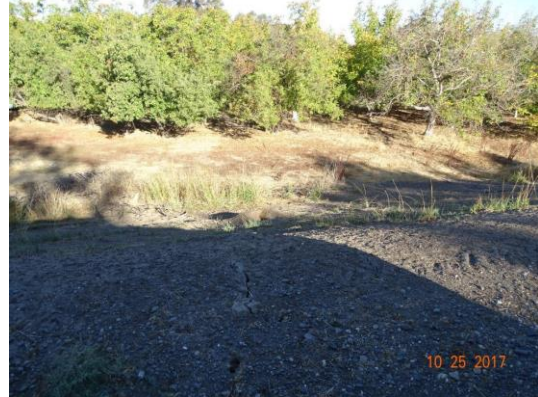
Photo 1 of 1 : FA_2024_LD0002_28_2_20240924_00001.jpg

LM Start	2.94	Rating **	M	Issue No.	2
LM End	2.94	Issue Type +	Ma	Location *	LS
Category	Earthen Levee			GPS Latitude/Longitude	
				Start	End
Item	Animal Control			39.453947°	39.453947°
				-122.015764°	-122.015764°
DWR ID	DWR_LD0002_01_f_2015_2				
Comment Code					
A3 : No rodents visible, but rodent burrows visible; need to backfill and compact or grout burrows.					
Inspector Comment

View of the rodent holes along the landside slope.

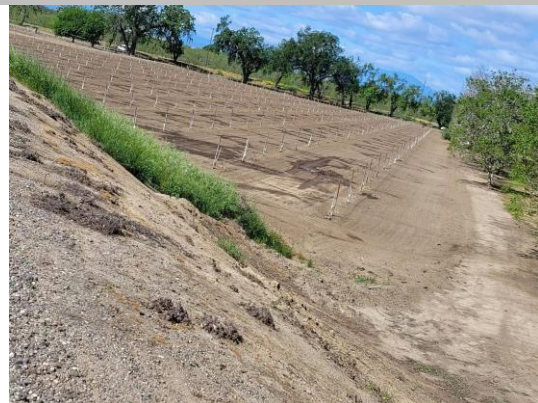
Photo 1 of 1 : FA_2024_LD0002_28_12_20240924_00004.jpg

LM Start	3.11	Rating **	U	Issue No.	12
LM End	3.13	Issue Type +	Ma	Location *	LS
Category	Earthen Levee			GPS Latitude/Longitude	
				Start	End
Item	Animal Control			39.455647°	39.455805°
				-122.013623°	-122.013286°
DWR ID	DWR_LD0002_01_s_2013_12				
Comment Code					
A1 : Exterminate rodents and backfill and compact or grout burrows.					
Inspector Comment

View of rodent activity on the landside slope. Spring 2022.

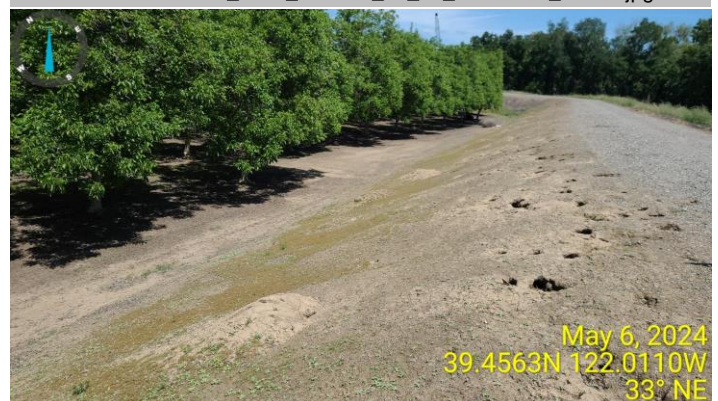
Photo 1 of 1 : FA_2024_LD0002_28_16_20240924_00006.jpg

LM Start	3.23	Rating **	U	Issue No.	16
LM End	3.32	Issue Type +	Ma	Location *	LS
Category	Earthen Levee			GPS Latitude/Longitude	
				Start	End
Item	Animal Control			39.456234°	39.456302°
				-122.011413°	-122.009772°
DWR ID	DWR_LD0002_01_f_2012_16				
Comment Code					
A3 : No rodents visible, but rodent burrows visible; need to backfill and compact or grout burrows.					
Inspector Comment

View of the rodent holes along the landside slope. Spring 2024.

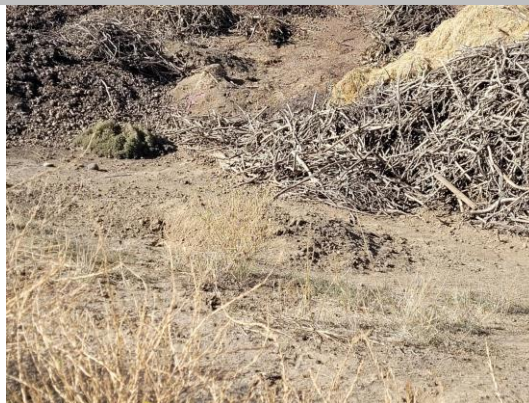
Photo 1 of 1 : FA_2024_LD0002_28_24_20240924_00007.jpg

LM Start	3.48	Rating **	U	Issue No.	24							
LM End	3.48	Issue Type +	Ma	Location *	LS							
Category	Earthen Levee		GPS Latitude/Longitude									
			Start	End								
Item	Animal Control		39.458193°	39.458193°								
			-122.009550°	-122.009550°								
DWR ID	DWR_LD0002_01_f_2021_24											
Comment Code												
A3 : No rodents visible, but rodent burrows visible; need to backfill and compact or grout burrows.												
Inspector Comment

View of rodent activity along the landside slope. Fall 2022.

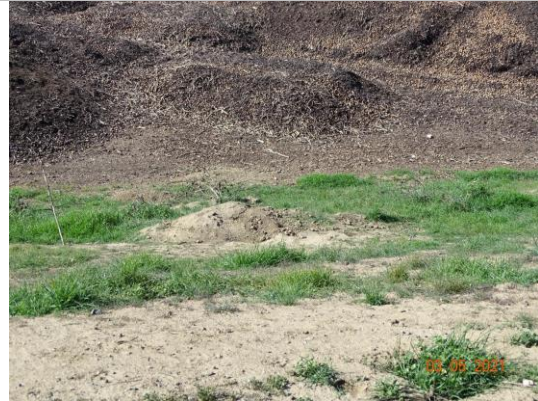
Photo 1 of 1 : FA_2024_LD0002_28_27_20240924_00008.jpg

LM Start	3.53	Rating **	M	Issue No.	27
LM End	3.59	Issue Type +	Ma	Location *	LS
Category	Earthen Levee			GPS Latitude/Longitude	
				Start	End
Item	Animal Control			39.458807°	39.459614°
				-122.009990°	-122.010741°
DWR ID	DWR_LD0002_01_s_2014_27				
Comment Code					
A3 : No rodents visible, but rodent burrows visible; need to backfill and compact or grout burrows.					
Inspector Comment

View of the rodent holes along the landside slope. Spring 2021.

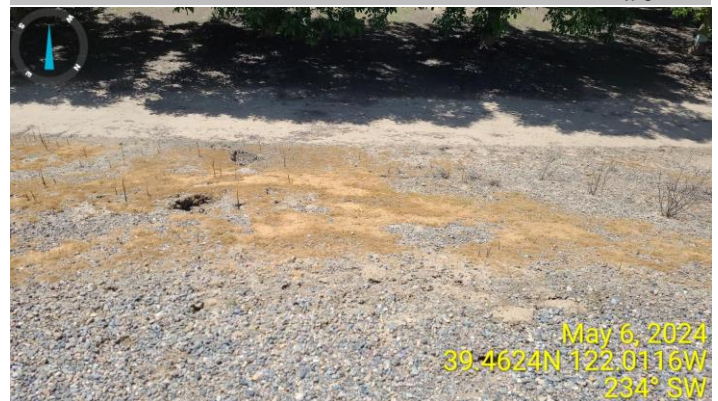
Photo 1 of 1 : FA_2024_LD0002_28_50_20240924_00014.jpg

LM Start	3.79	Rating **	M	Issue No.	50
LM End	3.79	Issue Type +	Ma	Location *	LS
Category	Earthen Levee			GPS Latitude/Longitude	
				Start	End
Item	Animal Control			39.462358°	39.462358°
				-122.011623°	-122.011623°
DWR ID	DWR_LD0002_01_s_2019_50				
Comment Code					
A3 : No rodents visible, but rodent burrows visible; need to backfill and compact or grout burrows.					
Inspector Comment

View of the rodent holes on the landside slope. Spring 2024.
