**Flood Control Project Maintenance
Levee Inspections**

Maintenance Issue Types Only, Levee Inspection Report By Mile - Spring 2015

Levee District No. 0002 (Glenn County)

Waterway	Bank	Unit Miles	Inspection Start/End	Inspector
Unit No. 01 Glenn County Sacramento River	Right	4.90	04/07/2015 04/07/2015	Bob Duffey

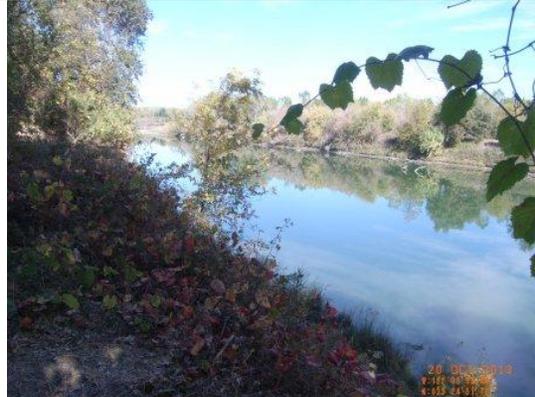
Photo 1 of 2 : SP_2015_LD0002_28_6_20150310_00004.jpg

LM Start	0.07	Rating **	M	Issue No.	6
LM End	0.28	Issue Type +	Ma	Location *	WS
Category	Supplemental			GPS Latitude/Longitude	
				Start	End
Item	USACE Erosion Survey			39.414649 °	39.417689 °
				-122.009853 °	-122.010369 °
DWR ID	DWR_LD0002_01_f_2014_6				
Action/Comments					
Inspector Comments: 2009 - Very slow retreat, hard toe, encroaching into the levee projection. 2010 - Slowly eroding. 2011 - Site extended downstream. 2013: No observed changes. [2013 Site ID: SAC_164-7_R]

USACE 2013 Photo #1

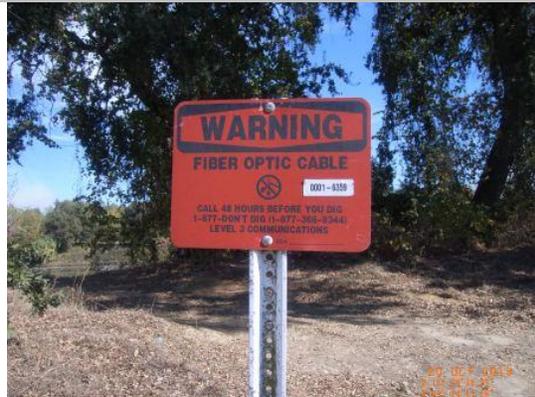
Photo 2 of 2 : SP_2015_LD0002_28_6_20150310_00005.jpg

USACE 2013 Photo #2

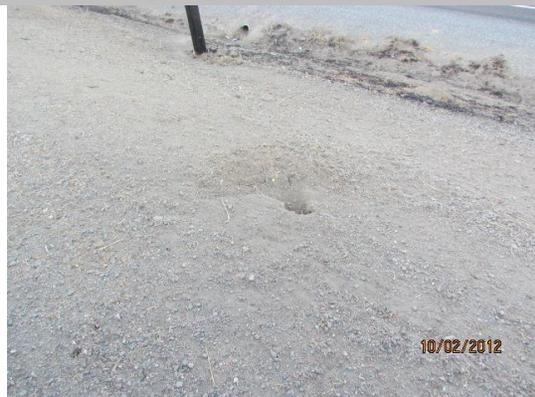
Photo 1 of 1 : SP_2015_LD0002_28_4_20150310_00002.jpg

LM Start	1.43	Rating **	M	Issue No.	4
LM End	1.43	Issue Type +	Ma	Location *	LS
Category	Earthen Levee			GPS Latitude/Longitude	
				Start	End
Item	Animal Control			39.434157 °	39.434157 °
				-122.010760 °	-122.010760 °
DWR ID	DWR_LD0002_01_f_2012_4				
Action/Comments					
No rodents visible, but rodent burrows visible; need to backfill and compact or grout burrows.

View of the rodent holes along the landside slope.

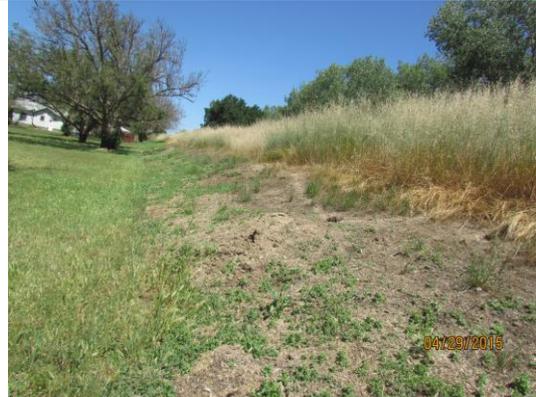
Photo 1 of 1 : SP_2015_LD0002_28_15_20150504_00018.jpg

LM Start	1.52	Rating **	M	Issue No.	15
LM End	1.60	Issue Type +	Ma	Location *	LS
Category	Earthen Levee		GPS Latitude/Longitude		
			Start	End	
Item	Animal Control		39.435485 °	39.436643 °	
			-122.010640 °	-122.010498 °	
DWR ID	DWR_LD0002_01_f_2012_15				
Action/Comments					
No rodents visible, but rodent burrows visible; need to backfill and compact or grout burrows. Inspector Comments: LMA needs to repair the rodent holes.

View of the rodent holes along the landside slope.

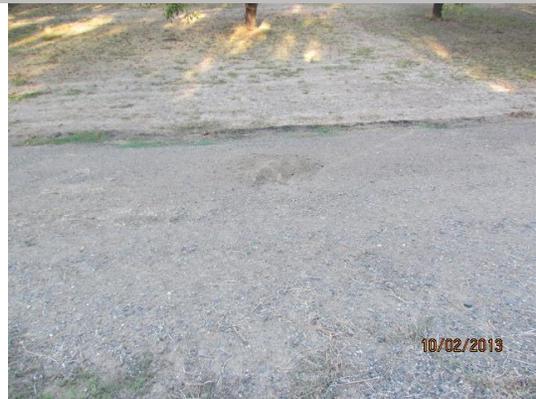
Photo 1 of 1 : SP_2015_LD0002_28_41_20150310_00014.jpg

LM Start	1.57	Rating **	A/W	Issue No.	41
LM End	1.57	Issue Type +	Ma	Location *	LS
Category	Earthen Levee		GPS Latitude/Longitude		
			Start	End	
Item	Animal Control		39.436149 °	39.436149 °	
			-122.010525 °	-122.010525 °	
DWR ID	DWR_LD0002_01_f_2013_41				
Action/Comments					
No rodents visible, but rodent burrows visible; need to backfill and compact or grout burrows.

View of the rodent holes along the slope of the levee.

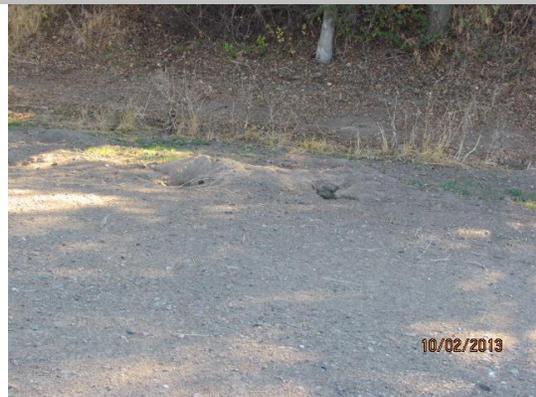
Photo 1 of 1 : SP_2015_LD0002_28_42_20150310_00015.jpg

LM Start	2.77	Rating **	A/W	Issue No.	42
LM End	2.77	Issue Type +	Ma	Location *	WS
Category	Earthen Levee		GPS Latitude/Longitude		
			Start	End	
Item	Animal Control		39.451841 °	39.451841 °	
			-122.017120 °	-122.017120 °	
DWR ID	DWR_LD0002_01_f_2013_42				
Action/Comments					
No rodents visible, but rodent burrows visible; need to backfill and compact or grout burrows.

View of the rodent holes along the slope of the levee.

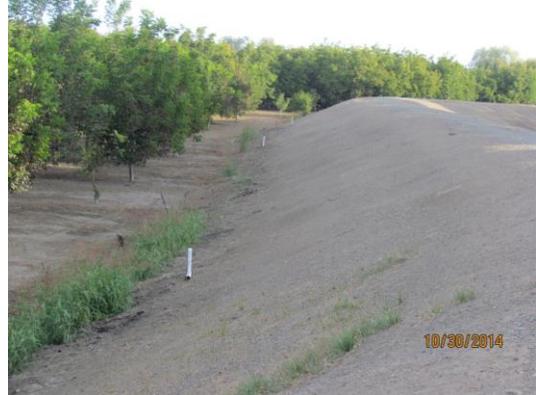
Photo 1 of 1 : SP_2015_LD0002_28_2_20150310_00001.jpg

LM Start	2.91	Rating **	A/W	Issue No.	2
LM End	2.96	Issue Type +	Ma	Location *	LS
Category	Earthen Levee		GPS Latitude/Longitude		
			Start	End	
Item	Animal Control		39.453595 °	39.454003 °	
			-122.016273 °	-122.015503 °	
DWR ID	DWR_LD0002_01_s_2012_2				
Action/Comments					
No rodents visible, but rodent burrows visible; need to backfill and compact or grout burrows.

View of the rodent holes and bait station along the landside slope.

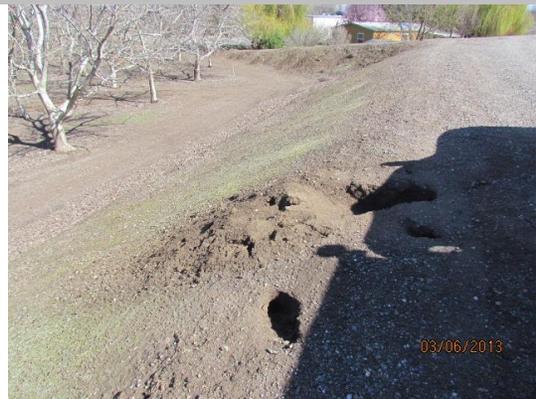
Photo 1 of 1 : SP_2015_LD0002_28_12_20150310_00009.jpg

LM Start	3.16	Rating **	M	Issue No.	12
LM End	3.16	Issue Type +	Ma	Location *	WS
Category	Earthen Levee		GPS Latitude/Longitude		
			Start	End	
Item	Animal Control		39.455992 °	39.455992 °	
			-122.012809 °	-122.012809 °	
DWR ID	DWR_LD0002_01_s_2013_12				
Action/Comments					
Exterminate rodents and backfill and compact or grout burrows.

View of the rodent activity along the landside slope.

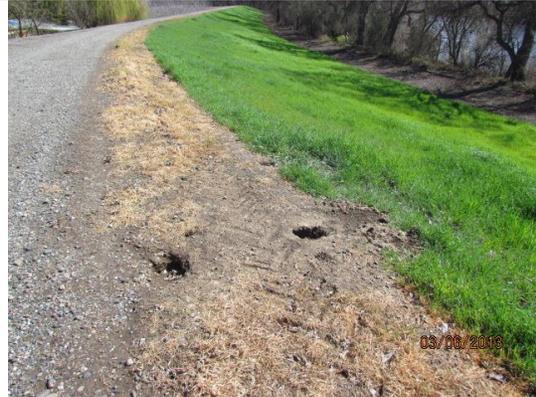
Photo 1 of 1 : SP_2015_LD0002_28_9_20150310_00007.jpg

LM Start	3.16	Rating **	M	Issue No.	9
LM End	3.16	Issue Type +	Ma	Location *	LS
Category	Earthen Levee		GPS Latitude/Longitude		
			Start	End	
Item	Animal Control		39.455992 °	39.455992 °	
			-122.012808 °	-122.012808 °	
DWR ID	DWR_LD0002_01_s_ 2013_9				
Action/Comments					
No rodents visible, but rodent burrows visible; need to backfill and compact or grout burrows.

View of the rodent activity along the waterside slope.

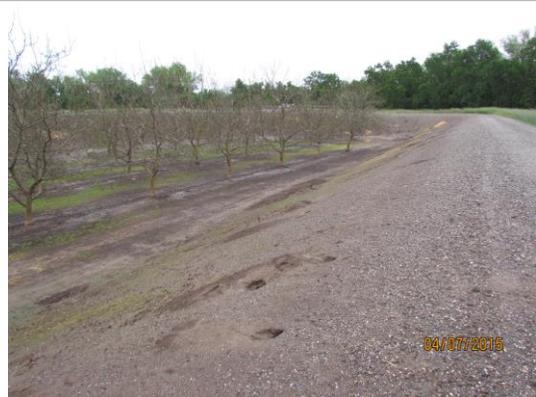
Photo 1 of 1 : SP_2015_LD0002_28_16_20150420_00016.jpg

LM Start	3.27	Rating **	M	Issue No.	16
LM End	3.30	Issue Type +	Ma	Location *	LS
Category	Earthen Levee		GPS Latitude/Longitude		
			Start	End	
Item	Animal Control		39.456237 °	39.456272 °	
			-122.010640 °	-122.010163 °	
DWR ID	DWR_LD0002_01_f_ 2012_16				
Action/Comments					
No rodents visible, but rodent burrows visible; need to backfill and compact or grout burrows. Inspector Comments: Grout or fill the rodent holes.

View of the rodent holes along the landside slope.

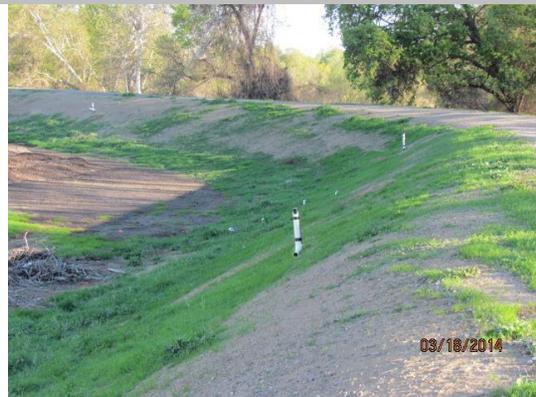
Photo 1 of 1 : SP_2015_LD0002_28_27_20150310_00012.jpg

LM Start	3.44	Rating **	A/W	Issue No.	27
LM End	3.52	Issue Type +	Ma	Location *	LS
Category	Earthen Levee		GPS Latitude/Longitude		
			Start	End	
Item	Animal Control		39.457692 °	39.458705 °	
			-122.009517 °	-122.009872 °	
DWR ID	DWR_LD0002_01_s_ 2014_27				
Action/Comments					
No rodents visible, but rodent burrows visible; need to backfill and compact or grout burrows.

View of the rodent activity along the l/s slope.

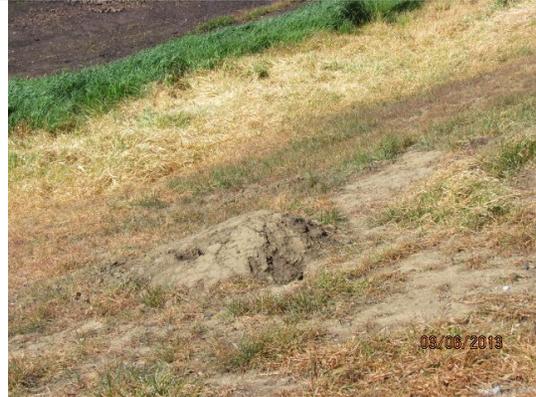
Photo 1 of 1 : SP_2015_LD0002_28_13_20150310_00010.jpg

LM Start	3.53	Rating **	M	Issue No.	13
LM End	3.57	Issue Type +	Ma	Location *	LS
Category	Earthen Levee		GPS Latitude/Longitude		
			Start	End	
Item	Animal Control		39.458803 °	39.459305 °	
			-122.009980 °	-122.010511 °	
DWR ID	DWR_LD0002_01_s_2013_13				
Action/Comments					
Exterminate rodents and backfill and compact or grout burrows.

View of the rodent activity along the landside slope.

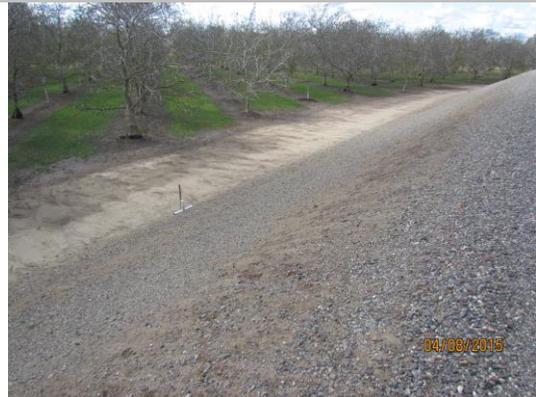
Photo 1 of 1 : SP_2015_LD0002_28_11_20150420_00017.jpg

LM Start	4.87	Rating **	A/W	Issue No.	11
LM End	4.87	Issue Type +	Ma	Location *	LS
Category	Earthen Levee		GPS Latitude/Longitude		
			Start	End	
Item	Animal Control		39.476676 °	39.476676 °	
			-122.017439 °	-122.017439 °	
DWR ID	DWR_LD0002_01_s_2012_11				
Action/Comments					
No rodents visible, but rodent burrows visible; need to backfill and compact or grout burrows. Inspector Comments: The rodent holes have been filled with dirt.

View of the removed rodent holes and bait station.
