**Flood Control Project Maintenance  
Levee Inspections**

**Fall 2011 Levee Maintenance Deficiency Summary Report**

**Levee Inspection Report By Mile - Fall 2011**

**Levee District No. 0003 (Glenn County)**

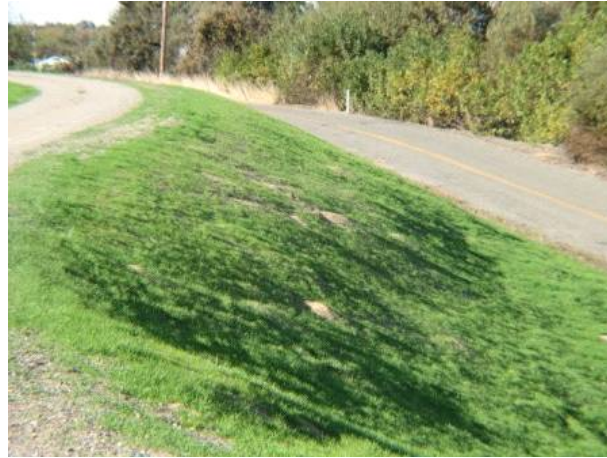
Levee Mile Report Line	1
Start Levee Mile	0.23
End Levee Mile	0.29
Location	Land Side
Category	Earthen Levee
Item	Animal Control

View of squirrel holes along the slope.

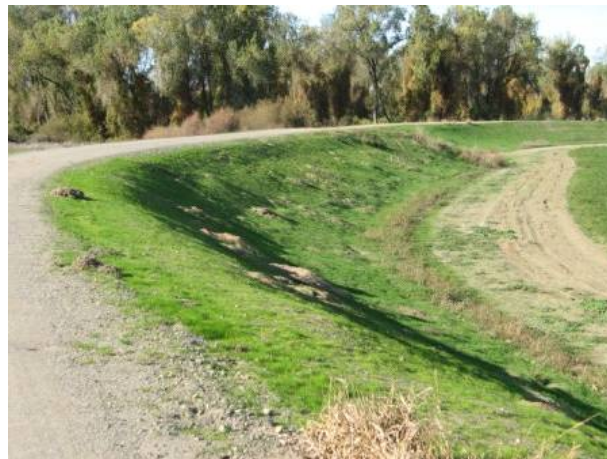
Levee Mile Report Line	3
Start Levee Mile	0.75
End Levee Mile	0.75
Location	Land Side
Category	Earthen Levee
Item	Animal Control

View of squirrel holes along the slope.

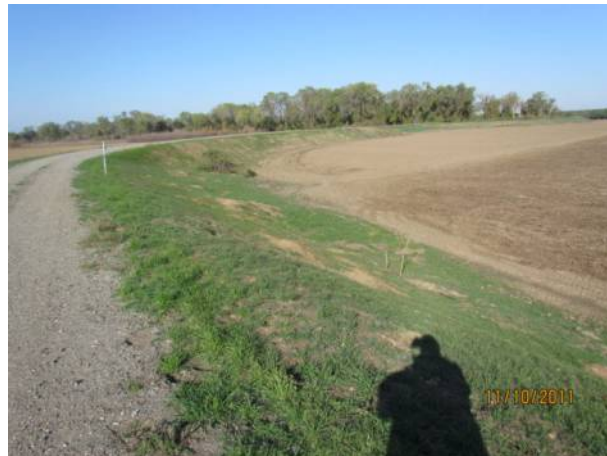
Levee Mile Report Line	4
Start Levee Mile	0.78
End Levee Mile	0.92
Location	Land Side
Category	Earthen Levee
Item	Animal Control

View of the rodents hole along the L/S slope.

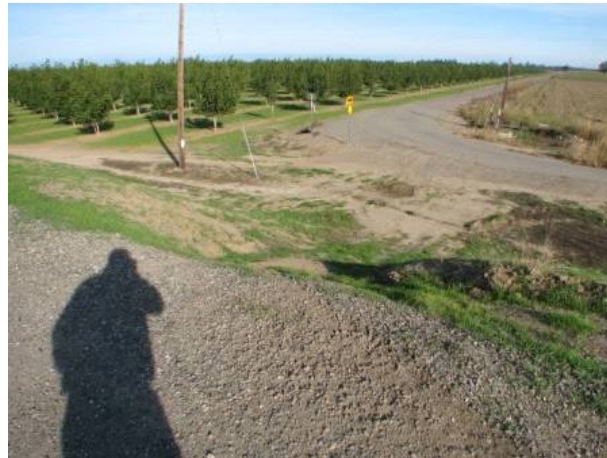
Levee Mile Report Line	12
Start Levee Mile	3.44
End Levee Mile	3.44
Location	Land Side
Category	Earthen Levee
Item	Slope Stability

View of the vehicle erosion on the landside slope of the levee.

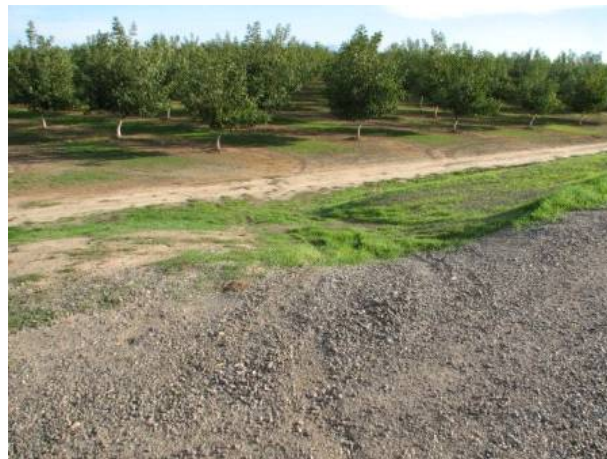
Levee Mile Report Line	15
Start Levee Mile	3.82
End Levee Mile	3.82
Location	Land Side
Category	Earthen Levee
Item	Slope Stability

View of vehicle erosion on the slope.

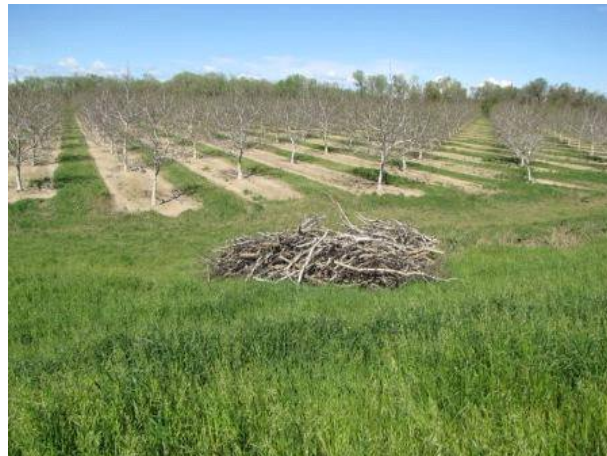
Levee Mile Report Line	16
Start Levee Mile	4.25
End Levee Mile	4.25
Location	Water Side
Category	Earthen Levee
Item	Encroachments

View of prunings along the W/S toe.

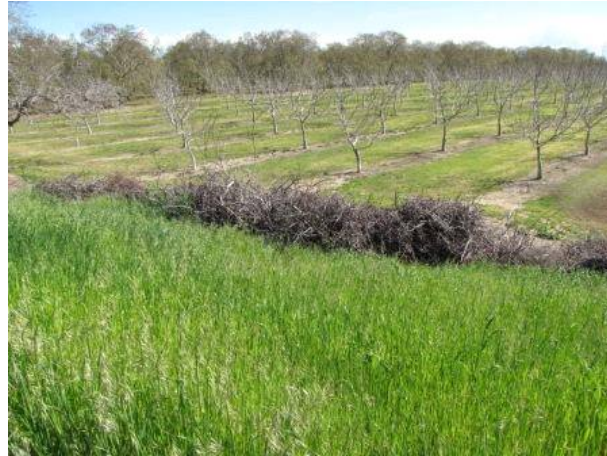
Levee Mile Report Line	17
Start Levee Mile	5.15
End Levee Mile	5.15
Location	Land Side
Category	Earthen Levee
Item	Encroachments

View of pruning along the L/S toe.

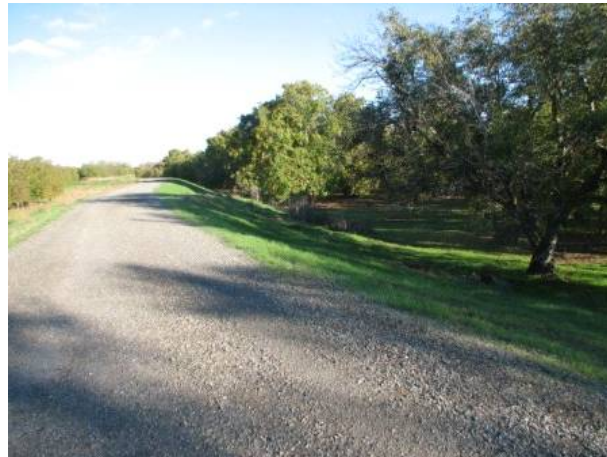
Levee Mile Report Line	18
Start Levee Mile	5.17
End Levee Mile	5.30
Location	Land Side
Category	Earthen Levee
Item	Trim / Thin Trees

View of squirrel along the slope.

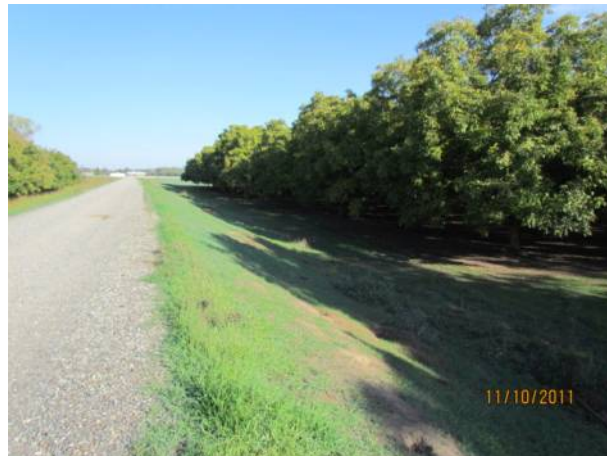
Levee Mile Report Line	20
Start Levee Mile	5.56
End Levee Mile	5.77
Location	Land Side
Category	Earthen Levee
Item	Animal Control

View of the rodent holes along the L/S slope.

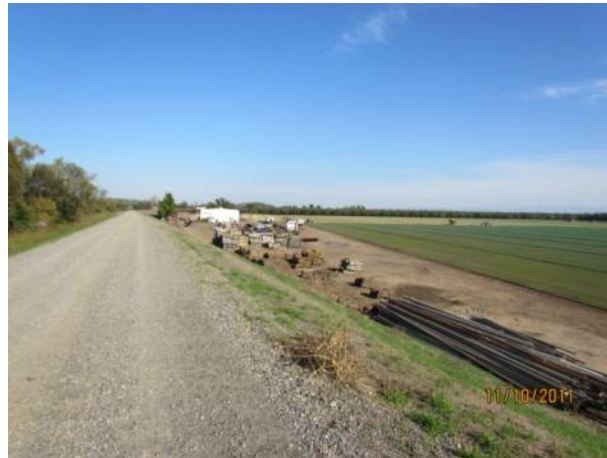
Levee Mile Report Line	22
Start Levee Mile	5.87
End Levee Mile	5.99
Location	Land Side
Category	Earthen Levee
Item	Encroachments

View of the equipment along the L/S toe.

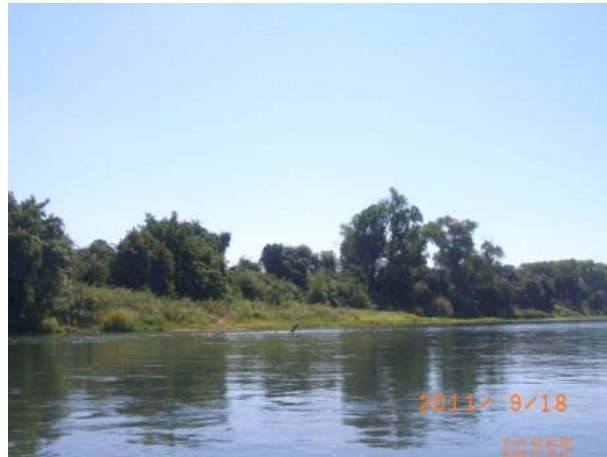
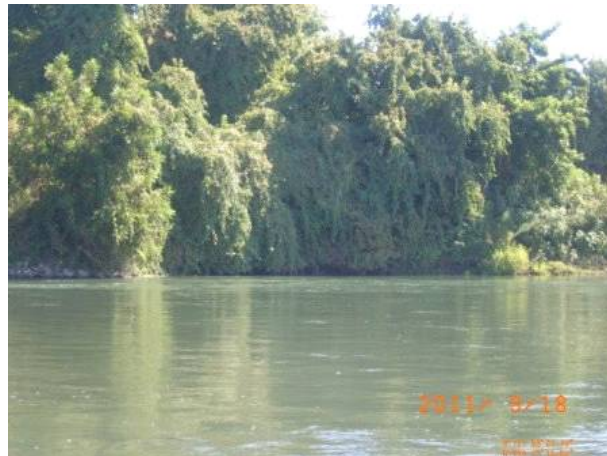
Levee Mile Report Line	23
Start Levee Mile	5.99
End Levee Mile	5.99
Location	Water Side
Category	Supplemental
Item	USACE Erosion Survey

23	5.99	5.99	Supplemental	USACE Erosion Survey	WS	M	Inspector Comments: 1997 - Erosion of top left bank; eroding downstream of rock section where levee is closest to the bank, approximately 40 to 50 ft of bank retreat, some berm left. 1999 - Some new beach sedimentation at toe. 2000 - Snags in eddy area could induce bank erosion at higher flows. 2002 - Small bar is gone. 2003 - Bar is present and higher. 2004 - Some new deposition on the bank at the upstream end. 2006 - New sand on bar and bank. 2007 - New sand deposition with vegetation colonizing bars between dikes. 2008 - More eddy sedimentation and vegetation on bar along bank. Bank is healing due to retreat of right bank. 2009 - Additional bar sedimentation. 2010 - some deposition at toe, new erosion on opposite bank. Site continues to heal. 2011: No observed change. [2011 Site ID: SAC_168-3_L]	39.453930 ° -121.993896 °	39.455394 ° -121.994300 °	51 Y

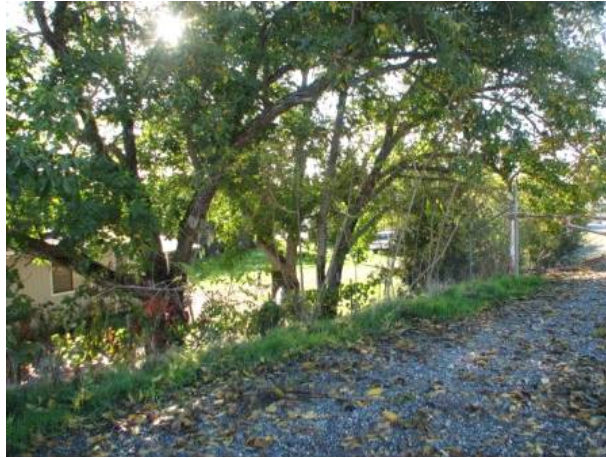
Levee Mile Report Line	34
Start Levee Mile	6.88
End Levee Mile	6.88
Location	Land Side
Category	Earthen Levee
Item	Trim / Thin Trees

View of the trees that are hanging over the landside slope of the levee.

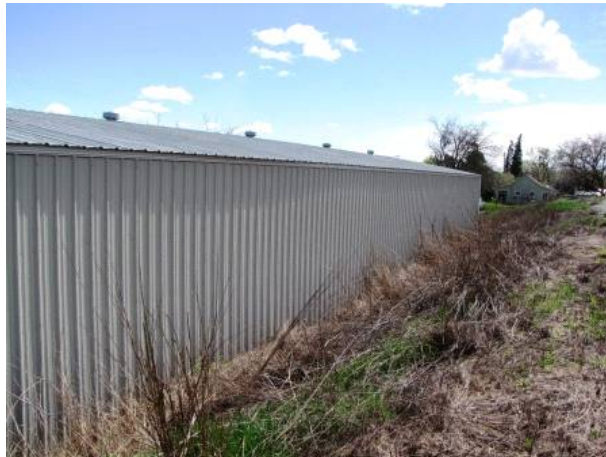
Levee Mile Report Line	35
Start Levee Mile	6.91
End Levee Mile	6.92
Location	Land Side
Category	Earthen Levee
Item	Encroachments

View of the building along the L/S toe.

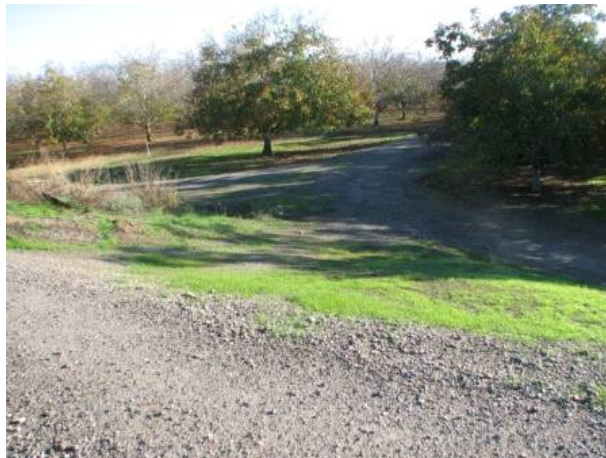
Levee Mile Report Line	37
Start Levee Mile	7.34
End Levee Mile	7.34
Location	Land Side
Category	Earthen Levee
Item	Slope Stability

Vehicle erosion along the slope.

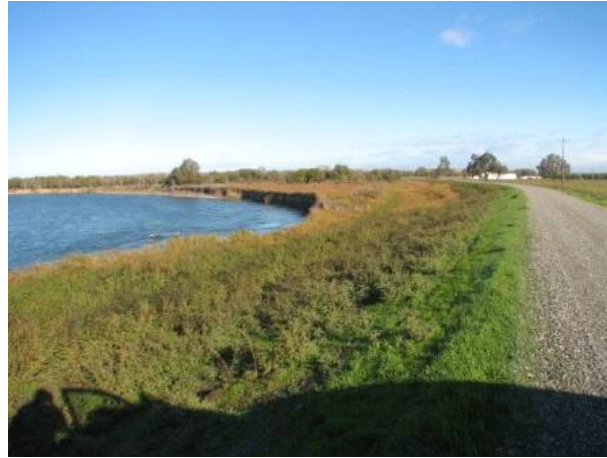
Levee Mile Report Line	46
Start Levee Mile	9.88
End Levee Mile	9.88
Location	Water Side
Category	Earthen Levee
Item	Erosion / Bank Caving

Erosion 30 ft from the levee toe.

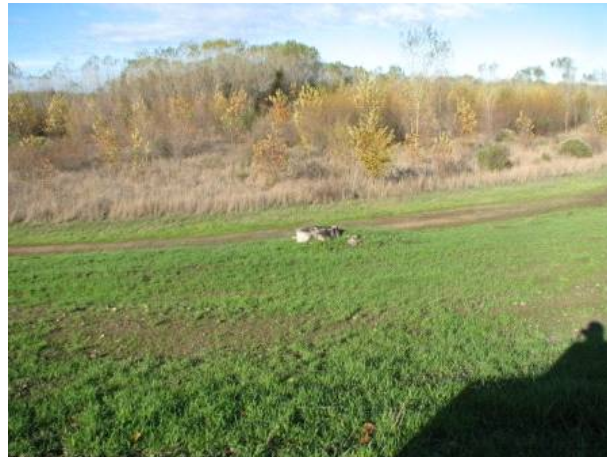
Levee Mile Report Line	48
Start Levee Mile	10.73
End Levee Mile	10.73
Location	Water Side
Category	Earthen Levee
Item	Trim / Thin Trees

View of the stump along the toe.

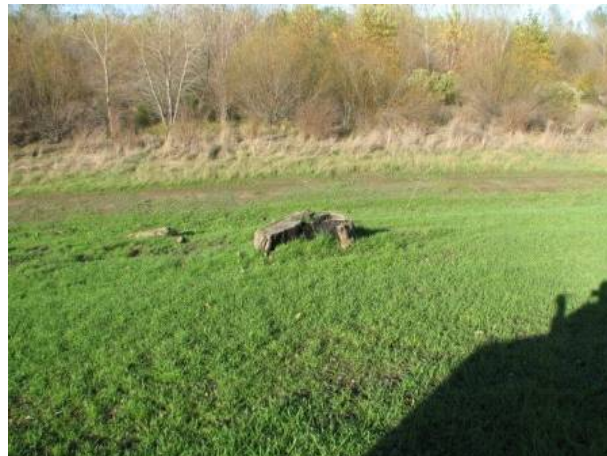
Levee Mile Report Line	49
Start Levee Mile	10.90
End Levee Mile	10.90
Location	Water Side
Category	Earthen Levee
Item	Trim / Thin Trees

View of the stump along the slope.

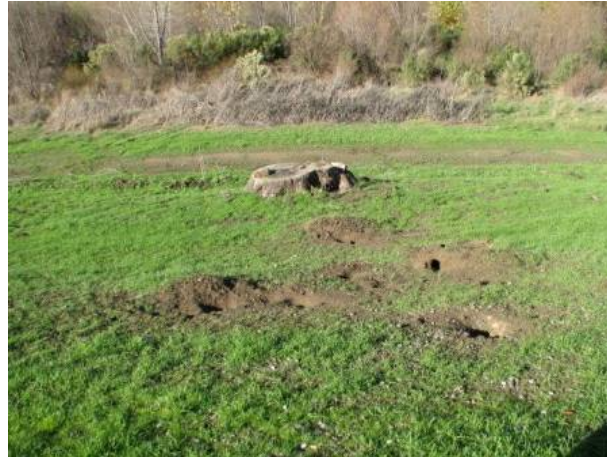
Levee Mile Report Line	50
Start Levee Mile	11.05
End Levee Mile	11.05
Location	Water Side
Category	Earthen Levee
Item	Animal Control

View of the squirrel holes along the slope & also a tree stump.

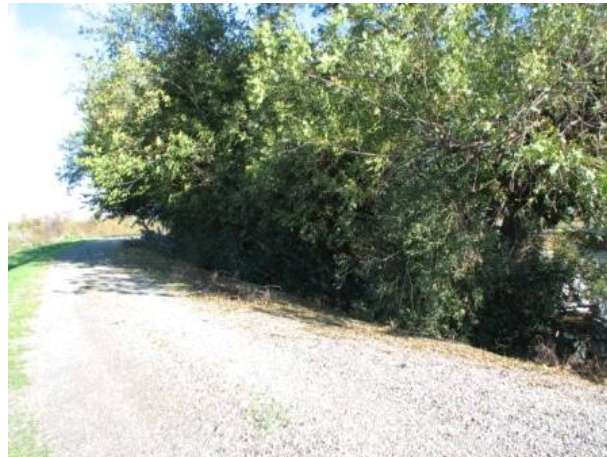
Levee Mile Report Line	52
Start Levee Mile	11.22
End Levee Mile	11.25
Location	Land Side
Category	Earthen Levee
Item	Trim / Thin Trees

View of the trees along the slope.

52	11.22	11.25	Earthen Levee	Trim / Thin Trees	LS	M	Thin trees to allow visibility of the ground and room to flood fight.	39.522058 ° -121.979133 °	39.522480 ° -121.979200 °	4 Y
