**Flood Control Project Maintenance
Levee Inspections**

Fall 2012 Levee Maintenance Deficiency Summary Report

**Flood Control Project Maintenance
Levee Inspections****LMA District Cover Sheet
Fall 2012 Levee Inspection Results****Levee District No. 0003 (Glenn County)**

Levee District No. 0003 (Glenn County)

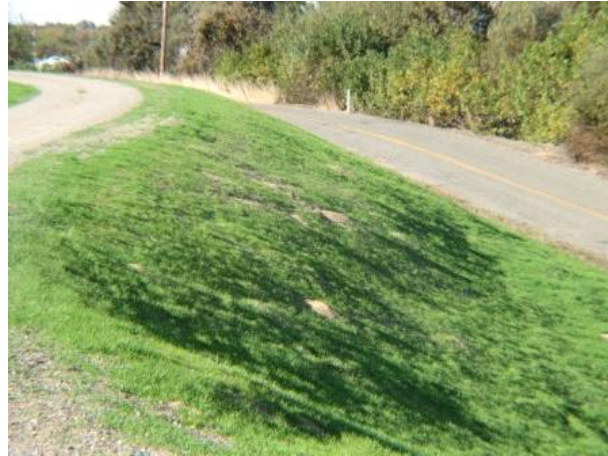
Levee Mile Report Line	4
Start Levee Mile	0.23
End Levee Mile	0.29
Location	Land Side
Category	Earthen Levee
Item	Animal Control

View of squirrel holes along the slope.

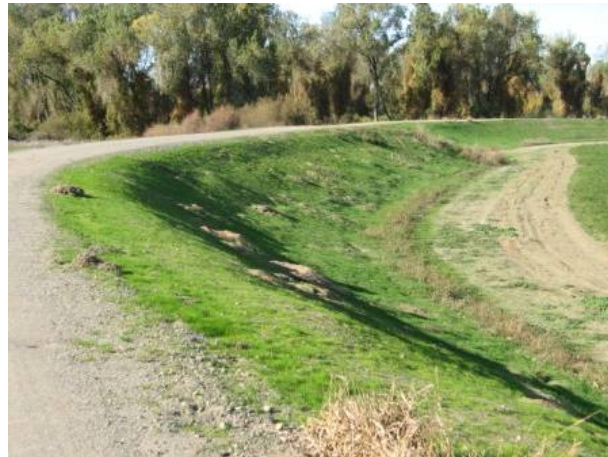
Levee Mile Report Line	6
Start Levee Mile	0.75
End Levee Mile	0.75
Location	Land Side
Category	Earthen Levee
Item	Animal Control

View of squirrel holes along the slope.

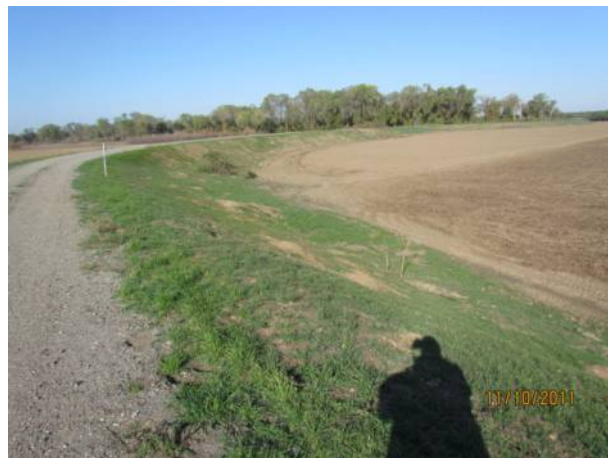
Levee Mile Report Line	7
Start Levee Mile	0.78
End Levee Mile	0.92
Location	Land Side
Category	Earthen Levee
Item	Animal Control

View of the rodent holes along the L/S slope.

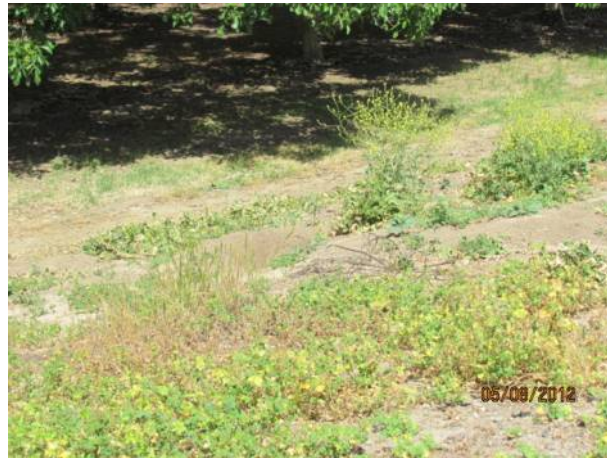
Levee Mile Report Line	11
Start Levee Mile	1.74
End Levee Mile	1.80
Location	Water Side
Category	Earthen Levee
Item	Animal Control

View of the rodent holes along the waterside slope.

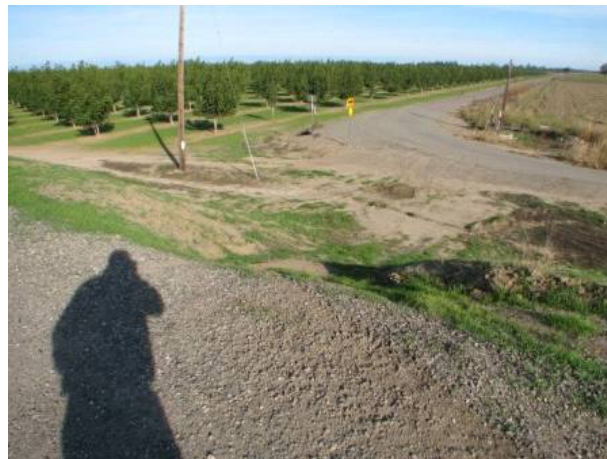
Levee Mile Report Line	16
Start Levee Mile	3.44
End Levee Mile	3.44
Location	Land Side
Category	Earthen Levee
Item	Slope Stability

View of the vehicle erosion on the landside slope of the levee.

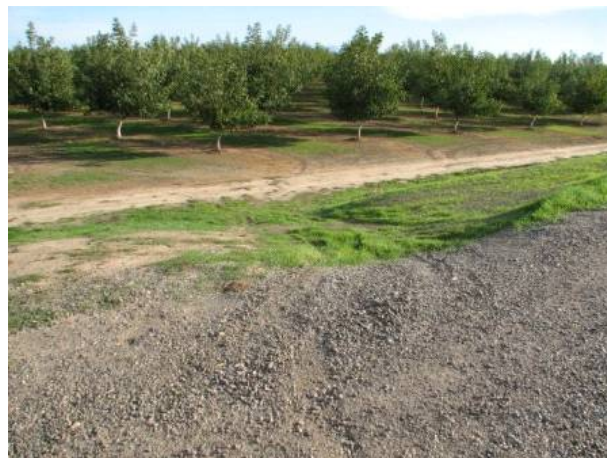
Levee Mile Report Line	19
Start Levee Mile	3.82
End Levee Mile	3.82
Location	Land Side
Category	Earthen Levee
Item	Slope Stability

View of vehicle erosion on the slope.

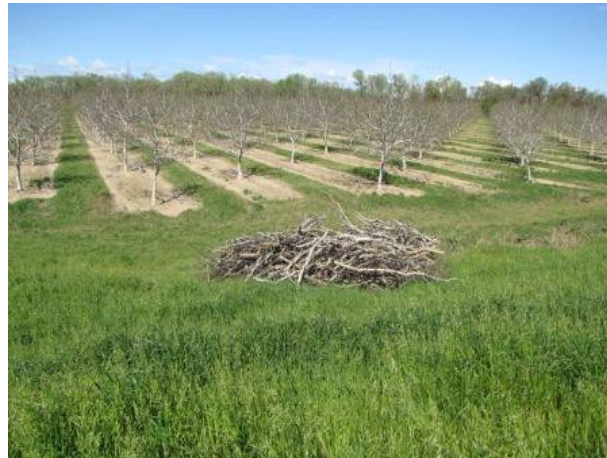
Levee Mile Report Line	20
Start Levee Mile	4.25
End Levee Mile	4.25
Location	Water Side
Category	Earthen Levee
Item	Encroachments

View of prunings along the W/S toe.

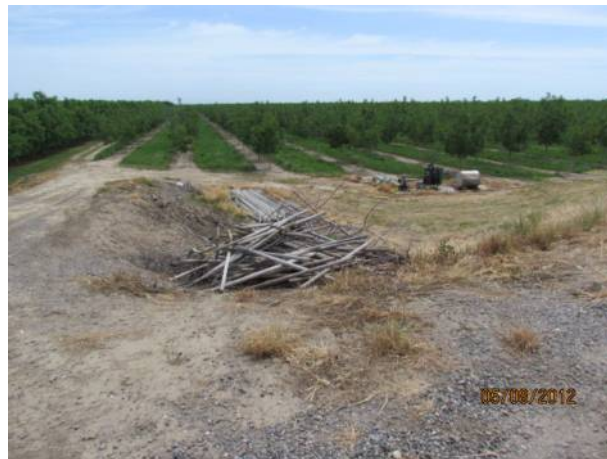
Levee Mile Report Line	21
Start Levee Mile	4.91
End Levee Mile	4.91
Location	Land Side
Category	Earthen Levee
Item	Encroachments

View of the tree stakes & debris along the landside toe.

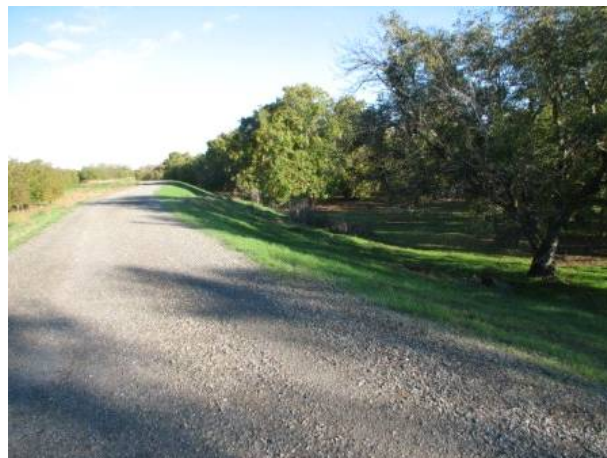
Levee Mile Report Line	22
Start Levee Mile	5.17
End Levee Mile	5.30
Location	Land Side
Category	Earthen Levee
Item	Animal Control

View of squirrel holes along the slope.

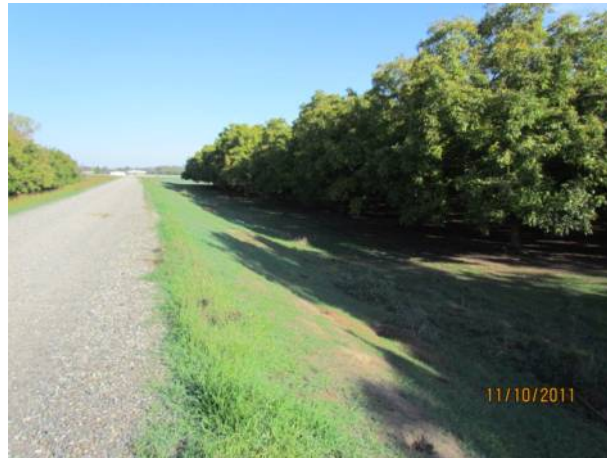
Levee Mile Report Line	24
Start Levee Mile	5.56
End Levee Mile	5.77
Location	Land Side
Category	Earthen Levee
Item	Animal Control

View of the rodent holes along the L/S slope.

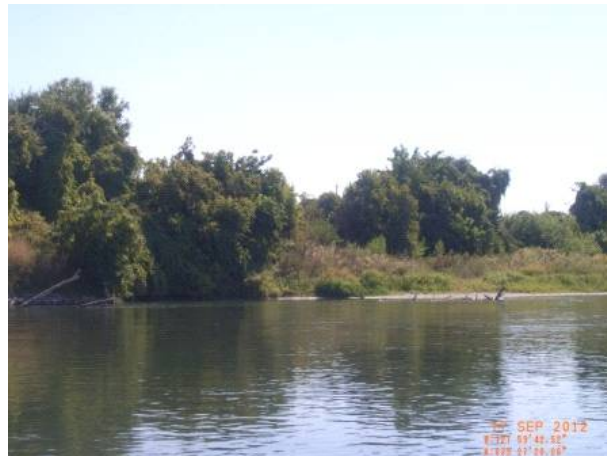
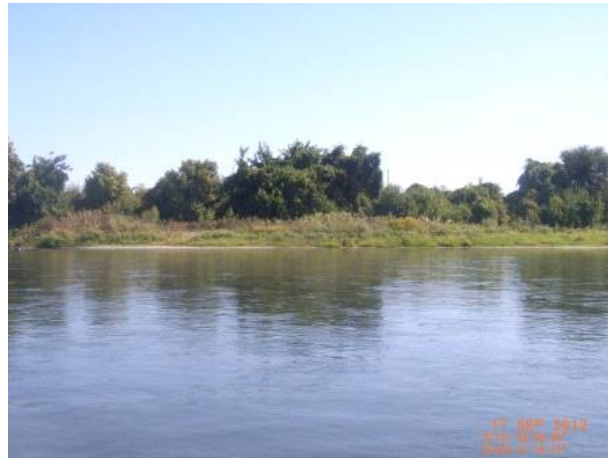
Levee Mile Report Line	27
Start Levee Mile	5.96
End Levee Mile	5.96
Location	Water Side
Category	Supplemental
Item	USACE Erosion Survey

LMR No.	Levee Mile		Category	Item	Location	Rating	Action/Comment	GPS Latitude/Longitude		Issue No.
	Start	End						Start	End	
27	5.96	5.96	Supplemental	USACE Erosion Survey	WS	M Ma	Inspector Comments: 1997 - Erosion of top left bank; eroding downstream of rock section where levee is closest to the bank, approximately 40 to 50 ft of bank retreat, some berm left. 1999 - Some new beach sedimentation at toe. 2000 - Snags in eddy area could induce bank erosion at higher flows. 2002 - Small bar is gone. 2003 - Bar is present and higher. 2004 - Some new deposition on the bank at the upstream end. 2006 - New sand on bar and bank. 2007 - New sand deposition with vegetation colonizing bars between dikes. 2008 - More eddy sedimentation and vegetation on bar along bank. Bank is healing due to retreat of right bank. 2009 - Additional bar sedimentation. 2010 - some deposition at toe, new erosion on opposite bank. Site continues to heal. 2012: Majority of site healed but upstream end still needs toe rock. [2012 Site ID: SAC_168-3_L]	39.455096 ° -121.994217 °	39.453930 ° -121.993896 °	26 Y

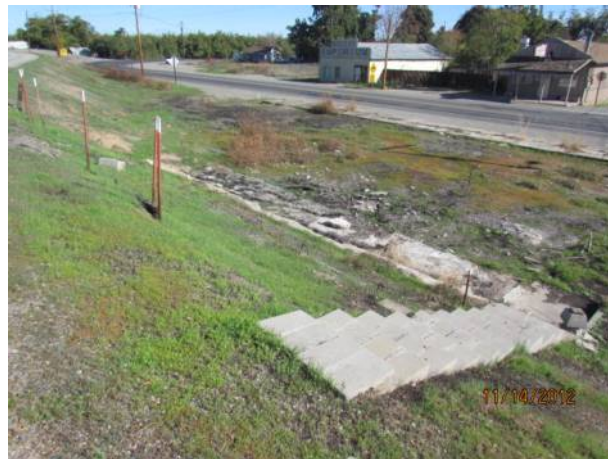
Levee Mile Report Line	36
Start Levee Mile	6.74
End Levee Mile	6.74
Location	Land Side
Category	Earthen Levee
Item	Slope Stability

View of concrete stairs & foundation along the slope of the levee.

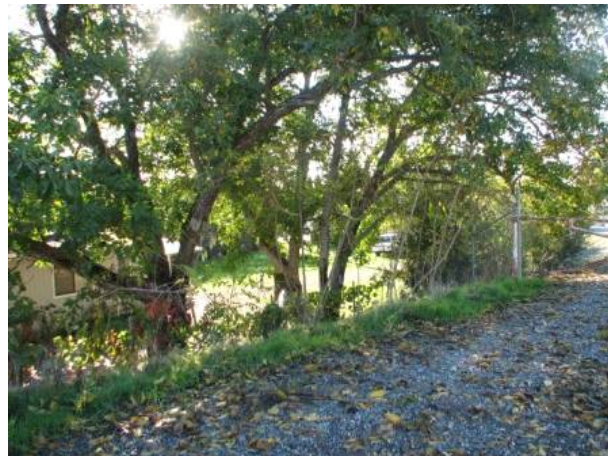
Levee Mile Report Line	39
Start Levee Mile	6.88
End Levee Mile	6.88
Location	Land Side
Category	Earthen Levee
Item	Trim / Thin Trees

View of the trees that are hanging over the landside slope of the levee.

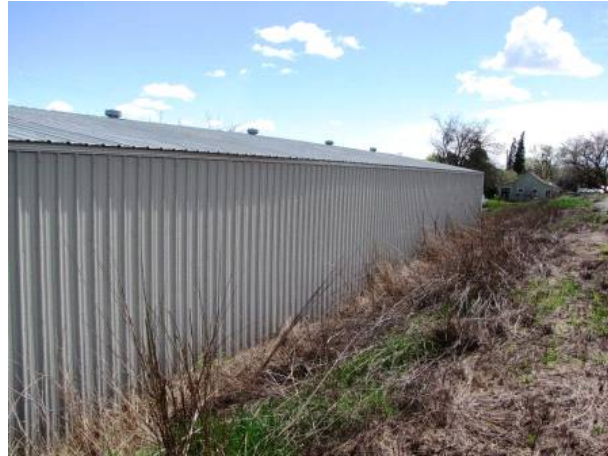
Levee Mile Report Line	40
Start Levee Mile	6.91
End Levee Mile	6.92
Location	Land Side
Category	Earthen Levee
Item	Encroachments

View of the building along the L/S toe.

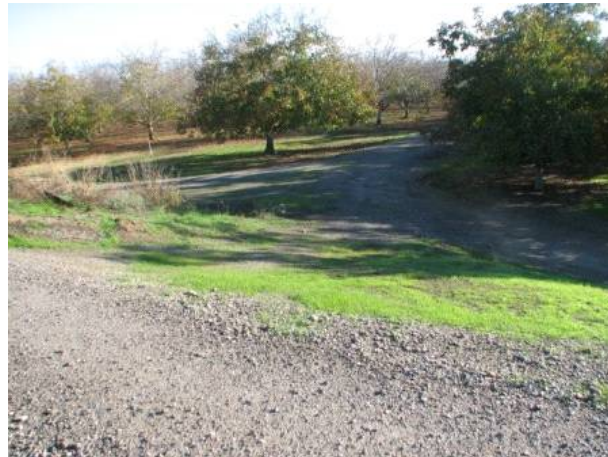
Levee Mile Report Line	41
Start Levee Mile	7.34
End Levee Mile	7.34
Location	Land Side
Category	Earthen Levee
Item	Slope Stability

Vehicle erosion along the slope.

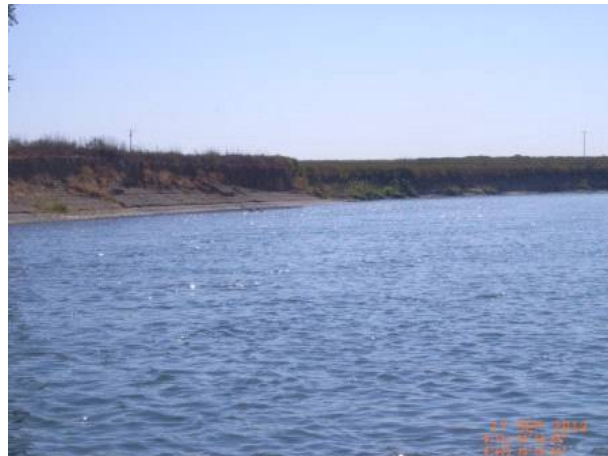
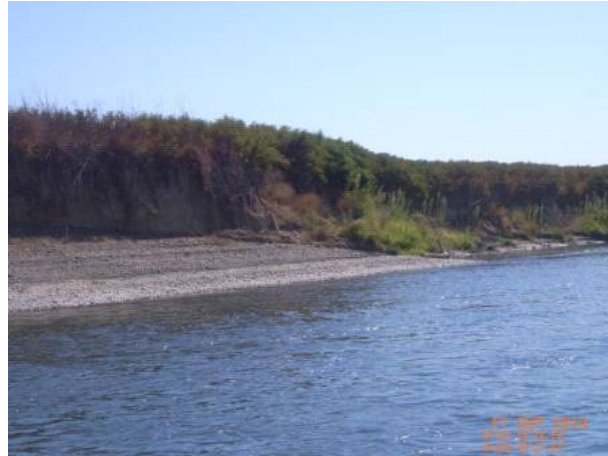
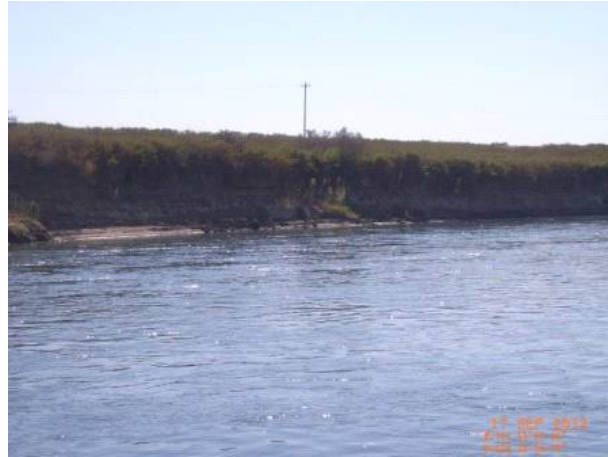
Levee Mile Report Line	47
Start Levee Mile	9.60
End Levee Mile	9.60
Location	Water Side
Category	Supplemental
Item	USACE Erosion Survey

DWR ID: DWR_LD0003_01_s_2012_28		
47	9.60	9.60	Supplemental	USACE Erosion Survey	WS	M Ma	Inspector Comments: 2007 - Getting close to the levee. Bank is clayey silt with clayey/silty toe. 2008 - Looks a little worse at the upstream end. 2009 - Some new erosion and slumping. 2010 - Some new erosion upstream of site, actively eroding at low flow. New bank swallow colony noted. 2011 - Significant erosion since last year, with an estimated 10 to 15 feet of berm lost. Large sections of the bank have slumped off. 2012: Part of the site appears to be stabilizing, but still minor slumping in other locations. [2012 Site ID: SAC_172-0_L]	39.508117 ° -121.986562 °	39.504388 ° -121.985301 °	31 Y
								DWR ID:		
48	10.36	10.47	Earthen Levee	Trim / Thin Trees	WS	N Ma	T5 : Tree stumps.	39.511788 ° -121.983750 °	39.512395 ° -121.981975 °	5
								DWR ID: DWR_LD0003_01_s_2012_5		
49	10.73	10.73	Earthen Levee	Trim / Thin Trees	WS	N Ma	T5 : Tree stumps.	39.515342 ° -121.979202 °	39.515342 ° -121.979202 °	29 Y

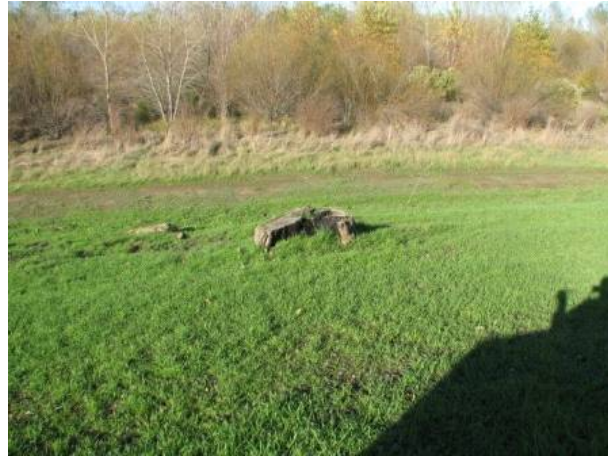
Levee Mile Report Line	50
Start Levee Mile	10.90
End Levee Mile	10.90
Location	Water Side
Category	Earthen Levee
Item	Trim / Thin Trees

View of the stump along the slope.

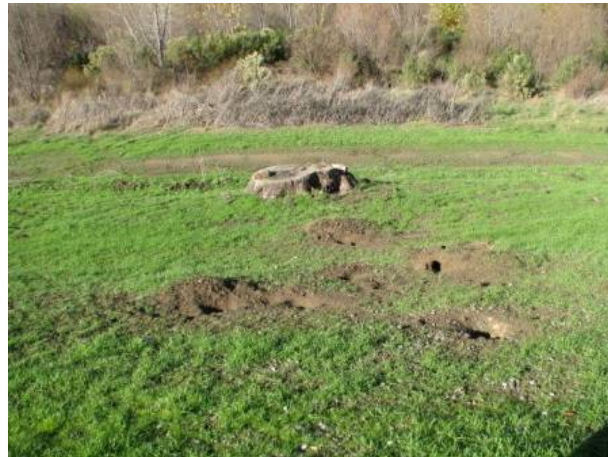
Levee Mile Report Line	51
Start Levee Mile	11.05
End Levee Mile	11.05
Location	Water Side
Category	Earthen Levee
Item	Animal Control

View of the squirrel holes along the slope & also a tree stump.

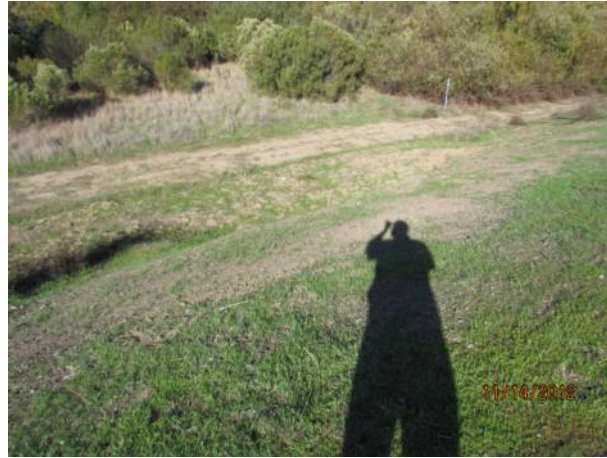
Levee Mile Report Line	53
Start Levee Mile	11.29
End Levee Mile	11.29
Location	Water Side
Category	Earthen Levee
Item	Slope Stability

View of the verical cut along the w/s toe.
