**Flood Control Project Maintenance
Levee Inspections**

Fall 2013 Levee Maintenance Deficiency Summary Report

Levee District No. 0003 (Glenn County)

Levee Inspection Report By Mile - Fall 2013

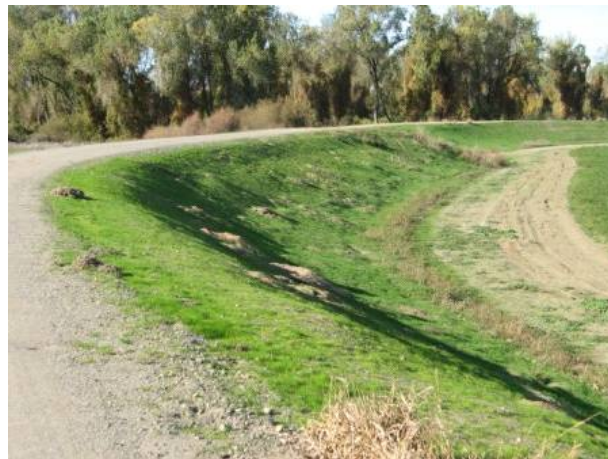
View of squirrel holes along the slope.

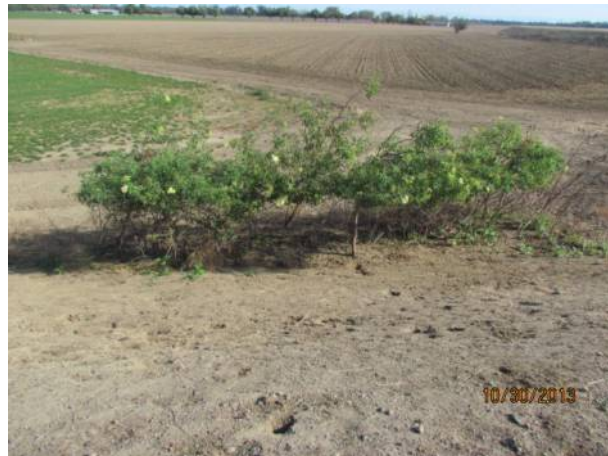
Levee Mile Report Line	7
Start Levee Mile	0.83
End Levee Mile	0.83
Location	Land Side
Category	Earthen Levee
Item	Vegetation

View of the elderberries along the landside toe.

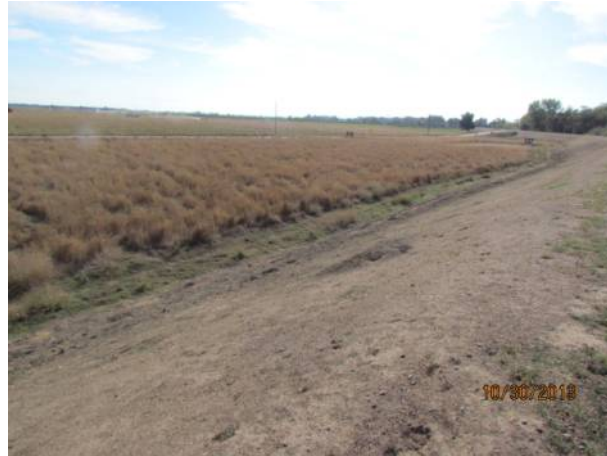
View of the rodent holes along the landside slope.

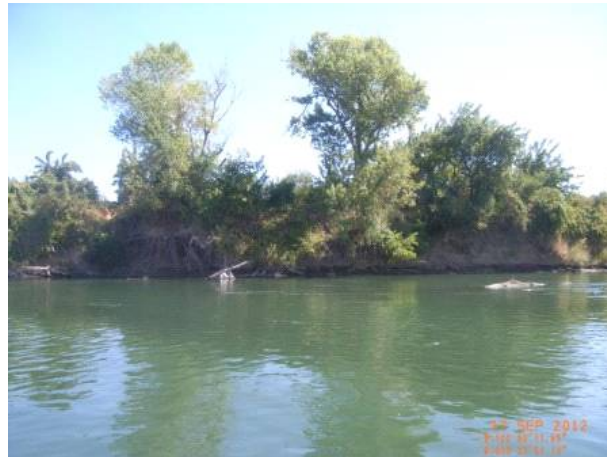
Levee Mile Report Line	9
Start Levee Mile	1.35
End Levee Mile	1.35
Location	Water Side
Category	Supplemental
Item	USACE Erosion Survey

USACE 2012 Photo #1

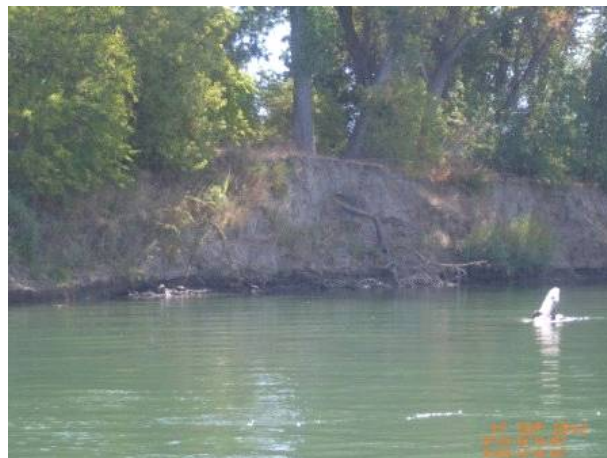
Levee Mile Report Line	9
Start Levee Mile	1.35
End Levee Mile	1.35
Location	Water Side
Category	Supplemental
Item	USACE Erosion Survey

USACE 2012 Photo #2

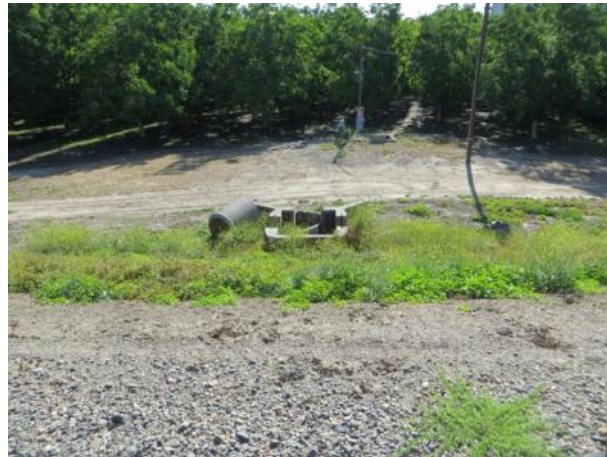
Levee Mile Report Line	10
Start Levee Mile	1.50
End Levee Mile	1.50
Location	Water Side
Category	Supplemental
Item	DWR UCIP Field Study

DWR ID:		
10	1.50	1.50	Supplemental	DWR UCIP Field Study	WS	M En	Inspector Comments: FS_ID:14573 EP_NO: 9930 Repair Type: Non-Urgent Crossing Status: Found UCIP Comments: Steel plate welded over WS end of pipe. Slide gate at WS toe missing. Appears abandoned. FIELD_STRUCT_DESC: 24-inch corrugated metal pipe through the levee 14.5 feet below the crown slide gate on waterward end, 7'X9' concrete diversion box at landward toe (ABO No. 9930-Steel Ranch). Originally included in O+M manual (1960). FS Date: 6/4/2013	39.397780 ° -122.002074 °	39.397780 ° -122.002074 °	11 Y
								DWR ID: DWR_LD0003_01_f_2013_11

Distribution box on LS toe.

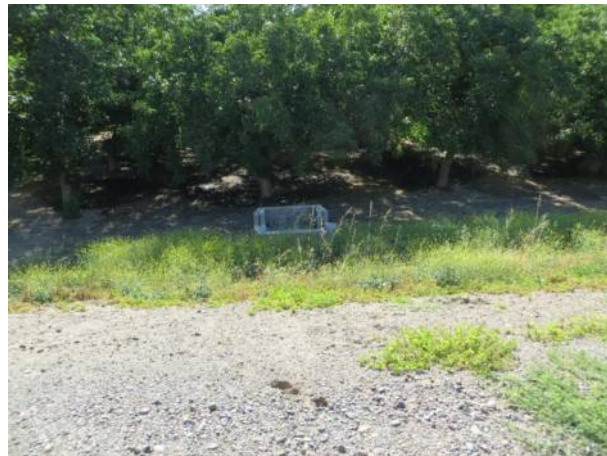
Levee Mile Report Line	11
Start Levee Mile	1.61
End Levee Mile	1.61
Location	Water Side
Category	Supplemental
Item	DWR UCIP Field Study

LMR No.	Levee Mile		Category	Item	Location	Rating	Action/Comment	GPS Latitude/Longitude		Issue No.
	Start	End						Start	End	
11	1.61	1.61	Supplemental	DWR UCIP Field Study	LS	M En	Inspector Comments: FS_ID:14576 EP_NO: 9931 Repair Type: Non-Urgent Crossing Status: Found UCIP Comments: Appears abandoned. Pipe buried at slide gate on WS toe. FIELD_STRUCT_DESC: 24-inch corrugated metal pipe through the levee 15.0 feet below the crown, slide gate on waterward end. 6'X7' concrete distribution box on LS toe. (ABO No. 9931-L. F. Steel). Originally included in the O+M manual (1960). FS Date: 6/4/2013	39.399330 ° -122.002402 °	39.399330 ° -122.002402 °	20 Y
DWR ID: DWR_LD0003_01_f_2013_20										
12	1.74	1.80	Earthen Levee	Animal Control	WS	M Ma	A1 : Exterminate rodents and backfill and compact or grout burrows.	39.401170 ° -122.002186 °	39.402123 ° -122.002067 °	58 Y
DWR ID: DWR_LD0003_01_s_2012_58

Concrete distribution box at LS toe.

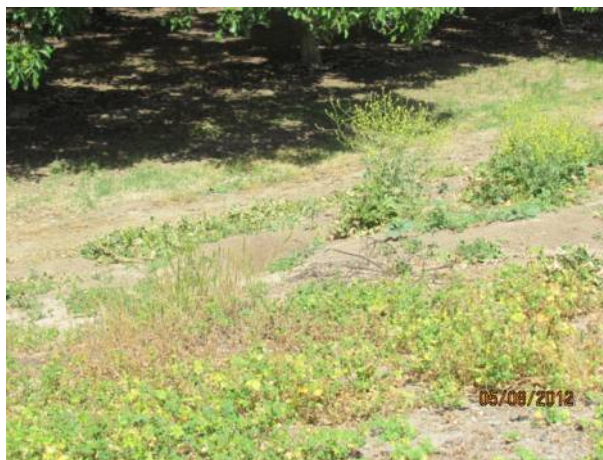
View of the rodent holes along the waterside slope.

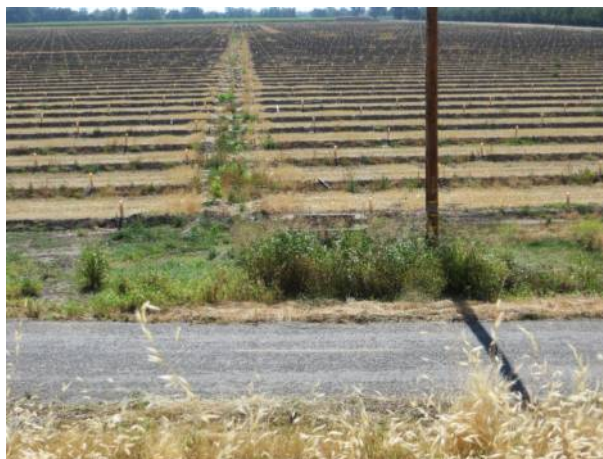
Levee Mile Report Line	15
Start Levee Mile	1.90
End Levee Mile	1.90
Location	Water Side
Category	Supplemental
Item	DWR UCIP Field Study

Concrete distribution box off LS toe.

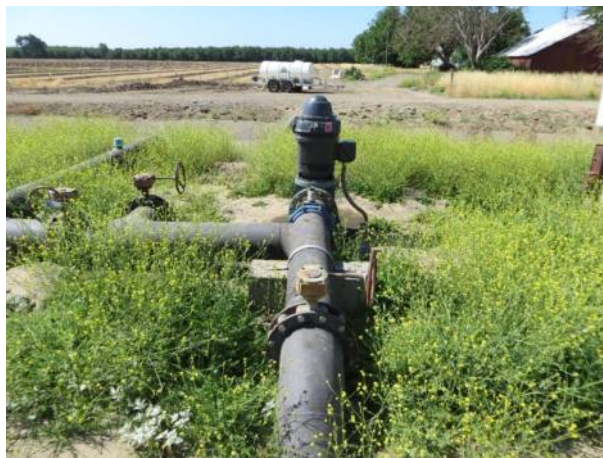
Levee Mile Report Line	16
Start Levee Mile	2.13
End Levee Mile	2.13
Location	Water Side
Category	Supplemental
Item	DWR UCIP Field Study

DWR ID: DWR_LD0003_01_f_2013_24										
16	2.13	2.13	Supplemental	DWR UCIP Field Study	LS	M En	Inspector Comments: FS_ID:15144 EP_NO: N/A Repair Type: Non-Urgent Crossing Status: Found UCIP Comments: No permit identified for this crossing. FIELD_STRUCT_DESC: 12-inch steel irrigation pipe through the levee 3.5-feet below the crown. Pump, butterfly valve, JP/meter at channel on LS toe. Siphon breaker in 12-inch steel riser on LS shoulder. 3-inch plastic drain on WS toe. FS Date: 6/4/2013	39.406353 ° -122.000674 °	39.406353 ° -122.000674 °	28 Y
DWR ID: DWR_LD0003_01_f_2013_28

Pump and butterfly valve off LS toe.

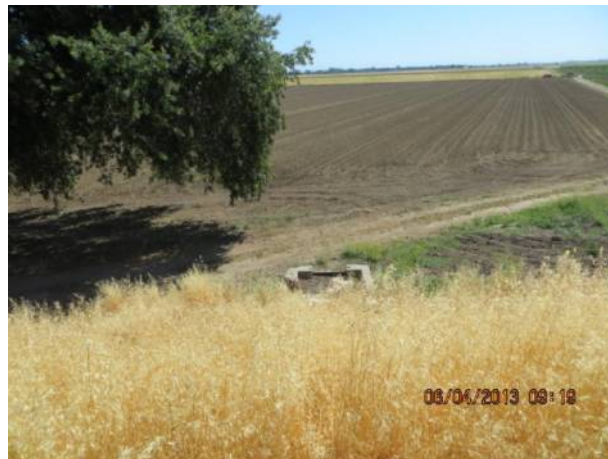
Levee Mile Report Line	18
Start Levee Mile	3.03
End Levee Mile	3.03
Location	Land Side
Category	Supplemental
Item	DWR UCIP Field Study

Distribution box on LS toe.

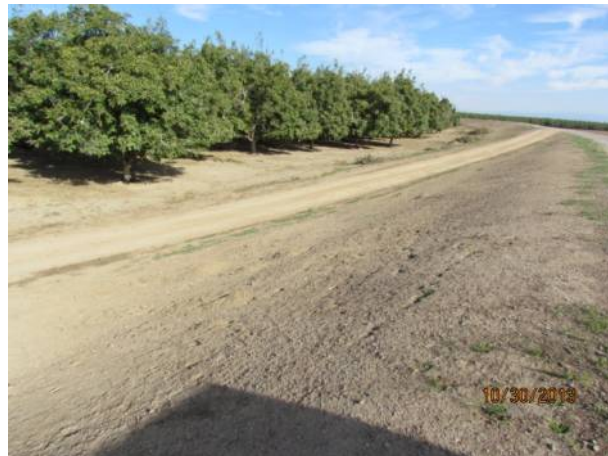
Levee Mile Report Line	19
Start Levee Mile	3.05
End Levee Mile	3.34
Location	Land Side
Category	Earthen Levee
Item	Animal Control

View of the rodent activity along the landside slope.

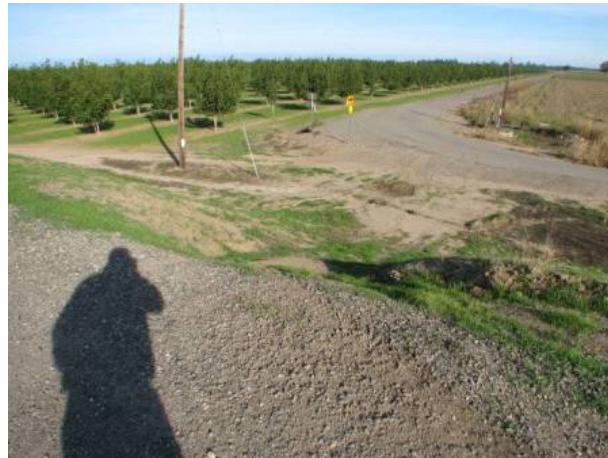
View of the vehicle erosion on the landside slope of the levee.

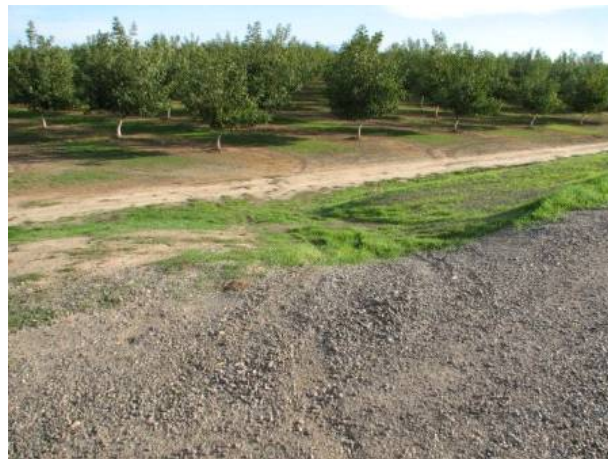
Levee Mile Report Line	21
Start Levee Mile	3.82
End Levee Mile	3.82
Location	Land Side
Category	Earthen Levee
Item	Slope Stability

View of vehicle erosion on the slope.

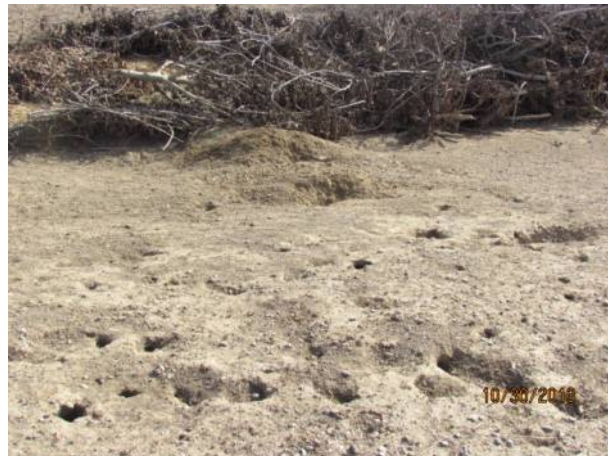
Levee Mile Report Line	22
Start Levee Mile	4.07
End Levee Mile	4.07
Location	Water Side
Category	Earthen Levee
Item	Animal Control

View of the rodent activity along the waterside slope.

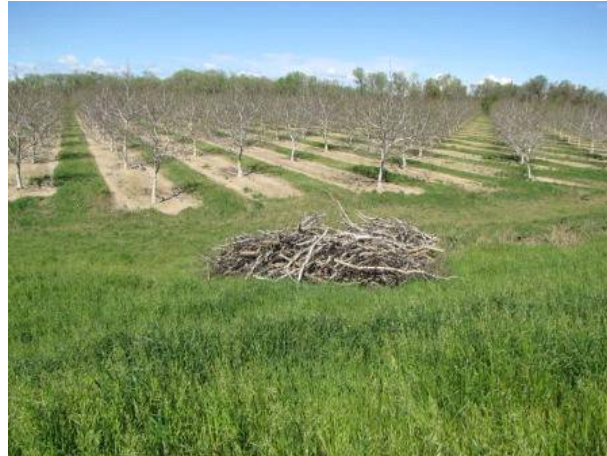
View of prunings along the W/S toe.

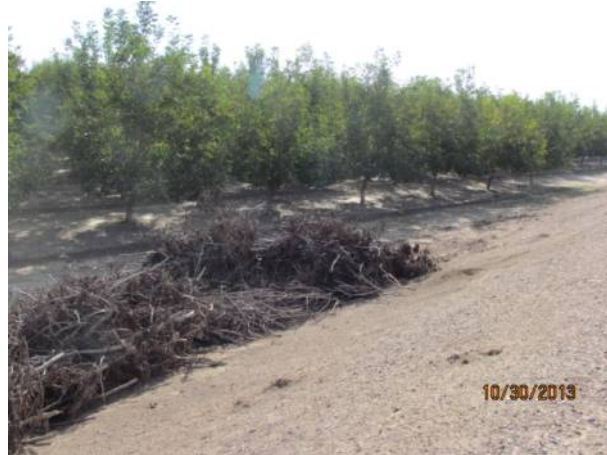
Levee Mile Report Line	24
Start Levee Mile	4.75
End Levee Mile	4.75
Location	Land Side
Category	Earthen Levee
Item	Encroachments

View of the prunings along the landside toe.

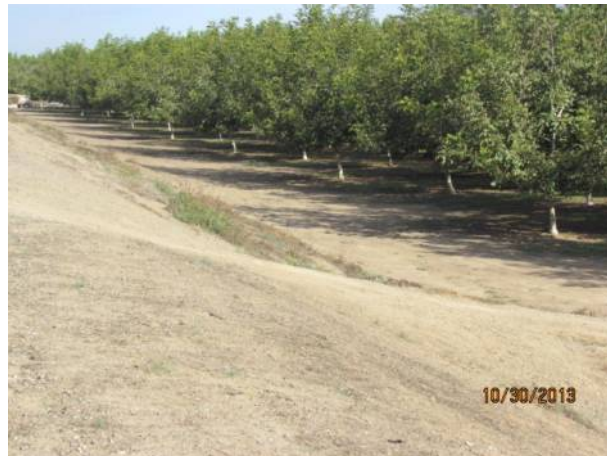
Levee Mile Report Line	25
Start Levee Mile	4.75
End Levee Mile	4.75
Location	Land Side
Category	Earthen Levee
Item	Animal Control

View of the rodent activity along the landside slope.

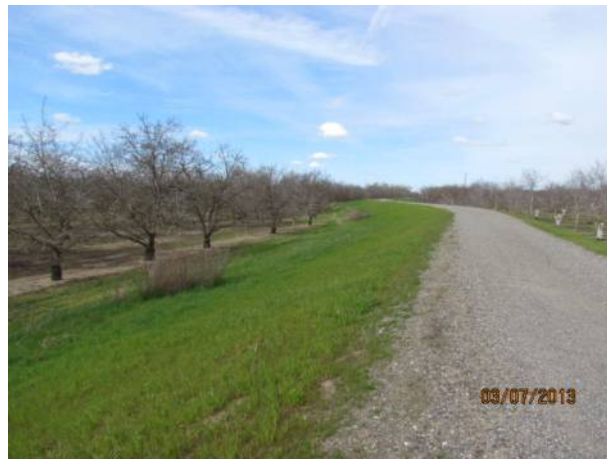
Levee Mile Report Line	28
Start Levee Mile	5.19
End Levee Mile	5.34
Location	Land Side
Category	Earthen Levee
Item	Animal Control

View of no rodent activity.

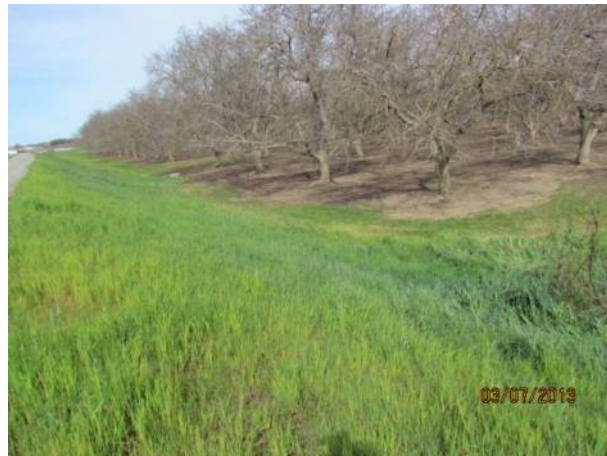
Levee Mile Report Line	29
Start Levee Mile	5.62
End Levee Mile	5.62
Location	Land Side
Category	Earthen Levee
Item	Encroachments

View of all prunings removed from site.

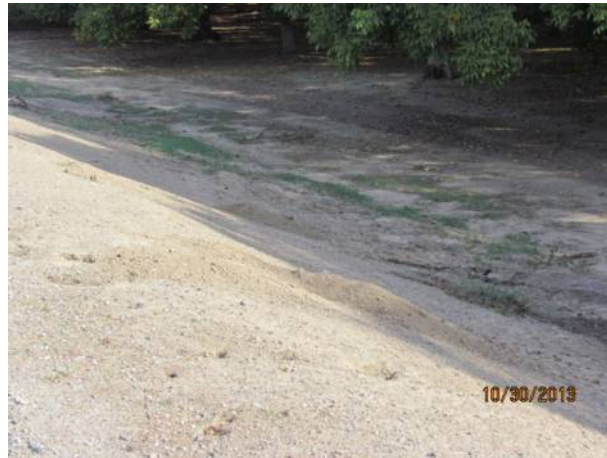
View of the rodent holes along the landside slope.

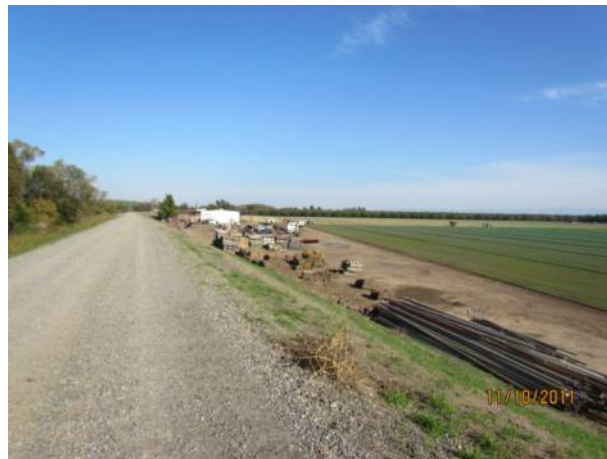
Levee Mile Report Line	31
Start Levee Mile	5.87
End Levee Mile	5.99
Location	Land Side
Category	Earthen Levee
Item	Encroachments

View of the equipment along the L/S toe.

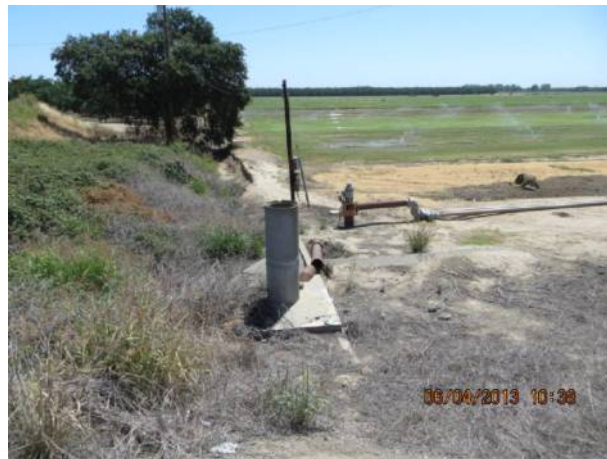
Levee Mile Report Line	33
Start Levee Mile	6.30
End Levee Mile	6.30
Location	Water Side
Category	Supplemental
Item	DWR UCIP Field Study

33	6.30	6.30	Supplemental	DWR UCIP Field Study	WS M En	Inspector Comments: FS_ID:14587 EP_NO: N/A Repair Type: Non-Urgent Crossing Status: Found UCIP Comments: Appears abandoned and should be done so properly. FIELD_STRUCT_DESC: 14-inch steel irrigation pipe through the levee 15-feet below the crown. Pump missing from WS slope. 36-inch concrete standpipe and concrete channel on LS toe. Originally included in O+M Manual 1955. FS Date: 6/4/2013	39.457140 ° -121.993838 °	39.457140 ° -121.993838 °	40 Y
----	------	------	--------------	----------------------	------------	---	------------------------------	------------------------------	---------

Concrete standpipe on LS toe.

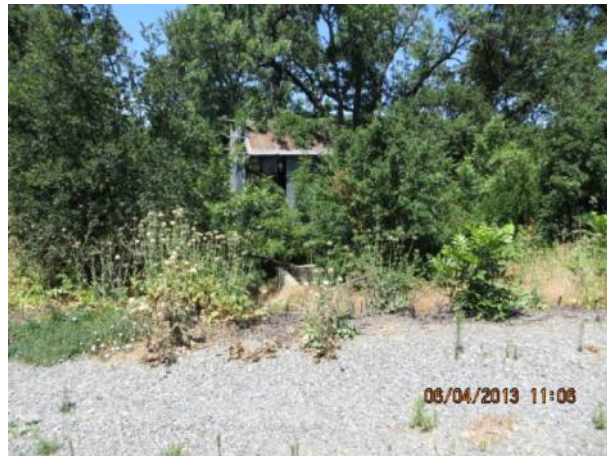
Levee Mile Report Line	37
Start Levee Mile	6.66
End Levee Mile	6.66
Location	Water Side
Category	Supplemental
Item	DWR UCIP Field Study

DWR ID: DWR_LD0003_01_s_2012_48										
37	6.66	6.66	Supplemental	DWR UCIP Field Study	WS	M En	Inspector Comments: FS_ID:14664 EP_NO: 9906 Repair Type: Non-Urgent Crossing Status: Found UCIP Comments: Pipe appears to be abandoned and should be done so properly. FIELD_STRUCT_DESC: 24-inch steel pipe through levee 13.0 feet below crown, slide gate on waterward end, pump house on berm. Slide gate in 7'X12' concrete pit on waterward side with flap gate on pipe from pumphouse. Pipe discharges into irrigation ditch on landward side (ABO No. 9906-Clare). Originally included in O+M manual 1955. FS Date: 6/4/2013	39.462146 ° -121.992832 °	39.462146 ° -121.992832 °	50 Y
DWR ID: DWR_LD0003_01_f_2013_50										
38	6.69	6.69	Earthen Levee	Slope Stability	LS	M Ma	S3 : Repair the levee slope damaged by vehicle traffic and prevent access where possible.	39.462505 ° -121.992698 °	39.462505 ° -121.992698 °	34

Pumphouse and 7'X12' concrete box on WS slope.

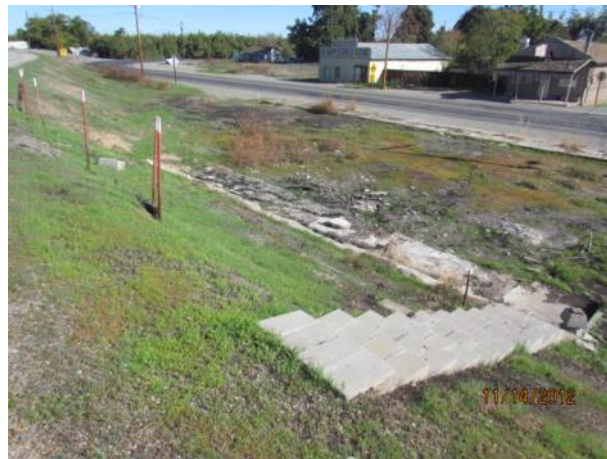
Levee Mile Report Line	44
Start Levee Mile	6.74
End Levee Mile	6.74
Location	Land Side
Category	Earthen Levee
Item	Slope Stability

View of concrete stairs & foundation along the slope of the levee.

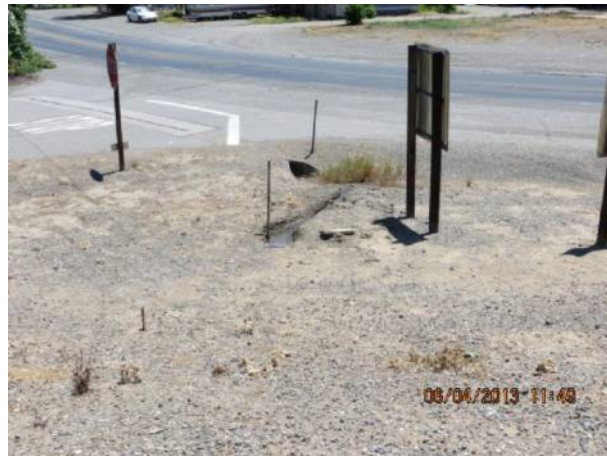
Levee Mile Report Line	46
Start Levee Mile	6.85
End Levee Mile	6.85
Location	Land Side
Category	Supplemental
Item	DWR UCIP Field Study

Pipe leaking at LS toe.

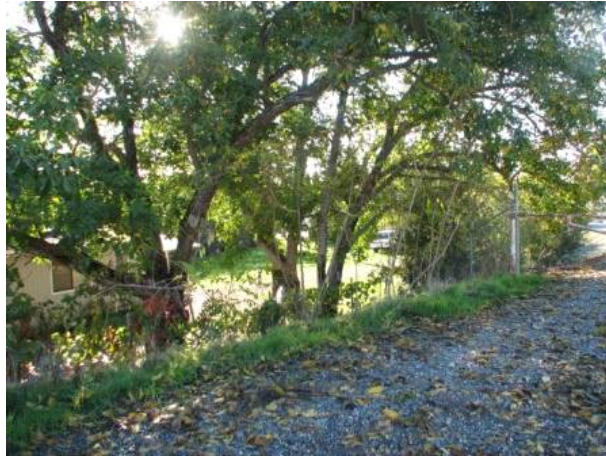
View of the trees that are hanging over the landside slope of the levee.

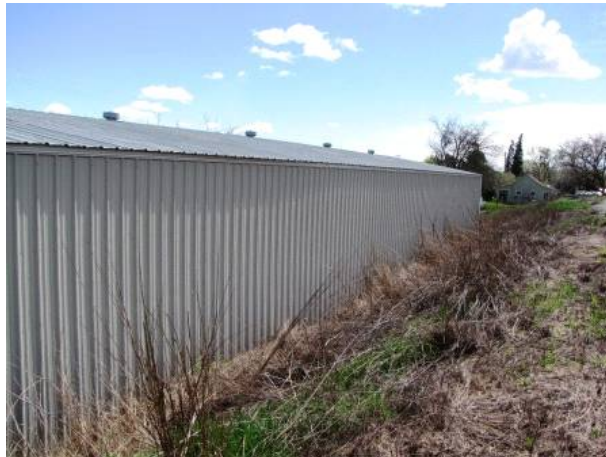
Levee Mile Report Line	48
Start Levee Mile	6.91
End Levee Mile	6.92
Location	Land Side
Category	Earthen Levee
Item	Encroachments

View of the building along the L/S toe.

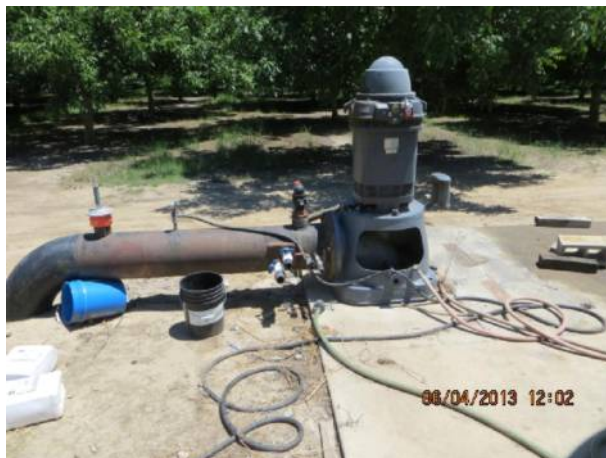
Levee Mile Report Line	49
Start Levee Mile	7.27
End Levee Mile	7.27
Location	Land Side
Category	Supplemental
Item	DWR UCIP Field Study

Pump located on LS toe next to concrete distribution box.

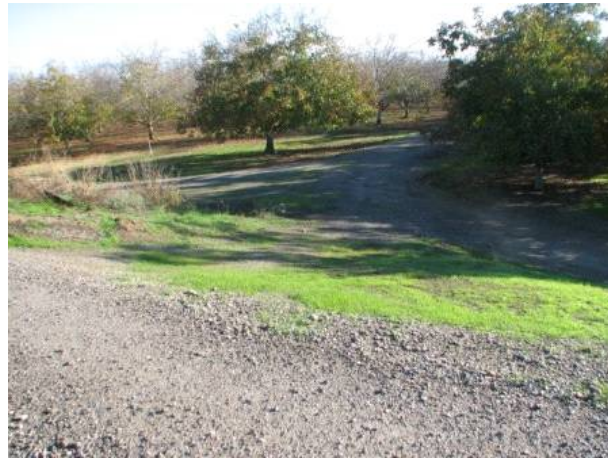
Vehicle erosion along the slope.

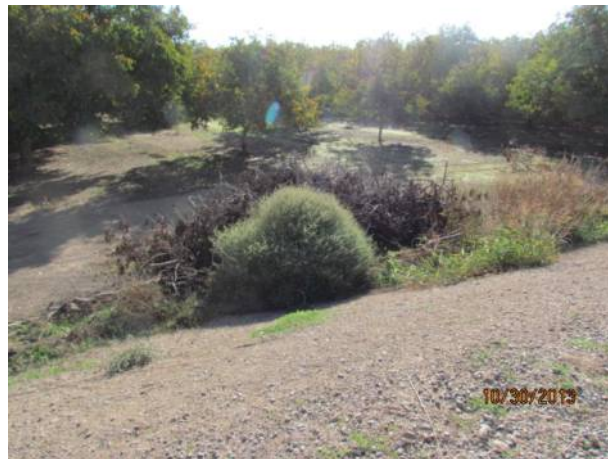
Levee Mile Report Line	53
Start Levee Mile	7.74
End Levee Mile	7.74
Location	Land Side
Category	Earthen Levee
Item	Encroachments

View of the pruning along the landside toe.

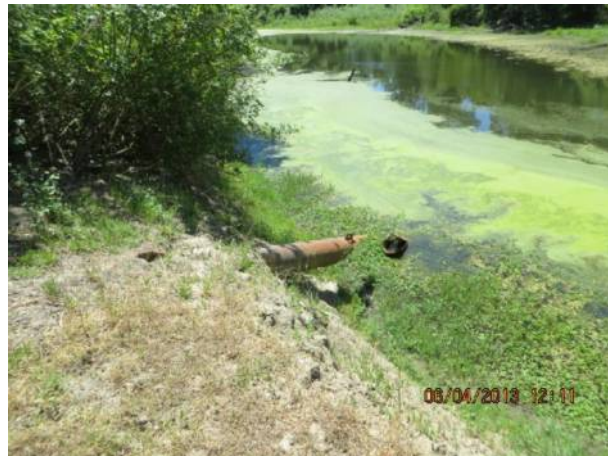
Levee Mile Report Line	54
Start Levee Mile	7.75
End Levee Mile	7.75
Location	Land Side
Category	Supplemental
Item	DWR UCIP Field Study

LMR No.	Levee Mile		Category	Item	Location	Rating	Action/Comment	GPS Latitude/Longitude		Issue No.
	Start	End						Start	End	
54	7.75	7.75	Supplemental	DWR UCIP Field Study	WS	M En	Inspector Comments: FS_ID:14687 EP_NO: N/A Repair Type: Non-Urgent Crossing Status: Found UCIP Comments: Verify pipe was abandoned properly FIELD_STRUCT_DESC: 18-inch steel irrigation pipe through the levee 14.7 feet below the crown. Pump and pipe visible at edge of pond off WS toe (Kaiser-Aetna) FS Date: 6/4/2013	39.477223 ° -121.991021 °	39.477223 ° -121.991021 °	54 Y
DWR ID: DWR_LD0003_01_f_2013_54										
55	7.84	7.84	Earthen Levee	Encroachments	LS	M En	PR : Prunings	39.478464 ° -121.990686 °	39.478464 ° -121.990686 °	60 Y
DWR ID: DWR_LD0003_01_f_2013_60										
56	9.32	9.32	Supplemental	DWR UCIP Field Study	LS	M En	Inspector Comments: FS_ID:14688 EP_NO: 1623 Repair Type: Non-Urgent Crossing Status: Found UCIP Comments: Abandoned and should be done so properly. FIELD_STRUCT_DESC: 1.5-inch galvanized iron pipe through the levee 8.0 feet below the crown (Permit No.1623-Holgersoo). FS Date: 6/4/2013	39.497575 ° -121.987548 °	39.497575 ° -121.987548 °	55 Y

Pipe visible at pond off WS toe.

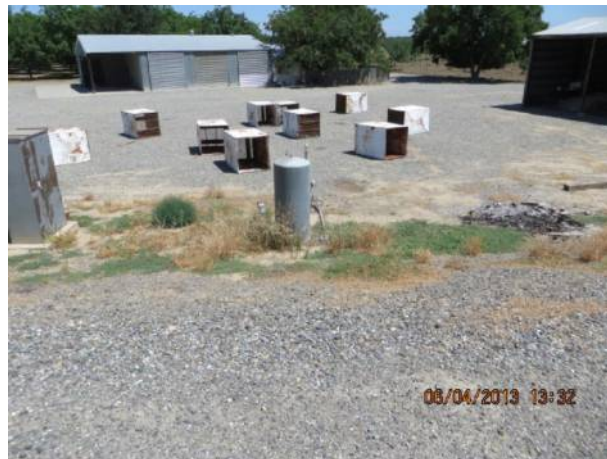
Levee Mile Report Line	56
Start Levee Mile	9.32
End Levee Mile	9.32
Location	Land Side
Category	Supplemental
Item	DWR UCIP Field Study

Water tank, pump, and well head on LS toe.

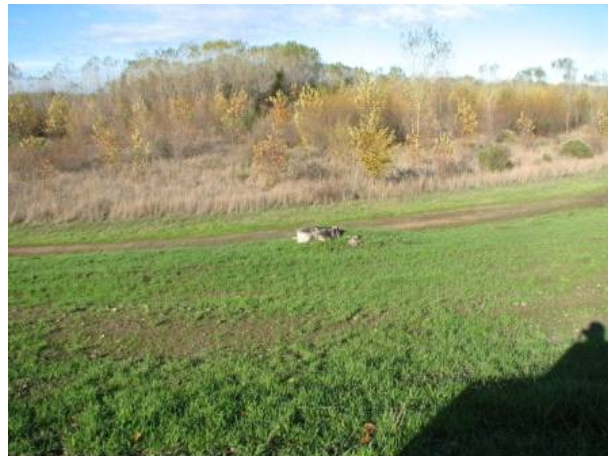
Levee Mile Report Line	61
Start Levee Mile	10.73
End Levee Mile	10.73
Location	Water Side
Category	Earthen Levee
Item	Trim / Thin Trees

View of the stump along the toe.

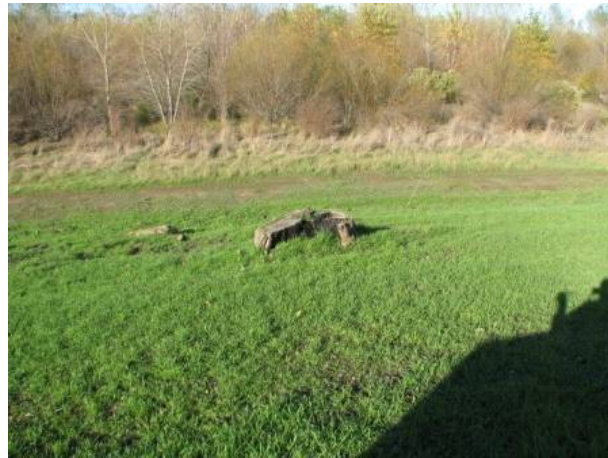
View of the stump along the slope.

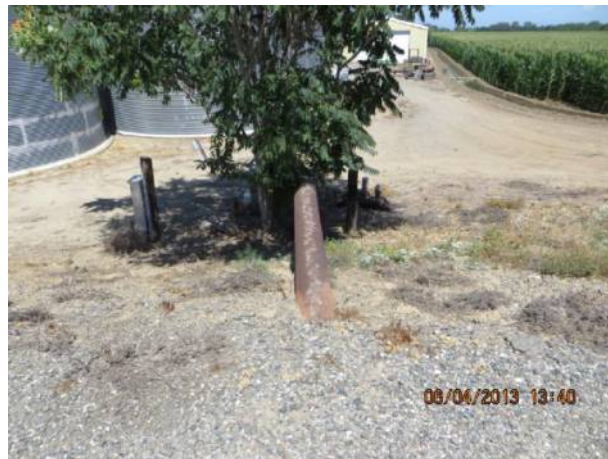
Levee Mile Report Line	63
Start Levee Mile	11.20
End Levee Mile	11.20
Location	Water Side
Category	Supplemental
Item	DWR UCIP Field Study

DWR ID: DWR_LD0003_01_s_2012_30										
63	11.20	11.20	Supplemental	DWR UCIP Field Study	WS	M En	Inspector Comments: FS_ID:14690 EP_NO: 3193 Repair Type: Non-Urgent Crossing Status: Found UCIP Comments: Pipe appears abandoned and should be done so properly. FIELD_STRUCT_DESC: 10-inch steel pipe through levee at crown elevation. 5.5-inch pipe extended out on waterward end, supplying water tanks at landward toe. Discharge into metal tank covered at landward toe. Pump and meter on landward side (Permit No. 3193- T. Southam). Design drawings available in permit. FS Date: 6/4/2013	39.521780 ° -121.979014 °	39.521780 ° -121.979014 °	59 Y
DWR ID: DWR_LD0003_01_f_2013_59										
64	11.22	11.25	Earthen Levee	Trim / Thin Trees	LS	M Ma	T2 : Thin trees to allow visibility of the ground and room to flood fight.	39.522058 ° -121.979133 °	39.522480 ° -121.979200 °	4 Y
DWR ID: DWR_LD0003_01_s_2012_4

10-inch pipe on LS.

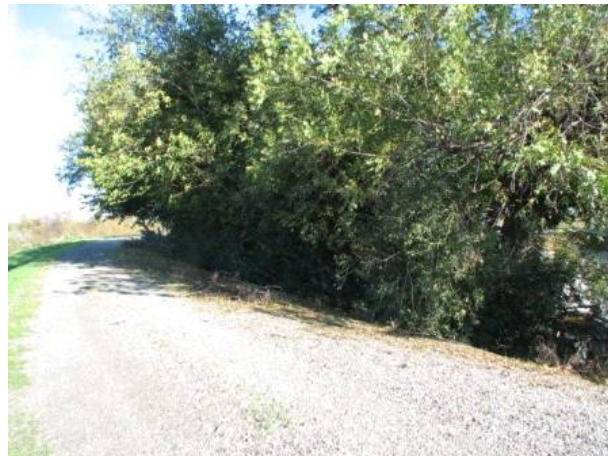
Levee Mile Report Line	64
Start Levee Mile	11.22
End Levee Mile	11.25
Location	Land Side
Category	Earthen Levee
Item	Trim / Thin Trees

View of the trees along the slope.

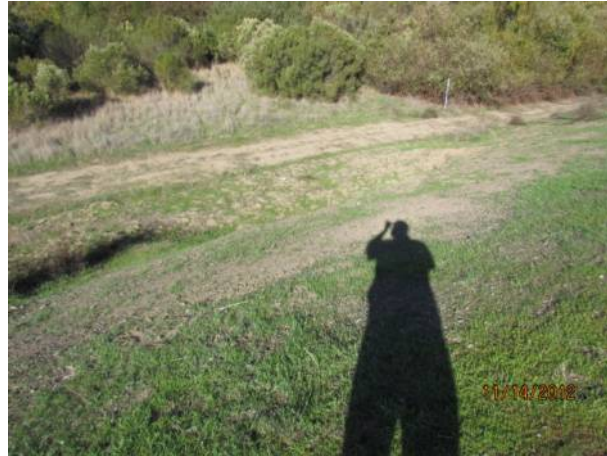
View of the verical cut along the w/s toe.
