**Flood Control Project Maintenance
Levee Inspections**

Fall 2014 Levee Maintenance Deficiency Summary Report

**Flood Control Project Maintenance
Levee Inspections**
LMA District Cover Sheet
Fall 2014 Levee Inspection Results

Levee District No. 0003 (Glenn County)

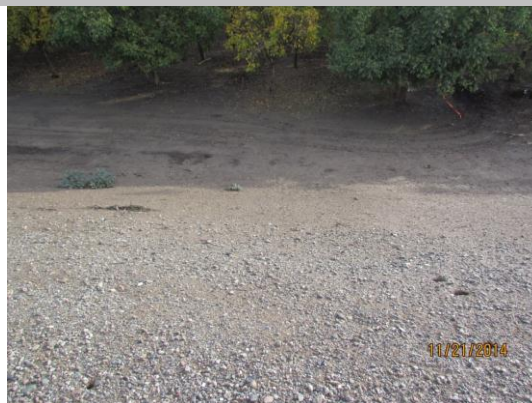
Photo 1 of 1 : FA_2014_LD0003_27_13_20141126_00053.jpg

LM Start	1.80	Rating **	A/W	Issue No.	13
LM End	2.45	Issue Type +	Ma	Location *	WS
Category	Earthen Levee			GPS Latitude/Longitude	
				Start	End
Item	Animal Control			39.402115 °	39.406538 °
				-122.002047 °	-121.994995 °
DWR ID	DWR_LD0003_01_s_2012_13				
Action/Comments					
No rodents visible, but rodent burrows visible; need to backfill and compact or grout burrows.

View of the rodent holes along the waterside slope.

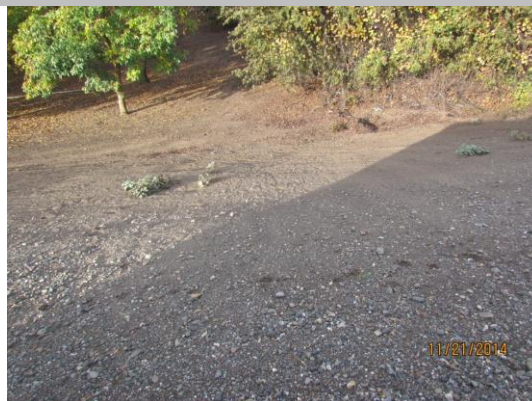
Photo 1 of 1 : FA_2014_LD0003_27_47_20141126_00054.jpg

LM Start	2.48	Rating **	M	Issue No.	47
LM End	2.48	Issue Type +	Ma	Location *	WS
Category	Earthen Levee			GPS Latitude/Longitude	
				Start	End
Item	Animal Control			39.406667 °	39.406667 °
				-121.994328 °	-121.994328 °
DWR ID	DWR_LD0003_01_f_2014_47				
Action/Comments					
No rodents visible, but rodent burrows visible; need to backfill and compact or grout burrows.

View of the rodent holes along the waterside slope.

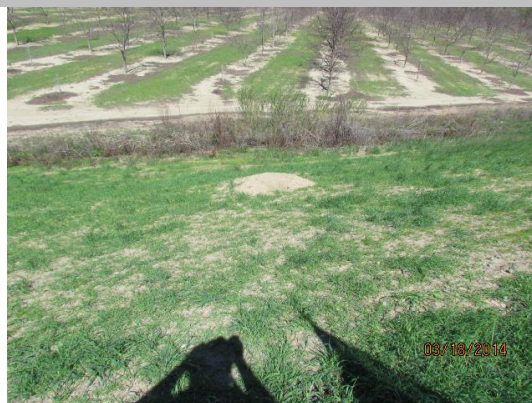
Photo 1 of 1 : FA_2014_LD0003_27_59_20141013_00024.jpg

LM Start	2.50	Rating **	M	Issue No.	59
LM End	2.50	Issue Type +	Ma	Location *	WS
Category	Earthen Levee			GPS Latitude/Longitude	
				Start	End
Item	Animal Control			39.406809 °	39.406809 °
				-121.994100 °	-121.994100 °
DWR ID	DWR_LD0003_01_s_2014_59				
Action/Comments					
No rodents visible, but rodent burrows visible; need to backfill and compact or grout burrows.

View of the rodent activity along the w/s slope.

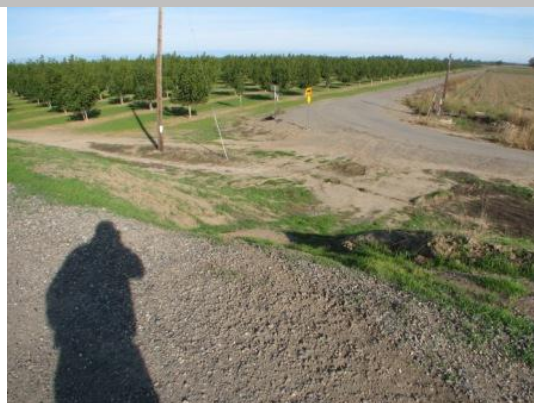
Photo 1 of 1 : FA_2014_LD0003_27_9_20141013_00005.jpg

LM Start	3.44	Rating **	M	Issue No.	9
LM End	3.44	Issue Type +	Ma	Location *	LS
Category	Earthen Levee			GPS Latitude/Longitude	
				Start	End
Item	Slope Stability			39.418267 °	39.418267 °
				-121.992472 °	-121.992472 °
DWR ID	DWR_LD0003_01_s_2012_9				
Action/Comments					
Repair the levee slope damaged by vehicle traffic and prevent access where possible.

View of the vehicle erosion on the landside slope of the levee.

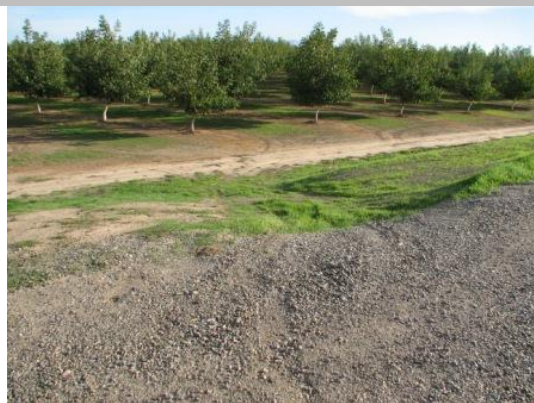
Photo 1 of 1 : FA_2014_LD0003_27_19_20141013_00009.jpg

LM Start	3.82	Rating **	M	Issue No.	19
LM End	3.82	Issue Type +	Ma	Location *	LS
Category	Earthen Levee			GPS Latitude/Longitude	
				Start	End
Item	Slope Stability			39.423747 °	39.423747 °
				-121.991667 °	-121.991667 °
DWR ID	DWR_LD0003_01_s_2012_19				
Action/Comments					
Repair the levee slope damaged by vehicle traffic and prevent access where possible.

View of vehicle erosion on the slope.

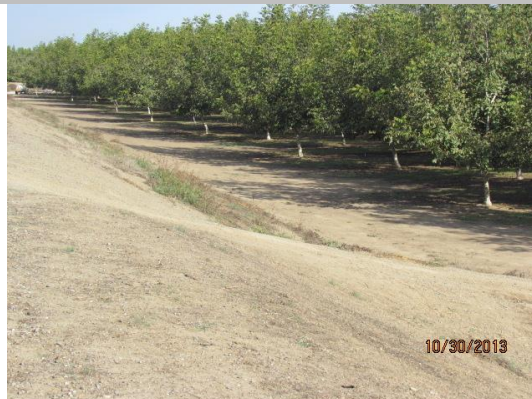
Photo 1 of 1 : FA_2014_LD0003_27_64_20141013_00029.jpg

LM Start	4.75	Rating **	M	Issue No.	64
LM End	4.75	Issue Type +	Ma	Location *	LS
Category	Earthen Levee			GPS Latitude/Longitude	
				Start	End
Item	Animal Control			39.435702 °	39.435702 °
				-121.988189 °	-121.988189 °
DWR ID	DWR_LD0003_01_f_2013_64				
Action/Comments					
No rodents visible, but rodent burrows visible; need to backfill and compact or grout burrows.

View of the rodent activity along the landside slope.

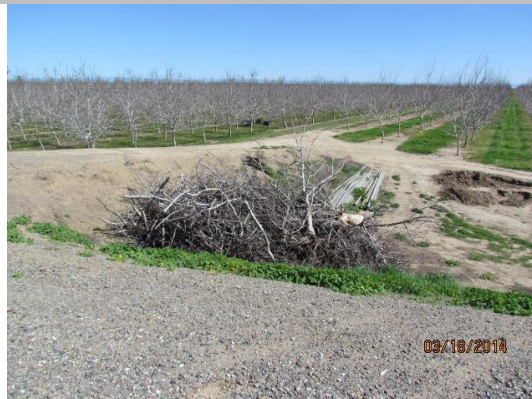
Photo 1 of 1 : FA_2014_LD0003_27_68_20141013_00033.jpg

LM Start	4.90	Rating **	M	Issue No.	68
LM End	4.90	Issue Type +	En	Location *	LS
Category	Earthen Levee			GPS Latitude/Longitude	
				Start	End
Item	Encroachments			39.437857 °	39.437857 °
				-121.988754 °	-121.988754 °
DWR ID	DWR_LD0003_01_s_2014_68				
Action/Comments					
Prunings

View of the prunings along the l/s toe.

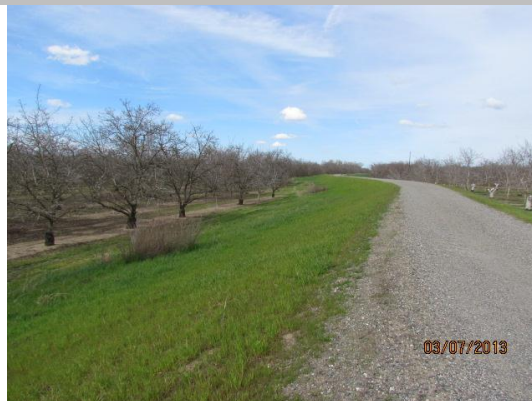
Photo 1 of 1 : FA_2014_LD0003_27_21_20141013_00010.jpg

LM Start	5.19	Rating **	A/W	Issue No.	21
LM End	5.34	Issue Type +	Ma	Location *	LS
Category	Earthen Levee			GPS Latitude/Longitude	
				Start	End
Item	Animal Control			39.441598 °	39.443793 °
				-121.990677 °	-121.991297 °
DWR ID	DWR_LD0003_01_s _ 2012_21				
Action/Comments					
No rodents visible, but rodent burrows visible; need to backfill and compact or grout burrows.

View of no rodent activity.

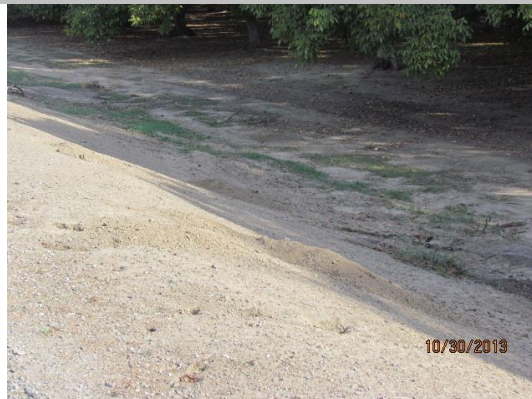
Photo 1 of 1 : FA_2014_LD0003_27_62_20141013_00027.jpg

LM Start	5.64	Rating **	M	Issue No.	62
LM End	5.76	Issue Type +	Ma	Location *	LS
Category	Earthen Levee			GPS Latitude/Longitude	
				Start	End
Item	Animal Control			39.447947 °	39.449739 °
				-121.991770 °	-121.991978 °
DWR ID	DWR_LD0003_01_f_2013_62				
Action/Comments					
No rodents visible, but rodent burrows visible; need to backfill and compact or grout burrows.

View of the rodent holes along the landside slope.

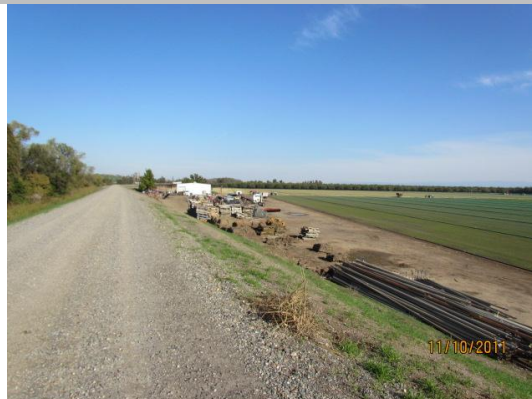
Photo 1 of 1 : FA_2014_LD0003_27_25_20141013_00011.jpg

LM Start	5.87	Rating **	M	Issue No.	25
LM End	5.99	Issue Type +	Ma	Location *	LS
Category	Earthen Levee			GPS Latitude/Longitude	
				Start	End
Item	Encroachments			39.451293 °	39.452872 °
				-121.992370 °	-121.992897 °
DWR ID	DWR_LD0003_01_s_ 2012_25				
Action/Comments					
Abandoned vehicles

View of the equipment along the L/S toe.

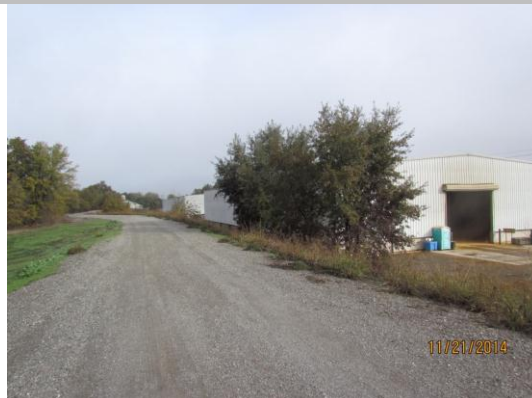
Photo 1 of 1 : FA_2014_LD0003_27_7_20141126_00056.jpg

LM Start	6.36	Rating **	M	Issue No.	7
LM End	6.42	Issue Type +	Ma	Location *	LS
Category	Earthen Levee			GPS Latitude/Longitude	
				Start	End
Item	Trim / Thin Trees			39.457968 °	39.458797 °
				-121.993712 °	-121.993753 °
DWR ID	DWR_LD0003_01_s_2012_7				
Action/Comments					
Trim trees to at least five feet above ground level.

Trim the trees 5 feet four better visibility.

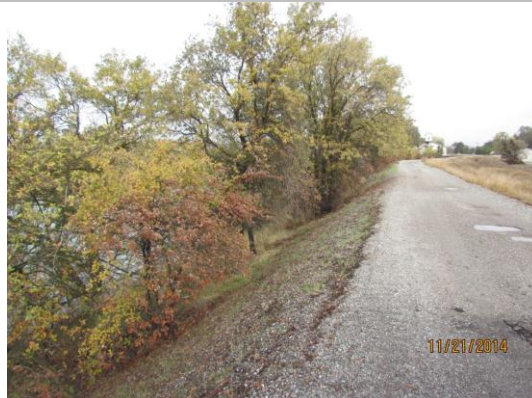
Photo 1 of 1 : FA_2014_LD0003_27_48_20141126_00058.jpg

LM Start	6.41	Rating **	M	Issue No.	48
LM End	6.50	Issue Type +	Ma	Location *	WS
Category	Earthen Levee			GPS Latitude/Longitude	
				Start	End
Item	Trim / Thin Trees			39.458587 °	39.459912 °
				-121.993777 °	-121.993592 °
DWR ID	DWR_LD0003_01_s_2012_48				
Action/Comments					
Trim trees to at least five feet above ground level.

Trim the trees up 5 feet for better visibility.

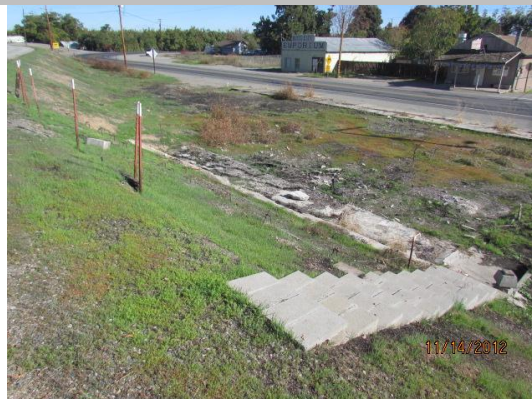
Photo 1 of 1 : FA_2014_LD0003_27_12_20141013_00007.jpg

LM Start	6.74	Rating **	M	Issue No.	12
LM End	6.74	Issue Type +	Ma	Location *	LS
Category	Earthen Levee			GPS Latitude/Longitude	
				Start	End
Item	Slope Stability			39.463366 °	39.463366 °
				-121.992586 °	-121.992586 °
DWR ID	DWR_LD0003_01_f_2012_12				
Action/Comments					
Repair slope instability.					
Inspector Comments: Building has burned down.

View of concrete stairs & foundation along the slope of the levee.

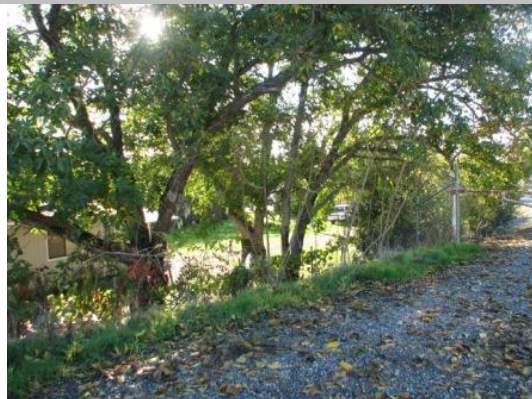
Photo 1 of 1 : FA_2014_LD0003_27_35_20141013_00017.jpg

LM Start	6.88	Rating **	M	Issue No.	35
LM End	6.88	Issue Type +	Ma	Location *	LS
Category	Earthen Levee			GPS Latitude/Longitude	
				Start	End
Item	Trim / Thin Trees			39.465013 °	39.465013 °
				-121.991455 °	-121.991455 °
DWR ID	DWR_LD0003_01_s_2012_35				
Action/Comments					
Trim trees to at least five feet above ground level.

View of the trees that are hanging over the landside slope of the levee.

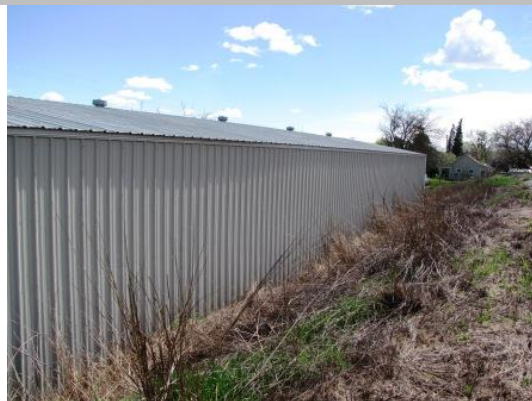
Photo 1 of 1 : FA_2014_LD0003_27_42_20141013_00018.jpg

LM Start	6.91	Rating **	M	Issue No.	42
LM End	6.92	Issue Type +	En	Location *	LS
Category	Earthen Levee			GPS Latitude/Longitude	
				Start	End
Item	Encroachments			39.465567 °	39.465595 °
				-121.991415 °	-121.991412 °
DWR ID	DWR_LD0003_01_s_2012_42				
Action/Comments					
Building

View of the building along the L/S toe.

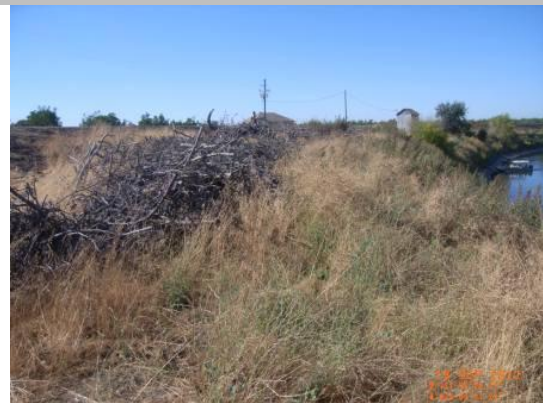
Photo 1 of 1 : FA_2014_LD0003_27_60_20141013_00025.jpg

LM Start	7.84	Rating **	M	Issue No.	60
LM End	7.84	Issue Type +	En	Location *	LS
Category	Earthen Levee			GPS Latitude/Longitude	
				Start	End
Item	Encroachments			39.478464 °	39.478464 °
				-121.990686 °	-121.990686 °
DWR ID	DWR_LD0003_01_f_2013_60				
Action/Comments					
Prunings

View of the prunings along the landside toe.

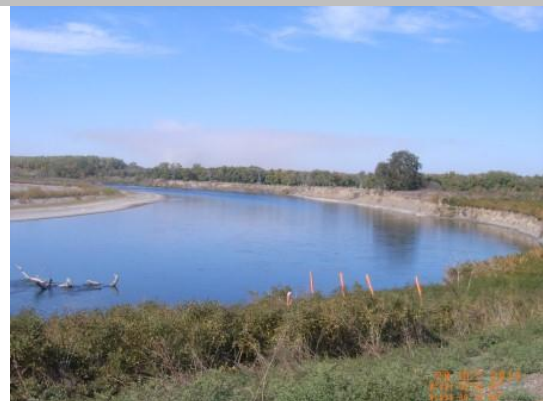
Photo 1 of 3 : FA_2014_LD0003_27_26_20141013_00012.jpg

LM Start	8.71	Rating **	M	Issue No.	26
LM End	9.86	Issue Type +	Ma	Location *	WS
Category	Supplemental			GPS Latitude/Longitude	
				Start	End
Item	USACE Erosion Survey			39.508117 °	39.504388 °
				-121.986562 °	-121.985301 °
DWR ID	DWR_LD0003_01_f_2014_26				
Action/Comments					
Inspector Comments: 2007 - Getting close to the levee. Bank is clayey silt with clayey/silty toe. 2008 - Looks a little worse at the upstream end. 2009 - Some new erosion and slumping. 2010 - Some new erosion upstream of site, actively eroding at low flow. New bank swallow colony noted. 2011 - Significant erosion since last year, with an estimated 10 to 15 feet of berm lost. Large sections of the bank have slumped off. 2012 - Part of the site appears to be stabilizing, but still minor slumping in other locations. 2013: Minor new erosion at the toe. [2013 Site ID: SAC_172-0_L]

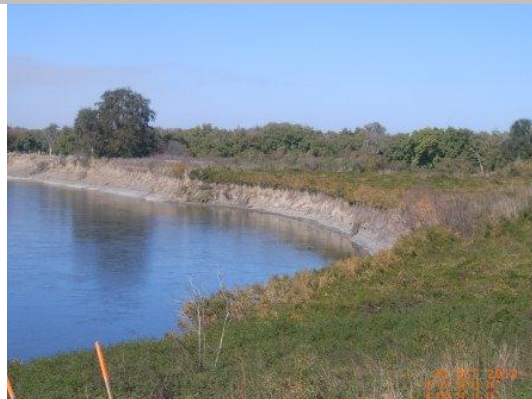
Photo 2 of 3 : FA_2014_LD0003_27_26_20141013_00013.jpg

LM Start	8.71	Rating **	M	Issue No.	26 (cont)	
LM End	9.86	Issue Type +	Ma	Location *	WS	
Category	Supplemental			GPS Latitude/Longitude		
				Start	End	
Item	USACE Erosion Survey			39.508117 °	39.504388 °	
				-121.986562 °	-121.985301 °	
DWR ID	DWR_LD0003_01_f_2014_26					
Action/Comments						
Inspector Comments: 2007 - Getting close to the levee. Bank is clayey silt with clayey/silty toe. 2008 - Looks a little worse at the upstream end. 2009 - Some new erosion and slumping. 2010 - Some new erosion upstream of site, actively eroding at low flow. New bank swallow colony noted. 2011 - Significant erosion since last year, with an estimated 10 to 15 feet of berm lost. Large sections of the bank have slumped off. 2012 - Part of the site appears to be stabilizing, but still minor slumping in other locations. 2013: Minor new erosion at the toe. [2013 Site ID: SAC_172-0_L]

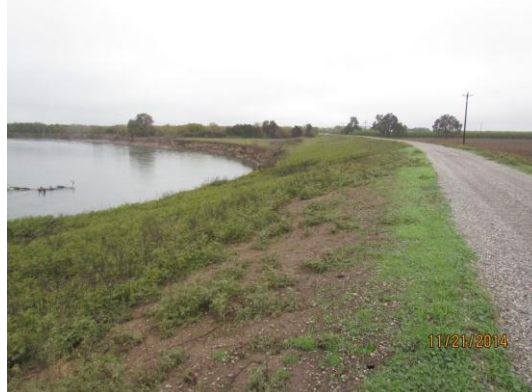
Photo 1 of 1 : FA_2014_LD0003_27_50_20141126_00061.jpg

LM Start	9.91	Rating **	U	Issue No.	50
LM End	9.91	Issue Type +	Ma	Location *	WS
Category	Earthen Levee			GPS Latitude/Longitude	
				Start	End
Item	Erosion / Bank Caving			39.505435 °	39.505435 °
				-121.984172 °	-121.984172 °
DWR ID	DWR_LD0003_01_f_2014_50				
Action/Comments					
Schedule repair of erosion site prior to the next inspection.

View of the erosion along the landside toe. Same site as the USACE erosion issue.

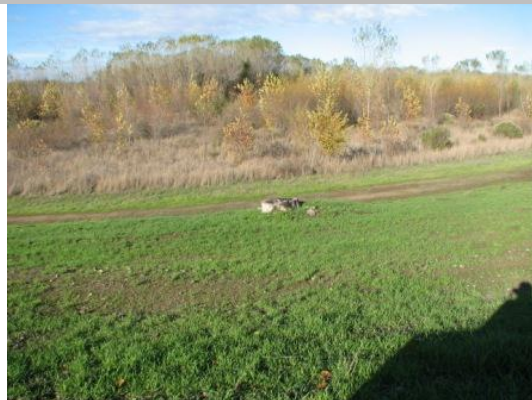
Photo 1 of 1 : FA_2014_LD0003_27_29_20141013_00015.jpg

LM Start	10.73	Rating **	N	Issue No.	29
LM End	10.73	Issue Type +	Ma	Location *	WS
Category	Earthen Levee			GPS Latitude/Longitude	
				Start	End
Item	Trim / Thin Trees			39.515342 °	39.515342 °
				-121.979202 °	-121.979202 °
DWR ID	DWR_LD0003_01_s_2012_29				
Action/Comments					
Tree stumps.

View of the stump along the toe.

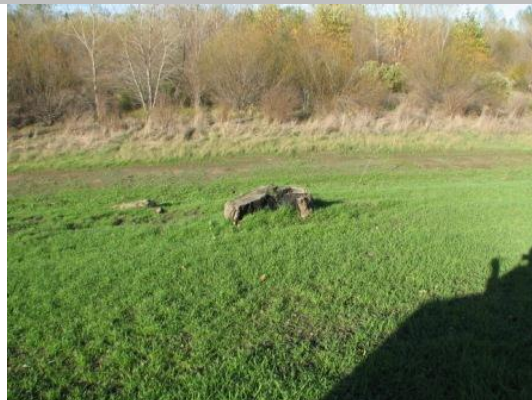
Photo 1 of 1 : FA_2014_LD0003_27_30_20141013_00016.jpg

LM Start	10.90	Rating **	N	Issue No.	30
LM End	10.90	Issue Type +	Ma	Location *	WS
Category	Earthen Levee			GPS Latitude/Longitude	
				Start	End
Item	Trim / Thin Trees			39.517715 °	39.517715 °
				-121.979155 °	-121.979155 °
DWR ID	DWR_LD0003_01_s_2012_30				
Action/Comments					
Tree stumps.

View of the stump along the slope.

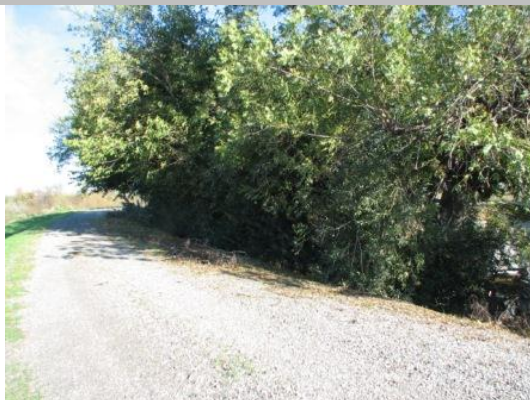
Photo 1 of 1 : FA_2014_LD0003_27_4_20141013_00003.jpg

LM Start	11.22	Rating **	M	Issue No.	4
LM End	11.25	Issue Type +	Ma	Location *	LS
Category	Earthen Levee			GPS Latitude/Longitude	
				Start	End
Item	Trim / Thin Trees			39.522058 °	39.522480 °
				-121.979133 °	-121.979200 °
DWR ID	DWR_LD0003_01_s_2012_4				
Action/Comments					
Thin trees to allow visibility of the ground and room to flood fight.

View of the trees along the slope.

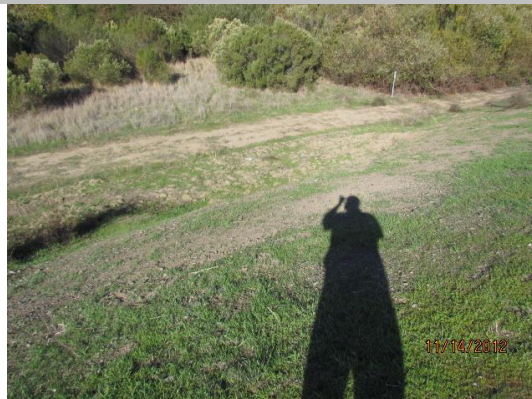
Photo 1 of 1 : FA_2014_LD0003_27_6_20141013_00004.jpg

LM Start	11.29	Rating **	M	Issue No.	6
LM End	11.29	Issue Type +	Ma	Location *	WS
Category	Earthen Levee			GPS Latitude/Longitude	
				Start	End
Item	Slope Stability			39.522921 °	39.522921 °
				-121.979172 °	-121.979172 °
DWR ID	DWR_LD0003_01_f_2012_6				
Action/Comments					
Repair slope instability.

View of the vertical cut along the w/s toe.
