**Flood Control Project Maintenance
Levee Inspections**

Fall 2015 Levee Maintenance Deficiency Summary Report

Sacramento River Basin

Levee District No. 0003 (Glenn County)

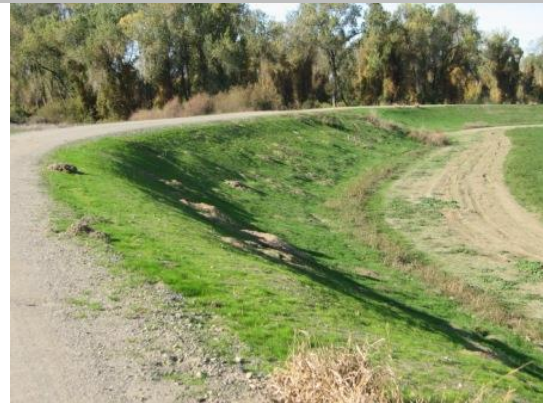
Photo 1 of 1 : FA_2015_LD0003_27_3_20150910_00002.jpg

View of squirrel holes along the slope.

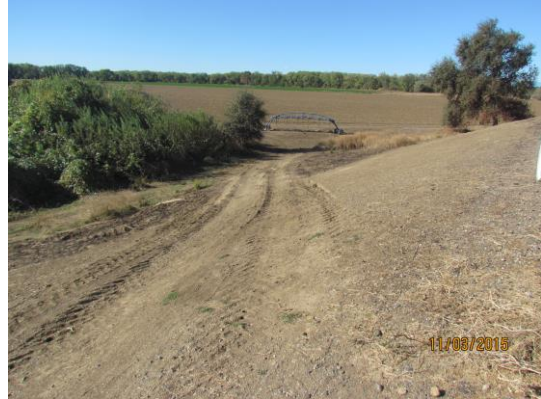
Photo 1 of 1 : FA_2015_LD0003_27_44_20151118_00049.jpg

LM Start	0.78	Rating **	M	Issue No.	44
LM End	0.78	Issue Type +	Ma	Location *	WS
Category	Earthen Levee			GPS Latitude/Longitude	
				Start	End
Item	Slope Stability			39.388440 °	39.388440 °
				-121.999175 °	-121.999175 °
DWR ID	DWR_LD0003_01_f_2015_44				
Action/Comments					
Repair the levee slope damaged by vehicle traffic and prevent access where possible.					
Inspector Comments: Repair the waterside slope damage caused by vehicle traffic.

View of the vehicle erosion along the waterside slope.

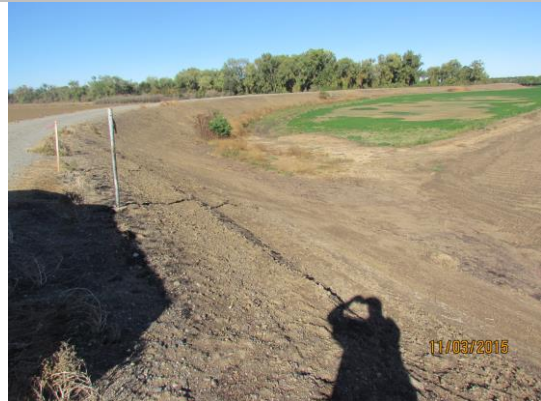
Photo 1 of 1 : FA_2015_LD0003_27_49_20151118_00050.jpg

LM Start	0.79	Rating **	M	Issue No.	49
LM End	0.79	Issue Type +	Ma	Location *	LS
Category	Earthen Levee			GPS Latitude/Longitude	
				Start	End
Item	Slope Stability			39.388508 °	39.388508 °
				-121.999407 °	-121.999407 °
DWR ID	DWR_LD0003_01_f_2015_49				
Action/Comments					
Repair the levee slope damaged by vehicle traffic and prevent access where possible.					
Inspector Comments: Repair the landside slope damaged by vehicle traffic.

View of the landside slope erosion caused by vehicle traffic.

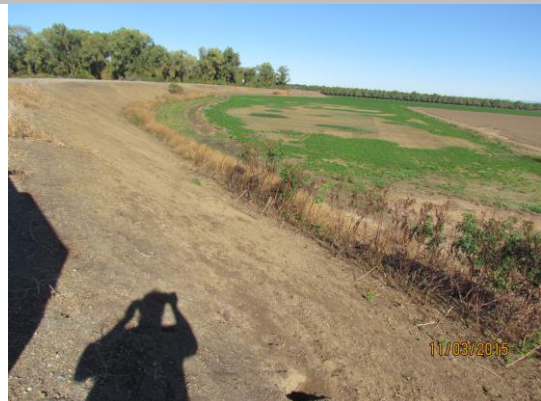
Photo 1 of 1 : FA_2015_LD0003_27_51_20151118_00051.jpg

LM Start	0.81	Rating **	U	Issue No.	51
LM End	0.91	Issue Type +	Ma	Location *	LS
Category	Earthen Levee			GPS Latitude/Longitude	
				Start	End
Item	Animal Control			39.388690 °	39.389867 °
				-121.999820 °	-122.000585 °
DWR ID	DWR_LD0003_01_f_2015_51				
Action/Comments					
No rodents visible, but rodent burrows visible; need to backfill and compact or grout burrows.					
Inspector Comments: Repair the rodent holes along the landside slope.

View of the rodent holes along the landside slope.

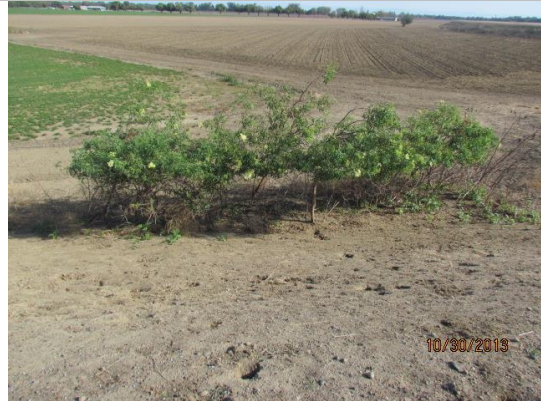
Photo 1 of 1 : FA_2015_LD0003_27_67_20150910_00033.jpg

View of the elderberries along the landside toe.

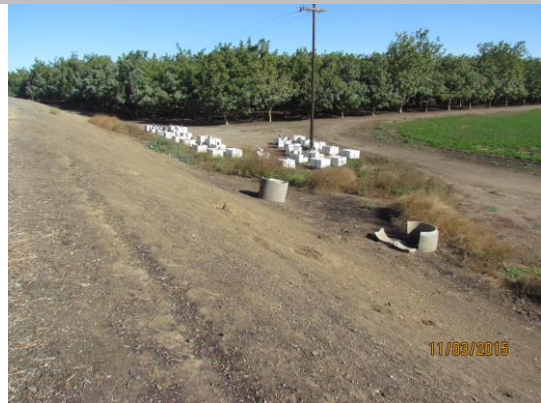
Photo 1 of 1 : FA_2015_LD0003_27_52_20151118_00052.jpg

LM Start	1.21	Rating **	M	Issue No.	52
LM End	1.21	Issue Type +	Ma	Location *	LS
Category	Earthen Levee			GPS Latitude/Longitude	
				Start	End
Item	Animal Control			39.394010 °	39.394010 °
				-122.000977 °	-122.000977 °
DWR ID	DWR_LD0003_01_f_2015_52				
Action/Comments					
No rodents visible, but rodent burrows visible; need to backfill and compact or grout burrows. Inspector Comments: Repair the rodent holes along the landside slope.

View of the rodent holes along the landside slope.

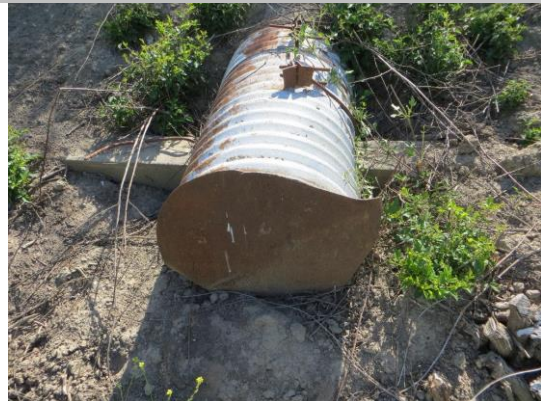
Photo 2 of 3 : UCIP_FA_2015_0968.jpg

Inspector Comments: FS_ID:14573
 DS_ID:18830
 EP_NO: 9930
 FS_HLM: 1.496
 Repair Type: Non-Urgent
 Crossing Status: Found
 UCIP Comments: Steel plate welded over WS end of pipe. Slide gate at WS toe missing. Appears abandoned.
 FIELD_STRUCT_DESC: 24-inch corrugated metal pipe through the levee 14.5 feet below the crown slide gate on waterward end, 7'X9' concrete diversion box at landward toe (ABO No. 9930-Steel Ranch). Originally included in O+M manual (1960).
 FS Date: 06/04/2013

Steel plate welded over end of pipe on WS toe.

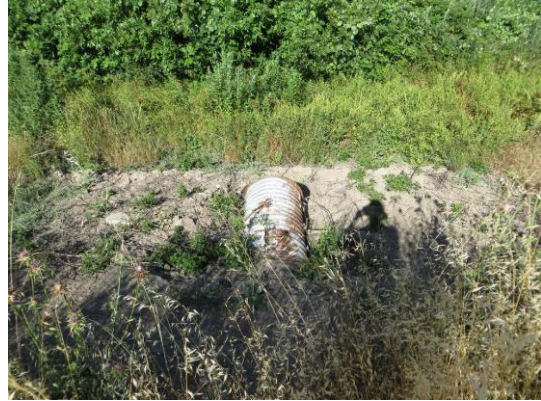
Photo 3 of 3 : UCIP_FA_2015_0969.jpg

LM Start	1.47	Rating **	M	Issue No.	83 (cont)
LM End	1.47	Issue Type +	En	Location *	WS
Category	Supplemental			GPS Latitude/Longitude	
				Start	End
Item	DWR UCIP Field Study			39.397780 °	39.397780 °
				-122.002074 °	-122.002074 °
DWR ID					
Action/Comments					
Inspector Comments: FS_ID:14573					
DS_ID:18830					
EP_NO: 9930					
FS_HLM: 1.496					
Repair Type: Non-Urgent					
Crossing Status: Found

24-inch CMP stormdrain on WS toe.

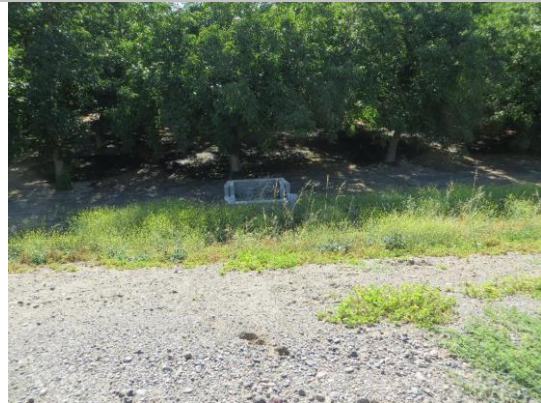
Photo 1 of 2 : UCIP_FA_2015_0970.jpg

LM Start	1.58	Rating **	M	Issue No.	84
LM End	1.58	Issue Type +	En	Location *	WS
Category	Supplemental			GPS Latitude/Longitude	
				Start	End
Item	DWR UCIP Field Study			39.399330 °	39.399330 °
				-122.002402 °	-122.002402 °
DWR ID					
Action/Comments					
Inspector Comments: FS_ID:14576					
DS_ID:18823					
EP_NO: 9931					
FS_HLM: 1.606					
Repair Type: Non-Urgent					
Crossing Status: Found					
UCIP Comments: Appears abandoned. Pipe buried at slide gate on WS toe.					
FIELD_STRUCT_DESC: 24-inch corrugated metal pipe through the levee 15.0 feet below the crown, slide gate on waterward end. 6'X7' concrete distribution box on LS toe. (ABO No. 9931-L. F. Steel).					
Originally included in the O+M manual (1960).					
FS Date: 06/04/2013

Concrete distribution box at LS toe.

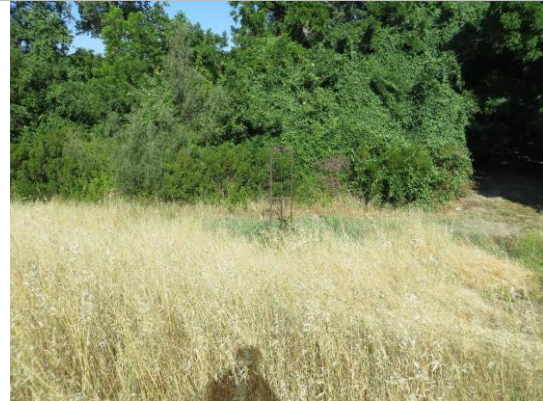
Photo 2 of 2 : UCIP_FA_2015_0971.jpg

Action/Comments					
Inspector Comments: FS_ID:14576 DS_ID:18823 EP_NO: 9931 FS_HLM: 1.606 Repair Type: Non-Urgent Crossing Status: Found UCIP Comments: Appears abandoned. Pipe buried at slide gate on WS toe. FIELD_STRUCT_DESC: 24-inch corrugated metal pipe through the levee 15.0 feet below the crown, slide gate on waterward end. 6'X7' concrete distribution box on LS toe. (ABO No. 9931-L. F. Steel). Originally included in the O+M manual (1960). FS Date: 06/04/2013

Slide gate at WS toe.

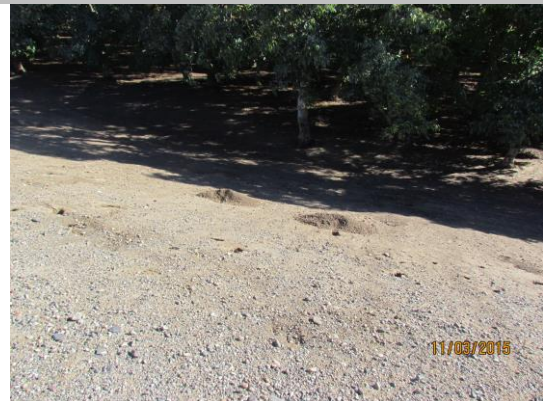
Photo 1 of 1 : FA_2015_LD0003_27_15_20151118_00053.jpg

LM Start	1.73	Rating **	U	Issue No.	15
LM End	2.41	Issue Type +	Ma	Location *	LS
Category	Earthen Levee			GPS Latitude/Longitude	
				Start	End
Item	Animal Control			39.401452 °	39.406557 °
				-122.002132 °	-121.995052 °
DWR ID	DWR_LD0003_01_s_2012_15

View of the rodent holes along the landside slope.

Action/Comments					
No rodents visible, but rodent burrows visible; need to backfill and compact or grout burrows. Inspector Comments: Repair the rodent holes along the landside slope.

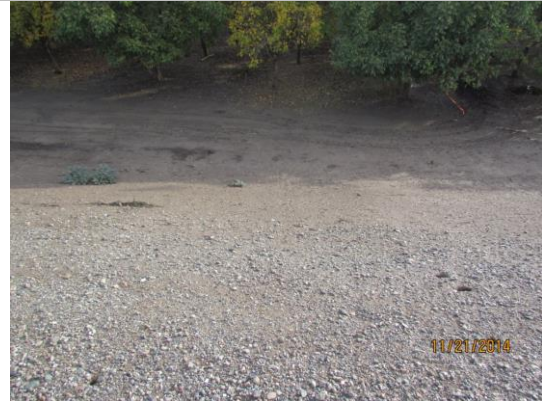
Photo 1 of 1 : FA_2015_LD0003_27_13_20150910_00008.jpg

View of the rodent holes along the waterside slope.

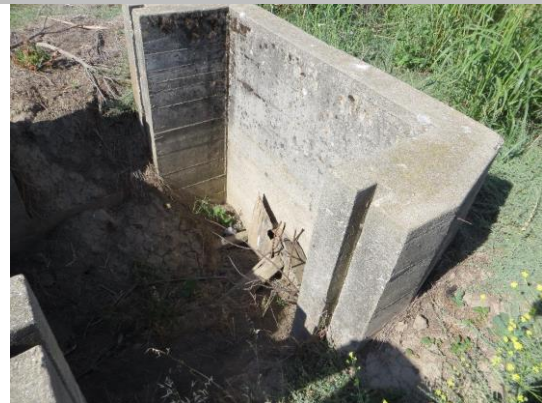
Photo 1 of 3 : UCIP_FA_2015_0972.jpg

LM Start	1.87	Rating **	M	Issue No.	85
LM End	1.87	Issue Type +	En	Location *	WS
Category	Supplemental			GPS Latitude/Longitude	
				Start	End
Item	DWR UCIP Field Study			39.403419 °	39.403419 °
				-122.001871 °	-122.001871 °
DWR ID					
Action/Comments					
Inspector Comments: FS_ID:14577					
DS_ID:18825					
EP_NO: 9935					
FS_HLM: 1.895					
Repair Type: Non-Urgent					
Crossing Status: Found					
UCIP Comments: Appears abandoned. Pipe buried on WS toe.					
Debris and steel plate blocking inlet on LS.					
FIELD_STRUCT_DESC: 24-inch corrugated metal pipe through the					
levee and beneath the roadway 18.0 feet below the crown, slide gate on					
waterward end (ABO No. 9935-Watt). Originally included in the O+M					
manual (1960).					
FS Date: 06/04/2013

Debris and steel plate blocking inlet on LS toe.

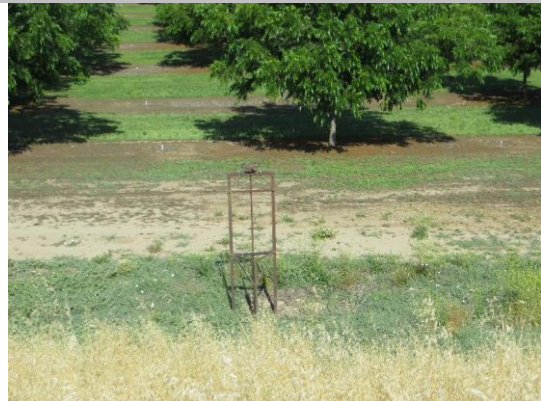
Photo 3 of 3 : UCIP_FA_2015_0974.jpg

Inspector Comments: FS_ID:14577
 DS_ID:18825
 EP_NO: 9935
 FS_HLM: 1.895
 Repair Type: Non-Urgent
 Crossing Status: Found
 UCIP Comments: Appears abandoned. Pipe buried on WS toe.
 Debris and steel plate blocking inlet on LS.
 FIELD_STRUCT_DESC: 24-inch corrugated metal pipe through the levee and beneath the roadway 18.0 feet below the crown, slide gate on waterward end (ABO No. 9935-Watt). Originally included in the O+M manual (1960).
 FS Date: 06/04/2013

Slide gate buried at WS toe.

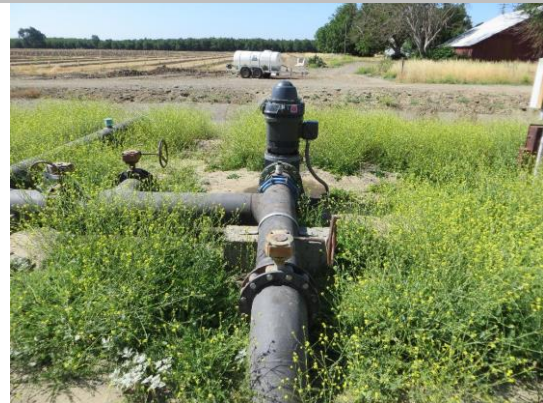
Photo 2 of 3 : UCIP_FA_2015_0655.jpg

LM Start	2.10	Rating **	M	Issue No.	86
LM End	2.10	Issue Type +	En	Location *	WS
Category	Supplemental			GPS Latitude/Longitude	
				Start	End
Item	DWR UCIP Field Study			39.406353 °	39.406353
				-122.000674 °	-122.000674
DWR ID					
Action/Comments					
Inspector Comments: FS_ID:15144 DS_ID:23151 EP_NO: N/A FS_HLM: 2.134 Repair Type: Non-Urgent Crossing Status: Found

Pump and butterfly valve off LS toe.

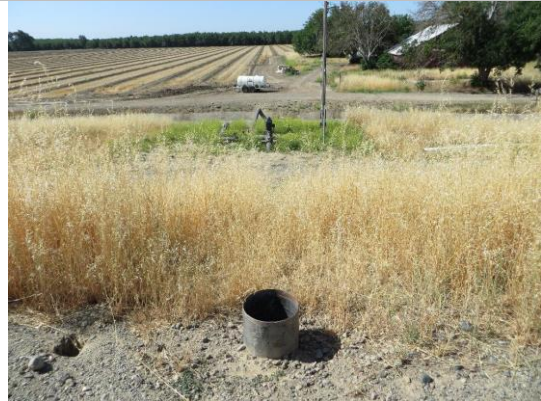
Photo 3 of 3 : UCIP_FA_2015_0656.jpg

LM Start	2.10	Rating **	M	Issue No.	86 (cont)
LM End	2.10	Issue Type +	En	Location *	WS
Category	Supplemental			GPS Latitude/Longitude	
				Start	End
Item	DWR UCIP Field Study			39.406353 °	39.406353
				-122.000674 °	-122.000674
DWR ID					
Action/Comments					
Inspector Comments: FS_ID:15144 DS_ID:23151 EP_NO: N/A FS_HLM: 2.134 Repair Type: Non-Urgent Crossing Status: Found

Siphon breaker in steel riser on LS shoulder with pump in background.

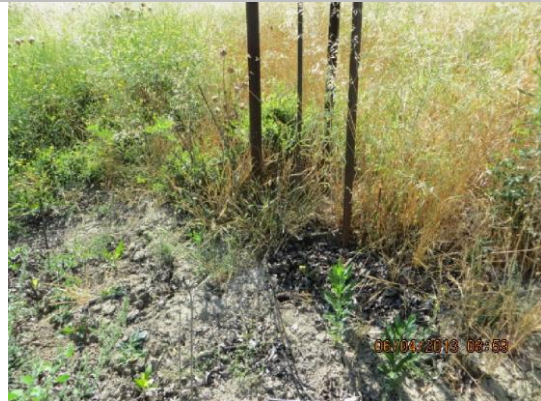
Photo 1 of 3 : UCIP_FA_2015_0975.jpg

LM Start	2.38	Rating **	M	Issue No.	87
LM End	2.38	Issue Type +	En	Location *	WS
Category	Supplemental			GPS Latitude/Longitude	
				Start	End
Item	DWR UCIP Field Study			39.406471 °	39.406471 °
				-121.995551 °	-121.995551 °
DWR ID					
Action/Comments					
Inspector Comments: FS_ID:14582					
DS_ID:18827					
EP_NO: 9936					
FS_HLM: 2.416					
Repair Type: Non-Urgent					
Crossing Status: Found					
UCIP Comments: Appears abandoned. Pipe buried on WS and blocked with tin and soil on the LS.					
FIELD_STRUCT_DESC: 24-inch corrugated metal pipe through the levee 18.3 feet below crown, slide gate on waterward end. 5-foot by 7-foot concrete distribution box at landward toe (ABO No. 9936-Watt). Originally included in the O+M manual (1960).					
FS Date: 06/04/2013

Slide gate at WS toe.

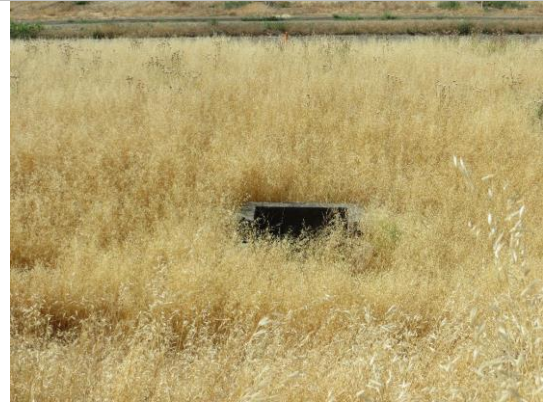
Photo 2 of 3 : UCIP_FA_2015_0976.jpg

Action/Comments					
Inspector Comments: FS_ID:14582 DS_ID:18827 EP_NO: 9936 FS_HLM: 2.416 Repair Type: Non-Urgent Crossing Status: Found UCIP Comments: Appears abandoned. Pipe buried on WS and blocked with tin and soil on the LS. FIELD_STRUCT_DESC: 24-inch corrugated metal pipe through the levee 18.3 feet below crown, slide gate on waterward end. 5-foot by 7-foot concrete distribution box at landward toe (ABO No. 9936-Watt). Originally included in the O+M manual (1960). FS Date: 06/04/2013

Concrete distribution box on LS toe.

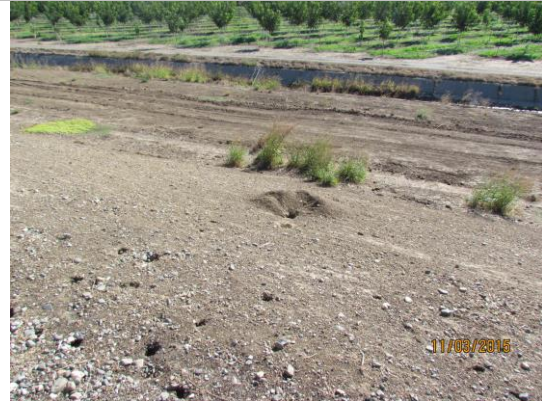
Photo 1 of 1 : FA_2015_LD0003_27_47_20151118_00054.jpg

LM Start	2.57	Rating **	U	Issue No.	47
LM End	2.57	Issue Type +	Ma	Location *	LS
Category	Earthen Levee			GPS Latitude/Longitude	
				Start	End
Item	Animal Control			39.407582 °	39.407582 °
				-121.992417 °	-121.992417 °
DWR ID	DWR_LD0003_01_f_2015_47				
Action/Comments					
No rodents visible, but rodent burrows visible; need to backfill and compact or grout burrows. Inspector Comments: Repair rodent hole on LS slope.

View of the rodent holes along the landside slope.

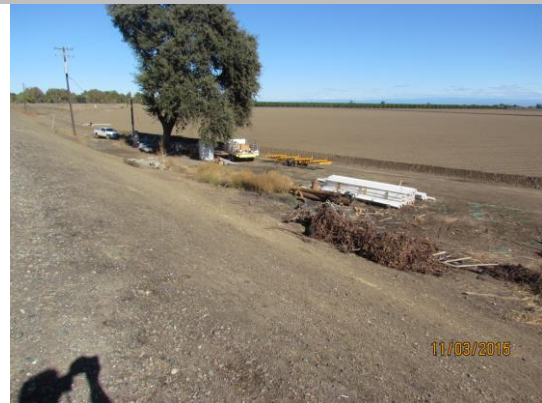
Photo 1 of 1 : FA_2015_LD0003_27_54_20151118_00055.jpg

LM Start	2.96	Rating **	U	Issue No.	54
LM End	3.09	Issue Type +	Ma	Location *	LS
Category	Earthen Levee			GPS Latitude/Longitude	
				Start	End
Item	Animal Control			39.412613 °	39.414392 °
				-121.991278 °	-121.992257 °
DWR ID	DWR_LD0003_01_f_2015_54				
Action/Comments					
Exterminate rodents and backfill and compact or grout burrows. Inspector Comments: Implement rodent control measures and repair rodent damage on LS slope.

View of the rodent holes along the landside slope.

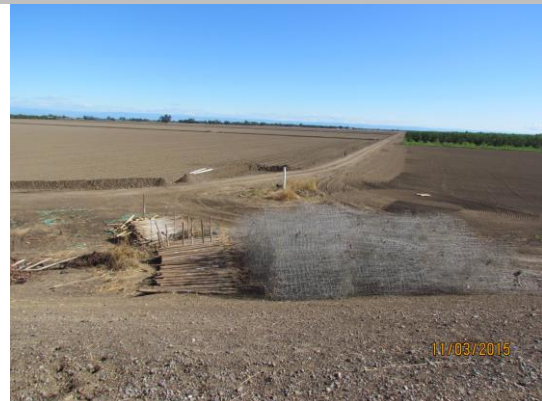
Photo 1 of 1 : FA_2015_LD0003_27_56_20151118_00056.jpg

View of the wire and tree stakes along the landside toe.

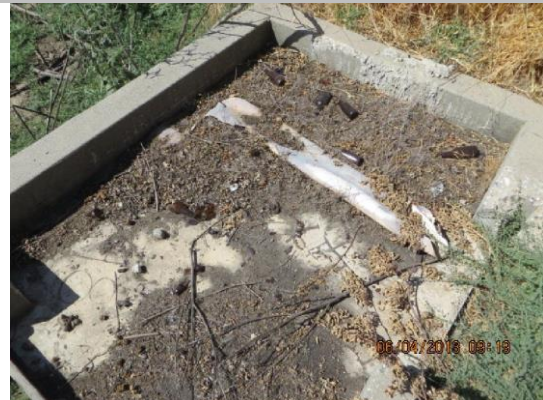
Photo 2 of 2 : UCIP_FA_2015_1058.jpg

Action/Comments					
Inspector Comments: FS_ID:14584 DS_ID:18829 EP_NO: 9919 FS_HLM: 3.027 Repair Type: Non-Urgent Crossing Status: Indicator Found UCIP Comments: Appears abandoned. Verify it was done correctly. FIELD_STRUCT_DESC: *Abandoned* 24-inch corrugated metal pipe through the levee 16.0 feet below the crown, slide gate on waterward end. 5'X7' concrete distribution box at LS toe is filled with grout (ABO No. 9919-Mills). Originally included in the O+M manual (1960) FS Date: 06/04/2013

5'X7' concrete distribution box filled in with grout.

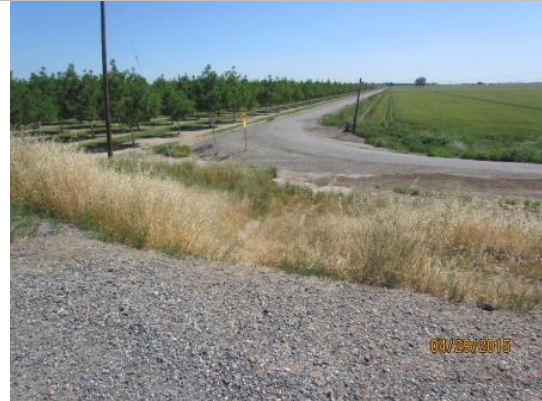
Photo 1 of 1 : FA_2015_LD0003_27_9_20150910_00006.jpg

LM Start	3.39	Rating **	M	Issue No.	9
LM End	3.39	Issue Type +	Ma	Location *	LS
Category	Earthen Levee			GPS Latitude/Longitude	
				Start	End
Item	Slope Stability			39.418382 °	39.418382
				-121.992480 °	-121.992480
DWR ID	DWR_LD0003_01_s_2012_9				
Action/Comments					
Repair the levee slope damaged by vehicle traffic and prevent access where possible.					
Inspector Comments: Repair the erosion along the landside slope and prevent vehicle access

View of the vehicle erosion along the landside slope.

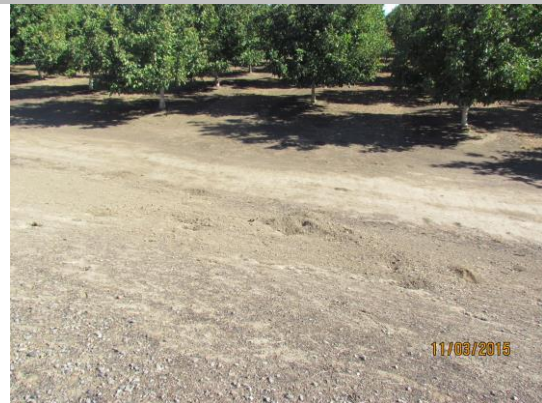
Photo 1 of 1 : FA_2015_LD0003_27_58_20151118_00057.jpg

LM Start	3.41	Rating **	U	Issue No.	58
LM End	3.48	Issue Type +	Ma	Location *	LS
Category	Earthen Levee			GPS Latitude/Longitude	
				Start	End
Item	Animal Control			39.418687 °	39.419762 °
				-121.992422 °	-121.992307 °
DWR ID	DWR_LD0003_01_f_2015_58				
Action/Comments					
No rodents visible, but rodent burrows visible; need to backfill and compact or grout burrows. Inspector Comments: Implement rodent control measures and repair rodent damage on LS slope.

View of the rodent. Holes along the landside slope.

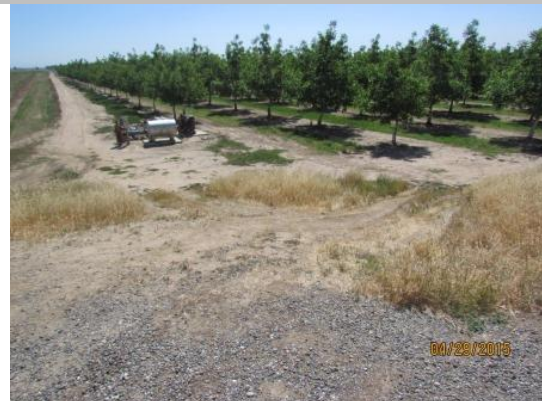
Photo 1 of 1 : FA_2015_LD0003_27_19_20150910_00010.jpg

LM Start	3.76	Rating **	M	Issue No.	19
LM End	3.76	Issue Type +	Ma	Location *	LS
Category	Earthen Levee			GPS Latitude/Longitude	
				Start	End
Item	Slope Stability			39.423747 °	39.423747 °
				-121.991667 °	-121.991667 °
DWR ID	DWR_LD0003_01_s_2012_19				
Action/Comments					
Repair the levee slope damaged by vehicle traffic and prevent access where possible.					
Inspector Comments: Repair the vehicle erosion on the landside slope.

View of the vehicle erosion along the landside slope.

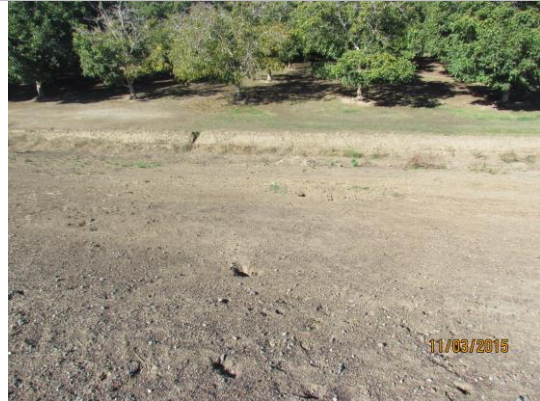
Photo 1 of 1 : FA_2015_LD0003_27_59_20151118_00058.jpg

LM Start	3.88	Rating **	U	Issue No.	59
LM End	3.88	Issue Type +	Ma	Location *	WS
Category	Earthen Levee			GPS Latitude/Longitude	
				Start	End
Item	Animal Control			39.425162 °	39.425162 °
				-121.990528 °	-121.990528 °
DWR ID	DWR_LD0003_01_f_2015_59				
Action/Comments					
No rodents visible, but rodent burrows visible; need to backfill and compact or grout burrows. Inspector Comments: Repair the rodent holes along the landside slope.

View of the rodent holes along the landside slope.

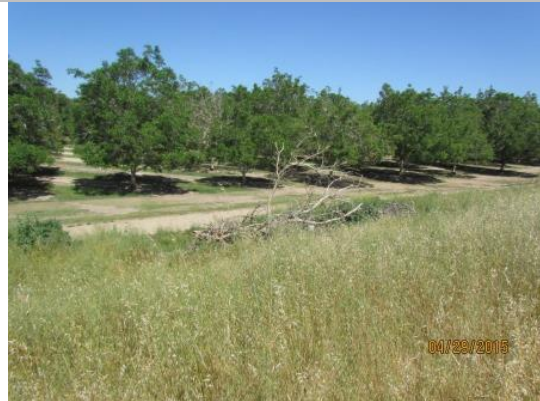
Photo 1 of 1 : FA_2015_LD0003_27_43_20150910_00021.jpg

View of the prunings along the waterside slope.

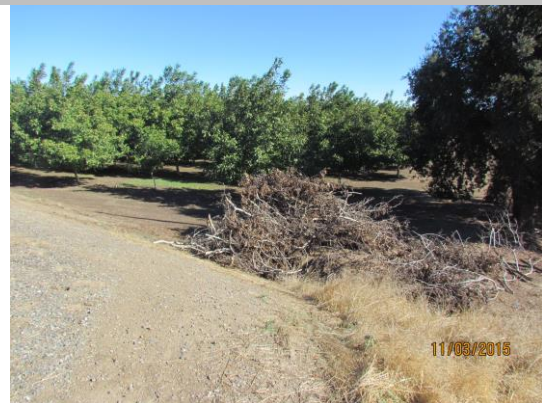
Photo 1 of 1 : FA_2015_LD0003_27_66_20151118_00061.jpg

View of the prunings along the landside toe.

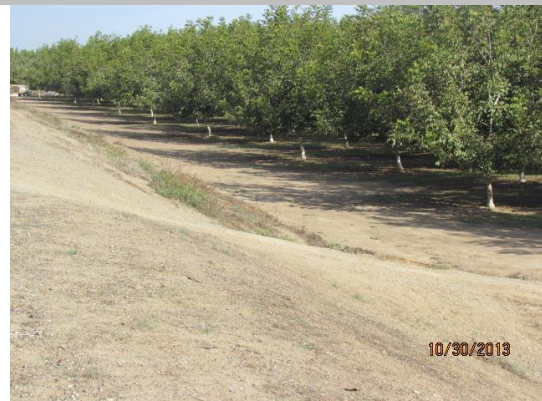
Photo 1 of 1 : FA_2015_LD0003_27_64_20150910_00031.jpg

LM Start	4.63	Rating **	U	Issue No.	64
LM End	4.68	Issue Type +	Ma	Location *	LS
Category	Earthen Levee			GPS Latitude/Longitude	
				Start	End
Item	Animal Control			39.435205 °	39.435855 °
				-121.988097 °	-121.988252 °
DWR ID	DWR_LD0003_01_f_2013_64				
Action/Comments					
No rodents visible, but rodent burrows visible; need to backfill and compact or grout burrows. Inspector Comments: Implement rodent control measures and repair rodent damage on LS slope.

View of the rodent activity along the landside slope.

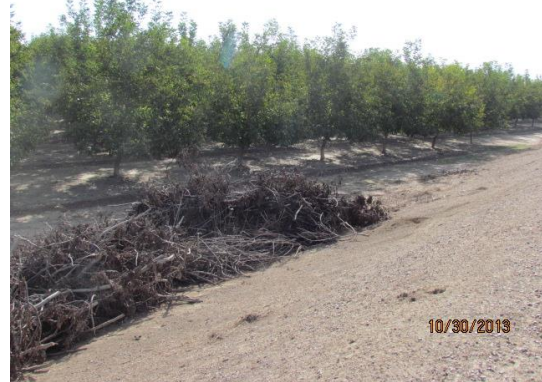
Photo 1 of 1 : FA_2015_LD0003_27_63_20150910_00030.jpg

View of the prunings along the landside toe.

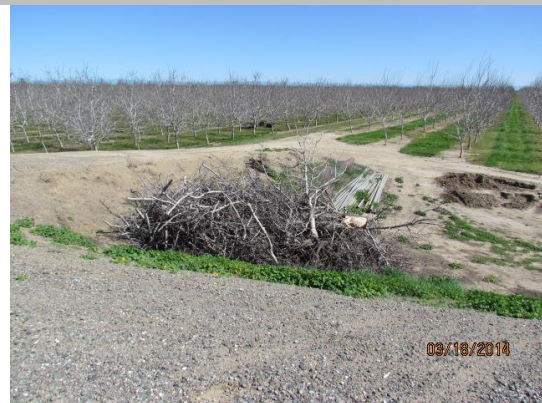
Photo 1 of 1 : FA_2015_LD0003_27_68_20150910_00034.jpg

View of the prunings along the l/s toe.

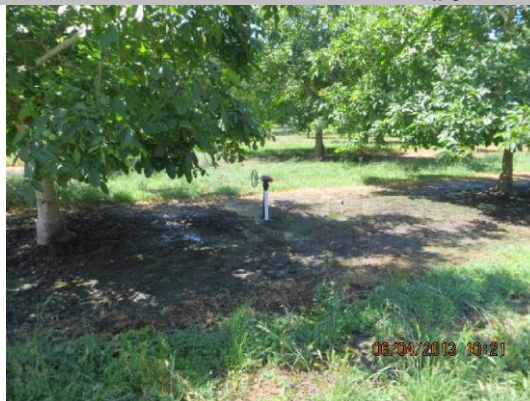
Photo 3 of 3 : UCIP_FA_2015_0659.jpg

Possible shutoff valve on WS toe.

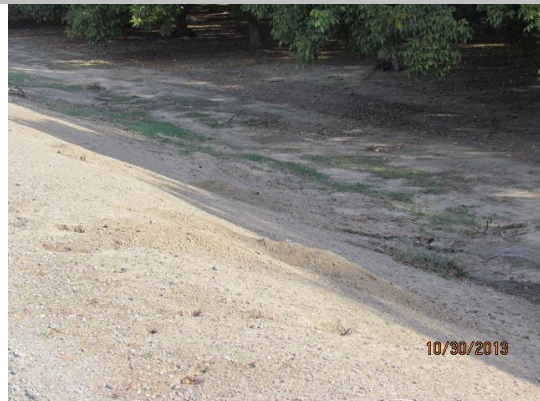
Photo 1 of 1 : FA_2015_LD0003_27_62_20150910_00029.jpg

View of the rodent holes along the landside slope.

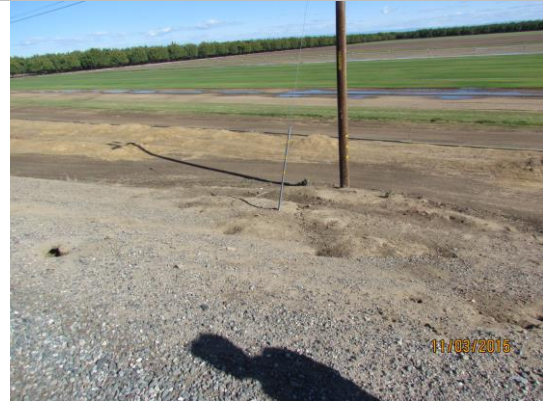
Photo 1 of 1 : FA_2015_LD0003_27_71_20151118_00065.jpg

View of the rodent holes along the landside slope.

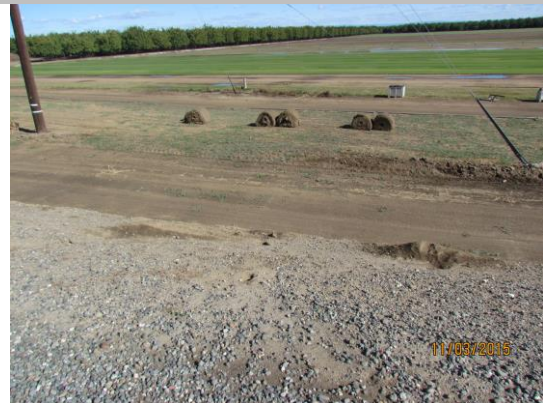
Photo 1 of 1 : FA_2015_LD0003_27_72_20151118_00066.jpg

View of the rodent holes along the landside slope.

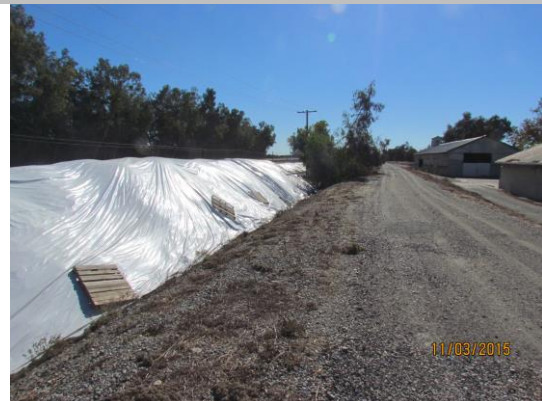
Photo 1 of 1 : FA_2015_LD0003_27_75_20151118_00069.jpg

View of the feed product stored along the landside toe.

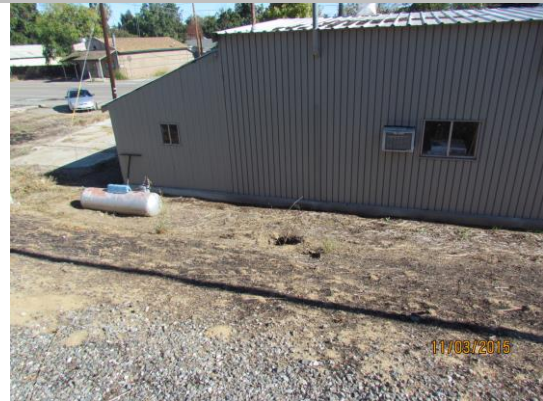
Photo 1 of 1 : FA_2015_LD0003_27_76_20151118_00070.jpg

View of the burned out stump hole along the landside toe.

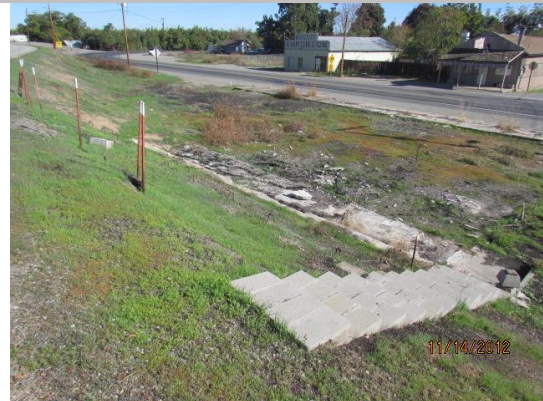
Photo 1 of 1 : FA_2015_LD0003_27_12_20150910_00007.jpg

View of concrete stairs & foundation along the slope of the levee.

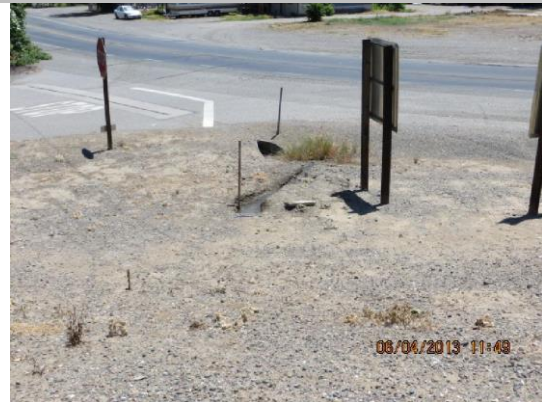
Photo 2 of 3 : UCIP_FA_2015_0874.jpg

Pipe leaking at LS toe.

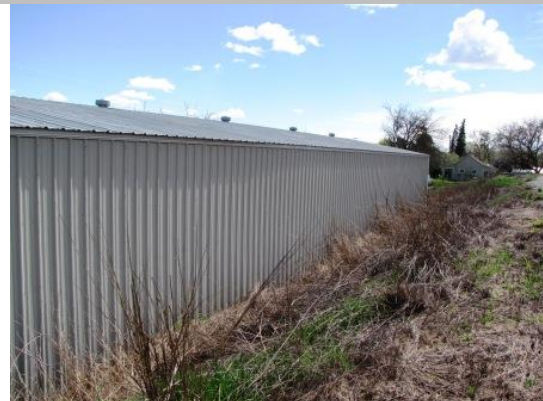
Photo 1 of 1 : FA_2015_LD0003_27_42_20150910_00020.jpg

View of the building along the L/S toe.

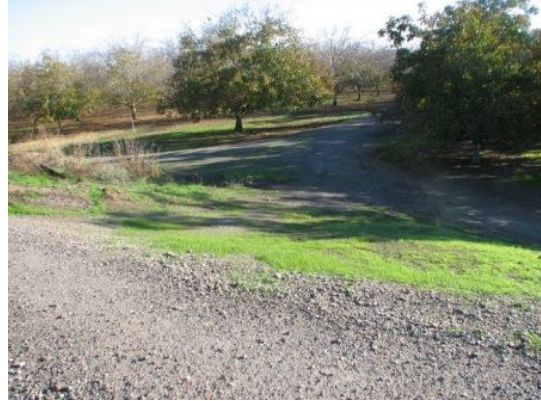
Photo 1 of 1 : FA_2015_LD0003_27_14_20150910_00009.jpg

Vehicle erosion along the slope.

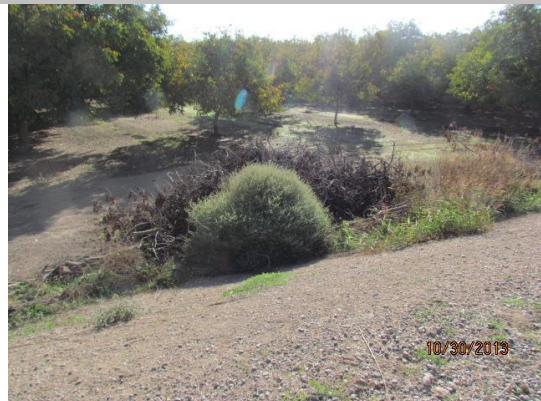
Photo 1 of 1 : FA_2015_LD0003_27_61_20150910_00028.jpg

View of the pruning along the landside toe.

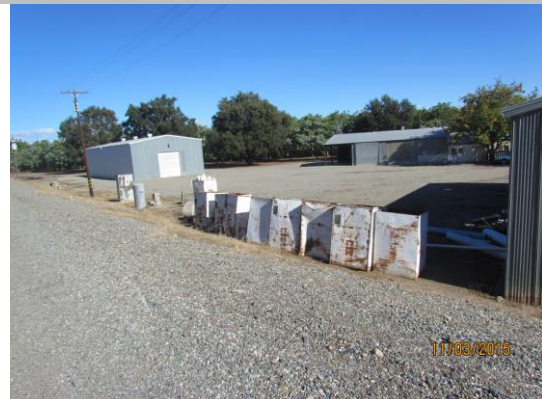
Photo 1 of 1 : FA_2015_LD0003_27_77_20151118_00071.jpg

View of the metal boxes along the landside toe.

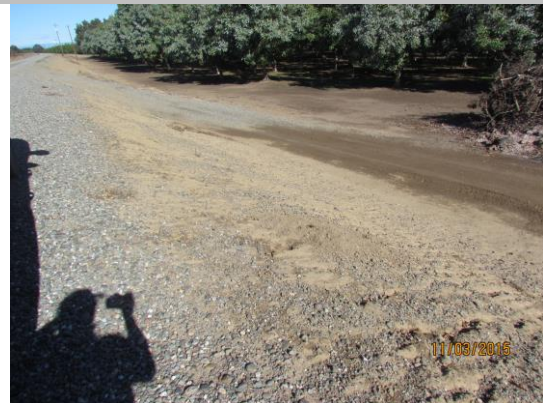
Photo 1 of 1 : FA_2015_LD0003_27_78_20151118_00074.jpg

View of the rodent holes along the landside slope.

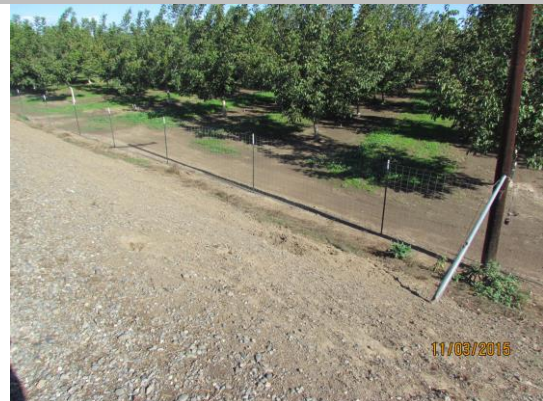
Photo 1 of 1 : FA_2015_LD0003_27_79_20151118_00075.jpg

View of the rodent holes along the landside slope.

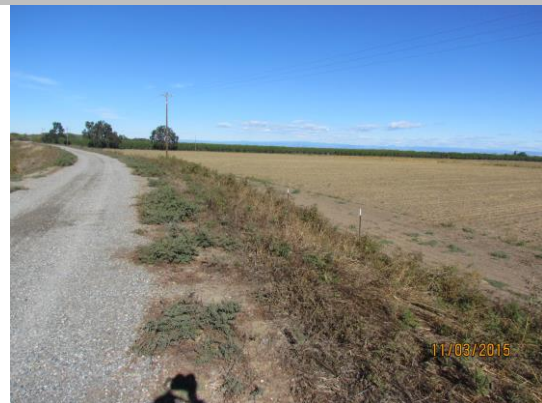
Photo 1 of 1 : FA_2015_LD0003_27_81_20151118_00078.jpg

View of the vegetation along the landside slope.

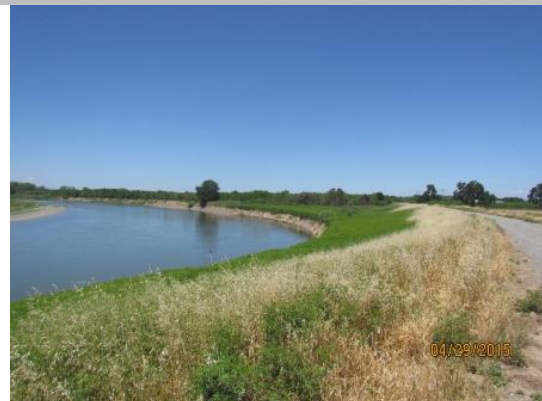
Photo 1 of 2 : FA_2015_LD0003_27_50_20150910_00024.jpg

View of erosion along the waterside toe. Same site as the USACE erosion issue.

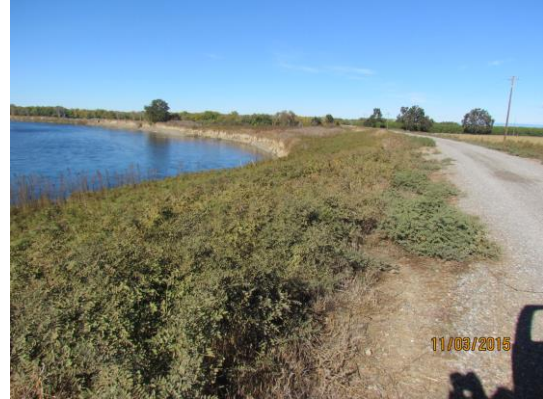
Photo 2 of 2 : FA_2015_LD0003_27_50_20151118_00076.jpg

View of the erosion along the waterside toe. Same site as the USACE erosion issue.

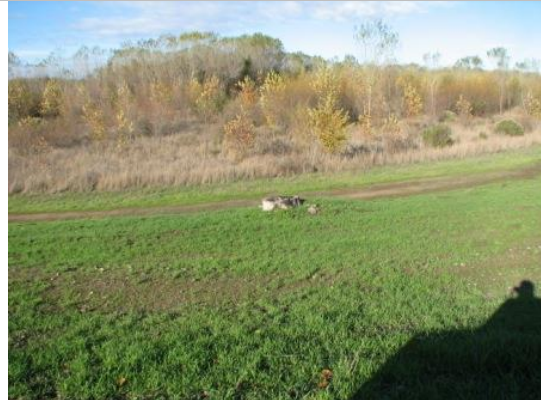
Photo 1 of 1 : FA_2015_LD0003_27_29_20150910_00016.jpg

View of the stump along the toe.

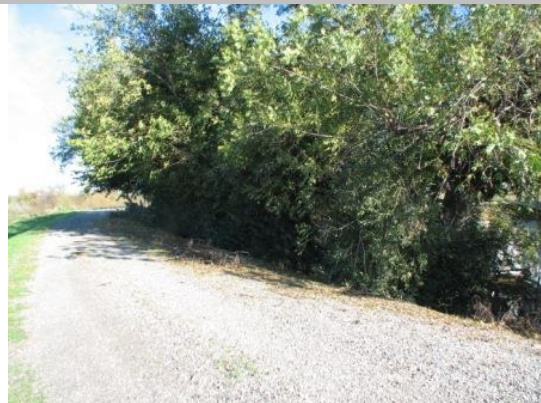
Photo 1 of 1 : FA_2015_LD0003_27_4_20150910_00003.jpg

View of the trees along the slope.

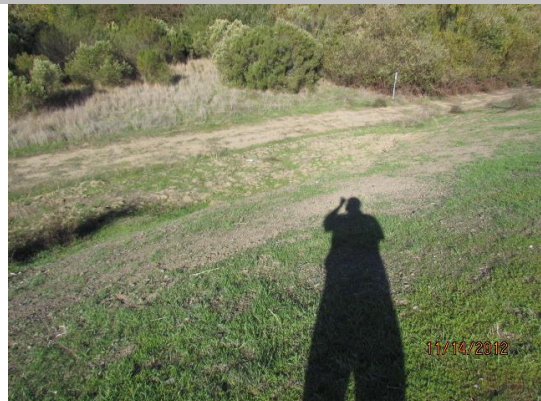
Photo 1 of 1 : FA_2015_LD0003_27_6_20150910_00004.jpg

View of the vertical cut along the w/s toe.
