**Flood Control Project Maintenance
Levee Inspections**

Fall 2016 Levee Maintenance Deficiency Summary Report

Levee District No. 0003 (Glenn County)

Fall 2016 Levee Inspection Results

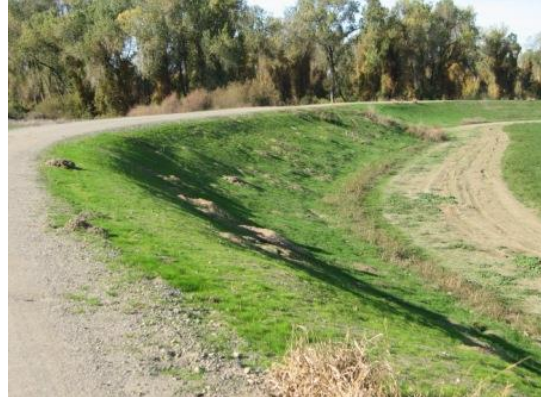
Photo 1 of 1 : FA_2016_LD0003_27_3_20160823_00001.jpg

View of squirrel holes along the landside slope.

LM Start	0.78	Rating **	C	Issue No.	44
LM End	0.78	Issue Type +	Ma	Location *	WS
Category	Earthen Levee			GPS Latitude/Longitude	
				Start	End
Item	Slope Stability			39.388440 °	39.388440 °
				-121.999175 °	-121.999175 °
DWR ID	DWR_LD0003_01_f_2015_44				
Comment Code					
S3 : Repair the levee slope damaged by vehicle traffic and prevent access where possible.					
Inspector Comment

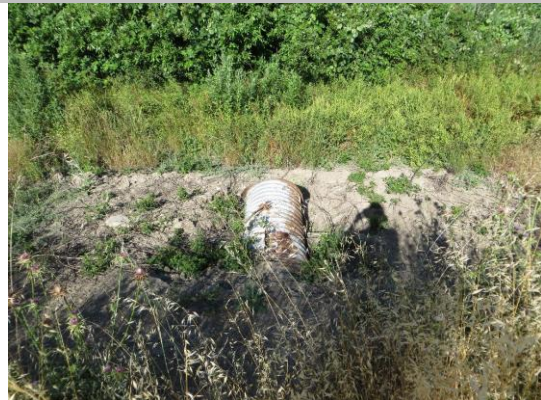
Photo 1 of 2 : UCIP_FA_2016_14573_24038.jpg

LM Start	1.47	Rating **	M	Issue No.	113
LM End	1.47	Issue Type +	En	Location *	WS
Category	Supplemental			GPS Latitude/Longitude	
				Start	End
Item	DWR UCIP Field Study			39.397780 °	39.397780 °
				-122.002074 °	-122.002074 °
DWR ID					
Comment Code					
Inspector Comment					
FS_ID:14573					
DS_ID:18830					
EP_NO: 9930					
Repair Type: Non-Urgent					
Crossing Status: Found					
UCIP Comments: Steel plate welded over WS end of pipe. Slide gate at WS toe missing. Appears abandoned.					
FIELD_STRUCT_DESC: 24-inch corrugated metal pipe through the levee 14.5 feet below the crown slide gate on waterward end, 7'X9' concrete diversion box at landward toe (ABO No. 9930-Steel Ranch). Originally included in O+M manual (1960).					
FS Date: 6/4/2013

24-inch CMP stormdrain on WS toe.

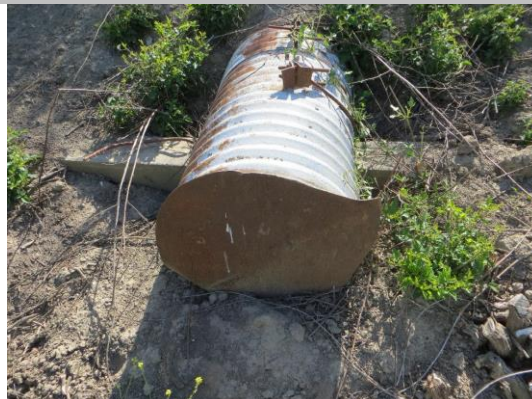
Photo 2 of 2 : UCIP_FA_2016_14573_24037.jpg

LM Start	1.47	Rating **	M	Issue No.	113 (cont)
LM End	1.47	Issue Type +	En	Location *	WS
Category	Supplemental			GPS Latitude/Longitude	
				Start	End
Item	DWR UCIP Field Study			39.397780 °	39.397780 °
				-122.002074 °	-122.002074 °
DWR ID					
Comment Code					
Inspector Comment					
FS_ID:14573					
DS_ID:18830					
EP_NO: 9930					
Repair Type: Non-Urgent					
Crossing Status: Found					
UCIP Comments: Steel plate welded over WS end of pipe. Slide gate at WS toe missing. Appears abandoned.					
FIELD_STRUCT_DESC: 24-inch corrugated metal pipe through the levee 14.5 feet below the crown slide gate on waterward end, 7'X9' concrete diversion box at landward toe (ABO No. 9930-Steel Ranch). Originally included in O+M manual (1960).					
FS Date: 6/4/2013

Steel plate welded over end of pipe on WS toe.

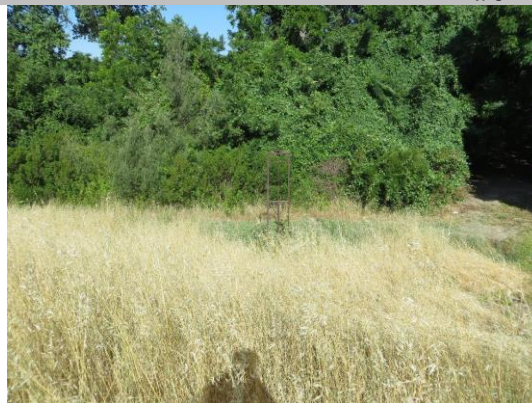
Photo 1 of 2 : UCIP_FA_2016_14576_24052.jpg

LM Start	1.58	Rating **	M	Issue No.	114
LM End	1.58	Issue Type +	En	Location *	WS
Category	Supplemental			GPS Latitude/Longitude	
				Start	End
Item	DWR UCIP Field Study			39.399330 °	39.399330 °
				-122.002402 °	-122.002402 °
DWR ID					
Comment Code					
Inspector Comment					
FS_ID:14576					
DS_ID:18823					
EP_NO: 9931					
Repair Type: Non-Urgent					
Crossing Status: Found					
UCIP Comments: Appears abandoned. Pipe burried at slide gate on WS toe.					
FIELD_STRUCT_DESC: 24-inch corrugated metal pipe through the levee 15.0 feet below the crown, slide gate on waterward end. 6'X7' concrete distribution box on LS toe. (ABO No. 9931-L. F. Steel).					
Originally included in the O+M manual (1960).					
FS Date: 6/4/2013

Slide gate at WS toe.

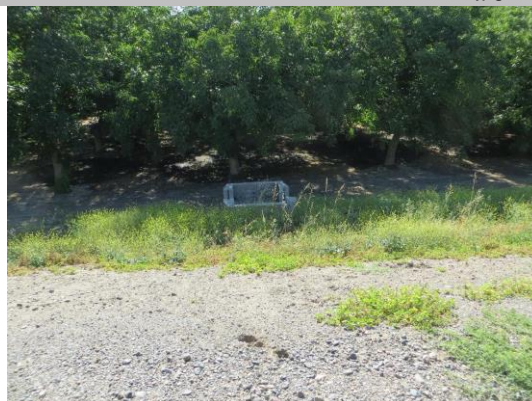
Photo 2 of 2 : UCIP_FA_2016_14576_24051.jpg

LM Start	1.58	Rating **	M	Issue No.	114 (cont)	
LM End	1.58	Issue Type +	En	Location *	WS	
Category	Supplemental			GPS Latitude/Longitude		
				Start	End	
Item	DWR UCIP Field Study			39.399330 °	39.399330 °	
				-122.002402 °	-122.002402 °	
DWR ID						
Comment Code						
Inspector Comment						
FS_ID:14576						
DS_ID:18823						
EP_NO: 9931						
Repair Type: Non-Urgent						
Crossing Status: Found						
UCIP Comments: Appears abandoned. Pipe burried at slide gate on WS toe.						
FIELD_STRUCT_DESC: 24-inch corrugated metal pipe through the levee 15.0 feet below the crown, slide gate on waterward end. 6'X7' concrete distribution box on LS toe. (ABO No. 9931-L. F. Steel).						
Originally included in the O+M manual (1960).						
FS Date: 6/4/2013

Concrete distribution box at LS toe.

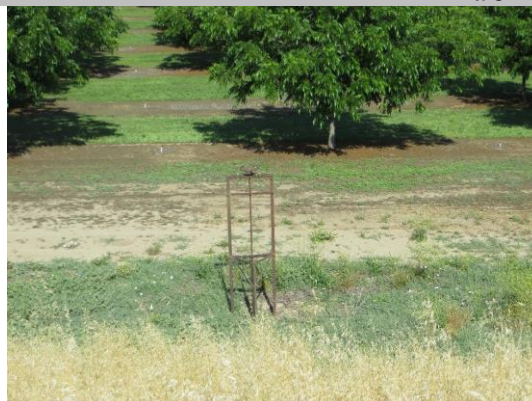
Photo 1 of 2 : UCIP_FA_2016_14577_24055.jpg

LM Start	1.87	Rating **	M	Issue No.	115
LM End	1.87	Issue Type +	En	Location *	WS
Category	Supplemental			GPS Latitude/Longitude	
				Start	End
Item	DWR UCIP Field Study			39.403419 °	39.403419 °
				-122.001871 °	-122.001871 °
DWR ID					
Comment Code					
Inspector Comment					
FS_ID:14577					
DS_ID:18825					
EP_NO: 9935					
Repair Type: Non-Urgent					
Crossing Status: Found					
UCIP Comments: Appears abandoned. Pipe buried on WS toe.					
Debris and steel plate blocking inlet on LS.					
FIELD_STRUCT_DESC: 24-inch corrugated metal pipe through the					
levee and beneath the roadway 18.0 feet below the crown, slide gate on					
waterward end (ABO No. 9935-Watt). Originally included in the O+M					
manual (1960).					
FS Date: 6/4/2013

Slide gate buried at WS toe.

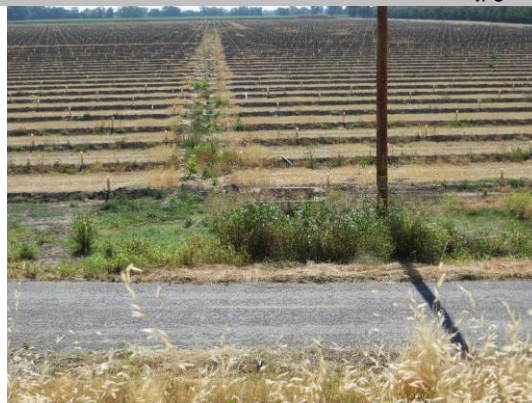
Photo 2 of 2 : UCIP_FA_2016_14577_24054.jpg

Concrete distribution box off LS toe.

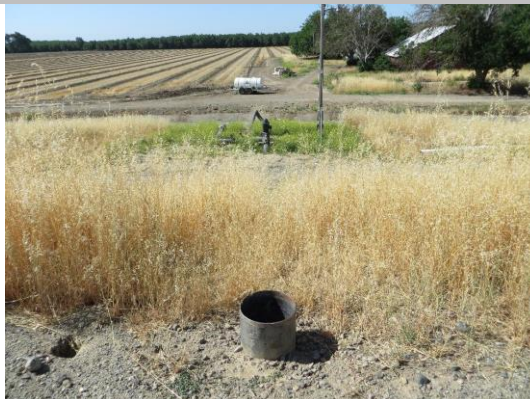
Photo 1 of 2 : UCIP_FA_2016_15144_24883.jpg

FS_ID:15144
DS_ID:23151
EP_NO: N/A
Repair Type: Non-Urgent
Crossing Status: Found
UCIP Comments: No permit identified for this crossing.
FIELD_STRUCT_DESC: 12-inch steel irrigation pipe through the levee 3.5-feet below the crown. Pump, butterfly valve, JP/meter at channel on LS toe. Siphon breaker in 12-inch steel riser on LS shoulder. 3-inch plastic drain on WS toe.
FS Date: 6/4/2013

Siphon breaker in steel riser on LS shoulder with pump in background.

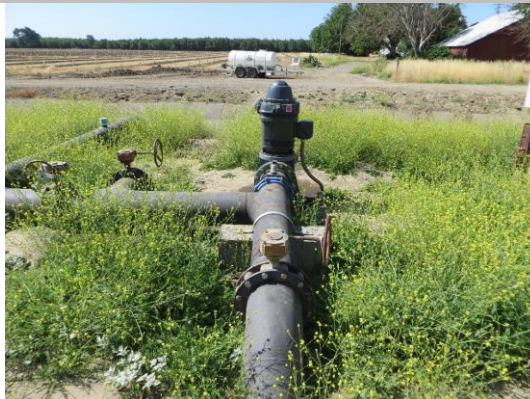
Photo 2 of 2 : UCIP_FA_2016_15144_24882.jpg

Pump and butterfly valve off LS toe.

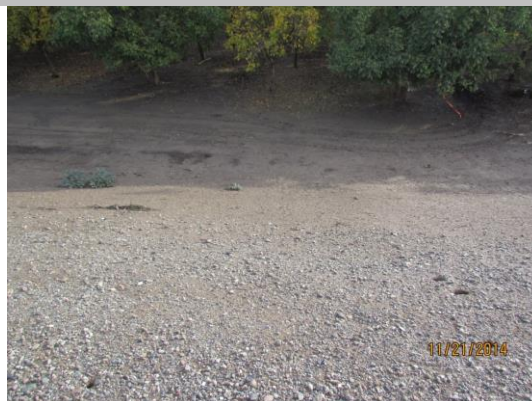
Photo 1 of 1 : FA_2016_LD0003_27_13_20160823_00010.jpg

View of the rodent holes along the waterside slope.

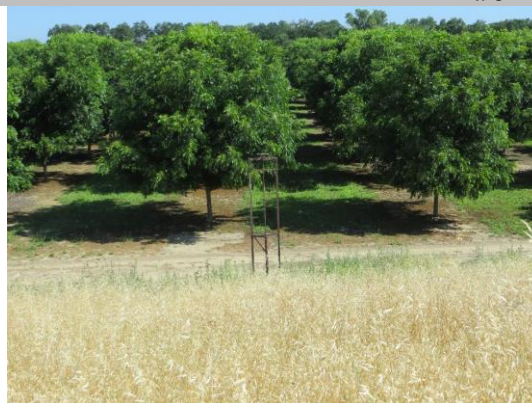
Photo 1 of 2 : UCIP_FA_2016_14582_24076.jpg

LM Start	2.38	Rating **	M	Issue No.	116
LM End	2.38	Issue Type +	En	Location *	WS
Category	Supplemental			GPS Latitude/Longitude	
				Start	End
Item	DWR UCIP Field Study			39.406471 °	39.406471 °
				-121.995551 °	-121.995551 °
DWR ID					
Comment Code					
Inspector Comment					
FS_ID:14582					
DS_ID:18827					
EP_NO: 9936					
Repair Type: Non-Urgent					
Crossing Status: Found					
UCIP Comments: Appears abandoned. Pipe buried on WS and blocked with tin and soil on the LS.					
FIELD_STRUCT_DESC: 24-inch corrugated metal pipe through the levee 18.3 feet below crown, slide gate on waterward end. 5-foot by 7-foot concrete distribution box at landward toe (ABO No. 9936-Watt). Originally included in the O+M manual (1960).					
FS Date: 6/4/2013

Slide gate at WS toe.

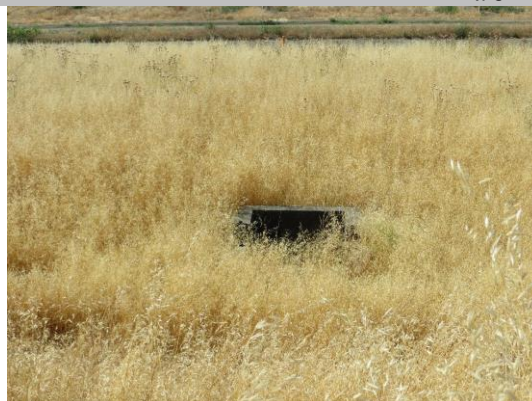
Photo 2 of 2 : UCIP_FA_2016_14582_24075.jpg

LM Start	2.38	Rating **	M	Issue No.	116 (cont)
LM End	2.38	Issue Type +	En	Location *	WS
Category	Supplemental			GPS Latitude/Longitude	
				Start	End
Item	DWR UCIP Field Study			39.406471 °	39.406471 °
				-121.995551 °	-121.995551 °
DWR ID					
Comment Code					
Inspector Comment					
FS_ID:14582					
DS_ID:18827					
EP_NO: 9936					
Repair Type: Non-Urgent					
Crossing Status: Found					
UCIP Comments: Appears abandoned. Pipe buried on WS and blocked with tin and soil on the LS.					
FIELD_STRUCT_DESC: 24-inch corrugated metal pipe through the levee 18.3 feet below crown, slide gate on waterward end. 5-foot by 7-foot concrete distribution box at landward toe (ABO No. 9936-Watt). Originally included in the O+M manual (1960).					
FS Date: 6/4/2013

Concrete distribution box on LS toe.

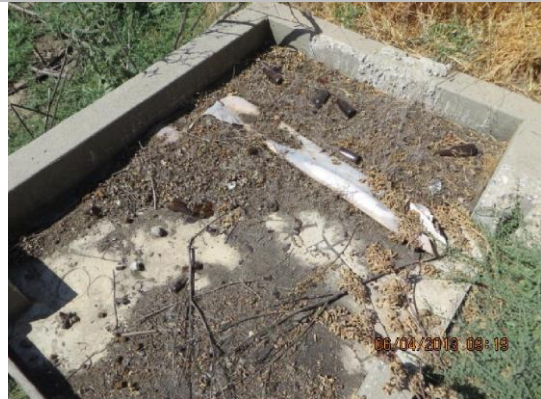
Photo 1 of 2 : UCIP_FA_2016_14584_24081.jpg

FS_ID:14584
DS_ID:18829
EP_NO: 9919
Repair Type: Non-Urgent
Crossing Status: Indicator Found
UCIP Comments: Appears abandoned. Verify it was done correctly.
FIELD_STRUCT_DESC: *Abandoned* 24-inch corrugated metal pipe through the levee 16.0 feet below the crown, slide gate on waterward end. 5'X7' concrete distribution box at LS toe is filled with grout (ABO No. 9919-Mills). Originally included in the O+M manual (1960)
FS Date: 6/4/2013

5'X7' concrete distribution box filled in with grout.

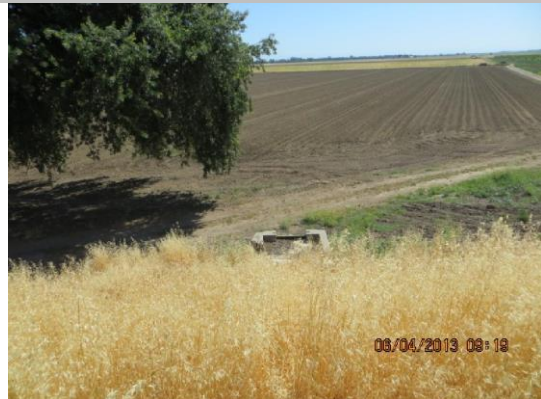
Photo 2 of 2 : UCIP_FA_2016_14584_24080.jpg

Distribution box on LS toe.

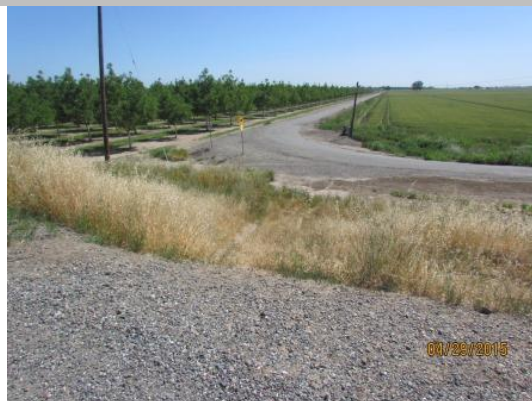
Photo 1 of 1 : FA_2016_LD0003_27_9_20160823_00005.jpg

LM Start	3.39	Rating **	M	Issue No.	9
LM End	3.39	Issue Type +	Ma	Location *	LS
Category	Earthen Levee			GPS Latitude/Longitude	
				Start	End
Item	Slope Stability			39.418382 °	39.418382 °
				-121.992480 °	-121.992480 °
DWR ID	DWR_LD0003_01_s_2012_9				
Comment Code					
S3 : Repair the levee slope damaged by vehicle traffic and prevent access where possible.					
Inspector Comment					
Repair the erosion along the landside slope and prevent vehicle access

View of the vehicle erosion along the landside slope.

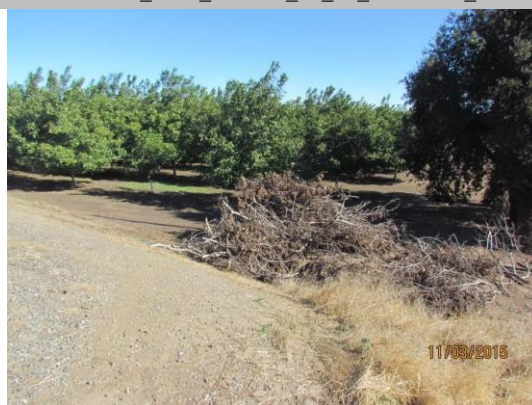
Photo 1 of 1 : FA_2016_LD0003_27_66_20160823_00044.jpg

View of the prunings along the landside toe.

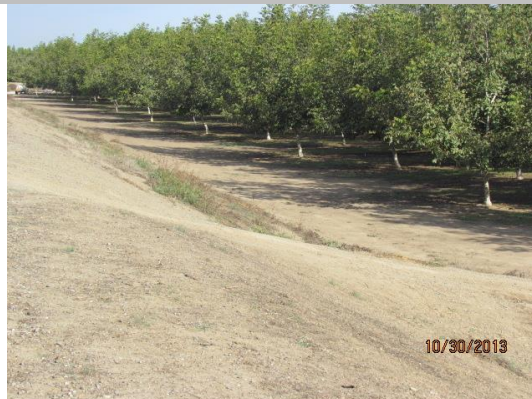
Photo 1 of 1 : FA_2016_LD0003_27_64_20160823_00042.jpg

View of the rodent activity along the landside slope.

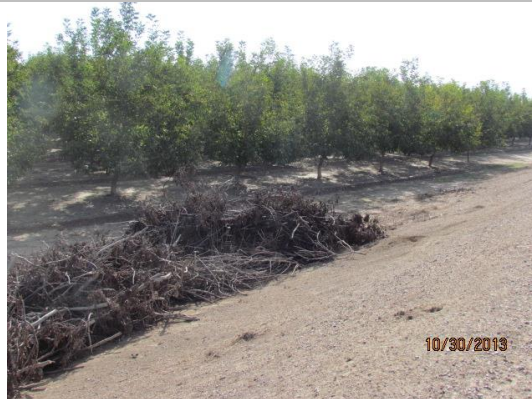
Photo 1 of 1 : FA_2016_LD0003_27_63_20160823_00041.jpg

LM Start	4.66	Rating **	M	Issue No.	63
LM End	4.66	Issue Type +	Ma	Location *	LS
Category	Earthen Levee			GPS Latitude/Longitude	
				Start	End
Item	Encroachments			39.435701 °	39.435701 °
				-121.988189 °	-121.988189 °
DWR ID	DWR_LD0003_01_f_2013_63				
Comment Code					
PR : Prunings					
Inspector Comment					
Remove the prunings from the landside toe.

View of the prunings along the landside toe.

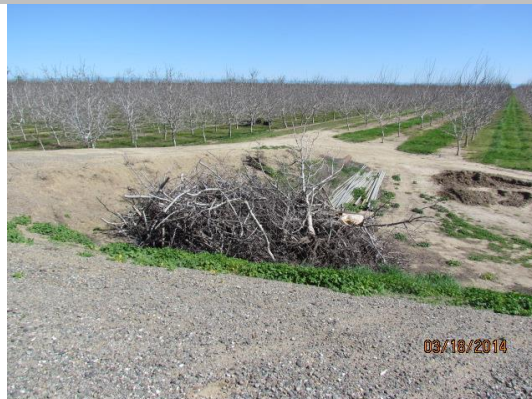
Photo 1 of 1 : FA_2016_LD0003_27_68_20160823_00045.jpg

View of the prunings along the landside toe.

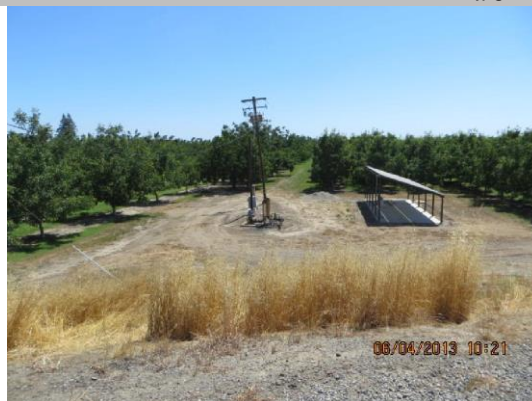
Photo 2 of 2 : UCIP_FA_2016_15163_24901.jpg

LM Start	4.96	Rating **	M	Issue No.	119 (cont)
LM End	4.96	Issue Type +	En	Location *	LS
Category	Supplemental			GPS Latitude/Longitude	
				Start	End
Item	DWR UCIP Field Study			39.439791 °	39.439791 °
				-121.989825 °	-121.989825 °
DWR ID					
Comment Code					
Inspector Comment					
FS_ID:15163 DS_ID:23152 EP_NO: N/A Repair Type: Non-Urgent Crossing Status: Found UCIP Comments: No permit identified for this crossing. FIELD_STRUCT_DESC: 4-inch steel irrigation pipe through the levee at an unknown depth. Pump, vent, and shutoff valve off LS toe. Possible shutoff valve off WS toe. FS Date: 6/4/2013

Pumping plant off LS toe.

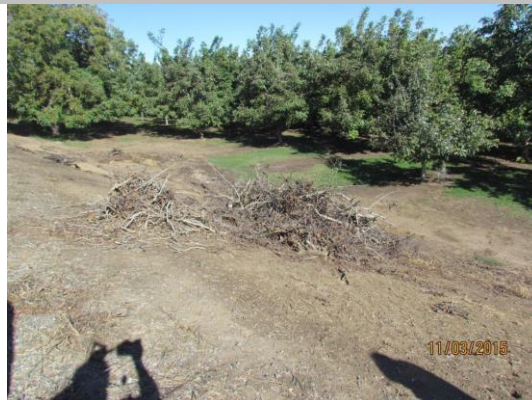
Photo 1 of 1 : FA_2016_LD0003_27_69_20160823_00046.jpg

LM Start	5.06	Rating **	M	Issue No.	69
LM End	5.06	Issue Type +	Ma	Location *	LS
Category	Earthen Levee			GPS Latitude/Longitude	
				Start	End
Item	Encroachments			39.441057 °	39.441057 °
				-121.990458 °	-121.990458 °
DWR ID	DWR_LD0003_01_f_2015_69				
Comment Code					
PR : Prunings					
Inspector Comment					
Remove the prunings from the landside slope.

View of the prunings along the landside slope.

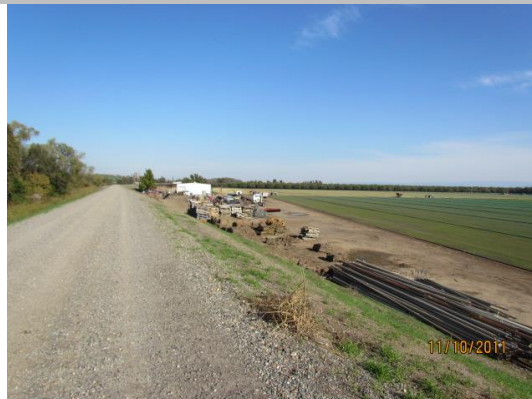
Photo 1 of 1 : FA_2016_LD0003_27_25_20160823_00016.jpg

View of the equipment along the landside toe.

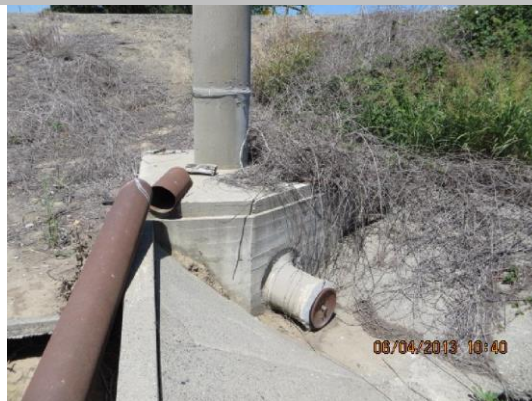
Photo 2 of 2 : UCIP_FA_2016_14643_24141.jpg

Concrete standpipe and channel on LS toe.

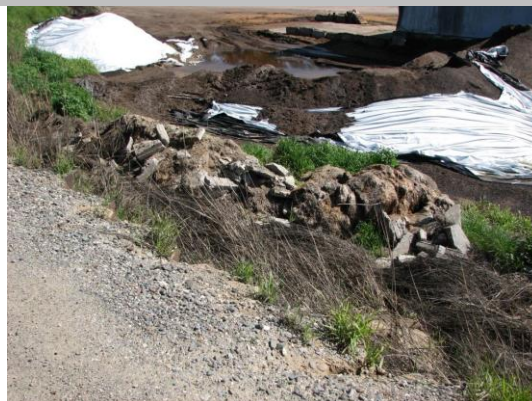
Photo 1 of 1 : FA_2016_LD0003_27_65_20160823_00043.jpg

LM Start	6.36	Rating **	U	Issue No.	65
LM End	6.36	Issue Type +	En	Location *	LS
Category	Earthen Levee			GPS Latitude/Longitude	
				Start	End
Item	Encroachments			39.459690 °	39.459690 °
				-121.993680 °	-121.993680 °
DWR ID	DWR_LD0003_01_s_2016_65				
Comment Code					
DE : Debris					
Inspector Comment					
broken concrete and soil

View of concrete and soil obstructing visibility and access.

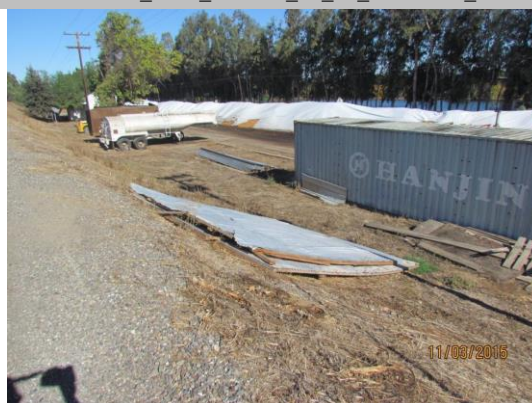
Photo 1 of 1 : FA_2016_LD0003_27_74_20160823_00051.jpg

View of the metal roof laying on the landside slope.

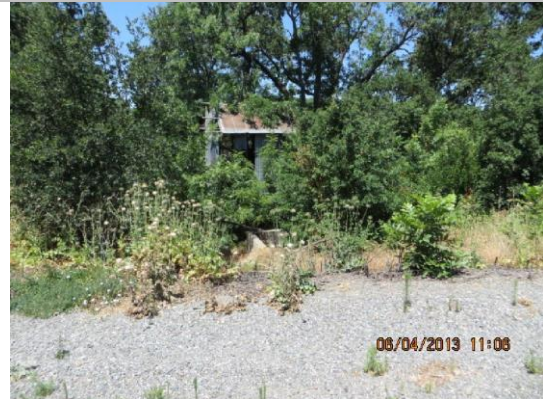
Photo 1 of 2 : UCIP_FA_2016_14664_24162.jpg

LM Start	6.54	Rating **	M	Issue No.	107
LM End	6.54	Issue Type +	En	Location *	LS
Category	Supplemental			GPS Latitude/Longitude	
				Start	End
Item	DWR UCIP Field Study			39.462146 °	39.462146 °
				-121.992832 °	-121.992832 °
DWR ID					
Comment Code					
Inspector Comment					
FS_ID:14664					
DS_ID:18834					
EP_NO: 9906					
Repair Type: Non-Urgent					
Crossing Status: Found					
UCIP Comments: Pipe appears to be abandoned and should be done so properly.					
FIELD_STRUCT_DESC: 24-inch steel pipe through levee 13.0 feet below crown, slide gate on waterward end, pump house on berm. Slide gate in 7'X12' concrete pit on waterward side with flap gate on pipe from pumphouse. Pipe discharges into irrigation ditch on landward side (ABO No. 9906-Clare). Originally included in O+M manual 1955.					
FS Date: 6/4/2013

Pumphouse and 7'X12' concrete box on WS slope.

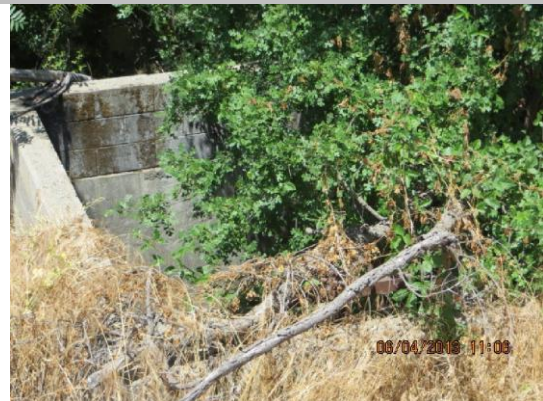
Photo 2 of 2 : UCIP_FA_2016_14664_24161.jpg

7'X12' Concrete box with flap gate and slide gate on WS slope.

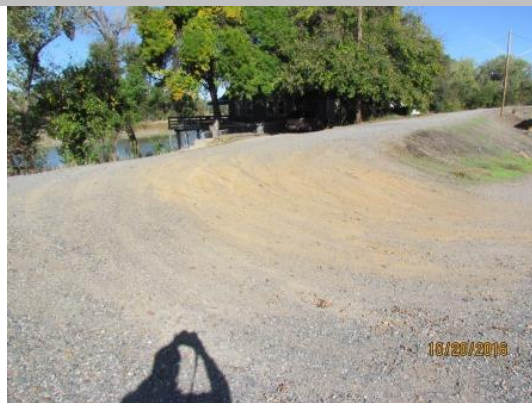
Photo 1 of 1 : FA_2016_LD0003_27_34_20161103_00103.jpg

LM Start	6.57	Rating **	M	Issue No.	34
LM End	6.57	Issue Type +	Ma	Location *	LS
Category	Earthen Levee			GPS Latitude/Longitude	
				Start	End
Item	Slope Stability			39.462505 °	39.462505 °
				-121.992698 °	-121.992698 °
DWR ID	DWR_LD0003_01_s_2012_34				
Comment Code					
S3 : Repair the levee slope damaged by vehicle traffic and prevent access where possible.					
Inspector Comment

View of slope instability caused by vehicle traffic.

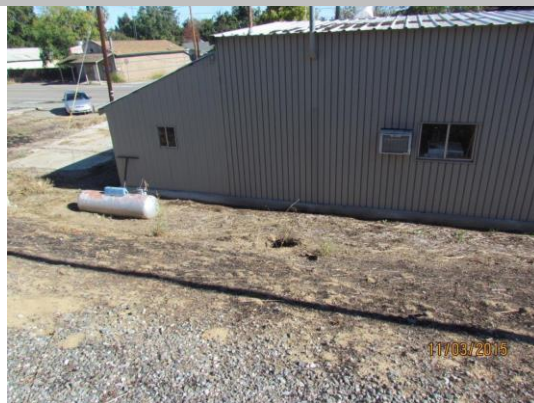
Photo 1 of 1 : FA_2016_LD0003_27_76_20160823_00053.jpg

LM Start	6.61	Rating **	U	Issue No.	76	
LM End	6.61	Issue Type +	Ma	Location *	LS	
Category	Earthen Levee			GPS Latitude/Longitude		
				Start		End
Item	Trim / Thin Trees			39.463185 °		39.463185 °
				-121.992657 °		-121.992657 °
DWR ID	DWR_LD0003_01_f_2015_76					
Comment Code						
T5 : Tree stumps.						
Inspector Comment						
Repair the burned out stump hole along the landside toe.

View of the burned out stump hole along the landside toe.

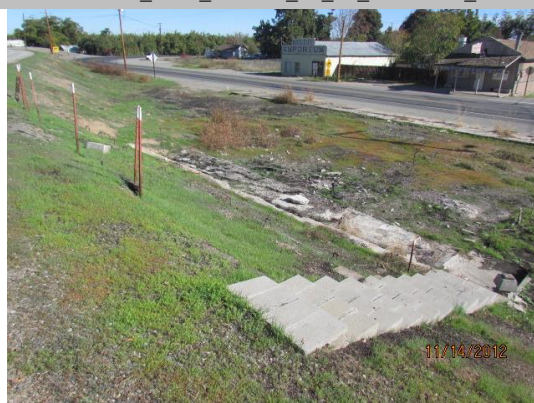
Photo 1 of 1 : FA_2016_LD0003_27_12_20160823_00009.jpg

View of concrete stairs & foundation along the slope of the levee.

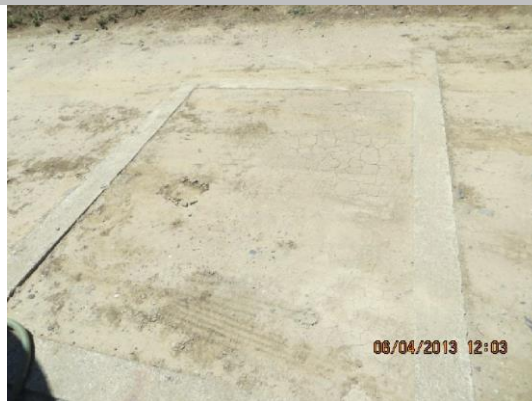
Photo 2 of 2 : UCIP_FA_2016_14686_24183.jpg

Soil filled concrete distribution box on LS toe.

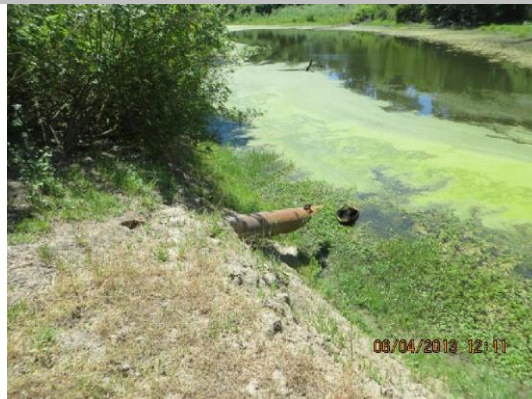
Photo 1 of 2 : UCIP_FA_2016_14687_24187.jpg

Pipe visible at pond off WS toe.

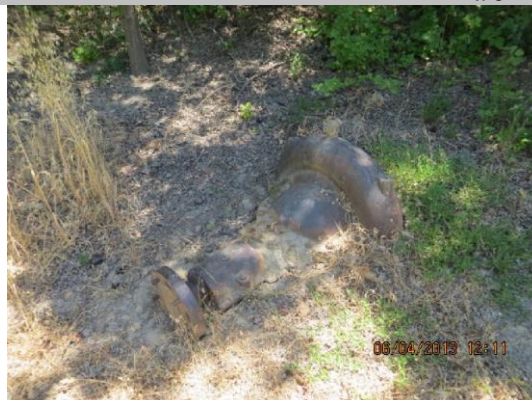
Photo 2 of 2 : UCIP_FA_2016_14687_24186.jpg

Pump visible off WS toe, next to pond.

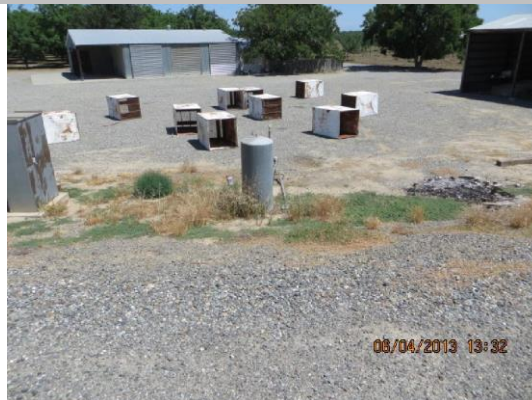
Photo 2 of 2 : UCIP_FA_2016_14688_24189.jpg

Water tank, pump, and well head on LS toe.

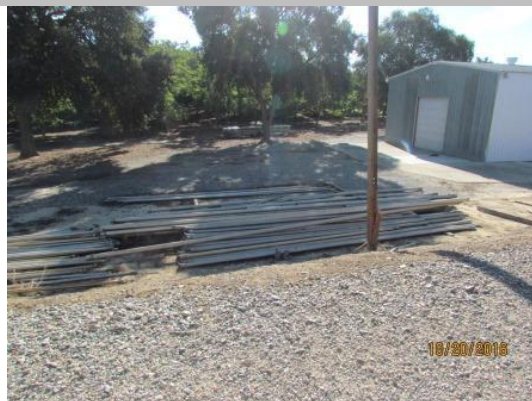
Photo 1 of 1 : FA_2016_LD0003_27_94_20161103_00109.jpg

View of the ag pipes along the landside toe.

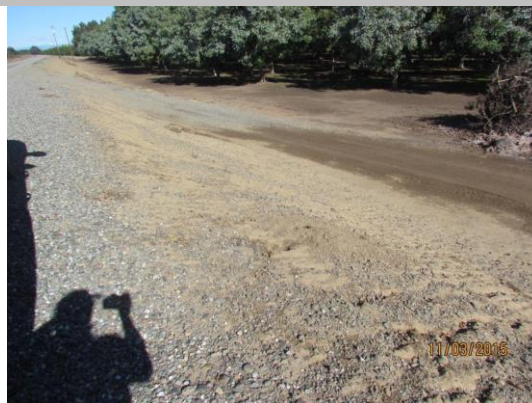
Photo 1 of 1 : FA_2016_LD0003_27_78_20160823_00055.jpg

View of the rodent holes along the landside slope.

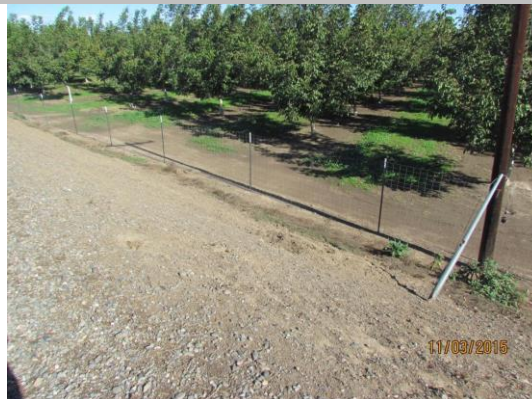
Photo 1 of 1 : FA_2016_LD0003_27_79_20160823_00056.jpg

View of the rodent holes along the landside slope.

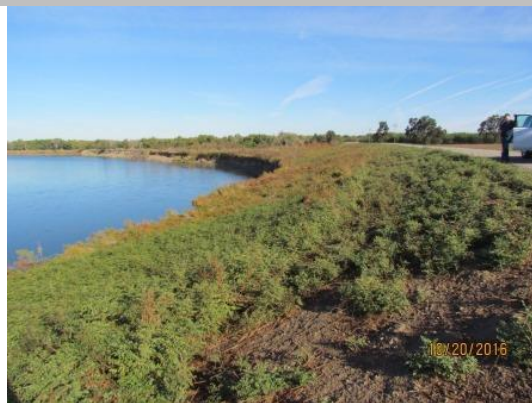
Photo 1 of 5 : FA_2016_LD0003_27_50_20161103_00112.jpg

View of the erosion along the waterside toe. Same site as the USACE erosion issue. Photo: 10/20/2016

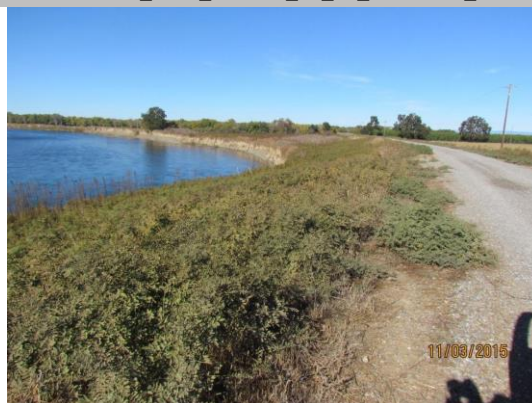
Photo 2 of 5 : FA_2016_LD0003_27_50_20160823_00030.jpg

View of the erosion along the waterside toe. Same site as the USACE erosion issue.

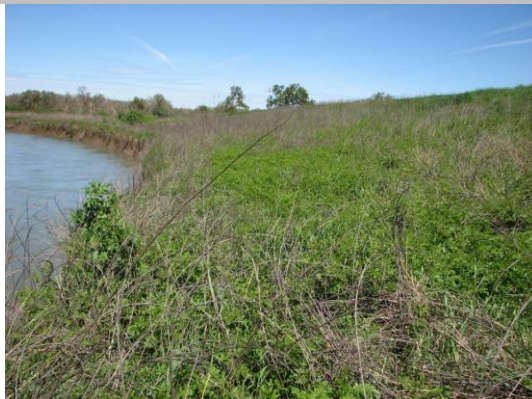
Photo 3 of 5 : FA_2016_LD0003_27_50_20160823_00029.jpg

View of erosion along the waterside toe. Same site as the USACE erosion issue. Photo 3/25/2016

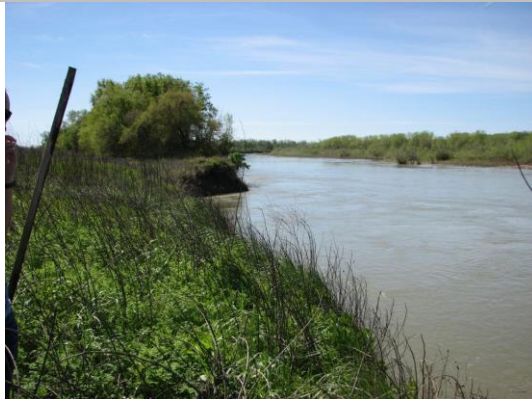
Photo 4 of 5 : FA_2016_LD0003_27_50_20160823_00028.jpg

View of erosion along the waterside toe, downstream. Same site as the USACE erosion issue. Photo 3/25/2016

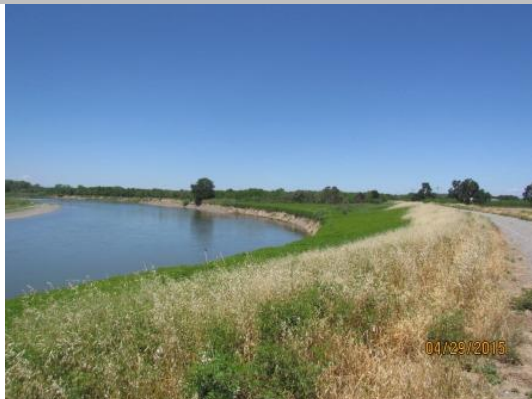
Photo 5 of 5 : FA_2016_LD0003_27_50_20160823_00027.jpg

View of erosion along the waterside toe. Same site as the USACE erosion issue.

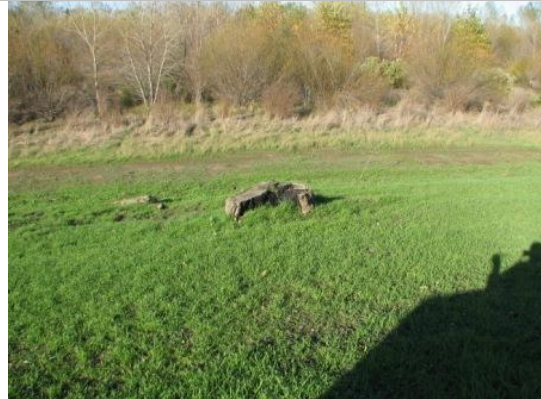
Photo 1 of 1 : FA_2016_LD0003_27_30_20160823_00018.jpg

View of the stump along the slope.

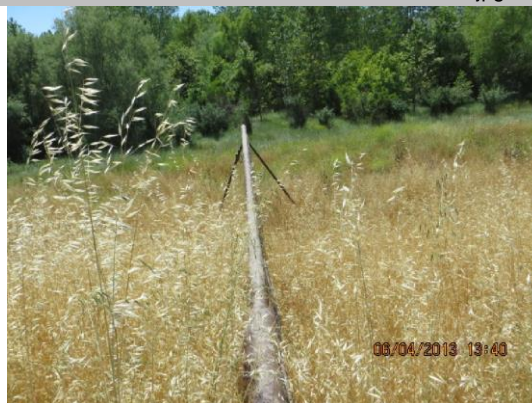
Photo 2 of 2 : UCIP_FA_2016_14690_24192.jpg

Pipe on WS shoulder.

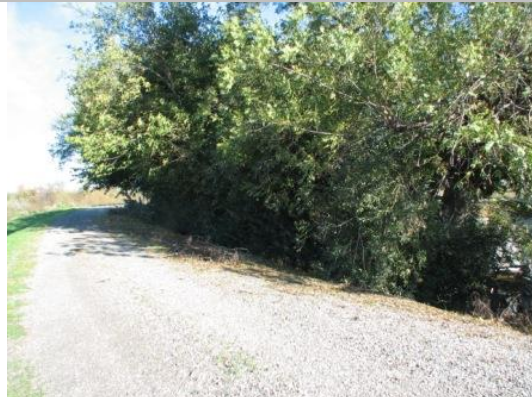
Photo 1 of 1 : FA_2016_LD0003_27_4_20160823_00002.jpg

View of the trees along the landside slope.

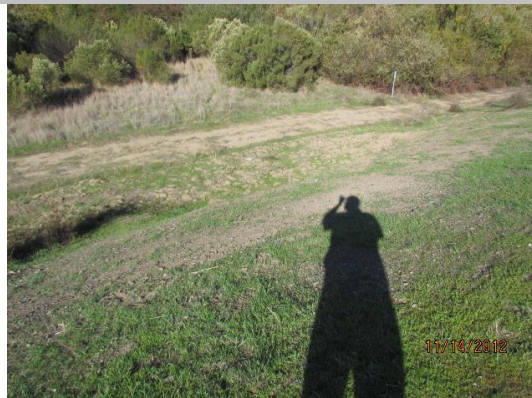
Photo 1 of 1 : FA_2016_LD0003_27_6_20160823_00003.jpg

View of the vertical cut along the waterside toe.
