**Flood Control Project Maintenance
Levee Inspections**

Fall 2017 Levee Maintenance Deficiency Summary Report

**Flood Control Project Maintenance
Levee Inspections****LMA District Cover Sheet
Fall 2017 Levee Inspection Results****Levee District No. 0003 (Glenn County)**

Levee District No. 0003 (Glenn County)

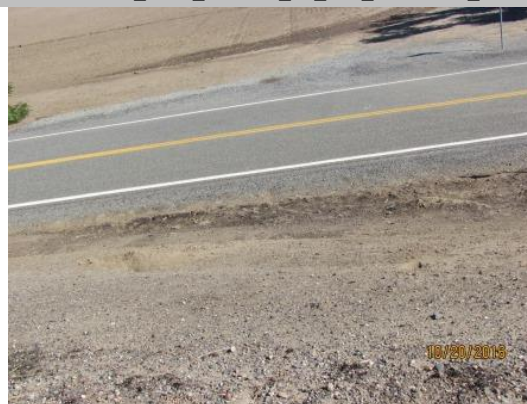
Photo 1 of 1 : FA_2017_LD0003_27_105_20170911_00067.jpg

View of the rodent holes along the landside slope.

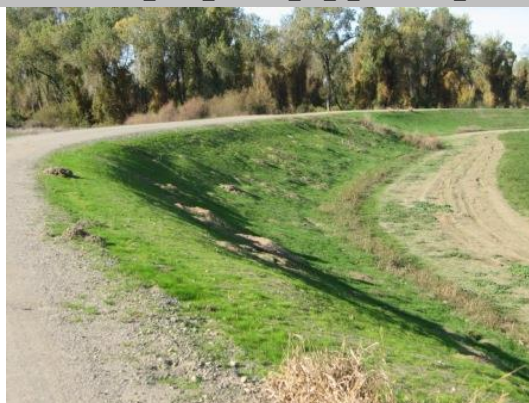
Photo 1 of 1 : FA_2017_LD0003_27_3_20170911_00001.jpg

View of squirrel holes along the landside slope.

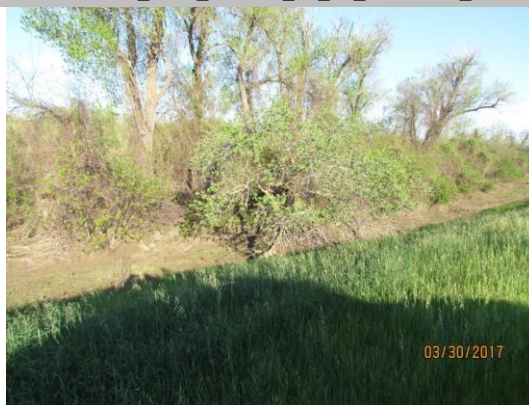
Photo 1 of 1 : FA_2017_LD0003_27_41_20170911_00021.jpg

View of the tree on the waterside slope and toe.

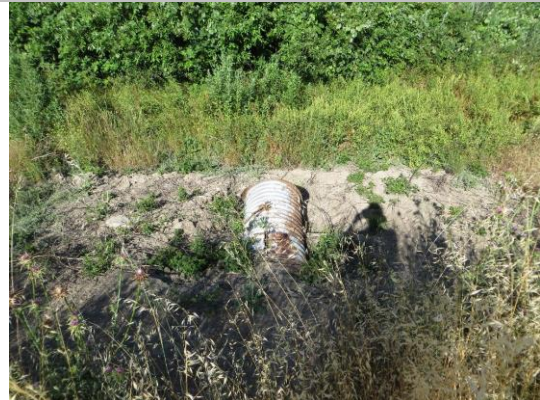
Photo 1 of 3 : UCIP_FA_2017_14573_24038.jpg

Comment Code					
Inspector Comment					
FS_ID:14573					
DS_ID:18830					
EP_NO: 9930					
Repair Type: Non-Urgent					
Crossing Status: Found					
UCIP Comments: Steel plate welded over WS end of pipe. Slide gate at WS toe missing. Appears abandoned.					
FIELD_STRUCT_DESC: 24-inch corrugated metal irrigation pipe through the levee, 14.5 feet below the crown. Slide gate on waterside (WS) end. 7-foot by 9-foot concrete diversion box at landward toe (Automatic Board Order (ABO) issued as Permit No. 9930, 1974 - Steel Ranch). [Additional Reference(s): DWR Levee Log, 1992. USACE Sacramento O&M Manual 136, March 1960 (HLM 21.89)].					
FS Date: 6/4/2013

24-inch CMP stormdrain on WS toe.

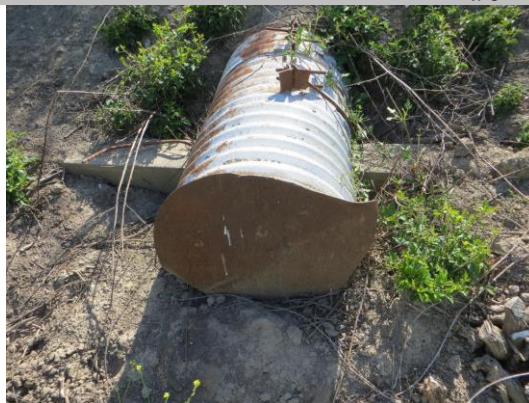
Photo 2 of 3 : UCIP_FA_2017_14573_24037.jpg

Steel plate welded over end of pipe on WS toe.

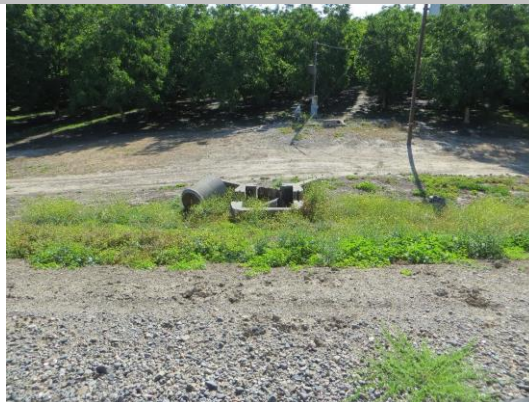
Photo 3 of 3 : UCIP_FA_2017_14573_24036.jpg

Distribution box on LS toe.

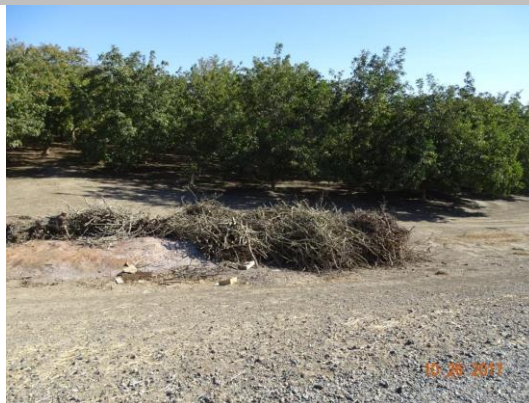
Photo 1 of 1 : FA_2017_LD0003_27_73_20171030_00112.jpg

View of the prunings along the landside toe.

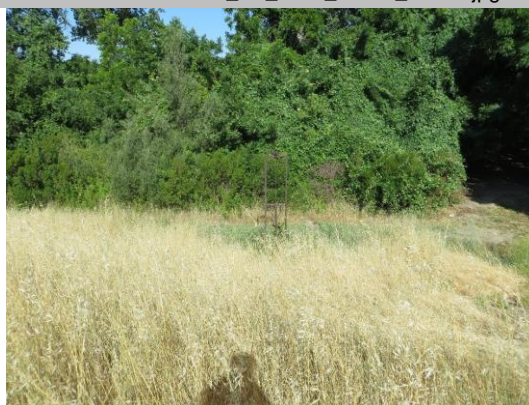
Photo 1 of 2 : UCIP_FA_2017_14576_24052.jpg

LM Start	1.58	Rating **	M	Issue No.	107
LM End	1.58	Issue Type +	En	Location *	
Category	Supplemental			GPS Latitude/Longitude	
				Start	End
Item	DWR UCIP Field Study			39.399330 °	39.399330 °
				-122.002402 °	-122.002402 °
DWR ID					
Comment Code					
Inspector Comment					
FS_ID:14576 DS_ID:18823 EP_NO: 9931 Repair Type: Non-Urgent Crossing Status: Found UCIP Comments: Appears abandoned. Pipe buried at slide gate on WS toe. FIELD_STRUCT_DESC: 24-inch corrugated metal irrigation pipe through the levee, 15 feet below the crown. Slide gate on the waterside (WS) end. 6-foot by 7-foot concrete distribution box on the landside (LS) toe. (Automatic Board Order (ABO) issued as Permit No. 9931, 1974 - Lowell F. Steel). [Additional Reference(s): DWR Levee Log, 1992. USACE Sacramento O&M Manual 136, March 1960 (HLM 22.00)]. FS Date: 6/4/2013

Slide gate at WS toe.

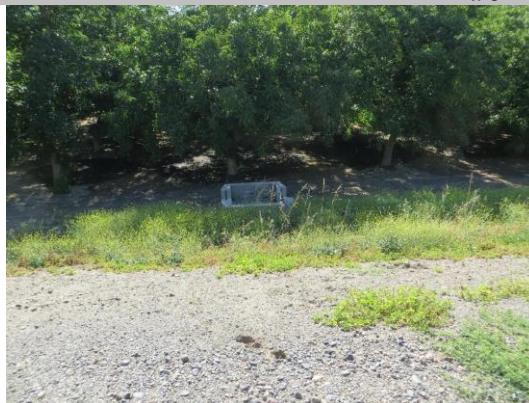
Photo 2 of 2 : UCIP_FA_2017_14576_24051.jpg

Concrete distribution box at LS toe.

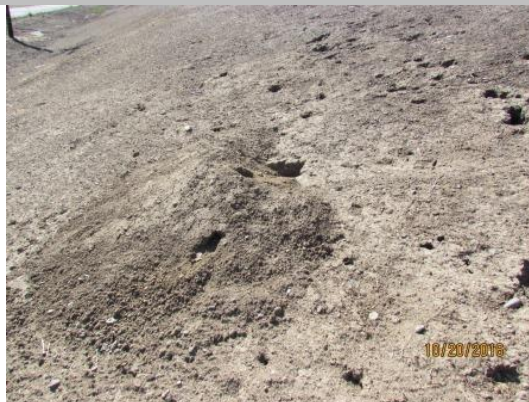
Photo 1 of 1 : FA_2017_LD0003_27_104_20170911_00066.jpg

LM Start	1.75	Rating **	U	Issue No.	104
LM End	1.98	Issue Type +	Ma	Location *	LS
Category	Earthen Levee			GPS Latitude/Longitude	
				Start	End
Item	Animal Control			39.401795 °	39.405018 °
				-122.002084 °	-122.001672 °
DWR ID	DWR_LD0003_01_f_2016_104				
Comment Code					
A1 : Exterminate rodents and backfill and compact or grout burrows.					
Inspector Comment

View of the rodent holes along the landside slope.

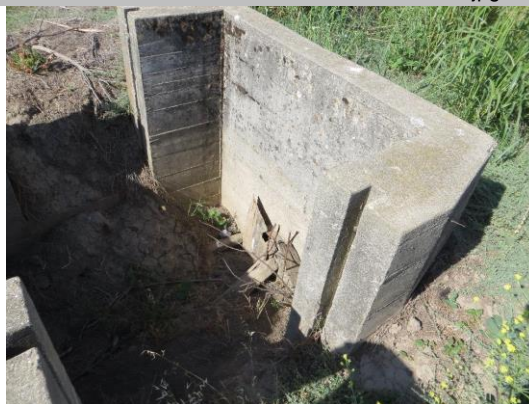
Photo 3 of 3 : UCIP_FA_2017_14577_24053.jpg

Debris and steel plate blocking inlet on LS toe.

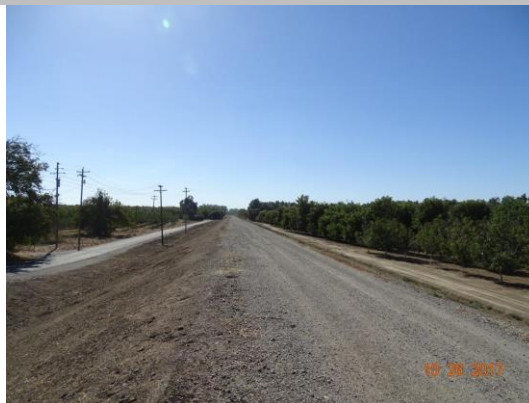
Photo 1 of 1 : FA_2017_LD0003_27_67_20171030_00111.jpg

View of no vegetation on both slopes.

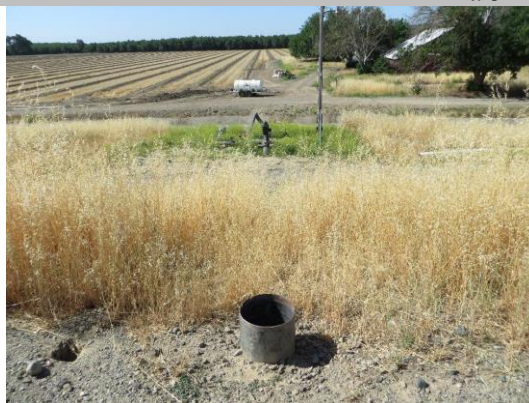
Photo 1 of 3 : UCIP_FA_2017_15144_24883.jpg

LM Start	2.10	Rating **	M	Issue No.	109	
LM End	2.10	Issue Type +	En	Location *		
Category	Supplemental			GPS Latitude/Longitude		
				Start	End	
Item	DWR UCIP Field Study			39.406353 °	39.406353 °	
				-122.000674 °	-122.000674 °	
DWR ID						
Comment Code						
Inspector Comment						
FS_ID:15144						
DS_ID:23151						
EP_NO: N/A						
Repair Type: Non-Urgent						
Crossing Status: Found						
UCIP Comments: No permit identified for this crossing.						
FIELD_STRUCT_DESC: 12-inch steel irrigation pipe through the levee, 3.5 feet below the crown. Pump, butterfly valve, and JP/meter at channel on landside (LS) toe. Siphon breaker inside a 12-inch steel riser unit on the LS shoulder. 3-inch plastic drain on the waterside (WS) toe.						
FS Date: 6/4/2013

Siphon breaker in steel riser on LS shoulder with pump in background.

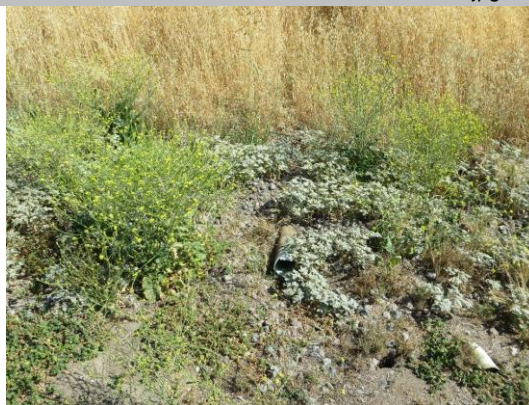
Photo 3 of 3 : UCIP_FA_2017_15144_24881.jpg

3-inch drain on WS toe (purpose unclear).

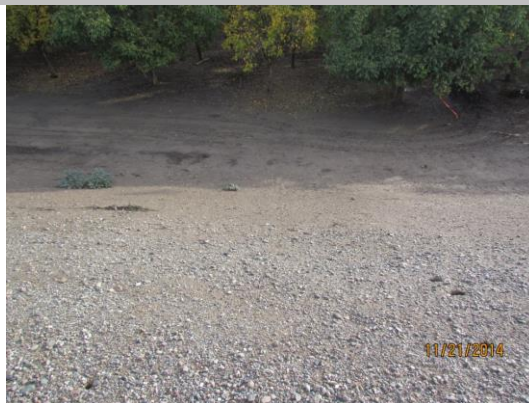
Photo 1 of 1 : FA_2017_LD0003_27_13_20170911_00011.jpg

View of the rodent holes along the waterside slope.

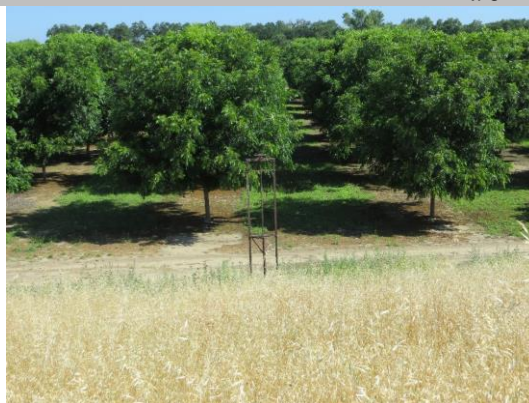
Photo 1 of 3 : UCIP_FA_2017_14582_24076.jpg

LM Start	2.38	Rating **	M	Issue No.	110	
LM End	2.38	Issue Type +	En	Location *		
Category	Supplemental			GPS Latitude/Longitude		
				Start	End	
Item	DWR UCIP Field Study			39.406471 °	39.406471 °	
				-121.995551 °	-121.995551 °	
DWR ID						
Comment Code						
Inspector Comment						
FS_ID:14582 DS_ID:18827 EP_NO: 9936 Repair Type: Non-Urgent Crossing Status: Found UCIP Comments: Appears abandoned. Pipe buried on WS and blocked with tin and soil on the LS. FIELD_STRUCT_DESC: 24-inch corrugated metal irrigation pipe through the levee, 18.3 feet below crown. Slide gate on the waterside (WS) end. 5-foot by 7-foot concrete distribution box at the landside (LS) toe. (Automatic Board Order (ABO) issued as Permit No. 9936, 1974 - J. A. and Florence Watt). [Additional Reference(s): DWR Levee Log, 1992. USACE Sacramento O&M Manual 136, March 1960 (HLM 22.82)]. FS Date: 6/4/2013

Slide gate at WS toe.

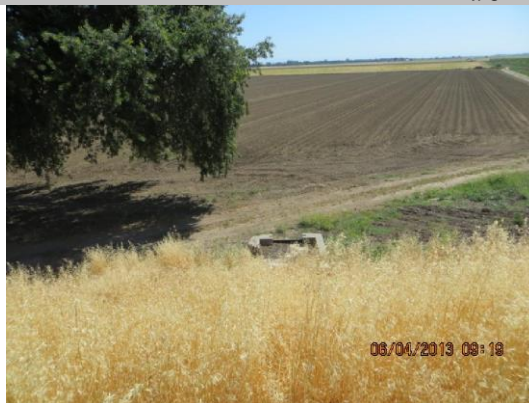
Photo 2 of 2 : UCIP_FA_2017_14584_24080.jpg

Comment Code						
Inspector Comment						
FS_ID:14584 DS_ID:18829 EP_NO: 9919 Repair Type: Non-Urgent Crossing Status: Indicator Found UCIP Comments: Appears abandoned. Verify it was done corectly. FIELD_STRUCT_DESC: *ABANDONED* 24-inch corrugated metal irrigation pipe through the levee, 16 feet below the crown. Slide gate on the waterside (WS) end. 5-foot by 7-foot concrete distribution box at landside (LS) toe is filled with grout. (Automatic Board Order (ABO) issued as Permit No. 9919, 1974 - Roy and Annie Mills). [Additional Reference(s): DWR Levee Log, 1992. USACE Sacramento O&M Manual 136, March 1960 (HLM 23.43)]. FS Date: 6/4/2013

Distribution box on LS toe.

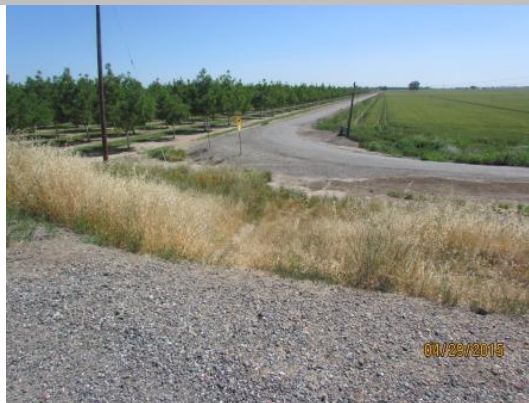
Photo 1 of 1 : FA_2017_LD0003_27_9_20170911_00006.jpg

LM Start	3.39	Rating **	M	Issue No.	9
LM End	3.39	Issue Type +	Ma	Location *	LS
Category	Earthen Levee			GPS Latitude/Longitude	
				Start	End
Item	Slope Stability			39.418382 °	39.418382 °
				-121.992480 °	-121.992480 °
DWR ID	DWR_LD0003_01_s_2012_9				
Comment Code					
S3 : Repair the levee slope damaged by vehicle traffic and prevent access where possible.					
Inspector Comment					
Repair the erosion along the landside slope and prevent vehicle access

View of the vehicle erosion along the landside slope.

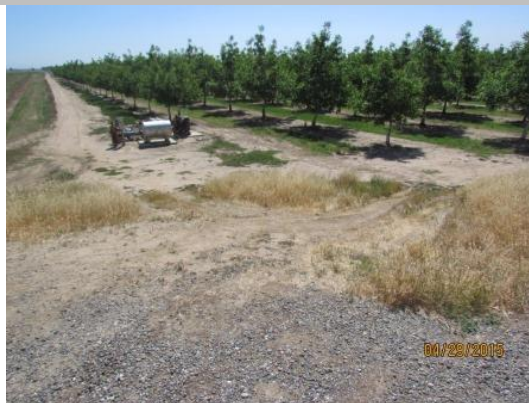
Photo 1 of 1 : FA_2017_LD0003_27_19_20170911_00013.jpg

LM Start	3.76	Rating **	M	Issue No.	19	
LM End	3.76	Issue Type +	Ma	Location *	LS	
Category	Earthen Levee			GPS Latitude/Longitude		
				Start	End	
Item	Slope Stability			39.423747 °	39.423747 °	
				-121.991667 °	-121.991667 °	
DWR ID	DWR_LD0003_01_s_2012_19					
Comment Code						
S3 : Repair the levee slope damaged by vehicle traffic and prevent access where possible.						
Inspector Comment

View of the vehicle erosion along the landside slope.

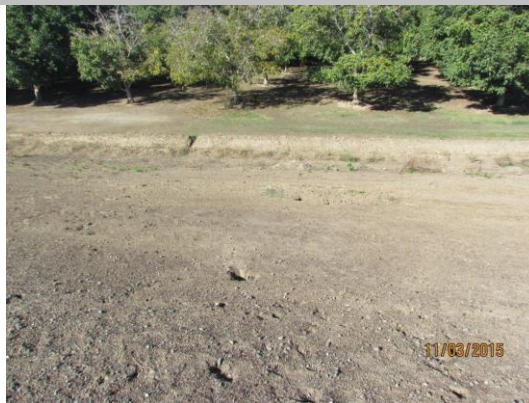
Photo 1 of 1 : FA_2017_LD0003_27_59_20170911_00038.jpg

View of the rodent holes along the landside slope.

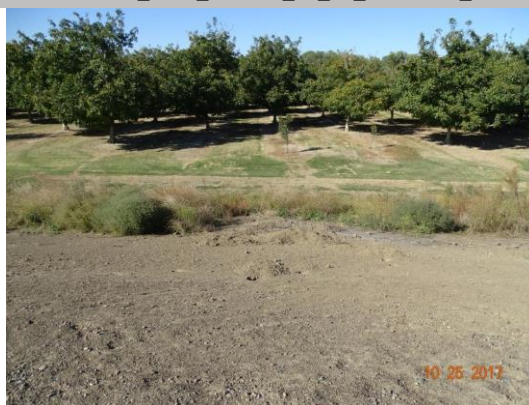
Photo 1 of 1 : FA_2017_LD0003_27_58_20171030_00109.jpg

LM Start	4.20	Rating **	U	Issue No.	58
LM End	4.20	Issue Type +	Ma	Location *	WS
Category	Earthen Levee			GPS Latitude/Longitude	
				Start	End
Item	Animal Control			39.429097 °	39.429097 °
				-121.987510 °	-121.987510 °
DWR ID	DWR_LD0003_01_f_2017_58				
Comment Code					
A3 : No rodents visible, but rodent burrows visible; need to backfill and compact or grout burrows.					
Inspector Comment					
Repair the rodent holes along the waterside slope.

View of the rodent holes along the waterside slope.

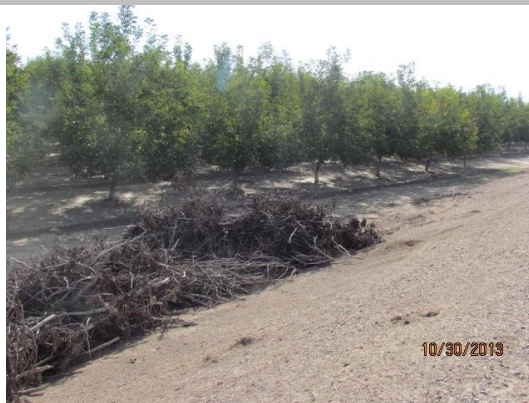
Photo 1 of 1 : FA_2017_LD0003_27_63_20170911_00042.jpg

View of the prunings along the landside toe.

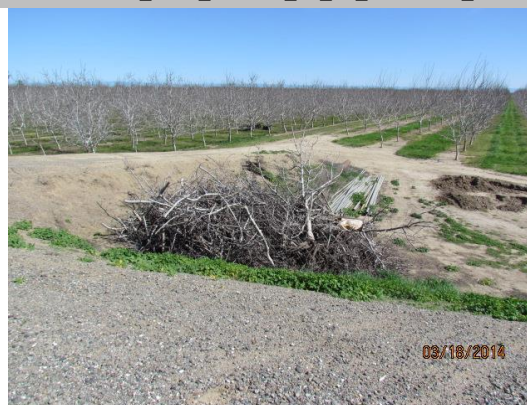
Photo 1 of 1 : FA_2017_LD0003_27_68_20170911_00046.jpg

View of the prunings along the landside toe.

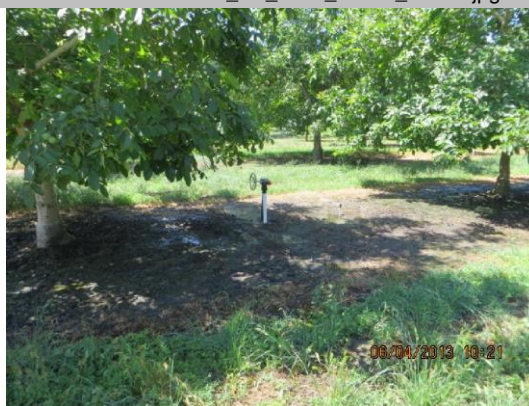
Photo 1 of 3 : UCIP_FA_2017_15163_24902.jpg

LM Start	4.96	Rating **	M	Issue No.	112
LM End	4.96	Issue Type +	En	Location *	
Category	Supplemental			GPS Latitude/Longitude	
				Start	End
Item	DWR UCIP Field Study			39.439791 °	39.439791 °
				-121.989825 °	-121.989825 °
DWR ID					
Comment Code					
Inspector Comment					
FS_ID:15163					
DS_ID:23152					
EP_NO: N/A					
Repair Type: Non-Urgent					
Crossing Status: Found					
UCIP Comments: No permit identified for this crossing.					
FIELD_STRUCT_DESC: 4-inch steel irrigation pipe through the levee,					
at an unknown depth. Pump, vent, and shutoff valve off the landside					
(LS) toe. Possible shutoff valve off the waterside (WS) toe.					
FS Date: 6/4/2013

Possible shutoff valve on WS toe.

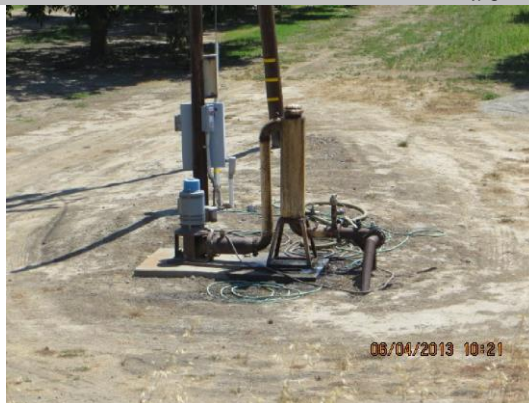
Photo 3 of 3 : UCIP_FA_2017_15163_24900.jpg

Pumping plant off LS toe.

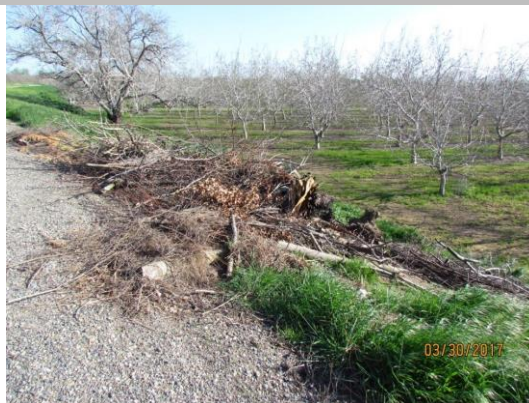
Photo 1 of 1 : FA_2017_LD0003_27_44_20170911_00024.jpg

View of the prunings along the landside slope and toe.

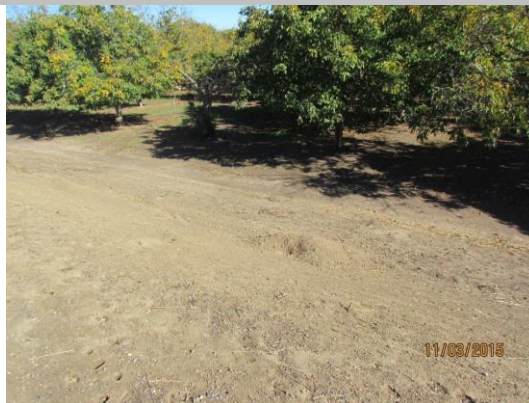
Photo 1 of 1 : FA_2017_LD0003_27_70_20170911_00048.jpg

View of the rodent holes along the landside slope.

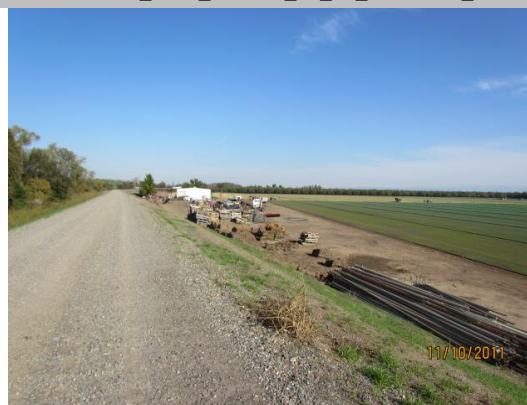
Photo 1 of 1 : FA_2017_LD0003_27_25_20170911_00015.jpg

View of the equipment along the landside toe.

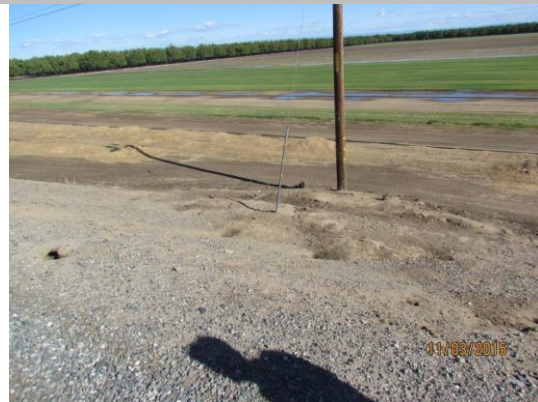
Photo 1 of 1 : FA_2017_LD0003_27_71_20170911_00049.jpg

View of the rodent holes along the landside slope.

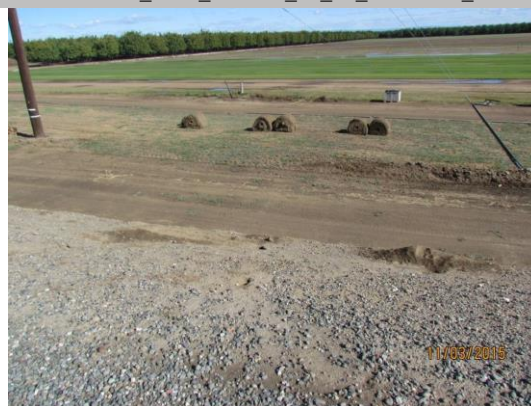
Photo 1 of 1 : FA_2017_LD0003_27_72_20170911_00050.jpg

View of the rodent holes along the landside slope.

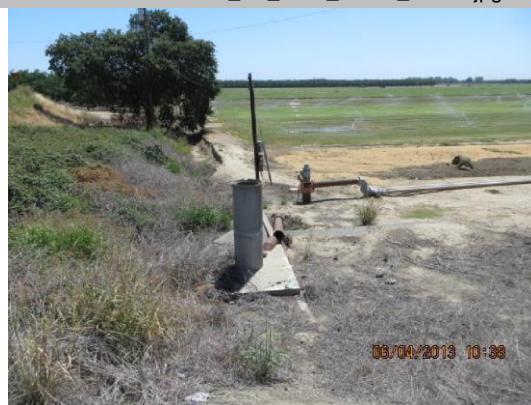
Photo 1 of 3 : UCIP_FA_2017_14643_24142.jpg

Concrete standpipe on LS toe.

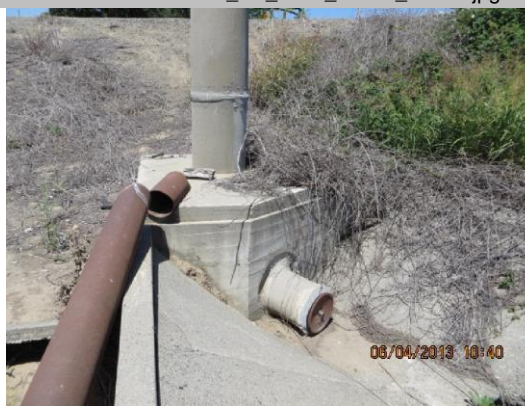
Photo 2 of 3 : UCIP_FA_2017_14643_24141.jpg

Concrete standpipe and channel on LS toe.

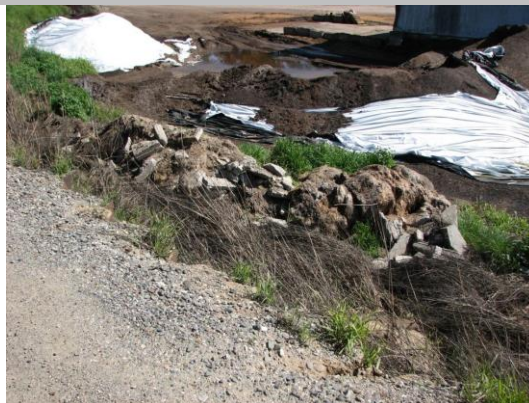
Photo 1 of 1 : FA_2017_LD0003_27_65_20170911_00044.jpg

View of concrete and soil obstructing visibility and access.

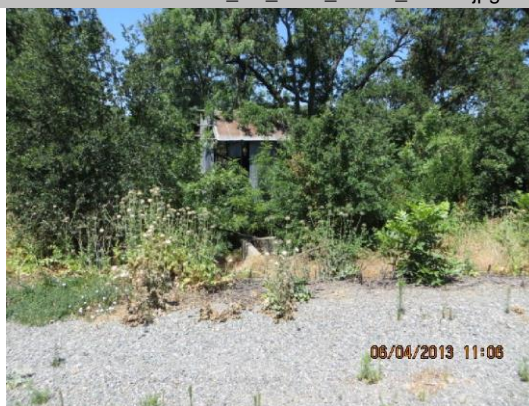
Photo 1 of 3 : UCIP_FA_2017_14664_24162.jpg

Pumphouse and 7'X12' concrete box on WS slope.

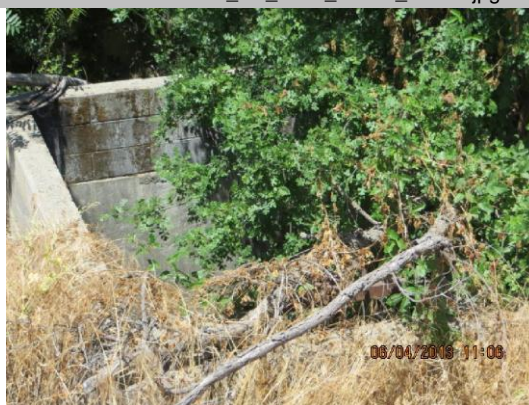
Photo 2 of 3 : UCIP_FA_2017_14664_24161.jpg

7'X12' Concrete box with flap gate and slide gate on WS slope.

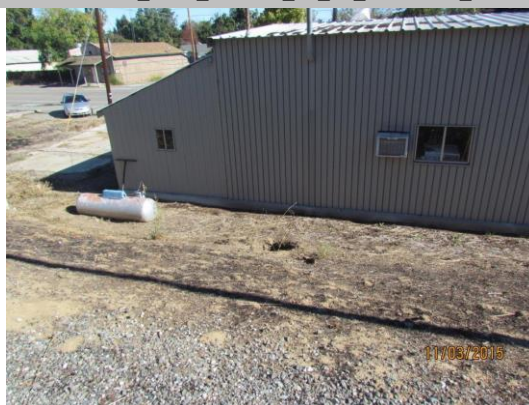
Photo 1 of 1 : FA_2017_LD0003_27_76_20170911_00052.jpg

View of the burned out stump hole along the landside toe.

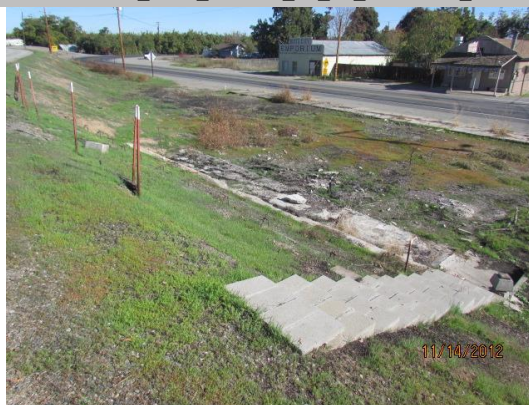
Photo 1 of 1 : FA_2017_LD0003_27_12_20170911_00010.jpg

View of concrete stairs & foundation along the slope of the levee.

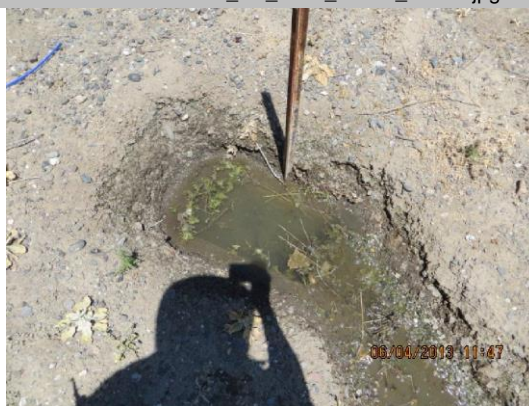
Photo 1 of 3 : UCIP_FA_2017_15165_24906.jpg

Christy box on LS toe with siphon breaker and meter.

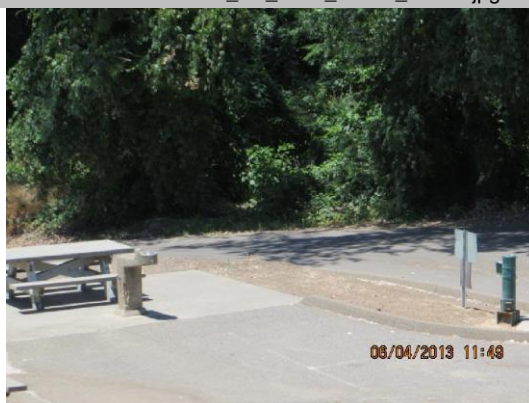
Photo 3 of 3 : UCIP_FA_2017_15165_24904.jpg

Possible reason for water service (water fountain).

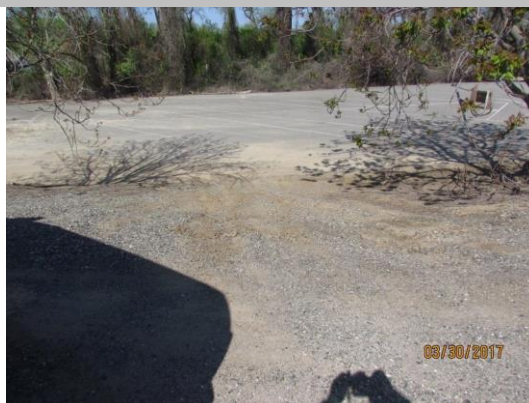
Photo 1 of 1 : FA_2017_LD0003_27_97_20170911_00062.jpg

View of the vehicle ruts on the waterside slope.

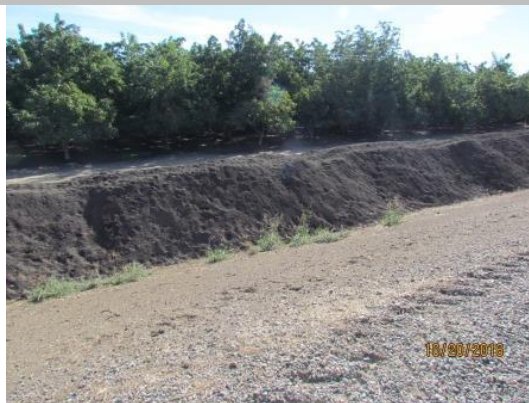
Photo 1 of 1 : FA_2017_LD0003_27_96_20170911_00061.jpg

View of a large pile of mulch along the landside toe.

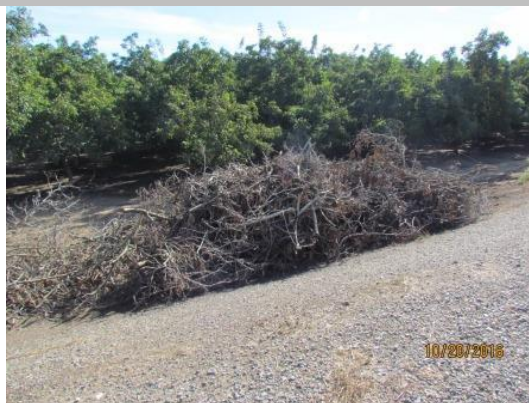
Photo 1 of 1 : FA_2017_LD0003_27_95_20170911_00060.jpg

View of the prunings along the landside toe.

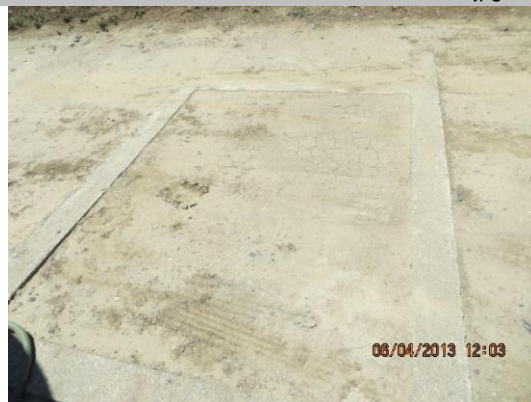
Photo 2 of 2 : UCIP_FA_2017_14686_24183.jpg

Soil filled concrete distribution box on LS toe.

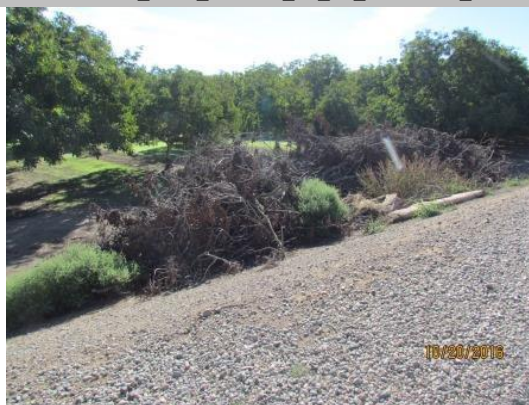
Photo 1 of 1 : FA_2017_LD0003_27_61_20170911_00040.jpg

View of the pruning along the landside toe.

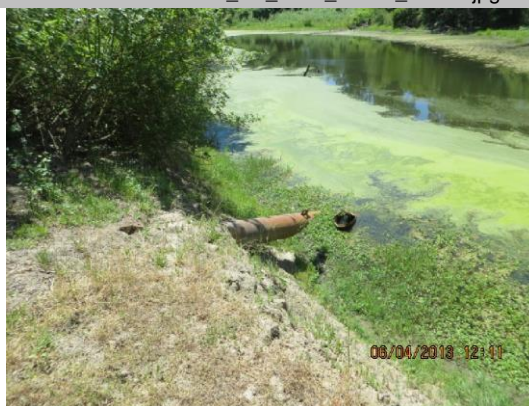
Photo 1 of 3 : UCIP_FA_2017_14687_24187.jpg

Pipe visible at pond off WS toe.

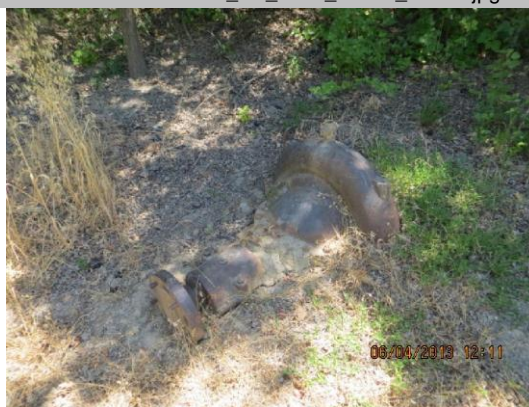
Photo 2 of 3 : UCIP_FA_2017_14687_24186.jpg

Pump visible off WS toe, next to pond.

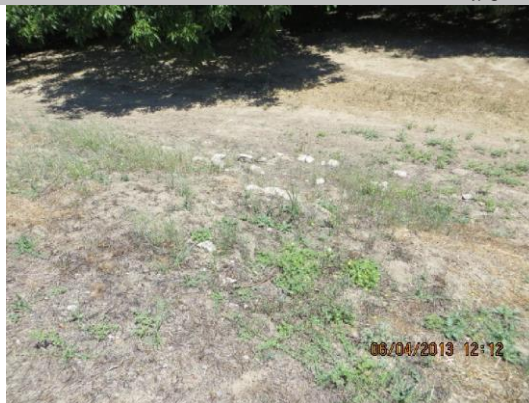
Photo 3 of 3 : UCIP_FA_2017_14687_24185.jpg

Remnants of concrete distribution box on LS toe.

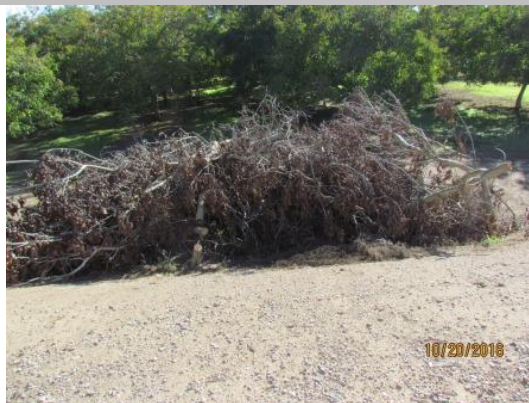
Photo 1 of 1 : FA_2017_LD0003_27_60_20170911_00039.jpg

View of the prunings along the landside toe.

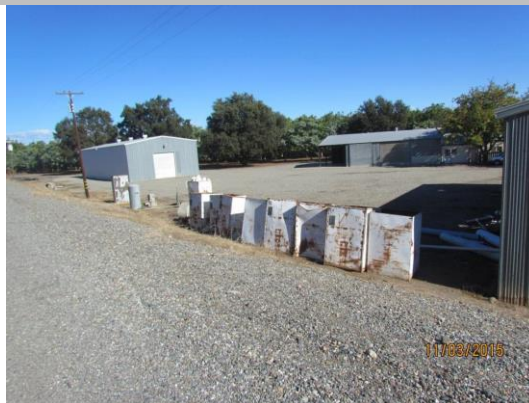
Photo 1 of 1 : FA_2017_LD0003_27_77_20170911_00053.jpg

View of the metal boxes along the landside toe.

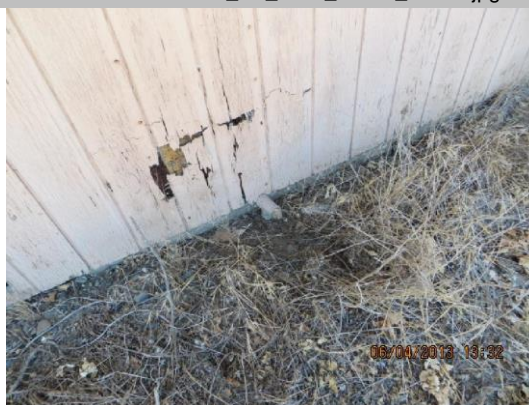
Photo 1 of 3 : UCIP_FA_2017_14688_24190.jpg

Pipe at side of building on WS shoulder.

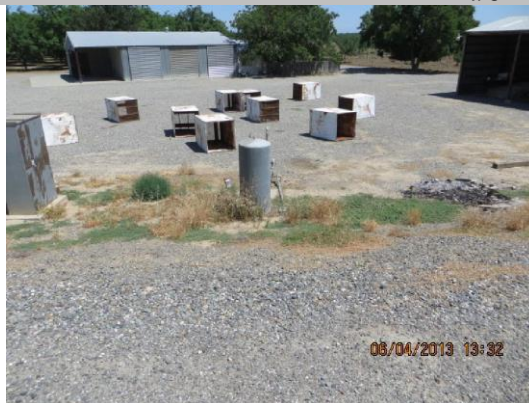
Photo 2 of 3 : UCIP_FA_2017_14688_24189.jpg

Water tank, pump, and well head on LS toe.

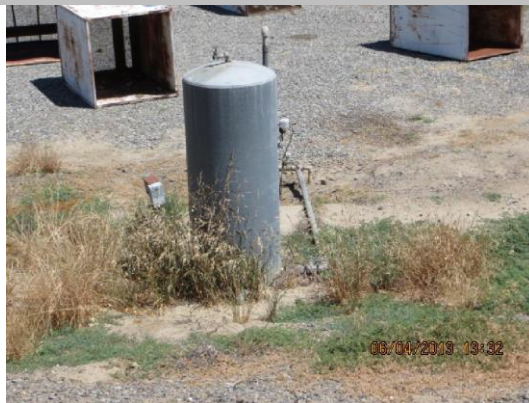
Photo 3 of 3 : UCIP_FA_2017_14688_24188.jpg

Water tank, pump, and well head on LS toe.

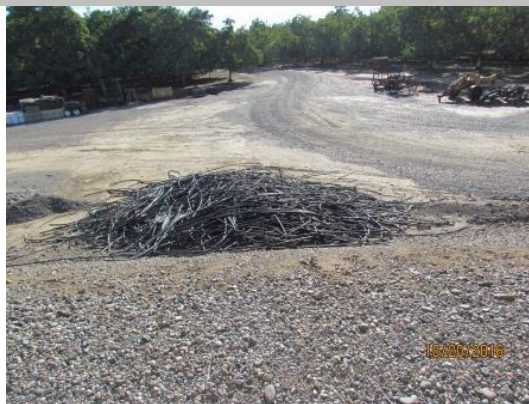
Photo 1 of 1 : FA_2017_LD0003_27_91_20170911_00057.jpg

View of the polyethylene pipes along the landside toe.

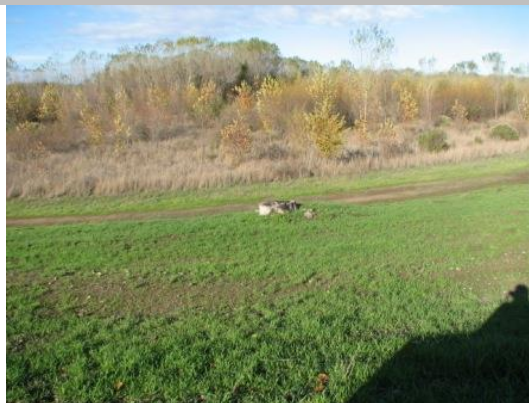
Photo 1 of 1 : FA_2017_LD0003_27_29_20170911_00016.jpg

View of the stump along the toe.

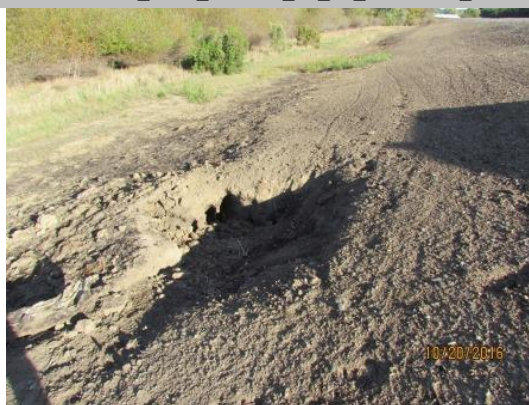
Photo 1 of 1 : FA_2017_LD0003_27_89_20170911_00056.jpg

View of a hole along the waterside slope that need to be backfilled and compacted.

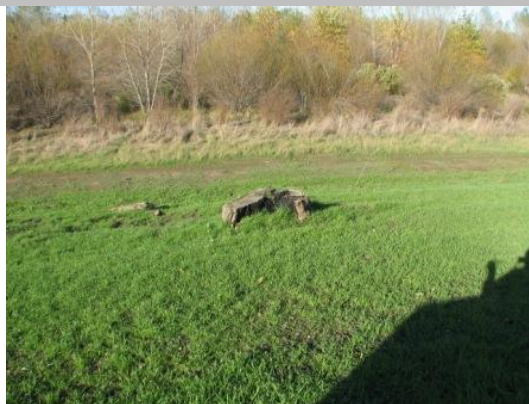
Photo 1 of 1 : FA_2017_LD0003_27_30_20170911_00017.jpg

View of the stump along the slope.

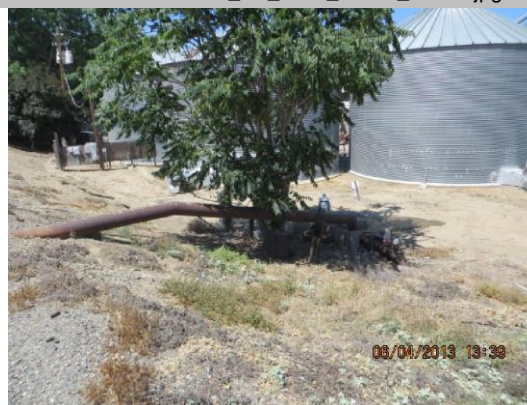
Photo 1 of 3 : UCIP_FA_2017_14690_24193.jpg

10-inch pipe and pump on LS.

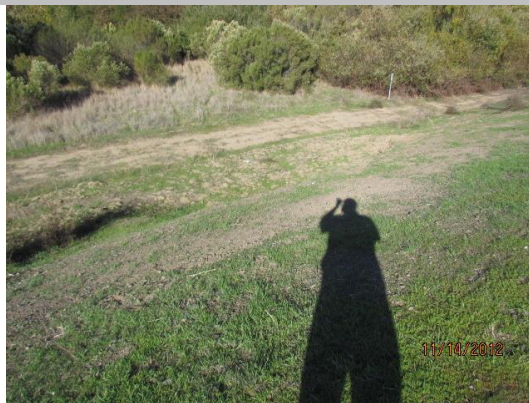
Photo 1 of 1 : FA_2017_LD0003_27_6_20170911_00004.jpg

View of the vertical cut along the waterside toe.
