**Flood Control Project Maintenance
Levee Inspections**

Fall 2018 Levee Maintenance Deficiency Summary Report

Sacramento River Basin

**Flood Control Project Maintenance
Levee Inspections****LMA District Cover Sheet****Fall 2018 Levee Inspection Results****Levee District No. 0003 (Glenn County)**

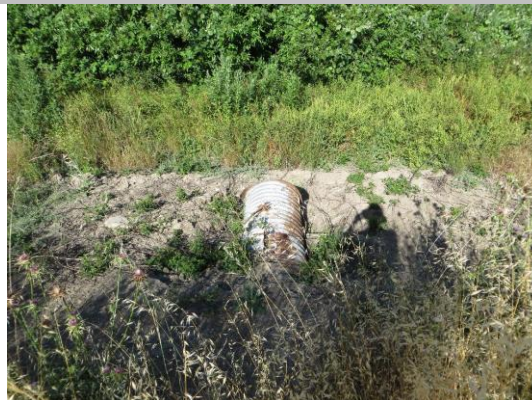
Photo 1 of 3 : UCIP_FA_2018_14573_24038.jpg

Comment Code					
Inspector Comment					
FS_ID:14573					
DS_ID:18830					
EP_NO: 9930					
Repair Type: Non-Urgent					
Crossing Status: Found					
UCIP Comments: Steel plate welded over WS end of pipe. Slide gate through the levee, 14.5 feet below the crown. Slide gate on waterside at WS toe missing. Appears abandoned.					
FIELD_STRUCT_DESC: 24-inch corrugated metal irrigation pipe through the levee, 14.5 feet below the crown. Slide gate on waterside (WS) end. 7-foot by 9-foot concrete diversion box at landward toe (Automatic Board Order (ABO) issued as Permit No. 9930, 1974 - Steel Ranch). [Additional Reference(s): DWR Levee Log, 1992. USACE Sacramento O&M Manual 136, March 1960 (HLM 21.89)].					
FS Date: 6/4/2013

24-inch CMP stormdrain on WS toe.

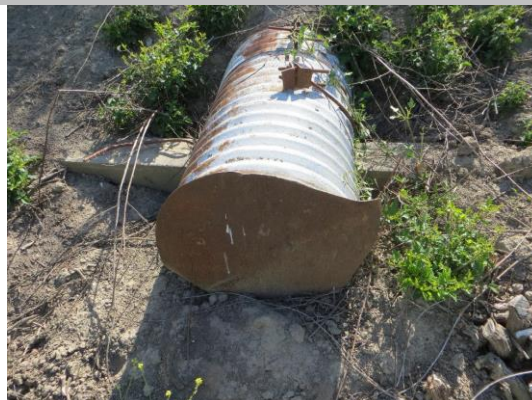
Photo 2 of 3 : UCIP_FA_2018_14573_24037.jpg

Steel plate welded over end of pipe on WS toe.

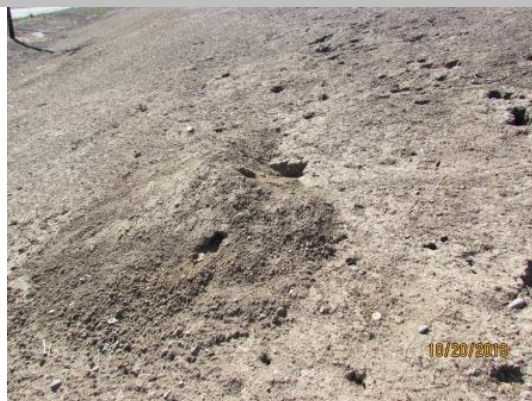
Photo 1 of 1 : FA_2018_LD0003_27_104_20180905_00064.jpg

View of the rodent holes along the landside slope.

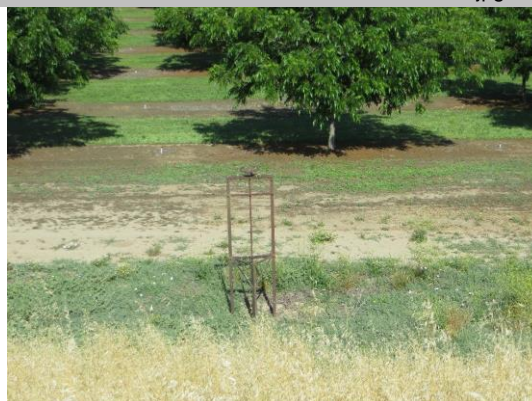
Photo 1 of 3 : UCIP_FA_2018_14577_24055.jpg

Comment Code						
Inspector Comment						
FS_ID:14577						
DS_ID:18825						
EP_NO: 9935						
Repair Type: Non-Urgent						
Crossing Status: Found						
UCIP Comments: Appears abandoned. Pipe burried on WS toe.						
Debris and steel plate blocking inlet on LS.						
FIELD_STRUCT_DESC: 24-inch corrugated metal irrigation pipe						
through the levee and beneath the roadway, 18 feet below the crown.						
Slide gate on the waterside (WS) end. (Automatic Board Order (ABO)						
issued as Permit No. 9935, 1974 - Florence Watt). [Additional						
Reference(s): DWR Levee Log, 1992. USACE Sacramento O&M						
Manual 136, March 1960 (HLM 22.30)].						
FS Date: 6/4/2013

Slide gate buried at WS toe.

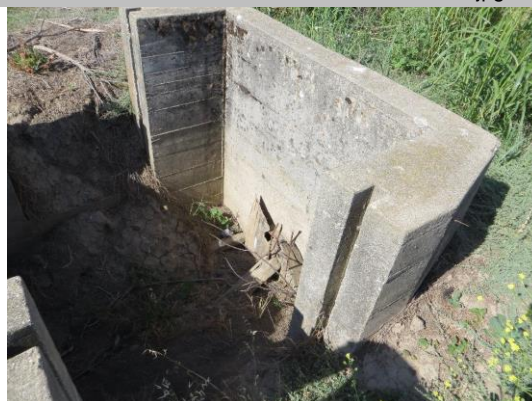
Photo 3 of 3 : UCIP_FA_2018_14577_24053.jpg

Debris and steel plate blocking inlet on LS toe.

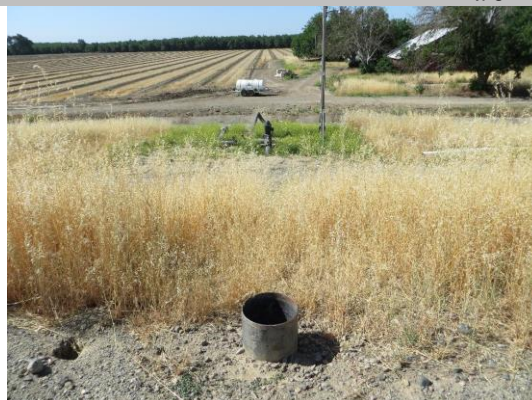
Photo 1 of 3 : UCIP_FA_2018_15144_24883.jpg

Siphon breaker in steel riser on LS shoulder with pump in background.

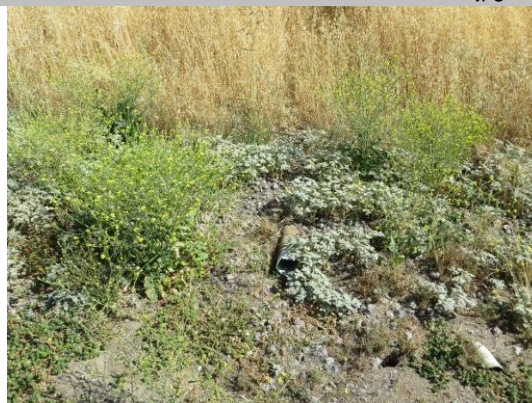
Photo 3 of 3 : UCIP_FA_2018_15144_24881.jpg

3-inch drain on WS toe (purpose unclear).

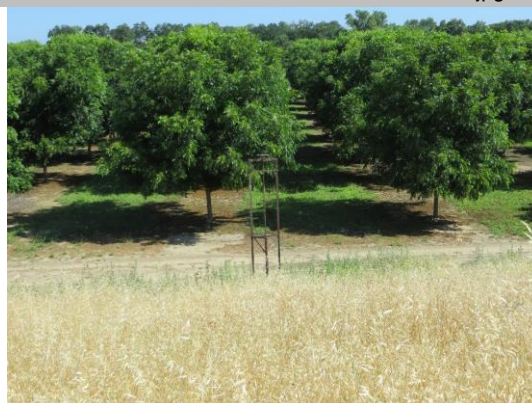
Photo 1 of 3 : UCIP_FA_2018_14582_24076.jpg

Comment Code					
Inspector Comment					
FS_ID:14582					
DS_ID:18827					
EP_NO: 9936					
Repair Type: Non-Urgent					
Crossing Status: Found					
UCIP Comments: Appears abandoned. Pipe burried on WS and blocked with tin and soil on the LS.					
FIELD_STRUCT_DESC: 24-inch corrugated metal irrigation pipe through the levee, 18.3 feet below crown. Slide gate on the waterside (WS) end. 5-foot by 7-foot concrete distribution box at the landside (LS) toe. (Automatic Board Order (ABO) issued as Permit No. 9936, 1974 - J. A. and Florence Watt). [Additional Reference(s): DWR Levee Log, 1992. USACE Sacramento O&M Manual 136, March 1960 (HLM 22.82)].					
FS Date: 6/4/2013

Slide gate at WS toe.

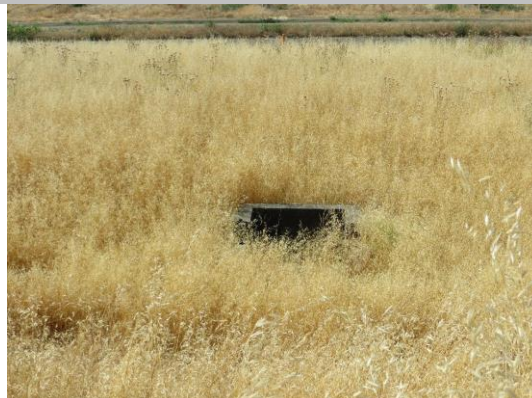
Photo 2 of 3 : UCIP_FA_2018_14582_24075.jpg

Concrete distribution box on LS toe.

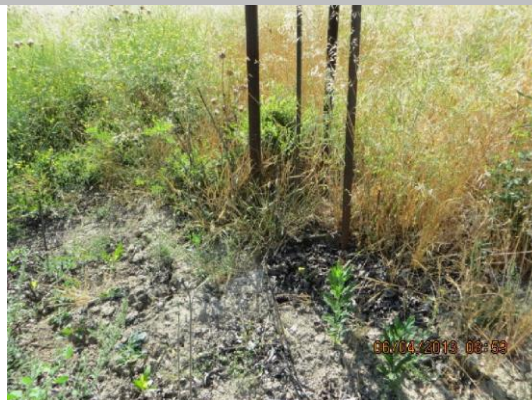
Photo 3 of 3 : UCIP_FA_2018_14582_24074.jpg

Slide gate at WS toe.

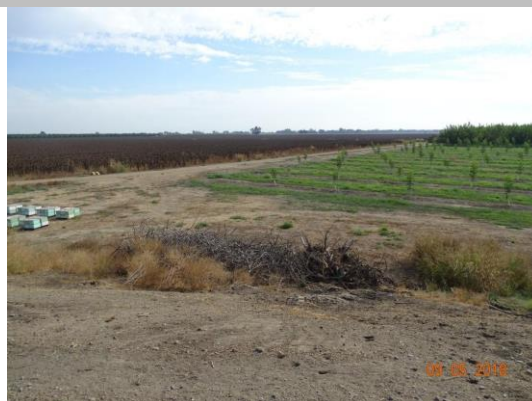
Photo 1 of 1 : FA_2018_LD0003_27_44_20181001_00106.jpg

View of the prunings along the landside toe.

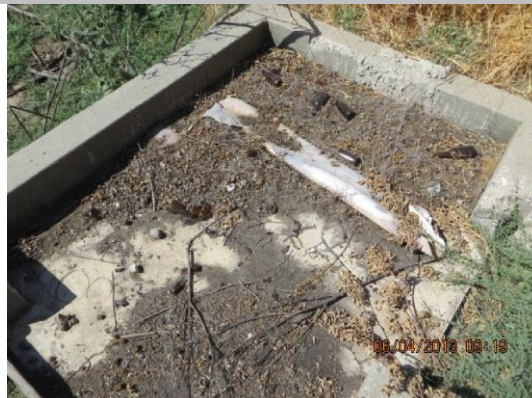
Photo 1 of 2 : UCIP_FA_2018_14584_24081.jpg

Comment Code						
Inspector Comment						
FS_ID:14584 DS_ID:18829 EP_NO: 9919 Repair Type: Non-Urgent Crossing Status: Indicator Found UCIP Comments: Appears abandoned. Verify it was done corectly. FIELD_STRUCT_DESC: *ABANDONED* 24-inch corrugated metal irrigation pipe through the levee, 16 feet below the crown. Slide gate on the waterside (WS) end. 5-foot by 7-foot concrete distribution box at landside (LS) toe is filled with grout. (Automatic Board Order (ABO) issued as Permit No. 9919, 1974 - Roy and Annie Mills). [Additional Reference(s): DWR Levee Log, 1992. USACE Sacramento O&M Manual 136, March 1960 (HLM 23.43)]. FS Date: 6/4/2013

5'X7' concrete distribution box filled in with grout.

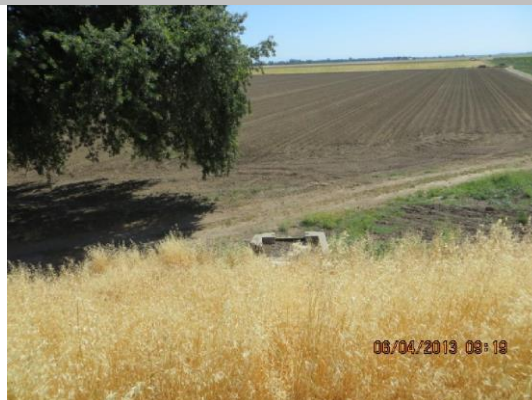
Photo 2 of 2 : UCIP_FA_2018_14584_24080.jpg

Distribution box on LS toe.

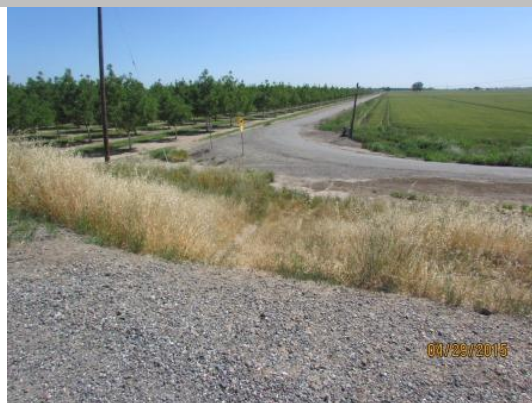
Photo 1 of 1 : FA_2018_LD0003_27_9_20180905_00006.jpg

LM Start	3.39	Rating **	M	Issue No.	9
LM End	3.39	Issue Type +	Ma	Location *	LS
Category	Earthen Levee			GPS Latitude/Longitude	
				Start	End
Item	Slope Stability			39.418382 °	39.418382 °
				-121.992480 °	-121.992480 °
DWR ID	DWR_LD0003_01_s_2012_9				
Comment Code					
S3 : Repair the levee slope damaged by vehicle traffic and prevent access where possible.					
Inspector Comment					
Repair the erosion along the landside slope and prevent vehicle access

View of the vehicle erosion along the landside slope.

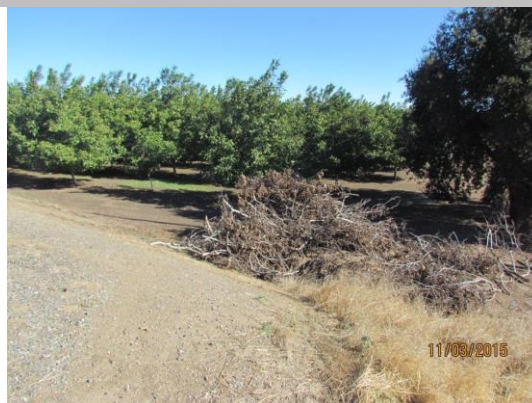
Photo 1 of 1 : FA_2018_LD0003_27_66_20180905_00044.jpg

View of the prunings along the landside toe.

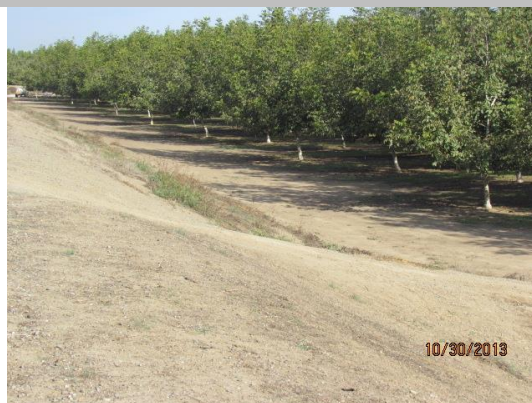
Photo 1 of 1 : FA_2018_LD0003_27_64_20180905_00042.jpg

LM Start	4.63	Rating **	U	Issue No.	64
LM End	4.68	Issue Type +	Ma	Location *	LS
Category	Earthen Levee			GPS Latitude/Longitude	
				Start	End
Item	Animal Control			39.435205 °	39.435855 °
				-121.988097 °	-121.988252 °
DWR ID	DWR_LD0003_01_f_2013_64				
Comment Code					
A3 : No rodents visible, but rodent burrows visible; need to backfill and compact or grout burrows.					
Inspector Comment

View of the rodent activity along the landside slope.

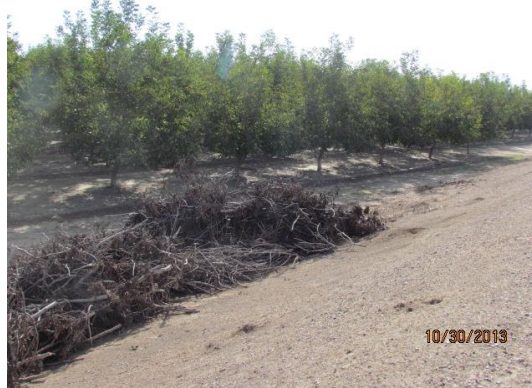
Photo 1 of 1 : FA_2018_LD0003_27_63_20180905_00041.jpg

View of the prunings along the landside toe.

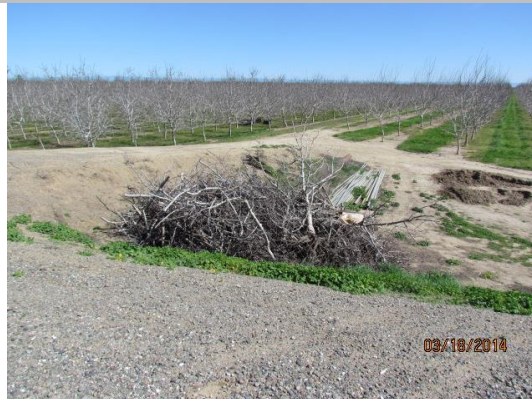
Photo 1 of 1 : FA_2018_LD0003_27_68_20180905_00046.jpg

View of the prunings along the landside toe.

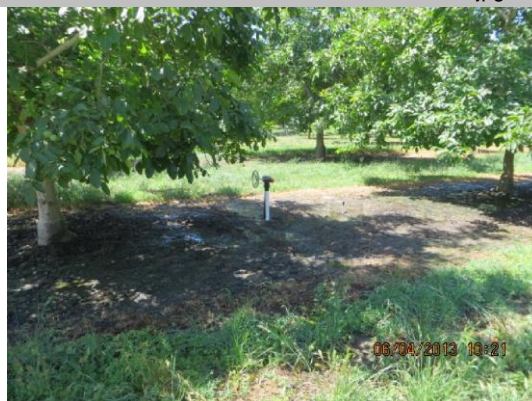
Photo 1 of 3 : UCIP_FA_2018_15163_24902.jpg

LM Start	4.96	Rating **	M	Issue No.	113
LM End	4.96	Issue Type +	En	Location *	
Category	Supplemental			GPS Latitude/Longitude	
				Start	End
Item	DWR UCIP Field Study			39.439791 °	39.439791 °
				-121.989825 °	-121.989825 °
DWR ID	23152				
Comment Code					
Inspector Comment					
FS_ID:15163 DS_ID:23152 EP_NO: N/A Repair Type: Non-Urgent Crossing Status: Found UCIP Comments: No permit identified for this crossing. FIELD_STRUCT_DESC: 4-inch steel irrigation pipe through the levee, at an unknown depth. Pump, vent, and shutoff valve off the landside (LS) toe. Possible shutoff valve off the waterside (WS) toe. FS Date: 6/4/2013

Possible shutoff valve on WS toe.

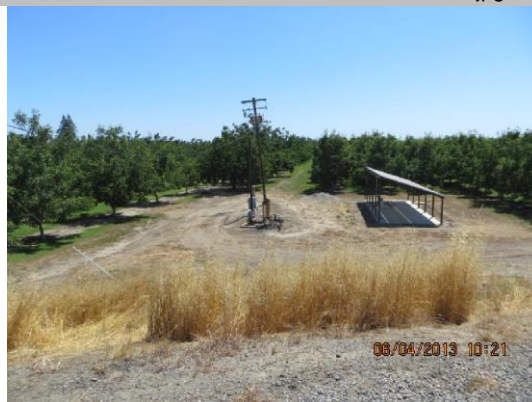
Photo 2 of 3 : UCIP_FA_2018_15163_24901.jpg

Pumping plant off LS toe.

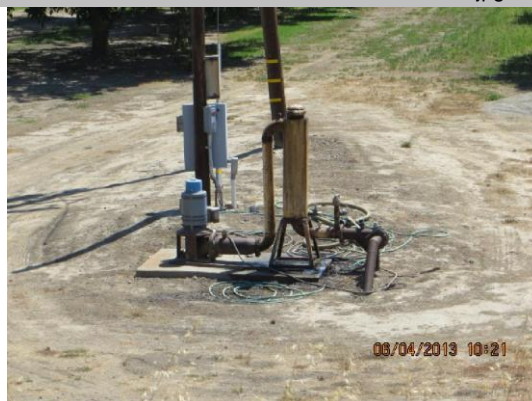
Photo 3 of 3 : UCIP_FA_2018_15163_24900.jpg

Pumping plant off LS toe.

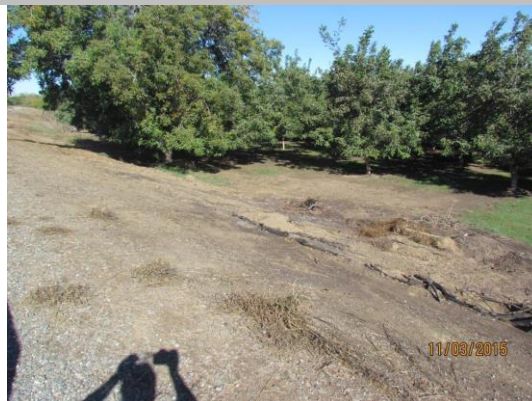
Photo 1 of 1 : FA_2018_LD0003_27_21_20180905_00014.jpg

View of the rodent holes along the landside slope.

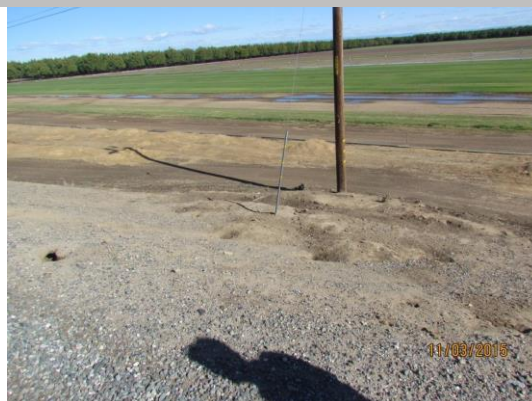
Photo 1 of 1 : FA_2018_LD0003_27_71_20180905_00048.jpg

View of the rodent holes along the landside slope.

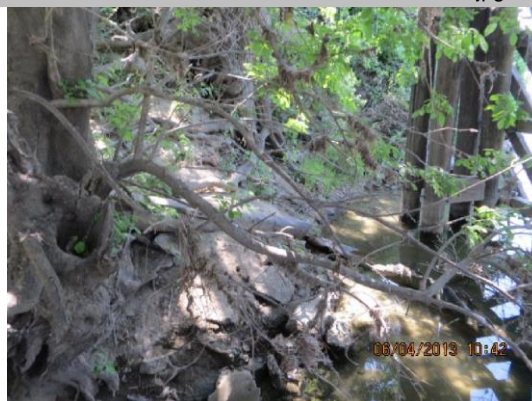
Photo 3 of 3 : UCIP_FA_2018_14643_24140.jpg

14-inch Pipe debris on WS toe.

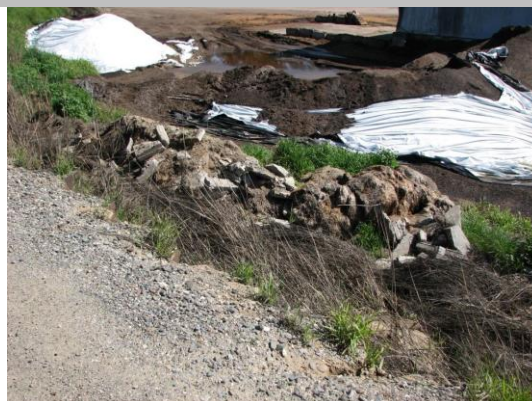
Photo 1 of 1 : FA_2018_LD0003_27_65_20180905_00043.jpg

LM Start	6.36	Rating **	U	Issue No.	65
LM End	6.36	Issue Type +	En	Location *	LS
Category	Earthen Levee			GPS Latitude/Longitude	
				Start	End
Item	Encroachments			39.459690 °	39.459690 °
				-121.993680 °	-121.993680 °
DWR ID	DWR_LD0003_01_s_2016_65				
Comment Code					
DE : Debris					
Inspector Comment					
broken concrete and soil

View of concrete and soil obstructing visibility and access.

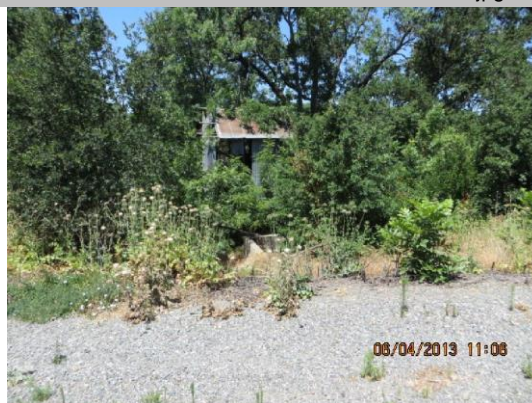
Photo 1 of 3 : UCIP_FA_2018_14664_24162.jpg

Comment Code						
Inspector Comment						
FS_ID:14664						
DS_ID:18834						
EP_NO: 9906						
Repair Type: Non-Urgent						
Crossing Status: Found						
UCIP Comments: Pipe appears to be abandoned and should be done so properly.						
FIELD_STRUCT_DESC: 24-inch steel irrigation pipe through the levee, 13 feet below the crown. Slide gate on the waterside (WS) end. Pump house on berm. Slide gate in 7-foot by 12-foot concrete pit on the WS with flap gate on pipe from pump house. Pipe discharges into irrigation ditch on landward side. (Automatic Board Order (ABO) issued as Permit No. 9906, 1974 - Jeanette S. Clare). [Additional Reference(s): DWR Levee Log, 1992. USACE Sacramento O&M Manual 138, July 1955 (Station 1148+70)].						
FS Date: 6/4/2013

Pumphouse and 7'X12' concrete box on WS slope.

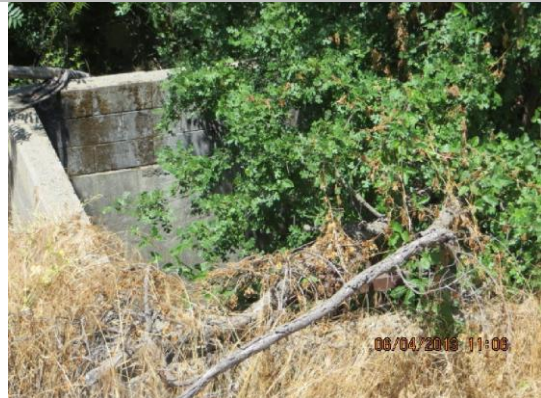
Photo 2 of 3 : UCIP_FA_2018_14664_24161.jpg

7'X12' Concrete box with flap gate and slide gate on WS slope.

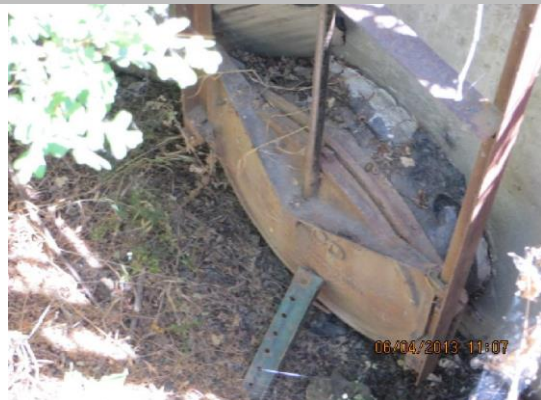
Photo 3 of 3 : UCIP_FA_2018_14664_24160.jpg

Slidegate inside concrete box on WS slope.

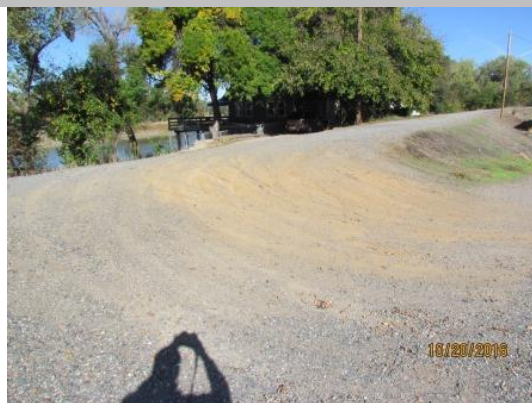
Photo 1 of 1 : FA_2018_LD0003_27_34_20180905_00018.jpg

View of slope instability caused by vehicle traffic.

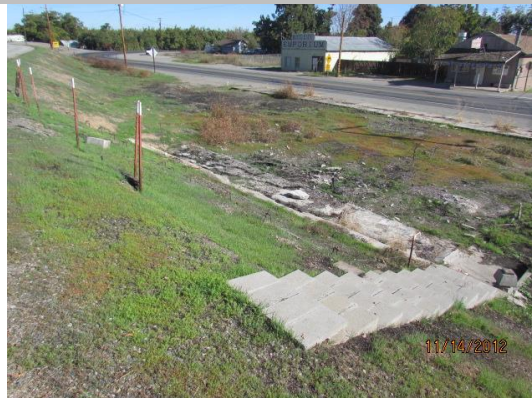
Photo 1 of 1 : FA_2018_LD0003_27_12_20180905_00010.jpg

View of concrete stairs & foundation along the slope of the levee.

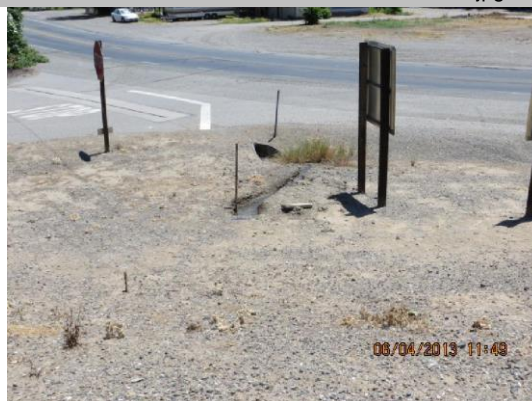
Photo 2 of 3 : UCIP_FA_2018_15165_24905.jpg

Pipe leaking at LS toe.

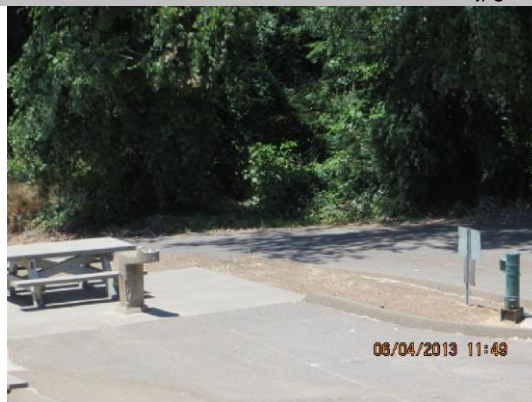
Photo 3 of 3 : UCIP_FA_2018_15165_24904.jpg

Possible reason for water service (water fountain).

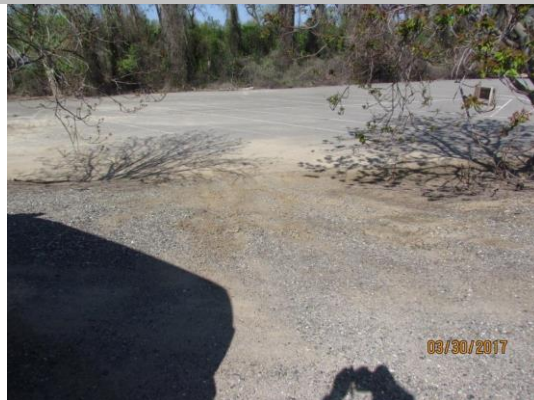
Photo 1 of 1 : FA_2018_LD0003_27_97_20180905_00061.jpg

View of the vehicle ruts on the waterside slope.

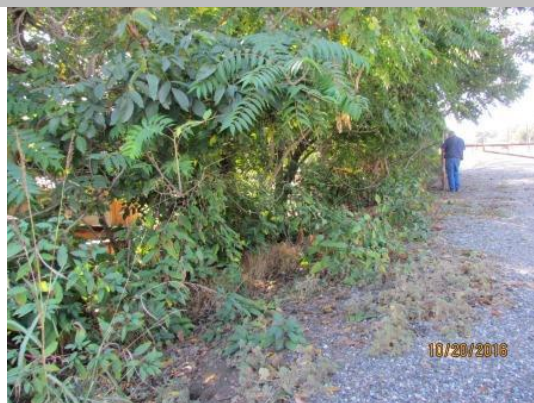
Photo 1 of 1 : FA_2018_LD0003_27_35_20180905_00019.jpg

View of the trees that are hanging over the landside slope of the levee.

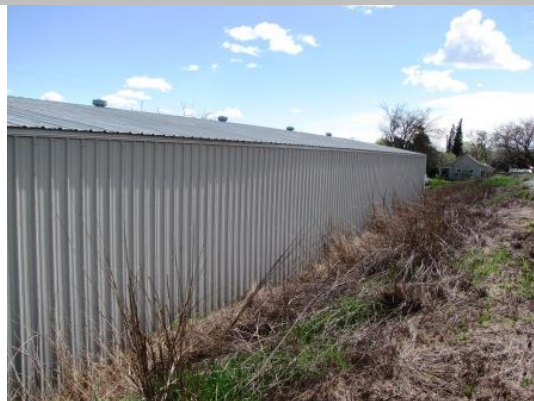
Photo 1 of 1 : FA_2018_LD0003_27_42_20180905_00021.jpg

View of the building along the landside toe.

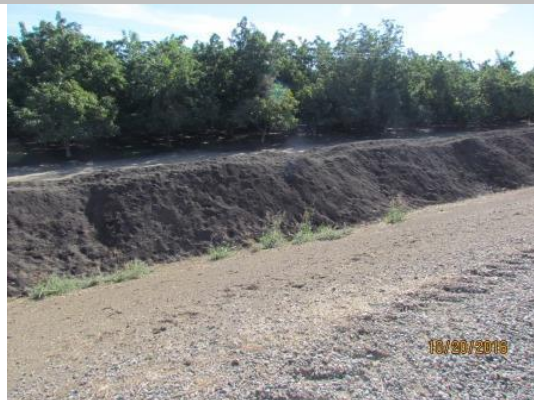
Photo 1 of 1 : FA_2018_LD0003_27_96_20180905_00060.jpg

View of a large pile of mulch along the landside toe.

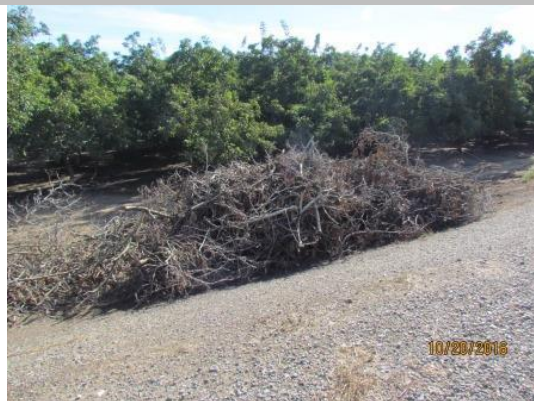
Photo 1 of 1 : FA_2018_LD0003_27_95_20180905_00059.jpg

View of the prunings along the landside toe.

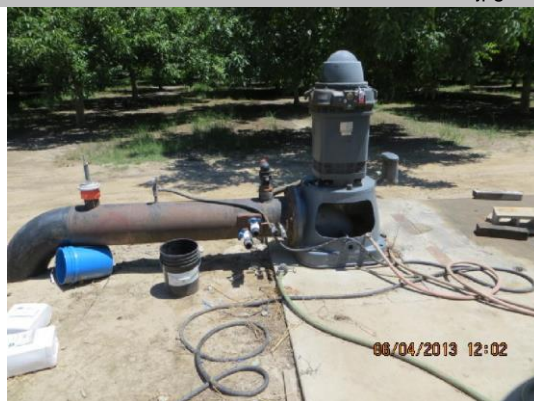
Photo 1 of 2 : UCIP_FA_2018_14686_24184.jpg

Pump located on LS toe next to concrete distribution box.

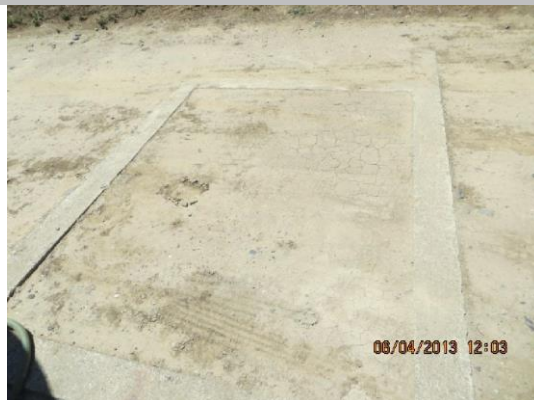
Photo 2 of 2 : UCIP_FA_2018_14686_24183.jpg

Soil filled concrete distribution box on LS toe.

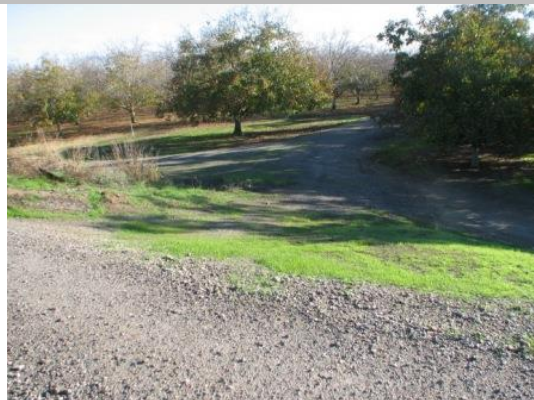
Photo 1 of 1 : FA_2018_LD0003_27_14_20180905_00012.jpg

View of the vehicle erosion along the landside slope.

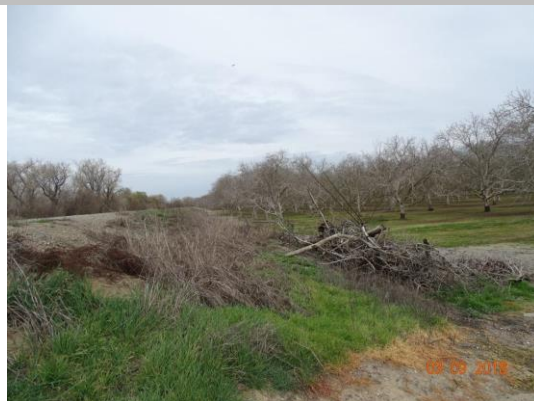
Photo 1 of 1 : FA_2018_LD0003_27_67_20180905_00045.jpg

View of the prunings on the landside slope.

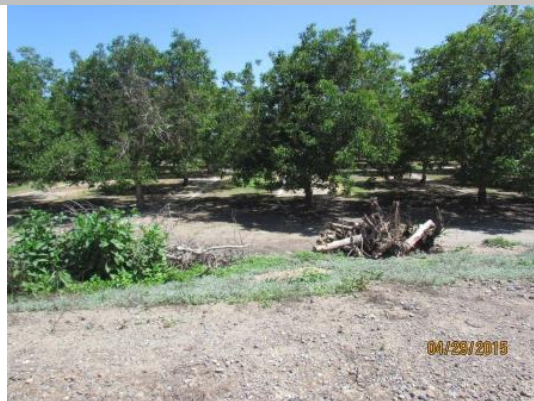
Photo 1 of 1 : FA_2018_LD0003_27_37_20180905_00020.jpg

View of the prunings along the landside slope.

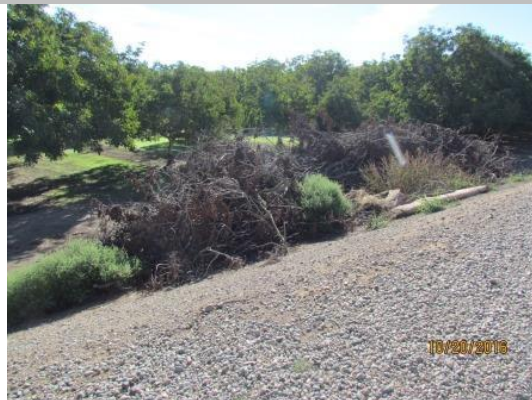
Photo 1 of 1 : FA_2018_LD0003_27_61_20180905_00039.jpg

View of the pruning along the landside toe.

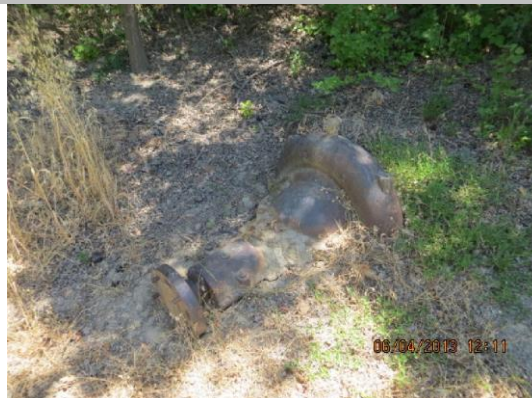
Photo 2 of 3 : UCIP_FA_2018_14687_24186.jpg

Pump visible off WS toe, next to pond.

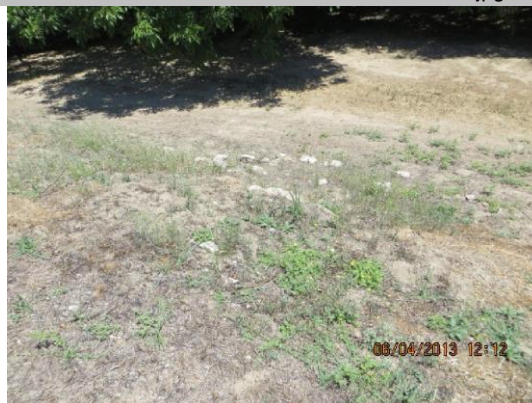
Photo 3 of 3 : UCIP_FA_2018_14687_24185.jpg

Remnants of concrete distribution box on LS toe.

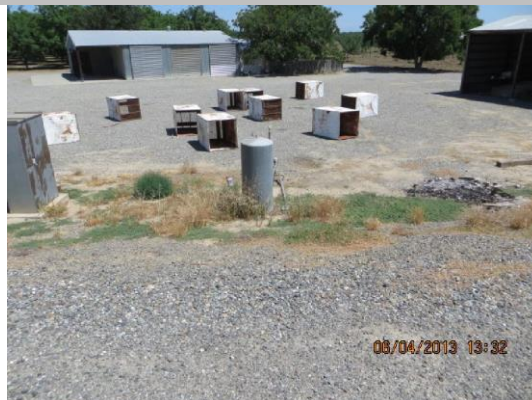
Photo 2 of 3 : UCIP_FA_2018_14688_24189.jpg

Water tank, pump, and well head on LS toe.

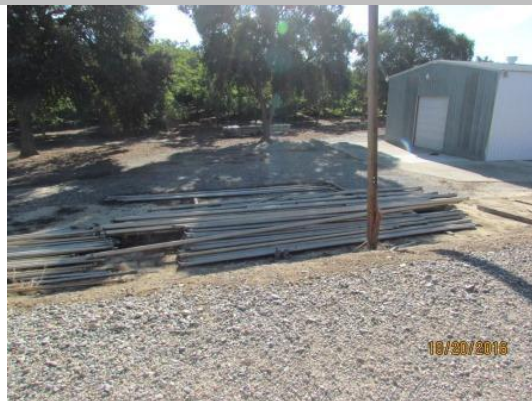
Photo 1 of 1 : FA_2018_LD0003_27_94_20180905_00058.jpg

View of the ag pipes along the landside toe.

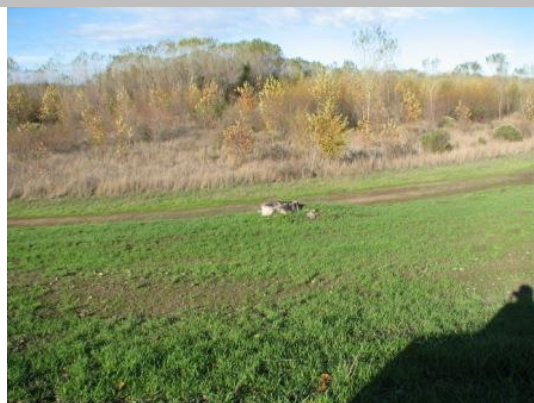
Photo 1 of 1 : FA_2018_LD0003_27_29_20180905_00016.jpg

View of the stump along the toe.

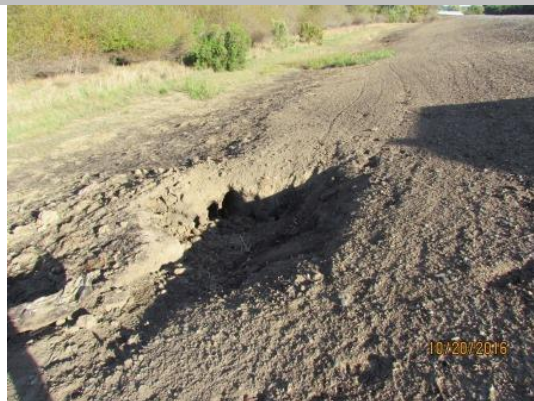
Photo 1 of 1 : FA_2018_LD0003_27_89_20180905_00055.jpg

View of a hole along the waterside slope that need to be backfilled and compacted.

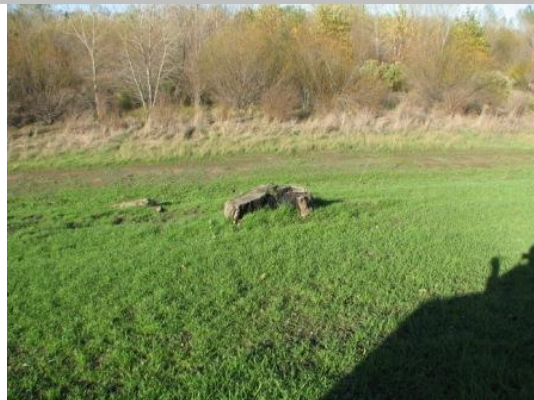
Photo 1 of 1 : FA_2018_LD0003_27_30_20180905_00017.jpg

View of the stump along the slope.

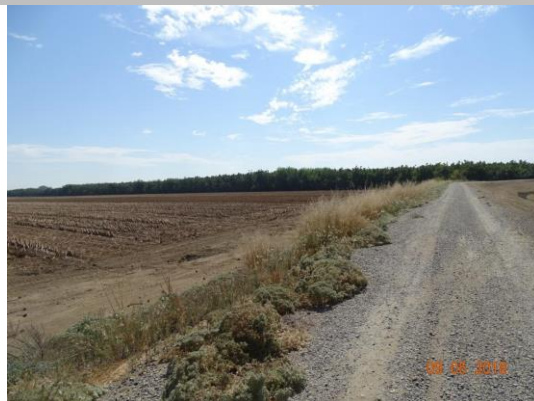
Photo 1 of 1 : FA_2018_LD0003_27_81_20181001_00113.jpg

View of the vegetation along the landside slope.

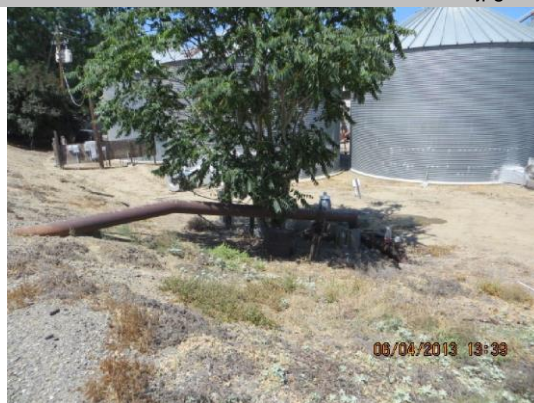
Photo 1 of 3 : UCIP_FA_2018_14690_24193.jpg

10-inch pipe and pump on LS.

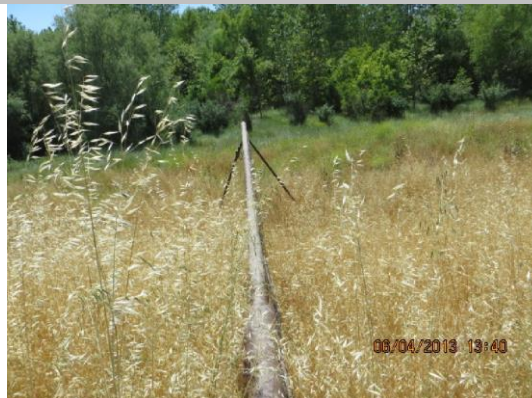
Photo 2 of 3 : UCIP_FA_2018_14690_24192.jpg

Pipe on WS shoulder.

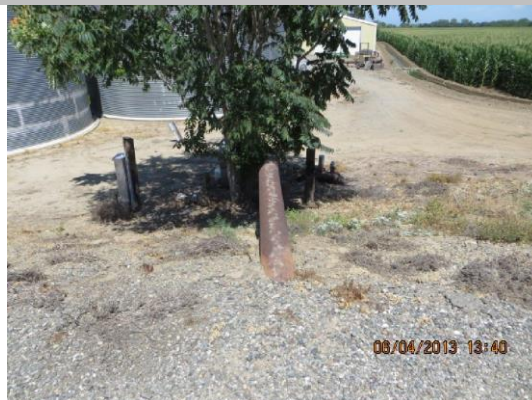
Photo 3 of 3 : UCIP_FA_2018_14690_24191.jpg

10-inch pipe on LS.

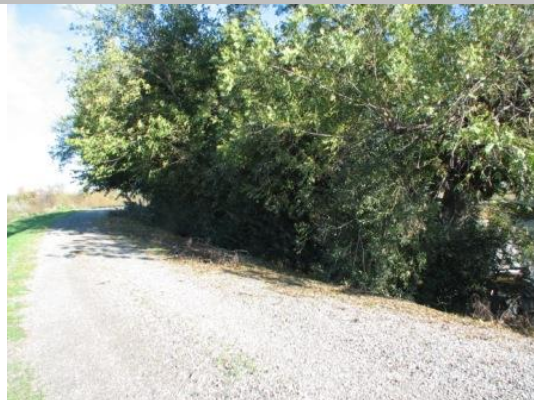
Photo 1 of 1 : FA_2018_LD0003_27_4_20180905_00002.jpg

View of the trees along the landside slope.

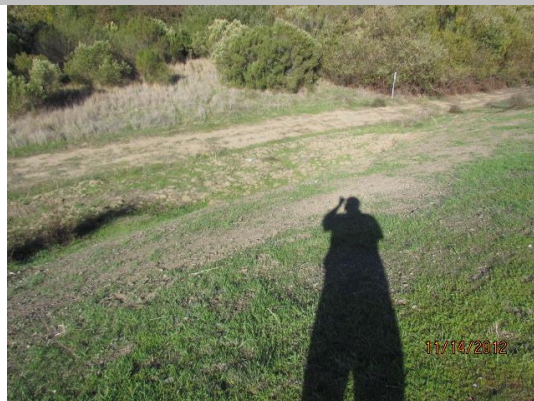
Photo 1 of 1 : FA_2018_LD0003_27_6_20180905_00004.jpg

View of the vertical cut along the waterside toe.
