**Flood Control Project Maintenance  
Levee Inspections**

**Fall 2019 Levee Maintenance Deficiency Summary Report**

**Flood Control Project Maintenance  
Levee Inspections****LMA District Cover Sheet****Fall 2019 Levee Inspection Results****Levee District No. 0003 (Glenn County)**

**Levee District No. 0003 (Glenn County)**

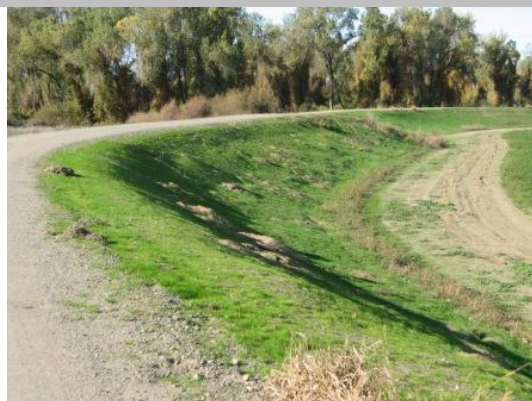
Photo 1 of 1 : FA\_2019\_LD0003\_27\_3\_20190822\_00001.jpg

View of squirrel holes along the landside slope.

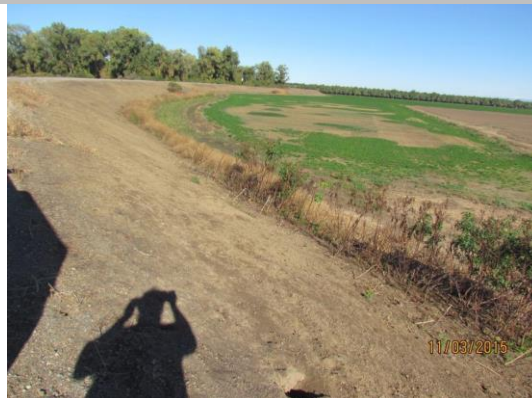
Photo 1 of 1 : FA\_2019\_LD0003\_27\_51\_20190822\_00017.jpg

View of the rodent holes along the landside slope.

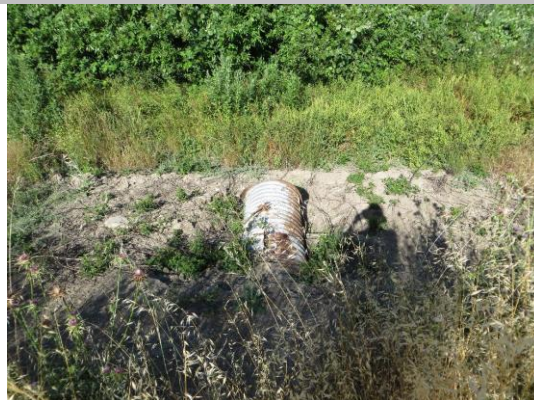
Photo 1 of 3 : UCIP\_FA\_2019\_14573\_24038.jpg

LM Start	1.47	Rating **	M	Issue No.	131
LM End	1.47	Issue Type +	En	Location *	
Category	Supplemental			GPS Latitude/Longitude	
				Start	End
Item	DRAFT DWR UCIP Field Study			39.397780 °	39.397780 °
				-122.002074 °	-122.002074 °
DWR ID	18830				
Comment Code					
Inspector Comment					
DS_ID:18830 FS_ID:14573 EP_NO: 9930 Repair Type: Non-Urgent Crossing Status: Found UCIP Comments: Steel plate welded over WS end of pipe. Slide gate through the levee, 14.5 feet below the crown. Slide gate on waterside (WS) end. 7-foot by 9-foot concrete diversion box at landward toe (Automatic Board Order (ABO) issued as Permit No. 9930, 1974 - Steel Ranch). [Additional Reference(s): DWR Levee Log, 1992. USACE Sacramento O&M Manual 136, March 1960 (HLM 21.89)]. FS Date: 6/4/2013

24-inch CMP stormdrain on WS toe.

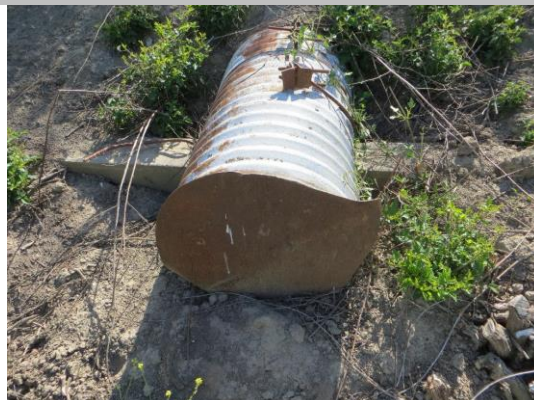
Photo 2 of 3 : UCIP\_FA\_2019\_14573\_24037.jpg

Steel plate welded over end of pipe on WS toe.

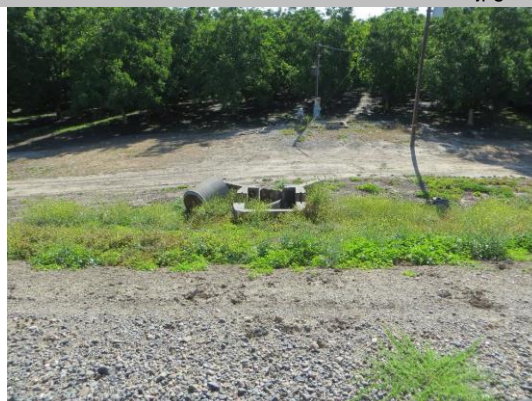
Photo 3 of 3 : UCIP\_FA\_2019\_14573\_24036.jpg

Distribution box on LS toe.

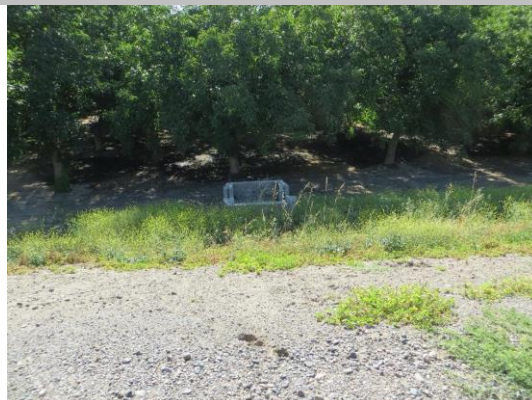
Photo 2 of 2 : UCIP\_FA\_2019\_14576\_24051.jpg

Concrete distribution box at LS toe.

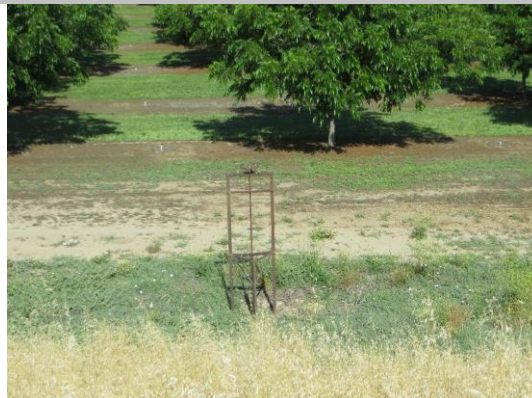
Photo 1 of 3 : UCIP\_FA\_2019\_14577\_24055.jpg

LM Start	1.87	Rating **	M	Issue No.	133	
LM End	1.87	Issue Type +	En	Location *		
Category	Supplemental			GPS Latitude/Longitude		
				Start	End	
Item	DRAFT DWR UCIP Field Study			39.403419 °	39.403419 °	
				-122.001871 °	-122.001871 °	
DWR ID	18825					
Comment Code						
Inspector Comment						
DS_ID:18825 FS_ID:14577 EP_NO: 9935 Repair Type: Non-Urgent Crossing Status: Found UCIP Comments: Appears abandoned. Pipe burried on WS toe. Debris and steel plate blocking inlet on LS. FIELD_STRUCT_DESC: 24-inch corrugated metal irrigation pipe through the levee and beneath the roadway, 18 feet below the crown. Slide gate on the waterside (WS) end. (Automatic Board Order (ABO) issued as Permit No. 9935, 1974 - Florence Watt). [Additional Reference(s): DWR Levee Log, 1992. USACE Sacramento O&M Manual 136, March 1960 (HLM 22.30)]. FS Date: 6/4/2013

Slide gate buried at WS toe.

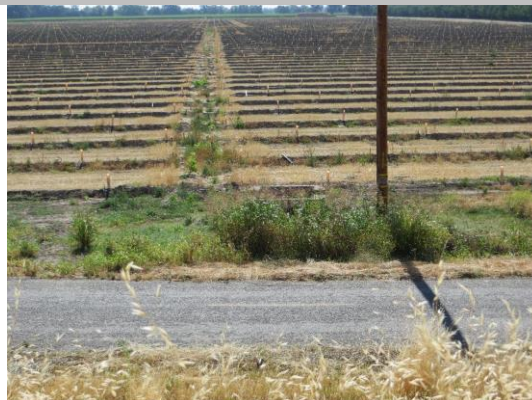
Photo 2 of 3 : UCIP\_FA\_2019\_14577\_24054.jpg

Concrete distribution box off LS toe.

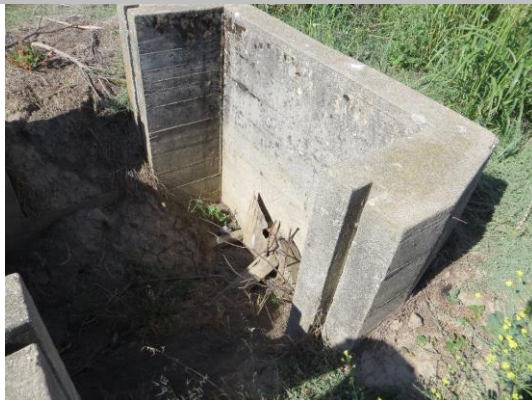
Photo 3 of 3 : UCIP\_FA\_2019\_14577\_24053.jpg

Debris and steel plate blocking inlet on LS toe.

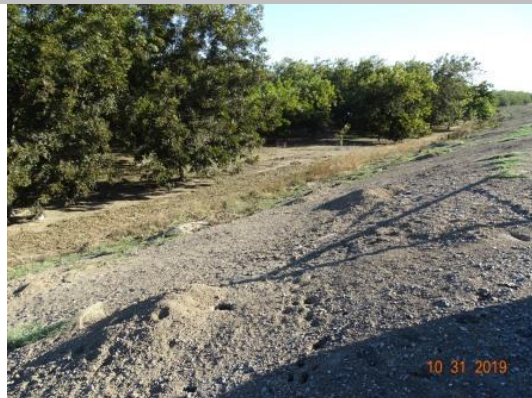
Photo 1 of 1 : FA\_2019\_LD0003\_27\_38\_20191101\_00102.jpg

View of rodent burrows along the waterside slope. Fall 2019.

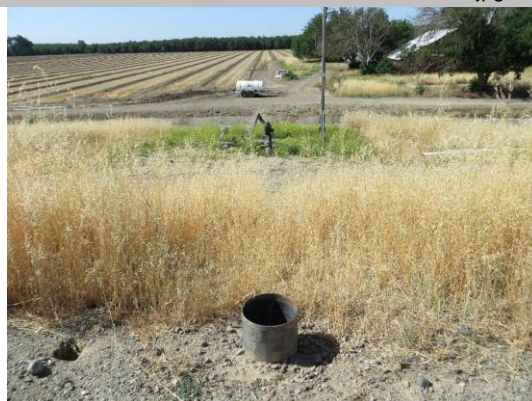
Photo 1 of 3 : UCIP\_FA\_2019\_15144\_24883.jpg

LM Start	2.10	Rating **	M	Issue No.	134	
LM End	2.10	Issue Type +	En	Location *		
Category	Supplemental			GPS Latitude/Longitude		
				Start	End	
Item	DRAFT DWR UCIP Field Study			39.406353 °	39.406353 °	
				-122.000674 °	-122.000674 °	
DWR ID	23151					
Comment Code						
Inspector Comment						
DS_ID:23151 FS_ID:15144 EP_NO: N/A Repair Type: Non-Urgent Crossing Status: Found UCIP Comments: No permit identified for this crossing. FIELD_STRUCT_DESC: 12-inch steel irrigation pipe through the levee, 3.5 feet below the crown. Pump, butterfly valve, and JP/meter at channel on landside (LS) toe. Siphon breaker inside a 12-inch steel riser unit on the LS shoulder. 3-inch plastic drain on the waterside (WS) toe. FS Date: 6/4/2013

Siphon breaker in steel riser on LS shoulder with pump in background.

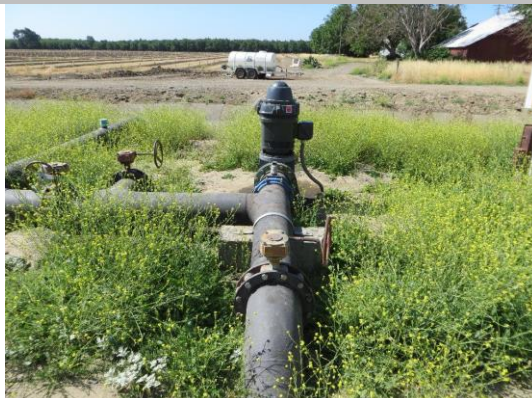
Photo 2 of 3 : UCIP\_FA\_2019\_15144\_24882.jpg

Pump and butterfly valve off LS toe.

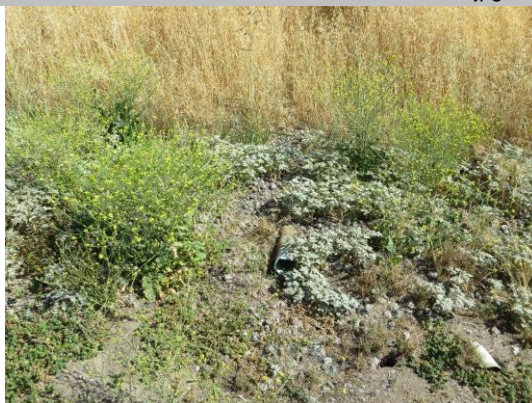
Photo 3 of 3 : UCIP\_FA\_2019\_15144\_24881.jpg

3-inch drain on WS toe (purpose unclear).

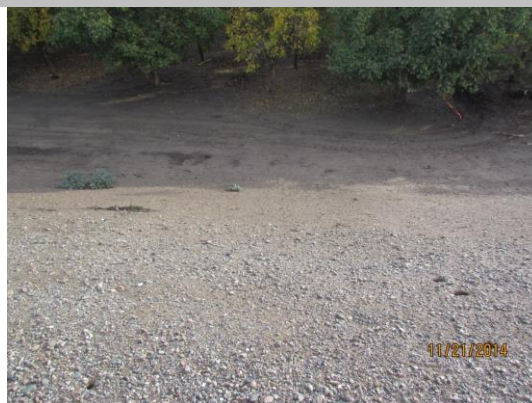
Photo 1 of 1 : FA\_2019\_LD0003\_27\_13\_20190822\_00007.jpg

View of the rodent holes along the waterside slope.

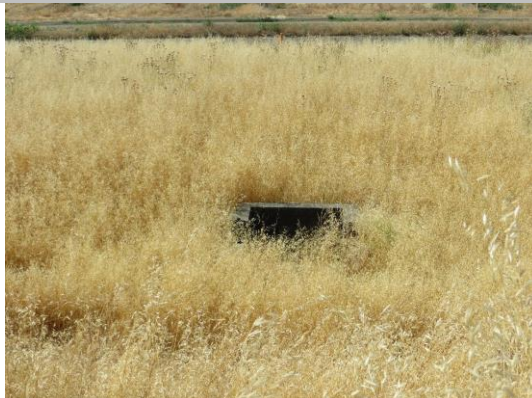
Photo 2 of 3 : UCIP\_FA\_2019\_14582\_24075.jpg

Concrete distribution box on LS toe.

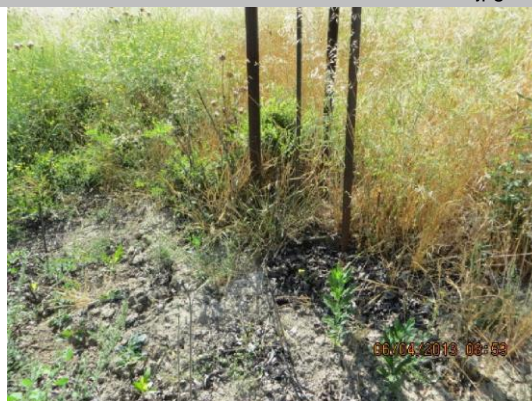
Photo 3 of 3 : UCIP\_FA\_2019\_14582\_24074.jpg

Slide gate at WS toe.

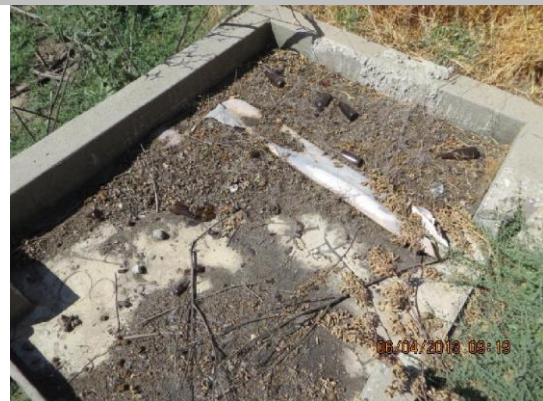
Photo 1 of 2 : UCIP\_FA\_2019\_14584\_24081.jpg

Item	DRAFT DWR UCIP Field Study		39.412827 °	39.412827 °	
			-121.991427 °	-121.991427 °	
DWR ID	18829				
Comment Code					
Inspector Comment					
DS_ID:18829 FS_ID:14584 EP_NO: 9919 Repair Type: Non-Urgent Crossing Status: Indicator Found UCIP Comments: Appears abandoned. Verify it was done correctly. FIELD_STRUCT_DESC: *ABANDONED* 24-inch corrugated metal irrigation pipe through the levee, 16 feet below the crown. Slide gate on the waterside (WS) end. 5-foot by 7-foot concrete distribution box at landside (LS) toe is filled with grout. (Automatic Board Order (ABO) issued as Permit No. 9919, 1974 - Roy and Annie Mills). [Additional Reference(s): DWR Levee Log, 1992. USACE Sacramento O&M Manual 136, March 1960 (HLM 23.43)]. FS Date: 6/4/2013

5'X7' concrete distribution box filled in with grout.

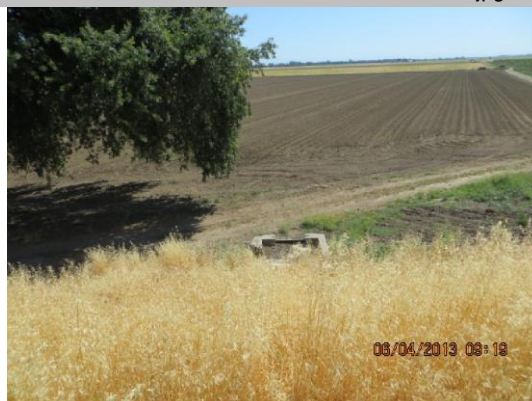
Photo 2 of 2 : UCIP\_FA\_2019\_14584\_24080.jpg

Distribution box on LS toe.

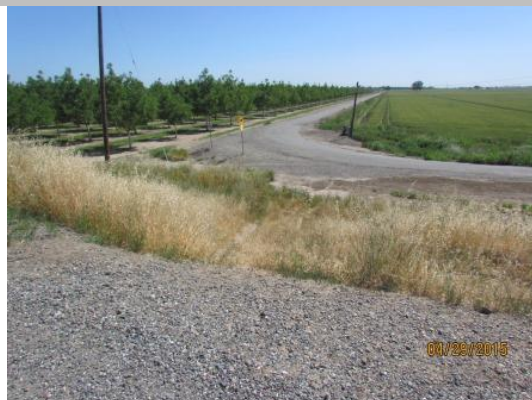
Photo 1 of 1 : FA\_2019\_LD0003\_27\_9\_20190822\_00005.jpg

LM Start	3.39	Rating **	M	Issue No.	9
LM End	3.39	Issue Type +	Ma	Location *	LS
Category	Earthen Levee			GPS Latitude/Longitude	
				Start	End
Item	Slope Stability			39.418382 °	39.418382 °
				-121.992480 °	-121.992480 °
DWR ID	DWR_LD0003_01_s_2012_9				
Comment Code					
S3 : Repair the levee slope damaged by vehicle traffic and prevent access where possible.					
Inspector Comment					
Repair the erosion along the landside slope and prevent vehicle access.

View of the vehicle erosion along the landside slope.

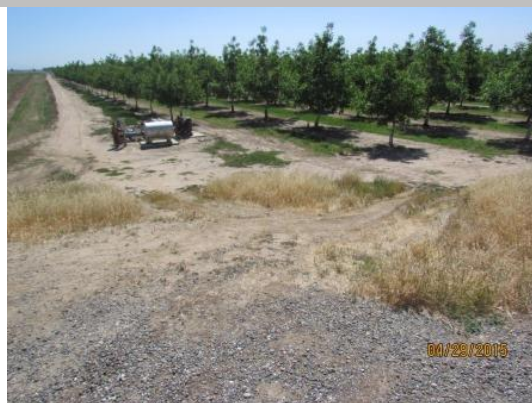
Photo 1 of 1 : FA\_2019\_LD0003\_27\_19\_20190822\_00009.jpg

LM Start	3.76	Rating **	M	Issue No.	19
LM End	3.76	Issue Type +	Ma	Location *	LS
Category	Earthen Levee			GPS Latitude/Longitude	
				Start	End
Item	Slope Stability			39.423747 °	39.423747 °
				-121.991667 °	-121.991667 °
DWR ID	DWR_LD0003_01_s_2012_19				
Comment Code					
S3 : Repair the levee slope damaged by vehicle traffic and prevent access where possible.					
Inspector Comment

View of the vehicle erosion along the landside slope.

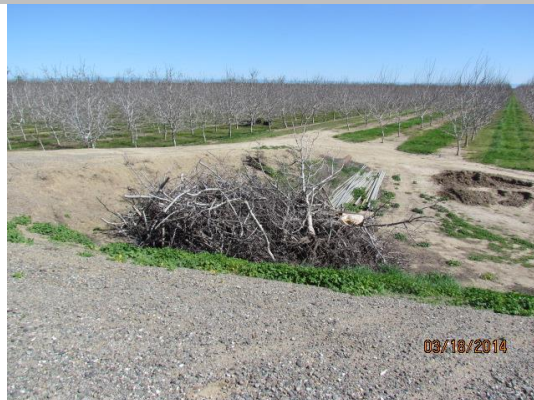
Photo 1 of 1 : FA\_2019\_LD0003\_27\_68\_20190822\_00029.jpg

View of the prunings along the landside toe.

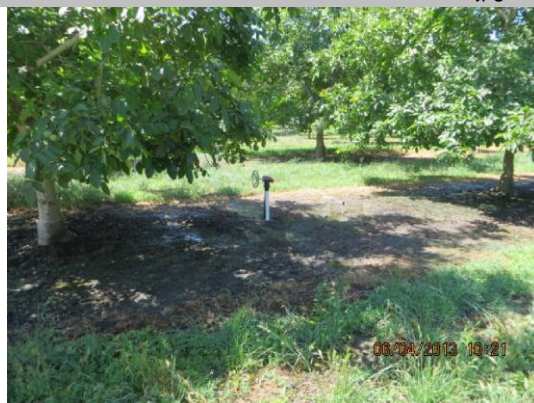
Photo 1 of 3 : UCIP\_FA\_2019\_15163\_24902.jpg

Possible shutoff valve on WS toe.

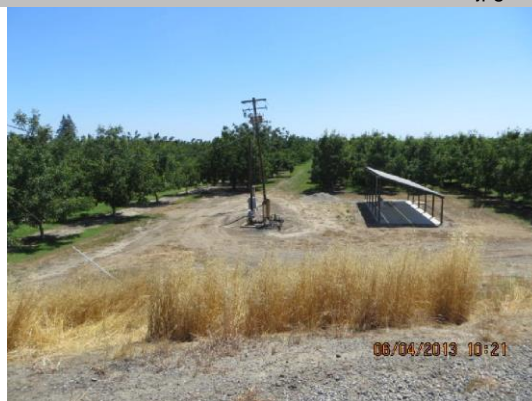
Photo 2 of 3 : UCIP\_FA\_2019\_15163\_24901.jpg

Pumping plant off LS toe.

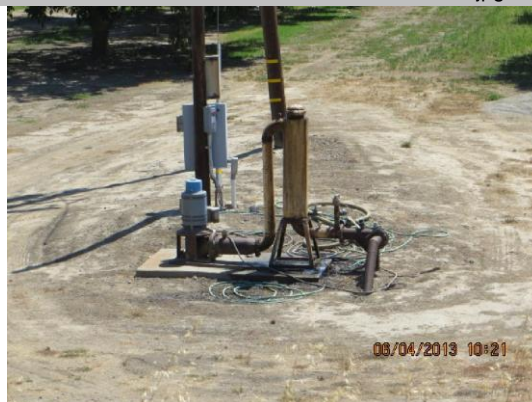
Photo 3 of 3 : UCIP\_FA\_2019\_15163\_24900.jpg

Pumping plant off LS toe.

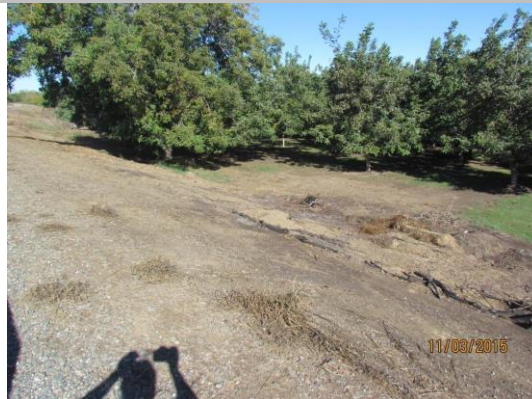
Photo 1 of 1 : FA\_2019\_LD0003\_27\_21\_20190822\_00010.jpg

View of the rodent holes along the landside slope.

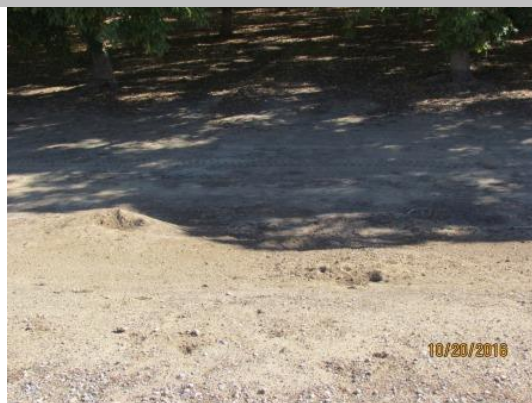
Photo 1 of 1 : FA\_2019\_LD0003\_27\_62\_20190822\_00023.jpg

View of the rodent holes along the landside slope.

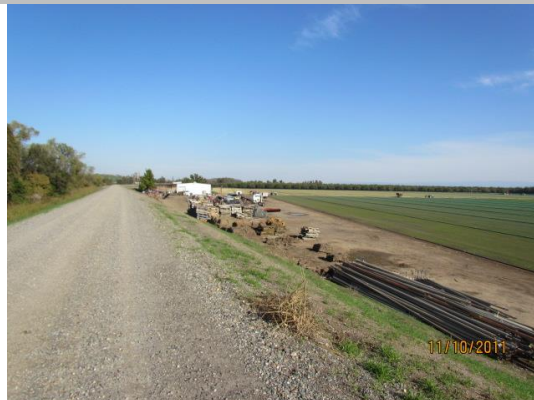
Photo 1 of 1 : FA\_2019\_LD0003\_27\_25\_20190822\_00011.jpg

View of the equipment along the landside toe.

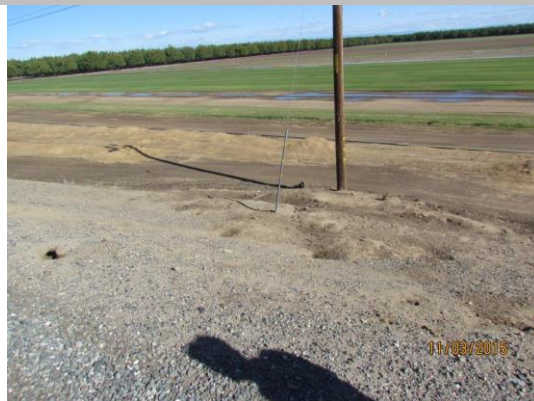
Photo 1 of 1 : FA\_2019\_LD0003\_27\_71\_20190822\_00032.jpg

View of the rodent holes along the landside slope.

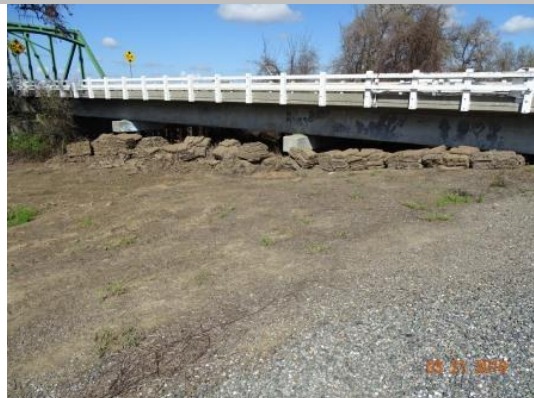
Photo 1 of 1 : FA\_2019\_LD0003\_27\_110\_20190822\_00052.jpg

View of the sod piles on the waterside slope within the floodway, facing upstream. (Spring 2019)

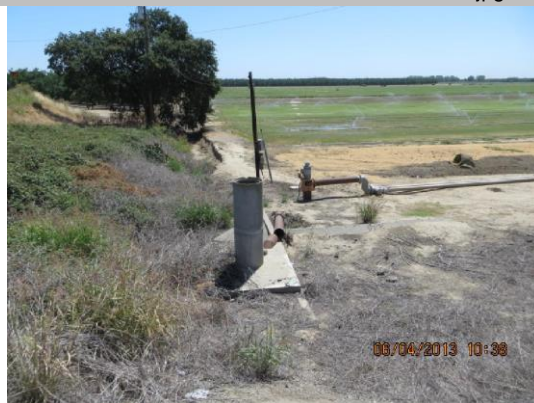
Photo 1 of 3 : UCIP\_FA\_2019\_14643\_24142.jpg

Concrete standpipe on LS toe.

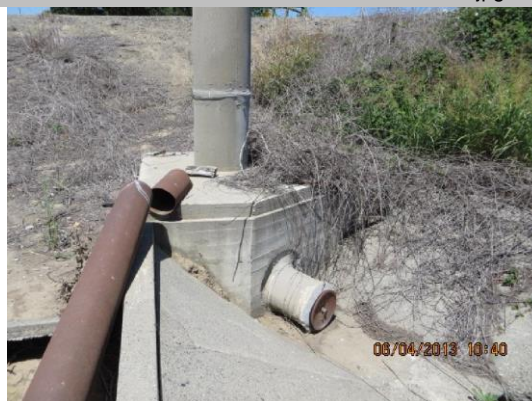
Photo 2 of 3 : UCIP\_FA\_2019\_14643\_24141.jpg

Concrete standpipe and channel on LS toe.

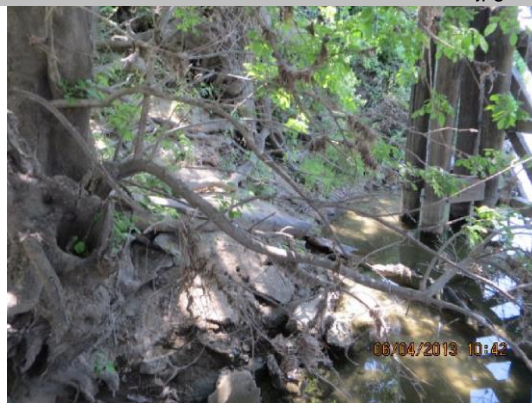
Photo 3 of 3 : UCIP\_FA\_2019\_14643\_24140.jpg

14-inch Pipe debris on WS toe.

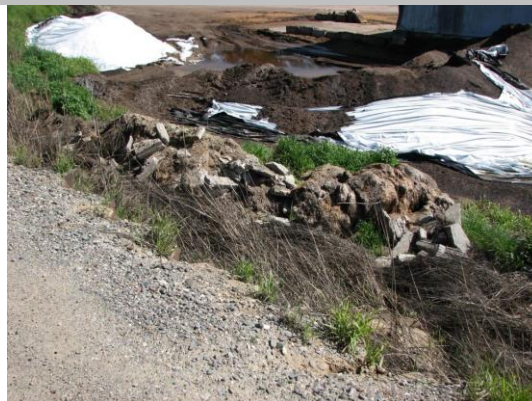
Photo 1 of 1 : FA\_2019\_LD0003\_27\_65\_20190822\_00026.jpg

View of concrete and soil obstructing visibility and access.

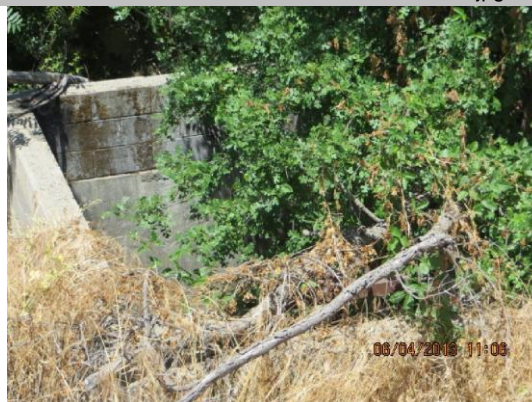
Photo 2 of 3 : UCIP\_FA\_2019\_14664\_24161.jpg

7'X12' Concrete box with flap gate and slide gate on WS slope.

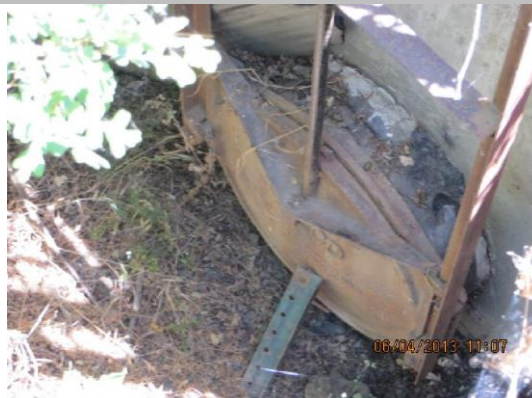
Photo 3 of 3 : UCIP\_FA\_2019\_14664\_24160.jpg

Slidegate inside concrete box on WS slope.

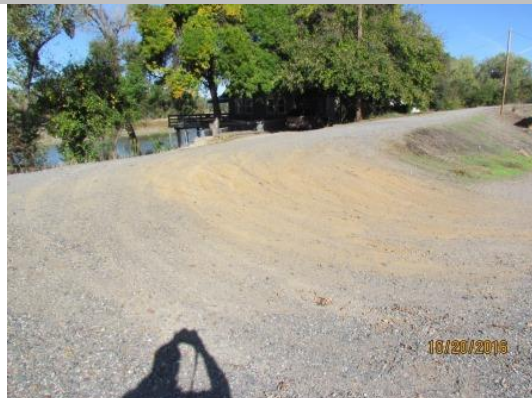
Photo 1 of 1 : FA\_2019\_LD0003\_27\_34\_20190822\_00012.jpg

View of slope instability caused by vehicle traffic.

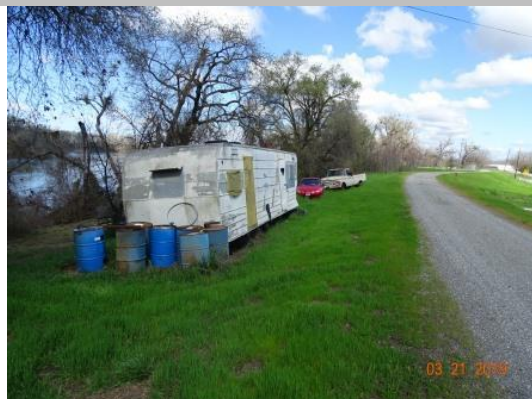
Photo 2 of 2 : FA\_2019\_LD0003\_27\_115\_20190822\_00054.jpg

Photo 2. View of an abandoned RV, cars and drums on the waterside slope, facing upstream.

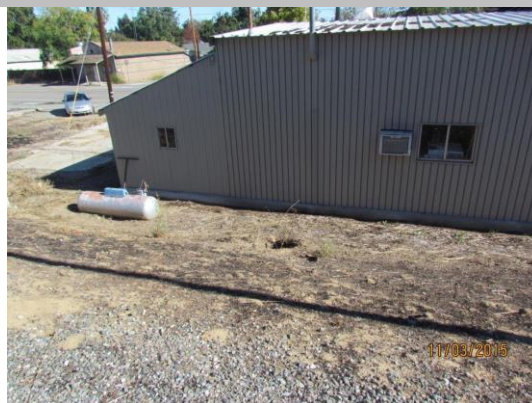
Photo 1 of 1 : FA\_2019\_LD0003\_27\_76\_20190822\_00036.jpg

View of the burned out stump hole along the landside toe.

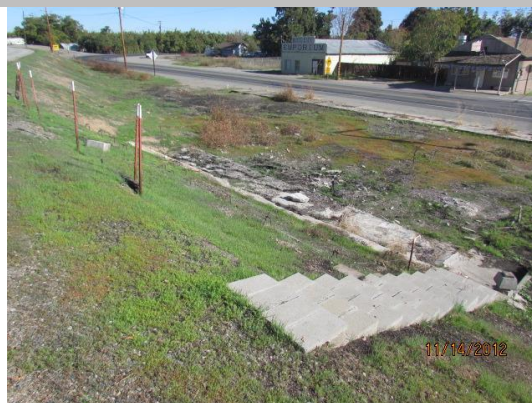
Photo 1 of 1 : FA\_2019\_LD0003\_27\_12\_20190822\_00006.jpg

View of concrete stairs &amp; foundation along the slope of the levee.

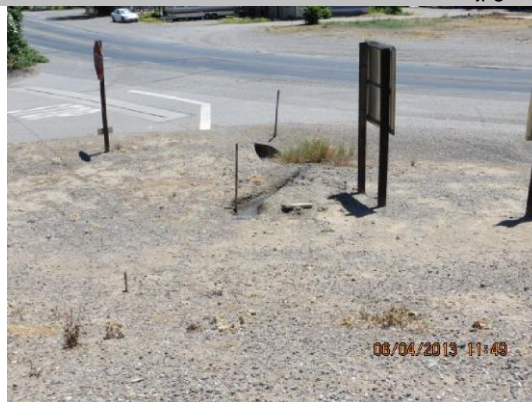
Photo 2 of 3 : UCIP\_FA\_2019\_15165\_24905.jpg

Pipe leaking at LS toe.

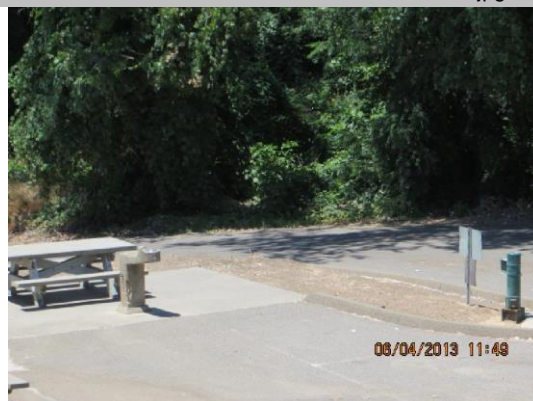
Photo 3 of 3 : UCIP\_FA\_2019\_15165\_24904.jpg

Possible reason for water service (water fountain).

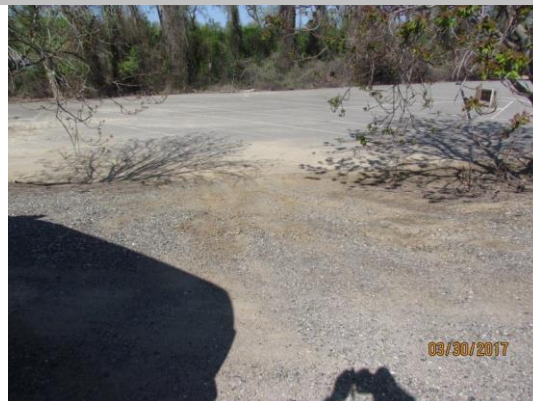
Photo 1 of 1 : FA\_2019\_LD0003\_27\_97\_20190822\_00046.jpg

View of the vehicle ruts on the waterside slope.

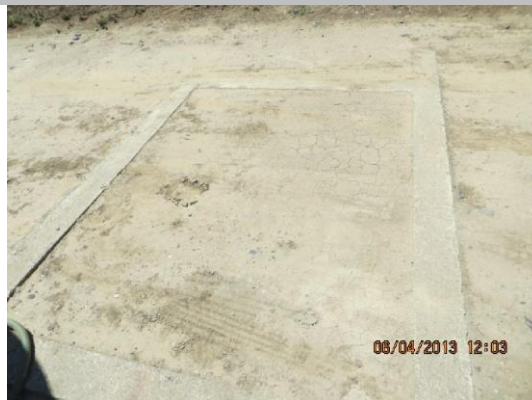
Photo 2 of 2 : UCIP\_FA\_2019\_14686\_24183.jpg

Soil filled concrete distribution box on LS toe.

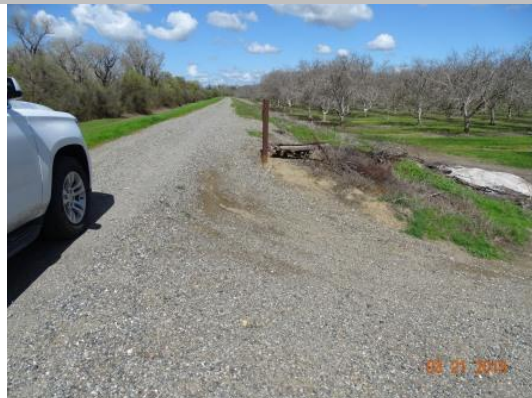
Photo 1 of 1 : FA\_2019\_LD0003\_27\_14\_20190822\_00008.jpg

View of the erosion caused by vehicle traffic along the landside slope and crown, facing upstream. (Spring 2019)

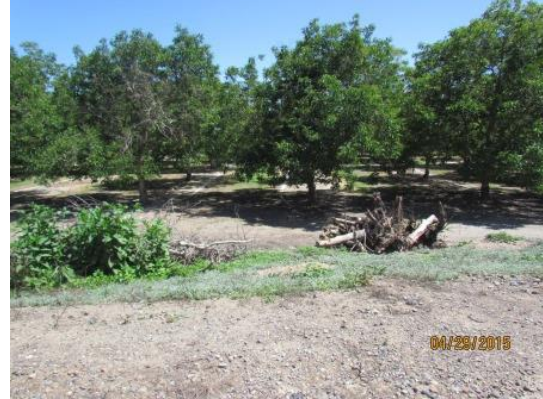
Photo 1 of 1 : FA\_2019\_LD0003\_27\_37\_20190822\_00014.jpg

View of the prunings along the landside slope.

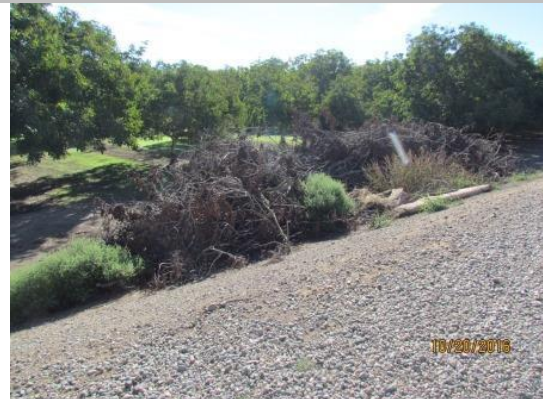
Photo 1 of 1 : FA\_2019\_LD0003\_27\_61\_20190822\_00022.jpg

View of the pruning along the landside toe.

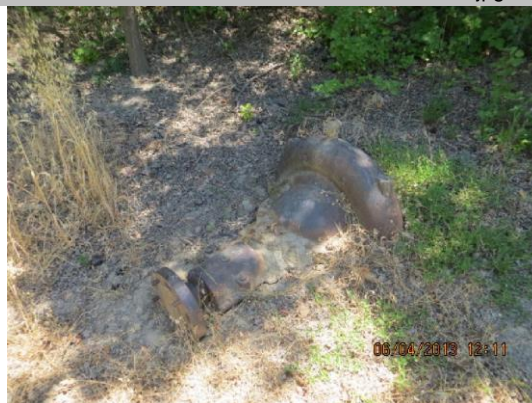
Photo 2 of 3 : UCIP\_FA\_2019\_14687\_24186.jpg

Pump visible off WS toe, next to pond.

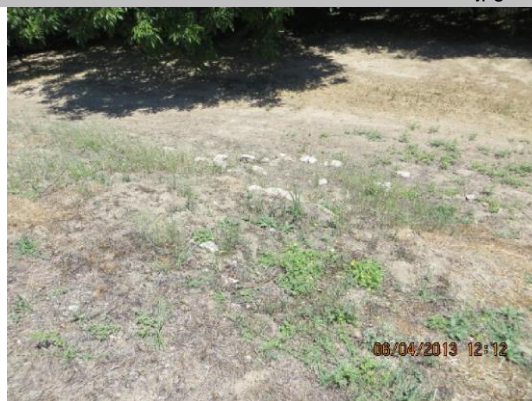
Photo 3 of 3 : UCIP\_FA\_2019\_14687\_24185.jpg

Remnants of concrete distribution box on LS toe.

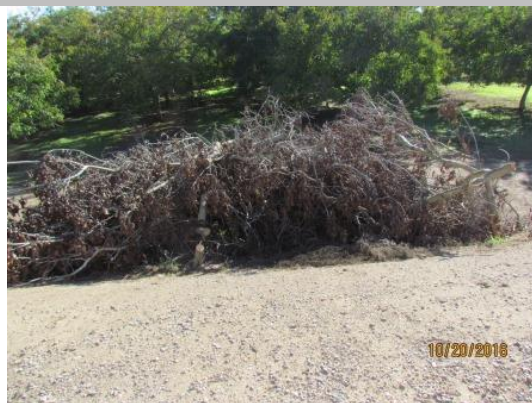
Photo 1 of 1 : FA\_2019\_LD0003\_27\_60\_20190822\_00021.jpg

View of the prunings along the landside toe.

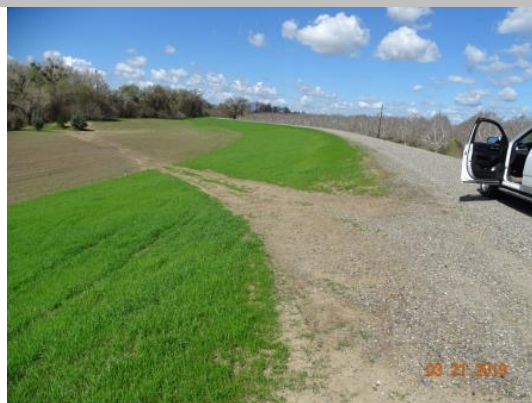
Photo 1 of 1 : FA\_2019\_LD0003\_27\_120\_20190822\_00056.jpg

View of the waterside slope damage caused by vehicle traffic, facing upstream. (Spring 2019)

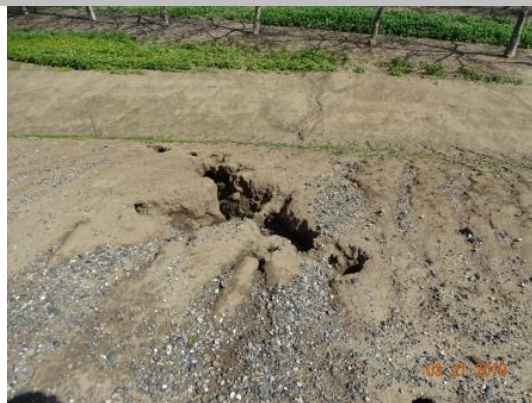
Photo 1 of 1 : FA\_2019\_LD0003\_27\_119\_20190822\_00055.jpg

View of the erosion caused by water runoff and rodent holes on the landside slope, facing east. (Spring 2019)

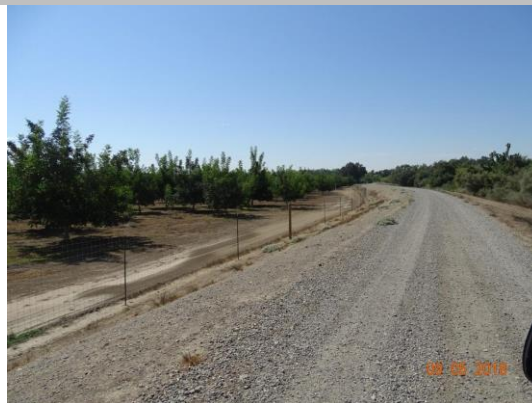
Photo 1 of 1 : FA\_2019\_LD0003\_27\_85\_20190822\_00042.jpg

View of the fence along the landside toe.

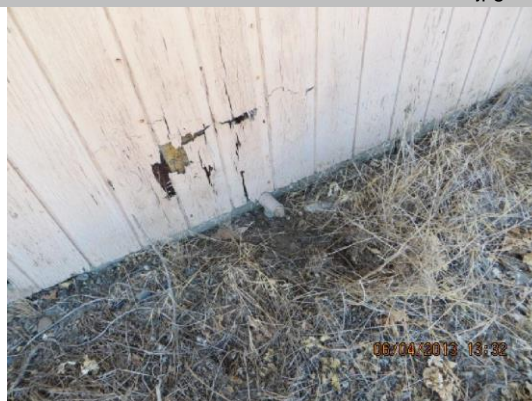
Photo 1 of 3 : UCIP\_FA\_2019\_14688\_24190.jpg

Pipe at side of building on WS shoulder.

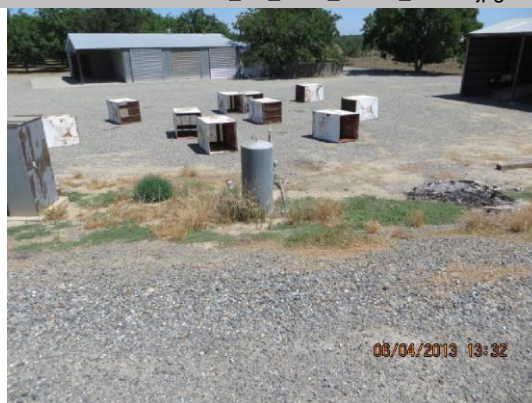
Photo 2 of 3 : UCIP\_FA\_2019\_14688\_24189.jpg

Water tank, pump, and well head on LS toe.

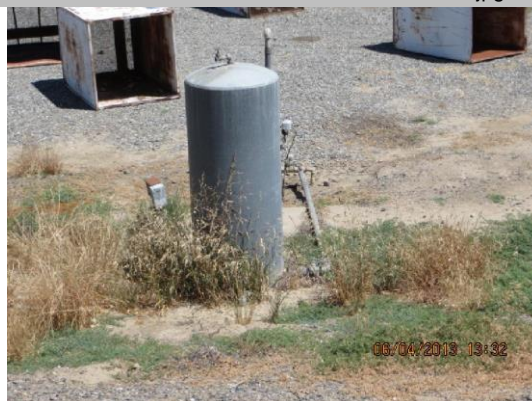
Photo 3 of 3 : UCIP\_FA\_2019\_14688\_24188.jpg

Water tank, pump, and well head on LS toe.

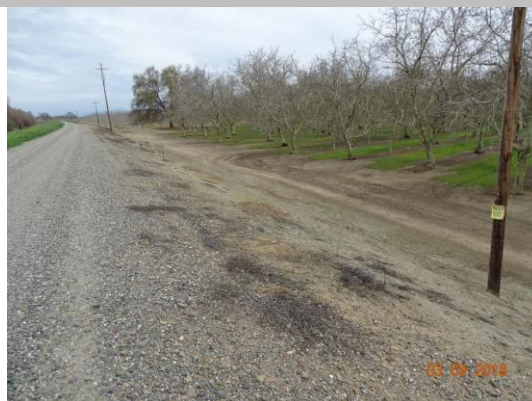
Photo 1 of 1 : FA\_2019\_LD0003\_27\_78\_20190822\_00038.jpg

View of the rodent holes along the landside slope.

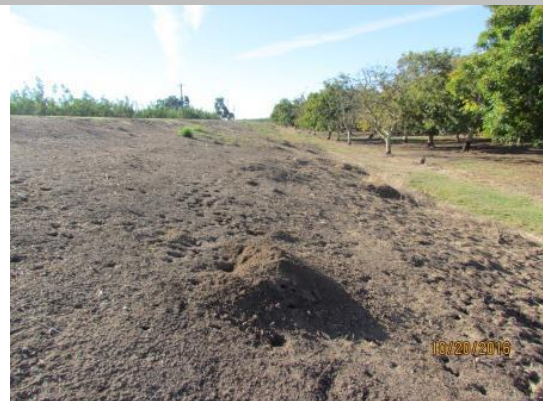
Photo 1 of 1 : FA\_2019\_LD0003\_27\_93\_20190822\_00044.jpg

View of the rodent holes along the waterside slope.

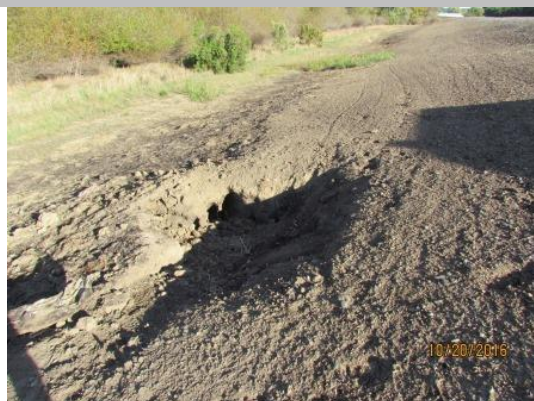
Photo 1 of 1 : FA\_2019\_LD0003\_27\_89\_20190822\_00043.jpg

View of a hole along the waterside slope that needs to be backfilled and compacted.

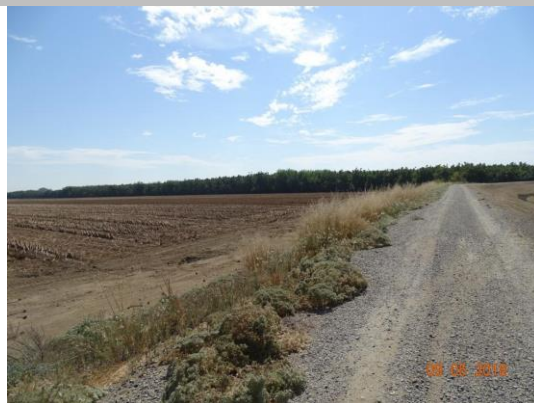
Photo 1 of 1 : FA\_2019\_LD0003\_27\_81\_20190822\_00040.jpg

View of the vegetation along the landside slope.

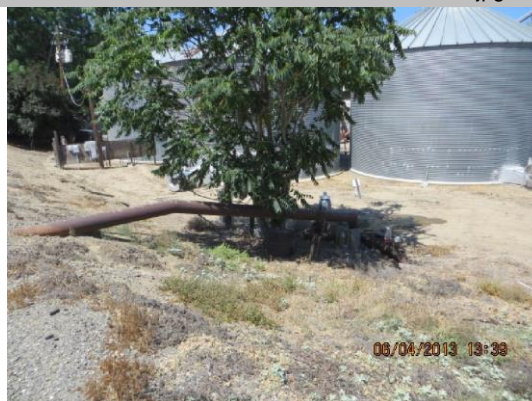
Photo 1 of 3 : UCIP\_FA\_2019\_14690\_24193.jpg

10-inch pipe and pump on LS.

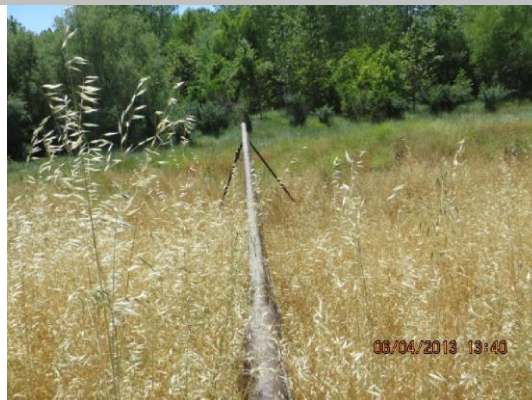
Photo 2 of 3 : UCIP\_FA\_2019\_14690\_24192.jpg

Pipe on WS shoulder.

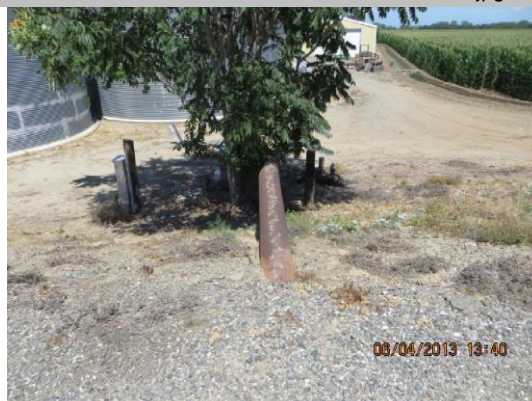
Photo 3 of 3 : UCIP\_FA\_2019\_14690\_24191.jpg

10-inch pipe on LS.

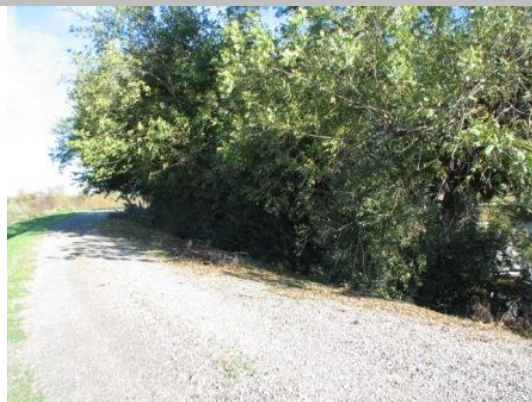
Photo 1 of 1 : FA\_2019\_LD0003\_27\_4\_20190822\_00002.jpg

View of the trees along the landside slope.

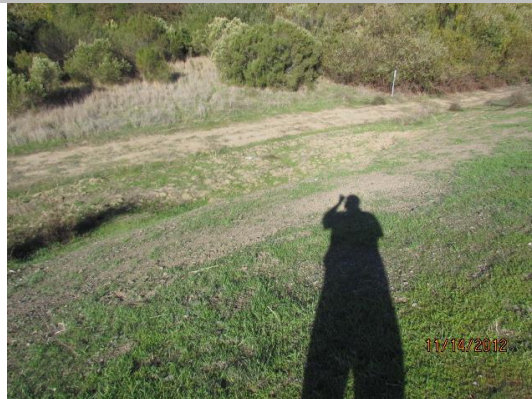
Photo 1 of 1 : FA\_2019\_LD0003\_27\_6\_20190822\_00003.jpg

View of the vertical cut along the waterside toe.

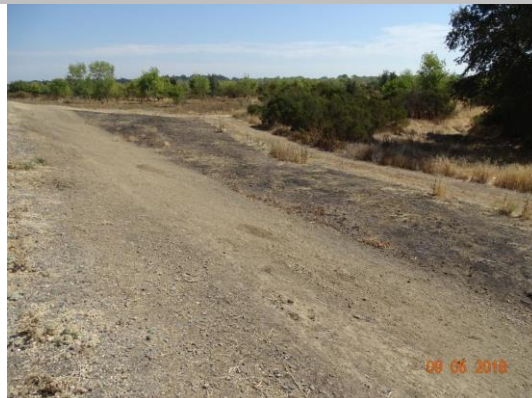
Photo 1 of 1 : FA\_2019\_LD0003\_27\_79\_20190822\_00039.jpg

View of the rodent holes along the landside slope.
