Flood Control Project Maintenance Levee Inspections

Fall 2020 Levee Maintenance Deficiency Summary Report

Sacramento River Basin

Levee District No. 0003 (Glenn County)

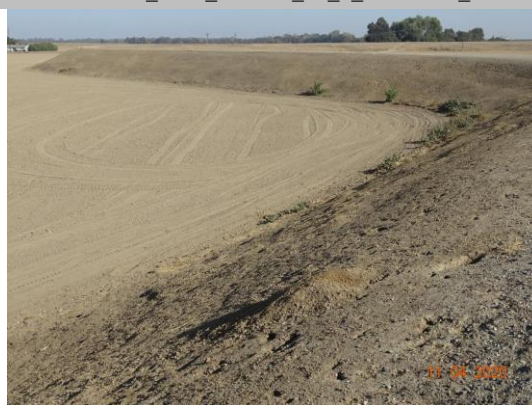
Photo 1 of 1 : FA_2020_LD0003_27_3_20201105_00093.jpg

View of the rodent activity along the landside slope. Fall 2020.

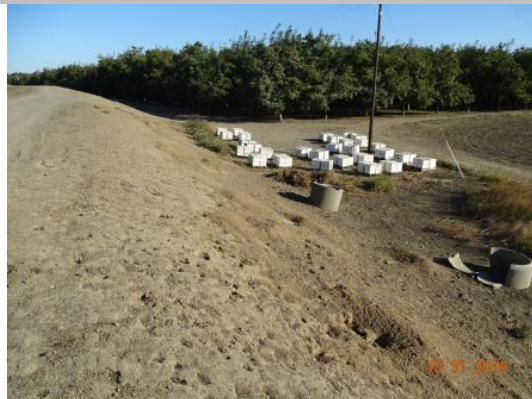
Photo 1 of 1 : FA_2020_LD0003_27_52_20200915_00019.jpg

View of the rodent burrows along the landside slope. Fall 2019.

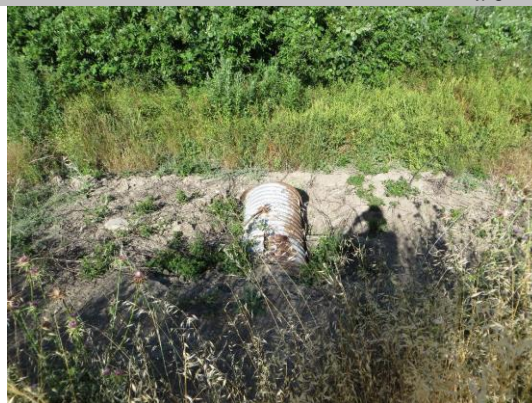
Photo 1 of 3 : UCIP_FA_2020_14573_24038.jpg

LM Start	1.47	Rating **	M	Issue No.	131
LM End	1.47	Issue Type +	En	Location *	
Category	Supplemental			GPS Latitude/Longitude	
				Start	End
Item	DWR UCIP Field Study			39.397780 °	39.397780 °
				-122.002074 °	-122.002074 °
DWR ID	18830				
Comment Code					
Inspector Comment					
DS_ID:18830 FS_ID:14573 EP_NO: 9930 Repair Type: Non-Urgent EVAL Issue: Crossing Status: Found UCIP Comments: Steel plate welded over WS end of pipe. Slide gate at WS toe missing. Appears abandoned. FIELD_STRUCT_DESC: 24-inch corrugated metal irrigation pipe through the levee, 14.5 feet below the crown. Slide gate on waterside (WS) end. 7-foot by 9-foot concrete diversion box at landward toe (Automatic Board Order (ABO) issued as Permit No. 9930, 1974 - Steel Ranch). [Additional Reference(s): DWR Levee Log, 1992. USACE Sacramento O&M Manual 136, March 1960 (HLM 21.89)]. FS Date: 6/4/2013

24-inch CMP stormdrain on WS toe.

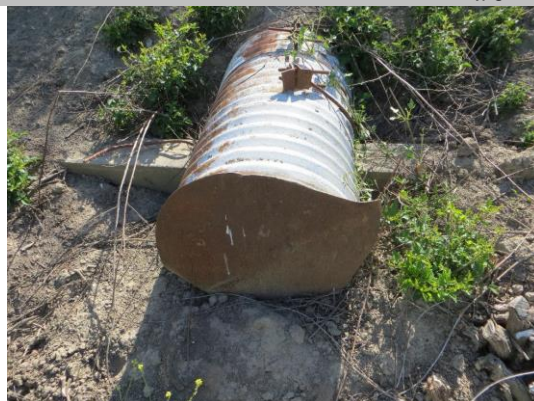
Photo 2 of 3 : UCIP_FA_2020_14573_24037.jpg

Steel plate welded over end of pipe on WS toe.

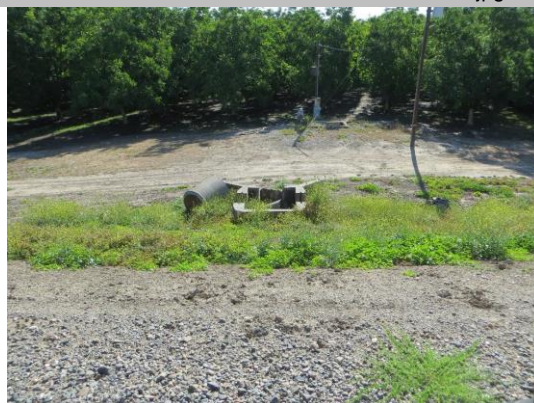
Photo 3 of 3 : UCIP_FA_2020_14573_24036.jpg

Distribution box on LS toe.

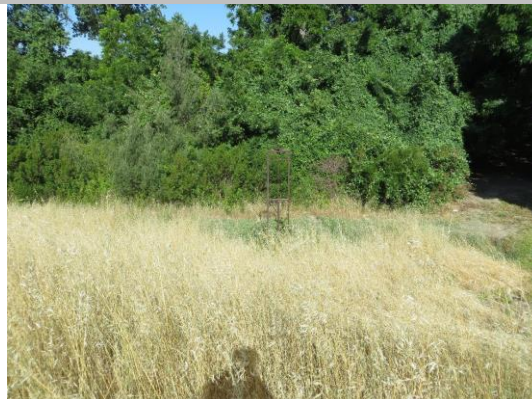
Photo 1 of 2 : UCIP_FA_2020_14576_24052.jpg

LM Start	1.58	Rating **	M	Issue No.	132
LM End	1.58	Issue Type +	En	Location *	
Category	Supplemental			GPS Latitude/Longitude	
				Start	End
Item	DWR UCIP Field Study			39.399330 °	39.399330 °
				-122.002402 °	-122.002402 °
DWR ID	18823				
Comment Code					
Inspector Comment					
DS_ID:18823 FS_ID:14576 EP_NO: 9931 Repair Type: Non-Urgent EVAL Issue: Crossing Status: Found UCIP Comments: Appears abandoned. Pipe burried at slide gate on WS toe. FIELD_STRUCT_DESC: 24-inch corrugated metal irrigation pipe through the levee, 15 feet below the crown. Slide gate on the waterside (WS) end. 6-foot by 7-foot concrete distribution box on the landside (LS) toe. (Automatic Board Order (ABO) issued as Permit No. 9931, 1974 - Lowell F. Steel). [Additional Reference(s): DWR Levee Log, 1992. USACE Sacramento O&M Manual 136, March 1960 (HLM 22.00)]. FS Date: 6/4/2013

Slide gate at WS toe.

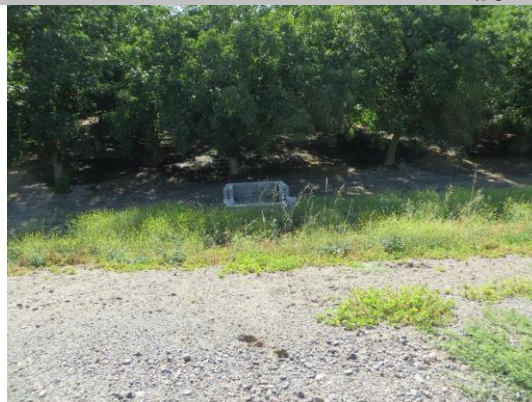
Photo 2 of 2 : UCIP_FA_2020_14576_24051.jpg

Concrete distribution box at LS toe.

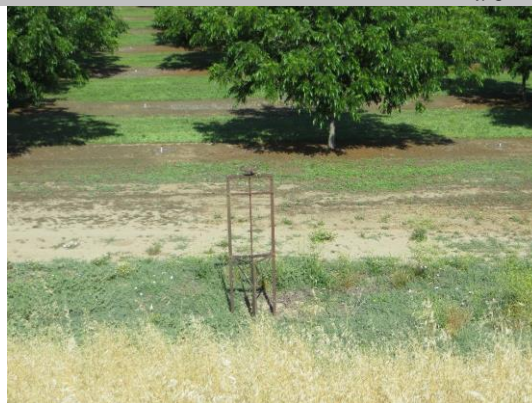
Photo 1 of 3 : UCIP_FA_2020_14577_24055.jpg

Comment Code						
Inspector Comment						
DS_ID:18825						
FS_ID:14577						
EP_NO: 9935						
Repair Type: Non-Urgent						
EVAL Issue:						
Crossing Status: Found						
UCIP Comments: Appears abandoned. Pipe buried on WS toe.						
Debris and steel plate blocking inlet on LS.						
FIELD_STRUCT_DESC: 24-inch corrugated metal irrigation pipe						
through the levee and beneath the roadway, 18 feet below the crown.						
Slide gate on the waterside (WS) end. (Automatic Board Order (ABO)						
issued as Permit No. 9935, 1974 - Florence Watt). [Additional						
Reference(s): DWR Levee Log, 1992. USACE Sacramento O&M						
Manual 136, March 1960 (HLM 22.30)].						
FS Date: 6/4/2013

Slide gate buried at WS toe.

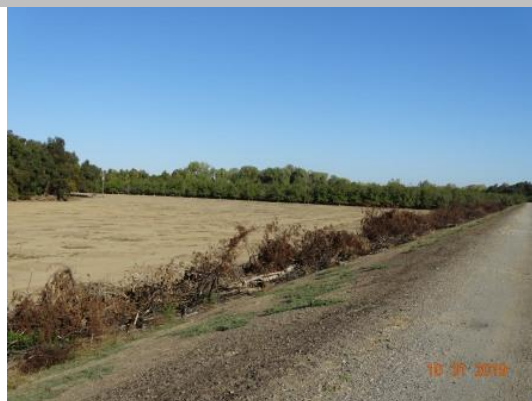
Photo 1 of 1 : FA_2020_LD0003_27_33_20200915_00011.jpg

LM Start	1.87	Rating **	M	Issue No.	33
LM End	1.97	Issue Type +	En	Location *	WS
Category	Earthen Levee			GPS Latitude/Longitude	
				Start	End
Item	Encroachments			39.403509 °	39.404939 °
				-122.001869 °	-122.001706 °
DWR ID	DWR_LD0003_01_f_2019_33				
Comment Code					
TR : Tree or limb					
Inspector Comment					
The tree limbs and prunings should be removed from the waterside slope and toe.

View of tree limbs and prunings along the waterside slope. Fall 2019.

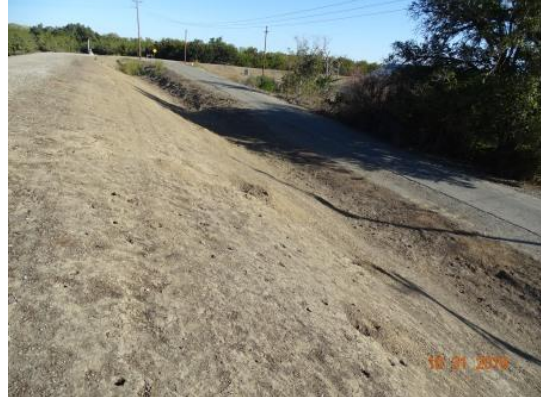
Photo 1 of 1 : FA_2020_LD0003_27_36_20200915_00013.jpg

View of the rodent burrows along the landside slope. Fall 2019.

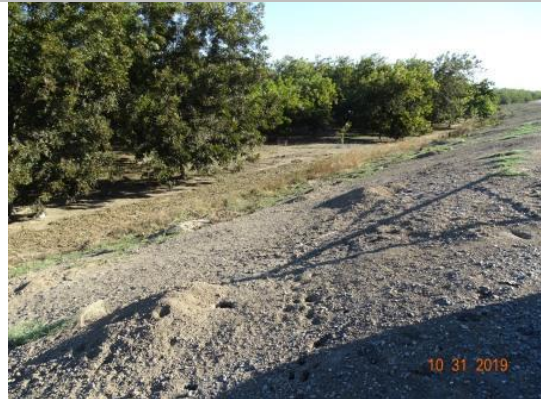
Photo 1 of 1 : FA_2020_LD0003_27_38_20200915_00014.jpg

LM Start	2.08	Rating **	U	Issue No.	38
LM End	2.10	Issue Type +	Ma	Location *	WS
Category	Earthen Levee			GPS Latitude/Longitude	
				Start	End
Item	Animal Control			39.406325 °	39.406347 °
				-122.001073 °	-122.000682 °
DWR ID	DWR_LD0003_01_f_2019_38				
Comment Code					
A3 : No rodents visible, but rodent burrows visible; need to backfill and compact or grout burrows.					
Inspector Comment

View of rodent burrows along the waterside slope. Fall 2019.

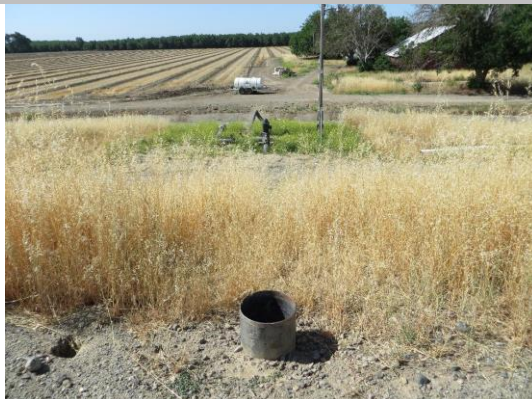
Photo 1 of 3 : UCIP_FA_2020_15144_24883.jpg

LM Start	2.10	Rating **	M	Issue No.	134
LM End	2.10	Issue Type +	En	Location *	
Category	Supplemental			GPS Latitude/Longitude	
				Start	End
Item	DWR UCIP Field Study			39.406353 °	39.406353 °
				-122.000674 °	-122.000674 °
DWR ID	23151				
Comment Code					
Inspector Comment					
DS_ID:23151 FS_ID:15144 EP_NO: N/A Repair Type: Non-Urgent EVAL Issue: Crossing Status: Found UCIP Comments: No permit identified for this crossing. FIELD_STRUCT_DESC: 12-inch steel irrigation pipe through the levee, 3.5 feet below the crown. Pump, butterfly valve, and JP/meter at channel on landside (LS) toe. Siphon breaker inside a 12-inch steel riser unit on the LS shoulder. 3-inch plastic drain on the waterside (WS) toe. FS Date: 6/4/2013

Siphon breaker in steel riser on LS shoulder with pump in background.

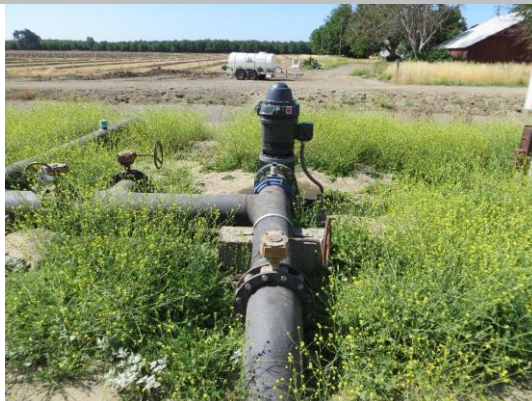
Photo 2 of 3 : UCIP_FA_2020_15144_24882.jpg

Pump and butterfly valve off LS toe.

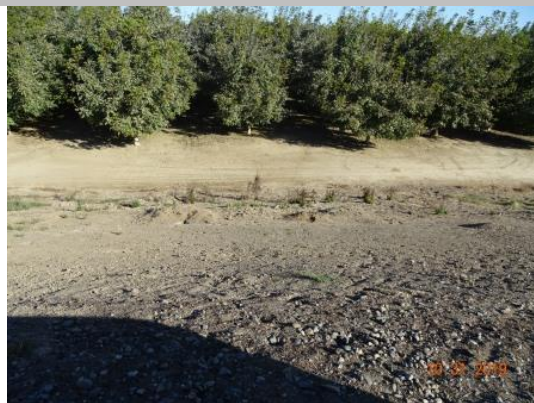
Photo 1 of 1 : FA_2020_LD0003_27_43_20200915_00015.jpg

View of the rodent burrows along the waterside slope. Fall 2019.

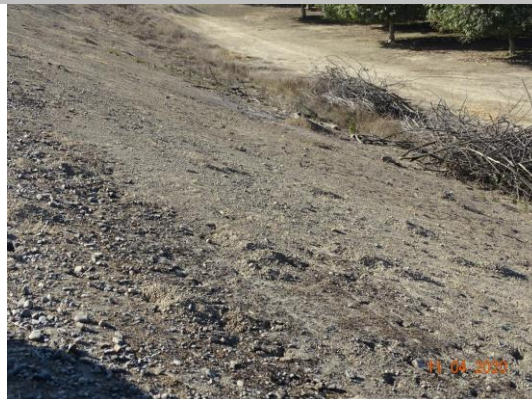
Photo 1 of 1 : FA_2020_LD0003_27_13_20201105_00095.jpg

View of the rodent activity along the waterside slope. Fall 2020.

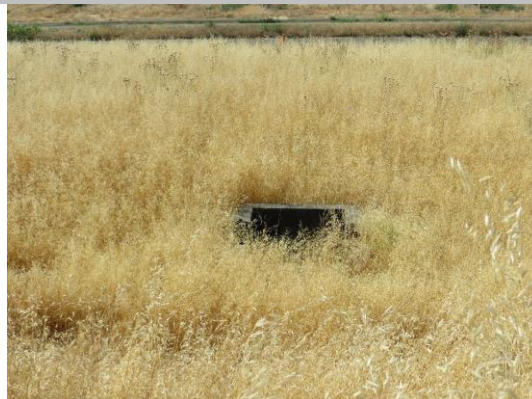
Photo 2 of 3 : UCIP_FA_2020_14582_24075.jpg

Concrete distribution box on LS toe.

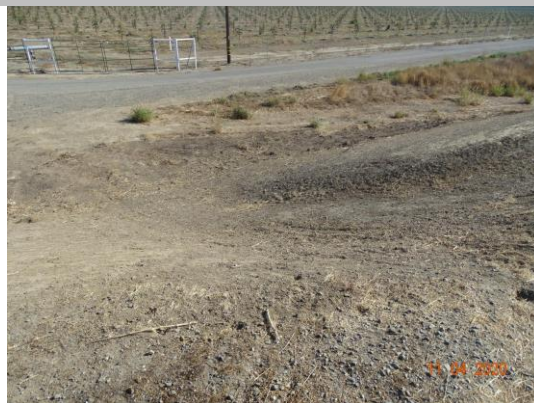
Photo 1 of 1 : FA_2020_LD0003_27_9_20201105_00096.jpg

LM Start	3.39	Rating **	M	Issue No.	9
LM End	3.39	Issue Type +	Ma	Location *	LS
Category	Earthen Levee			GPS Latitude/Longitude	
				Start	End
Item	Slope Stability			39.418382 °	39.418382 °
				-121.992480 °	-121.992480 °
DWR ID	DWR_LD0003_01_s_2012_9				
Comment Code					
S3 : Repair the levee slope damaged by vehicle traffic and prevent access where possible.					
Inspector Comment

View of the damaged landside slope due to vehicle traffic. Fall 2020.

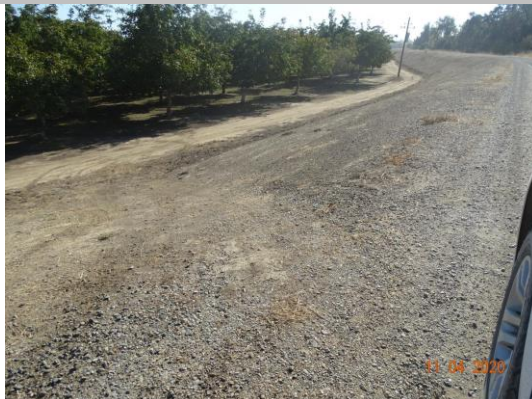
Photo 1 of 1 : FA_2020_LD0003_27_19_20201105_00097.jpg

LM Start	3.76	Rating **	M	Issue No.	19
LM End	3.76	Issue Type +	Ma	Location *	LS
Category	Earthen Levee			GPS Latitude/Longitude	
				Start	End
Item	Slope Stability			39.423747 °	39.423747 °
				-121.991667 °	-121.991667 °
DWR ID	DWR_LD0003_01_s _ 2012_19				
Comment Code					
S3 : Repair the levee slope damaged by vehicle traffic and prevent access where possible.					
Inspector Comment

View of the damaged landside slope due to vehicle traffic. Fall 2020.

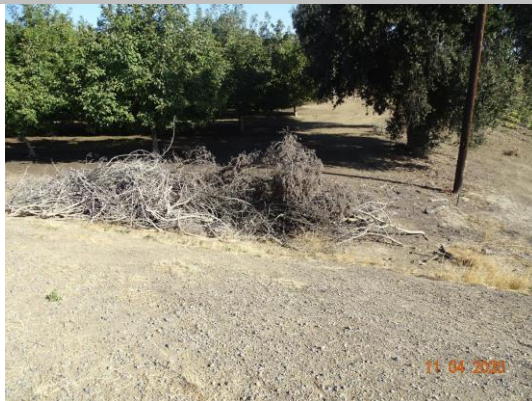
Photo 1 of 1 : FA_2020_LD0003_27_66_20201105_00098.jpg

View of the prunings along the landside toe. Fall 2020.

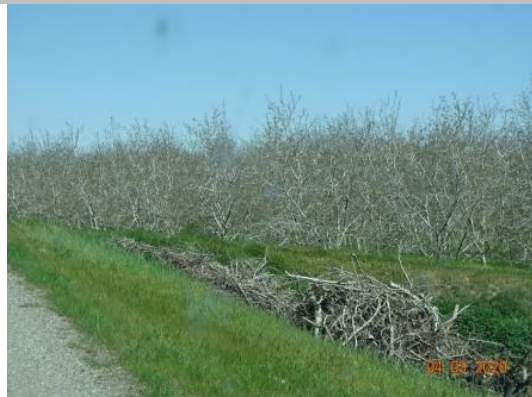
Photo 1 of 1 : FA_2020_LD0003_27_68_20200915_00028.jpg

View of the prunings on the landside slope and toe. Spring 2020.

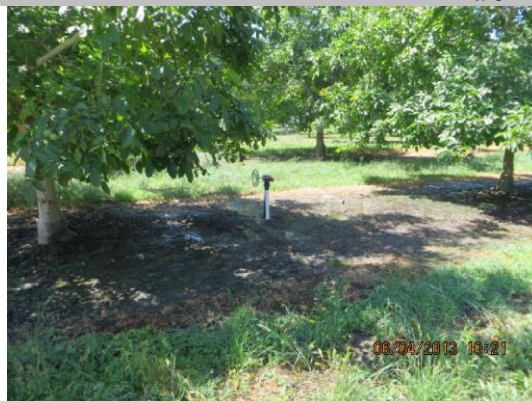
Photo 1 of 3 : UCIP_FA_2020_15163_24902.jpg

LM Start	4.96	Rating **	M	Issue No.	137	
LM End	4.96	Issue Type +	En	Location *		
Category	Supplemental			GPS Latitude/Longitude		
				Start	End	
Item	DWR UCIP Field Study			39.439791 °	39.439791 °	
				-121.989825 °	-121.989825 °	
DWR ID	23152					
Comment Code						
Inspector Comment						
DS_ID:23152						
FS_ID:15163						
EP_NO: N/A						
Repair Type: Non-Urgent						
EVAL Issue:						
Crossing Status: Found						
UCIP Comments: No permit identified for this crossing.						
FIELD_STRUCT_DESC: 4-inch steel irrigation pipe through the levee,						
(LS) toe. Possible shutoff valve off the waterside (WS) toe.						
FS Date: 6/4/2013

Possible shutoff valve on WS toe.

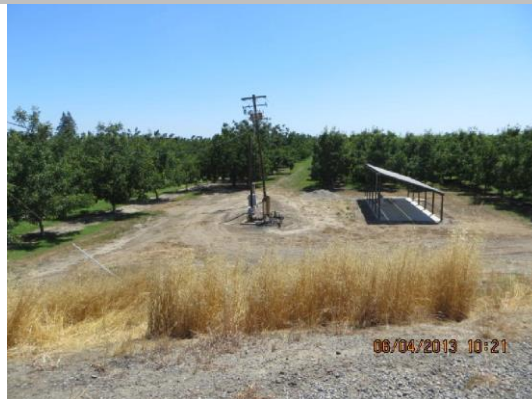
Photo 2 of 3 : UCIP_FA_2020_15163_24901.jpg

Pumping plant off LS toe.

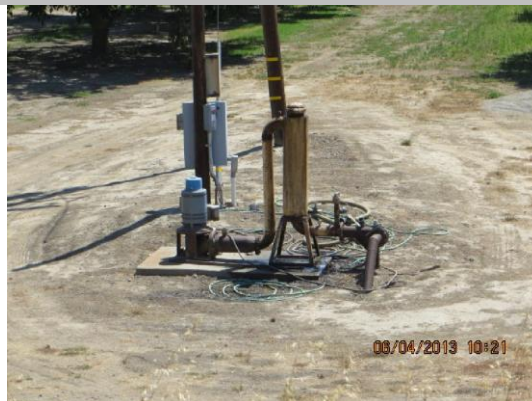
Photo 3 of 3 : UCIP_FA_2020_15163_24900.jpg

Pumping plant off LS toe.

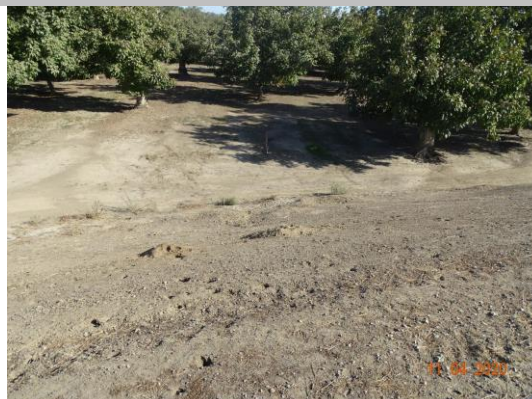
Photo 1 of 1 : FA_2020_LD0003_27_21_20201105_00099.jpg

View of the rodent activity along the landside slope. Fall 2020.

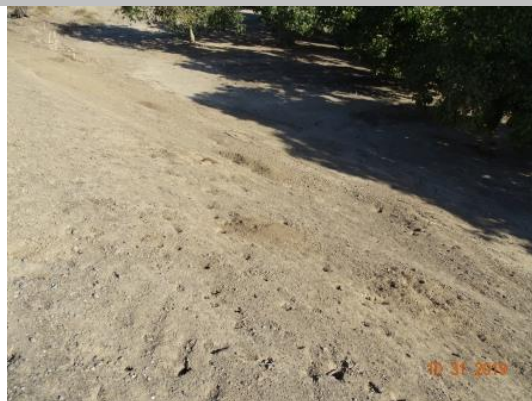
Photo 1 of 1 : FA_2020_LD0003_27_96_20200915_00040.jpg

View of the rodent burrows on the landside slope. Fall 2019.

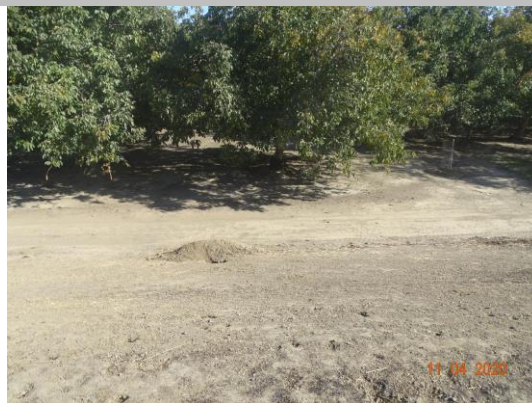
Photo 1 of 1 : FA_2020_LD0003_27_70_20201105_00100.jpg

View of the rodent activity along the landside slope. Fall 2020.

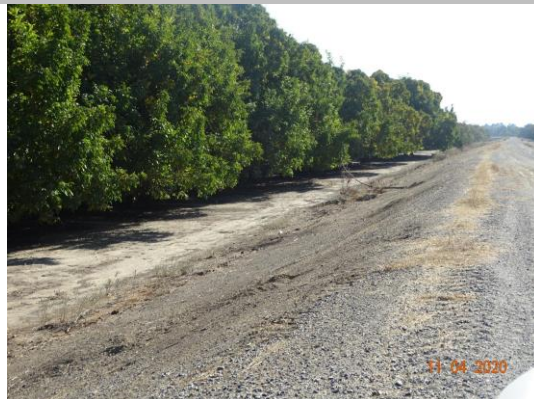
Photo 1 of 1 : FA_2020_LD0003_27_62_20201105_00101.jpg

View of the rodent activity along the landside slope. Fall 2020.

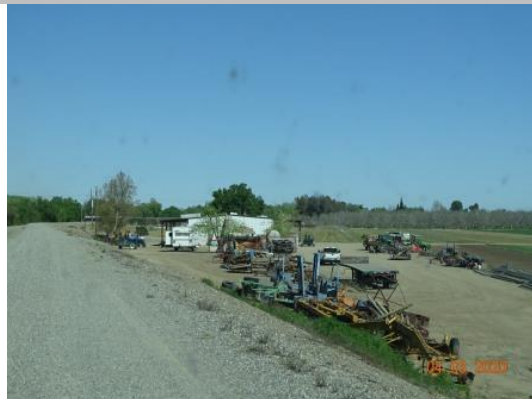
Photo 1 of 1 : FA_2020_LD0003_27_25_20200915_00010.jpg

View of the equipment along the landside toe. Spring 2020.

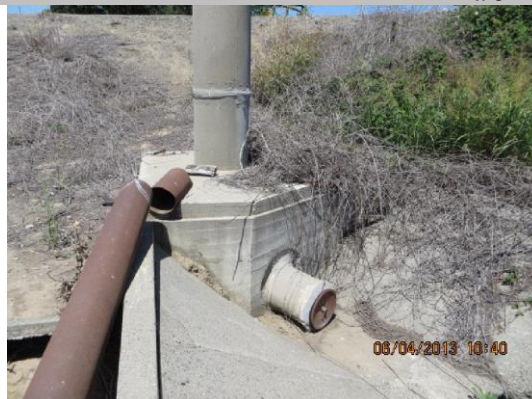
Photo 2 of 3 : UCIP_FA_2020_14643_24141.jpg

Concrete standpipe and channel on LS toe.

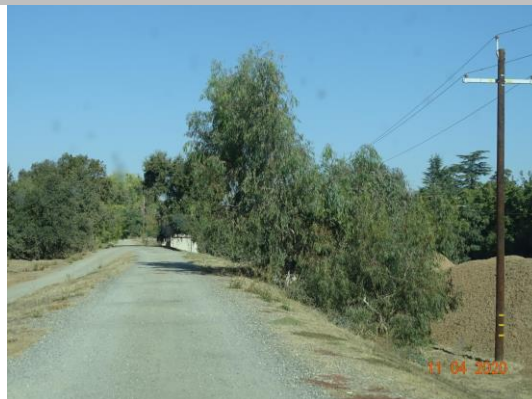
Photo 1 of 1 : FA_2020_LD0003_27_84_20201105_00103.jpg

View of the trees that require trimming along the landside slope and toe.
Fall 2020.

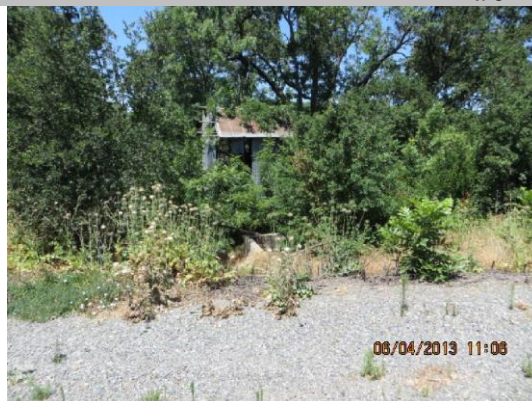
Photo 1 of 3 : UCIP_FA_2020_14664_24162.jpg

Pumphouse and 7'X12' concrete box on WS slope.

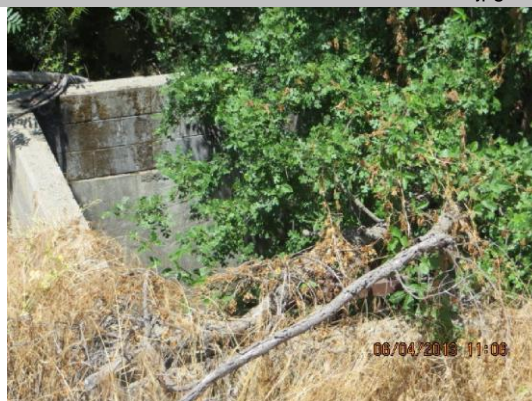
Photo 2 of 3 : UCIP_FA_2020_14664_24161.jpg

7'X12' Concrete box with flap gate and slide gate on WS slope.

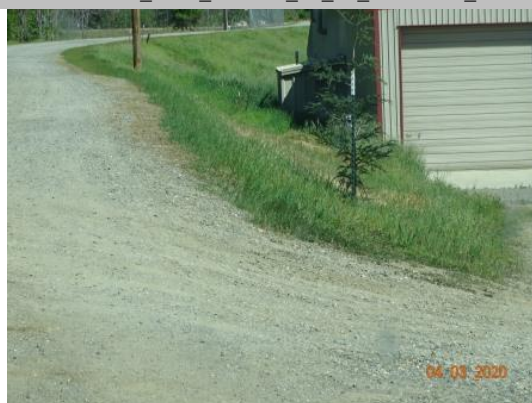
Photo 1 of 1 : FA_2020_LD0003_27_34_20200915_00012.jpg

View of damaged landside slope caused by vehicle traffic. Spring 2020.

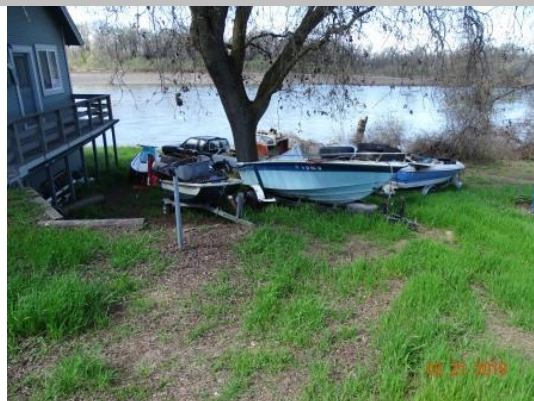
Photo 1 of 2 : FA_2020_LD0003_27_115_20200915_00048.jpg

View of the boats on the waterside slope and toe, facing west.

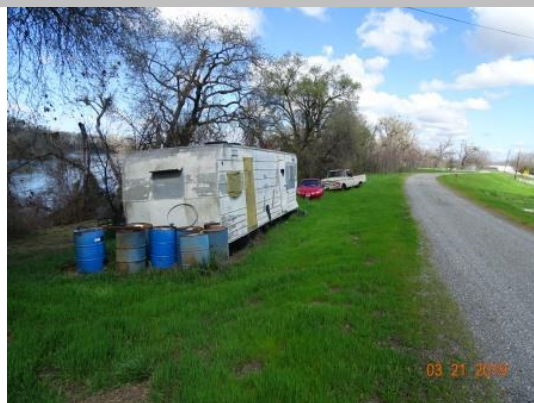
Photo 2 of 2 : FA_2020_LD0003_27_115_20200915_00049.jpg

View of an abandoned RV, cars and drums on the waterside slope, facing upstream.

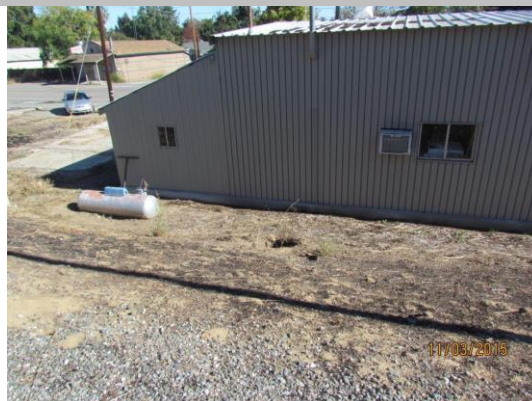
Photo 1 of 1 : FA_2020_LD0003_27_76_20200915_00031.jpg

View of the burned out stump hole along the landside toe.

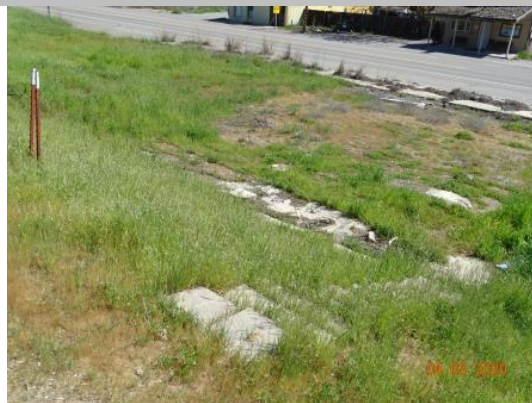
Photo 1 of 1 : FA_2020_LD0003_27_12_20200915_00005.jpg

View of the concrete stairs and foundation along the landside slope and toe. Spring 2020.

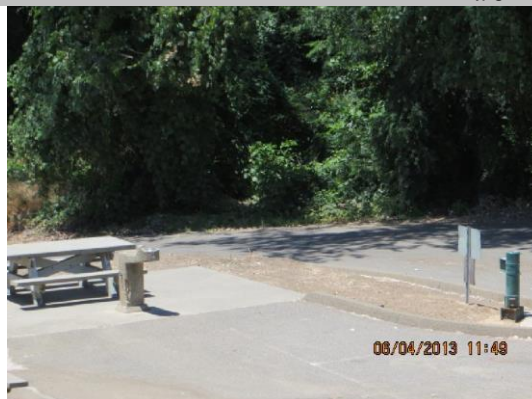
Photo 3 of 3 : UCIP_FA_2020_15165_24904.jpg

Possible reason for water service (water fountain).

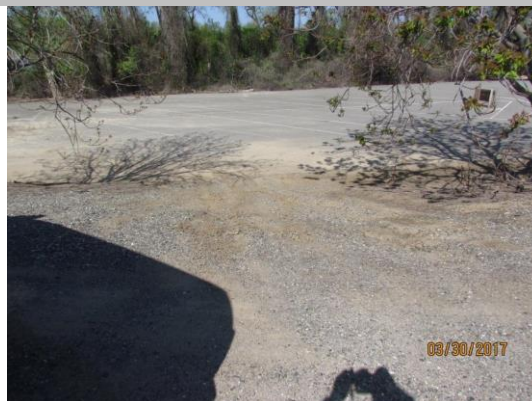
Photo 1 of 1 : FA_2020_LD0003_27_97_20200915_00041.jpg

View of the vehicle ruts on the waterside slope.

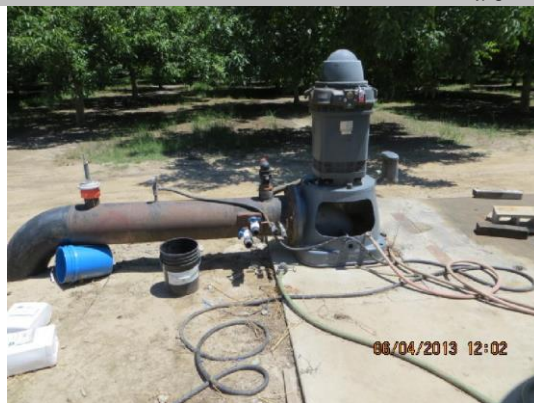
Photo 1 of 2 : UCIP_FA_2020_14686_24184.jpg

Pump located on LS toe next to concrete distribution box.

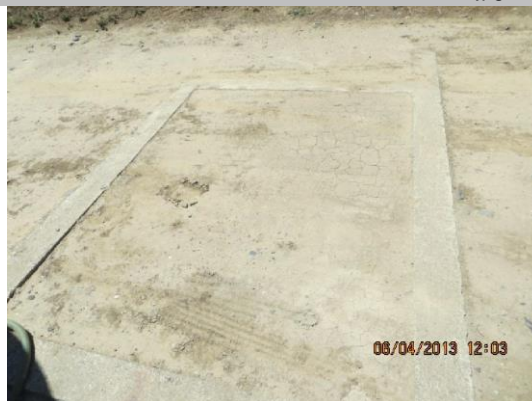
Photo 2 of 2 : UCIP_FA_2020_14686_24183.jpg

Soil filled concrete distribution box on LS toe.

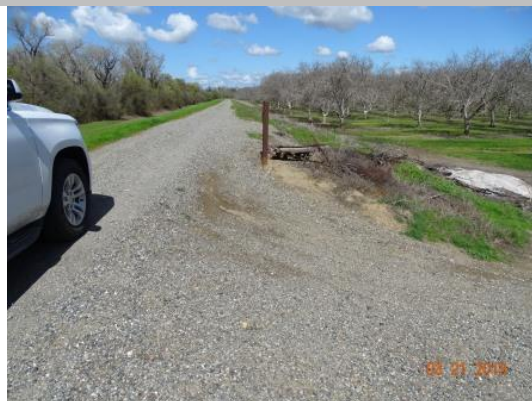
Photo 1 of 1 : FA_2020_LD0003_27_14_20200915_00007.jpg

View of the erosion caused by vehicle traffic along the landside slope and crown, facing upstream. (Spring 2019)

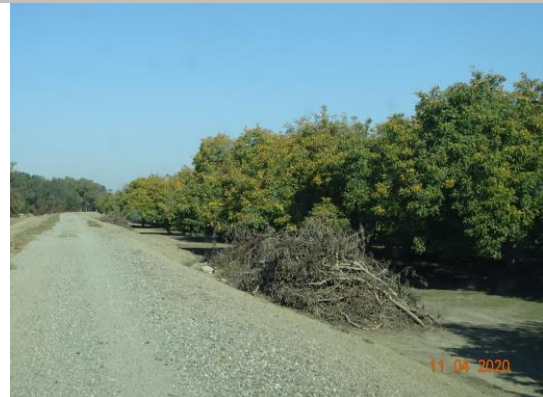
Photo 1 of 1 : FA_2020_LD0003_27_61_20201105_00104.jpg

View of the prunings along the landside toe. Fall 2020.

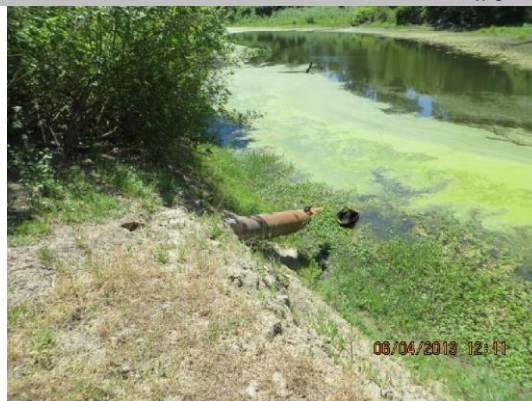
Photo 1 of 3 : UCIP_FA_2020_14687_24187.jpg

Pipe visible at pond off WS toe.

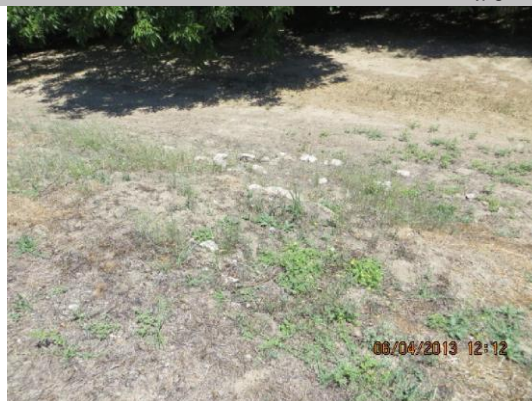
Photo 3 of 3 : UCIP_FA_2020_14687_24185.jpg

Remnants of concrete distribution box on LS toe.

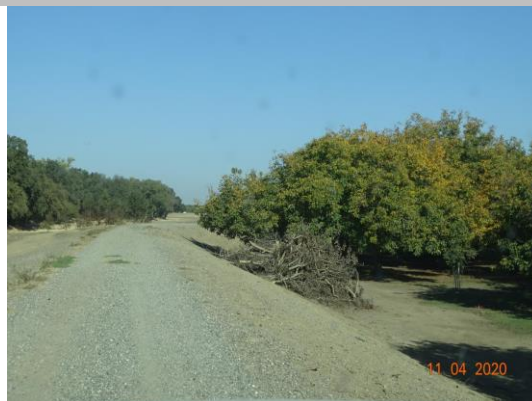
Photo 1 of 1 : FA_2020_LD0003_27_60_20201105_00105.jpg

View of the prunings along the landside toe. Fall 2020.

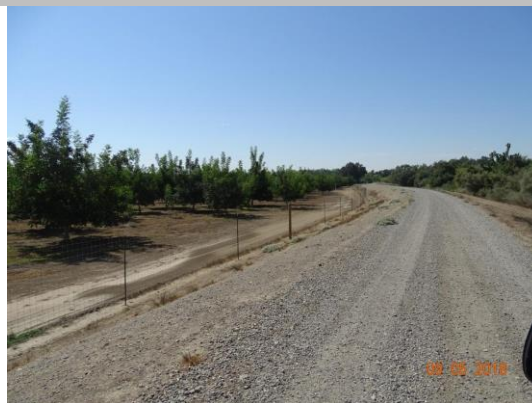
Photo 1 of 1 : FA_2020_LD0003_27_85_20200915_00036.jpg

View of the fence along the landside toe.

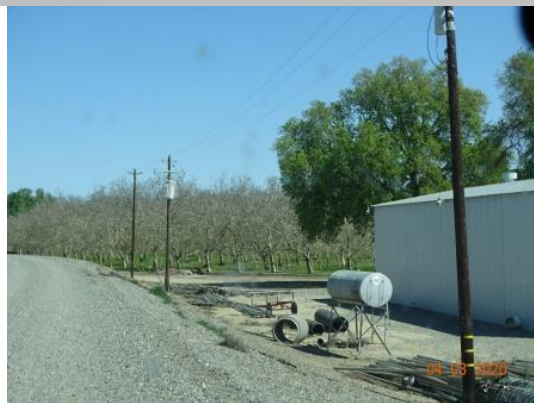
Photo 1 of 1 : FA_2020_LD0003_27_77_20200915_00032.jpg

View of the equipment along the landside toe. Spring 2020.

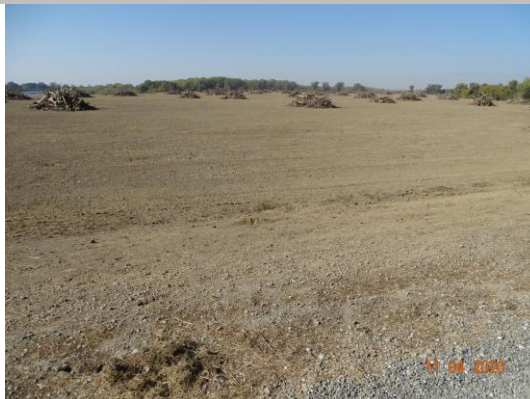
Photo 1 of 1 : FA_2020_LD0003_27_93_20201105_00107.jpg

View of the rodent activity along the waterside slope. Fall 2020.

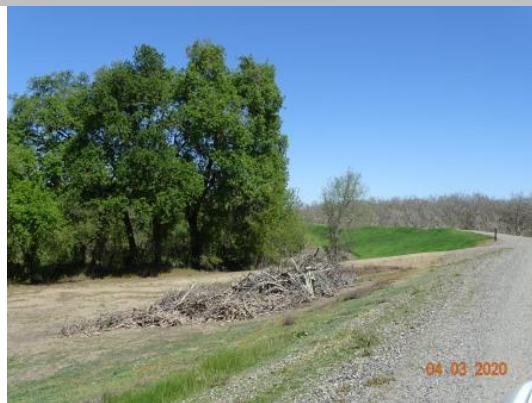
Photo 1 of 1 : FA_2020_LD0003_27_102_20200915_00042.jpg

View of the pruning pile at the waterside toe. Spring 2020.

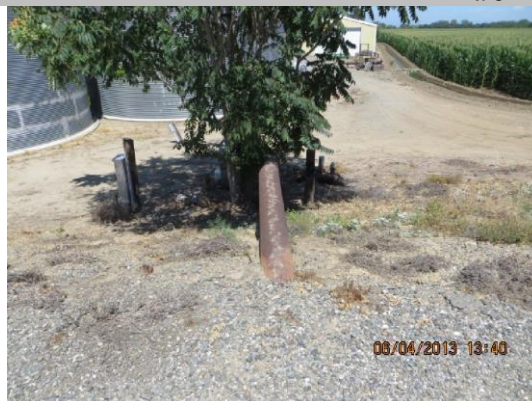
Photo 3 of 3 : UCIP_FA_2020_14690_24191.jpg

10-inch pipe on LS.

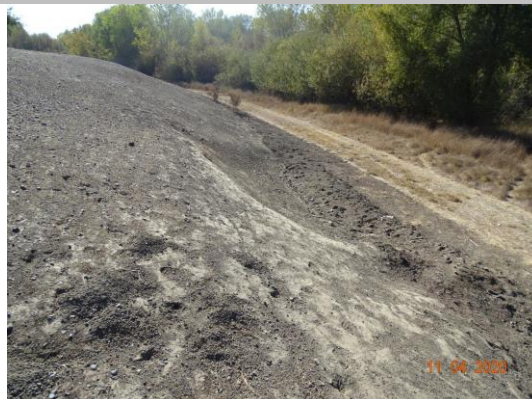
Photo 1 of 1 : FA_2020_LD0003_27_6_20201105_00109.jpg

View of the vertical cut along the waterside slope and toe. Fall 2020.

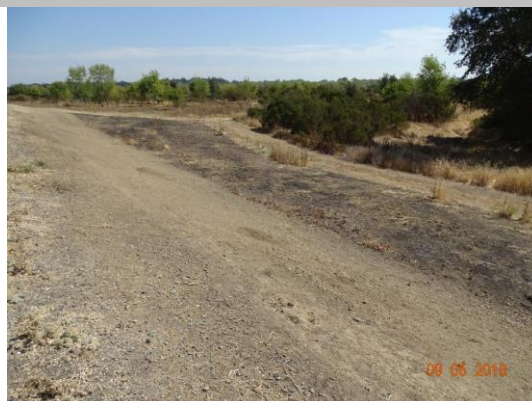
Photo 1 of 1 : FA_2020_LD0003_27_79_20200915_00034.jpg

View of the rodent holes along the landside slope.
