Flood Control Project Maintenance Levee Inspections

Fall 2021 Levee Maintenance Deficiency Summary Report

Sacramento River Basin

Levee District No. 0003 (Glenn County)

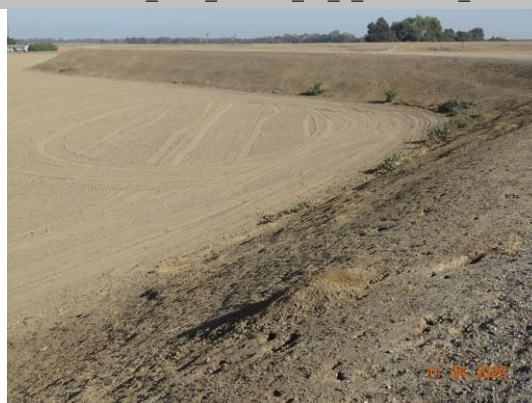
Photo 1 of 1 : FA_2021_LD0003_27_3_20210928_00001.jpg

View of the rodent activity along the landside slope. Fall 2020.

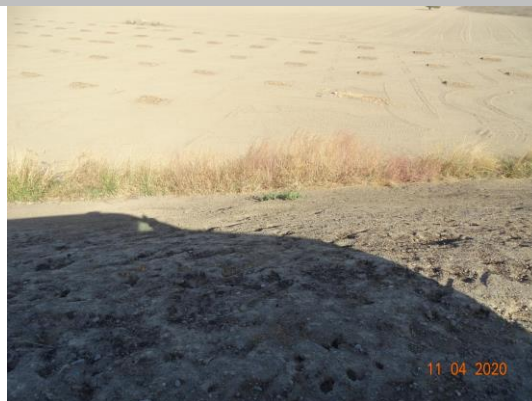
Photo 1 of 1 : FA_2021_LD0003_27_51_20210928_00017.jpg

View of the rodent activity along the landside slope. Fall 2020.

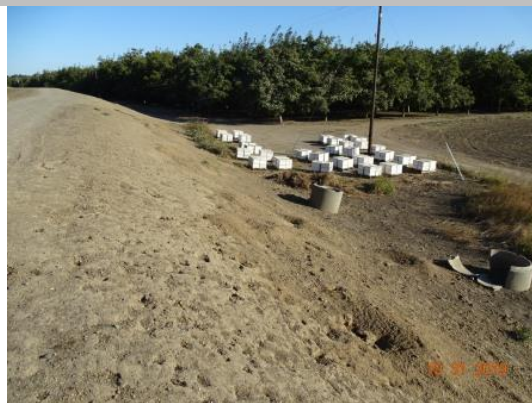
Photo 1 of 1 : FA_2021_LD0003_27_52_20210928_00018.jpg

LM Start	1.21	Rating **	M	Issue No.	52
LM End	1.21	Issue Type +	Ma	Location *	LS
Category	Earthen Levee			GPS Latitude/Longitude	
				Start	End
Item	Animal Control			39.394010 °	39.394010 °
				-122.000977 °	-122.000977 °
DWR ID	DWR_LD0003_01_f_2015_52				
Comment Code					
A3 : No rodents visible, but rodent burrows visible; need to backfill and compact or grout burrows.					
Inspector Comment

View of the rodent burrows along the landside slope. Fall 2019.

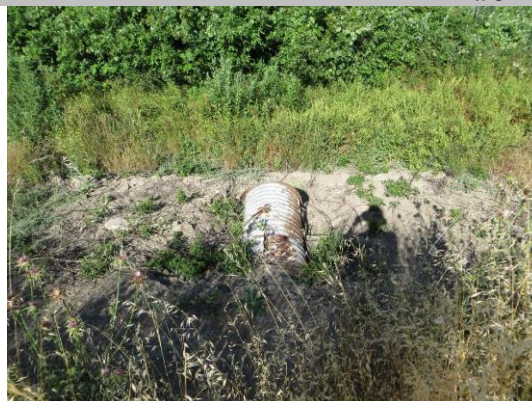
Photo 1 of 3 : UCIP_FA_2021_14573_24038.jpg

Comment Code						
Inspector Comment						
DS_ID:18830						
FS_ID:14573						
EP_NO: 9930						
Repair Type: Non-Urgent						
EVAL Issue:						
Crossing Status: Found						
UCIP Comments: Steel plate welded over WS end of pipe. Slide gate through the levee, 14.5 feet below the crown. Slide gate on waterside at WS toe missing. Appears abandoned.						
FIELD_STRUCT_DESC: 24-inch corrugated metal irrigation pipe through the levee, 14.5 feet below the crown. Slide gate on waterside (WS) end. 7-foot by 9-foot concrete diversion box at landward toe (Automatic Board Order (ABO) issued as Permit No. 9930, 1974 - Steel Ranch). [Additional Reference(s): DWR Levee Log, 1992. USACE Sacramento O&M Manual 136, March 1960 (HLM 21.89)].						
FS Date: 6/4/2013

24-inch CMP stormdrain on WS toe.

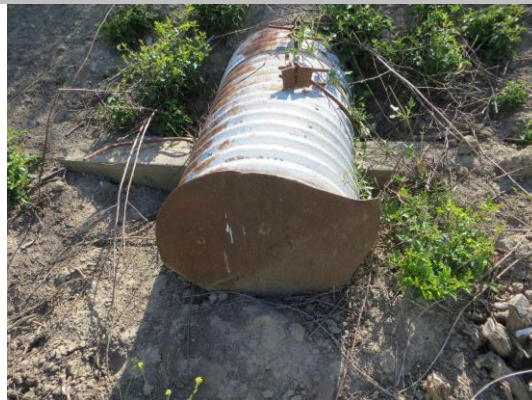
Photo 2 of 3 : UCIP_FA_2021_14573_24037.jpg

Steel plate welded over end of pipe on WS toe.

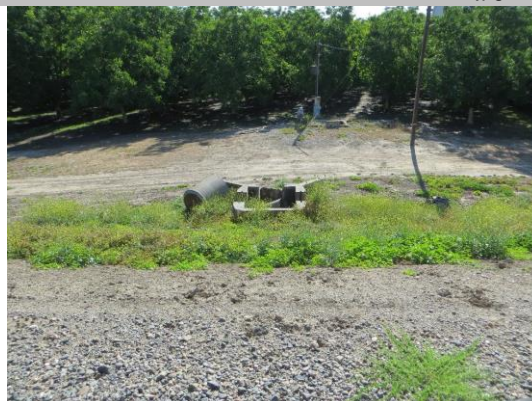
Photo 3 of 3 : UCIP_FA_2021_14573_24036.jpg

Distribution box on LS toe.

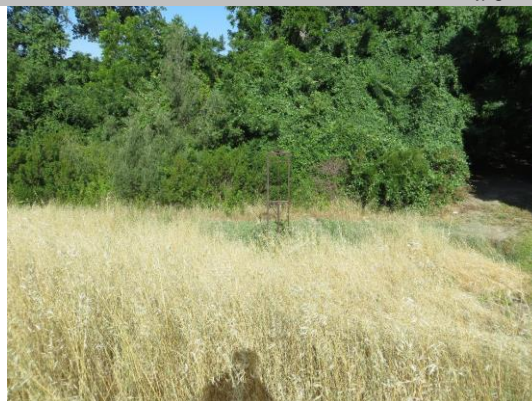
Photo 1 of 2 : UCIP_FA_2021_14576_24052.jpg

DS_ID:18823
 FS_ID:14576
 EP_NO: 9931
 Repair Type: Non-Urgent
 EVAL Issue:
 Crossing Status: Found
 UCIP Comments: Appears abandoned. Pipe buried at slide gate on WS toe.
 FIELD_STRUCT_DESC: 24-inch corrugated metal irrigation pipe through the levee, 15 feet below the crown. Slide gate on the waterside (WS) end. 6-foot by 7-foot concrete distribution box on the landside (LS) toe. (Automatic Board Order (ABO) issued as Permit No. 9931, 1974 - Lowell F. Steel). [Additional Reference(s): DWR Levee Log, 1992. USACE Sacramento O&M Manual 136, March 1960 (HLM 22.00)].
 FS Date: 6/4/2013

Slide gate at WS toe.

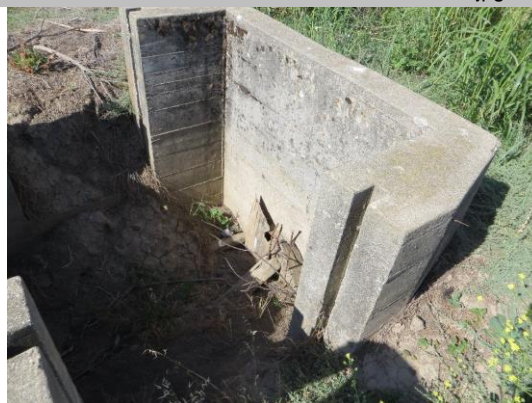
Photo 3 of 3 : UCIP_FA_2021_14577_24053.jpg

Debris and steel plate blocking inlet on LS toe.

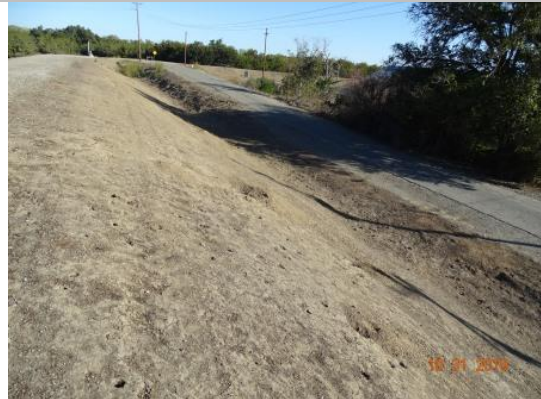
Photo 1 of 1 : FA_2021_LD0003_27_36_20210928_00012.jpg

View of the rodent burrows along the landside slope. Fall 2019.

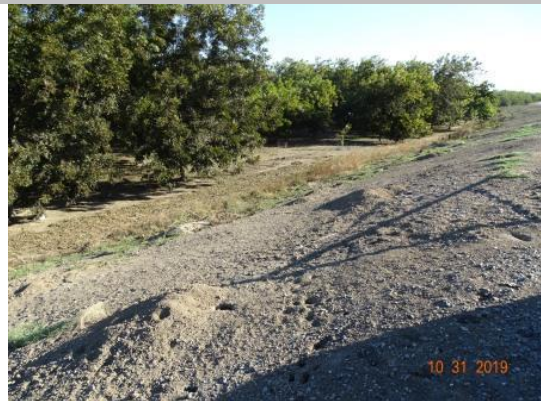
Photo 1 of 1 : FA_2021_LD0003_27_38_20210928_00013.jpg

LM Start	2.08	Rating **	U	Issue No.	38
LM End	2.10	Issue Type +	Ma	Location *	WS
Category	Earthen Levee			GPS Latitude/Longitude	
				Start	End
Item	Animal Control			39.406325 °	39.406347 °
				-122.001073 °	-122.000682 °
DWR ID	DWR_LD0003_01_f _ 2019_38				
Comment Code					
A3 : No rodents visible, but rodent burrows visible; need to backfill and compact or grout burrows.					
Inspector Comment

View of rodent burrows along the waterside slope. Fall 2019.

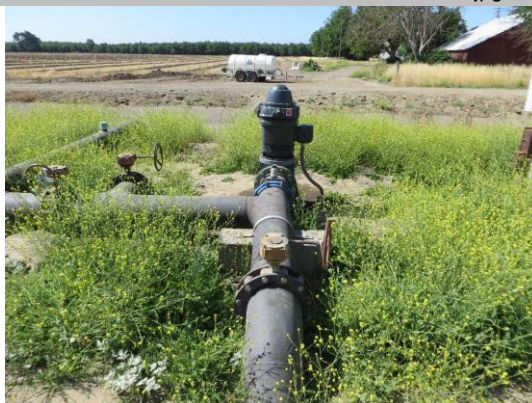
Photo 2 of 3 : UCIP_FA_2021_15144_24882.jpg

Pump and butterfly valve off LS toe.

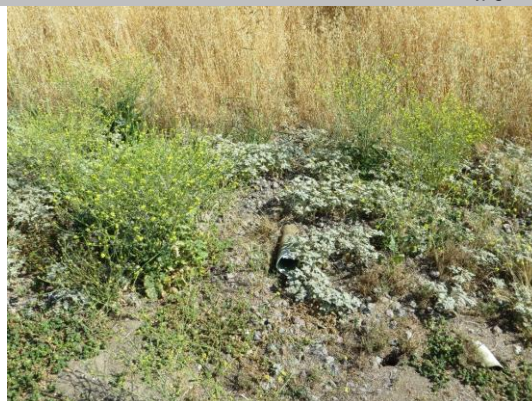
Photo 3 of 3 : UCIP_FA_2021_15144_24881.jpg

3-inch drain on WS toe (purpose unclear).

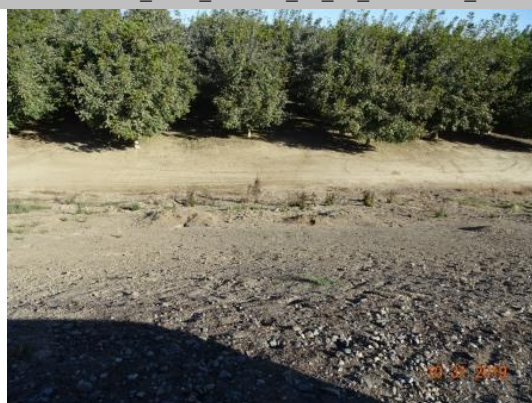
Photo 1 of 1 : FA_2021_LD0003_27_43_20210928_00014.jpg

LM Start	2.11	Rating **	M	Issue No.	41
LM End	2.29	Issue Type +	Ma	Location *	WS
Category	Earthen Levee			GPS Latitude/Longitude	
				Start	End
Item	Animal Control			39.406330 °	39.406444 °
				-122.000524 °	-121.997127 °
DWR ID	DWR_LD0003_01_f_2019_41				
Comment Code					
A1 : Exterminate rodents and backfill and compact or grout burrows.					
Inspector Comment

View of the rodent burrows along the waterside slope. Fall 2019.

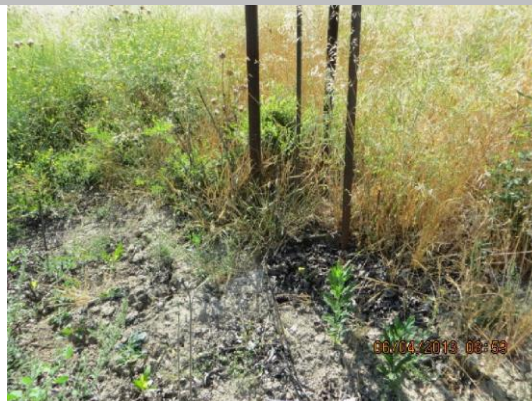
Photo 3 of 3 : UCIP_FA_2021_14582_24074.jpg

Slide gate at WS toe.

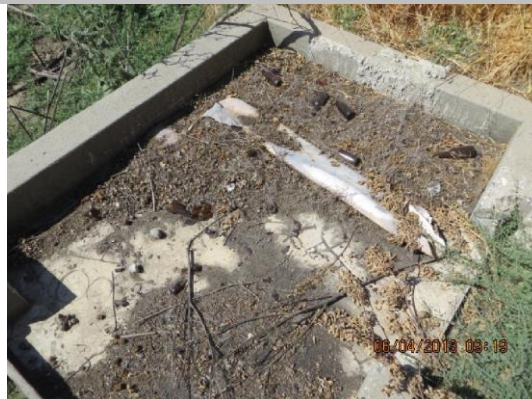
Photo 1 of 2 : UCIP_FA_2021_14584_24081.jpg

Comment Code					
Inspector Comment					
DS_ID:18829 FS_ID:14584 EP_NO: 9919 Repair Type: Non-Urgent EVAL Issue: Crossing Status: Indicator Found UCIP Comments: Appears abandoned. Verify it was done corectly. FIELD_STRUCT_DESC: *ABANDONED* 24-inch corrugated metal irrigation pipe through the levee, 16 feet below the crown. Slide gate on the waterside (WS) end. 5-foot by 7-foot concrete distribution box at landside (LS) toe is filled with grout. (Automatic Board Order (ABO) issued as Permit No. 9919, 1974 - Roy and Annie Mills). [Additional Reference(s): DWR Levee Log, 1992. USACE Sacramento O&M Manual 136, March 1960 (HLM 23.43)]. FS Date: 6/4/2013

5'X7' concrete distribution box filled in with grout.

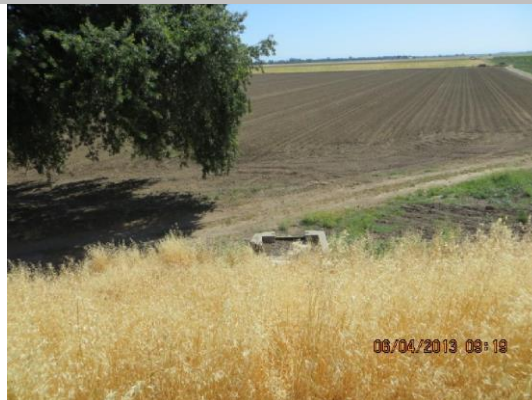
Photo 2 of 2 : UCIP_FA_2021_14584_24080.jpg

Distribution box on LS toe.

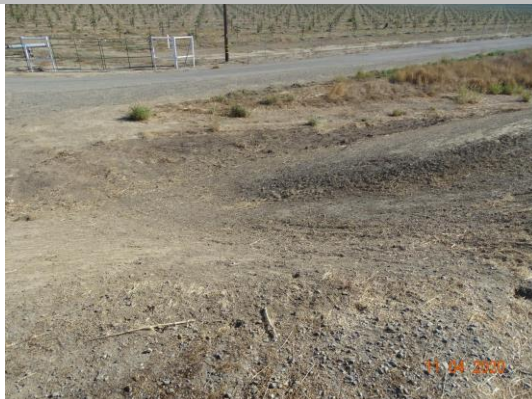
Photo 1 of 1 : FA_2021_LD0003_27_9_20210928_00004.jpg

LM Start	3.39	Rating **	M	Issue No.	9
LM End	3.39	Issue Type +	Ma	Location *	LS
Category	Earthen Levee			GPS Latitude/Longitude	
				Start	End
Item	Slope Stability			39.418382 °	39.418382 °
				-121.992480 °	-121.992480 °
DWR ID	DWR_LD0003_01_s _ 2012_9				
Comment Code					
S3 : Repair the levee slope damaged by vehicle traffic and prevent access where possible.					
Inspector Comment

View of the damaged landside slope due to vehicle traffic. Fall 2020.

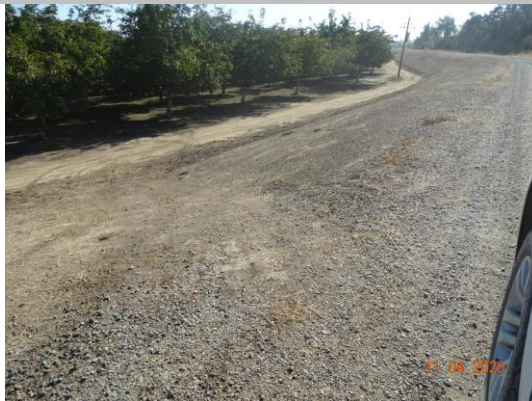
Photo 1 of 1 : FA_2021_LD0003_27_19_20210928_00008.jpg

LM Start	3.76	Rating **	M	Issue No.	19
LM End	3.76	Issue Type +	Ma	Location *	LS
Category	Earthen Levee			GPS Latitude/Longitude	
				Start	End
Item	Slope Stability			39.423747 °	39.423747 °
				-121.991667 °	-121.991667 °
DWR ID	DWR_LD0003_01_s _ 2012_19				
Comment Code					
S3 : Repair the levee slope damaged by vehicle traffic and prevent access where possible.					
Inspector Comment

View of the damaged landside slope due to vehicle traffic. Fall 2020.

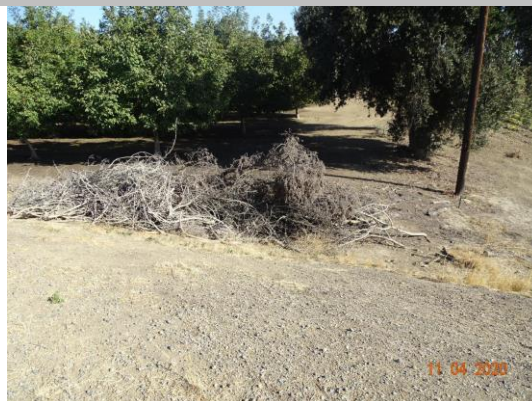
Photo 1 of 1 : FA_2021_LD0003_27_66_20210928_00022.jpg

View of the prunings along the landside toe. Fall 2020.

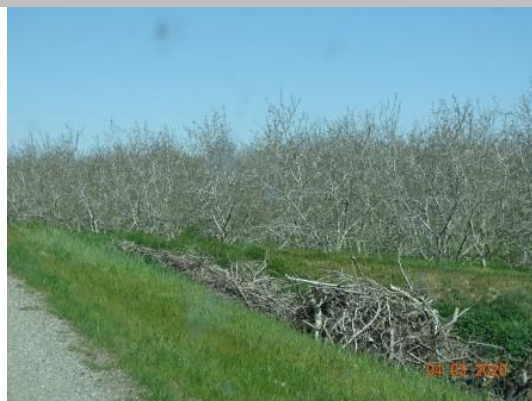
Photo 1 of 1 : FA_2021_LD0003_27_68_20210928_00023.jpg

View of the prunings on the landside slope and toe. Spring 2020.

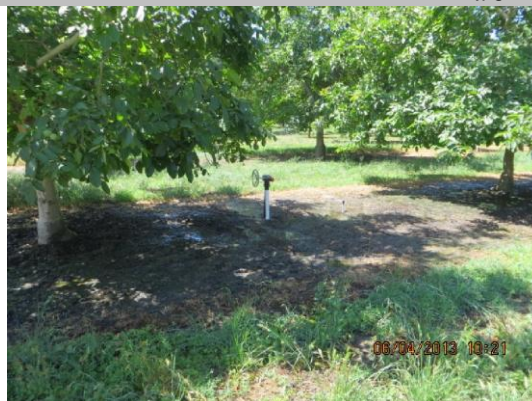
Photo 1 of 3 : UCIP_FA_2021_15163_24902.jpg

DS_ID:23152
FS_ID:15163
EP_NO: N/A
Repair Type: Non-Urgent
EVAL Issue:
Crossing Status: Found
UCIP Comments: No permit identified for this crossing.
FIELD_STRUCT_DESC: 4-inch steel irrigation pipe through the levee, at an unknown depth. Pump, vent, and shutoff valve off the landside (LS) toe. Possible shutoff valve off the waterside (WS) toe.
FS Date: 6/4/2013

Possible shutoff valve on WS toe.

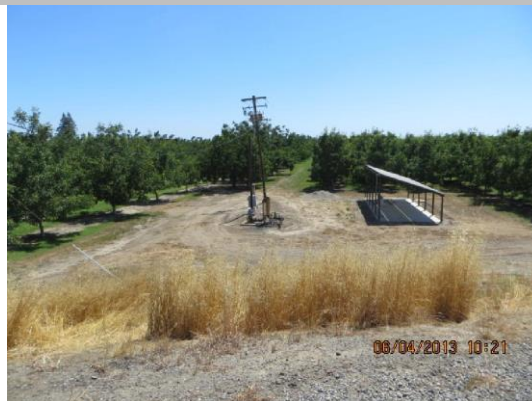
Photo 2 of 3 : UCIP_FA_2021_15163_24901.jpg

Pumping plant off LS toe.

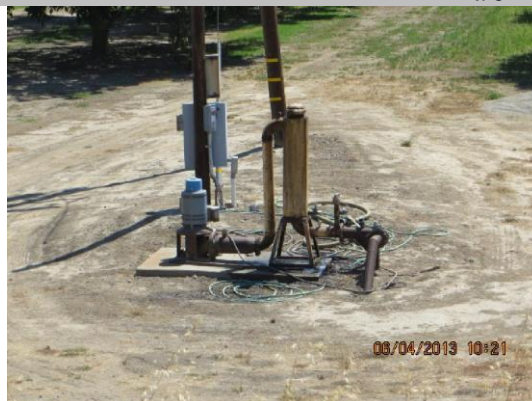
Photo 3 of 3 : UCIP_FA_2021_15163_24900.jpg

Pumping plant off LS toe.

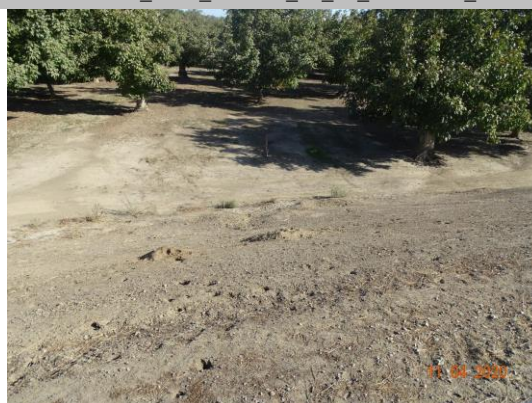
Photo 1 of 1 : FA_2021_LD0003_27_21_20210928_00009.jpg

View of the rodent activity along the landside slope. Fall 2020.

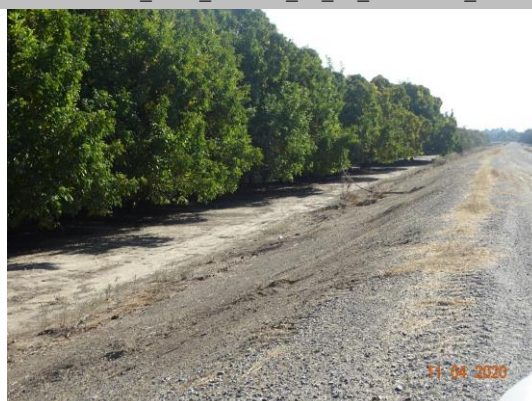
Photo 1 of 1 : FA_2021_LD0003_27_62_20210928_00020.jpg

View of the rodent activity along the landside slope. Fall 2020.

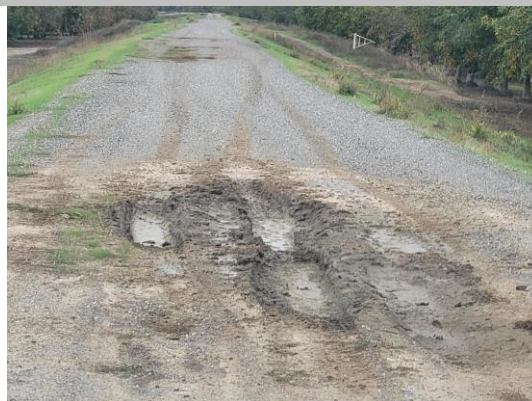
Photo 1 of 1 : FA_2021_LD0003_27_67_20211101_00083.jpg

LM Start	5.65	Rating **	M	Issue No.	67
LM End	5.65	Issue Type +	Ma	Location *	CR
Category	Earthen Levee			GPS Latitude/Longitude	
				Start	End
Item	Crown Surface / Depressions / Rutting			39.449534 °	39.449534 °
				-121.991943 °	-121.991943 °
DWR ID	DWR_LD0003_01_f_2021_67				
Comment Code					
C2 : Repair depressions or ruts in the crown or slope.					
Inspector Comment

View of the tire ruts on the crown. Fall 2021.

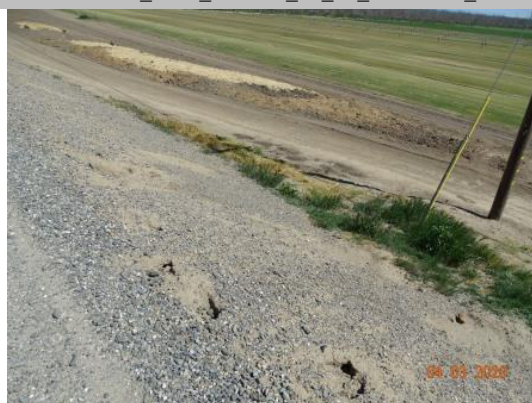
Photo 1 of 1 : FA_2021_LD0003_27_71_20210928_00025.jpg

View of the rodent holes along the landside slope. Spring 2020.

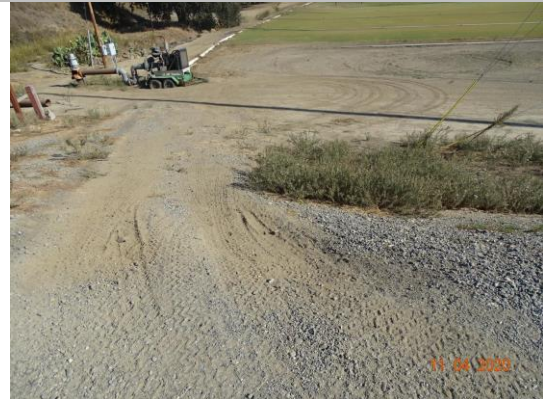
Photo 1 of 1 : FA_2021_LD0003_27_44_20210928_00015.jpg

LM Start	6.17	Rating **	M	Issue No.	44
LM End	6.17	Issue Type +	Ma	Location *	LS
Category	Earthen Levee			GPS Latitude/Longitude	
				Start	End
Item	Slope Stability			39.456960 °	39.456960 °
				-121.993869 °	-121.993869 °
DWR ID	DWR_LD0003_01_f_2020_44				
Comment Code					
S3 : Repair the levee slope damaged by vehicle traffic and prevent access where possible.					
Inspector Comment

View of the damaged landside slope due to vehicle traffic. Fall 2020.

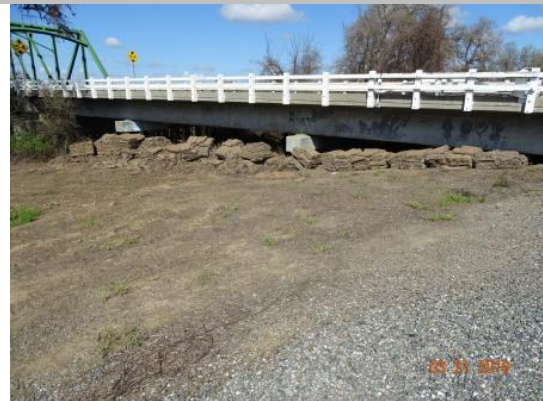
Photo 1 of 1 : FA_2021_LD0003_27_110_20210928_00038.jpg

View of the sod piles on the waterside slope within the floodway, facing upstream. (Spring 2019)

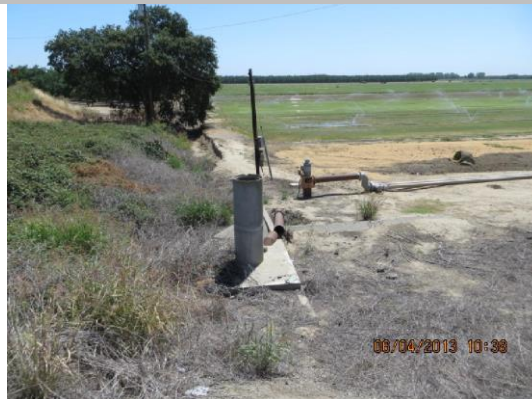
Photo 1 of 3 : UCIP_FA_2021_14643_24142.jpg

LM Start	6.19	Rating **	M	Issue No.	138
LM End	6.19	Issue Type +	En	Location *	
Category	Supplemental			GPS Latitude/Longitude	
				Start	End
Item	DWR UCIP Field Study			39.457170 °	39.457170 °
				-121.993836 °	-121.993836 °
DWR ID	18846				
Comment Code					
Inspector Comment					
DS_ID:18846 FS_ID:14643 EP_NO: N/A Repair Type: Non-Urgent EVAL Issue: Crossing Status: Found UCIP Comments: Appears abandoned and should be done so properly. FIELD_STRUCT_DESC: 14-inch steel irrigation pipe through the levee, 15 feet below the crown. Pump missing from waterside (WS) slope. 36-inch concrete standpipe and concrete channel on landside (LS) toe. [Additional Reference(s): USACE Sacramento O&M Manual 138, July 1955 (Station 1129+75)]. FS Date: 6/4/2013

Concrete standpipe on LS toe.

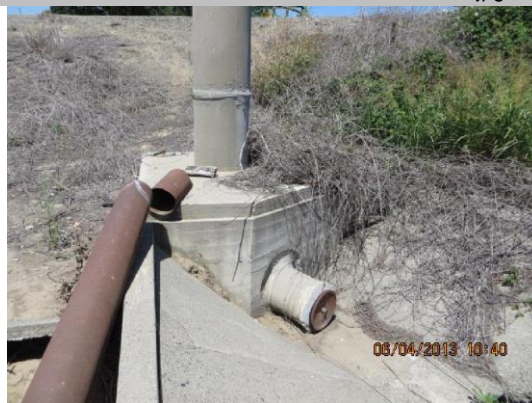
Photo 2 of 3 : UCIP_FA_2021_14643_24141.jpg

Concrete standpipe and channel on LS toe.

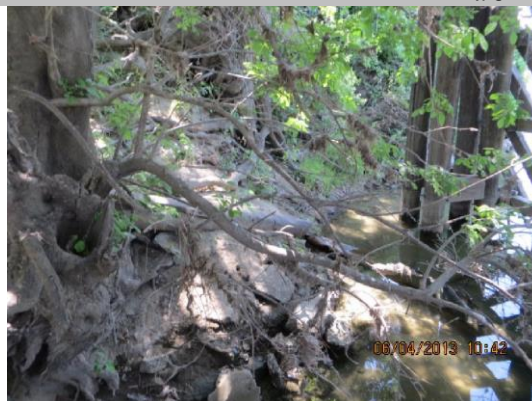
Photo 3 of 3 : UCIP_FA_2021_14643_24140.jpg

14-inch Pipe debris on WS toe.

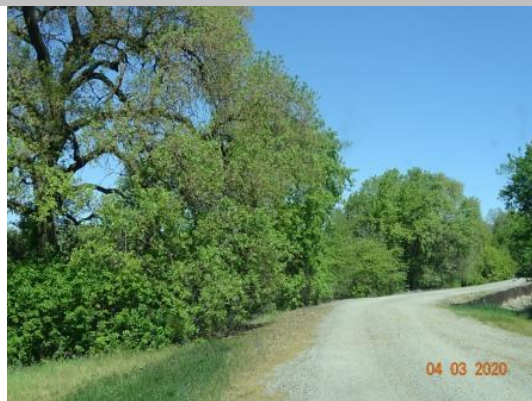
Photo 1 of 1 : FA_2021_LD0003_27_48_20210928_00016.jpg

View of the trees that need to be trimmed to at least 5 feet above the ground. Spring 2020.

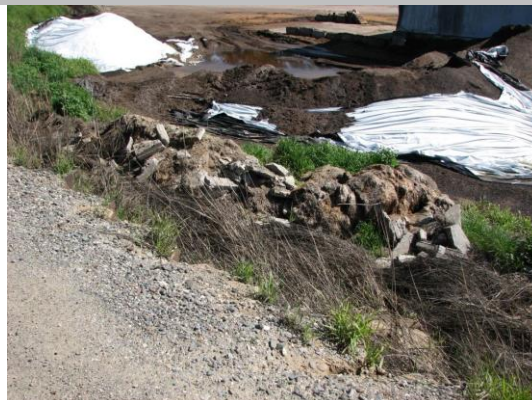
Photo 1 of 1 : FA_2021_LD0003_27_65_20210928_00021.jpg

LM Start	6.36	Rating **	U	Issue No.	65
LM End	6.36	Issue Type +	En	Location *	LS
Category	Earthen Levee			GPS Latitude/Longitude	
				Start	End
Item	Encroachments			39.459690 °	39.459690 °
				-121.993680 °	-121.993680 °
DWR ID	DWR_LD0003_01_s_2016_65				
Comment Code					
DE : Debris					
Inspector Comment					
Remove the broken concrete and soil from slope and toe.

View of concrete and soil obstructing visibility and access.

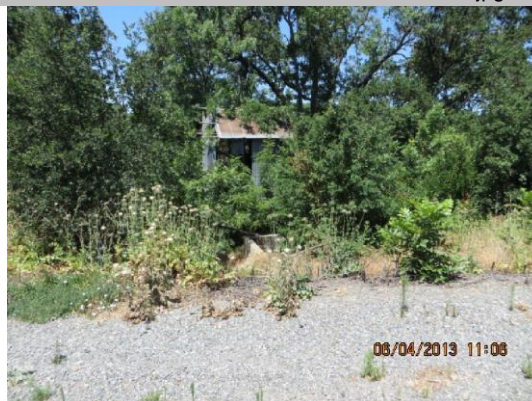
Photo 1 of 3 : UCIP_FA_2021_14664_24162.jpg

Comment Code						
Inspector Comment						
DS_ID:18834 FS_ID:14664 EP_NO: 9906 Repair Type: Non-Urgent EVAL Issue: Crossing Status: Found UCIP Comments: Pipe appears to be abandoned and should be done so properly. FIELD_STRUCT_DESC: 24-inch steel irrigation pipe through the levee, 13 feet below the crown. Slide gate on the waterside (WS) end. Pump house on berm. Slide gate in 7-foot by 12-foot concrete pit on the WS with flap gate on pipe from pump house. Pipe discharges into irrigation ditch on landward side. (Automatic Board Order (ABO) issued as Permit No. 9906, 1974 - Jeanette S. Clare). [Additional Reference(s): DWR Levee Log, 1992. USACE Sacramento O&M Manual 138, July 1955 (Station 1148+70)]. FS Date: 6/4/2013

Pumphouse and 7'X12' concrete box on WS slope.

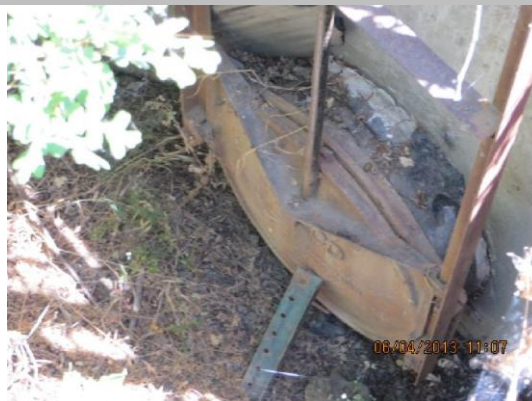
Photo 3 of 3 : UCIP_FA_2021_14664_24160.jpg

Slidegate inside concrete box on WS slope.

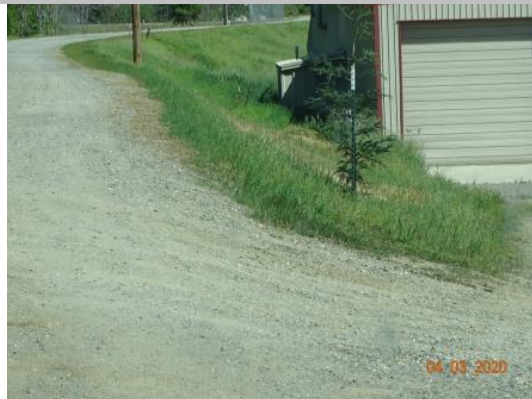
Photo 1 of 1 : FA_2021_LD0003_27_34_20210928_00011.jpg

View of damaged landside slope caused by vehicle traffic. Spring 2020.

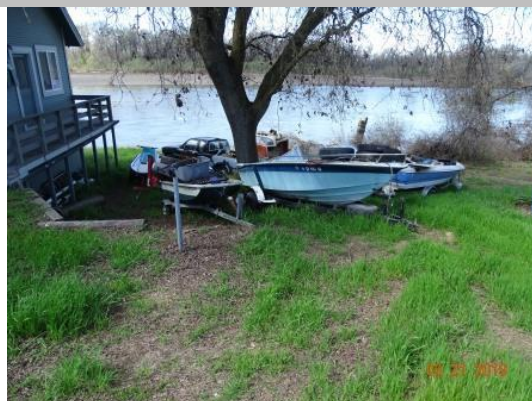
Photo 1 of 2 : FA_2021_LD0003_27_115_20210928_00039.jpg

View of the boats on the waterside slope and toe, facing west.

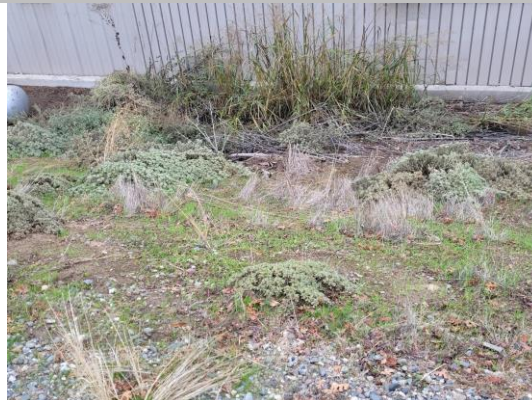
Photo 1 of 1 : FA_2021_LD0003_27_76_20211101_00084.jpg

View of the burned out stump hole along the landside toe. Fall 2021.

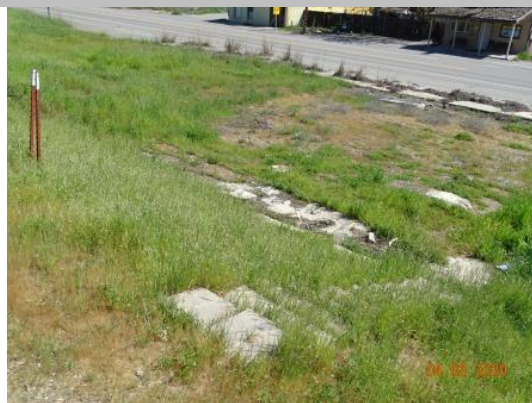
Photo 1 of 1 : FA_2021_LD0003_27_12_20210928_00005.jpg

View of the concrete stairs and foundation along the landside slope and toe. Spring 2020.

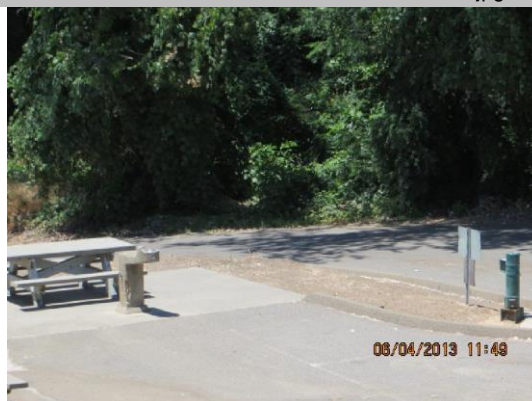
Photo 3 of 3 : UCIP_FA_2021_15165_24904.jpg

Possible reason for water service (water fountain).

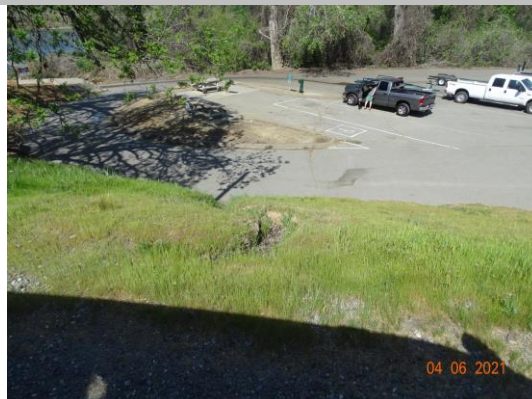
Photo 1 of 1 : FA_2021_LD0003_27_97_20210928_00036.jpg

View of the erosion on the waterside slope. Spring 2021.

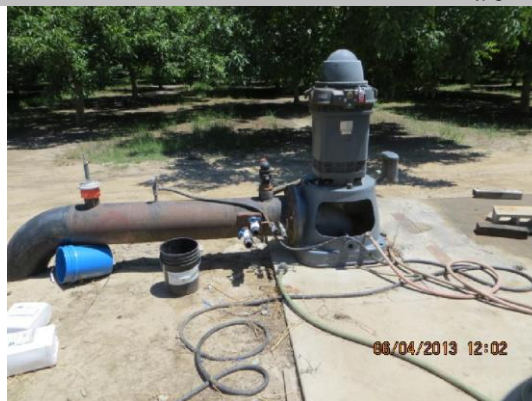
Photo 1 of 2 : UCIP_FA_2021_14686_24184.jpg

Pump located on LS toe next to concrete distribution box.

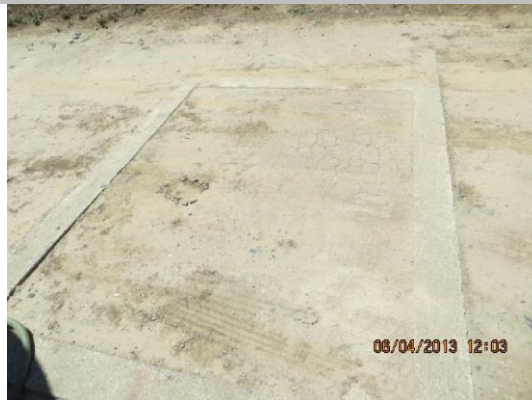
Photo 2 of 2 : UCIP_FA_2021_14686_24183.jpg

Soil filled concrete distribution box on LS toe.

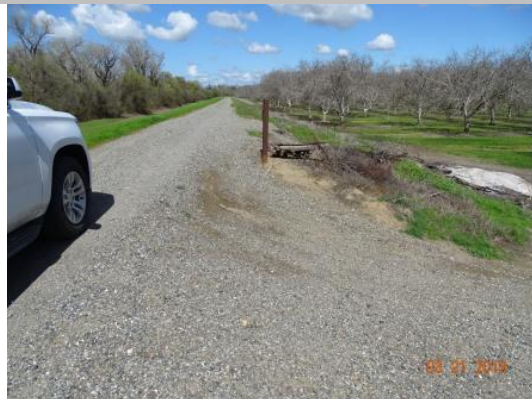
Photo 1 of 1 : FA_2021_LD0003_27_14_20210928_00007.jpg

View of the erosion caused by vehicle traffic along the landside slope and crown, facing upstream. (Spring 2019)

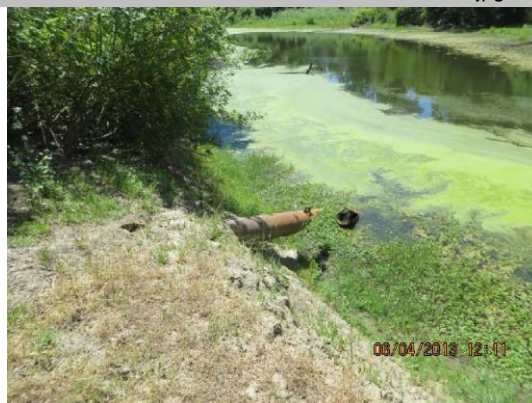
Photo 1 of 3 : UCIP_FA_2021_14687_24187.jpg

Pipe visible at pond off WS toe.

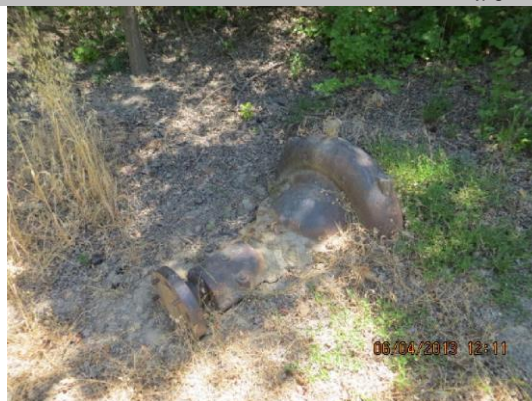
Photo 2 of 3 : UCIP_FA_2021_14687_24186.jpg

Pump visible off WS toe, next to pond.

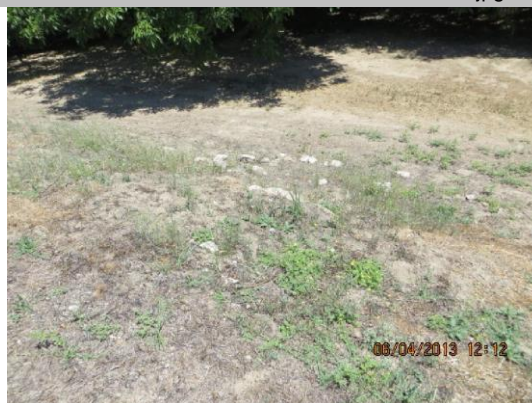
Photo 3 of 3 : UCIP_FA_2021_14687_24185.jpg

Remnants of concrete distribution box on LS toe.

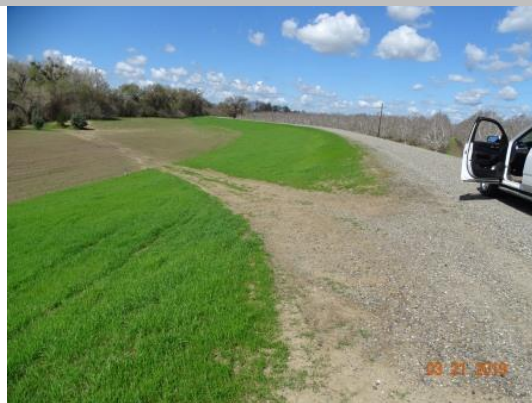
Photo 1 of 1 : FA_2021_LD0003_27_120_20210928_00042.jpg

View of the waterside slope damage caused by vehicle traffic, facing upstream. (Spring 2019)

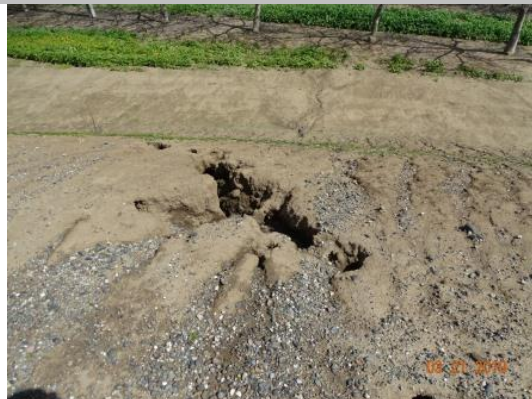
Photo 1 of 1 : FA_2021_LD0003_27_119_20210928_00041.jpg

View of the erosion caused by water runoff and rodent holes on the landside slope, facing east. (Spring 2019)

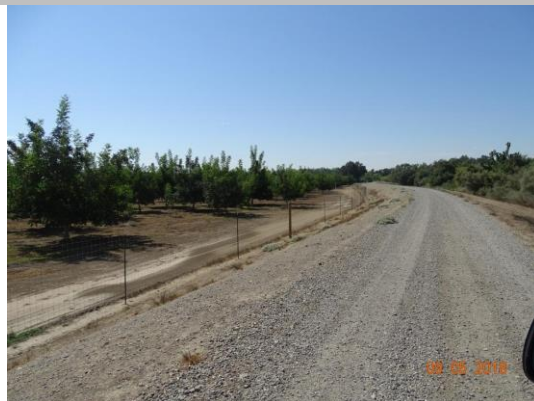
Photo 1 of 1 : FA_2021_LD0003_27_85_20210928_00031.jpg

View of the fence along the landside toe.

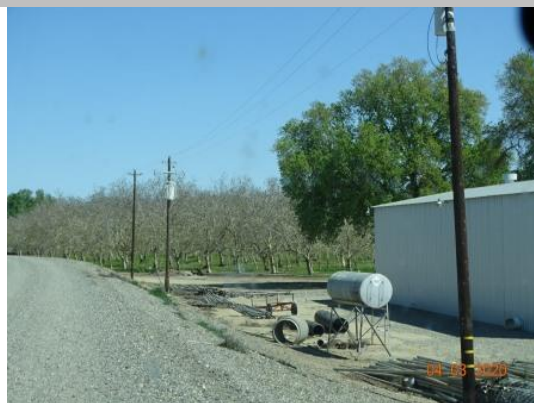
Photo 1 of 1 : FA_2021_LD0003_27_77_20210928_00027.jpg

View of the equipment along the landside toe. Spring 2020.

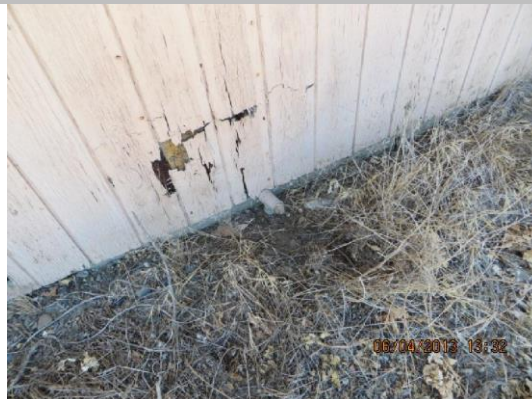
Photo 1 of 3 : UCIP_FA_2021_14688_24190.jpg

Pipe at side of building on WS shoulder.

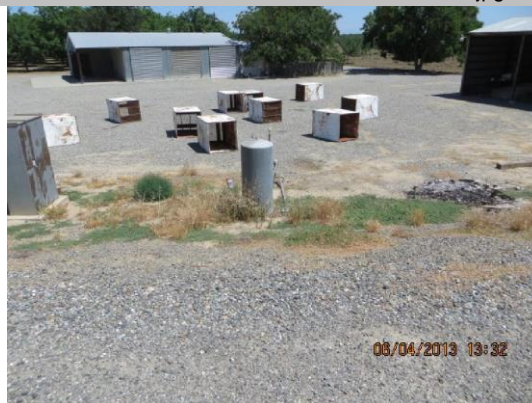
Photo 2 of 3 : UCIP_FA_2021_14688_24189.jpg

Water tank, pump, and well head on LS toe.

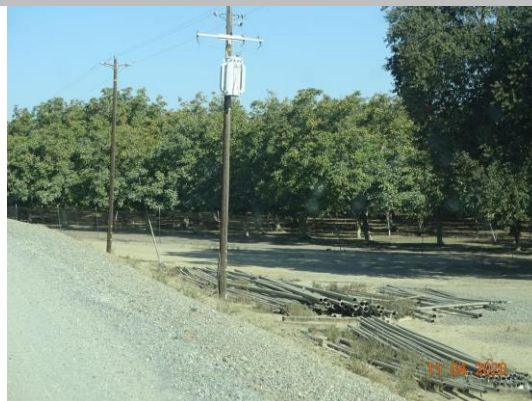
Photo 1 of 1 : FA_2021_LD0003_27_94_20210928_00034.jpg

View of the ag pipes along the landside toe. Fall 2020.

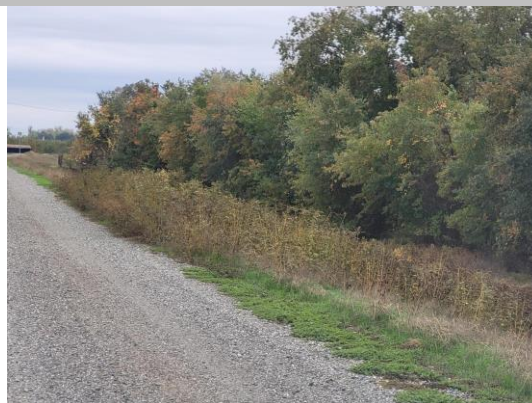
Photo 1 of 1 : FA_2021_LD0003_27_55_20211101_00085.jpg

View of the vegetation on the waterside slope. Fall 2021.

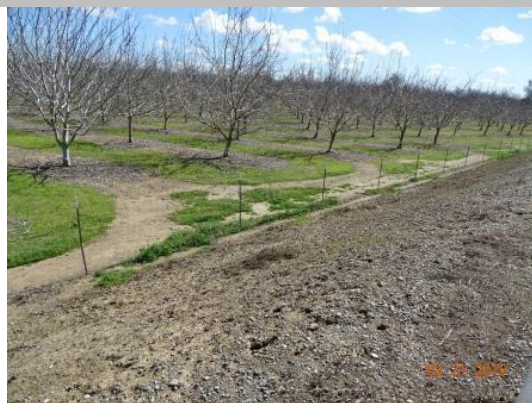
Photo 1 of 1 : FA_2021_LD0003_27_125_20210928_00043.jpg

View of the rodent holes along the landside slope, facing downstream.
(Spring 2019)

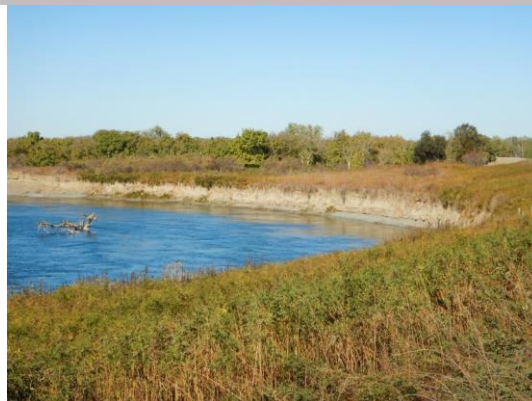
Photo 1 of 2 : FA_2021_LD0003_27_72_20211218_26.jpg

USACE 2018 Erosion Photo #1

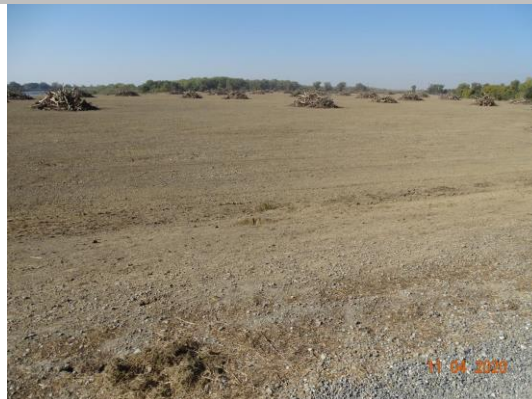
Photo 1 of 1 : FA_2021_LD0003_27_93_20210928_00033.jpg

View of the rodent activity along the waterside slope. Fall 2020.

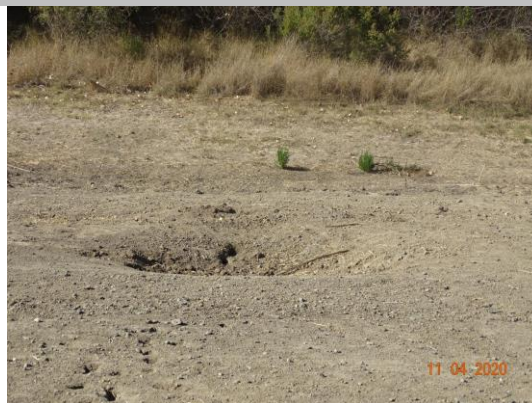
Photo 1 of 1 : FA_2021_LD0003_27_89_20210928_00032.jpg

View of a hole on the waterside slope. Fall 2020.

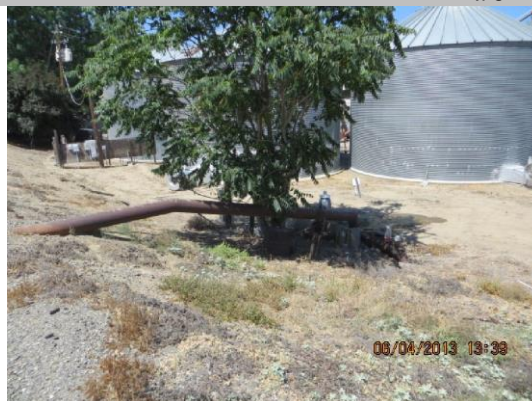
Photo 1 of 3 : UCIP_FA_2021_14690_24193.jpg

10-inch pipe and pump on LS.

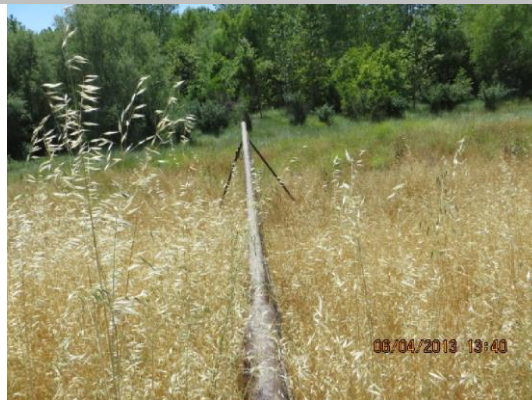
Photo 2 of 3 : UCIP_FA_2021_14690_24192.jpg

Pipe on WS shoulder.

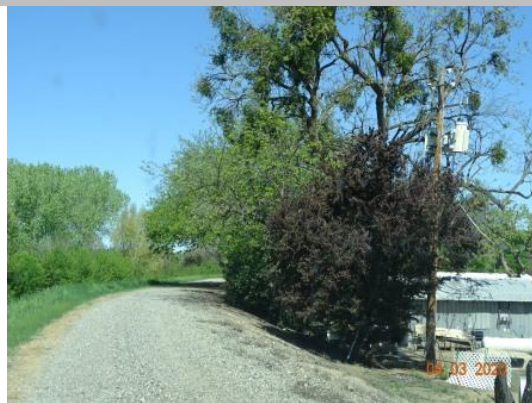
Photo 1 of 1 : FA_2021_LD0003_27_4_20210928_00002.jpg

View of the landscaping along the landside slope. Spring 2020.

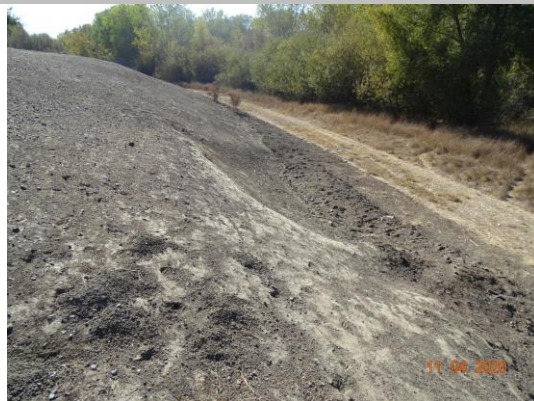
Photo 1 of 1 : FA_2021_LD0003_27_6_20210928_00003.jpg

View of the vertical cut along the waterside slope and toe. Fall 2020.

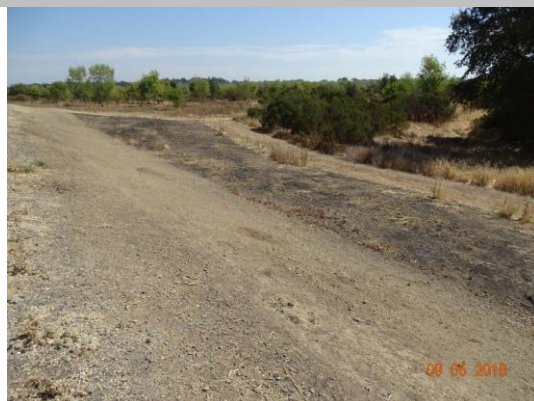
Photo 1 of 1 : FA_2021_LD0003_27_79_20210928_00029.jpg

View of the rodent holes along the landside slope.
