**Flood Control Project Maintenance
Levee Inspections
Fall 2022 Levee Maintenance Deficiency Summary Report**

Sacramento River Basin

Levee District No. 0003 (Glenn County)

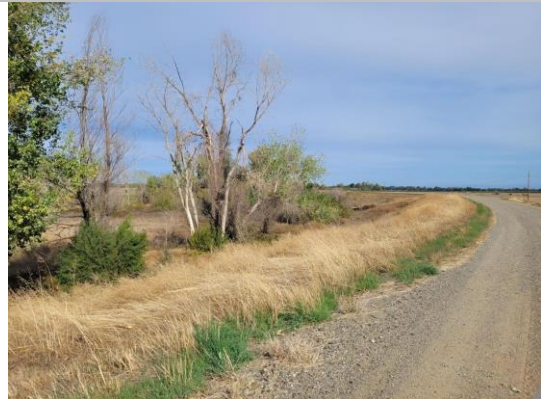
Photo 1 of 1 : FA_2022_LD0003_27_58_20221101_00047.jpg

View of the vegetation along the landside levee slope. Fall 2022.

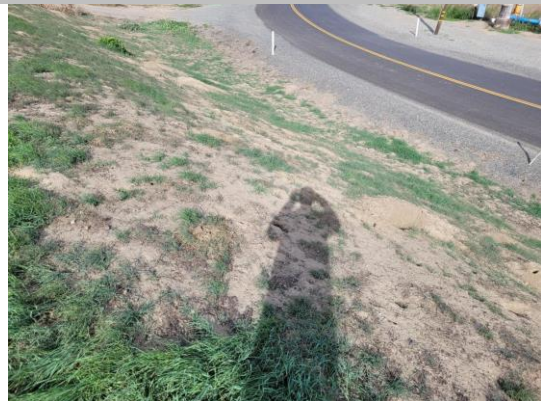
Photo 1 of 1 : FA_2022_LD0003_27_23_20221101_00048.jpg

LM Start	0.45	Rating **	M	Issue No.	23
LM End	0.72	Issue Type +	Ma	Location *	LS
Category	Earthen Levee			GPS Latitude/Longitude	
				Start	End
Item	Animal Control			39.389057 °	39.388475 °
				-121.993599 °	-121.998131 °
DWR ID	DWR_LD0003_01_s_2012_23				
Comment Code					
A3 : No rodents visible, but rodent burrows visible; need to backfill and compact or grout burrows.					
Inspector Comment

View of the animal burrows along the landside slope. Fall 2022.

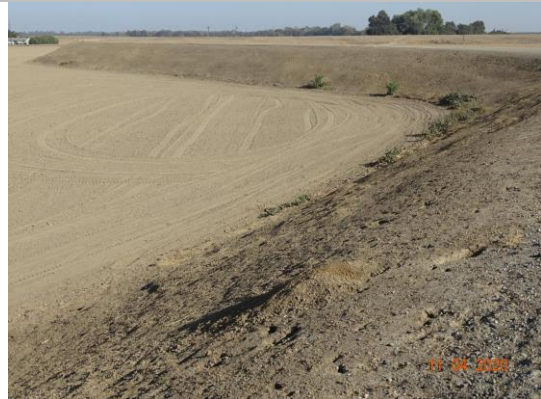
Photo 1 of 1 : FA_2022_LD0003_27_3_20220906_00001.jpg

View of the rodent activity along the landside slope. Fall 2020.

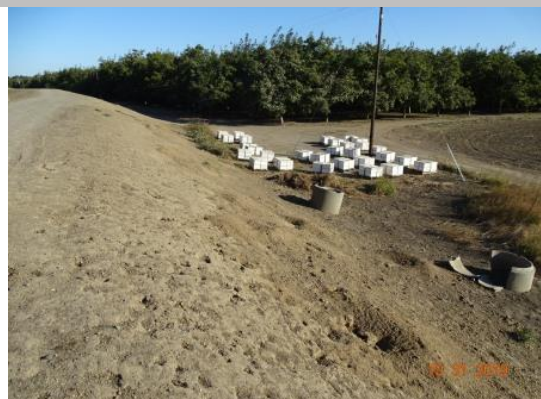
Photo 1 of 1 : FA_2022_LD0003_27_52_20220906_00018.jpg

View of the rodent burrows along the landside slope. Fall 2019.

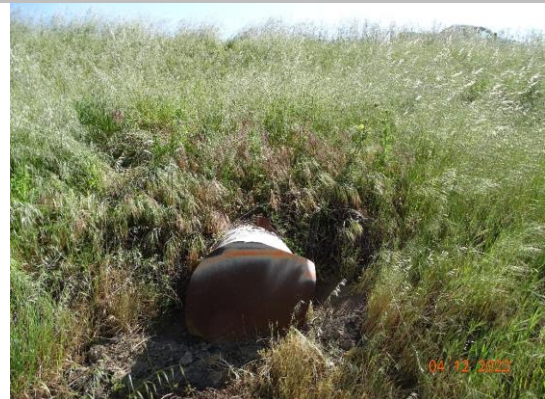
Photo 3 of 3 : UCIP_FA_2022_75909_114044.jpg

Comment Code					
Inspector Comment					
DS_ID:18830 FS_ID:75909 EP_NO: 9930 Repair Type: Non-Urgent EVAL Issue: 5, Pipe Damage Crossing Status: Found UCIP Comments: 04/12/2022 Record remains Non-Urgent. DMP internal video inspection has found pipe integrity issues. LOF of crossing is greater than or equal to 4.1 and less than 5. Crossing will be monitored until funding becomes available for rehabilitation. Crossing appears abandoned. Waterside pipe end was steel plate welded. Abandoned concrete box at landside toe. No permit has been identified authorizing pipe. Need to have CVFPB review ABO and determine current owner. (O.Yakimov - DWR UCIP) 06/04/2013 Steel plate welded over WS end of pipe. Slide gate at WS toe missing. Appears abandoned. (W.Wylie - DWR UCIP) FIELD_STRUCT_DESC: 24-inch corrugated metal irrigation pipe through the levee, 14.5 feet below the crown. Slide gate on waterside (WS) end. 7-foot by 9-foot concrete diversion box at landward toe (Automatic Board Order (ABO) issued as Permit No. 9930, 1974 - Steel Ranch). [Additional Reference(s): DWR Levee Log, 1992. USACE Sacramento O&M Manual 136, March 1960 (HLM 21.89)]. FS Date: 4/12/2022 4:11:31 PM

Water-Side: Capped pipe end at levee toe

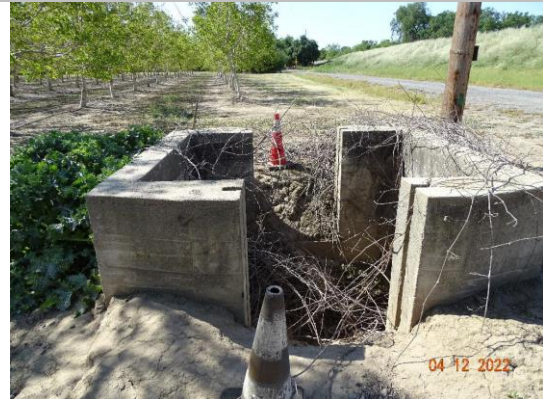
Photo 3 of 3 : UCIP_FA_2022_75911_114057.jpg

Comment Code						
Inspector Comment						
DS_ID:18825 FS_ID:75911 EP_NO: 9935 Repair Type: Non-Urgent EVAL Issue: 5, Pipe Damage Crossing Status: Found UCIP Comments: 04/12/2022 Record remains Non-Urgent. DMP internal video inspection has found pipe integrity issues. LOF of crossing is greater than or equal to 4.1 and less than 5. Crossing will be monitored until funding becomes available for rehabilitation. Crossing appears abandoned. Abandoned slide gate at waterside toe, abandoned concrete box on road shoulder. No permit has been identified authorizing pipe. Need to have CVFPB review ABO and determine current owner. (O.Yakimov - DWR UCIP) 06/04/2013 Appears abandoned. Pipe buried on WS toe. Debris and steel plate blocking inlet on LS. (W.Wylie - DWR UCIP) FIELD_STRUCT_DESC: 24-inch corrugated metal irrigation pipe through the levee and beneath the roadway, 18 feet below the crown. Slide gate on the waterside (WS) end. (Automatic Board Order (ABO) issued as Permit No. 9935, 1974 - Florence Watt). [Additional Reference(s): DWR Levee Log, 1992. USACE Sacramento O&M Manual 136, March 1960 (HLM 22.30)]. FS Date: 4/12/2022 8:09:01 AM

Land-Side: View of concrete distribution box that looks abandoned

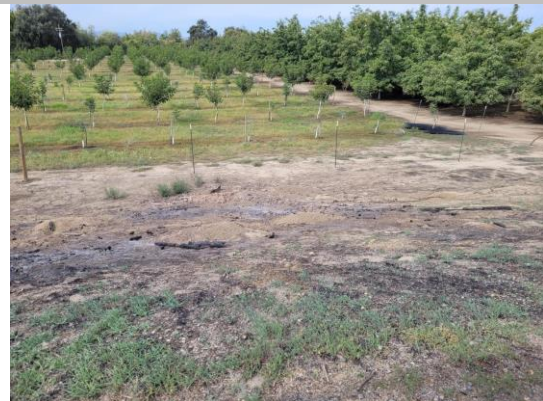
Photo 1 of 1 : FA_2022_LD0003_27_82_20221101_00049.jpg

LM Start	1.97	Rating **	U	Issue No.	82
LM End	1.97	Issue Type +	Ma	Location *	WS
Category	Earthen Levee			GPS Latitude/Longitude	
				Start	End
Item	Animal Control			39.404919 °	39.404919 °
				-122.001699 °	-122.001699 °
DWR ID	DWR_LD0003_01_f_2022_82				
Comment Code					
A3 : No rodents visible, but rodent burrows visible; need to backfill and compact or grout burrows.					
Inspector Comment

View of the animal burrows along the waterside slope. Fall 2022.

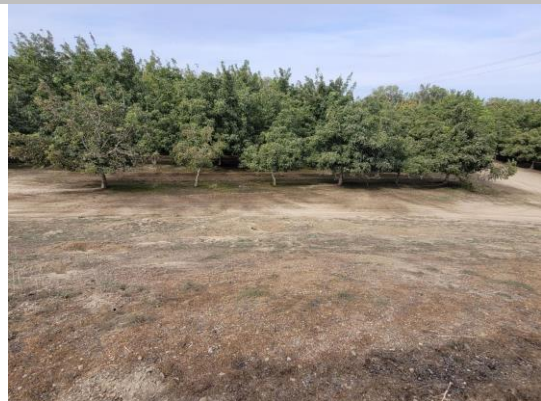
Photo 1 of 1 : FA_2022_LD0003_27_88_20221101_00050.jpg

View of the animal burrows along the waterside slope. Fall 2022.

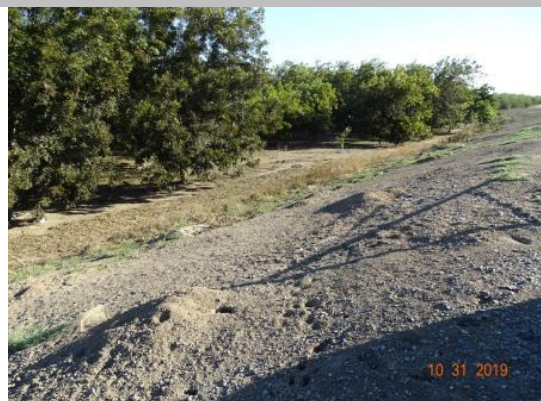
Photo 1 of 1 : FA_2022_LD0003_27_38_20220906_00012.jpg

View of rodent burrows along the waterside slope. Fall 2019.

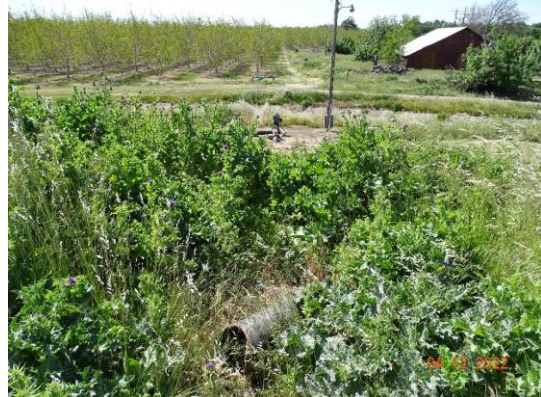
Photo 1 of 3 : UCIP_FA_2022_75921_114116.jpg

Comment Code						
Inspector Comment						
DS_ID:23151 FS_ID:75921 EP_NO: N/A Repair Type: Non-Urgent EVAL Issue: 11, Maintenance Compliance Issue Crossing Status: Found UCIP Comments: 04/12/2022 Record remains Non-Urgent. No permit has been found authorizing this pipe through the levee. Steel riser on landside shoulder was knocked down and needs repair. (O.Yakimov - DWR UCIP) 06/04/2013 No permit identified for this crossing. (W.Wylie - DWR UCIP) FIELD_STRUCT_DESC: 12-inch steel irrigation pipe through the levee, 3.5 feet below the crown. Agricultural water well, butterfly valve, and JP/meter at channel on landside (LS) toe. Three discharge pipes are coming from the well: towards orchard on LS, to fill LS irrigation canal, and through the levee. Siphon breaker inside a 12-inch steel riser unit on the LS shoulder. 3-inch plastic drain on the waterside (WS) toe. FS Date: 4/12/2022 1:11:30 PM

Land-Side: View of levee slope looking from crown. Steel riser on levee shouldes was knocked down

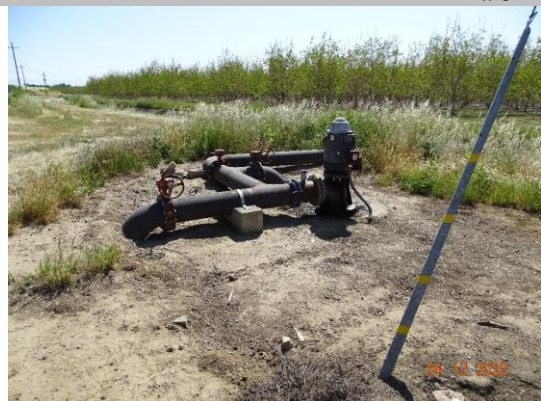
Photo 2 of 3 : UCIP_FA_2022_75921_114114.jpg

Land-Side: Agricultural well on levee berm

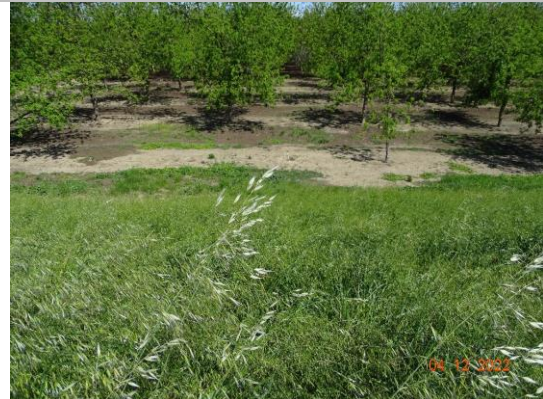
Photo 3 of 3 : UCIP_FA_2022_75921_114117.jpg

Water-Side: View of levee slope looking from crown. Pipe outlet not found

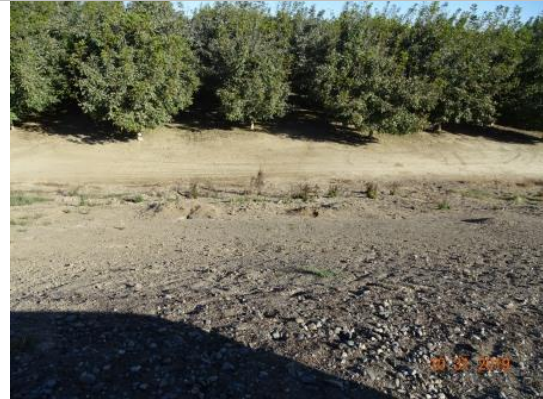
Photo 1 of 1 : FA_2022_LD0003_27_43_20220906_00013.jpg

View of the rodent burrows along the waterside slope. Fall 2019.

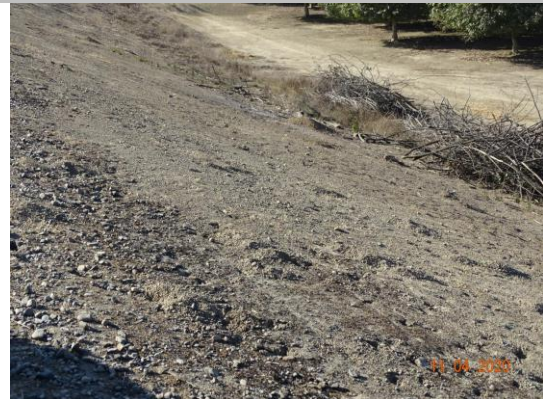
Photo 1 of 1 : FA_2022_LD0003_27_13_20220906_00005.jpg

View of the rodent activity along the waterside slope. Fall 2020.

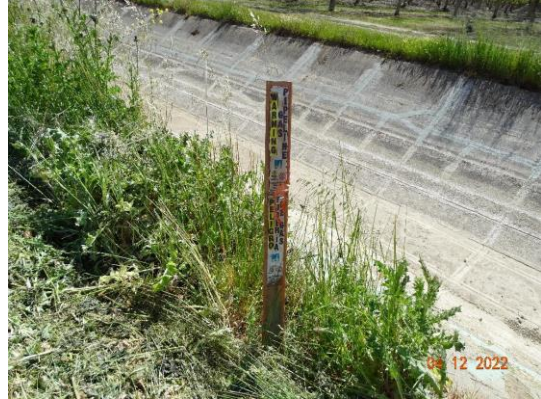
Photo 3 of 3 : UCIP_FA_2022_75922_114119.jpg

Comment Code						
Inspector Comment						
DS_ID:18826 FS_ID:75922 EP_NO: 2045 Repair Type: Non-Urgent EVAL Issue: 11, Maintenance Compliance Issue Crossing Status: Indicator Found UCIP Comments: 04/12/2022 Record updated from No Action Needed to Non-Urgent. No inspection records were available to determine status of line through the levee. Gas line sign on levee crown was removed. No markers on waterside found. Recommend owner to install additional markers. (O.Yakimov - DWR UCIP) FIELD_STRUCT_DESC: 12.75-inch steel high pressure gas line through the levee, 2 feet below the crown, PG&E. Concrete cutoff wall. Shutoff valve on LS toe. Gas line marker at irrigation canal on LS. (Permit. No. 2045, 1955 - PG&E). [Additional Reference(s): DWR Levee Log, 1992]. FS Date: 4/12/2022 1:22:02 PM

Land-Side: Closeup view of gas line marker at irrigation canal

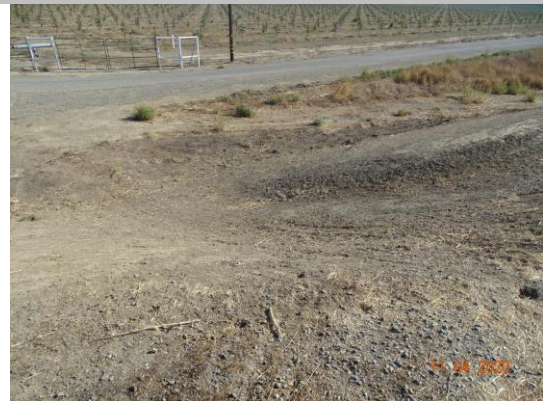
Photo 1 of 1 : FA_2022_LD0003_27_9_20220906_00003.jpg

LM Start	3.39	Rating **	M	Issue No.	9
LM End	3.39	Issue Type +	Ma	Location *	LS
Category	Earthen Levee			GPS Latitude/Longitude	
				Start	End
Item	Erosion / Vehicle Traffic			39.418382 °	39.418382 °
				-121.992480 °	-121.992480 °
DWR ID	DWR_LD0003_01_s_2012_9				
Comment Code					
E6 : Repair the levee slope damaged by vehicle traffic and prevent access where possible.					
Inspector Comment

View of the damaged landside slope due to vehicle traffic. Fall 2020.

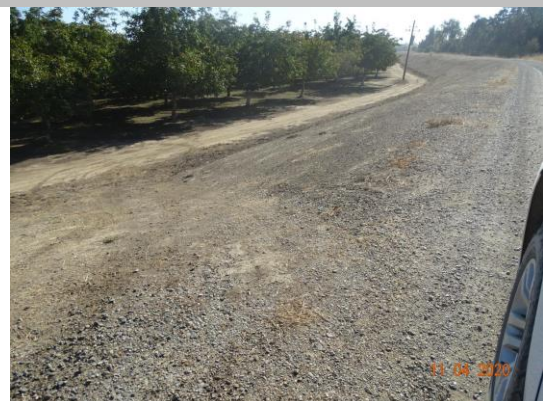
Photo 1 of 1 : FA_2022_LD0003_27_19_20220906_00007.jpg

LM Start	3.76	Rating **	M	Issue No.	19
LM End	3.76	Issue Type +	Ma	Location *	LS
Category	Earthen Levee			GPS Latitude/Longitude	
				Start	End
Item	Erosion / Vehicle Traffic			39.423747 °	39.423747 °
				-121.991667 °	-121.991667 °
DWR ID	DWR_LD0003_01_s_2012_19				
Comment Code					
E6 : Repair the levee slope damaged by vehicle traffic and prevent access where possible.					
Inspector Comment

View of the damaged landside slope due to vehicle traffic. Fall 2020.

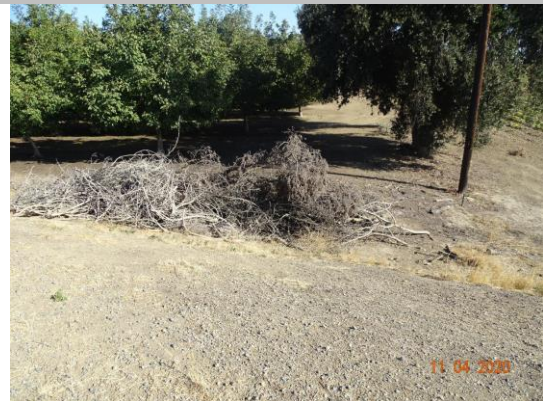
Photo 1 of 1 : FA_2022_LD0003_27_66_20220906_00022.jpg

View of the prunings along the landside toe. Fall 2020.

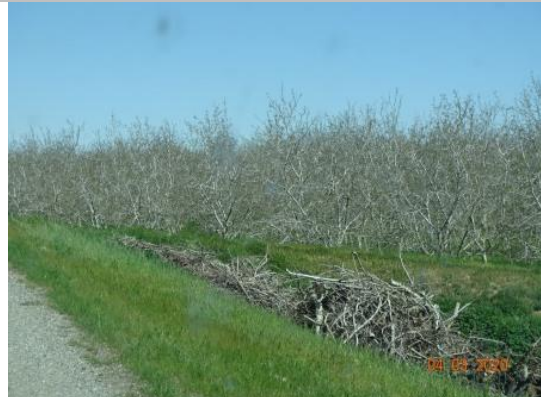
Photo 1 of 1 : FA_2022_LD0003_27_68_20220906_00024.jpg

View of the prunings on the landside slope and toe. Spring 2020.

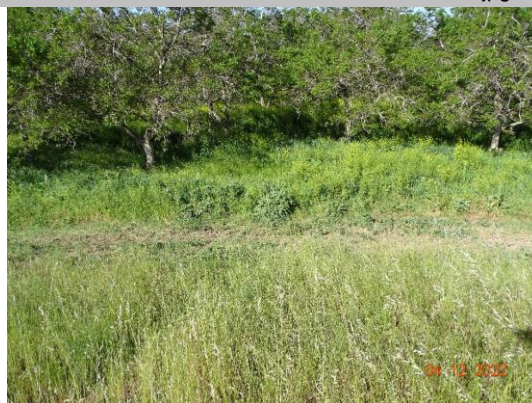
Photo 3 of 3 : UCIP_FA_2022_75931_114150.jpg

Comment Code					
Inspector Comment					
DS_ID:18822 FS_ID:75931 EP_NO: 9915 Repair Type: Non-Urgent EVAL Issue: 10, Unauthorized Modification or Non-Compliant Permit Crossing Status: Found UCIP Comments: 04/12/2022 Record updated from No Action Needed to Non-Urgent. Unauthorized encroachment recorded in Levee Log. Unauthorized pipe material used: PVC pipe through the levee. (O.Yakimov - DWR UCIP) FIELD_STRUCT_DESC: 3-inch polyvinyl chloride (PVC) irrigation pipe through the levee, at an unknown depth. Water well, shutoff valve, vent, power pole, and meter at the landside (LS) toe. Guy wire anchor in the LS slope. (Well and pump at the landward toe [HLM 5.11] authorized under Automatic Board Order (ABO) issued as Permit No. 9915, 1974 - B. J. and Edward Gordon). FS Date: 4/12/2022 3:14:31 PM

Water-Side: View of levee slope looking from crown. Crossing not found here

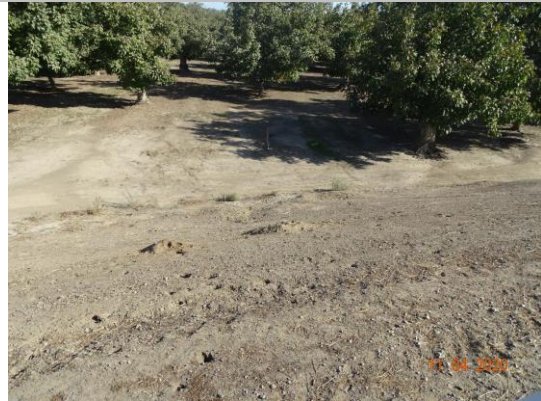
Photo 1 of 1 : FA_2022_LD0003_27_21_20220906_00008.jpg

View of the rodent activity along the landside slope. Fall 2020.

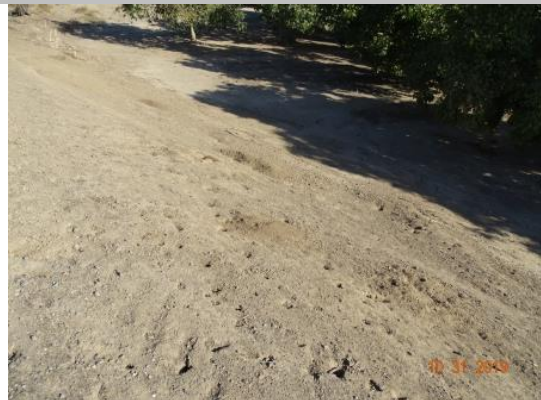
Photo 1 of 1 : FA_2022_LD0003_27_96_20220906_00038.jpg

View of the rodent burrows on the landside slope. Fall 2019.

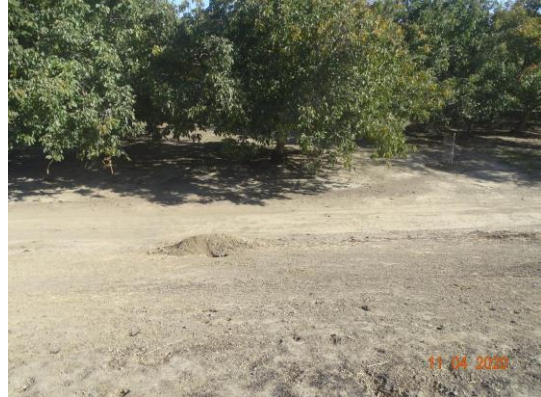
Photo 1 of 1 : FA_2022_LD0003_27_70_20220906_00025.jpg

View of the rodent activity along the landside slope. Fall 2020.

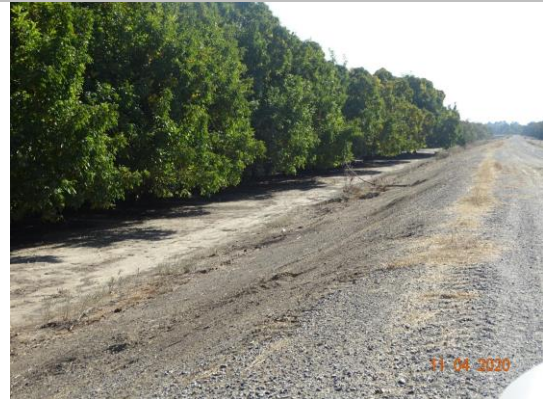
Photo 1 of 1 : FA_2022_LD0003_27_62_20220906_00020.jpg

View of the rodent activity along the landside slope. Fall 2020.

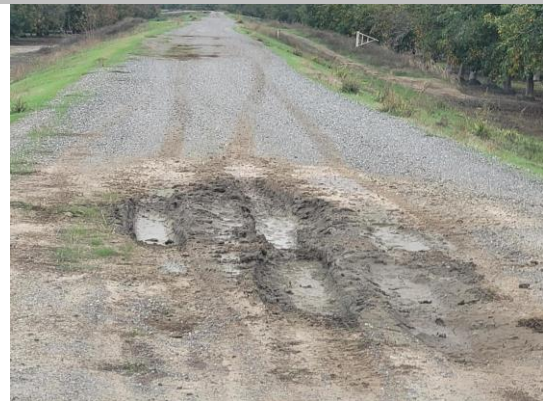
Photo 1 of 1 : FA_2022_LD0003_27_67_20220906_00023.jpg

View of the tire ruts on the crown. Fall 2021.

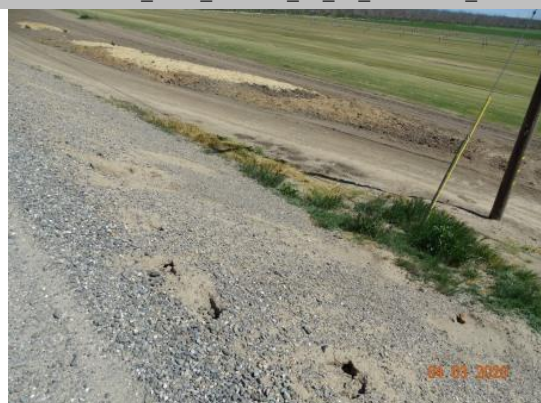
Photo 1 of 1 : FA_2022_LD0003_27_71_20220906_00026.jpg

View of the rodent holes along the landside slope. Spring 2020.

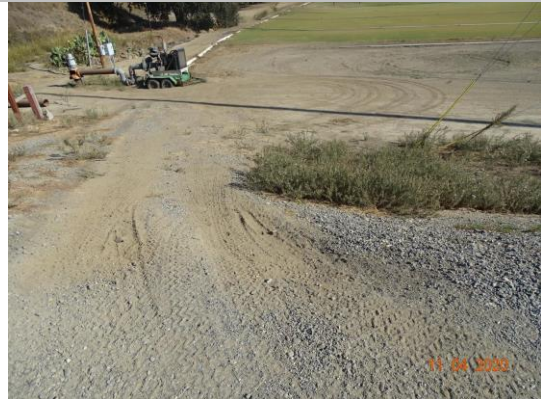
Photo 1 of 1 : FA_2022_LD0003_27_44_20220906_00014.jpg

View of the damaged landside slope due to vehicle traffic. Fall 2020.

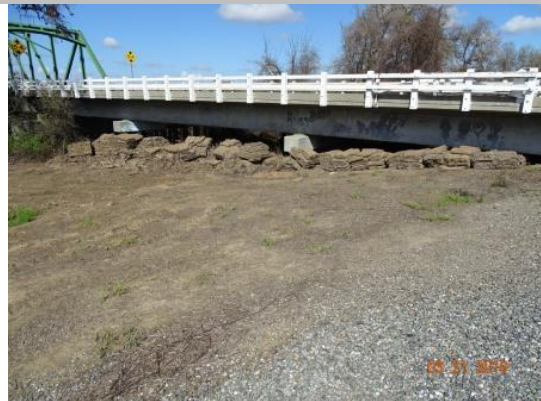
Photo 1 of 1 : FA_2022_LD0003_27_110_20220906_00040.jpg

View of the sod piles on the waterside slope within the floodway, facing upstream. (Spring 2019)

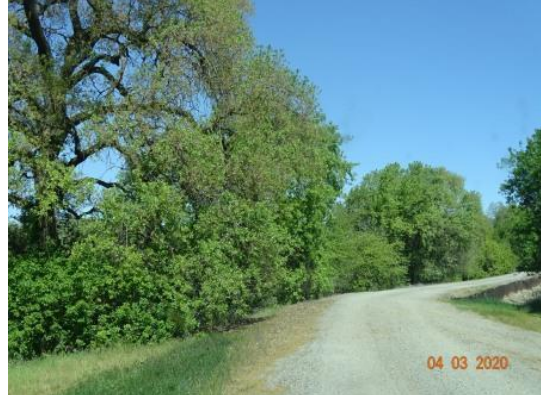
Photo 1 of 1 : FA_2022_LD0003_27_48_20220906_00015.jpg

View of the trees that need to be trimmed to at least 5 feet above the ground. Spring 2020.

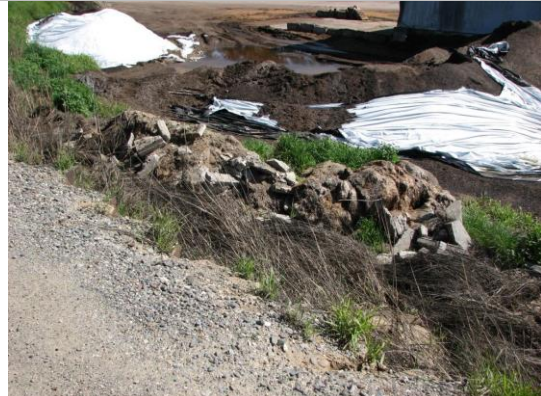
Photo 1 of 1 : FA_2022_LD0003_27_65_20220906_00021.jpg

View of concrete and soil obstructing visibility and access.

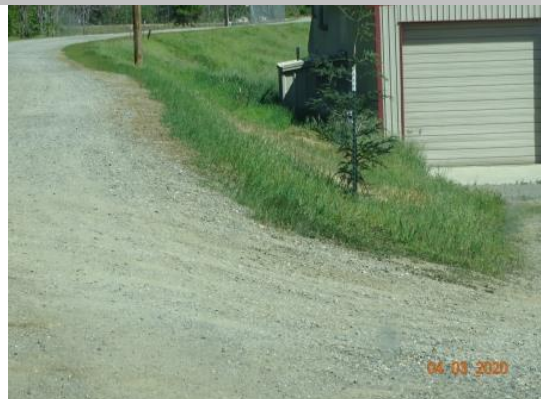
Photo 1 of 1 : FA_2022_LD0003_27_34_20220906_00010.jpg

View of damaged landside slope caused by vehicle traffic. Spring 2020.

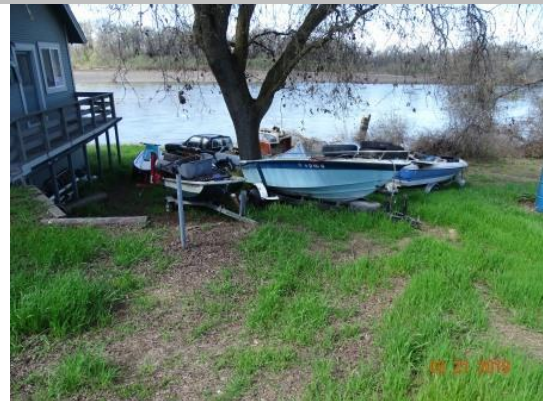
Photo 1 of 2 : FA_2022_LD0003_27_115_20220906_00041.jpg

View of the boats on the waterside slope and toe, facing west.

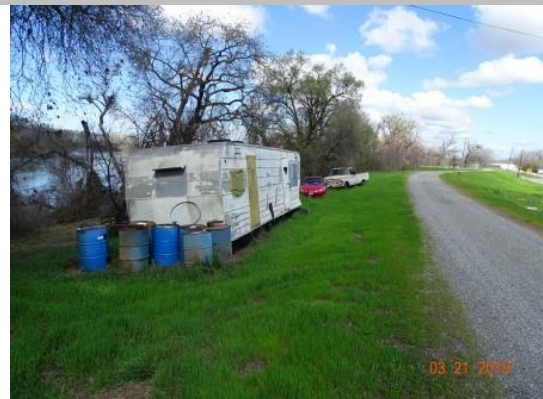
Photo 2 of 2 : FA_2022_LD0003_27_115_20220906_00042.jpg

View of an abandoned RV, cars and drums on the waterside slope, facing upstream.

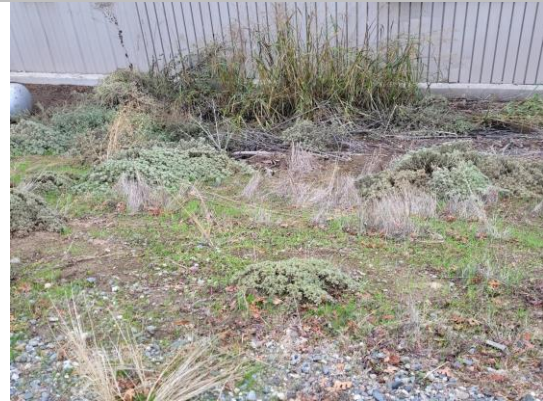
Photo 1 of 1 : FA_2022_LD0003_27_76_20220906_00029.jpg

View of the burned out stump hole along the landside toe. Fall 2021.

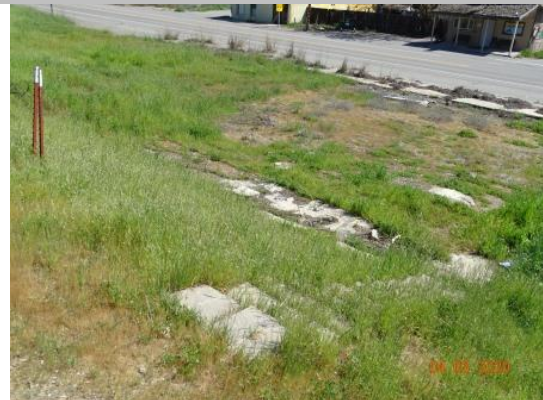
Photo 1 of 1 : FA_2022_LD0003_27_12_20220906_00004.jpg

View of the concrete stairs and foundation along the landside slope and toe. Spring 2020.

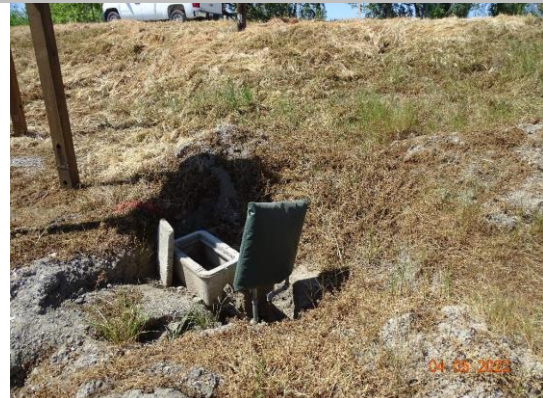
Photo 2 of 3 : UCIP_FA_2022_75967_114259.jpg

Land-Side: View of levee slope looking from toe. Pipe and christy box in excavation

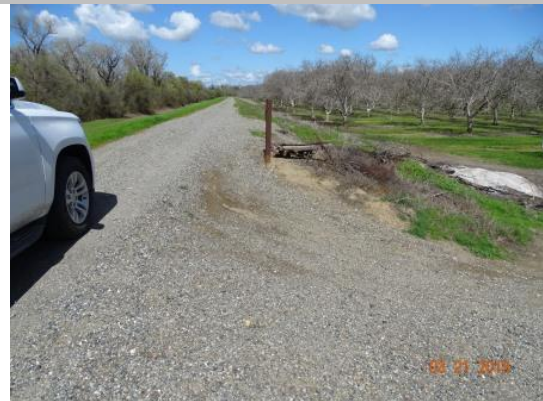
Photo 1 of 1 : FA_2022_LD0003_27_14_20220906_00006.jpg

View of the erosion caused by vehicle traffic along the landside slope and crown, facing upstream. (Spring 2019)

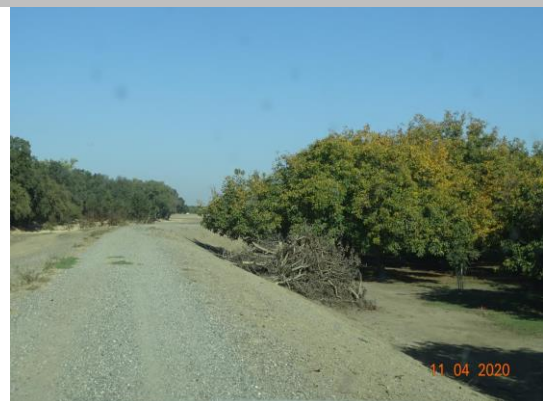
Photo 1 of 1 : FA_2022_LD0003_27_60_20220906_00019.jpg

View of the prunings along the landside toe. Fall 2020.

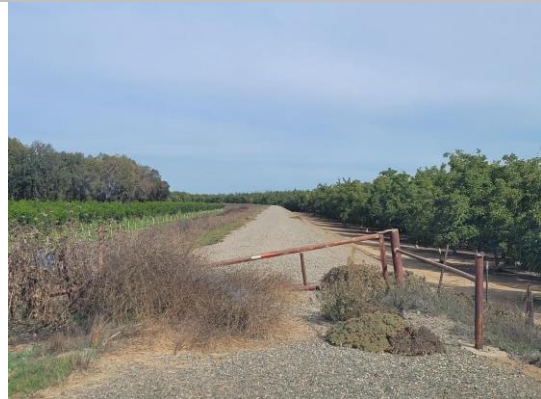
Photo 1 of 1 : FA_2022_LD0003_27_117_20221101_00051.jpg

View of a broken unauthorized gate. Fall 2022.

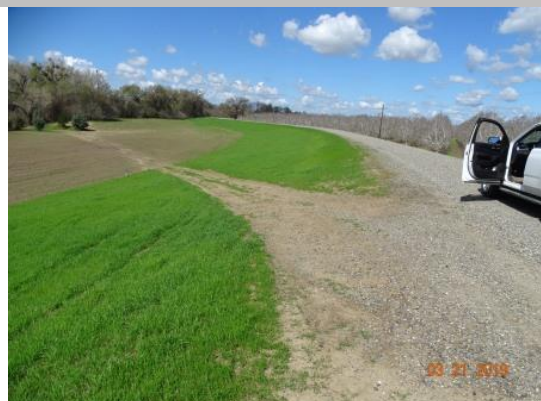
Photo 1 of 1 : FA_2022_LD0003_27_120_20220906_00044.jpg

View of the waterside slope damage caused by vehicle traffic, facing upstream. (Spring 2019)

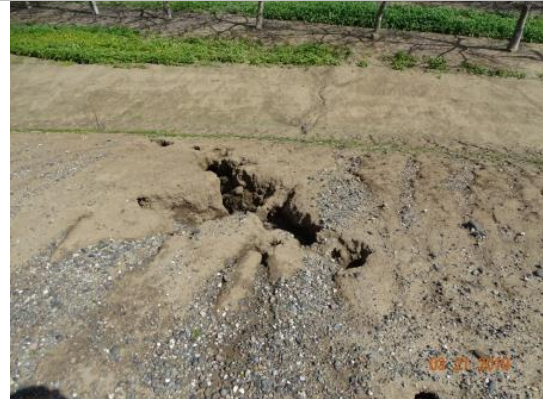
Photo 1 of 1 : FA_2022_LD0003_27_119_20220906_00043.jpg

View of the erosion caused by water runoff and rodent holes on the landside slope, facing east. (Spring 2019)

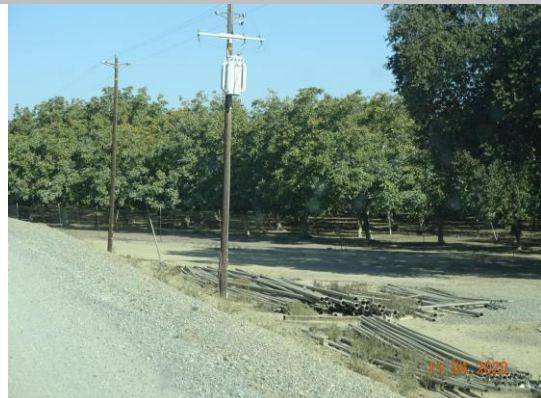
Photo 1 of 1 : FA_2022_LD0003_27_94_20220906_00037.jpg

View of the ag pipes along the landside toe. Fall 2020.

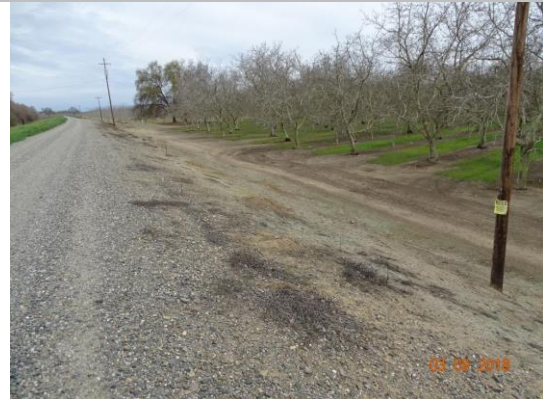
Photo 1 of 1 : FA_2022_LD0003_27_78_20220906_00031.jpg

View of the rodent holes along the landside slope.

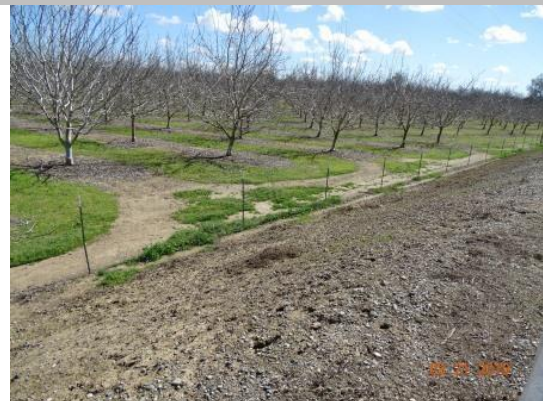
Photo 1 of 1 : FA_2022_LD0003_27_125_20220906_00045.jpg

View of the rodent holes along the landside slope, facing downstream.
(Spring 2019)

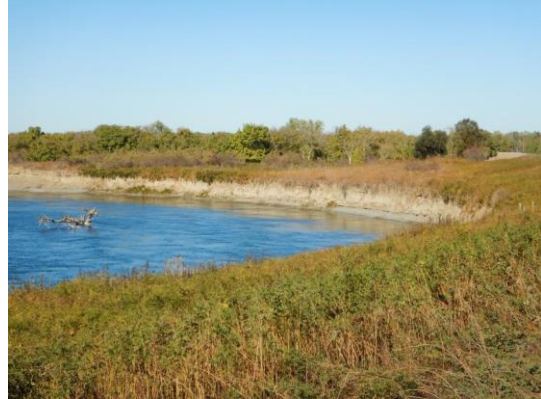
Photo 1 of 2 : FA_2022_LD0003_27_72_20220906_00027.jpg

USACE 2018 Erosion Photo #1

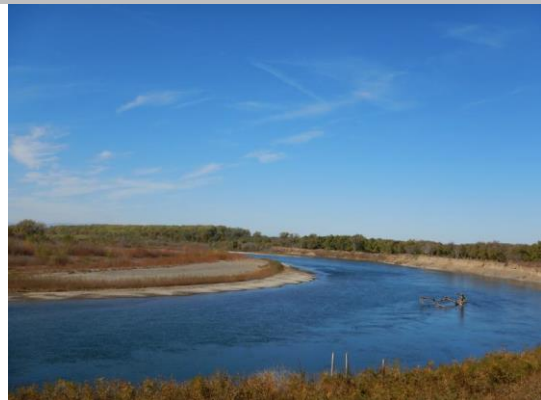
Photo 2 of 2 : FA_2022_LD0003_27_72_20220906_00028.jpg

USACE 2018 Erosion Photo #2

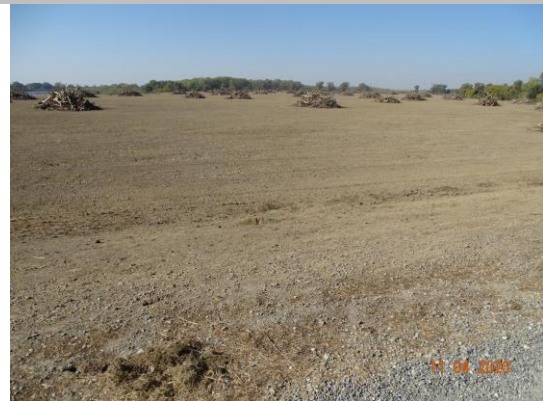
Photo 1 of 1 : FA_2022_LD0003_27_93_20220906_00036.jpg

View of the rodent activity along the waterside slope. Fall 2020.

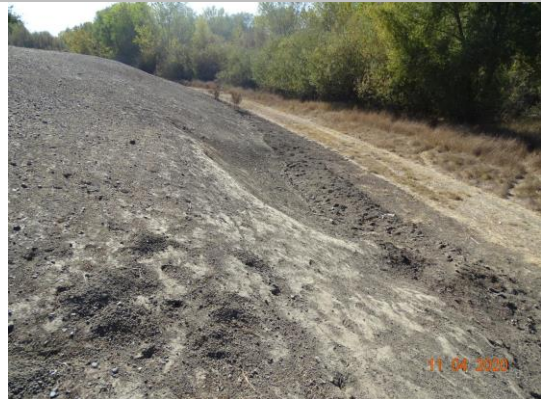
Photo 1 of 1 : FA_2022_LD0003_27_6_20220906_00002.jpg

View of the vertical cut along the waterside slope and toe. Fall 2020.
