**Flood Control Project Maintenance
Levee Inspections
Fall 2023 Levee Maintenance Deficiency Summary Report**

Sacramento River Basin

Levee District No. 0003 (Glenn County)

Waterway			Bank	Unit Miles
Unit No. 01 Glenn County Sacramento River			Left	11.97
	Spring (March - May)	Summer (June - August)	(September - November) Fall	Winter (December - February)
Unit Maintenance Rating (Fall Only)			U	
Date of Inspection	5/11/2023 - 5/11/2023		10/4/2023 - 10/4/2023	
DWR Inspector	Makar Sokol		Makar Sokol	
Accompanied By

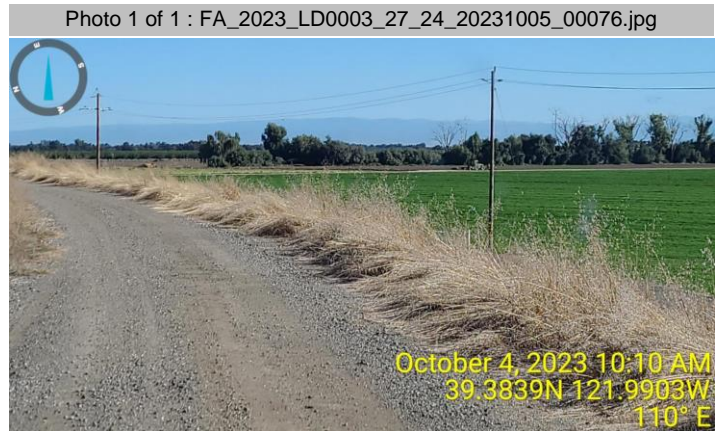
LM Start	0.00	Rating **	U	Issue No.	24
LM End	0.82	Issue Type +	Ma	Location *	LS
Category	Earthen Levee			GPS Latitude/Longitude	
				Start	End
Item	Vegetation			39.383941°	39.388736°
				-121.990286°	-121.999920°
DWR ID	DWR_LD0003_01_f_2023_24				
Comment Code					
V1 : Control annual grass and weeds on the levee slopes and easements.					
Inspector Comment

View of the vegetation along the landside slope. Fall 2023.

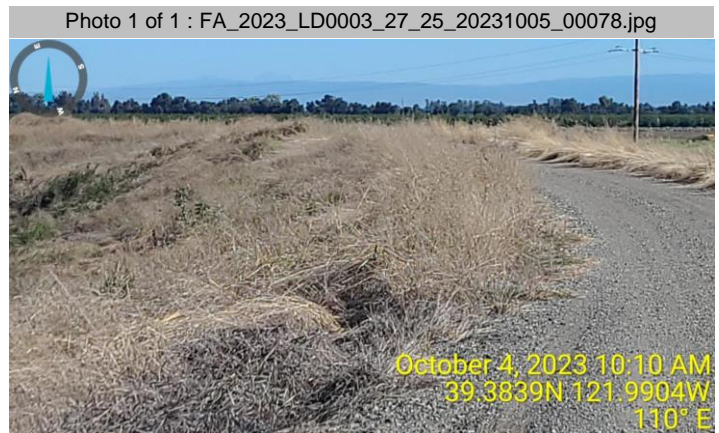
LM Start	0.00	Rating **	U	Issue No.	25
LM End	0.83	Issue Type +	Ma	Location *	WS
Category	Earthen Levee			GPS Latitude/Longitude	
				Start	End
Item	Vegetation			39.383945°	39.388815°
				-121.990289°	-122.000016°
DWR ID	DWR_LD0003_01_f_2023_25				
Comment Code					
V1 : Control annual grass and weeds on the levee slopes and easements.					
Inspector Comment

View of the vegetation along the waterside slope. Fall 2023.

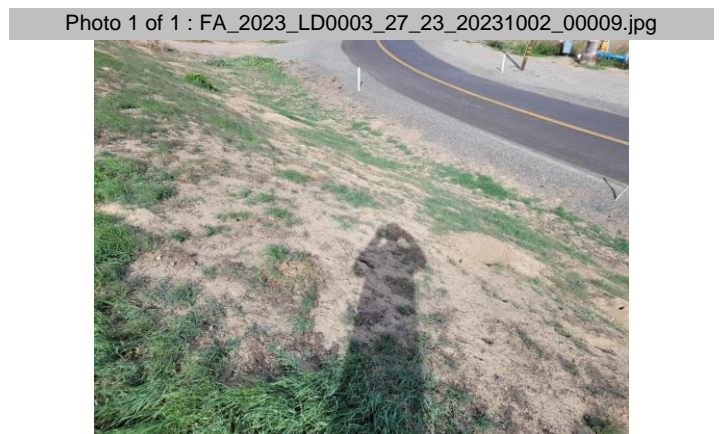
LM Start	0.45	Rating **	M	Issue No.	23
LM End	0.72	Issue Type +	Ma	Location *	LS
Category	Earthen Levee			GPS Latitude/Longitude	
				Start	End
Item	Animal Control			39.389057°	39.388475°
				-121.993599°	-121.998131°
DWR ID	DWR_LD0003_01_s _ 2012_23				
Comment Code					
A3 : No rodents visible, but rodent burrows visible; need to backfill and compact or grout burrows.					
Inspector Comment

View of the animal burrows along the landside slope. Fall 2022.

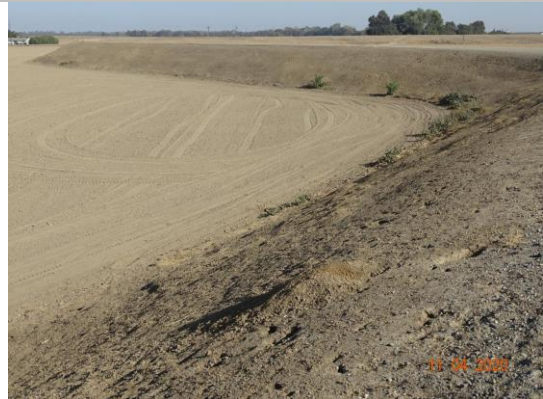
Photo 1 of 1 : FA_2023_LD0003_27_3_20231002_00001.jpg

View of the rodent activity along the landside slope. Fall 2020.

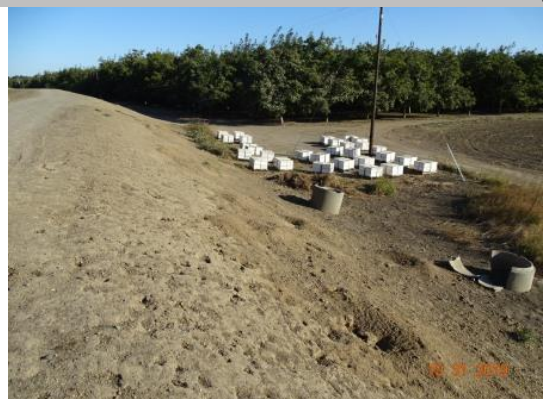
Photo 1 of 1 : FA_2023_LD0003_27_52_20231002_00016.jpg

View of the rodent burrows along the landside slope. Fall 2019.

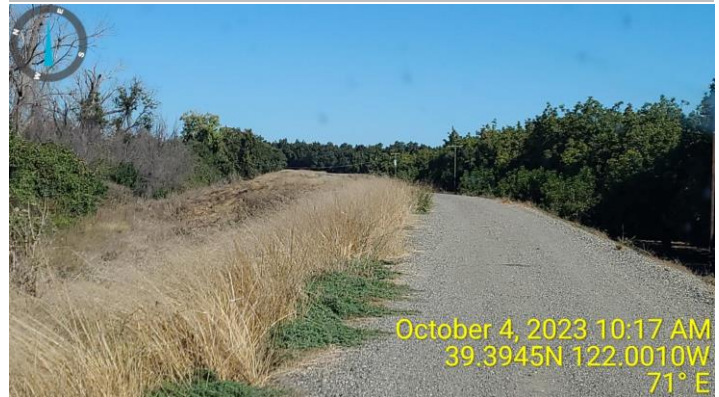
Photo 1 of 1 : FA_2023_LD0003_27_28_20231005_00080.jpg

View of the vegetation along the waterside slope. Fall 2023.

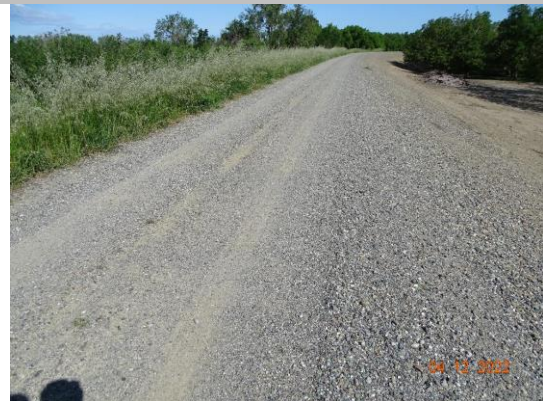
Photo 1 of 3 : UCIP_FA_2023_75909_114047.jpg

DS_ID:18830
 FS_ID:75909
 EP_NO: 9930
 Repair Type: Non-Urgent
 EVAL Issue: 5, Pipe Damage
 Crossing Status: Found
 UCIP Comments: 04/12/2022 Record remains Non-Urgent. DMP internal video inspection has found pipe integrity issues. LOF of crossing is greater than or equal to 4.1 and less than 5. Crossing will be monitored until funding becomes available for rehabilitation. Crossing appears abandoned. Waterside pipe end was steel plate welded. Abandoned concrete box at landside toe. No permit has been identified authorizing pipe. Need to have CVFPB review ABO and determine current owner. (O.Yakimov - DWR UCIP)
 06/04/2013 Steel plate welded over WS end of pipe. Slide gate at WS toe missing. Appears abandoned. (W.Wylie - DWR UCIP)
 FIELD_STRUCT_DESC: 24-inch corrugated metal irrigation pipe through the levee, 14.5 feet below the crown. Slide gate on waterside (WS) end. 7-foot by 9-foot concrete diversion box at landward toe (Automatic Board Order (ABO) issued as Permit No. 9930, 1974 - Steel Ranch). [Additional Reference(s): DWR Levee Log, 1992. USACE Sacramento O&M Manual 136, March 1960 (HLM 21.89)].

Top of Levee: View of levee crown looking upstream

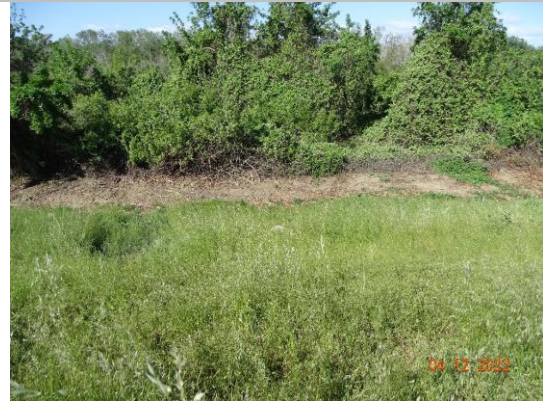
Photo 2 of 3 : UCIP_FA_2023_75909_114045.jpg

Water-Side: View of levee slope looking from crown

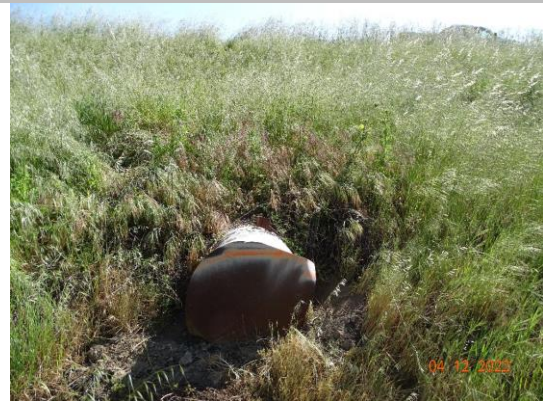
Photo 3 of 3 : UCIP_FA_2023_75909_114044.jpg

Water-Side: Capped pipe end at levee toe

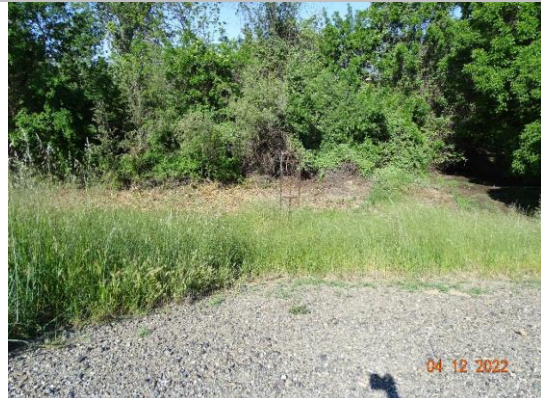
Photo 2 of 3 : UCIP_FA_2023_75910_114051.jpg

Comment Code					
Inspector Comment					
DS_ID:18823 FS_ID:75910 EP_NO: 9931 Repair Type: Non-Urgent EVAL Issue: 5, Pipe Damage Crossing Status: Found UCIP Comments: 04/12/2022 Record remains Non-Urgent. DMP internal video inspection has found pipe integrity issues. LOF of crossing is greater than or equal to 4.1 and less than 5. Crossing will be monitored until funding becomes available for rehabilitation. Crossing appears abandoned. Abandoned concrete box at landside toe, slide gate at waterside toe buried in soil. No permit has been identified authorizing pipe. Need to have CVFPB review ABO and determine current owner. (O.Yakimov - DWR UCIP) 06/04/2013 Appears abandoned. Pipe buried at slide gate on WS toe. (W.Wylie - DWR UCIP) FIELD_STRUCT_DESC: 24-inch corrugated metal irrigation pipe through the levee, 15 feet below the crown. Slide gate on the waterside (WS) end. 6-foot by 7-foot concrete distribution box on the landside (LS) toe. (Automatic Board Order (ABO) issued as Permit No. 9931, 1974 - Lowell F. Steel). [Additional Reference(s): DWR Levee Log, 1992. USACE Sacramento O&M Manual 136, March 1960 (HLM 22.00)]. FS Date: 4/12/2022 7:51:34 AM

Water-Side: View of levee slope looking from crown

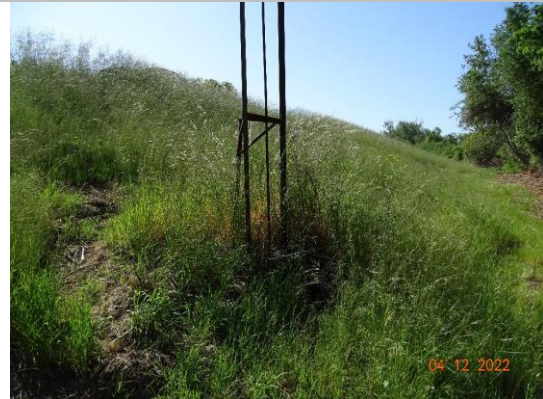
Photo 3 of 3 : UCIP_FA_2023_75910_114052.jpg

Water-Side: Slide gate at levee toe buried in soil

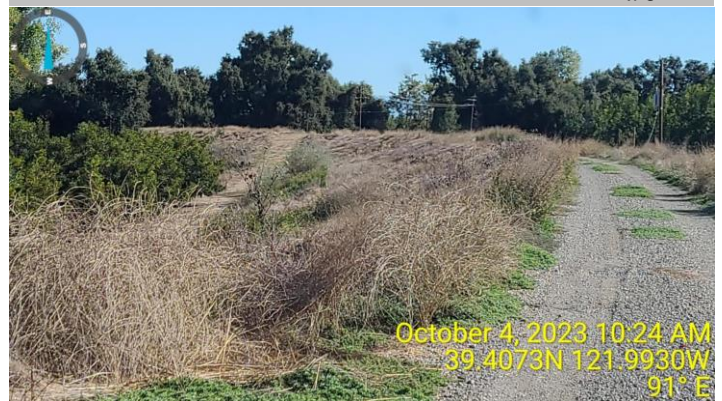
Photo 1 of 1 : FA_2023_LD0003_27_29_20231005_00081.jpg

View of the vegetation along the waterside slope. Fall 2023.

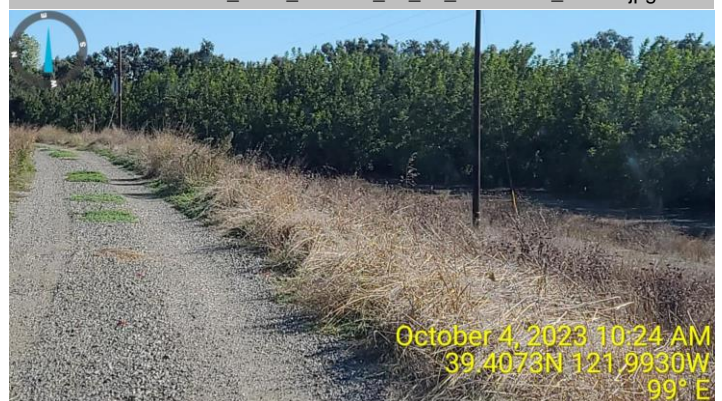
Photo 1 of 1 : FA_2023_LD0003_27_30_20231005_00082.jpg

View of the vegetation along the landside slope. Fall 2023.

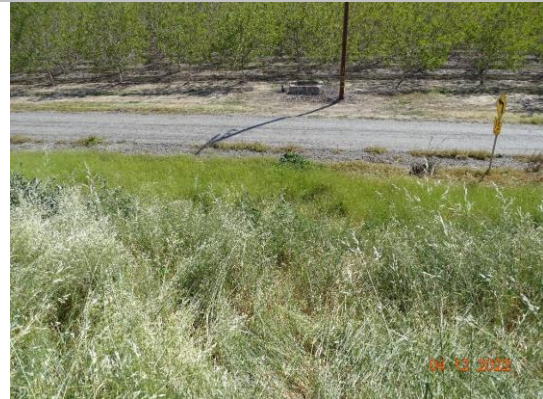
Photo 2 of 3 : UCIP_FA_2023_75911_114055.jpg

Land-Side: View of levee slope looking from crown, concrete distribution box on road shoulder

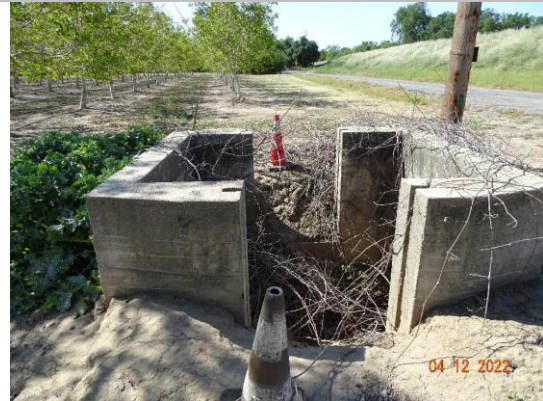
Photo 3 of 3 : UCIP_FA_2023_75911_114057.jpg

Land-Side: View of concrete distribution box that looks abandoned

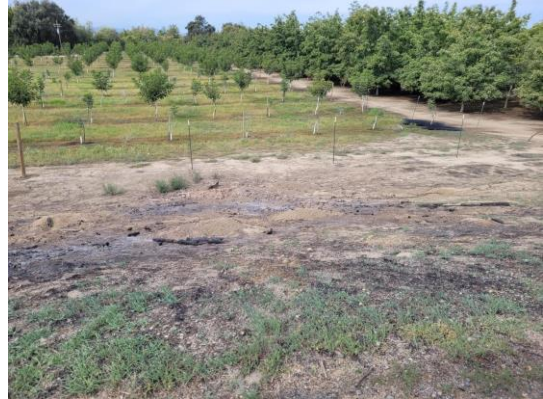
Photo 1 of 1 : FA_2023_LD0003_27_82_20231002_00030.jpg

View of the animal burrows along the waterside slope. Fall 2022.

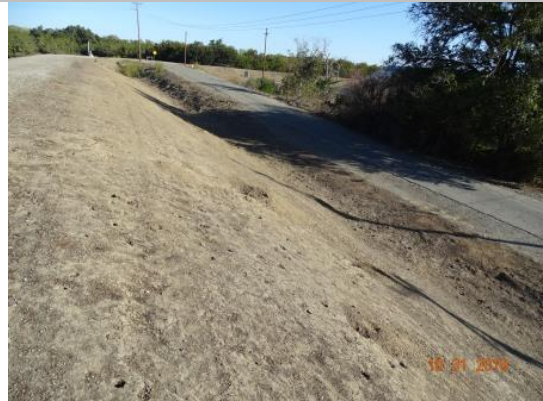
Photo 1 of 1 : FA_2023_LD0003_27_36_20231002_00012.jpg

View of the rodent burrows along the landside slope. Fall 2019.

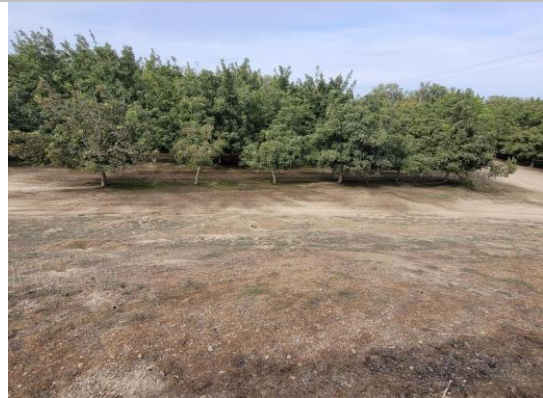
Photo 1 of 1 : FA_2023_LD0003_27_88_20231002_00033.jpg

View of the animal burrows along the waterside slope. Fall 2022.

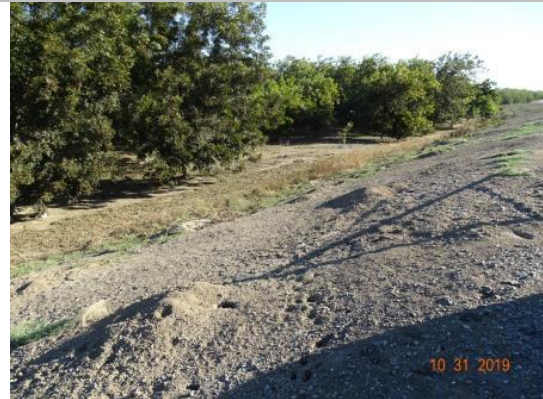
Photo 1 of 1 : FA_2023_LD0003_27_38_20231002_00013.jpg

View of rodent burrows along the waterside slope. Fall 2019.

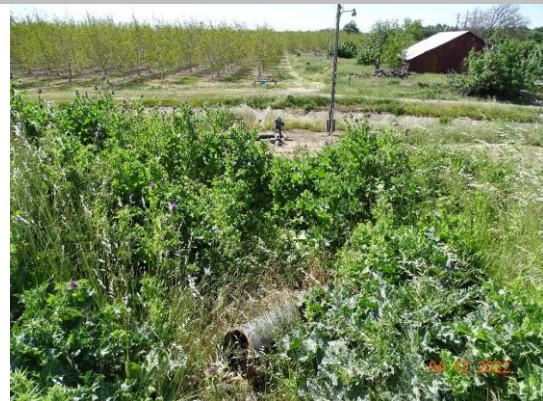
Photo 1 of 3 : UCIP_FA_2023_75921_114116.jpg

Comment Code						
Inspector Comment						
DS_ID:23151 FS_ID:75921 EP_NO: N/A Repair Type: Non-Urgent EVAL Issue: 11, Maintenance Compliance Issue Crossing Status: Found UCIP Comments: 04/12/2022 Record remains Non-Urgent. No permit has been found authorizing this pipe through the levee. Steel riser on landside shoulder was knocked down and needs repair. (O.Yakimov - DWR UCIP) 06/04/2013 No permit identified for this crossing. (W.Wylie - DWR UCIP) FIELD_STRUCT_DESC: 12-inch steel irrigation pipe through the levee, 3.5 feet below the crown. Agricultural water well, butterfly valve, and JP/meter at channel on landside (LS) toe. Three discharge pipes are coming from the well: towards orchard on LS, to fill LS irrigation canal, and through the levee. Siphon breaker inside a 12-inch steel riser unit on the LS shoulder. 3-inch plastic drain on the waterside (WS) toe. FS Date: 4/12/2022 1:11:30 PM

Land-Side: View of levee slope looking from crown. Steel riser on levee shoulder was knocked down

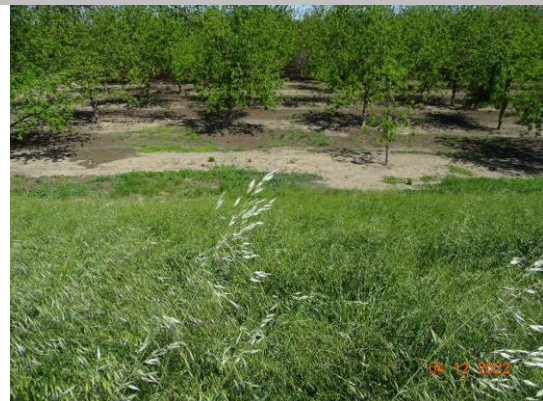
Photo 3 of 3 : UCIP_FA_2023_75921_114117.jpg

Water-Side: View of levee slope looking from crown. Pipe outlet not found

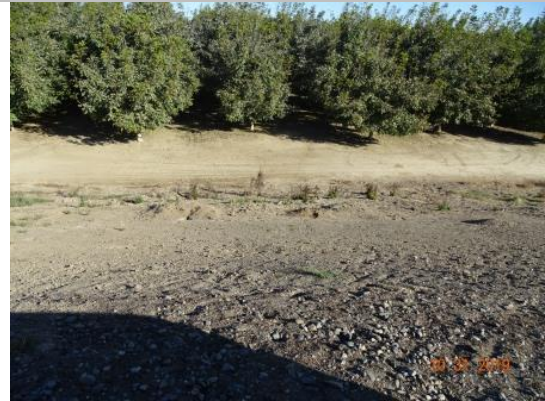
Photo 1 of 1 : FA_2023_LD0003_27_43_20231002_00014.jpg

View of the rodent burrows along the waterside slope. Fall 2019.

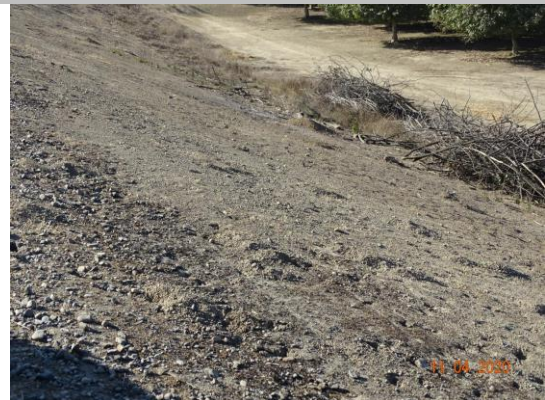
Photo 1 of 1 : FA_2023_LD0003_27_13_20231002_00005.jpg

View of the rodent activity along the waterside slope. Fall 2020.

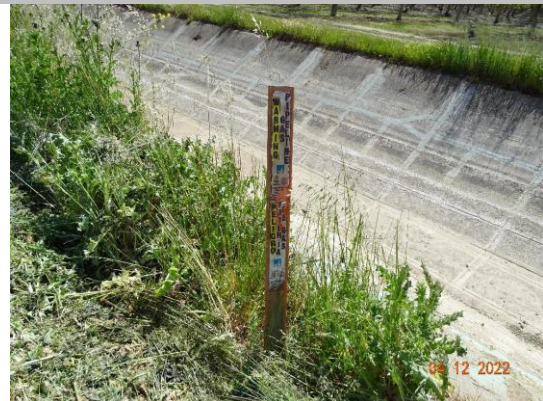
Photo 3 of 3 : UCIP_FA_2023_75922_114119.jpg

Comment Code					
Inspector Comment					
DS_ID:18826 FS_ID:75922 EP_NO: 2045 Repair Type: Non-Urgent EVAL Issue: 11, Maintenance Compliance Issue Crossing Status: Indicator Found UCIP Comments: 04/12/2022 Record updated from No Action Needed to Non-Urgent. No inspection records were available to determine status of line through the levee. Gas line sign on levee crown was removed. No markers on waterside found. Recommend owner to install additional markers. (O.Yakimov - DWR UCIP) FIELD_STRUCT_DESC: 12.75-inch steel high pressure gas line through the levee, 2 feet below the crown, PG&E. Concrete cutoff wall. Shutoff valve on LS toe. Gas line marker at irrigation canal on LS. (Permit. No. 2045, 1955 - PG&E). [Additional Reference(s): DWR Levee Log, 1992]. FS Date: 4/12/2022 1:22:02 PM

Land-Side: Closeup view of gas line marker at irrigation canal

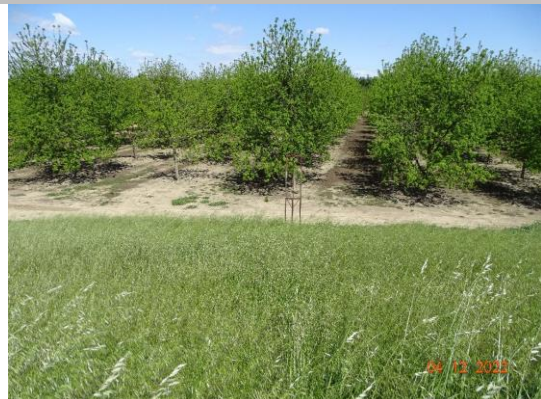
Photo 2 of 3 : UCIP_FA_2023_75924_114123.jpg

DS_ID:18827
FS_ID:75924
EP_NO: 9936
Repair Type: Non-Urgent
EVAL Issue: 5, Pipe Damage
Crossing Status: Found
UCIP Comments: 04/12/2022 Record remains Non-Urgent. DMP internal video inspection has found pipe integrity issues. LOF of crossing is greater than or equal to 4.1 and less than 5. Crossing will be monitored until funding becomes available for rehabilitation. Crossing appears abandoned. DMP cleared from soil concrete distribution box on landside berm that appears abandoned. Abandoned and buried in soil slide gate at waterside toe. No permit has been identified authorizing pipe. Need to have CVFPB review ABO and determine current owner. (O.Yakimov - DWR UCIP)
06/04/2013 Appears abandoned. Pipe buried on WS and blocked with tin and soil on the LS. (W.Wylie - DWR UCIP)
FIELD_STRUCT_DESC: 24-inch corrugated metal irrigation pipe through the levee, 18.3 feet below crown. Slide gate on the waterside (WS) end. 5-foot by 7-foot concrete distribution box at the landside (LS) toe. (Automatic Board Order (ABO) issued as Permit No. 9936, 1974 - J. A. and Florence Watt). [Additional Reference(s): DWR Levee Log, 1992. USACE Sacramento O&M Manual 136, March 1960 (HLM 22.82)].

Water-Side: View of levee slope looking from crown. Abandoned slide gate at levee toe

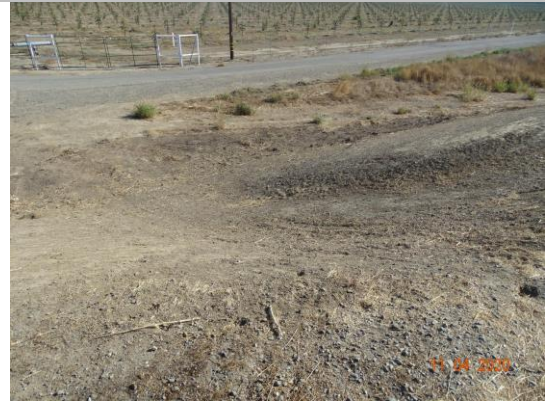
Photo 1 of 1 : FA_2023_LD0003_27_9_20231002_00003.jpg

LM Start	3.39	Rating **	M	Issue No.	9
LM End	3.39	Issue Type +	Ma	Location *	LS
Category	Earthen Levee			GPS Latitude/Longitude	
				Start	End
Item	Erosion / Vehicle Traffic			39.418382°	39.418382°
				-121.992480°	-121.992480°
DWR ID	DWR_LD0003_01_s_2012_9				
Comment Code					
E6 : Repair the levee slope damaged by vehicle traffic and prevent access where possible.					
Inspector Comment

View of the damaged landside slope due to vehicle traffic. Fall 2020.

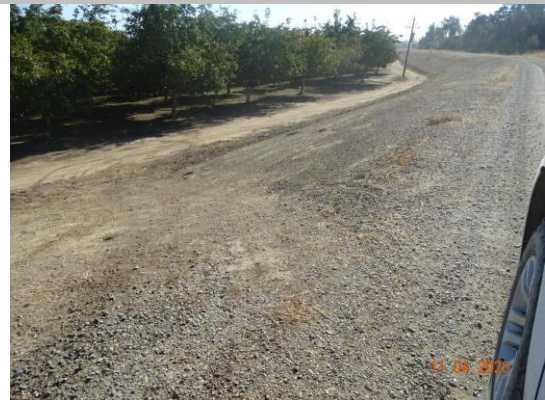
Photo 1 of 1 : FA_2023_LD0003_27_19_20231002_00007.jpg

LM Start	3.76	Rating **	M	Issue No.	19
LM End	3.76	Issue Type +	Ma	Location *	LS
Category	Earthen Levee			GPS Latitude/Longitude	
				Start	End
Item	Erosion / Vehicle Traffic			39.423747°	39.423747°
				-121.991667°	-121.991667°
DWR ID	DWR_LD0003_01_s _ 2012_19				
Comment Code					
E6 : Repair the levee slope damaged by vehicle traffic and prevent access where possible.					
Inspector Comment

View of the damaged landside slope due to vehicle traffic. Fall 2020.

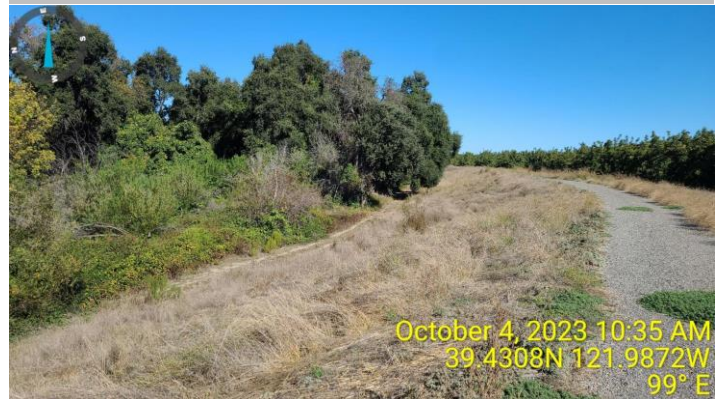
Photo 1 of 1 : FA_2023_LD0003_27_44_20231005_00079.jpg

View of the vegetation along the waterside slope. Fall 2023.

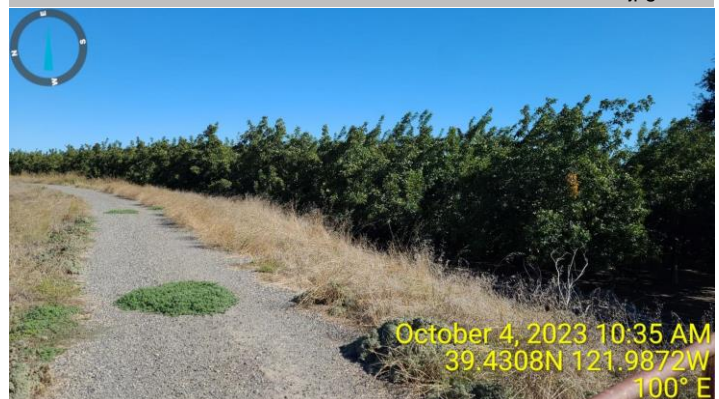
Photo 1 of 1 : FA_2023_LD0003_27_45_20231005_00077.jpg

View of the vegetation along the landside slope. Fall 2023.

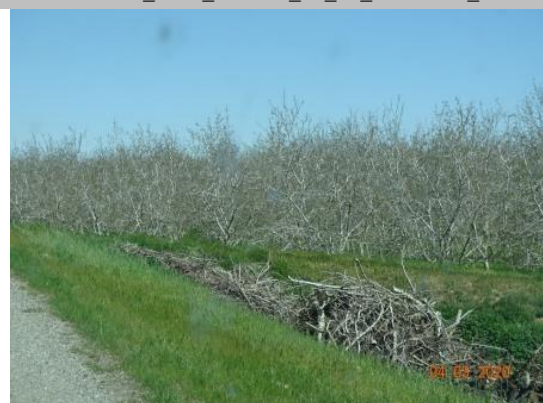
Photo 1 of 1 : FA_2023_LD0003_27_68_20231002_00021.jpg

View of the prunings on the landside slope and toe. Spring 2020.

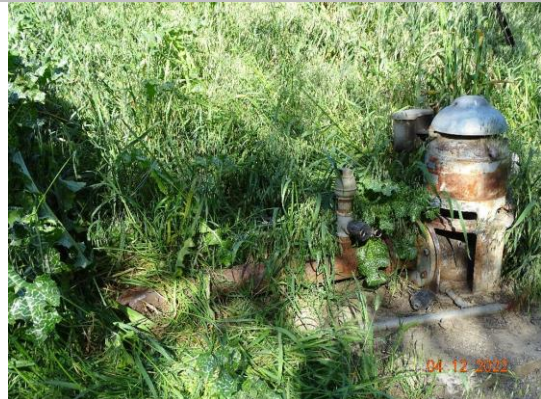
Photo 2 of 3 : UCIP_FA_2023_75931_114151.jpg

DS_ID:18822
FS_ID:75931
EP_NO: 9915
Repair Type: Non-Urgent
EVAL Issue: 10, Unauthorized Modification or Non-Compliant Permit
Crossing Status: Found
UCIP Comments: 04/12/2022 Record updated from No Action Needed to Non-Urgent. Unauthorized encroachment recorded in Levee Log.
Unauthorized pipe material used: PVC pipe through the levee.
(O.Yakimov - DWR UCIP)

Land-Side: Water well at levee toe. PVC pipe is entering levee slope

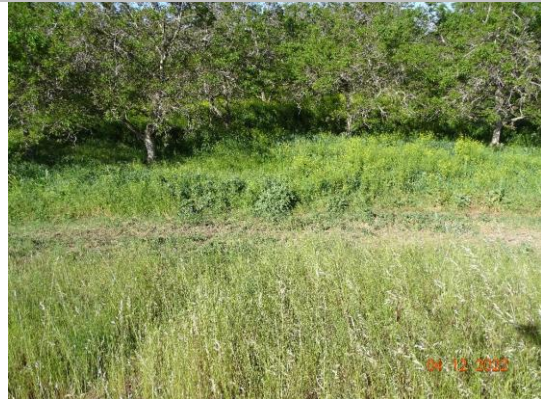
Photo 3 of 3 : UCIP_FA_2023_75931_114150.jpg

Water-Side: View of levee slope looking from crown. Crossing not found here

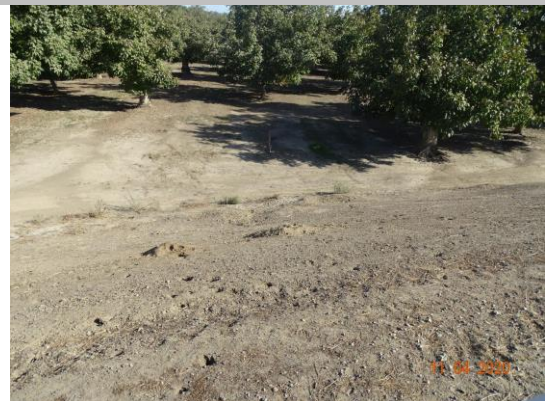
Photo 1 of 1 : FA_2023_LD0003_27_21_20231002_00008.jpg

View of the rodent activity along the landside slope. Fall 2020.

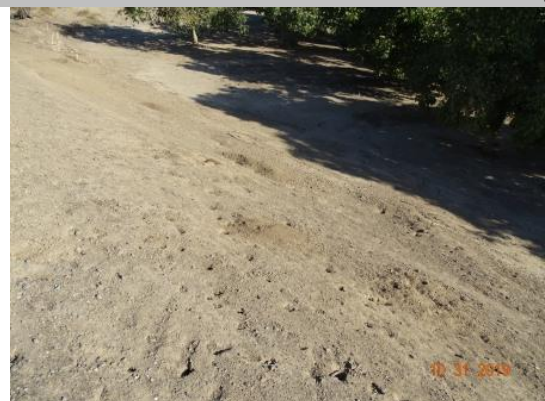
Photo 1 of 1 : FA_2023_LD0003_27_96_20231002_00037.jpg

View of the rodent burrows on the landside slope. Fall 2019.

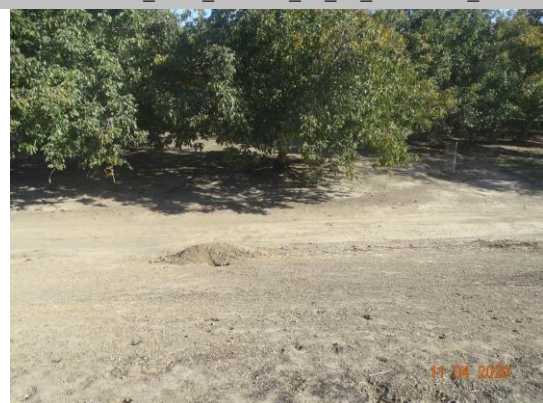
Photo 1 of 1 : FA_2023_LD0003_27_70_20231002_00022.jpg

View of the rodent activity along the landside slope. Fall 2020.

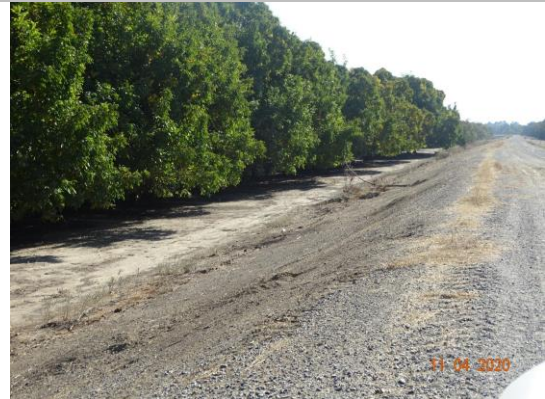
Photo 1 of 1 : FA_2023_LD0003_27_62_20231002_00018.jpg

View of the rodent activity along the landside slope. Fall 2020.

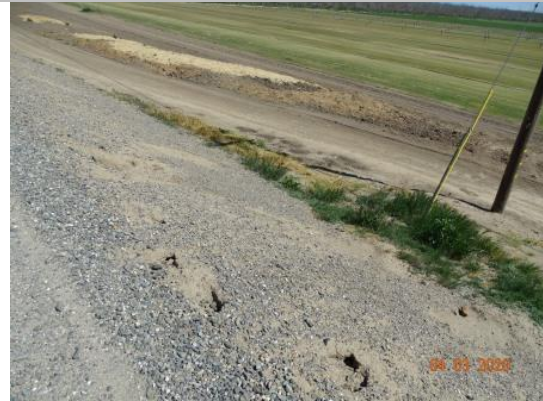
Photo 1 of 1 : FA_2023_LD0003_27_71_20231002_00023.jpg

View of the rodent holes along the landside slope. Spring 2020.

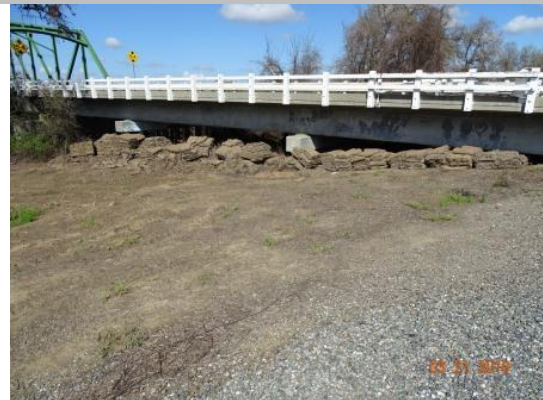
Photo 1 of 1 : FA_2023_LD0003_27_110_20231002_00039.jpg

View of the sod piles on the waterside slope within the floodway, facing upstream. (Spring 2019)

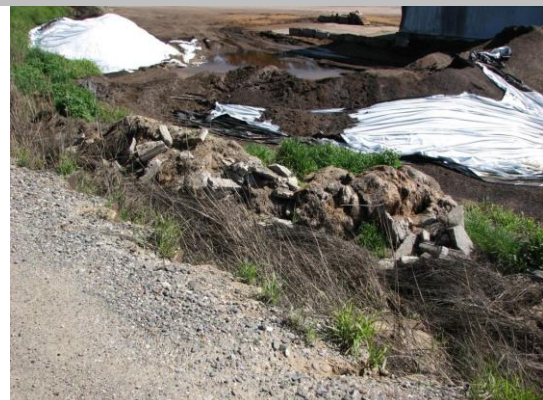
Photo 1 of 1 : FA_2023_LD0003_27_65_20231002_00019.jpg

View of concrete and soil obstructing visibility and access.

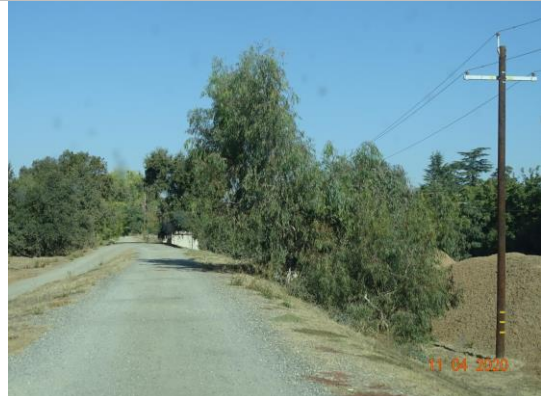
Photo 1 of 1 : FA_2023_LD0003_27_84_20231002_00031.jpg

View of the trees that require trimming along the landside slope and toe. Fall 2020.

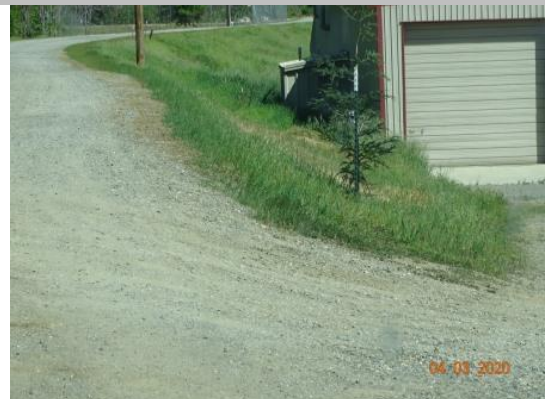
Photo 1 of 1 : FA_2023_LD0003_27_34_20231002_00011.jpg

View of damaged landside slope caused by vehicle traffic. Spring 2020.

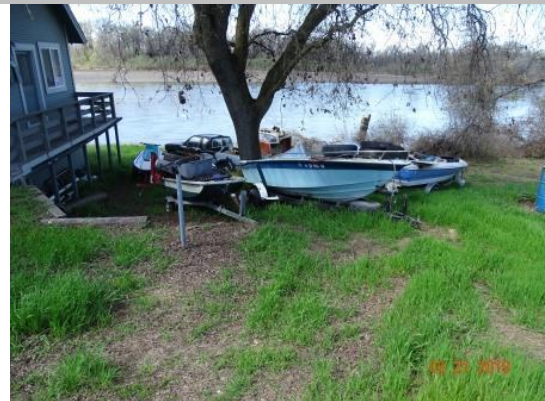
Photo 1 of 2 : FA_2023_LD0003_27_115_20231002_00040.jpg

View of the boats on the waterside slope and toe, facing west.

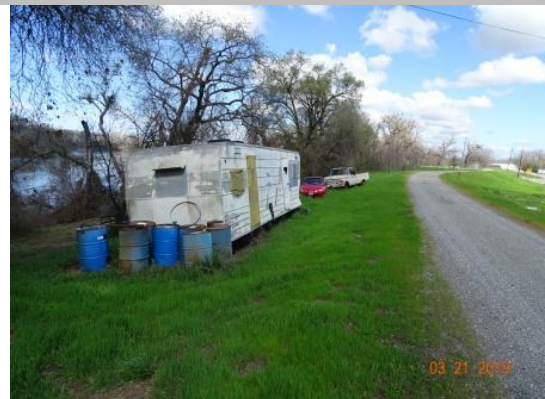
Photo 2 of 2 : FA_2023_LD0003_27_115_20231002_00041.jpg

View of an abandoned RV, cars and drums on the waterside slope, facing upstream.

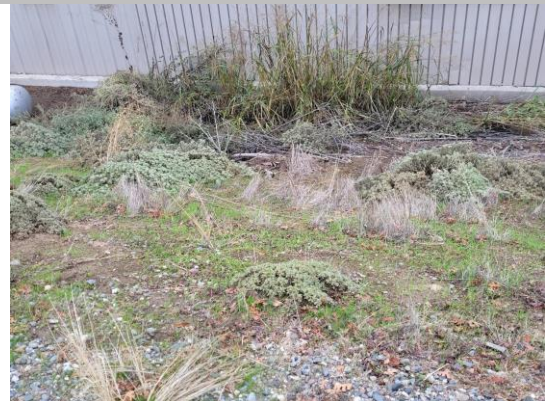
Photo 1 of 1 : FA_2023_LD0003_27_76_20231002_00026.jpg

View of the burned out stump hole along the landside toe. Fall 2021.

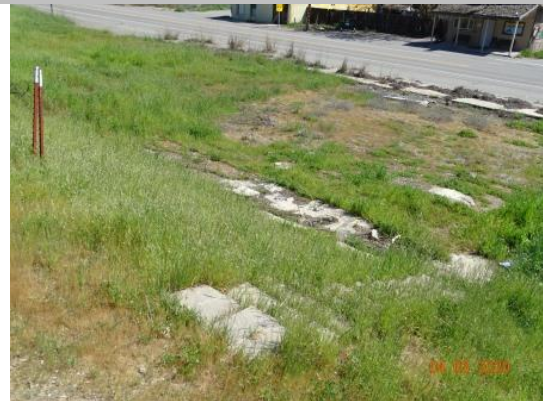
Photo 1 of 1 : FA_2023_LD0003_27_12_20231002_00004.jpg

View of the concrete stairs and foundation along the landside slope and toe. Spring 2020.

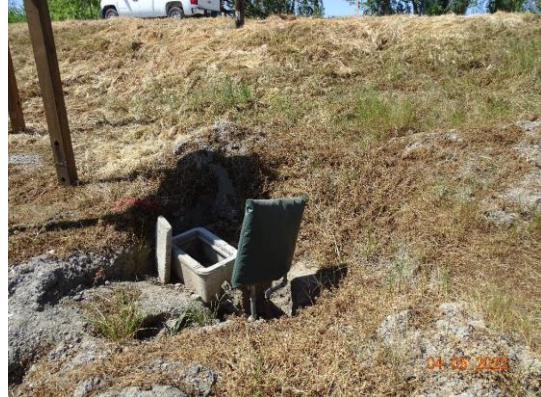
Photo 2 of 3 : UCIP_FA_2023_75967_114259.jpg

Land-Side: View of levee slope looking from toe. Pipe and christy box in excavation

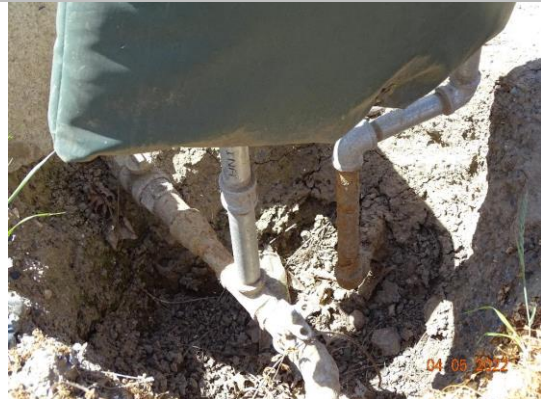
Photo 3 of 3 : UCIP_FA_2023_75967_114258.jpg

Land-Side: Pipe exposed in excavation at levee toe

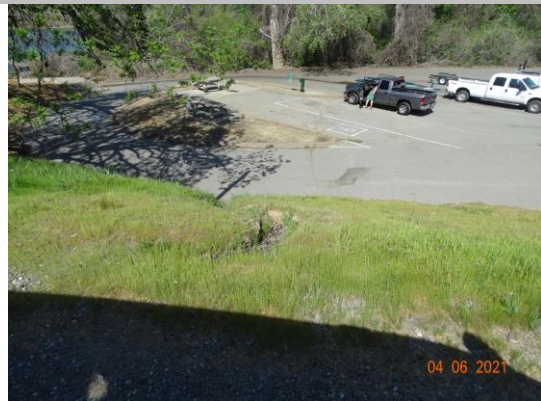
Photo 1 of 1 : FA_2023_LD0003_27_97_20231002_00038.jpg

View of the erosion on the waterside slope. Spring 2021.

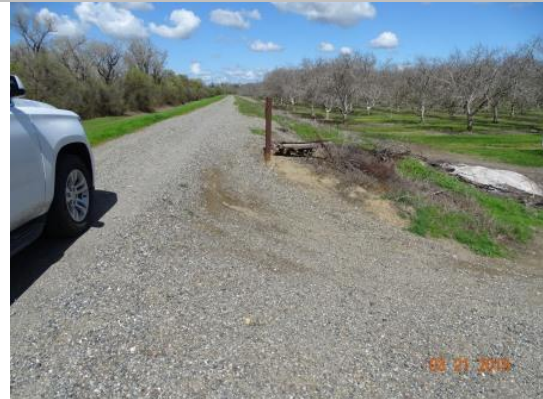
Photo 1 of 1 : FA_2023_LD0003_27_14_20231002_00006.jpg

View of the erosion caused by vehicle traffic along the landside slope and crown, facing upstream. (Spring 2019)

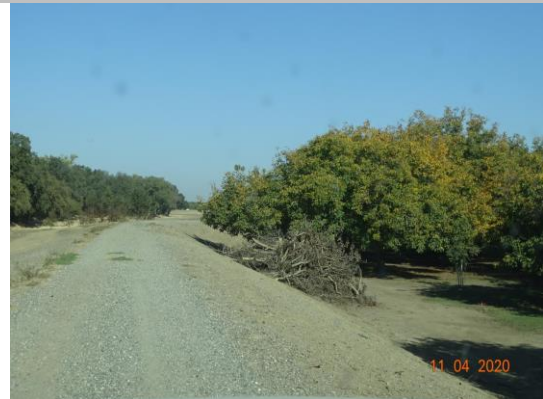
Photo 1 of 1 : FA_2023_LD0003_27_60_20231002_00017.jpg

View of the prunings along the landside toe. Fall 2020.

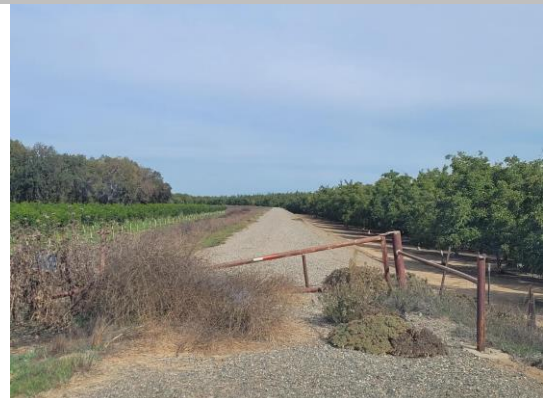
Photo 1 of 1 : FA_2023_LD0003_27_117_20231002_00042.jpg

View of a broken unauthorized gate. Fall 2022.

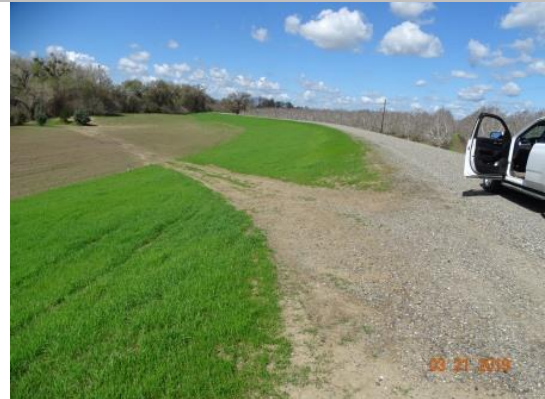
Photo 1 of 1 : FA_2023_LD0003_27_120_20231002_00044.jpg

View of the waterside slope damage caused by vehicle traffic, facing upstream. (Spring 2019)

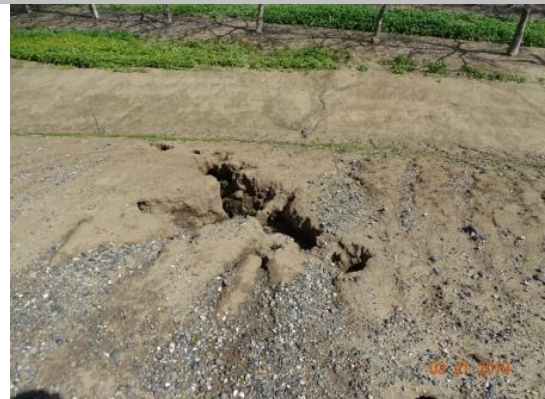
Photo 1 of 1 : FA_2023_LD0003_27_119_20231002_00043.jpg

View of the erosion caused by water runoff and rodent holes on the landside slope, facing east. (Spring 2019)

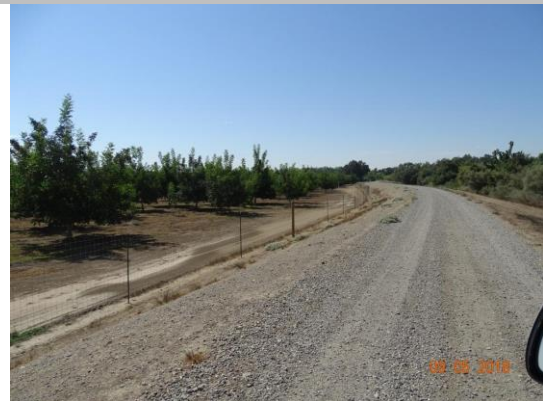
Photo 1 of 1 : FA_2023_LD0003_27_85_20231002_00032.jpg

View of the fence along the landside toe.

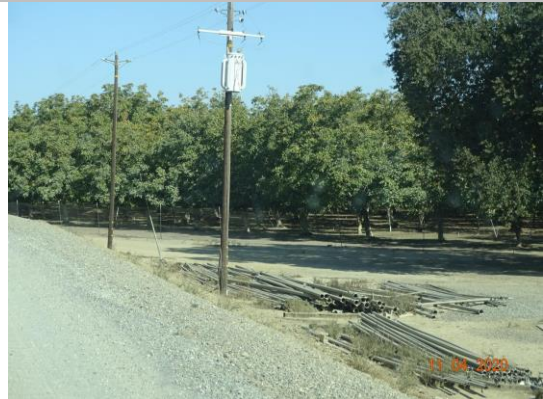
Photo 1 of 1 : FA_2023_LD0003_27_94_20231002_00036.jpg

View of the ag pipes along the landside toe. Fall 2020.

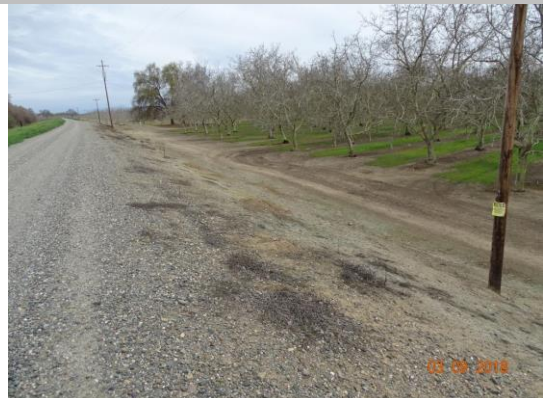
Photo 1 of 1 : FA_2023_LD0003_27_78_20231002_00028.jpg

View of the rodent holes along the landside slope.

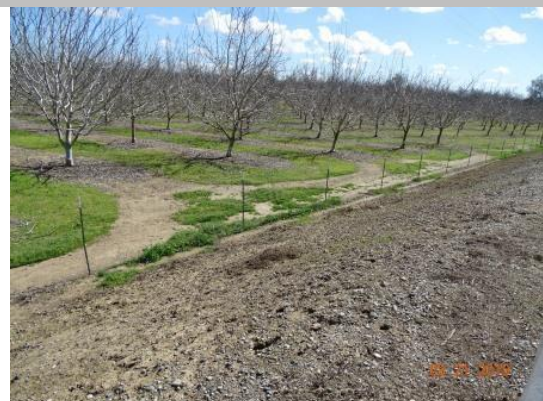
Photo 1 of 1 : FA_2023_LD0003_27_125_20231002_00045.jpg

View of the rodent holes along the landside slope, facing downstream.
(Spring 2019)

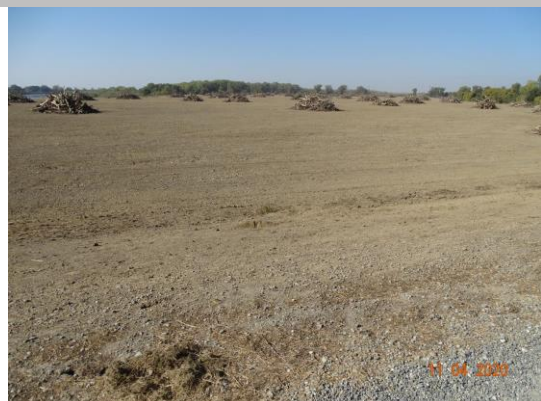
Photo 1 of 1 : FA_2023_LD0003_27_93_20231002_00035.jpg

View of the rodent activity along the waterside slope. Fall 2020.

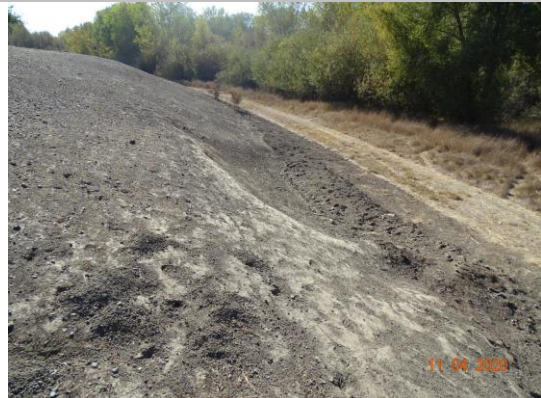
Photo 1 of 1 : FA_2023_LD0003_27_6_20231002_00002.jpg

View of the vertical cut along the waterside slope and toe. Fall 2020.

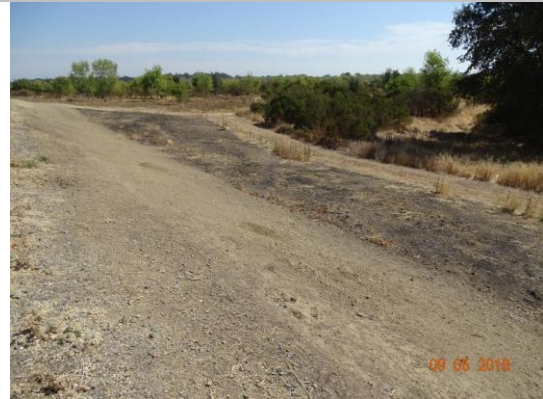
Photo 1 of 1 : FA_2023_LD0003_27_79_20231002_00029.jpg

View of the rodent holes along the landside slope.
