## Flood Control Project Maintenance Levee Inspections

### Fall 2024 Levee Maintenance Deficiency Summary Report

#### Sacramento River Basin

**Levee District No. 0003 (Glenn County)**

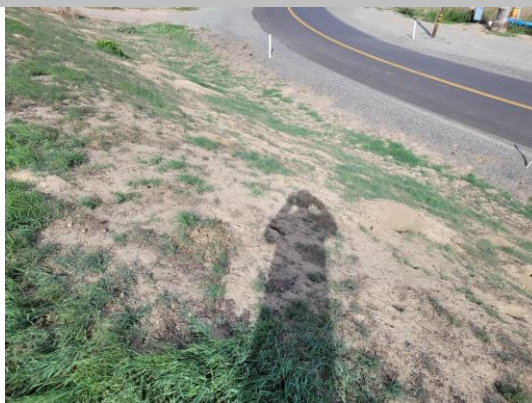
Photo 1 of 1 : FA\_2024\_LD0003\_27\_23\_20240924\_00009.jpg

View of the animal burrows along the landside slope. Fall 2022.

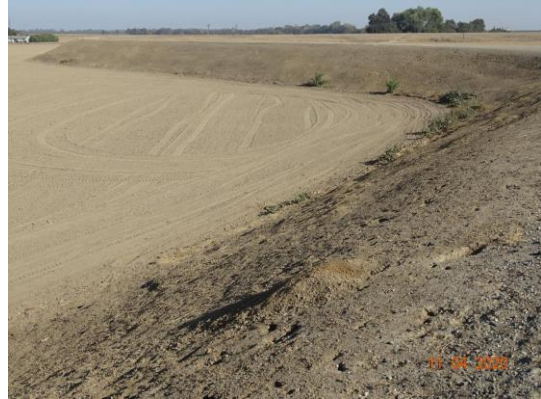
Photo 1 of 1 : FA\_2024\_LD0003\_27\_3\_20240924\_00001.jpg

View of the rodent activity along the landside slope. Fall 2020.

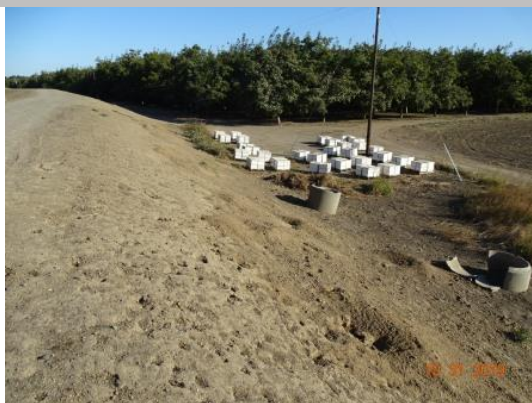
Photo 1 of 1 : FA\_2024\_LD0003\_27\_52\_20240924\_00016.jpg

View of the rodent burrows along the landside slope. Fall 2019.

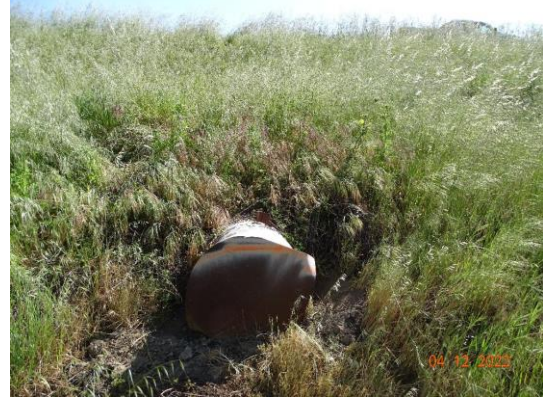
Photo 3 of 3 : UCIP\_FA\_2024\_75909\_114044.jpg

DS\_ID:18830  
FS\_ID:75909  
EP\_NO: 9930  
Repair Type: Non-Urgent  
EVAL Issue: 5, Pipe Damage  
Crossing Status: Found  
UCIP Comments: 04/12/2022 Record remains Non-Urgent. DMP internal video inspection has found pipe integrity issues. LOF of crossing is greater than or equal to 4.1 and less than 5. Crossing will be monitored until funding becomes available for rehabilitation. Crossing appears abandoned. Waterside pipe end was steel plate welded. Abandoned concrete box at landside toe. No permit has been identified authorizing pipe. Need to have CVFPB review ABO and determine current owner. (O.Yakimov - DWR UCIP)  
06/04/2013 Steel plate welded over WS end of pipe. Slide gate at WS toe missing. Appears abandoned. (W.Wylie - DWR UCIP)  
FIELD\_STRUCT\_DESC: 24-inch corrugated metal irrigation pipe through the levee, 14.5 feet below the crown. Slide gate on waterside (WS) end. 7-foot by 9-foot concrete diversion box at landward toe. (24-inch pipe [HLM 1.50] authorized under Automatic Board Order (ABO) issued as Permit No. 9930, 1974 - Steel Ranch). [Additional Reference(s): DWR Levee Log, 1992 (HLM 1.50). USACE Sacramento O&M Manual, Unit 136, March 1960, Revised May 2022, (HLM 21.89), listed as 24-inch pipe].

Water-Side: Capped pipe end at levee toe

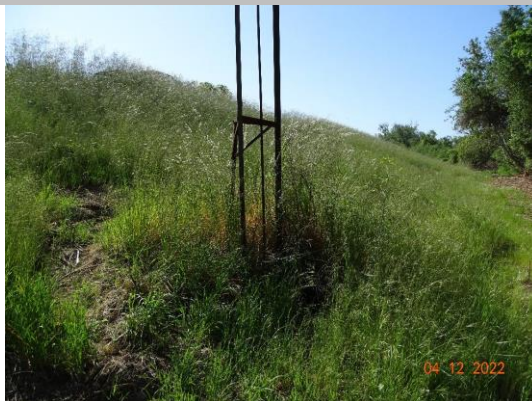
Photo 3 of 3 : UCIP\_FA\_2024\_75910\_114052.jpg

DS\_ID:18823  
FS\_ID:75910  
EP\_NO: 9931  
Repair Type: Non-Urgent  
EVAL Issue: 5, Pipe Damage  
Crossing Status: Found  
UCIP Comments: 04/12/2022 Record remains Non-Urgent. DMP internal video inspection has found pipe integrity issues. LOF of crossing is greater than or equal to 4.1 and less than 5. Crossing will be monitored until funding becomes available for rehabilitation. Crossing appears abandoned. Abandoned concrete box at landside toe, slide gate at waterside toe buried in soil. No permit has been identified authorizing pipe. Need to have CVFPB review ABO and determine current owner. (O.Yakimov - DWR UCIP)  
06/04/2013 Appears abandoned. Pipe buried at slide gate on WS toe. (W.Wylie - DWR UCIP)  
FIELD\_STRUCT\_DESC: 24-inch corrugated metal irrigation pipe through the levee, 15 feet below the crown. Slide gate on the waterside (WS) end. 6-foot by 7-foot concrete distribution box on the landside (LS) toe. (24-inch pipe [HLM 1.61] authorized under Automatic Board Order (ABO) issued as Permit No. 9931, 1974 - Lowell F. Steel). [Additional Reference(s): DWR Levee Log, 1992 (HLM 1.61). USACE Sacramento O&M Manual, Unit 136, March 1960, Revised May 2022, (HLM 22.00), listed as 24-inch pipe].

Water-Side: Slide gate at levee toe buried in soil

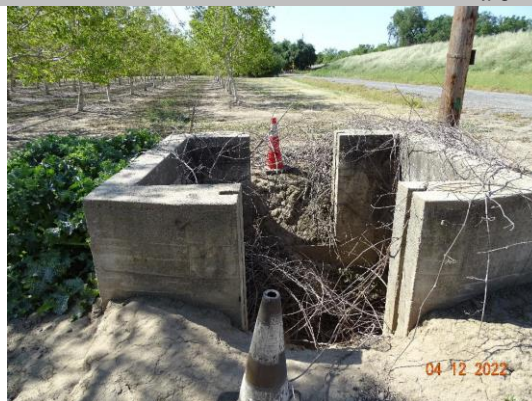
Photo 3 of 3 : UCIP\_FA\_2024\_75911\_114057.jpg

DS\_ID:18825  
FS\_ID:75911  
EP\_NO: 9935  
Repair Type: Non-Urgent  
EVAL Issue: 5, Pipe Damage  
Crossing Status: Found  
UCIP Comments: 04/12/2022 Record remains Non-Urgent. DMP internal video inspection has found pipe integrity issues. LOF of crossing is greater than or equal to 4.1 and less than 5. Crossing will be monitored until funding becomes available for rehabilitation. Crossing appears abandoned. Abandoned slide gate at waterside toe, abandoned concrete box on road shoulder. No permit has been identified authorizing pipe. Need to have CVFPB review ABO and determine current owner. (O.Yakimov - DWR UCIP)  
06/04/2013 Appears abandoned. Pipe buried on WS toe. Debris and steel plate blocking inlet on LS. (W.Wylie - DWR UCIP)  
FIELD\_STRUCT\_DESC: 24-inch corrugated metal irrigation pipe through the levee and beneath the roadway, 18 feet below the crown. Slide gate on the waterside (WS) end. (24-inch pipe [HLM 1.91] authorized under Automatic Board Order (ABO) issued as Permit No. 9935, 1974 - Florence Watt). [Additional Reference(s): DWR Levee Log, 1992 (HLM 1.90). USACE Sacramento O&M Manual, Unit 136, March 1960, Revised May 2022, (HLM 22.30), listed as 24-inch pipe].

Land-Side: View of concrete distribution box that looks abandoned

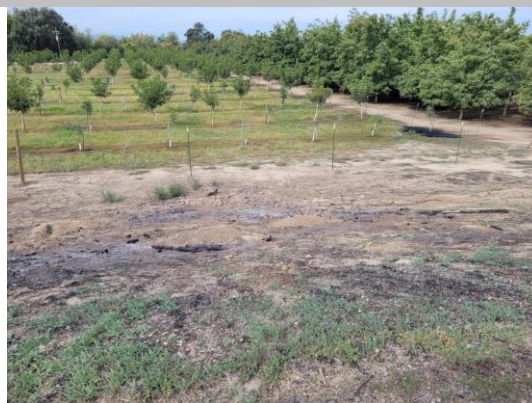
Photo 1 of 1 : FA\_2024\_LD0003\_27\_82\_20240924\_00027.jpg

View of the animal burrows along the waterside slope. Fall 2022.

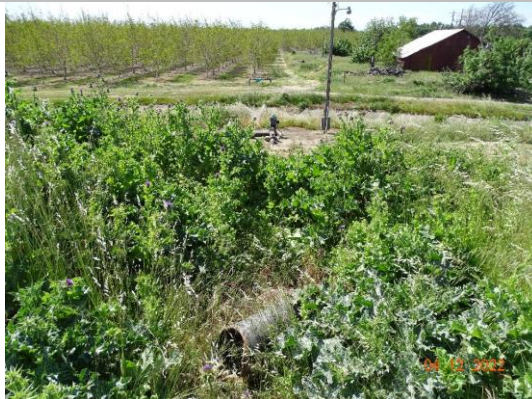
Photo 1 of 3 : UCIP\_FA\_2024\_75921\_114116.jpg

DS\_ID:23151  
FS\_ID:75921  
EP\_NO: N/A  
Repair Type: Non-Urgent  
EVAL Issue: 11, Maintenance Compliance Issue  
Crossing Status: Found  
UCIP Comments: 04/12/2022 Record remains Non-Urgent. No permit has been found authorizing this pipe through the levee. Steel riser on landside shoulder was knocked down and needs repair. (O.Yakimov - DWR UCIP)  
06/04/2013 No permit identified for this crossing. (W.Wylie - DWR UCIP)  
FIELD\_STRUCT\_DESC: 12-inch steel irrigation pipe through the levee, 3.5 feet below the crown. Agricultural water well, butterfly valve, and JP/meter at channel on landside (LS) toe. Three discharge pipes are coming from the well: towards orchard on LS, to fill LS irrigation canal, and through the levee. Siphon breaker inside a 12-inch steel riser unit on the LS shoulder. 3-inch plastic drain on the waterside (WS) toe.  
FS Date: 4/12/2022 1:11:30 PM

Land-Side: View of levee slope looking from crown. Steel riser on levee shoulder was knocked down

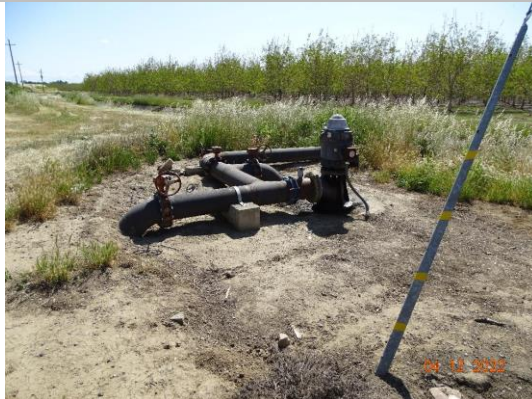
Photo 2 of 3 : UCIP\_FA\_2024\_75921\_114114.jpg

Land-Side: Agricultural well on levee berm

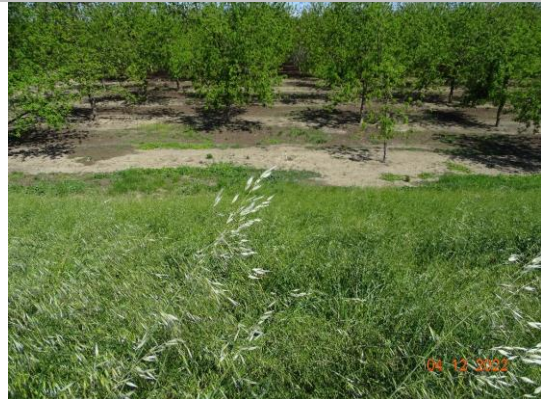
Photo 3 of 3 : UCIP\_FA\_2024\_75921\_114117.jpg

Water-Side: View of levee slope looking from crown. Pipe outlet not found

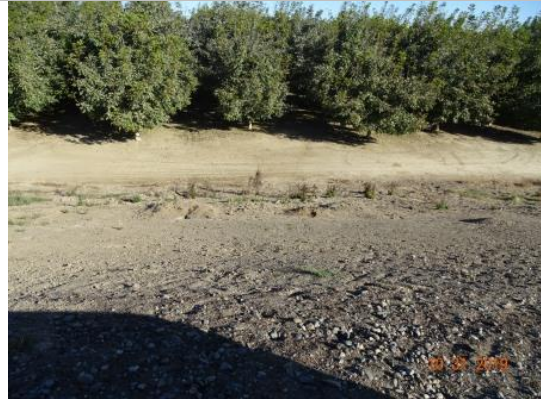
Photo 1 of 1 : FA\_2024\_LD0003\_27\_43\_20240924\_00014.jpg

View of the rodent burrows along the waterside slope. Fall 2019.

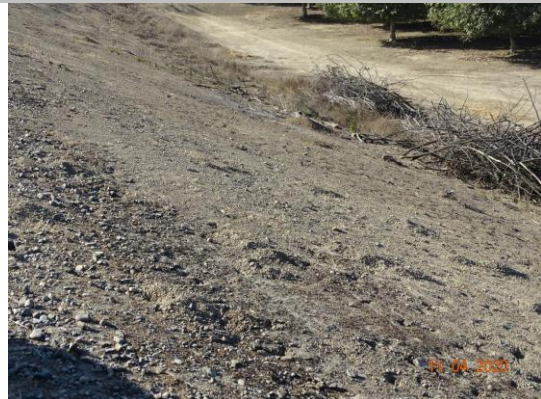
Photo 1 of 1 : FA\_2024\_LD0003\_27\_13\_20240924\_00005.jpg

View of the rodent activity along the waterside slope. Fall 2020.

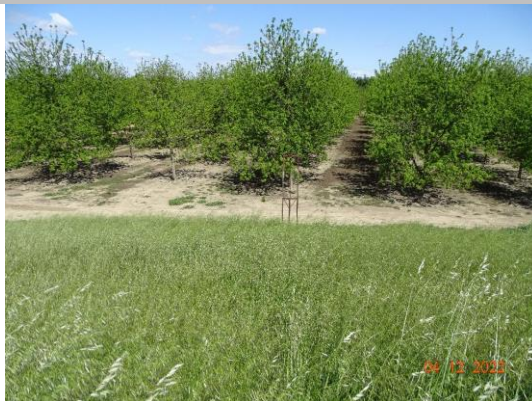
Photo 2 of 3 : UCIP\_FA\_2024\_75924\_114123.jpg

UCIP Comments: 04/12/2022 Record remains Non-Urgent. DMP internal video inspection has found pipe integrity issues. LOF of crossing is greater than or equal to 4.1 and less than 5. Crossing will be monitored until funding becomes available for rehabilitation. Crossing appears abandoned. DMP cleared from soil concrete distribution box on landside berm that appears abandoned. Abandoned and buried in soil slide gate at waterside toe. No permit has been identified authorizing pipe. Need to have CVFPB review ABO and determine current owner. (O.Yakimov - DWR UCIP)

Water-Side: View of levee slope looking from crown. Abandoned slide gate at levee toe

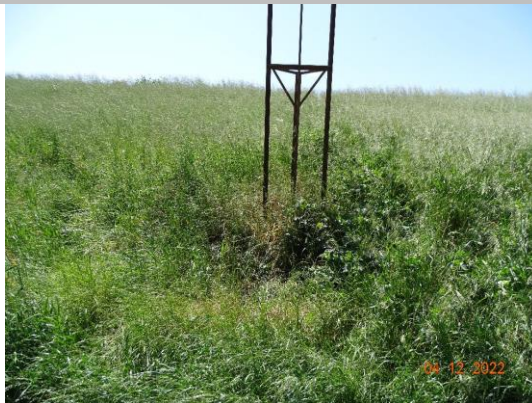
Photo 3 of 3 : UCIP\_FA\_2024\_75924\_114127.jpg

Water-Side: Buried in soil slide gate at levee toe

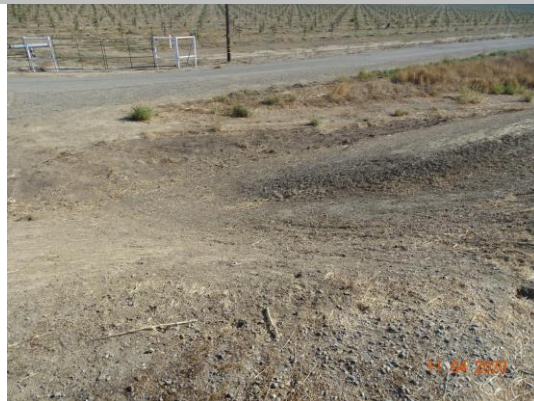
Photo 1 of 1 : FA\_2024\_LD0003\_27\_9\_20240924\_00003.jpg

LM Start	3.39	Rating **	M	Issue No.	9
LM End	3.39	Issue Type +	Ma	Location *	LS
Category	Earthen Levee			GPS Latitude/Longitude	
				Start	End
Item	Erosion / Vehicle Traffic			39.418382 °	39.418382 °
				-121.992480 °	-121.992480 °
DWR ID	DWR_LD0003_01_s_2012_9				
Comment Code					
E6 : Repair the levee slope damaged by vehicle traffic and prevent access where possible.					
Inspector Comment

View of the damaged landside slope due to vehicle traffic. Fall 2020.

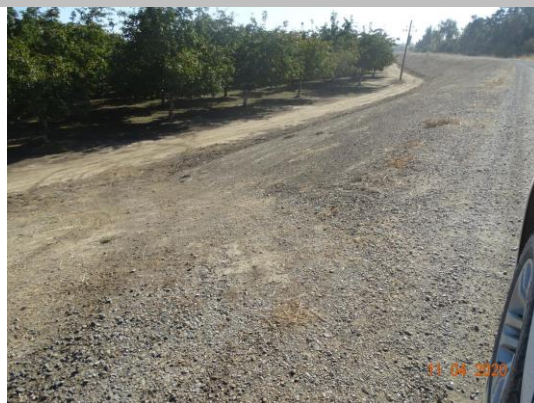
Photo 1 of 1 : FA\_2024\_LD0003\_27\_19\_20240924\_00007.jpg

LM Start	3.76	Rating **	M	Issue No.	19
LM End	3.76	Issue Type +	Ma	Location *	LS
Category	Earthen Levee			GPS Latitude/Longitude	
				Start	End
Item	Erosion / Vehicle Traffic			39.423747 °	39.423747 °
				-121.991667 °	-121.991667 °
DWR ID	DWR_LD0003_01_s _ 2012_19				
Comment Code					
E6 : Repair the levee slope damaged by vehicle traffic and prevent access where possible.					
Inspector Comment

View of the damaged landside slope due to vehicle traffic. Fall 2020.

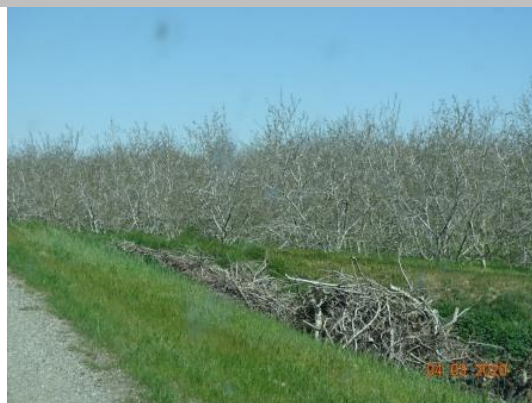
Photo 1 of 1 : FA\_2024\_LD0003\_27\_68\_20240924\_00019.jpg

View of the prunings on the landside slope and toe. Spring 2020.

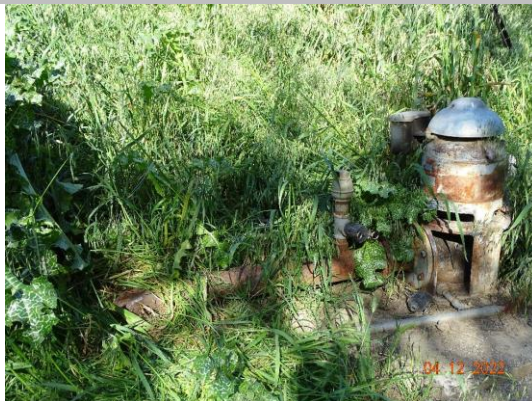
Photo 2 of 3 : UCIP\_FA\_2024\_75931\_114151.jpg

Land-Side: Water well at levee toe. PVC pipe is entering levee slope

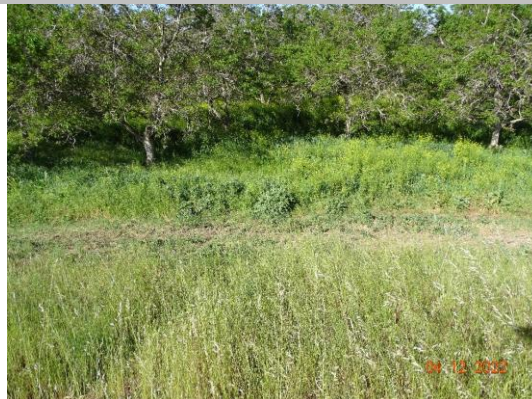
Photo 3 of 3 : UCIP\_FA\_2024\_75931\_114150.jpg

Water-Side: View of levee slope looking from crown. Crossing not found here

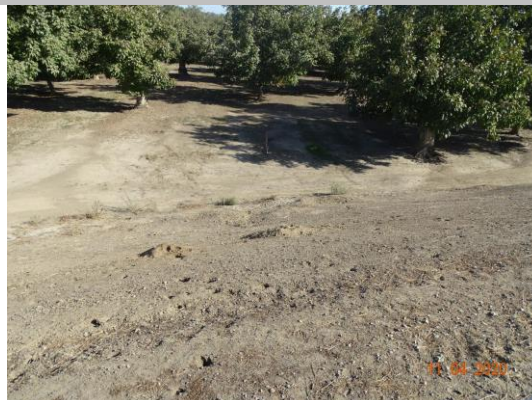
Photo 1 of 1 : FA\_2024\_LD0003\_27\_21\_20240924\_00008.jpg

View of the rodent activity along the landside slope. Fall 2020.

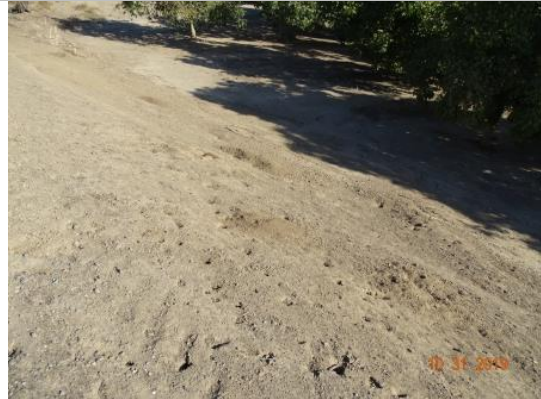
Photo 1 of 1 : FA\_2024\_LD0003\_27\_96\_20240924\_00032.jpg

View of the rodent burrows on the landside slope. Fall 2019.

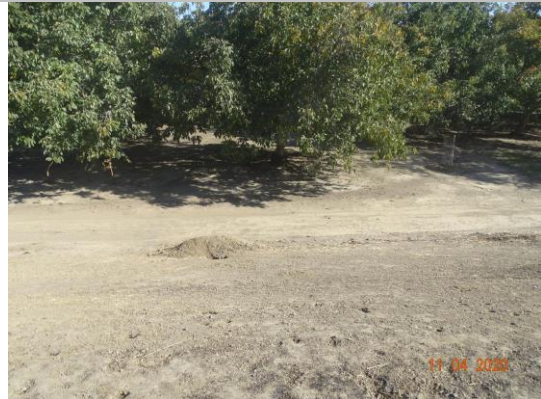
Photo 1 of 1 : FA\_2024\_LD0003\_27\_70\_20240924\_00020.jpg

View of the rodent activity along the landside slope. Fall 2020.

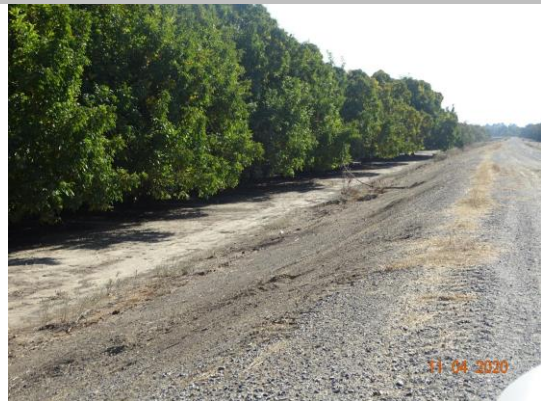
Photo 1 of 1 : FA\_2024\_LD0003\_27\_62\_20240924\_00018.jpg

View of the rodent activity along the landside slope. Fall 2020.

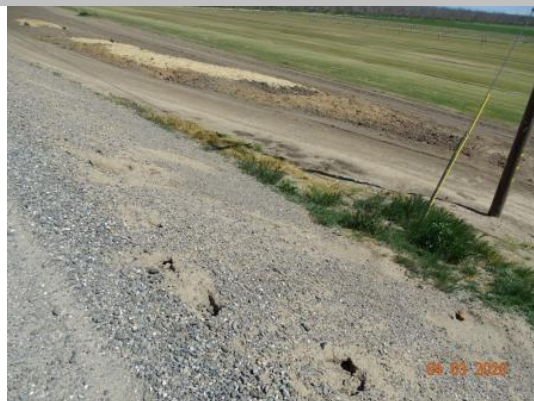
Photo 1 of 1 : FA\_2024\_LD0003\_27\_71\_20240924\_00021.jpg

View of the rodent holes along the landside slope. Spring 2020.

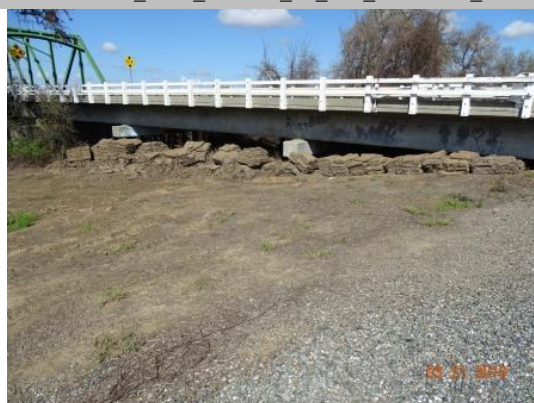
Photo 1 of 1 : FA\_2024\_LD0003\_27\_110\_20240924\_00034.jpg

View of the sod piles on the waterside slope within the floodway, facing upstream. (Spring 2019)

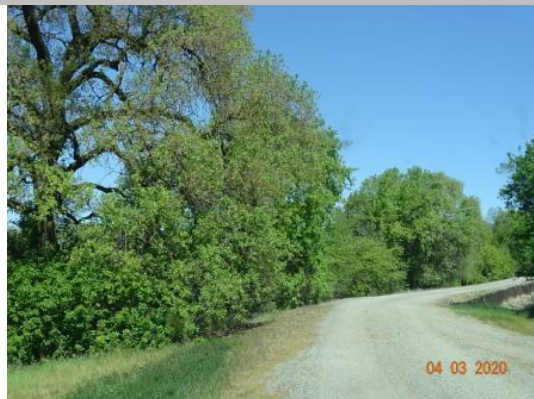
Photo 1 of 1 : FA\_2024\_LD0003\_27\_48\_20240924\_00015.jpg

View of the trees that need to be trimmed to at least 5 feet above the ground. Spring 2020.

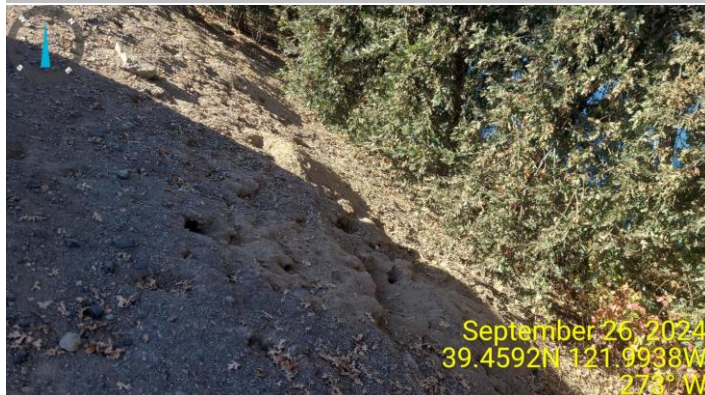
Photo 1 of 1 : FA\_2024\_LD0003\_27\_27\_20241016\_00070.jpg

View of rodent holes along the waterside slope. Fall 2024.

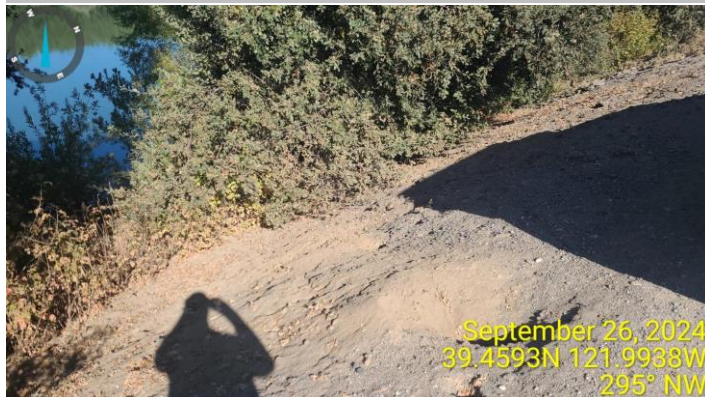
Photo 1 of 1 : FA\_2024\_LD0003\_27\_25\_20241016\_00071.jpg

View of large rodent holes along the waterside slope. Fall 2024.

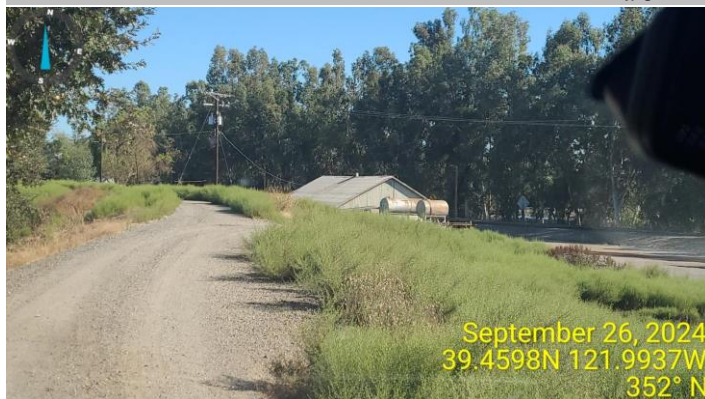
Photo 1 of 1 : FA\_2024\_LD0003\_27\_45\_20241016\_00074.jpg

View of the vegetation along the landside slope. Fall 2024.

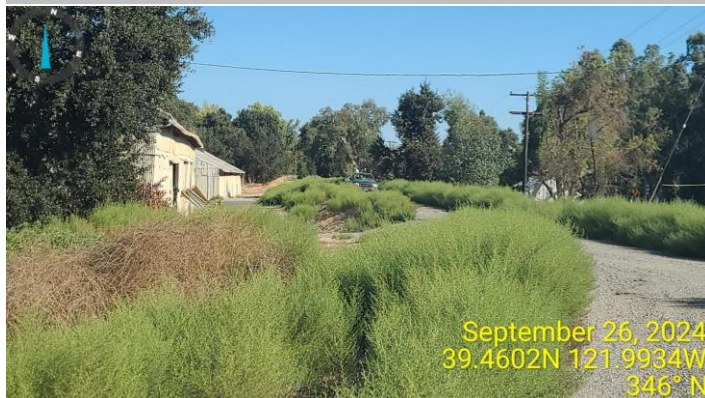
Photo 1 of 1 : FA\_2024\_LD0003\_27\_30\_20241016\_00073.jpg

View of the vegetation along the waterside slope. Fall 2024.

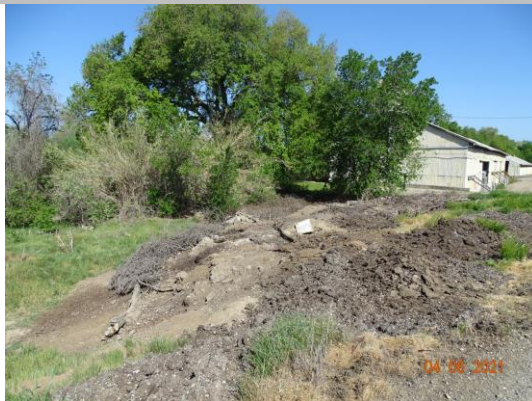
Photo 1 of 1 : FA\_2024\_LD0003\_27\_32\_20240924\_00010.jpg

View of the pile of materials and prunings along the waterside slope and toe. Spring 2021.

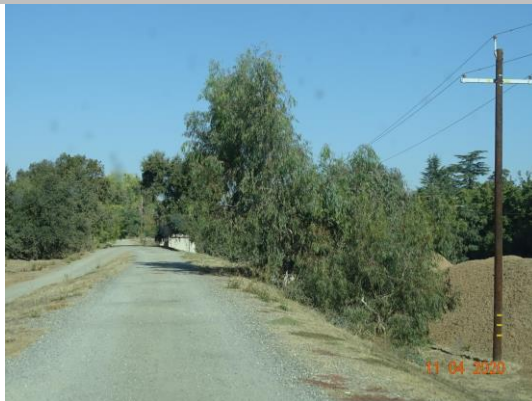
Photo 1 of 1 : FA\_2024\_LD0003\_27\_84\_20240924\_00028.jpg

View of the trees that require trimming along the landside slope and toe. Fall 2020.

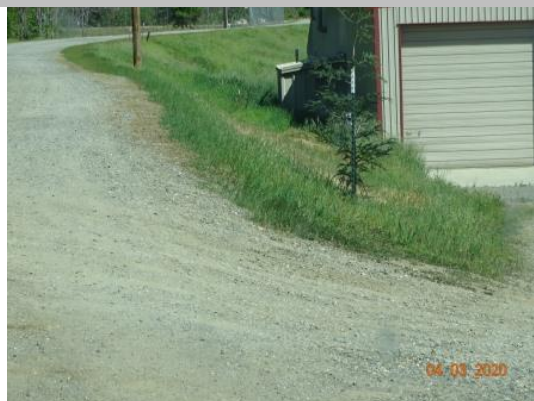
Photo 1 of 1 : FA\_2024\_LD0003\_27\_34\_20240924\_00011.jpg

View of damaged landside slope caused by vehicle traffic. Spring 2020.

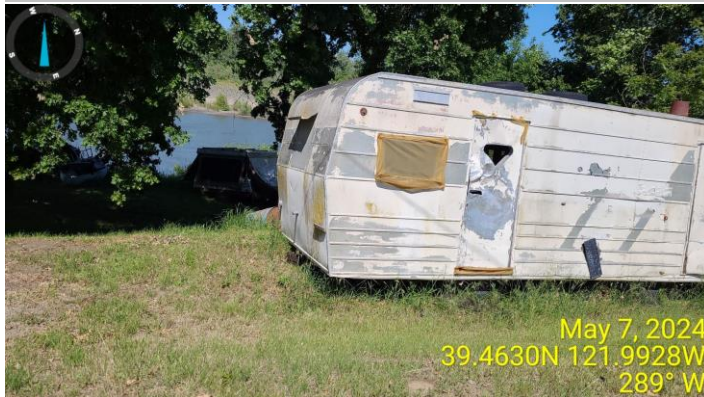
Photo 1 of 1 : FA\_2024\_LD0003\_27\_115\_20240924\_00035.jpg

View of an abandoned RV, car and boat. Spring 2024.

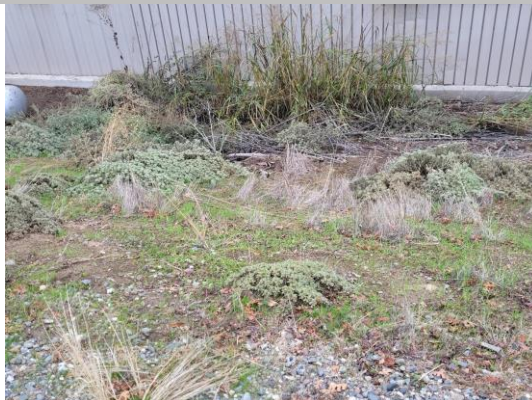
Photo 1 of 1 : FA\_2024\_LD0003\_27\_76\_20240924\_00024.jpg

View of the burned out stump hole along the landside toe. Fall 2021.

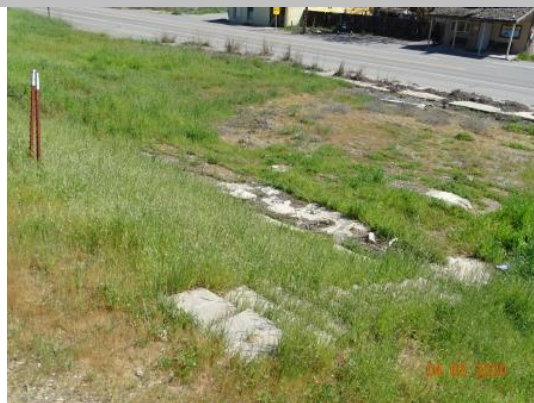
Photo 1 of 1 : FA\_2024\_LD0003\_27\_12\_20240924\_00004.jpg

View of the concrete stairs and foundation along the landside slope and toe. Spring 2020.

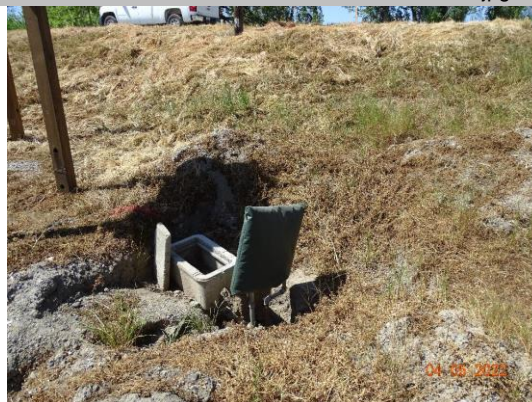
Photo 2 of 3 : UCIP\_FA\_2024\_75967\_114259.jpg

Land-Side: View of levee slope looking from toe. Pipe and christy box in excavation

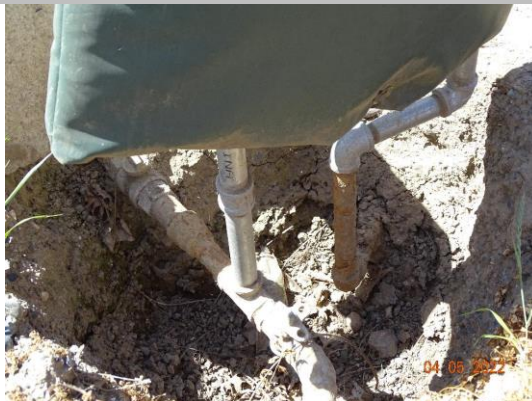
Photo 3 of 3 : UCIP\_FA\_2024\_75967\_114258.jpg

Land-Side: Pipe exposed in excavation at levee toe

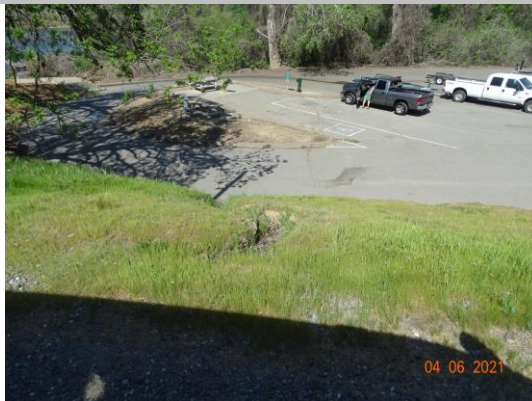
Photo 1 of 1 : FA\_2024\_LD0003\_27\_97\_20240924\_00033.jpg

View of the erosion on the waterside slope. Spring 2021.

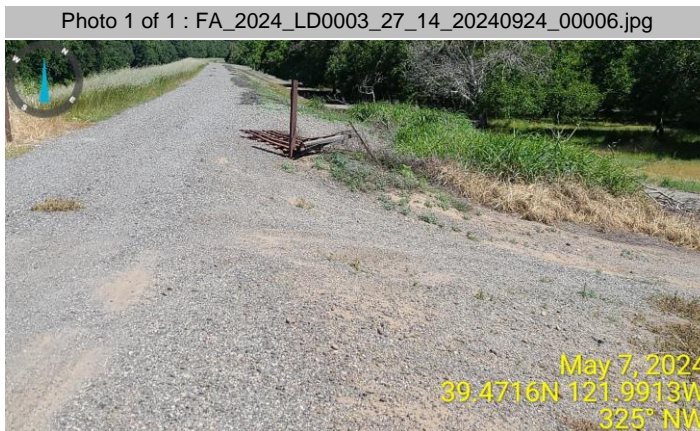
LM Start	7.21	Rating **	M	Issue No.	14
LM End	7.21	Issue Type +	Ma	Location *	LS
Category	Earthen Levee			GPS Latitude/Longitude	
				Start	End
Item	Erosion / Vehicle Traffic			39.471658 °	39.471658 °
				-121.991245 °	-121.991245 °
DWR ID	DWR_LD0003_01_s_2012_14				
Comment Code					
E6 : Repair the levee slope damaged by vehicle traffic and prevent access where possible.					
Inspector Comment

View of the erosion caused by vehicle traffic along the landside slope.  
Spring 2024.

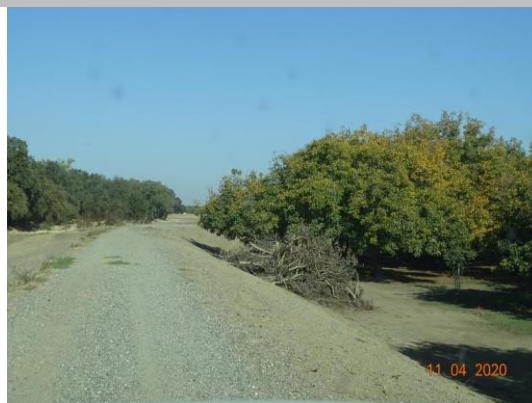
Photo 1 of 1 : FA\_2024\_LD0003\_27\_60\_20240924\_00017.jpg

View of the prunings along the landside toe. Fall 2020.

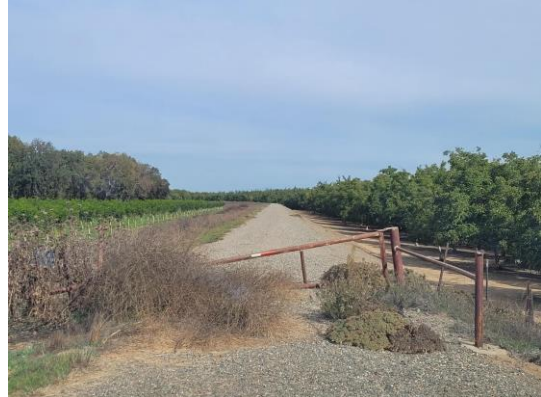
Photo 1 of 1 : FA\_2024\_LD0003\_27\_117\_20240924\_00036.jpg

View of a broken unauthorized gate. Fall 2022.

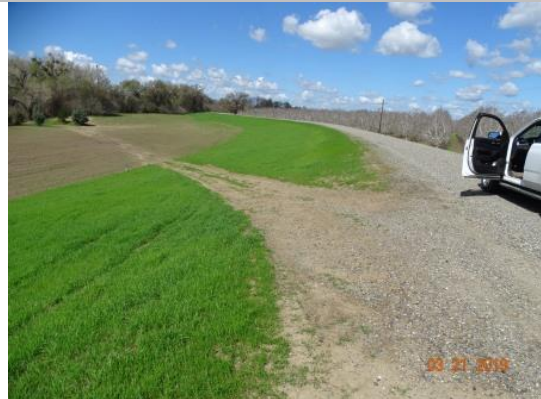
Photo 1 of 1 : FA\_2024\_LD0003\_27\_120\_20240924\_00038.jpg

View of the waterside slope damage caused by vehicle traffic, facing upstream. (Spring 2019)

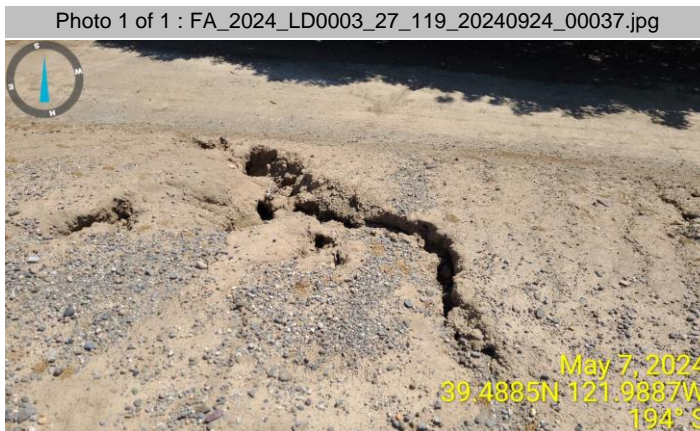
LM Start	8.40	Rating **	U	Issue No.	119
LM End	8.40	Issue Type +	Ma	Location *	LS
Category	Earthen Levee			GPS Latitude/Longitude	
				Start	End
Item	Erosion / Rills			39.488427 °	39.488427 °
				-121.988732 °	-121.988732 °
DWR ID	DWR_LD0003_01_s_ 2019_119				
Comment Code					
E5 : Schedule repair of rills prior to the next inspection.					
Inspector Comment					
Repair the erosion site and address the rodent activity.

View of the erosion caused by water runoff and rodent holes on the landside slope. Spring 2024.

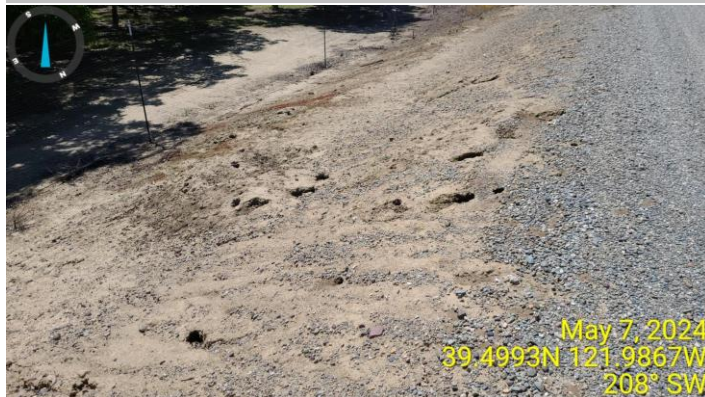
Photo 1 of 1 : FA\_2024\_LD0003\_27\_78\_20240924\_00025.jpg

View of the rodent holes along the landside slope. Spring 2024.

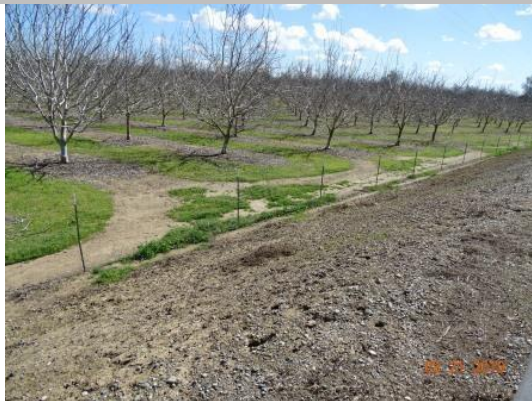
Photo 1 of 1 : FA\_2024\_LD0003\_27\_125\_20240924\_00039.jpg

View of the rodent holes along the landside slope, facing downstream.  
(Spring 2019)

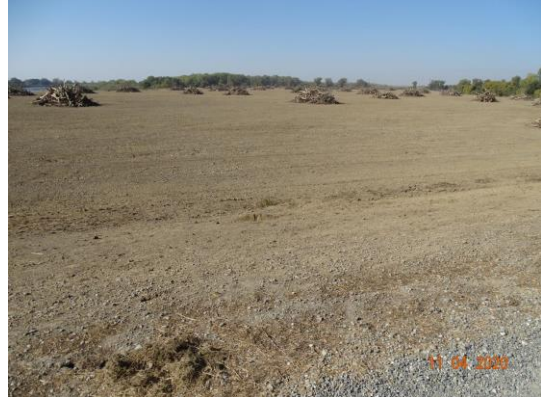
Photo 1 of 1 : FA\_2024\_LD0003\_27\_93\_20240924\_00031.jpg

View of the rodent activity along the waterside slope. Fall 2020.

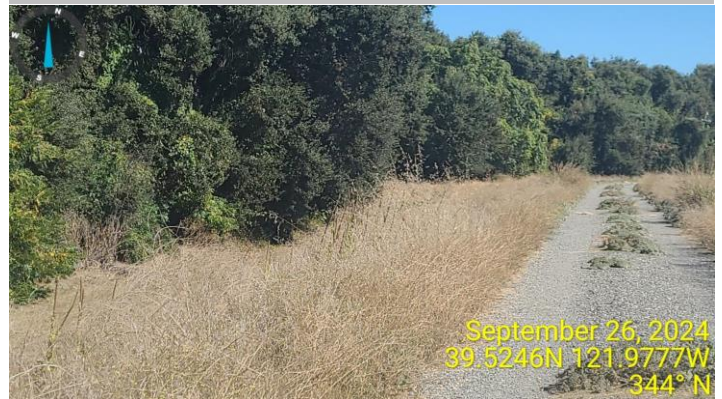
Photo 1 of 1 : FA\_2024\_LD0003\_27\_56\_20241016\_00075.jpg

View of the vegetation along the waterside slope. Fall 2024.

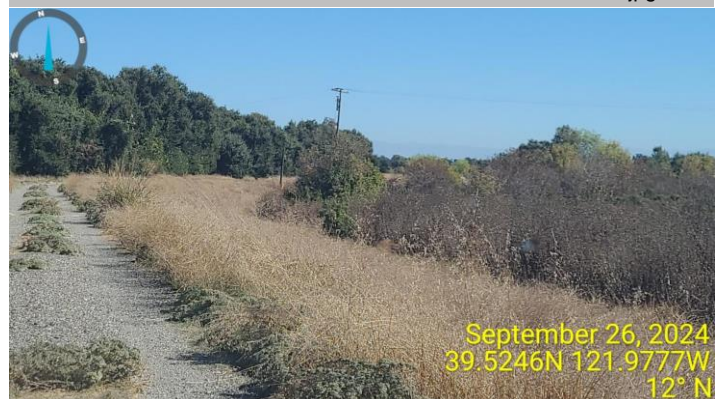
Photo 1 of 1 : FA\_2024\_LD0003\_27\_57\_20241016\_00076.jpg

View of the vegetation along the landside slope. Fall 2024.

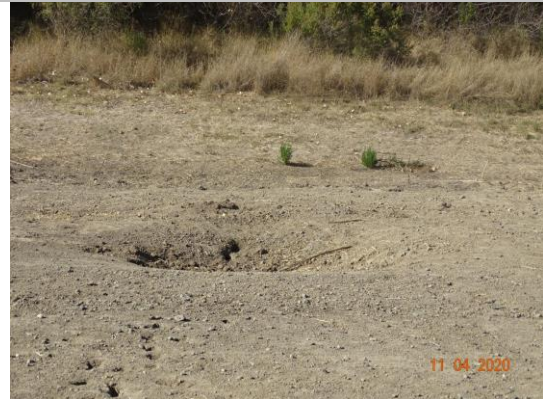
Photo 1 of 1 : FA\_2024\_LD0003\_27\_89\_20240924\_00030.jpg

View of a hole on the waterside slope. Fall 2020.

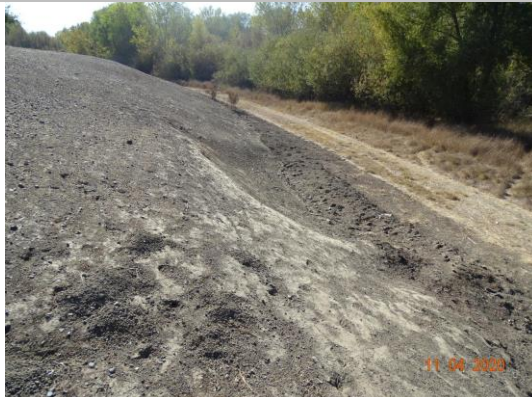
Photo 1 of 1 : FA\_2024\_LD0003\_27\_6\_20240924\_00002.jpg

View of the vertical cut along the waterside slope and toe. Fall 2020.

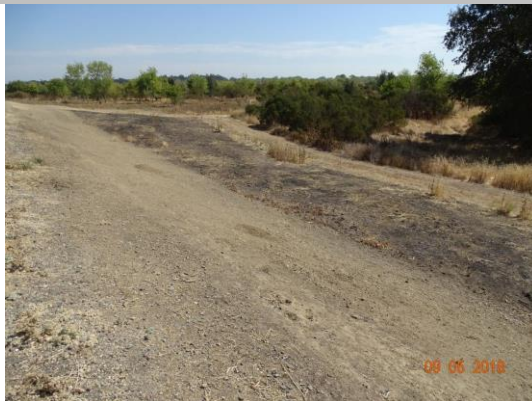
Photo 1 of 1 : FA\_2024\_LD0003\_27\_79\_20240924\_00026.jpg

View of the rodent holes along the landside slope.
