**Flood Control Project Maintenance  
Levee Inspections**  
**LMA District Cover Sheet**  
**Spring 2014 Levee Inspection Results**

**Levee District No. 0003 (Glenn County)**

**Spring 2014 Levee Inspection Results**

Waterway	Bank	Unit Miles
Unit No. 01 Glenn County Sacramento River	Left	12.24

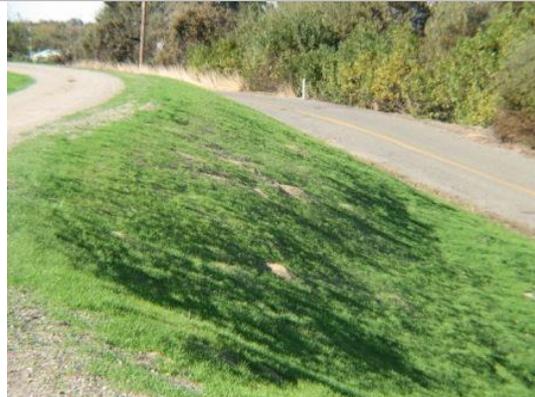
Photo 1 of 1 : rduffey\_s\_20140304\_267.jpg

View of squirrel holes along the slope.

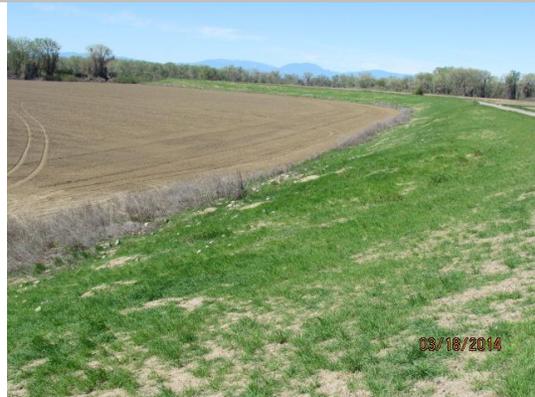
Photo 1 of 1 : rduffey\_s\_20140407\_156.jpg

LM Start	<b>0.37</b>	Rating **	M	Issue No.	<b>54</b>
LM End	<b>0.44</b>	Issue Type +	Ma	Location *	WS
Category	Earthen Levee		GPS Latitude/Longitude		
			Start	End	
Item	Animal Control		39.388530 °	39.388997 °	
			-121.992217 °	-121.993449 °	
DWR ID	DWR_LD0003_01_s_2014_54				
Action/Comments					
No rodents visible, but rodent burrows visible; need to backfill and compact or grout burrows.

View of the rodent holes along the w/s slope.

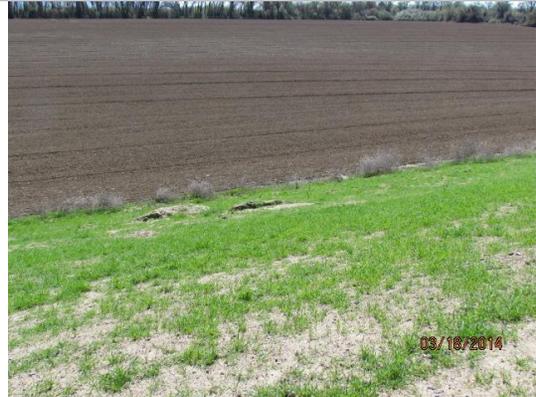
Photo 1 of 1 : rduffey\_s\_20140407\_157.jpg

View of the rodent activity along the w/s slope.

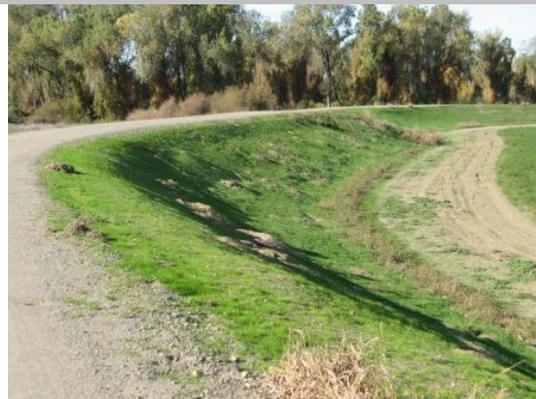
Photo 1 of 1 : rduffey\_s\_20140304\_260.jpg

LM Start	<b>0.75</b>	Rating **	M	Issue No.	<b>3</b>
LM End	<b>0.75</b>	Issue Type +	Ma	Location *	LS
Category	Earthen Levee		GPS Latitude/Longitude		
			Start	End	
Item	Animal Control		39.388323 °	39.388323 °	
			-121.998727 °	-121.998727 °	
DWR ID	DWR_LD0003_01_s_2012_3				
Action/Comments					
No rodents visible, but rodent burrows visible; need to backfill and compact or grout burrows.

View of squirrel holes along the slope.

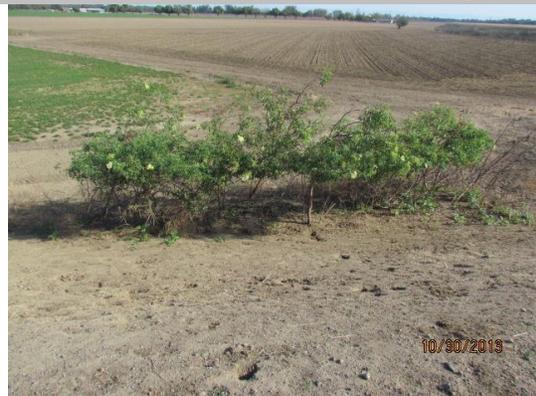
Photo 1 of 1 : rduffey\_s\_20140304\_293.jpg

LM Start	<b>0.83</b>	Rating **	M	Issue No.	<b>67</b>
LM End	<b>0.83</b>	Issue Type +	Ma	Location *	LS
Category	Earthen Levee		GPS Latitude/Longitude		
			Start	End	
Item	Vegetation		39.388725 °	39.388725 °	
			-121.999870 °	-121.999870 °	
DWR ID	DWR_LD0003_01_f_2013_67				
Action/Comments					
Elderberries are blocking visibility and flood fight capability.

View of the elderberries along the landside toe.

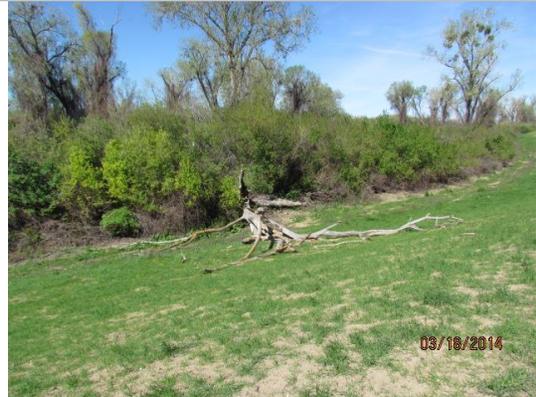
Photo 1 of 1 : rduffey\_s\_20140407\_158.jpg

View of the down tree along the w/s toe.

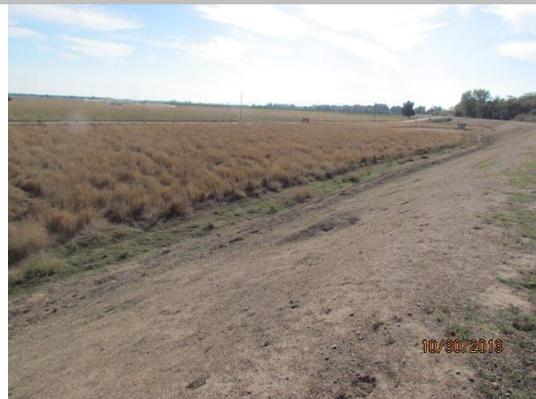
Photo 1 of 1 : SP\_2014\_LD0003\_27\_49\_06177.jpg

LM Start	<b>1.20</b>	Rating **	M	Issue No.	<b>49</b>
LM End	<b>1.27</b>	Issue Type +	Ma	Location *	LS
Category	Earthen Levee		GPS Latitude/Longitude		
			Start	End	
Item	Animal Control		39.393653 °	39.394658 °	
			-122.000865 °	-122.001022 °	
DWR ID	DWR_LD0003_01_s_2012_49				
Action/Comments					
Exterminate rodents and backfill and compact or grout burrows.

View of the rodent holes along the landside slope.

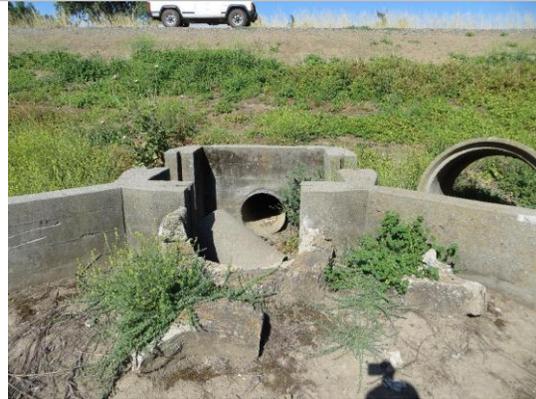
Photo 1 of 1 : UCIP\_1063.jpg

LM Start	<b>1.50</b>	Rating **	M	Issue No.	<b>11</b>
LM End	<b>1.50</b>	Issue Type +	En	Location *	LS
Category	Supplemental		GPS Latitude/Longitude		
			Start	End	
Item	DWR UCIP Field Study		39.397780 °	39.397780 °	
			-122.002074 °	-122.002074 °	
DWR ID	DWR_LD0003_01_s_2014_11				
Action/Comments					
Inspector Comments: FS_ID:14573 EP_NO: 9930 Repair Type: Crossing Status: UCIP Comments: Steel plate welded over WS end of pipe. Slide gate at WS toe missing. Appears abandoned. FIELD_STRUCT_DESC: 24-inch corrugated metal pipe through the levee 14.5 feet below the crown slide gate on waterward end, 7'X9' concrete diversion box at landward toe (ABO No. 9930-Steel Ranch). Originally included in O+M manual (1960). FS Date: 6/4/2013

Pipe open on LS toe at distribution box.

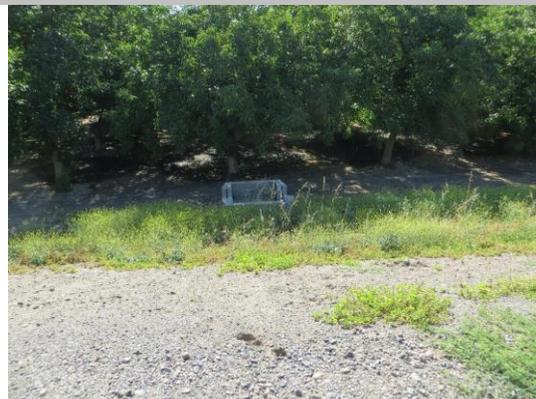
Photo 1 of 1 : UCIP\_1064.jpg

LM Start	<b>1.61</b>	Rating **	M	Issue No.	<b>20</b>
LM End	<b>1.61</b>	Issue Type +	En	Location *	LS
Category	Supplemental		GPS Latitude/Longitude		
			Start	End	
Item	DWR UCIP Field Study		39.399330 °	39.399330 °	
			-122.002401 °	-122.002401 °	
DWR ID	DWR_LD0003_01_s_2014_20				
Action/Comments					
Inspector Comments: FS_ID:14576 EP_NO: 9931 Repair Type: Crossing Status: UCIP Comments: Appears abandoned. Pipe buried at slide gate on WS toe. FIELD_STRUCT_DESC: 24-inch corrugated metal pipe through the levee 15.0 feet below the crown, slide gate on waterward end. 6'X7' concrete distribution box on LS toe. (ABO No. 9931-L. F. Steel). Originally included in the O+M manual (1960). FS Date: 6/4/2013

Concrete distribution box at LS toe.

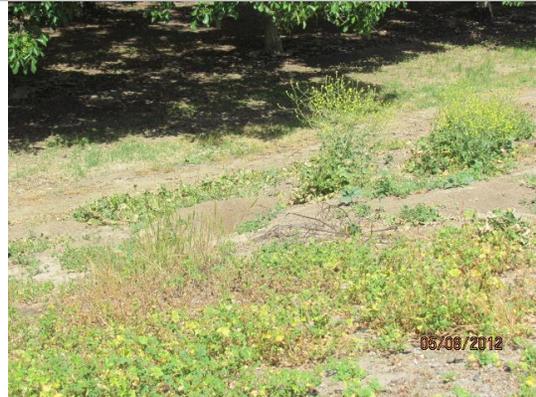
Photo 1 of 1 : rduffey\_s\_20140304\_285.jpg

View of the rodent holes along the waterside slope.

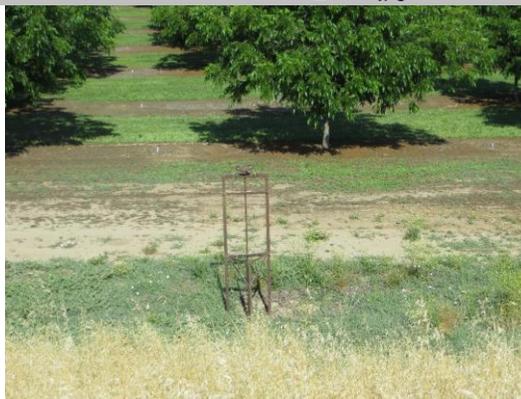
Photo 1 of 1 : UCIP\_1068.jpg

LM Start	<b>1.90</b>	Rating **	M	Issue No.	<b>24</b>
LM End	<b>1.90</b>	Issue Type +	En	Location *	LS
Category	Supplemental			GPS Latitude/Longitude	
				Start	End
Item	DWR UCIP Field Study			39.403419 °	39.403419 °
				-122.001871 °	-122.001871 °
DWR ID	DWR_LD0003_01_s_2014_24				
Action/Comments					
Inspector Comments: FS_ID:14577 EP_NO: 9935 Repair Type: Crossing Status: UCIP Comments: Appears abandoned. Pipe buried on WS toe. Debris and steel plate blocking inlet on LS. FIELD_STRUCT_DESC: 24-inch corrugated metal pipe through the levee and beneath the roadway 18.0 feet below the crown, slide gate on waterward end (ABO No. 9935-Watt). Originally included in the O+M manual (1960). FS Date: 6/4/2013

Slide gate buried at WS toe.

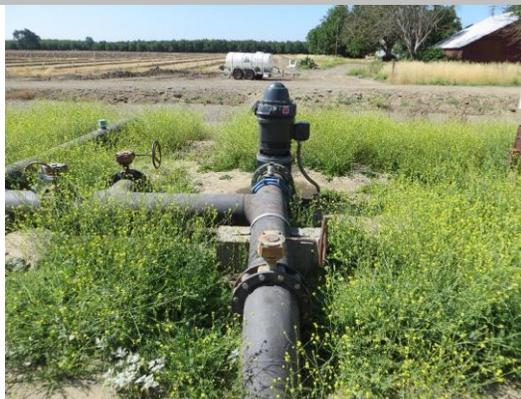
Photo 1 of 1 : UCIP\_1227.jpg

LM Start	<b>2.13</b>	Rating **	M	Issue No.	<b>28</b>
LM End	<b>2.13</b>	Issue Type +	En	Location *	LS
Category	Supplemental			GPS Latitude/Longitude	
				Start	End
Item	DWR UCIP Field Study			39.406353 °	39.406353 °
				-122.000674 °	-122.000674 °
DWR ID	DWR_LD0003_01_s_2014_28				
Action/Comments					
Inspector Comments: FS_ID:15144 EP_NO: N/A Repair Type: Crossing Status: UCIP Comments: No permit identified for this crossing. FIELD_STRUCT_DESC: 12-inch steel irrigation pipe through the levee 3.5-feet below the crown. Pump, butterfly valve, JP/meter at channel on LS toe. Siphon breaker in 12-inch steel riser on LS shoulder. 3-inch plastic drain on WS toe. FS Date: 6/4/2013

Pump and butterfly valve off LS toe.

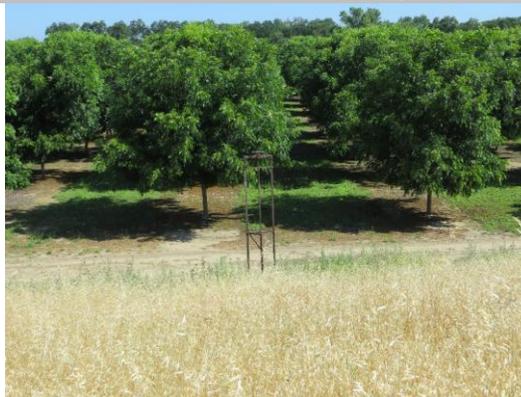
Photo 1 of 1 : UCIP\_1071.jpg

LM Start	<b>2.42</b>	Rating **	M	Issue No.	<b>32</b>
LM End	<b>2.42</b>	Issue Type +	En	Location *	LS
Category	Supplemental			GPS Latitude/Longitude	
				Start	End
Item	DWR UCIP Field Study			39.406471 °	39.406471 °
				-121.995551 °	-121.995551 °
DWR ID	DWR_LD0003_01_s_2014_32				
Action/Comments					
Inspector Comments: FS_ID:14582 EP_NO: 9936 Repair Type: Crossing Status: UCIP Comments: Appears abandoned. Pipe buried on WS and blocked with tin and soil on the LS. FIELD_STRUCT_DESC: 24-inch corrugated metal pipe through the levee 18.3 feet below crown, slide gate on waterward end. 5-foot by 7-foot concrete distribution box at landward toe (ABO No. 9936-Watt). Originally included in the O+M manual (1960). FS Date: 6/4/2013

Slide gate at WS toe.

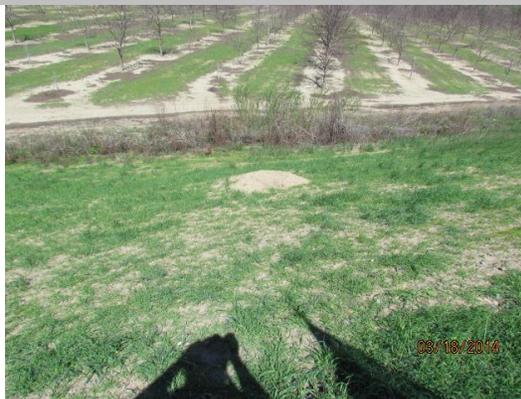
Photo 1 of 1 : ruffey\_s\_20140407\_159.jpg

LM Start	<b>2.50</b>	Rating **	M	Issue No.	<b>59</b>
LM End	<b>2.50</b>	Issue Type +	Ma	Location *	WS
Category	Earthen Levee			GPS Latitude/Longitude	
				Start	End
Item	Animal Control			39.406809 °	39.406809 °
				-121.994100 °	-121.994100 °
DWR ID	DWR_LD0003_01_s_2014_59				
Action/Comments					
No rodents visible, but rodent burrows visible; need to backfill and compact or grout burrows.

View of the rodent activity along the w/s slope.

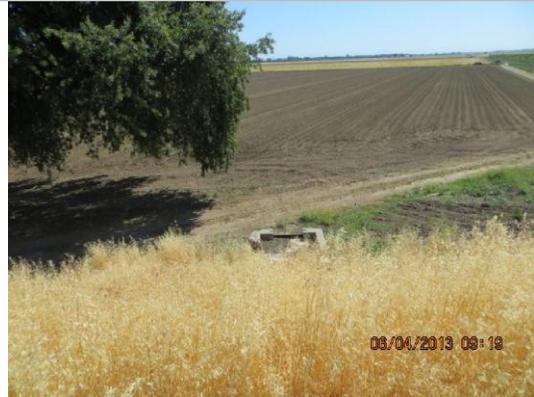
Photo 1 of 1 : UCIP\_1073.jpg

LM Start	<b>3.03</b>	Rating **	M	Issue No.	<b>36</b>
LM End	<b>3.03</b>	Issue Type +	En	Location *	WS
Category	Supplemental			GPS Latitude/Longitude	
				Start	End
Item	DWR UCIP Field Study			39.412827 °	39.412827 °
				-121.991427 °	-121.991427 °
DWR ID	DWR_LD0003_01_s_2014_36				
Action/Comments					
Inspector Comments: FS_ID:14584 EP_NO: 9919 Repair Type: Crossing Status: UCIP Comments: Appears abandoned. Verify it was done corectly. FIELD_STRUCT_DESC: *Abandoned* 24-inch corrugated metal pipe through the levee 16.0 feet below the crown, slide gate on waterward end. 5'X7' concrete distribution box at LS toe is filled with grout (ABO No. 9919-Mills). Originally included in the O+M manual (1960) FS Date: 6/4/2013

Distribution box on LS toe.

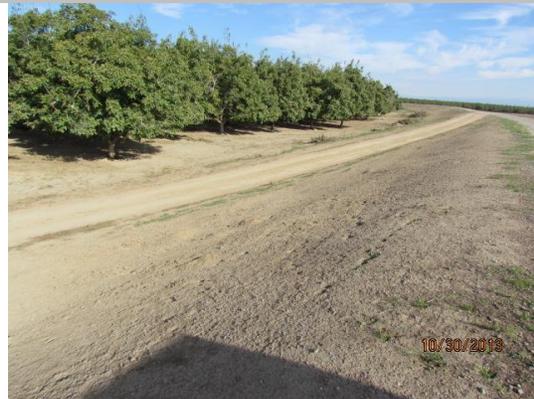
Photo 1 of 1 : rduffey\_s\_20140304\_292.jpg

LM Start	<b>3.05</b>	Rating **	M	Issue No.	<b>66</b>
LM End	<b>3.34</b>	Issue Type +	Ma	Location *	LS
Category	Earthen Levee			GPS Latitude/Longitude	
				Start	End
Item	Animal Control			39.413161 °	39.417055 °
				-121.991573 °	-121.993158 °
DWR ID	DWR_LD0003_01_f_2013_66				
Action/Comments					
No rodents visible, but rodent burrows visible; need to backfill and compact or grout burrows.

View of the rodent activity along the landside slope.

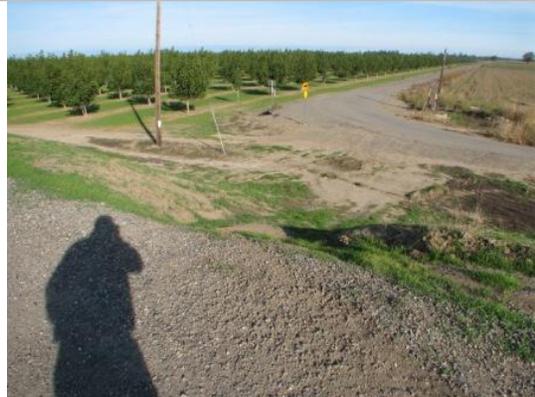
Photo 1 of 1 : rduffey\_s\_20140304\_266.jpg

LM Start	<b>3.44</b>	Rating **	M	Issue No.	<b>9</b>
LM End	<b>3.44</b>	Issue Type +	Ma	Location *	LS
Category	Earthen Levee		GPS Latitude/Longitude		
			Start	End	
Item	Slope Stability		39.418267 °	39.418267 °	
			-121.992472 °	-121.992472 °	
DWR ID	DWR_LD0003_01_s_2012_9				
Action/Comments					
Repair the levee slope damaged by vehicle traffic and prevent access where possible.

View of the vehicle erosion on the landside slope of the levee.

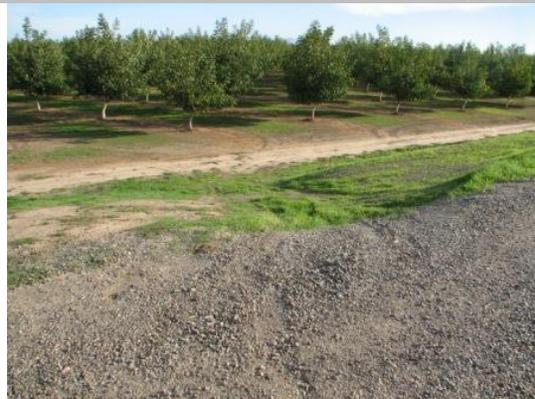
Photo 1 of 1 : rduffey\_s\_20140304\_270.jpg

LM Start	<b>3.82</b>	Rating **	M	Issue No.	<b>19</b>
LM End	<b>3.82</b>	Issue Type +	Ma	Location *	LS
Category	Earthen Levee		GPS Latitude/Longitude		
			Start	End	
Item	Slope Stability		39.423747 °	39.423747 °	
			-121.991667 °	-121.991667 °	
DWR ID	DWR_LD0003_01_s_2012_19				
Action/Comments					
Repair the levee slope damaged by vehicle traffic and prevent access where possible.

View of vehicle erosion on the slope.

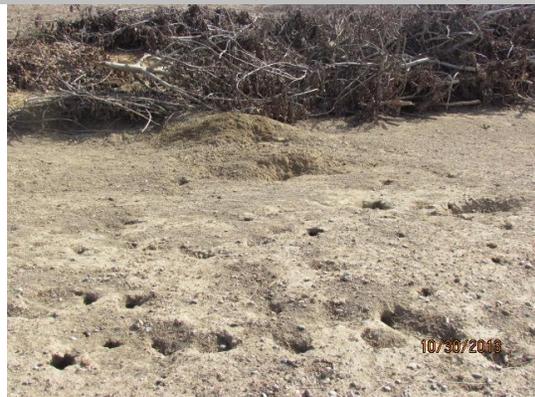
Photo 1 of 1 : rduffey\_s\_20140304\_291.jpg

LM Start	<b>4.07</b>	Rating **	M	Issue No.	<b>65</b>
LM End	<b>4.07</b>	Issue Type +	Ma	Location *	WS
Category	Earthen Levee		GPS Latitude/Longitude		
			Start	End	
Item	Animal Control		39.426571 °	39.426571 °	
			-121.988942 °	-121.988942 °	
DWR ID	DWR_LD0003_01_f_2013_65				
Action/Comments					
No rodents visible, but rodent burrows visible; need to backfill and compact or grout burrows.

View of the rodent activity along the waterside slope.

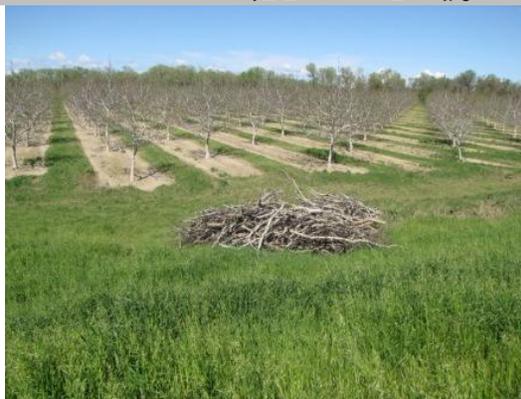
Photo 1 of 1 : rduffey\_s\_20140304\_259.jpg

View of prunings along the W/S toe.

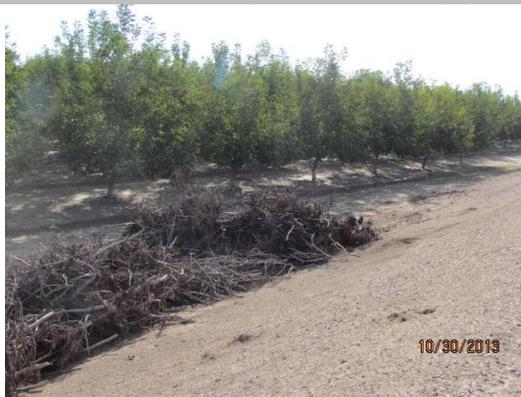
Photo 1 of 1 : rduffey\_s\_20140304\_289.jpg

LM Start	<b>4.75</b>	Rating **	M	Issue No.	<b>63</b>
LM End	<b>4.75</b>	Issue Type +	Ma	Location *	LS
Category	Earthen Levee		GPS Latitude/Longitude		
			Start	End	
Item	Encroachments		39.435701 °	39.435701 °	
			-121.988189 °	-121.988189 °	
DWR ID	DWR_LD0003_01_f_2013_63				
Action/Comments					
Prunings

View of the prunings along the landside toe.

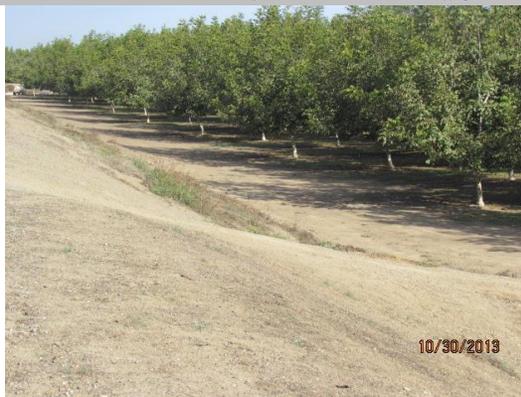
Photo 1 of 1 : rduffey\_s\_20140304\_290.jpg

LM Start	<b>4.75</b>	Rating **	M	Issue No.	<b>64</b>
LM End	<b>4.75</b>	Issue Type +	Ma	Location *	LS
Category	Earthen Levee		GPS Latitude/Longitude		
			Start	End	
Item	Animal Control		39.435702 °	39.435702 °	
			-121.988189 °	-121.988189 °	
DWR ID	DWR_LD0003_01_f_2013_64				
Action/Comments					
No rodents visible, but rodent burrows visible; need to backfill and compact or grout burrows.

View of the rodent activity along the landside slope.

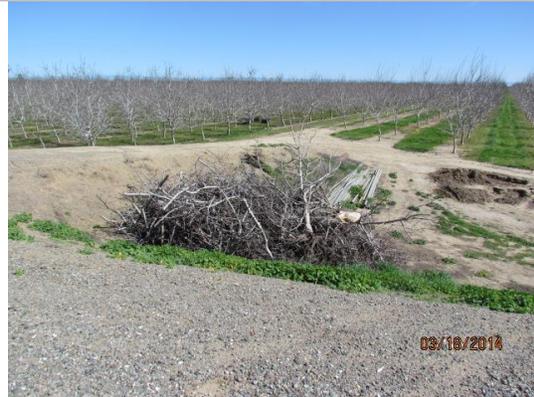
Photo 1 of 1 : rduffey\_s\_20140407\_160.jpg

View of the prunings along the l/s toe.

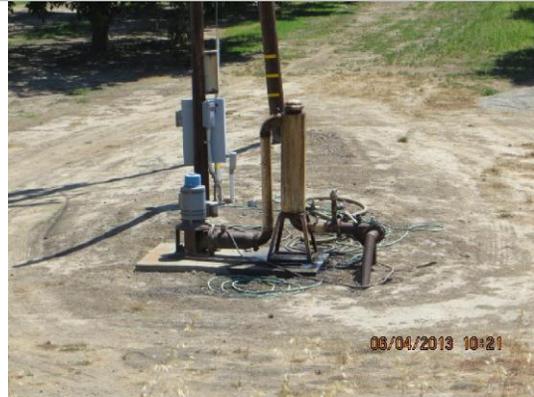
Photo 1 of 1 : UCIP\_1229.jpg

LM Start	<b>5.05</b>	Rating **	M	Issue No.	<b>38</b>
LM End	<b>5.05</b>	Issue Type +	En	Location *	LS
Category	Supplemental			GPS Latitude/Longitude	
				Start	End
Item	DWR UCIP Field Study			39.439791 °	39.439791 °
				-121.989825 °	-121.989825 °
DWR ID	DWR_LD0003_01_s_2014_38				
Action/Comments					
Inspector Comments: FS_ID:15163 EP_NO: N/A Repair Type: Crossing Status: UCIP Comments: No permit identified for this crossing. FIELD_STRUCT_DESC: 4-inch steel irrigation pipe through the levee at an unknown depth. Pump, vent, and shutoff valve off LS toe. Possible shutoff valve off WS toe. FS Date: 6/4/2013

Pumping plant off LS toe.

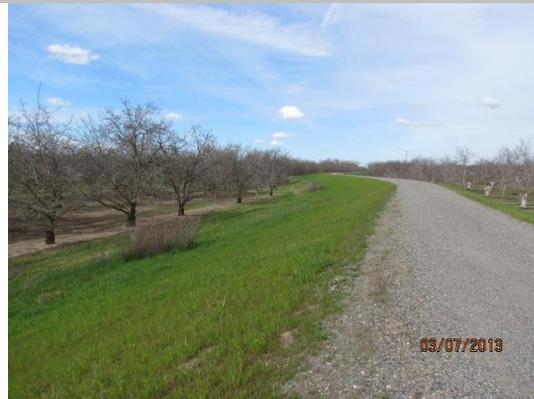
Photo 1 of 1 : rduffey\_s\_20140304\_271.jpg

LM Start	<b>5.19</b>	Rating **	A/W	Issue No.	<b>21</b>
LM End	<b>5.34</b>	Issue Type +	Ma	Location *	LS
Category	Earthen Levee			GPS Latitude/Longitude	
				Start	End
Item	Animal Control			39.441598 °	39.443793 °
				-121.990677 °	-121.991297 °
DWR ID	DWR_LD0003_01_s_2012_21				
Action/Comments					
No rodents visible, but rodent burrows visible; need to backfill and compact or grout burrows.

View of no rodent activity.

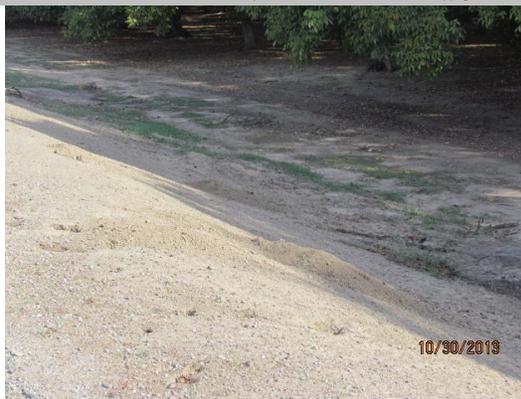
Photo 1 of 1 : rduffey\_s\_20140304\_288.jpg

View of the rodent holes along the landside slope.

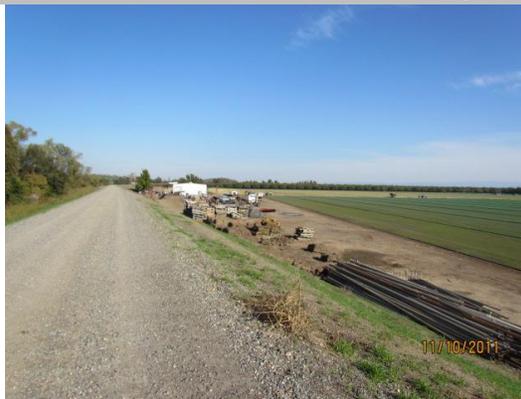
Photo 1 of 1 : rduffey\_s\_20140304\_273.jpg

LM Start	<b>5.87</b>	Rating **	M	Issue No.	<b>25</b>
LM End	<b>5.99</b>	Issue Type +	Ma	Location *	LS
Category	Earthen Levee		GPS Latitude/Longitude		
			Start	End	
Item	Encroachments		39.451293 °	39.452872 °	
			-121.992370 °	-121.992897 °	
DWR ID	DWR_LD0003_01_s_2012_25				
Action/Comments					
Abandoned vehicles

View of the equipment along the L/S toe.

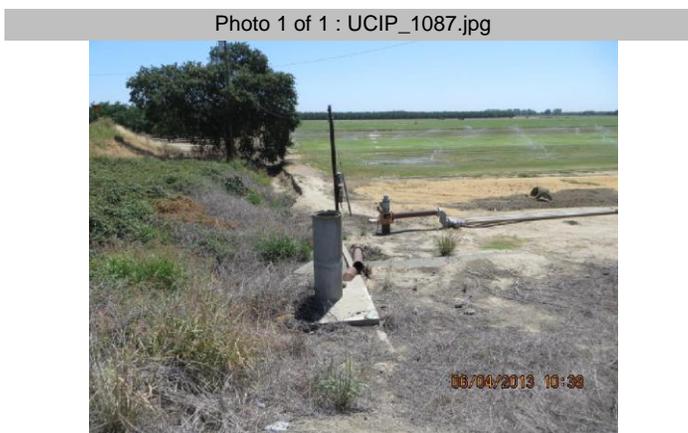
Concrete standpipe on LS toe.

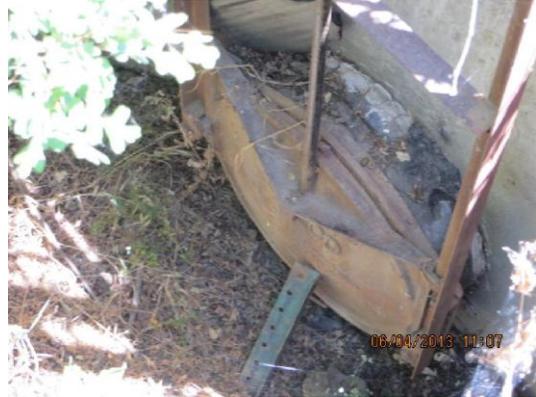
Photo 1 of 1 : UCIP\_1089.jpg

LM Start	<b>6.66</b>	Rating **	M	Issue No.	<b>40</b>
LM End	<b>6.66</b>	Issue Type +	En	Location *	WS
Category	Supplemental			GPS Latitude/Longitude	
				Start	End
Item	DWR UCIP Field Study			39.462145 °	39.462145 °
				-121.992831 °	-121.992831 °
DWR ID	DWR_LD0003_01_s_2014_40				
Action/Comments					
Inspector Comments: FS_ID:14664 EP_NO: 9906 Repair Type: Crossing Status: UCIP Comments: Pipe appears to be abandoned and should be done so properly. FIELD_STRUCT_DESC: 24-inch steel pipe through levee 13.0 feet below crown, slide gate on waterward end, pump house on berm. Slide gate in 7'X12' concrete pit on waterward side with flap gate on pipe from pumphouse. Pipe discharges into irrigation ditch on landward side (ABO No. 9906-Clare). Originally included in O+M manual 1955. FS Date: 6/4/2013

Slidegate inside concrete box on WS slope.

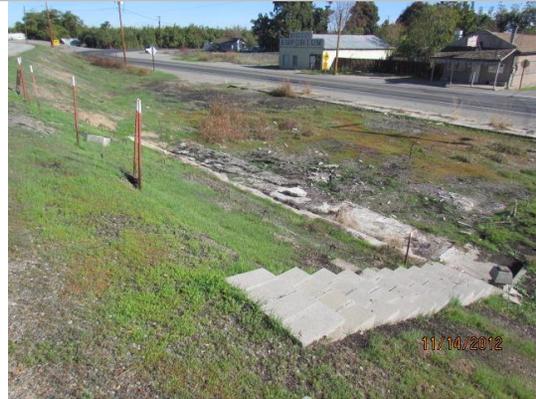
Photo 1 of 1 : rduffey\_s\_20140304\_268.jpg

LM Start	<b>6.74</b>	Rating **	M	Issue No.	<b>12</b>
LM End	<b>6.74</b>	Issue Type +	Ma	Location *	LS
Category	Earthen Levee			GPS Latitude/Longitude	
				Start	End
Item	Slope Stability			39.463366 °	39.463366 °
				-121.992586 °	-121.992586 °
DWR ID	DWR_LD0003_01_f_2012_12				
Action/Comments					
Repair slope instability. Inspector Comments: Building has burned down.

View of concrete stairs & foundation along the slope of the levee.

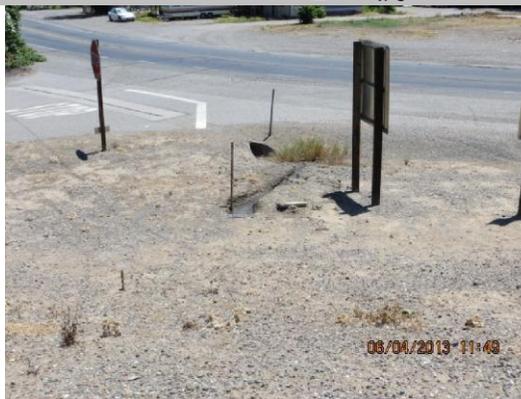
Photo 1 of 1 : UCIP\_1234.jpg

LM Start	<b>6.85</b>	Rating **	M	Issue No.	<b>41</b>
LM End	<b>6.85</b>	Issue Type +	En	Location *	WS
Category	Supplemental			GPS Latitude/Longitude	
				Start	End
Item	DWR UCIP Field Study			39.464596 °	39.464596 °
				-121.991850 °	-121.991850 °
DWR ID	DWR_LD0003_01_s_2014_41				
Action/Comments					
Inspector Comments: FS_ID:15165 EP_NO: 13972 Repair Type: Crossing Status: UCIP Comments: Pipe leaking on LS toe. FIELD_STRUCT_DESC: 1-inch steel waterline service through the levee at an unknown depth below the crown. Meter and siphon valve in concrete box at LS toe. (Permit No. 13972, 1984) FS Date: 6/4/2013

Pipe leaking at LS toe.

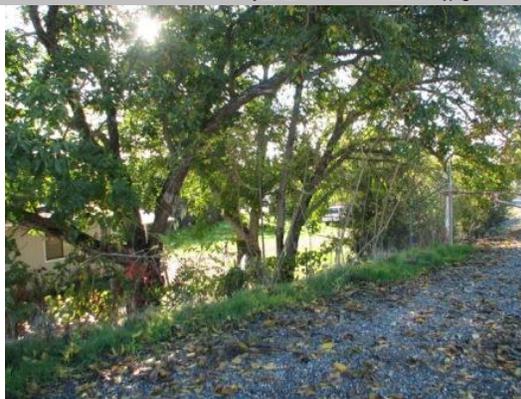
Photo 1 of 1 : rduffey\_s\_20140304\_282.jpg

View of the trees that are hanging over the landside slope of the levee.

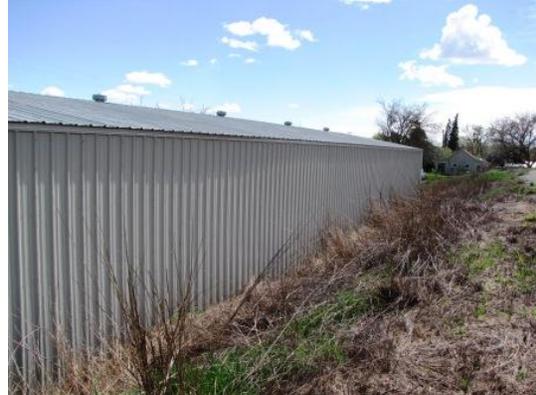
Photo 1 of 1 : SP\_2014\_LD0003\_27\_42\_06178.jpg

View of the building along the L/S toe.

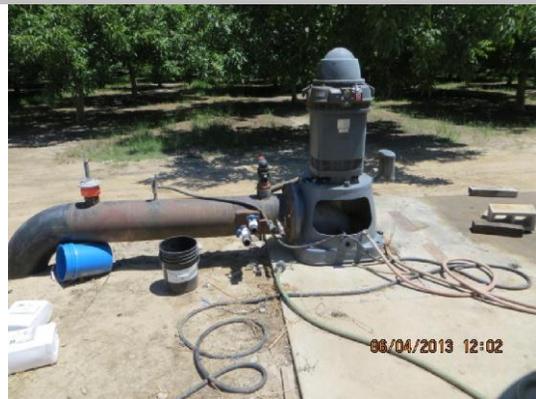
Photo 1 of 1 : UCIP\_1094.jpg

LM Start	<b>7.27</b>	Rating **	M	Issue No.	<b>43</b>
LM End	<b>7.27</b>	Issue Type +	En	Location *	LS
Category	Supplemental		GPS Latitude/Longitude		
			Start	End	
Item	DWR UCIP Field Study		39.470471 °	39.470471 °	
			-121.991278 °	-121.991278 °	
DWR ID	DWR_LD0003_01_s_2014_43				
Action/Comments					
Inspector Comments: FS_ID:14686 EP_NO: N/A Repair Type: Crossing Status: UCIP Comments: Distribution box filled in with soil on LS toe. Need to verify proper abandonment. FIELD_STRUCT_DESC: *Abandoned* 24-inch steel pipe through levee, 10.0 feet below crown. 7'X9' Concrete distribution box at landward toe filled in with soil (Torres). FS Date: 6/4/2013

Pump located on LS toe next to concrete distribution box.

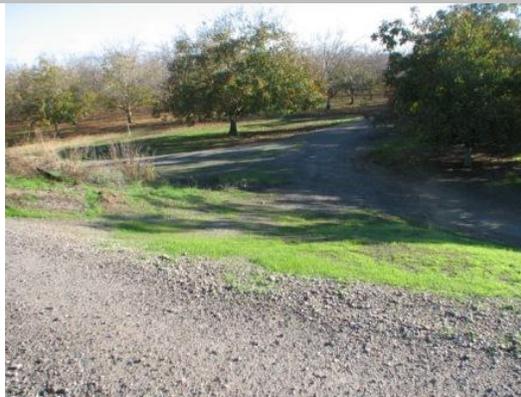
Photo 1 of 1 : rduffey\_s\_20140304\_269.jpg

LM Start	<b>7.34</b>	Rating **	M	Issue No.	<b>14</b>
LM End	<b>7.34</b>	Issue Type +	Ma	Location *	LS
Category	Earthen Levee		GPS Latitude/Longitude		
			Start	End	
Item	Slope Stability		39.471658 °	39.471658 °	
			-121.991245 °	-121.991245 °	
DWR ID	DWR_LD0003_01_s_2012_14				
Action/Comments					
Repair the levee slope damaged by vehicle traffic and prevent access where possible.

Vehicle erosion along the slope.

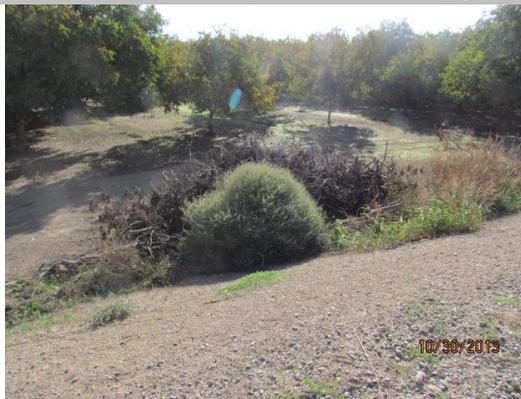
Photo 1 of 1 : rduffey\_s\_20140304\_287.jpg

View of the pruning along the landside toe.

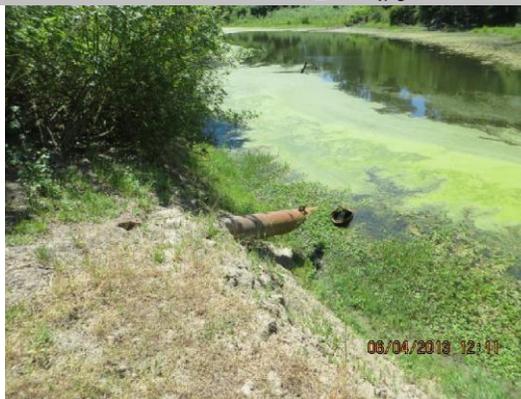
Photo 1 of 1 : UCIP\_1097.jpg

LM Start	<b>7.75</b>	Rating **	M	Issue No.	<b>47</b>
LM End	<b>7.75</b>	Issue Type +	En	Location *	LS
Category	Supplemental			GPS Latitude/Longitude	
				Start	End
Item	DWR UCIP Field Study			39.477223 °	39.477223 °
				-121.991021 °	-121.991021 °
DWR ID	DWR_LD0003_01_s_2014_47				
Action/Comments					
Inspector Comments: FS_ID:14687 EP_NO: N/A Repair Type: Crossing Status: UCIP Comments: Verify pipe was abandoned properly FIELD_STRUCT_DESC: 18-inch steel irrigation pipe through the levee 14.7 feet below the crown. Pump and pipe visible at edge of pond off WS toe (Kaiser-Aetna) FS Date: 6/4/2013

Pipe visible at pond off WS toe.

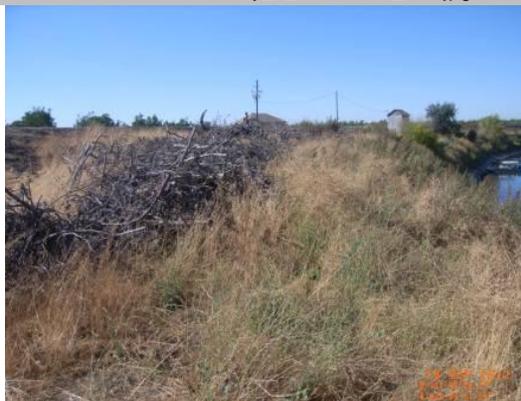
Photo 1 of 1 : rduffey\_s\_20140304\_286.jpg

View of the prunings along the landside toe.

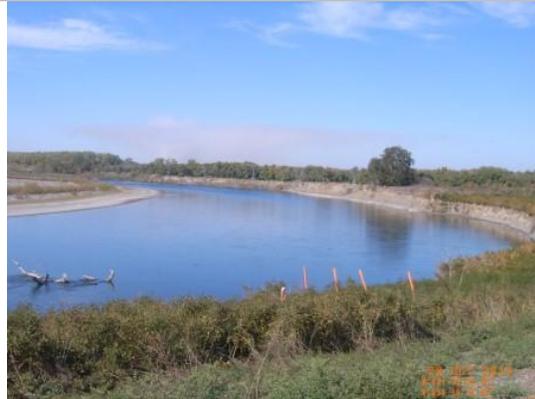
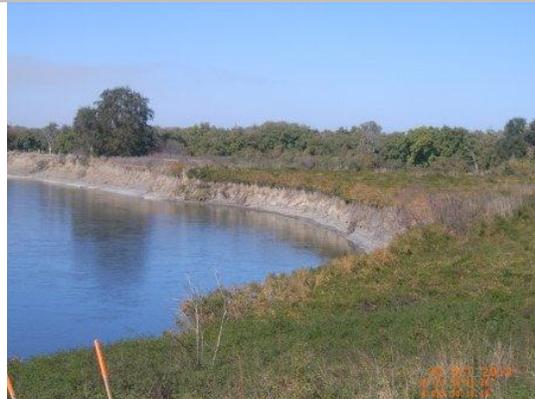
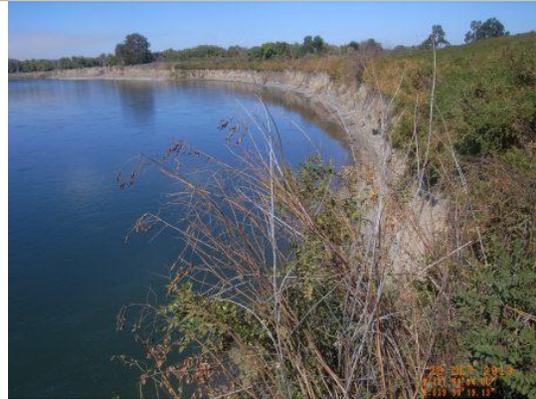
LM Start	<b>8.71</b>	Rating **	M	Issue No.	<b>26</b>
LM End	<b>9.86</b>	Issue Type +	Ma	Location *	WS
Category	Supplemental			GPS Latitude/Longitude	
				Start	End
Item	USACE Erosion Survey			39.508117 °	39.504388 °
				-121.986562 °	-121.985301 °
DWR ID					
<b>Action/Comments</b>					
Inspector Comments: 2007 - Getting close to the levee. Bank is clayey silt with clayey/silty toe. 2008 - Looks a little worse at the upstream end. 2009 - Some new erosion and slumping. 2010 - Some new erosion upstream of site, actively eroding at low flow. New bank swallow colony noted. 2011 - Significant erosion since last year, with an estimated 10 to 15 feet of berm lost. Large sections of the bank have slumped off. 2012 - Part of the site appears to be stabilizing, but still minor slumping in other locations. 2013: Minor new erosion at the toe. [2013 Site ID: SAC_172-0_L]

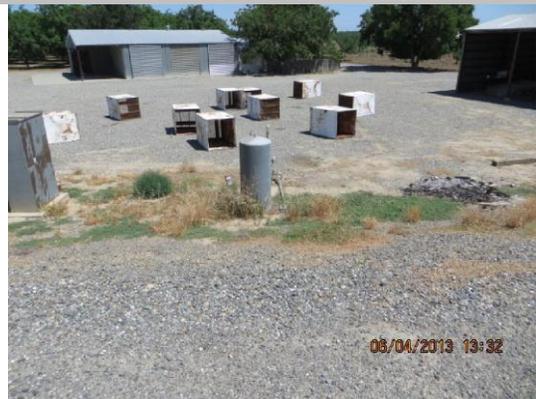
Photo 1 of 1 : UCIP\_1099.jpg

LM Start	<b>9.32</b>	Rating **	M	Issue No.	<b>50</b>
LM End	<b>9.32</b>	Issue Type +	En	Location *	WS
Category	Supplemental		GPS Latitude/Longitude		
			Start	End	
Item	DWR UCIP Field Study		39.497574 °	39.497574 °	
			-121.987548 °	-121.987548 °	
DWR ID	DWR_LD0003_01_s_2014_50				
Action/Comments					
Inspector Comments: FS_ID:14688 EP_NO: 1623 Repair Type: Crossing Status: UCIP Comments: Abandoned and should be done so properly. FIELD_STRUCT_DESC: 1.5-inch galvanized iron pipe through the levee 8.0 feet below the crown (Permit No.1623-Holgersoo). FS Date: 6/4/2013

Water tank, pump, and well head on LS toe.

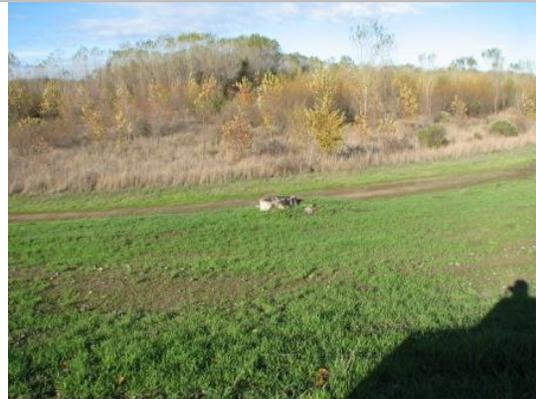
Photo 1 of 1 : SP\_2014\_LD0003\_27\_29\_06179.jpg

View of the stump along the toe.

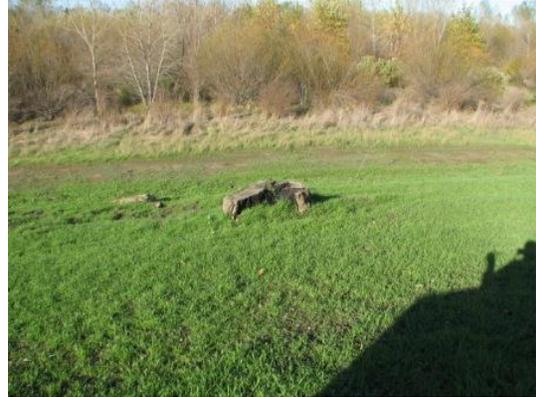
Photo 1 of 1 : SP\_2014\_LD0003\_27\_30\_06180.jpg

View of the stump along the slope.

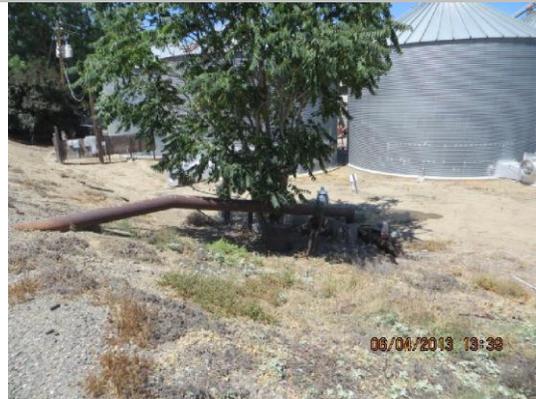
Photo 1 of 1 : UCIP\_1103.jpg

10-inch pipe and pump on LS.

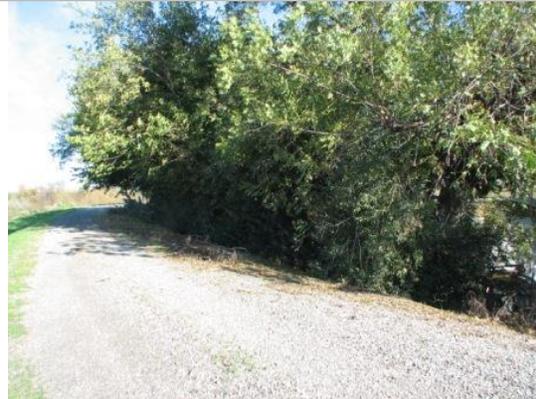
Photo 1 of 1 : rduffey\_s\_20140304\_261.jpg

View of the trees along the slope.

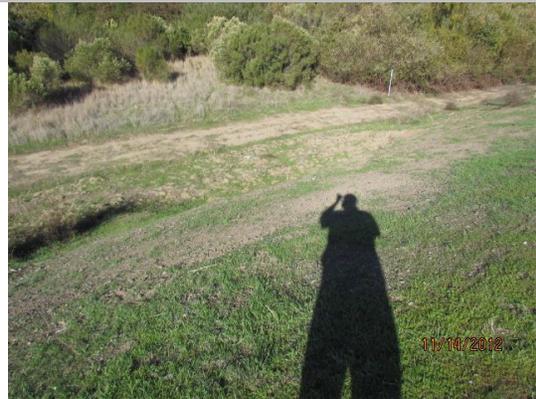
Photo 1 of 1 : rduffey\_s\_20140304\_262.jpg

View of the verical cut along the w/s toe.
