**Flood Control Project Maintenance
Levee Inspections**
LMA District Cover Sheet
Spring 2016 Levee Inspection Results

Levee District No. 0003 (Glenn County)

Spring 2016 Levee Inspection Results

Waterway	Bank	Unit Miles
Unit No. 01 Glenn County Sacramento River	Left	11.97

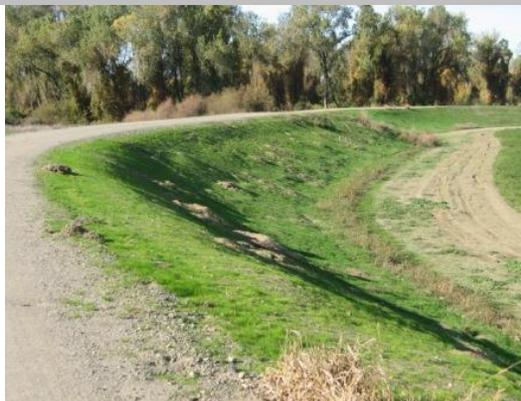
Photo 1 of 1 : SP_2016_LD0003_27_3_20160324_00001.jpg

View of squirrel holes along the slope.

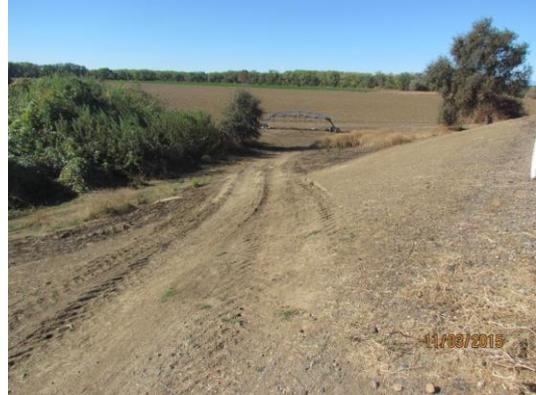
Photo 1 of 1 : SP_2016_LD0003_27_44_20160324_00023.jpg

LM Start	0.78	Rating **	M	Issue No.	44
LM End	0.78	Issue Type +	Ma	Location *	WS
Category	Earthen Levee		GPS Latitude/Longitude		
			Start	End	
Item	Slope Stability		39.388440 °	39.388440 °	
			-121.999175 °	-121.999175 °	
DWR ID	DWR_LD0003_01_f_2015_44				
Comment Code					
S3 : Repair the levee slope damaged by vehicle traffic and prevent access where possible.					
Inspector Comment					
Repair the waterside slope damage caused by vehicle traffic.

View of the vehicle erosion along the waterside slope.

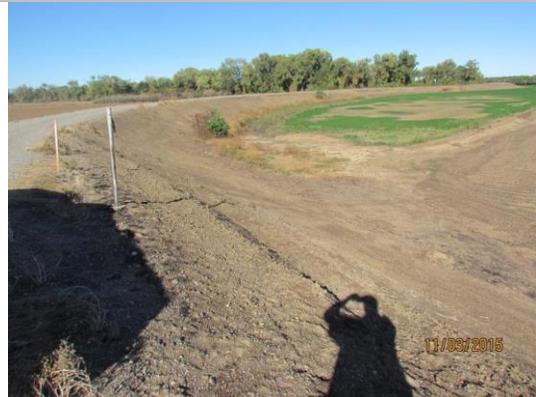
Photo 1 of 1 : SP_2016_LD0003_27_49_20160324_00026.jpg

LM Start	0.79	Rating **	M	Issue No.	49
LM End	0.79	Issue Type +	Ma	Location *	LS
Category	Earthen Levee		GPS Latitude/Longitude		
			Start	End	
Item	Slope Stability		39.388508 °	39.388508 °	
			-121.999407 °	-121.999407 °	
DWR ID	DWR_LD0003_01_f_2015_49				
Comment Code					
S3 : Repair the levee slope damaged by vehicle traffic and prevent access where possible.					
Inspector Comment					
Repair the landside slope damaged by vehicle traffic.

View of the landside slope erosion caused by vehicle traffic.

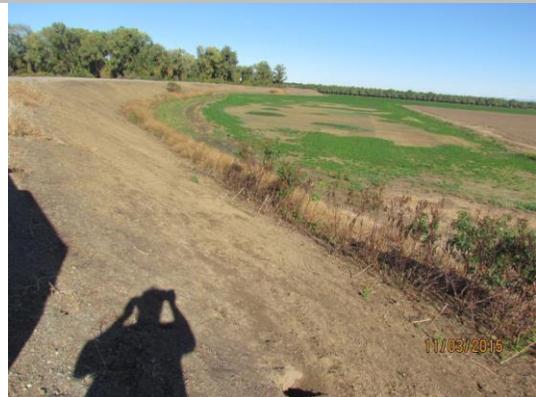
Photo 1 of 1 : SP_2016_LD0003_27_51_20160324_00029.jpg

LM Start	0.81	Rating **	U	Issue No.	51
LM End	0.91	Issue Type +	Ma	Location *	LS
Category	Earthen Levee		GPS Latitude/Longitude		
			Start	End	
Item	Animal Control		39.388690 °	39.389867 °	
			-121.999820 °	-122.000585 °	
DWR ID	DWR_LD0003_01_f_2015_51				
Comment Code					
A3 : No rodents visible, but rodent burrows visible; need to backfill and compact or grout burrows.					
Inspector Comment					
Repair the rodent holes along the landside slope.

View of the rodent holes along the landside slope.

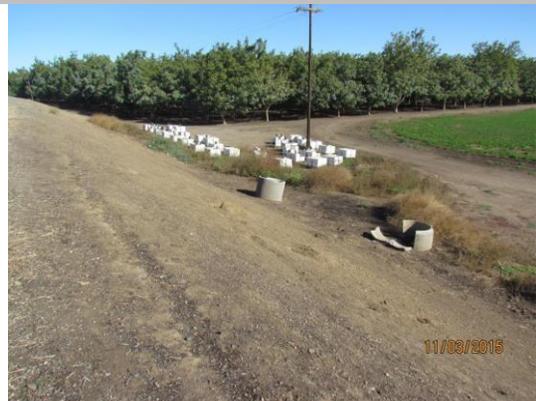
Photo 1 of 1 : SP_2016_LD0003_27_52_20160324_00030.jpg

LM Start	1.21	Rating **	M	Issue No.	52
LM End	1.21	Issue Type +	Ma	Location *	LS
Category	Earthen Levee		GPS Latitude/Longitude		
			Start	End	
Item	Animal Control		39.394010 °	39.394010 °	
			-122.000977 °	-122.000977 °	
DWR ID	DWR_LD0003_01_f_2015_52				
Comment Code					
A3 : No rodents visible, but rodent burrows visible; need to backfill and compact or grout burrows.					
Inspector Comment					
Repair the rodent holes along the landside slope.

View of the rodent holes along the landside slope.

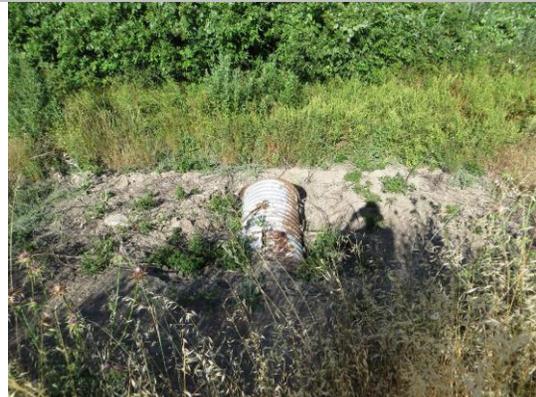
Photo 1 of 2 : UCIP_SP_2016_14573_24038.jpg

LM Start	1.47	Rating **	M	Issue No.	95
LM End	1.47	Issue Type +	En	Location *	WS
Category	Supplemental			GPS Latitude/Longitude	
				Start	End
Item	DWR UCIP Field Study			39.397780 °	39.397780 °
				-122.002074 °	-122.002074 °
DWR ID					
Comment Code					
Inspector Comment					
FS_ID:14573 DS_ID:18830 EP_NO: 9930 Repair Type: Non-Urgent Crossing Status: Found UCIP Comments: Steel plate welded over WS end of pipe. Slide gate at WS toe missing. Appears abandoned. FIELD_STRUCT_DESC: 24-inch corrugated metal pipe through the levee 14.5 feet below the crown slide gate on waterward end, 7'X9' concrete diversion box at landward toe (ABO No. 9930-Steel Ranch). Originally included in O+M manual (1960). FS Date: 6/4/2013

24-inch CMP stormdrain on WS toe.

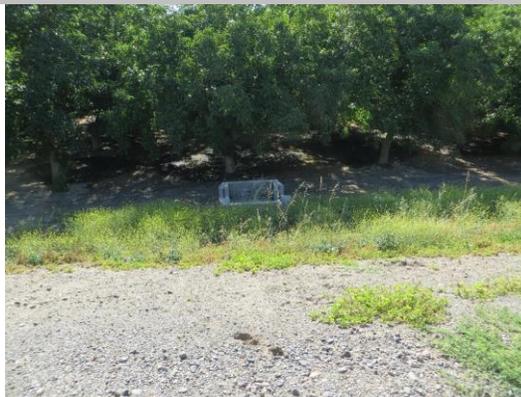
Photo 2 of 2 : UCIP_SP_2016_14576_24051.jpg

LM Start	1.58	Rating **	M	Issue No.	96 (cont)
LM End	1.58	Issue Type +	En	Location *	WS
Category	Supplemental			GPS Latitude/Longitude	
				Start	End
Item	DWR UCIP Field Study			39.399330 °	39.399330 °
				-122.002402 °	-122.002402 °
DWR ID					
Comment Code					
Inspector Comment					
FS_ID:14576 DS_ID:18823 EP_NO: 9931 Repair Type: Non-Urgent Crossing Status: Found UCIP Comments: Appears abandoned. Pipe burried at slide gate on WS toe. FIELD_STRUCT_DESC: 24-inch corrugated metal pipe through the levee 15.0 feet below the crown, slide gate on waterward end. 6'X7' concrete distribution box on LS toe. (ABO No. 9931-L. F. Steel). Originally included in the O+M manual (1960). FS Date: 6/4/2013

Concrete distribution box at LS toe.

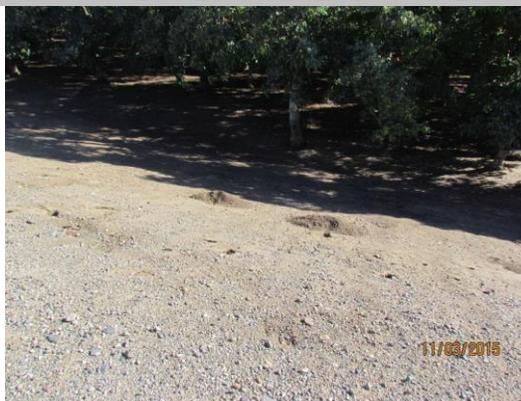
Photo 1 of 1 : SP_2016_LD0003_27_15_20160324_00012.jpg

LM Start	1.73	Rating **	U	Issue No.	15
LM End	2.41	Issue Type +	Ma	Location *	LS
Category	Earthen Levee			GPS Latitude/Longitude	
				Start	End
Item	Animal Control			39.401452 °	39.406557 °
				-122.002132 °	-121.995052 °
DWR ID	DWR_LD0003_01_s_ 2012_15				
Comment Code					
A3 : No rodents visible, but rodent burrows visible; need to backfill and compact or grout burrows.					
Inspector Comment					
Repair the rodent holes along the landside slope.

View of the rodent holes along the landside slope.

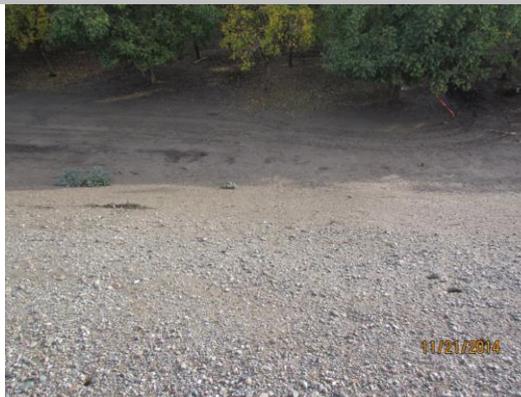
Photo 1 of 1 : SP_2016_LD0003_27_13_20160324_00010.jpg

View of the rodent holes along the waterside slope.

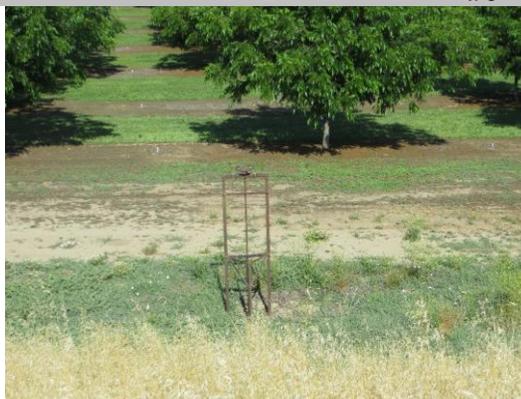
Photo 1 of 2 : UCIP_SP_2016_14577_24055.jpg

LM Start	1.87	Rating **	M	Issue No.	97
LM End	1.87	Issue Type +	En	Location *	WS
Category	Supplemental		GPS Latitude/Longitude		
			Start	End	
Item	DWR UCIP Field Study		39.403419 °	39.403419 °	
			-122.001871 °	-122.001871 °	
DWR ID					
Comment Code					
Inspector Comment					
FS_ID:14577 DS_ID:18825 EP_NO: 9935 Repair Type: Non-Urgent Crossing Status: Found UCIP Comments: Appears abandoned. Pipe buried on WS toe. Debris and steel plate blocking inlet on LS. FIELD_STRUCT_DESC: 24-inch corrugated metal pipe through the levee and beneath the roadway 18.0 feet below the crown, slide gate on waterward end (ABO No. 9935-Watt). Originally included in the O+M manual (1960). FS Date: 6/4/2013

Slide gate buried at WS toe.

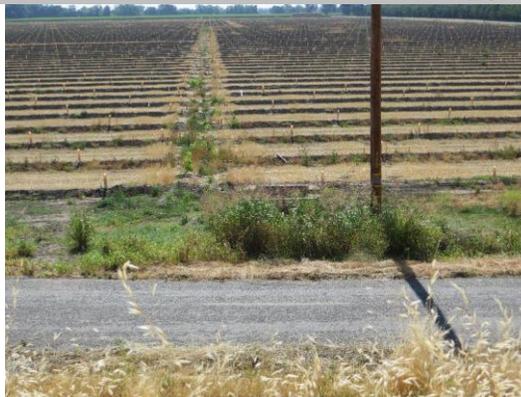
Photo 2 of 2 : UCIP_SP_2016_14577_24054.jpg

LM Start	1.87	Rating **	M	Issue No.	97 (cont)
LM End	1.87	Issue Type +	En	Location *	WS
Category	Supplemental			GPS Latitude/Longitude	
				Start	End
Item	DWR UCIP Field Study			39.403419 °	39.403419 °
				-122.001871 °	-122.001871 °
DWR ID					
Comment Code					
Inspector Comment					
FS_ID:14577 DS_ID:18825 EP_NO: 9935 Repair Type: Non-Urgent Crossing Status: Found UCIP Comments: Appears abandoned. Pipe buried on WS toe. Debris and steel plate blocking inlet on LS. FIELD_STRUCT_DESC: 24-inch corrugated metal pipe through the levee and beneath the roadway 18.0 feet below the crown, slide gate on waterward end (ABO No. 9935-Watt). Originally included in the O+M manual (1960). FS Date: 6/4/2013

Concrete distribution box off LS toe.

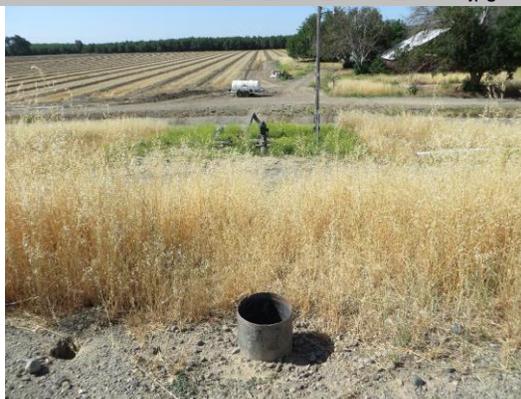
Photo 1 of 2 : UCIP_SP_2016_15144_24883.jpg

LM Start	2.10	Rating **	M	Issue No.	100
LM End	2.10	Issue Type +	En	Location *	WS
Category	Supplemental			GPS Latitude/Longitude	
				Start	End
Item	DWR UCIP Field Study			39.406353 °	39.406353 °
				-122.000674 °	-122.000674 °
DWR ID					
Comment Code					
Inspector Comment					
FS_ID:15144 DS_ID:23151 EP_NO: N/A Repair Type: Non-Urgent Crossing Status: Found UCIP Comments: No permit identified for this crossing. FIELD_STRUCT_DESC: 12-inch steel irrigation pipe through the levee 3.5-feet below the crown. Pump, butterfly valve, JP/meter at channel on LS toe. Siphon breaker in 12-inch steel riser on LS shoulder. 3-inch plastic drain on WS toe. FS Date: 6/4/2013

Siphon breaker in steel riser on LS shoulder with pump in background.

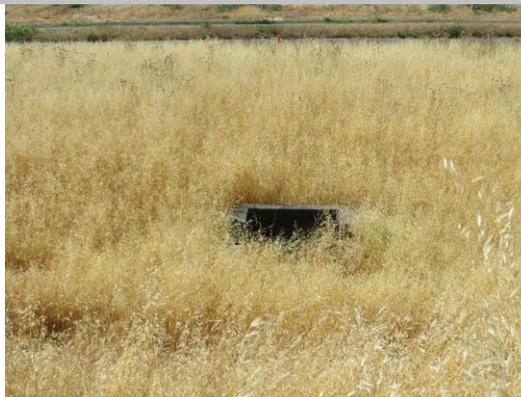
Photo 2 of 2 : UCIP_SP_2016_14582_24075.jpg

LM Start	2.38	Rating **	M	Issue No.	98 (cont)
LM End	2.38	Issue Type +	En	Location *	WS
Category	Supplemental			GPS Latitude/Longitude	
				Start	End
Item	DWR UCIP Field Study			39.406471 °	39.406471 °
				-121.995551 °	-121.995551 °
DWR ID					
Comment Code					
Inspector Comment					
FS_ID:14582 DS_ID:18827 EP_NO: 9936 Repair Type: Non-Urgent Crossing Status: Found UCIP Comments: Appears abandoned. Pipe buried on WS and blocked with tin and soil on the LS. FIELD_STRUCT_DESC: 24-inch corrugated metal pipe through the levee 18.3 feet below crown, slide gate on waterward end. 5-foot by 7-foot concrete distribution box at landward toe (ABO No. 9936-Watt). Originally included in the O+M manual (1960). FS Date: 6/4/2013

Concrete distribution box on LS toe.

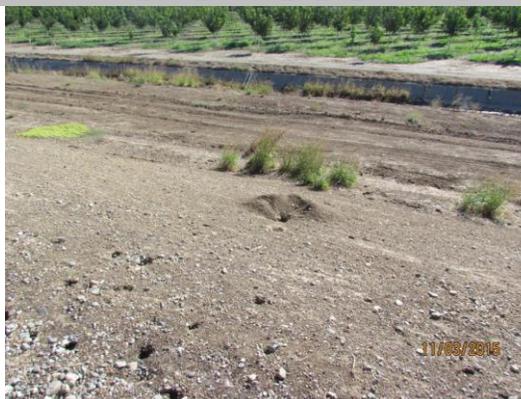
Photo 1 of 1 : SP_2016_LD0003_27_47_20160324_00024.jpg

LM Start	2.57	Rating **	U	Issue No.	47
LM End	2.57	Issue Type +	Ma	Location *	LS
Category	Earthen Levee			GPS Latitude/Longitude	
				Start	End
Item	Animal Control			39.407582 °	39.407582 °
				-121.992417 °	-121.992417 °
DWR ID	DWR_LD0003_01_f_2015_47				
Comment Code					
A3 : No rodents visible, but rodent burrows visible; need to backfill and compact or grout burrows.					
Inspector Comment					
Repair rodent hole on LS slope.

View of the rodent holes along the landside slope.

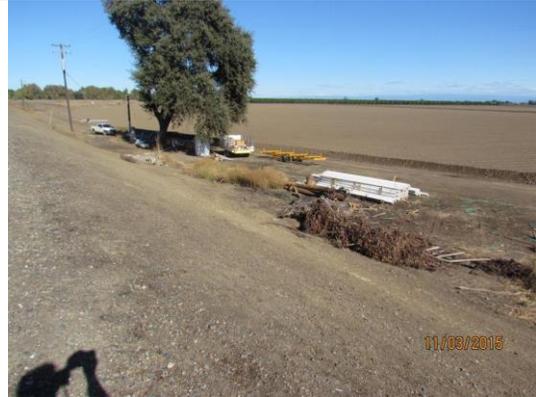
Photo 1 of 1 : SP_2016_LD0003_27_54_20160324_00031.jpg

LM Start	2.96	Rating **	U	Issue No.	54
LM End	3.09	Issue Type +	Ma	Location *	LS
Category	Earthen Levee		GPS Latitude/Longitude		
			Start	End	
Item	Animal Control		39.412613 °	39.414392 °	
			-121.991278 °	-121.992257 °	
DWR ID	DWR_LD0003_01_f_2015_54				
Comment Code					
A1 : Exterminate rodents and backfill and compact or grout burrows.					
Inspector Comment					
Implement rodent control measures and repair rodent damage on LS slope.

View of the rodent holes along the landside slope.

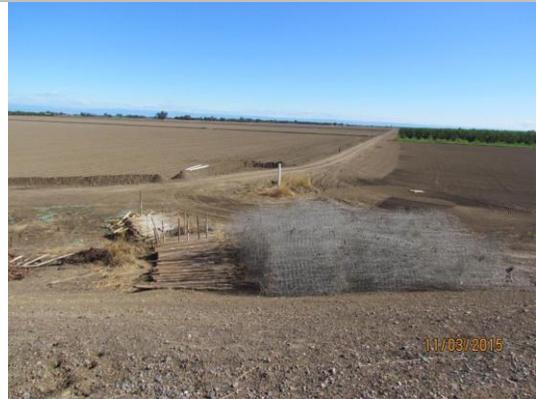
Photo 1 of 1 : SP_2016_LD0003_27_56_20160324_00033.jpg

View of the wire and tree stakes along the landside toe.

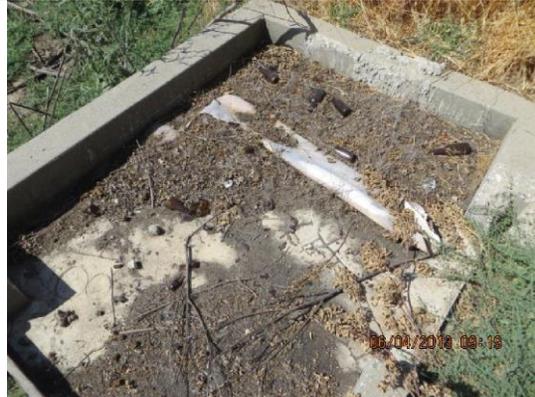
Photo 1 of 2 : UCIP_SP_2016_14584_24081.jpg

LM Start	2.98	Rating **	M	Issue No.	99
LM End	2.98	Issue Type +	En	Location *	LS
Category	Supplemental			GPS Latitude/Longitude	
				Start	End
Item	DWR UCIP Field Study			39.412827 °	39.412827 °
				-121.991427 °	-121.991427 °
DWR ID					
Comment Code					
Inspector Comment					
FS_ID:14584 DS_ID:18829 EP_NO: 9919 Repair Type: Non-Urgent Crossing Status: Indicator Found UCIP Comments: Appears abandoned. Verify it was done corectly. FIELD_STRUCT_DESC: *Abandoned* 24-inch corrugated metal pipe through the levee 16.0 feet below the crown, slide gate on waterward end. 5'X7' concrete distribution box at LS toe is filled with grout (ABO No. 9919-Mills). Originally included in the O+M manual (1960) FS Date: 6/4/2013

5'X7' concrete distribution box filled in with grout.

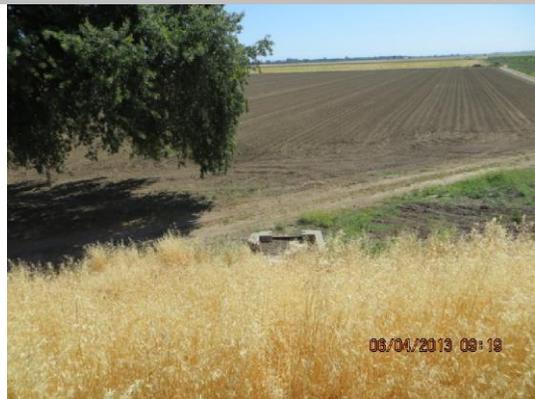
Photo 2 of 2 : UCIP_SP_2016_14584_24080.jpg

Distribution box on LS toe.

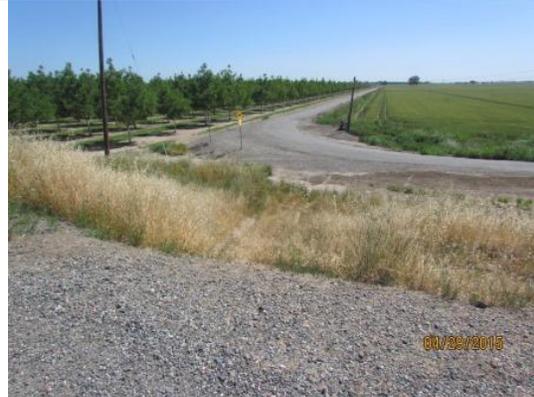
Photo 1 of 1 : SP_2016_LD0003_27_9_20160324_00005.jpg

LM Start	3.39	Rating **	M	Issue No.	9
LM End	3.39	Issue Type +	Ma	Location *	LS
Category	Earthen Levee		GPS Latitude/Longitude		
			Start	End	
Item	Slope Stability		39.418382 °	39.418382 °	
			-121.992480 °	-121.992480 °	
DWR ID	DWR_LD0003_01_s_2012_9				
Comment Code					
S3 : Repair the levee slope damaged by vehicle traffic and prevent access where possible.					
Inspector Comment					
Repair the erosion along the landside slope and prevent vehicle access

View of the vehicle erosion along the landside slope.

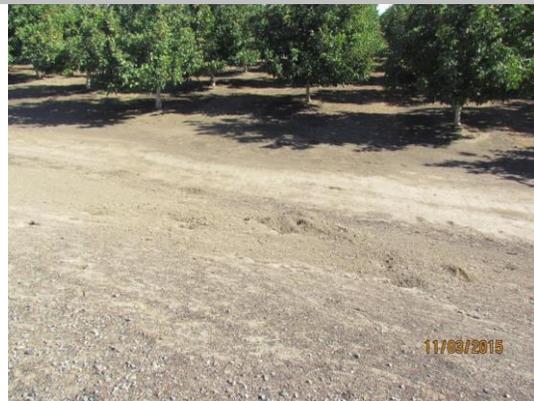
Photo 1 of 1 : SP_2016_LD0003_27_58_20160324_00034.jpg

LM Start	3.41	Rating **	U	Issue No.	58
LM End	3.48	Issue Type +	Ma	Location *	LS
Category	Earthen Levee		GPS Latitude/Longitude		
			Start	End	
Item	Animal Control		39.418687 °	39.419762 °	
			-121.992422 °	-121.992307 °	
DWR ID	DWR_LD0003_01_f_2015_58				
Comment Code					
A3 : No rodents visible, but rodent burrows visible; need to backfill and compact or grout burrows.					
Inspector Comment					
Implement rodent control measures and repair rodent damage on LS slope.

View of the rodent. Holes along the landside slope.

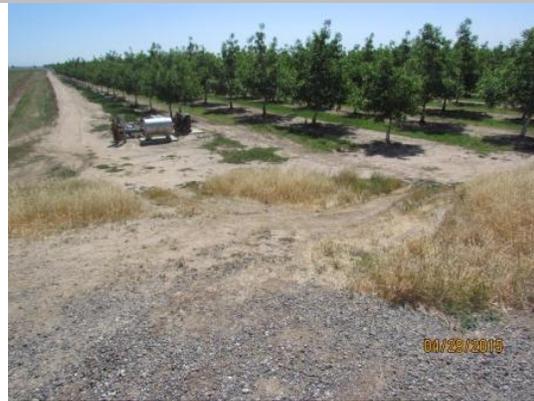
Photo 1 of 1 : SP_2016_LD0003_27_19_20160324_00013.jpg

LM Start	3.76	Rating **	M	Issue No.	19
LM End	3.76	Issue Type +	Ma	Location *	LS
Category	Earthen Levee		GPS Latitude/Longitude		
			Start	End	
Item	Slope Stability		39.423747 °	39.423747 °	
			-121.991667 °	-121.991667 °	
DWR ID	DWR_LD0003_01_s_2012_19				
Comment Code					
S3 : Repair the levee slope damaged by vehicle traffic and prevent access where possible.					
Inspector Comment					
Repair the vehicle erosion on the landside slope.

View of the vehicle erosion along the landside slope.

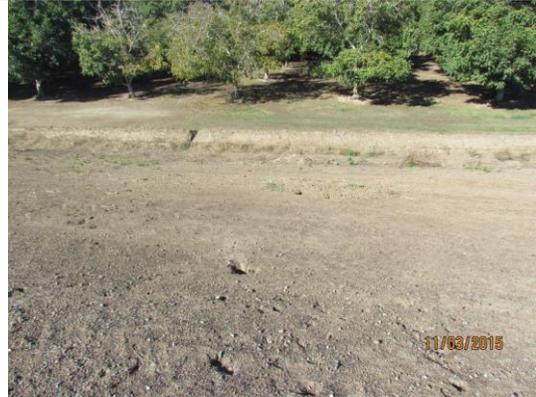
Photo 1 of 1 : SP_2016_LD0003_27_59_20160324_00035.jpg

LM Start	3.88	Rating **	U	Issue No.	59
LM End	3.88	Issue Type +	Ma	Location *	WS
Category	Earthen Levee		GPS Latitude/Longitude		
			Start	End	
Item	Animal Control		39.425162 °	39.425162 °	
			-121.990528 °	-121.990528 °	
DWR ID	DWR_LD0003_01_f_2015_59				
Comment Code					
A3 : No rodents visible, but rodent burrows visible; need to backfill and compact or grout burrows.					
Inspector Comment					
Repair the rodent holes along the landside slope.

View of the rodent holes along the landside slope.

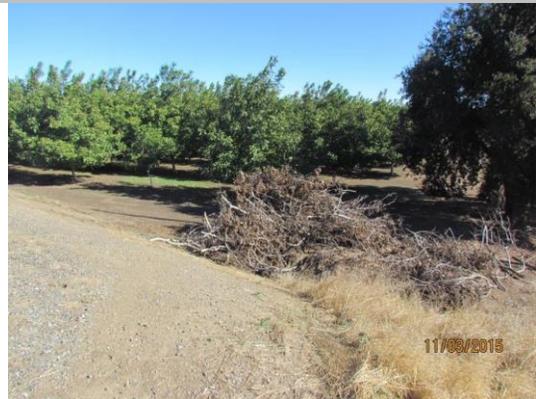
Photo 1 of 1 : SP_2016_LD0003_27_66_20160324_00041.jpg

View of the prunings along the landside toe.

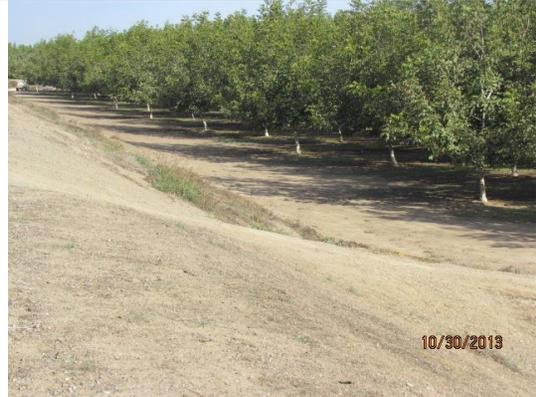
Photo 1 of 1 : SP_2016_LD0003_27_64_20160324_00040.jpg

LM Start	4.63	Rating **	U	Issue No.	64
LM End	4.68	Issue Type +	Ma	Location *	LS
Category	Earthen Levee		GPS Latitude/Longitude		
			Start	End	
Item	Animal Control		39.435205 °	39.435855 °	
			-121.988097 °	-121.988252 °	
DWR ID	DWR_LD0003_01_f_2013_64				
Comment Code					
A3 : No rodents visible, but rodent burrows visible; need to backfill and compact or grout burrows.					
Inspector Comment					
Implement rodent control measures and repair rodent damage on LS slope.

View of the rodent activity along the landside slope.

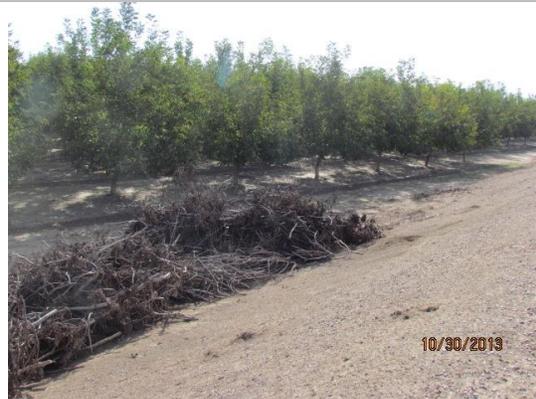
Photo 1 of 1 : SP_2016_LD0003_27_63_20160324_00039.jpg

View of the prunings along the landside toe.

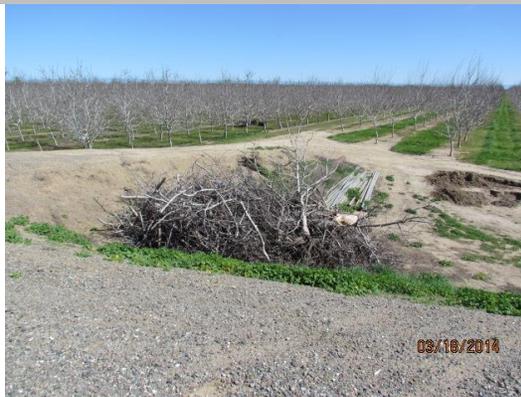
Photo 1 of 1 : SP_2016_LD0003_27_68_20160324_00043.jpg

View of the prunings along the l/s toe.

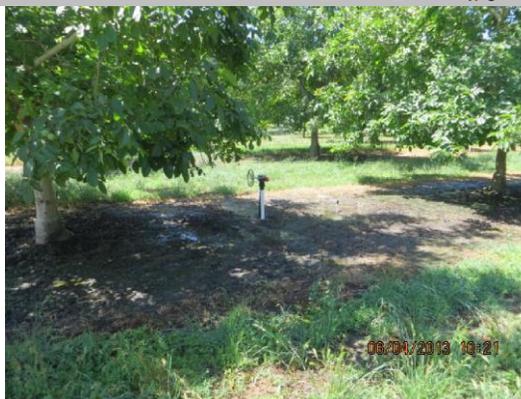
Photo 1 of 2 : UCIP_SP_2016_15163_24902.jpg

LM Start	4.96	Rating **	M	Issue No.	101
LM End	4.96	Issue Type +	En	Location *	LS
Category	Supplemental		GPS Latitude/Longitude		
			Start	End	
Item	DWR UCIP Field Study		39.439791 °	39.439791 °	
			-121.989825 °	-121.989825 °	
DWR ID					
Comment Code					
Inspector Comment					
FS_ID:15163 DS_ID:23152 EP_NO: N/A Repair Type: Non-Urgent Crossing Status: Found UCIP Comments: No permit identified for this crossing. FIELD_STRUCT_DESC: 4-inch steel irrigation pipe through the levee at an unknown depth. Pump, vent, and shutoff valve off LS toe. Possible shutoff valve off WS toe. FS Date: 6/4/2013

Possible shutoff valve on WS toe.

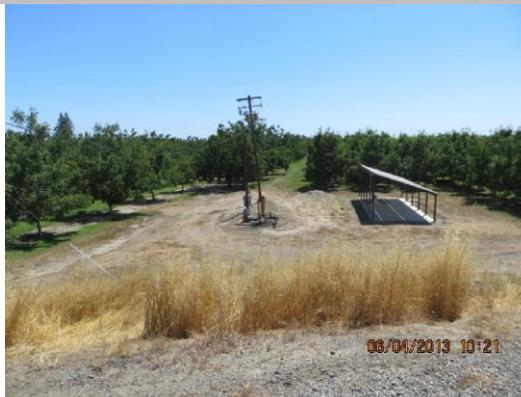
Photo 2 of 2 : UCIP_SP_2016_15163_24901.jpg

LM Start	4.96	Rating **	M	Issue No.	101 (cont)
LM End	4.96	Issue Type +	En	Location *	LS
Category	Supplemental			GPS Latitude/Longitude	
				Start	End
Item	DWR UCIP Field Study			39.439791 °	39.439791 °
				-121.989825 °	-121.989825 °
DWR ID					
Comment Code					
Inspector Comment					
FS_ID:15163 DS_ID:23152 EP_NO: N/A Repair Type: Non-Urgent Crossing Status: Found UCIP Comments: No permit identified for this crossing. FIELD_STRUCT_DESC: 4-inch steel irrigation pipe through the levee at an unknown depth. Pump, vent, and shutoff valve off LS toe. Possible shutoff valve off WS toe. FS Date: 6/4/2013

Pumping plant off LS toe.

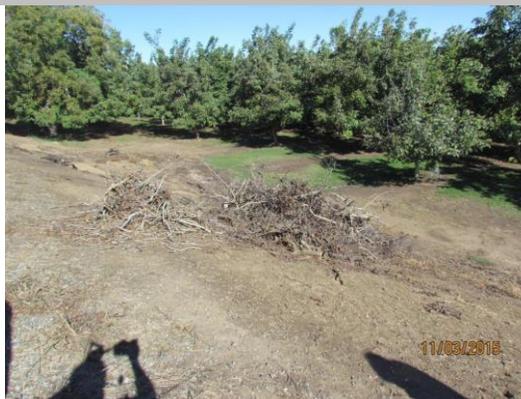
Photo 1 of 1 : SP_2016_LD0003_27_69_20160324_00044.jpg

View of the prunings along the landside slope.

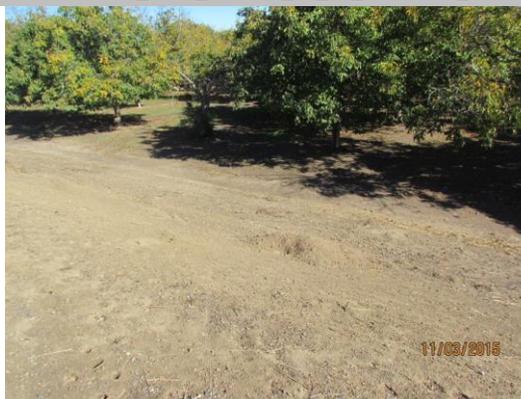
Photo 1 of 1 : SP_2016_LD0003_27_70_20160324_00045.jpg

View of the rodent holes along the landside slope.

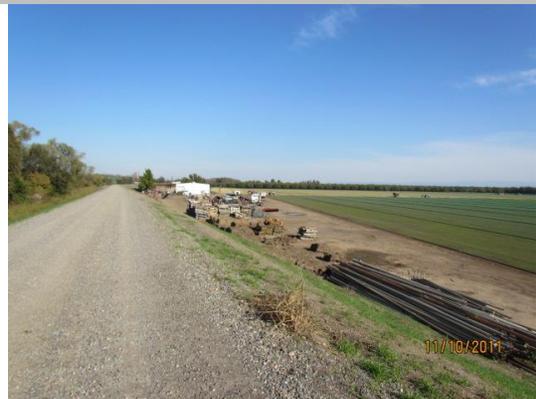
Photo 1 of 1 : SP_2016_LD0003_27_25_20160324_00016.jpg

View of the equipment along the L/S toe.

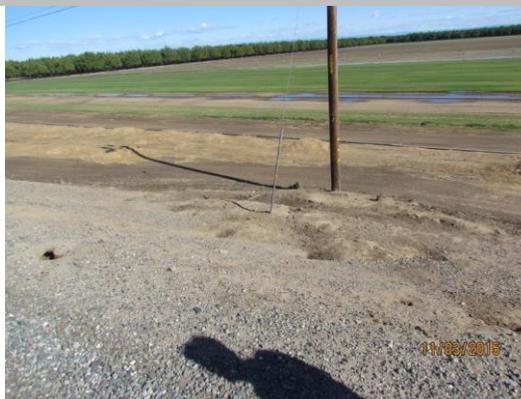
Photo 1 of 1 : SP_2016_LD0003_27_71_20160324_00046.jpg

LM Start	6.06	Rating **	U	Issue No.	71
LM End	6.06	Issue Type +	Ma	Location *	LS
Category	Earthen Levee			GPS Latitude/Longitude	
				Start	End
Item	Animal Control			39.455313 °	39.455313 °
				-121.993712 °	-121.993712 °
DWR ID	DWR_LD0003_01_f_2015_71				
Comment Code					
A3 : No rodents visible, but rodent burrows visible; need to backfill and compact or grout burrows.					
Inspector Comment					
Repair rodent damage on LS slope.

View of the rodent holes along the landside slope.

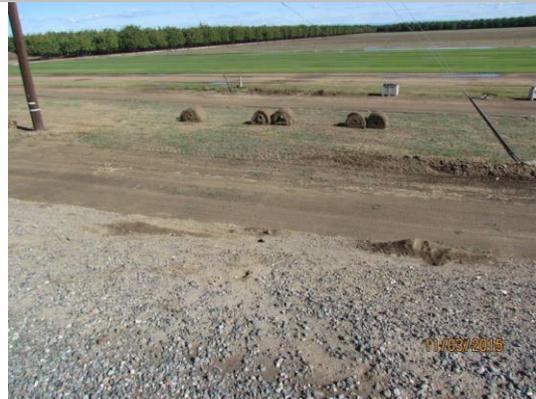
Photo 1 of 1 : SP_2016_LD0003_27_72_20160324_00047.jpg

View of the rodent holes along the landside slope.

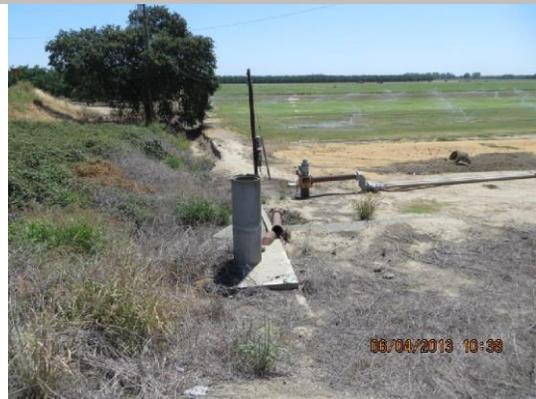
Photo 1 of 2 : UCIP_SP_2016_14643_24142.jpg

Concrete standpipe on LS toe.

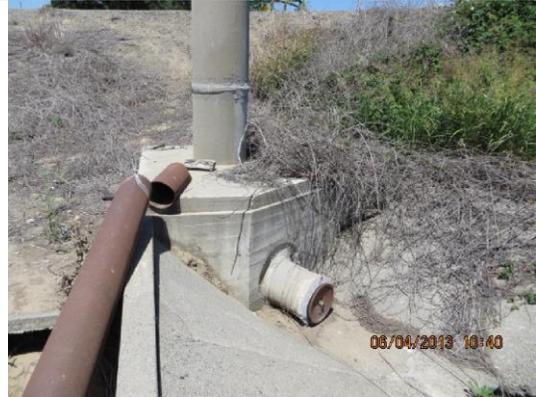
Photo 2 of 2 : UCIP_SP_2016_14643_24141.jpg

Concrete standpipe and channel on LS toe.

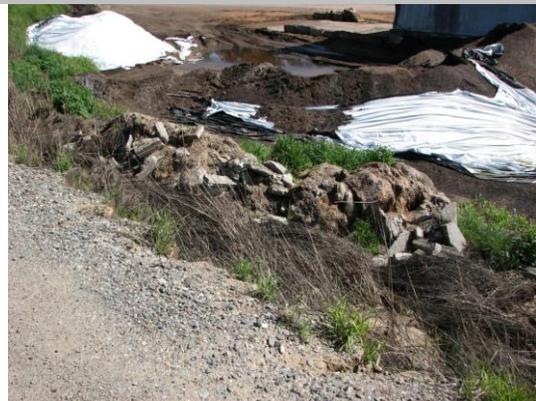
Photo 1 of 1 : SP_2016_LD0003_27_65_20160405_00096.jpg

Concrete and soil obstructing visibility and access

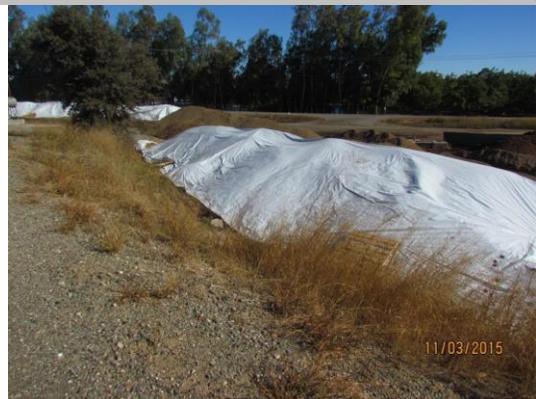
Photo 1 of 1 : SP_2016_LD0003_27_73_20160324_00048.jpg

View of the feed product stored along the landside toe.

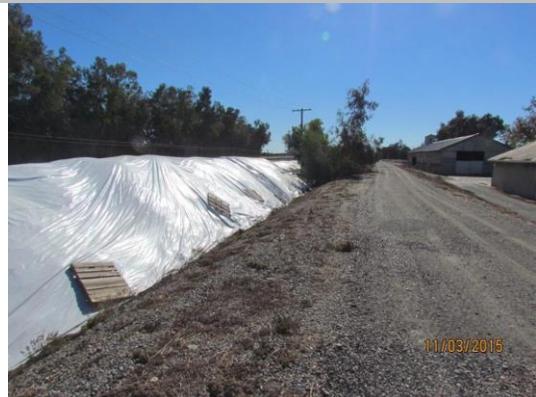
Photo 1 of 1 : SP_2016_LD0003_27_75_20160324_00050.jpg

View of the feed product stored along the landside toe.

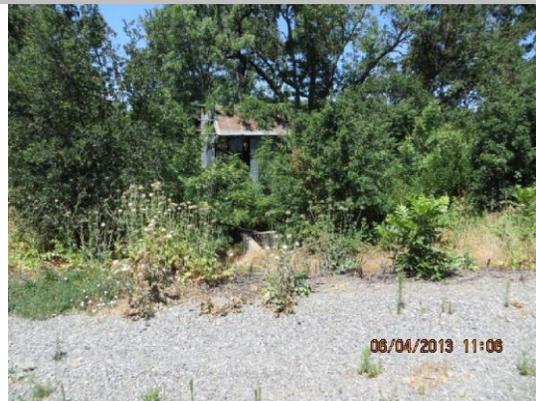
Photo 1 of 2 : UCIP_SP_2016_14664_24162.jpg

Pumphouse and 7'X12' concrete box on WS slope.

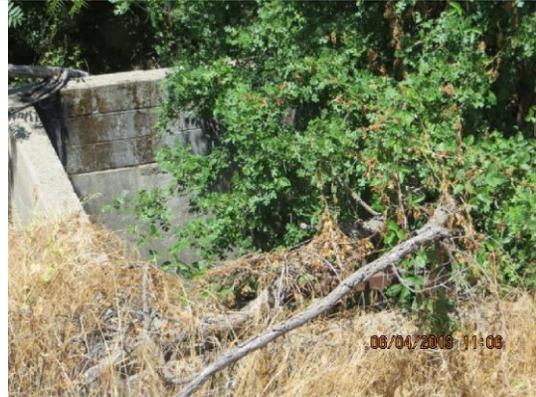
Photo 2 of 2 : UCIP_SP_2016_14664_24161.jpg

7'X12' Concrete box with flap gate and slide gate on WS slope.

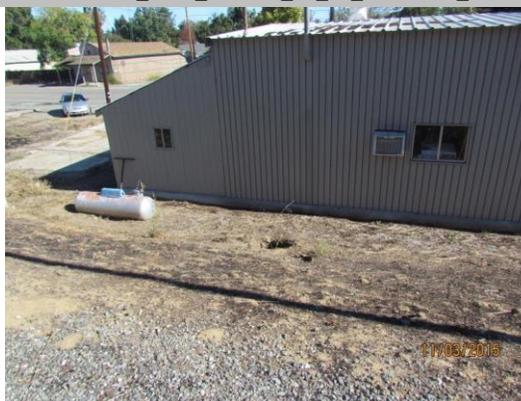
Photo 1 of 1 : SP_2016_LD0003_27_76_20160324_00051.jpg

View of the burned out stump hole along the landside toe.

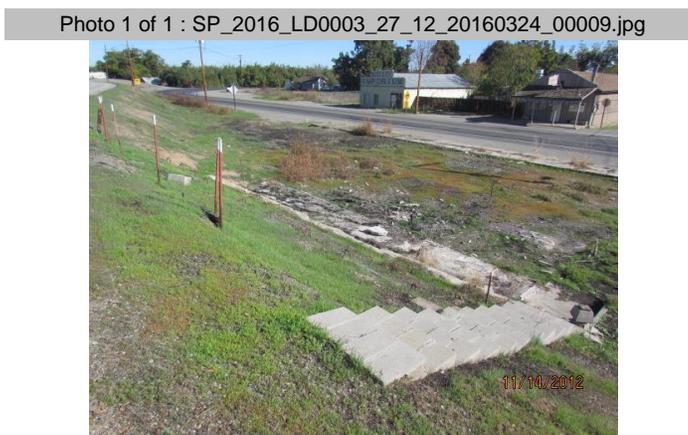
LM Start	6.63	Rating **	M	Issue No.	12
LM End	6.63	Issue Type +	Ma	Location *	LS
Category	Earthen Levee		GPS Latitude/Longitude		
			Start	End	
Item	Slope Stability		39.463366 °	39.463366 °	
			-121.992586 °	-121.992586 °	
DWR ID	DWR_LD0003_01_f_2012_12				
Comment Code					
S1 : Repair slope instability.					
Inspector Comment					
Building has burned down.

View of concrete stairs & foundation along the slope of the levee.

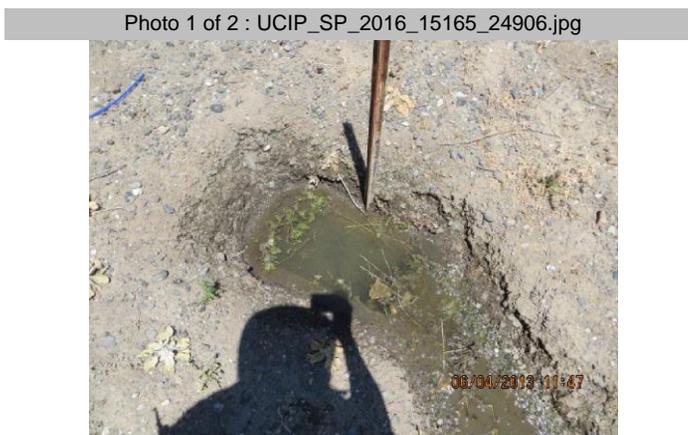
LM Start	6.72	Rating **	M	Issue No.	102
LM End	6.72	Issue Type +	En	Location *	LS
Category	Supplemental		GPS Latitude/Longitude		
			Start	End	
Item	DWR UCIP Field Study		39.464596 °	39.464596 °	
			-121.991850 °	-121.991850 °	
DWR ID					
Comment Code					
Inspector Comment					
FS_ID:15165 DS_ID:23154 EP_NO: 13972 Repair Type: Non-Urgent Crossing Status: Found UCIP Comments: Pipe leaking on LS toe. FIELD_STRUCT_DESC: 1-inch steel waterline service through the levee at an unknown depth below the crown. Meter and siphon valve in concrete box at LS toe. (Permit No. 13972, 1984) FS Date: 6/4/2013

Christy box on LS toe with siphon breaker and meter.

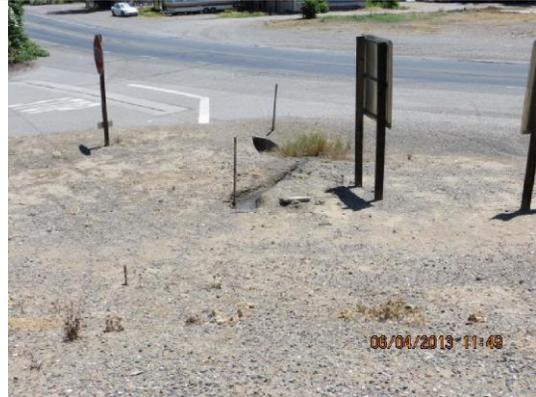
Photo 2 of 2 : UCIP_SP_2016_15165_24905.jpg

Pipe leaking at LS toe.

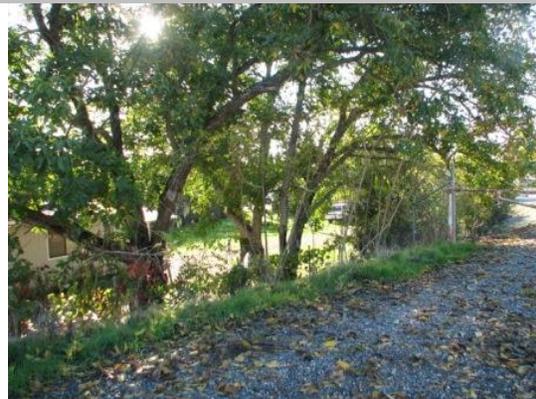
Photo 1 of 1 : SP_2016_LD0003_27_35_20160324_00019.jpg

View of the trees that are hanging over the landside slope of the levee.

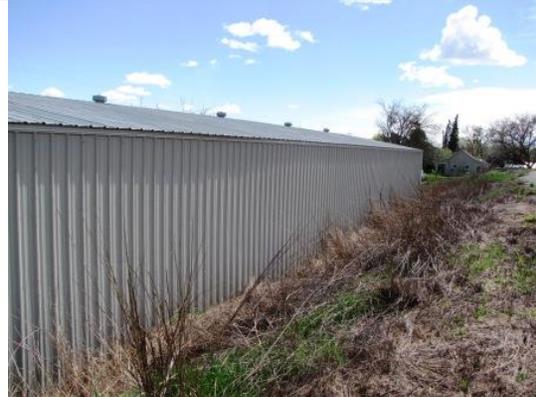
Photo 1 of 1 : SP_2016_LD0003_27_42_20160324_00021.jpg

View of the building along the L/S toe.

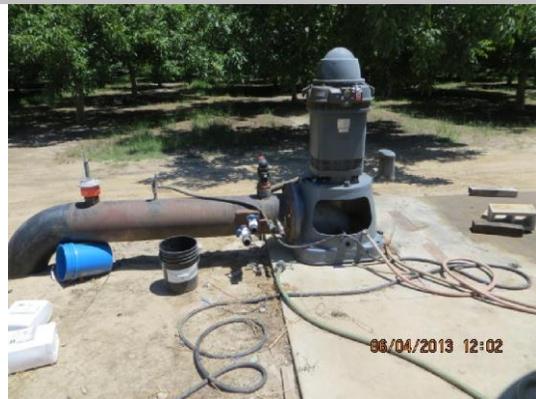
Photo 1 of 2 : UCIP_SP_2016_14686_24184.jpg

Pump located on LS toe next to concrete distribution box.

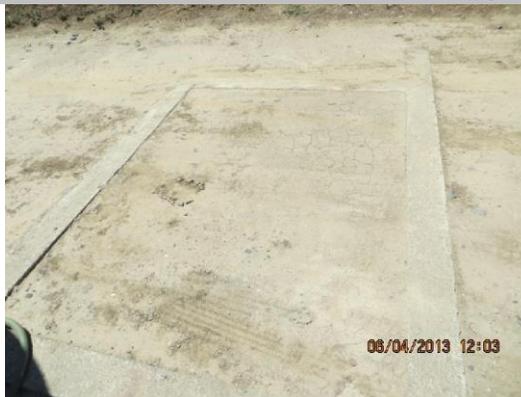
Photo 2 of 2 : UCIP_SP_2016_14686_24183.jpg

Soil filled concrete distribution box on LS toe.

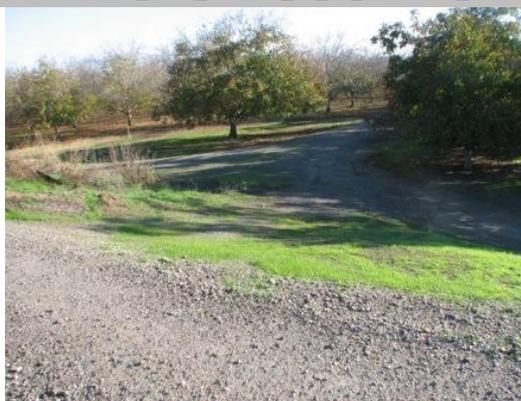
Photo 1 of 1 : SP_2016_LD0003_27_14_20160324_00011.jpg

Vehicle erosion along the slope.

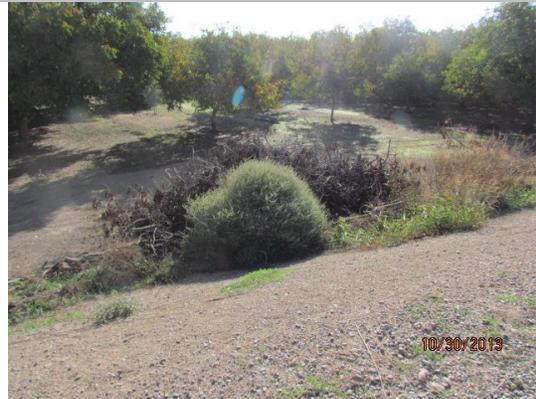
Photo 1 of 1 : SP_2016_LD0003_27_61_20160324_00037.jpg

View of the pruning along the landside toe.

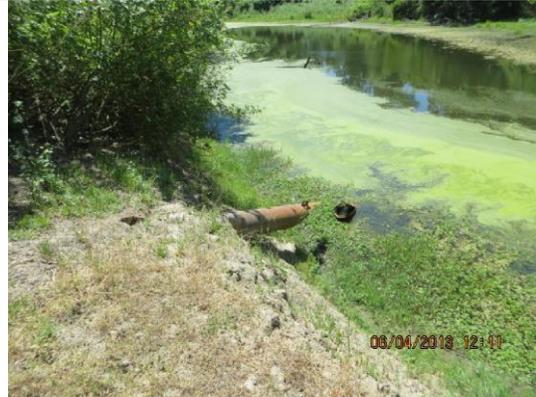
Photo 1 of 2 : UCIP_SP_2016_14687_24187.jpg

Pipe visible at pond off WS toe.

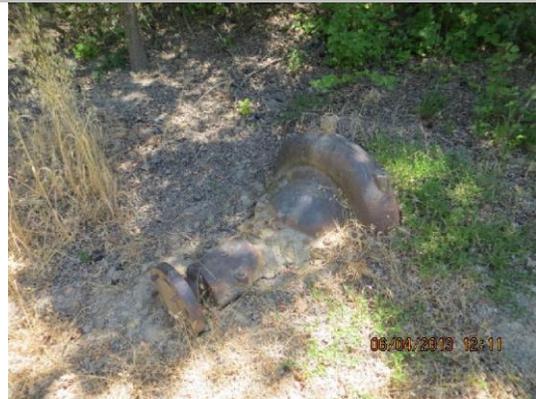
Photo 2 of 2 : UCIP_SP_2016_14687_24186.jpg

Pump visible off WS toe, next to pond.

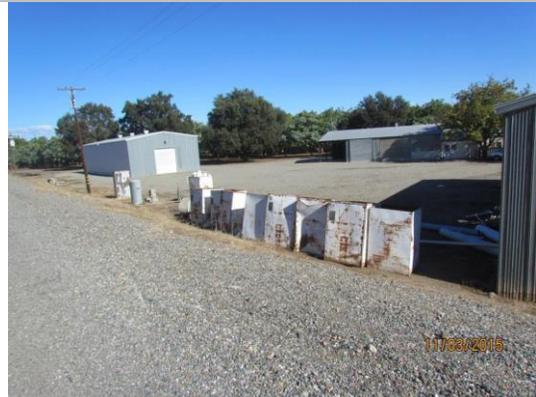
Photo 1 of 1 : SP_2016_LD0003_27_77_20160324_00052.jpg

View of the metal boxes along the landside toe.

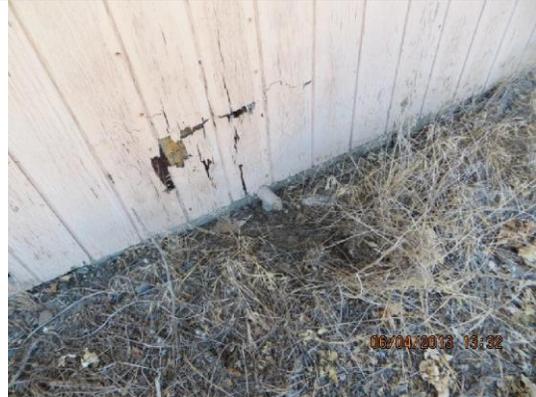
Photo 1 of 2 : UCIP_SP_2016_14688_24190.jpg

Pipe at side of building on WS shoulder.

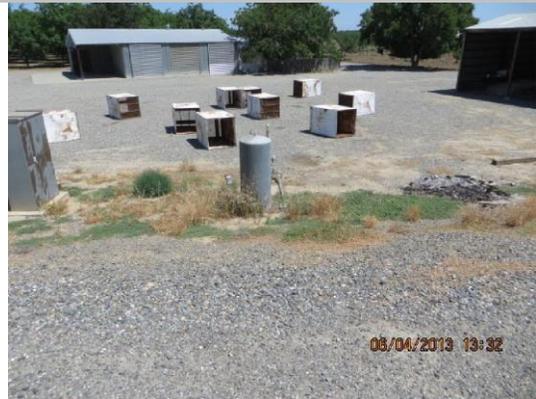
Photo 2 of 2 : UCIP_SP_2016_14688_24189.jpg

Water tank, pump, and well head on LS toe.

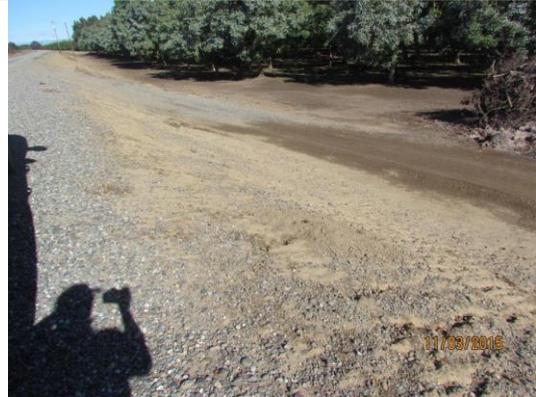
Photo 1 of 1 : SP_2016_LD0003_27_78_20160324_00053.jpg

View of the rodent holes along the landside slope.

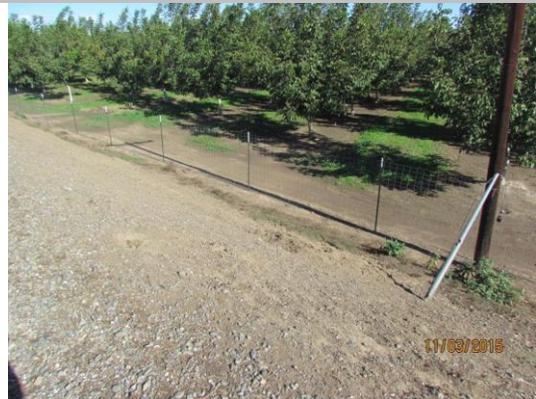
Photo 1 of 1 : SP_2016_LD0003_27_79_20160324_00054.jpg

View of the rodent holes along the landside slope.

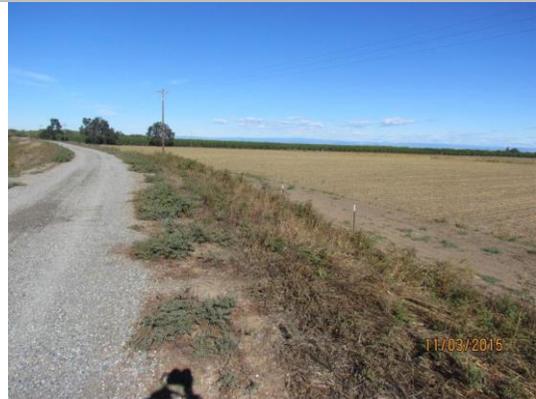
Photo 1 of 1 : SP_2016_LD0003_27_81_20160324_00056.jpg

View of the vegetation along the landside slope.

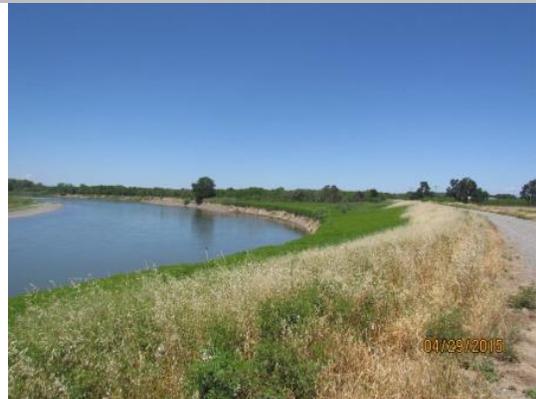
Photo 1 of 4 : SP_2016_LD0003_27_50_20160324_00027.jpg

View of erosion along the waterside toe. Same site as the USACE erosion issue.

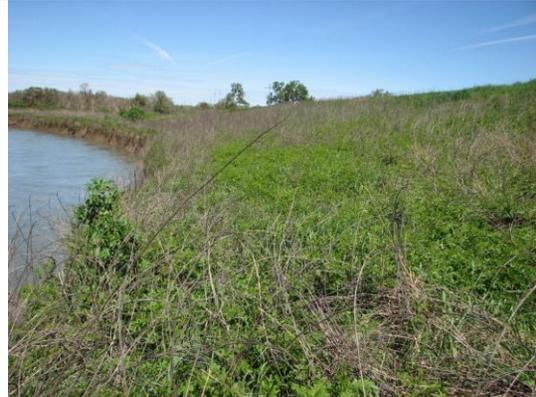
Photo 2 of 4 : SP_2016_LD0003_27_50_20160411_00101.jpg

View of erosion along the waterside toe. Same site as the USACE erosion issue. Photo 3/25/2016

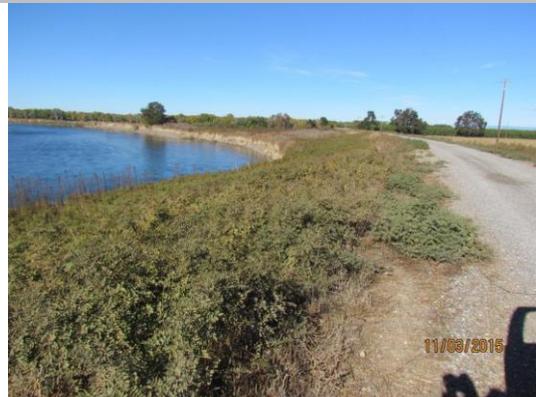
Photo 4 of 4 : SP_2016_LD0003_27_50_20160324_00028.jpg

View of the erosion along the waterside toe. Same site as the USACE erosion issue.

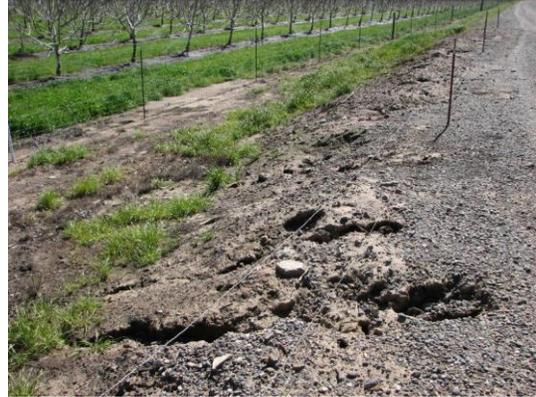
Photo 1 of 1 : SP_2016_LD0003_27_87_20160405_00100.jpg

Erosion ruts on l/s slope

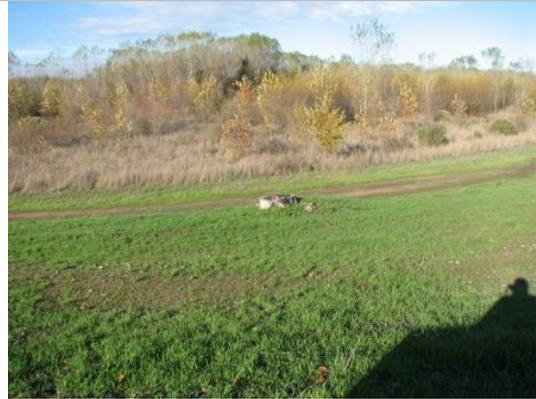
Photo 1 of 1 : SP_2016_LD0003_27_29_20160324_00017.jpg

View of the stump along the toe.

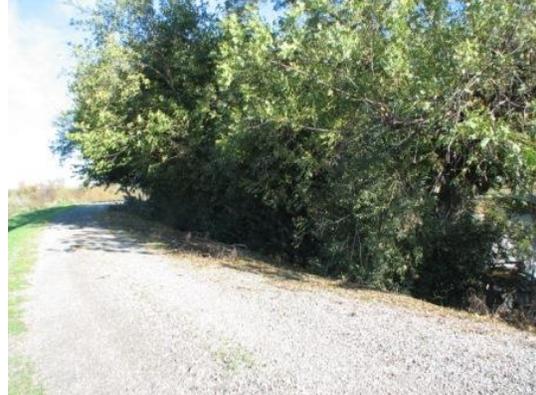
Photo 1 of 1 : SP_2016_LD0003_27_4_20160324_00002.jpg

View of the trees along the slope.

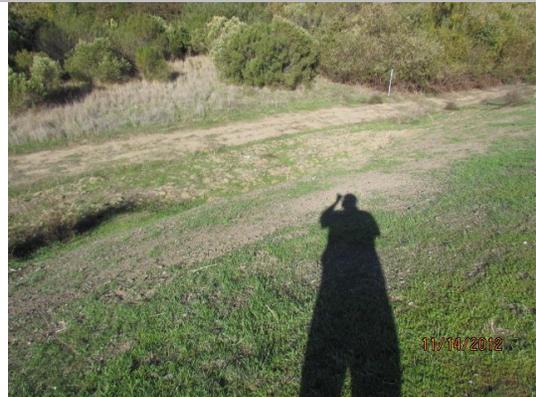
Photo 1 of 1 : SP_2016_LD0003_27_6_20160324_00003.jpg

View of the vertical cut along the w/s toe.
