**Flood Control Project Maintenance
Levee Inspections**

Maintenance Issue Types Only, Levee Inspection Report By Mile - Fall 2015

Levee District No. 0003 (Glenn County)

Waterway	Bank	Unit Miles	Inspection Start/End	Inspector
Unit No. 01 Glenn County Sacramento River	Left	11.97	11/03/2015 11/03/2015	Bob Duffey

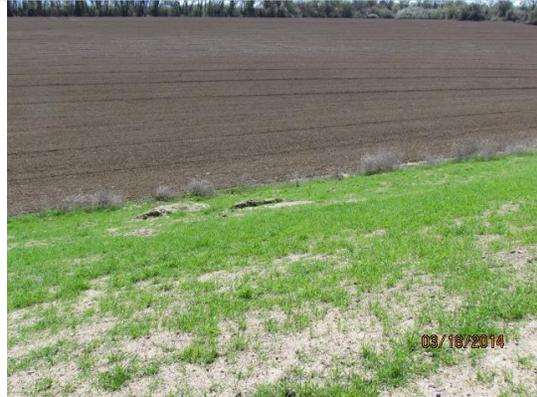
Photo 1 of 1 : FA_2015_LD0003_27_55_20150910_00025.jpg

LM Start	0.69	Rating **	M	Issue No.	55
LM End	0.69	Issue Type +	Ma	Location *	WS
Category	Earthen Levee		GPS Latitude/Longitude		
			Start	End	
Item	Animal Control		39.388716 °	39.388716 °	
			-121.997774 °	-121.997774 °	
DWR ID	DWR_LD0003_01_s_2014_55				
Action/Comments					
Exterminate rodents and backfill and compact or grout burrows.

View of the rodent activity along the w/s slope.

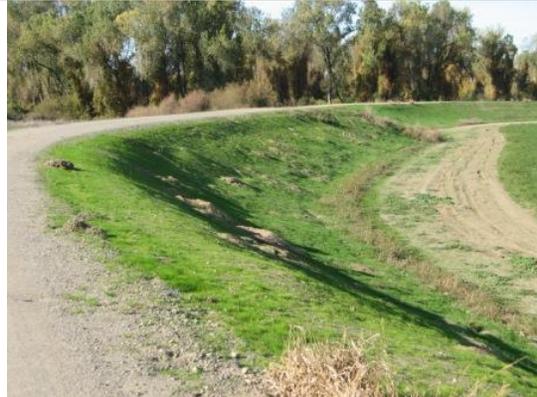
Photo 1 of 1 : FA_2015_LD0003_27_3_20150910_00002.jpg

LM Start	0.71	Rating **	U	Issue No.	3
LM End	0.75	Issue Type +	Ma	Location *	LS
Category	Earthen Levee		GPS Latitude/Longitude		
			Start	End	
Item	Animal Control		39.388578 °	39.388323 °	
			-121.997987 °	-121.998727 °	
DWR ID	DWR_LD0003_01_s_2012_3				
Action/Comments					
No rodents visible, but rodent burrows visible; need to backfill and compact or grout burrows.

View of squirrel holes along the slope.

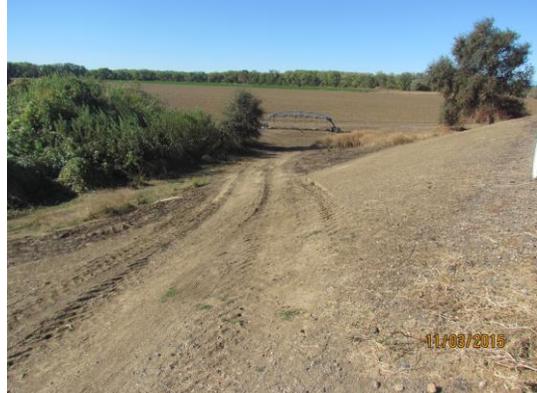
Photo 1 of 1 : FA_2015_LD0003_27_44_20151118_00049.jpg

LM Start	0.78	Rating **	M	Issue No.	44
LM End	0.78	Issue Type +	Ma	Location *	WS
Category	Earthen Levee		GPS Latitude/Longitude		
			Start	End	
Item	Slope Stability		39.388440 °	39.388440 °	
			-121.999175 °	-121.999175 °	
DWR ID	DWR_LD0003_01_f_2015_44				
Action/Comments					
Repair the levee slope damaged by vehicle traffic and prevent access where possible. Inspector Comments: Repair the waterside slope damage caused by vehicle traffic.

View of the vehicle erosion along the waterside slope.

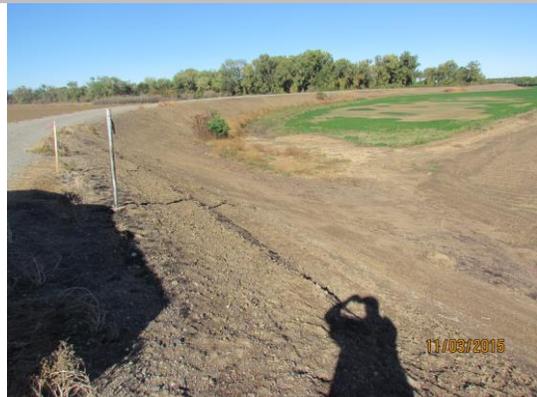
Photo 1 of 1 : FA_2015_LD0003_27_49_20151118_00050.jpg

LM Start	0.79	Rating **	M	Issue No.	49
LM End	0.79	Issue Type +	Ma	Location *	LS
Category	Earthen Levee		GPS Latitude/Longitude		
			Start	End	
Item	Slope Stability		39.388508 °	39.388508 °	
			-121.999407 °	-121.999407 °	
DWR ID	DWR_LD0003_01_f_2015_49				
Action/Comments					
Repair the levee slope damaged by vehicle traffic and prevent access where possible. Inspector Comments: Repair the landside slope damaged by vehicle traffic.

View of the landside slope erosion caused by vehicle traffic.

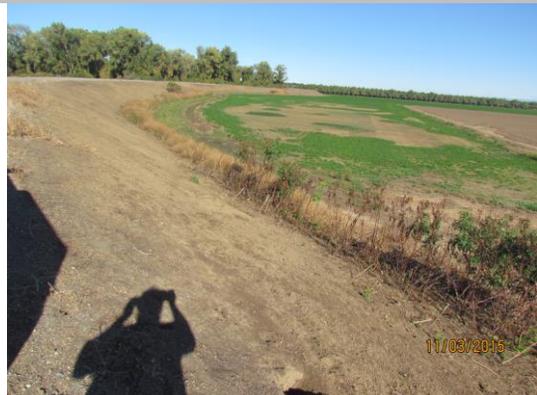
Photo 1 of 1 : FA_2015_LD0003_27_51_20151118_00051.jpg

LM Start	0.81	Rating **	U	Issue No.	51
LM End	0.91	Issue Type +	Ma	Location *	LS
Category	Earthen Levee		GPS Latitude/Longitude		
			Start	End	
Item	Animal Control		39.388690 °	39.389867 °	
			-121.999820 °	-122.000585 °	
DWR ID	DWR_LD0003_01_f_2015_51				
Action/Comments					
No rodents visible, but rodent burrows visible; need to backfill and compact or grout burrows. Inspector Comments: Repair the rodent holes along the landside slope.

View of the rodent holes along the landside slope.

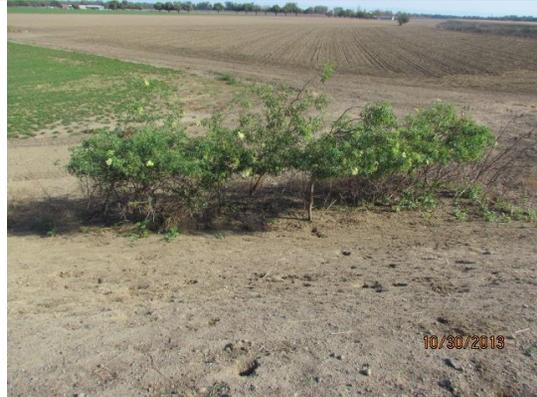
Photo 1 of 1 : FA_2015_LD0003_27_67_20150910_00033.jpg

LM Start	0.82	Rating **	M	Issue No.	67
LM End	0.82	Issue Type +	Ma	Location *	LS
Category	Earthen Levee		GPS Latitude/Longitude		
			Start	End	
Item	Vegetation		39.388725 °	39.388725 °	
			-121.999870 °	-121.999870 °	
DWR ID	DWR_LD0003_01_f_2013_67				
Action/Comments					
Elderberries are blocking visibility and flood fight capability.

View of the elderberries along the landside toe.

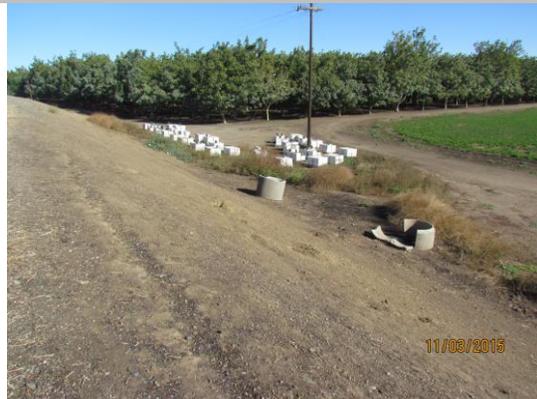
Photo 1 of 1 : FA_2015_LD0003_27_52_20151118_00052.jpg

LM Start	1.21	Rating **	M	Issue No.	52
LM End	1.21	Issue Type +	Ma	Location *	LS
Category	Earthen Levee		GPS Latitude/Longitude		
			Start	End	
Item	Animal Control		39.394010 °	39.394010 °	
			-122.000977 °	-122.000977 °	
DWR ID	DWR_LD0003_01_f_2015_52				
Action/Comments					
No rodents visible, but rodent burrows visible; need to backfill and compact or grout burrows. Inspector Comments: Repair the rodent holes along the landside slope.

View of the rodent holes along the landside slope.

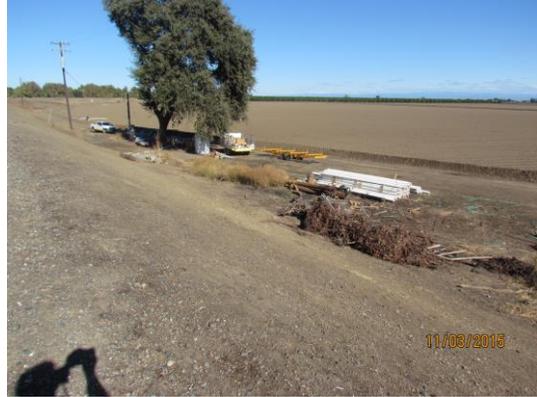
Photo 1 of 1 : FA_2015_LD0003_27_54_20151118_00055.jpg

LM Start	2.96	Rating **	U	Issue No.	54
LM End	3.09	Issue Type +	Ma	Location *	LS
Category	Earthen Levee		GPS Latitude/Longitude		
			Start	End	
Item	Animal Control		39.412613 °	39.414392 °	
			-121.991278 °	-121.992257 °	
DWR ID	DWR_LD0003_01_f_2015_54				
Action/Comments					
Exterminate rodents and backfill and compact or grout burrows. Inspector Comments: Implement rodent control measures and repair rodent damage on LS slope.

View of the rodent holes along the landside slope.

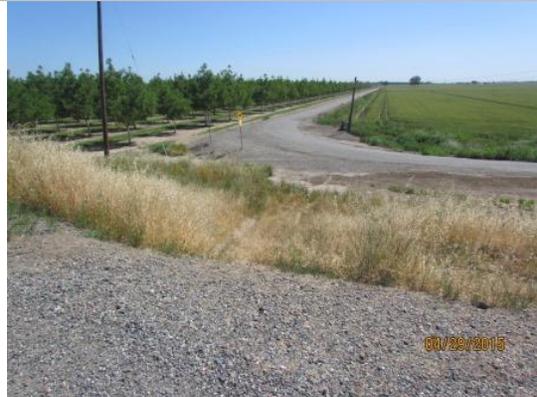
Photo 1 of 1 : FA_2015_LD0003_27_9_20150910_00006.jpg

LM Start	3.39	Rating **	M	Issue No.	9
LM End	3.39	Issue Type +	Ma	Location *	LS
Category	Earthen Levee		GPS Latitude/Longitude		
			Start	End	
Item	Slope Stability		39.418382 °	39.418382 °	
			-121.992480 °	-121.992480 °	
DWR ID	DWR_LD0003_01_s_2012_9				
Action/Comments					
Repair the levee slope damaged by vehicle traffic and prevent access where possible. Inspector Comments: Repair the erosion along the landside slope and prevent vehicle access

View of the vehicle erosion along the landside slope.

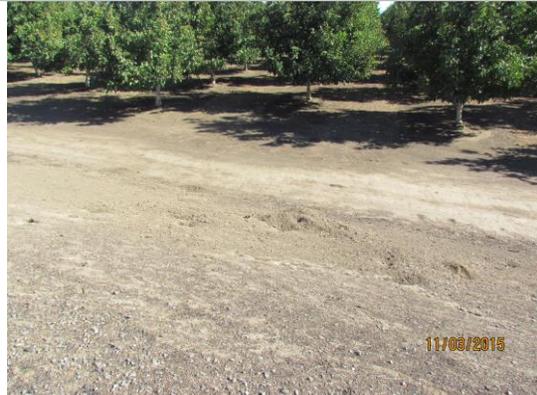
Photo 1 of 1 : FA_2015_LD0003_27_58_20151118_00057.jpg

LM Start	3.41	Rating **	U	Issue No.	58
LM End	3.48	Issue Type +	Ma	Location *	LS
Category	Earthen Levee		GPS Latitude/Longitude		
			Start	End	
Item	Animal Control		39.418687 °	39.419762 °	
			-121.992422 °	-121.992307 °	
DWR ID	DWR_LD0003_01_f_2015_58				
Action/Comments					
No rodents visible, but rodent burrows visible; need to backfill and compact or grout burrows. Inspector Comments: Implement rodent control measures and repair rodent damage on LS slope.

View of the rodent. Holes along the landside slope.

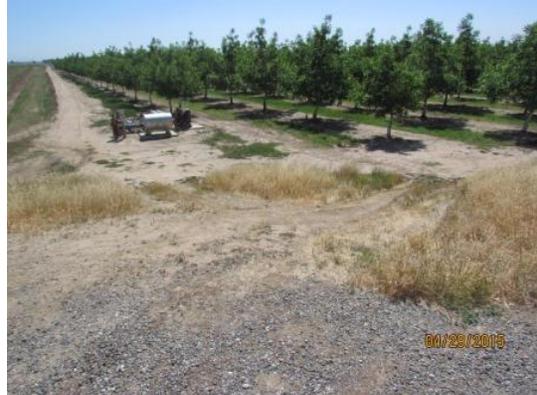
Photo 1 of 1 : FA_2015_LD0003_27_19_20150910_00010.jpg

LM Start	3.76	Rating **	M	Issue No.	19
LM End	3.76	Issue Type +	Ma	Location *	LS
Category	Earthen Levee		GPS Latitude/Longitude		
			Start	End	
Item	Slope Stability		39.423747 °	39.423747 °	
			-121.991667 °	-121.991667 °	
DWR ID	DWR_LD0003_01_s_2012_19				
Action/Comments					
Repair the levee slope damaged by vehicle traffic and prevent access where possible. Inspector Comments: Repair the vehicle erosion on the landside slope.

View of the vehicle erosion along the landside slope.

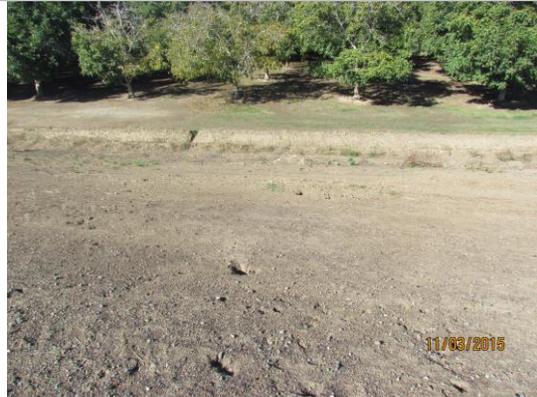
Photo 1 of 1 : FA_2015_LD0003_27_59_20151118_00058.jpg

LM Start	3.88	Rating **	U	Issue No.	59
LM End	3.88	Issue Type +	Ma	Location *	WS
Category	Earthen Levee		GPS Latitude/Longitude		
			Start	End	
Item	Animal Control		39.425162 °	39.425162 °	
			-121.990528 °	-121.990528 °	
DWR ID	DWR_LD0003_01_f_2015_59				
Action/Comments					
No rodents visible, but rodent burrows visible; need to backfill and compact or grout burrows. Inspector Comments: Repair the rodent holes along the landside slope.

View of the rodent holes along the landside slope.

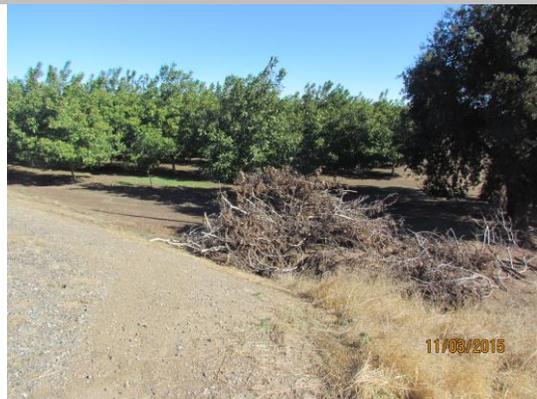
Photo 1 of 1 : FA_2015_LD0003_27_66_20151118_00061.jpg

LM Start	4.33	Rating **	M	Issue No.	66
LM End	4.33	Issue Type +	Ma	Location *	LS
Category	Earthen Levee		GPS Latitude/Longitude		
			Start	End	
Item	Encroachments		39.430927 °	39.430927 °	
			-121.987142 °	-121.987142 °	
DWR ID	DWR_LD0003_01_f_2015_66				
Action/Comments					
Prunings Inspector Comments: Remove prunings from LS toe.

View of the prunings along the landside toe.

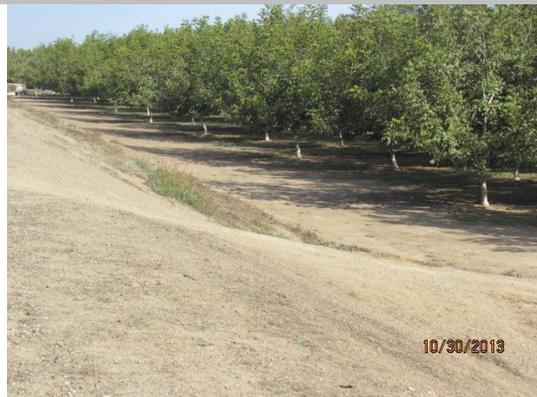
Photo 1 of 1 : FA_2015_LD0003_27_64_20150910_00031.jpg

LM Start	4.63	Rating **	U	Issue No.	64
LM End	4.68	Issue Type +	Ma	Location *	LS
Category	Earthen Levee		GPS Latitude/Longitude		
			Start	End	
Item	Animal Control		39.435205 °	39.435855 °	
			-121.988097 °	-121.988252 °	
DWR ID	DWR_LD0003_01_f_2013_64				
Action/Comments					
No rodents visible, but rodent burrows visible; need to backfill and compact or grout burrows. Inspector Comments: Implement rodent control measures and repair rodent damage on LS slope.

View of the rodent activity along the landside slope.

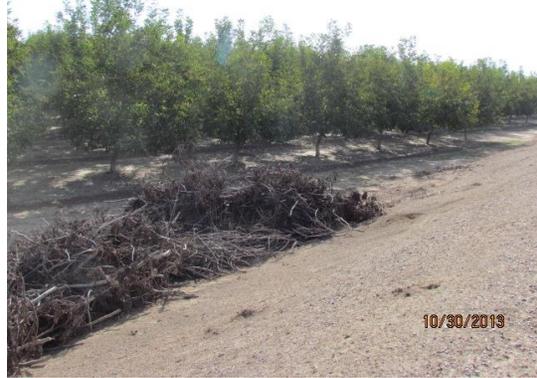
Photo 1 of 1 : FA_2015_LD0003_27_63_20150910_00030.jpg

LM Start	4.66	Rating **	M	Issue No.	63
LM End	4.66	Issue Type +	Ma	Location *	LS
Category	Earthen Levee		GPS Latitude/Longitude		
			Start	End	
Item	Encroachments		39.435701 °	39.435701 °	
			-121.988189 °	-121.988189 °	
DWR ID	DWR_LD0003_01_f_2013_63				
Action/Comments					
Prunings

View of the prunings along the landside toe.

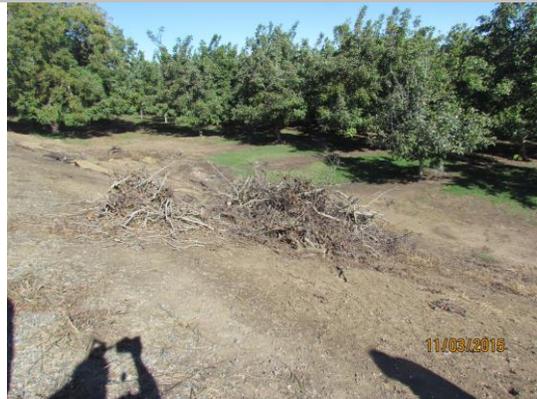
Photo 1 of 1 : FA_2015_LD0003_27_69_20151118_00062.jpg

LM Start	5.06	Rating **	M	Issue No.	69
LM End	5.06	Issue Type +	Ma	Location *	LS
Category	Earthen Levee		GPS Latitude/Longitude		
			Start	End	
Item	Encroachments		39.441057 °	39.441057 °	
			-121.990458 °	-121.990458 °	
DWR ID	DWR_LD0003_01_f_2015_69				
Action/Comments					
Prunings Inspector Comments: Remove prunings from LS slope.

View of the prunings along the landside slope.

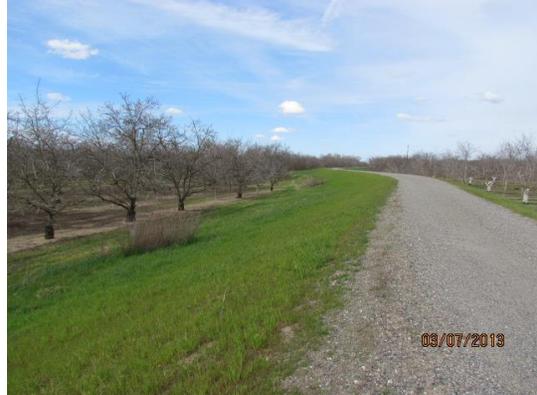
Photo 1 of 2 : FA_2015_LD0003_27_21_20150910_00011.jpg

LM Start	5.06	Rating **	U	Issue No.	21
LM End	5.25	Issue Type +	Ma	Location *	LS
Category	Earthen Levee			GPS Latitude/Longitude	
				Start	End
Item	Animal Control			39.441128 °	39.443793 °
				-121.990475 °	-121.991297 °
DWR ID	DWR_LD0003_01_f_2015_21				
Action/Comments					
No rodents visible, but rodent burrows visible; need to backfill and compact or grout burrows. Inspector Comments: Remove the rodent holes along the landside slope.

View of no rodent activity.

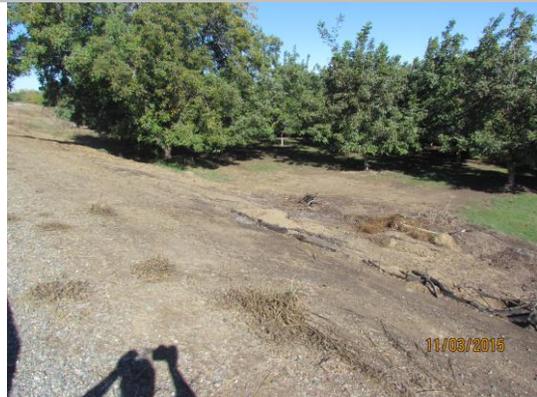
Photo 2 of 2 : FA_2015_LD0003_27_21_20151118_00063.jpg

LM Start	5.06	Rating **	U	Issue No.	21 (cont)
LM End	5.25	Issue Type +	Ma	Location *	LS

View of the rodent holes along the landside slope.

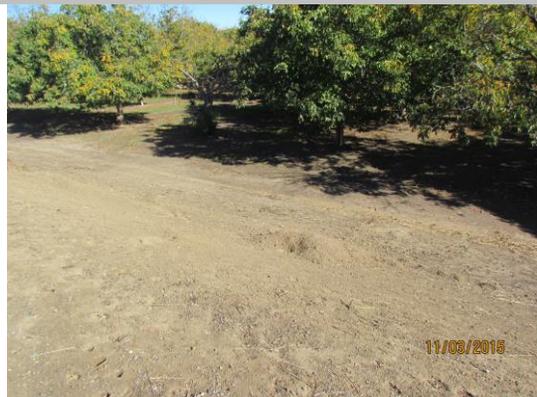
Photo 1 of 1 : FA_2015_LD0003_27_70_20151118_00064.jpg

LM Start	5.39	Rating **	U	Issue No.	70
LM End	5.39	Issue Type +	Ma	Location *	LS
Category	Earthen Levee			GPS Latitude/Longitude	
				Start	End
Item	Animal Control			39.445808 °	39.445808 °
				-121.991552 °	-121.991552 °
DWR ID	DWR_LD0003_01_f_2015_70				
Action/Comments					
No rodents visible, but rodent burrows visible; need to backfill and compact or grout burrows. Inspector Comments: Remove the rodent holes along the landside slope.

View of the rodent holes along the landside slope.

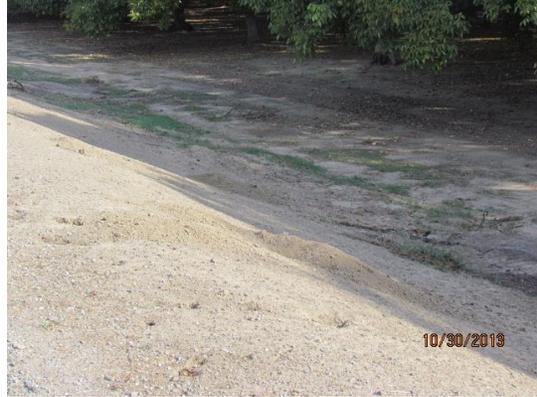
Photo 1 of 1 : FA_2015_LD0003_27_62_20150910_00029.jpg

View of the rodent holes along the landside slope.

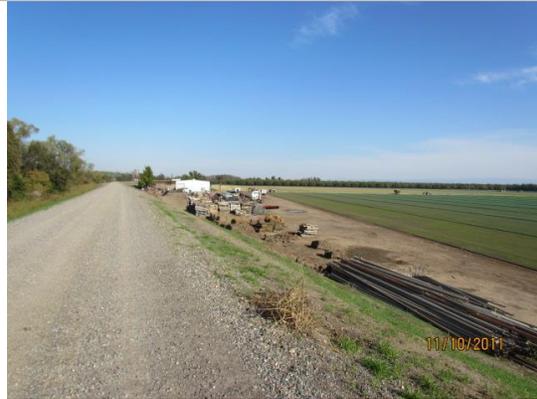
Photo 1 of 1 : FA_2015_LD0003_27_25_20150910_00012.jpg

LM Start	5.77	Rating **	M	Issue No.	25
LM End	5.88	Issue Type +	Ma	Location *	LS
Category	Earthen Levee			GPS Latitude/Longitude	
				Start	End
Item	Encroachments			39.451293 °	39.452872 °
				-121.992370 °	-121.992897 °
DWR ID	DWR_LD0003_01_s_2012_25				
Action/Comments					
Abandoned vehicles

View of the equipment along the L/S toe.

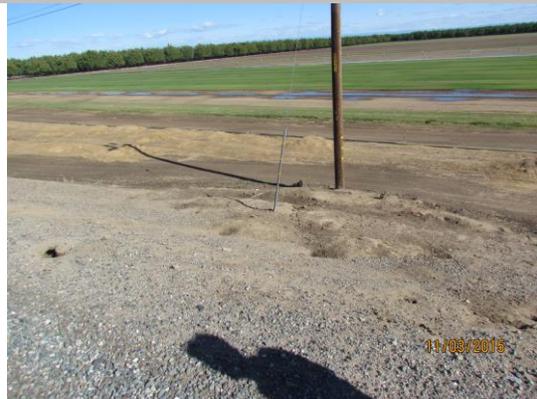
Photo 1 of 1 : FA_2015_LD0003_27_71_20151118_00065.jpg

LM Start	6.06	Rating **	U	Issue No.	71
LM End	6.06	Issue Type +	Ma	Location *	LS
Category	Earthen Levee			GPS Latitude/Longitude	
				Start	End
Item	Animal Control			39.455313 °	39.455313 °
				-121.993712 °	-121.993712 °
DWR ID	DWR_LD0003_01_f_2015_71				
Action/Comments					
No rodents visible, but rodent burrows visible; need to backfill and compact or grout burrows. Inspector Comments: Repair rodent damage on LS slope.

View of the rodent holes along the landside slope.

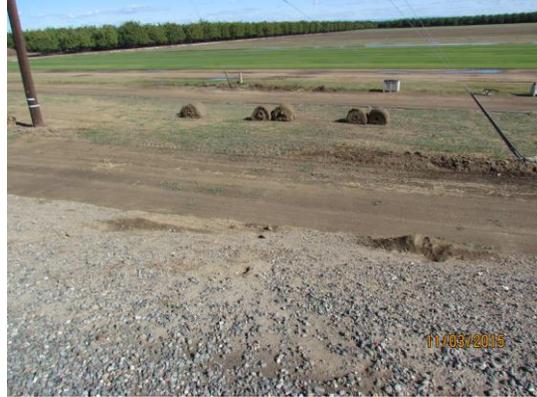
Photo 1 of 1 : FA_2015_LD0003_27_72_20151118_00066.jpg

LM Start	6.11	Rating **	U	Issue No.	72
LM End	6.11	Issue Type +	Ma	Location *	LS
Category	Earthen Levee		GPS Latitude/Longitude		
			Start	End	
Item	Animal Control		39.456018 °	39.456018 °	
			-121.993772 °	-121.993772 °	
DWR ID	DWR_LD0003_01_f_2015_72				
Action/Comments					
No rodents visible, but rodent burrows visible; need to backfill and compact or grout burrows. Inspector Comments: Repair rodent damage on LS slope

View of the rodent holes along the landside slope.

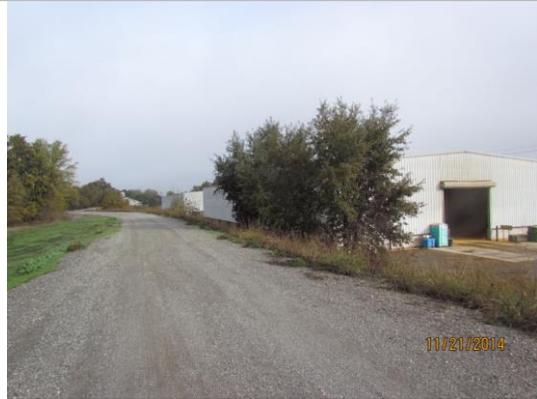
Photo 1 of 1 : FA_2015_LD0003_27_7_20150910_00005.jpg

LM Start	6.24	Rating **	M	Issue No.	7
LM End	6.38	Issue Type +	Ma	Location *	LS
Category	Earthen Levee		GPS Latitude/Longitude		
			Start	End	
Item	Trim / Thin Trees		39.457968 °	39.459955 °	
			-121.993712 °	-121.993512 °	
DWR ID	DWR_LD0003_01_s_2012_7				
Action/Comments					
Trim trees to at least five feet above ground level.

Trim the trees 5 feet for better visibility.

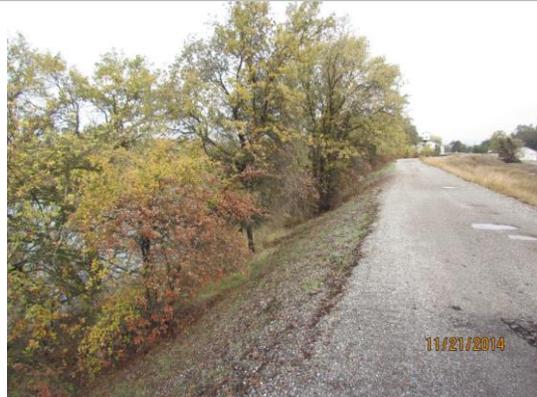
Photo 1 of 1 : FA_2015_LD0003_27_48_20150910_00023.jpg

LM Start	6.29	Rating **	M	Issue No.	48
LM End	6.38	Issue Type +	Ma	Location *	WS
Category	Earthen Levee		GPS Latitude/Longitude		
			Start	End	
Item	Trim / Thin Trees		39.458587 °	39.459912 °	
			-121.993777 °	-121.993592 °	
DWR ID	DWR_LD0003_01_s_2012_48				
Action/Comments					
Trim trees to at least five feet above ground level.

Trim the trees up 5 feet for better visibility.

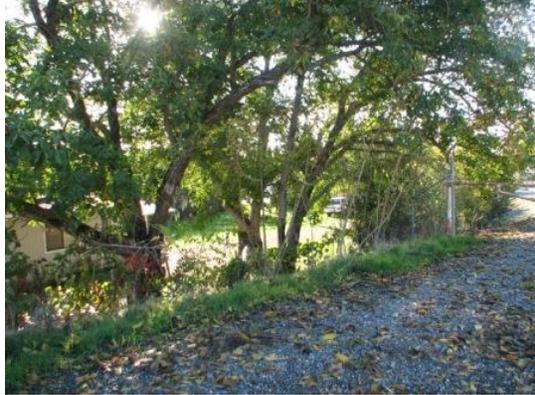
Photo 1 of 1 : FA_2015_LD0003_27_35_20150910_00018.jpg

View of the trees that are hanging over the landside slope of the levee.

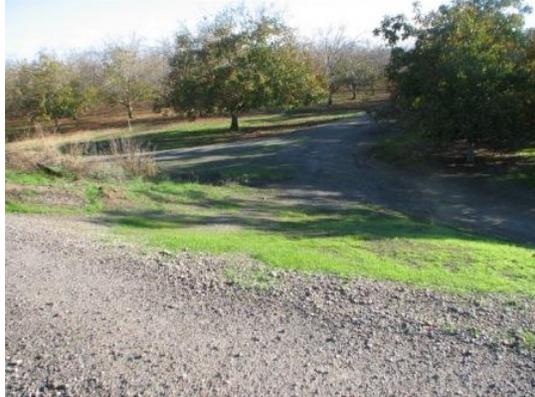
Photo 1 of 1 : FA_2015_LD0003_27_14_20150910_00009.jpg

LM Start	7.21	Rating **	M	Issue No.	14
LM End	7.21	Issue Type +	Ma	Location *	LS
Category	Earthen Levee		GPS Latitude/Longitude		
			Start	End	
Item	Slope Stability		39.471658 °	39.471658 °	
			-121.991245 °	-121.991245 °	
DWR ID	DWR_LD0003_01_s_2012_14				
Action/Comments					
Repair the levee slope damaged by vehicle traffic and prevent access where possible.

Vehicle erosion along the slope.

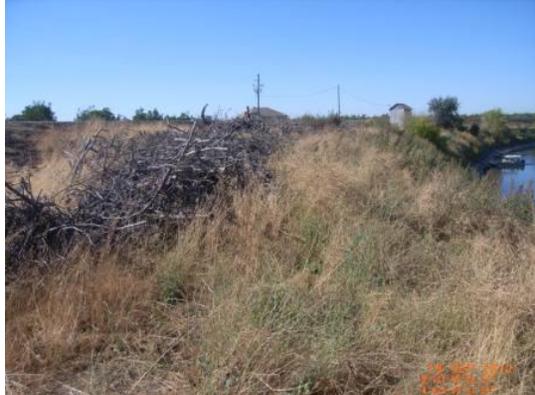
Photo 1 of 1 : FA_2015_LD0003_27_60_20150910_00027.jpg

LM Start	7.68	Rating **	M	Issue No.	60
LM End	7.68	Issue Type +	Ma	Location *	LS
Category	Earthen Levee		GPS Latitude/Longitude		
			Start	End	
Item	Encroachments		39.478464 °	39.478464 °	
			-121.990686 °	-121.990686 °	
DWR ID	DWR_LD0003_01_f_2013_60				
Action/Comments					
Prunings

View of the prunings along the landside toe.

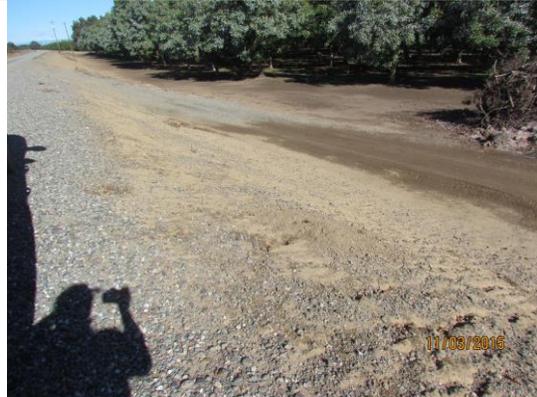
Photo 1 of 1 : FA_2015_LD0003_27_78_20151118_00074.jpg

LM Start	9.23	Rating **	M	Issue No.	78
LM End	9.23	Issue Type +	Ma	Location *	LS
Category	Earthen Levee		GPS Latitude/Longitude		
			Start	End	
Item	Animal Control		39.498897 °	39.498897 °	
			-121.986827 °	-121.986827 °	
DWR ID	DWR_LD0003_01_f_2015_78				
Action/Comments					
Exterminate rodents and backfill and compact or grout burrows. Inspector Comments: Repair rodent hole on LS shoulder.

View of the rodent holes along the landside slope.

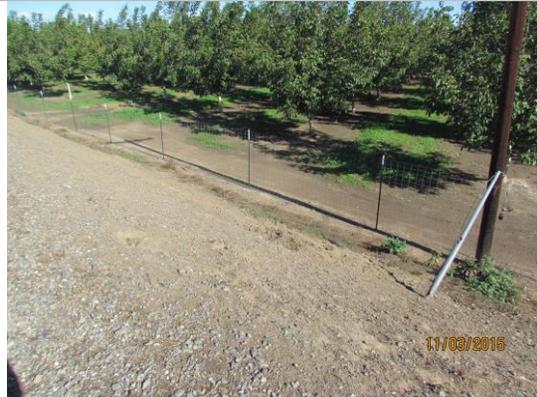
Photo 1 of 1 : FA_2015_LD0003_27_79_20151118_00075.jpg

LM Start	9.50	Rating **	U	Issue No.	79
LM End	9.50	Issue Type +	Ma	Location *	LS
Category	Earthen Levee		GPS Latitude/Longitude		
			Start	End	
Item	Animal Control		39.502698 °	39.502698 °	
			-121.985235 °	-121.985235 °	
DWR ID	DWR_LD0003_01_f_2015_79				
Action/Comments					
No rodents visible, but rodent burrows visible; need to backfill and compact or grout burrows. Inspector Comments: Repair rodent damage on LS slope.

View of the rodent holes along the landside slope.

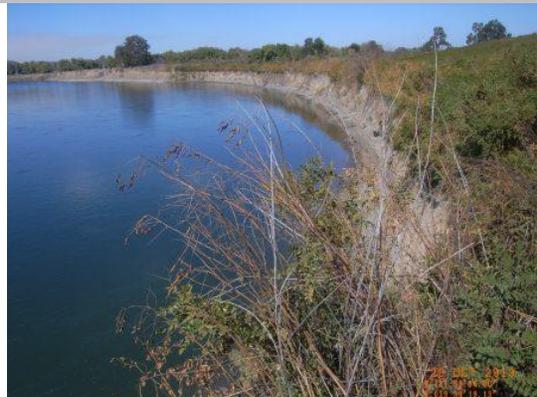
Photo 1 of 3 : USACE2013A_SAC_172-0_L_10.jpg

LM Start	9.61	Rating **	M	Issue No.	10
LM End	9.88	Issue Type +	Ma	Location *	WS
Category	Supplemental		GPS Latitude/Longitude		
			Start	End	
Item	2015 USACE Erosion Survey, DRAFT		39.504388 °	39.508117 °	
			-121.985301 °	-121.986562 °	
DWR ID					
Action/Comments					
Inspector Comments: 2007 - Getting close to the levee. Bank is clayey silt with clayey/silty toe. 2008 - Looks a little worse at the upstream end. 2009 - Some new erosion and slumping. 2010 - Some new erosion upstream of site, actively eroding at low flow. New bank swallow colony noted. 2011 - Significant erosion since last year, with an estimated 10 to 15 feet of berm lost. Large sections of the bank have slumped off. 2012 - Part of the site appears to be stabilizing, but still minor slumping in other locations. 2013 - Minor new erosion at toe. 2015: Last observed in 2013. [2015 Site ID: SAC_172-0_L]

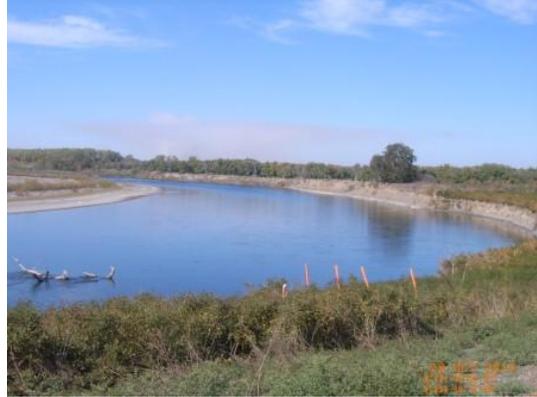
Photo 2 of 3 : USACE2013A_SAC_172-0_L_3.jpg

LM Start	9.61	Rating **	M	Issue No.	10 (cont)
LM End	9.88	Issue Type +	Ma	Location *	WS
Category	Supplemental			GPS Latitude/Longitude	
			Start	End	
Item	2015 USACE Erosion Survey, DRAFT			39.504388 °	39.508117 °
DWR ID				-121.985301 °	-121.986562 °
Action/Comments					
Inspector Comments: 2007 - Getting close to the levee. Bank is clayey silt with clayey/silty toe. 2008 - Looks a little worse at the upstream end. 2009 - Some new erosion and slumping. 2010 - Some new erosion upstream of site, actively eroding at low flow. New bank swallow colony noted. 2011 - Significant erosion since last year, with an estimated 10 to 15 feet of berm lost. Large sections of the bank have slumped off. 2012 - Part of the site appears to be stabilizing, but still minor slumping in other locations. 2013 - Minor new erosion at toe. 2015: Last observed in 2013. [2015 Site ID: SAC_172-0_L]

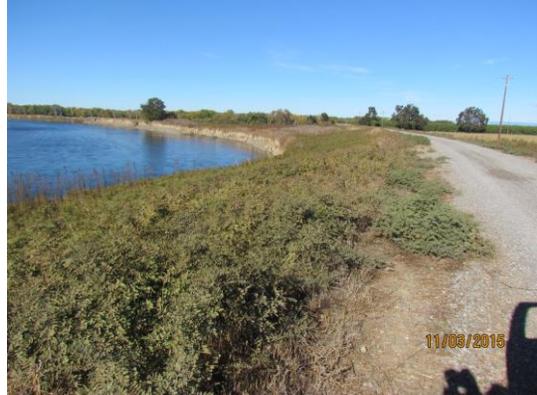
Photo 1 of 1 : FA_2015_LD0003_27_80_20151118_00077.jpg

View of the vegetation along the waterside slope and toe.

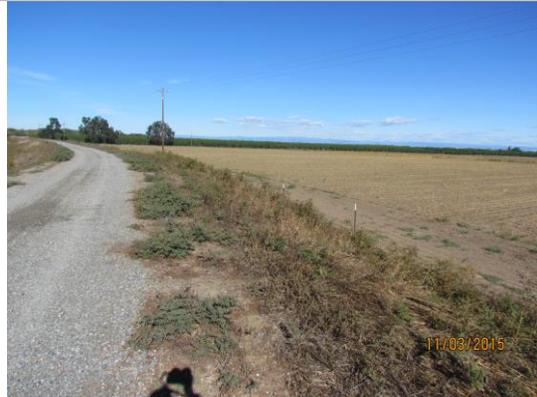
Photo 1 of 1 : FA_2015_LD0003_27_81_20151118_00078.jpg

View of the vegetation along the landside slope.

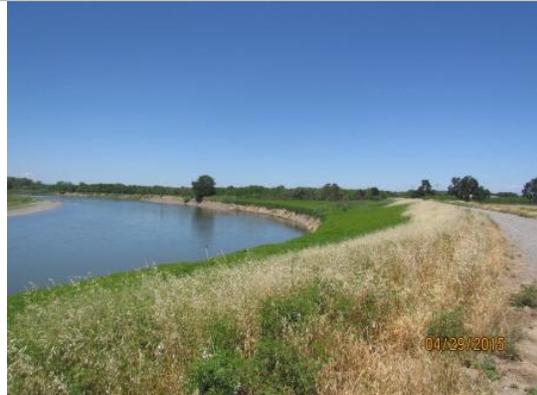
Photo 1 of 2 : FA_2015_LD0003_27_50_20150910_00024.jpg

LM Start	9.70	Rating **	U	Issue No.	50
LM End	9.70	Issue Type +	Ma	Location *	WS
Category	Earthen Levee		GPS Latitude/Longitude		
			Start	End	
Item	Erosion / Bank Caving		39.505435 °	39.505435 °	
			-121.984172 °	-121.984172 °	
DWR ID	DWR_LD0003_01_f_2014_50				
Action/Comments					
Schedule repair of erosion site prior to the next inspection. Inspector Comments: Repair the erosion along the waterside toe.

View of erosion along the waterside toe. Same site as the USACE erosion issue.

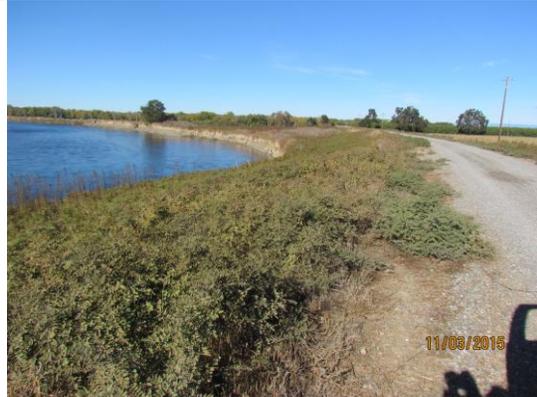
Photo 2 of 2 : FA_2015_LD0003_27_50_20151118_00076.jpg

LM Start	9.70	Rating **	U	Issue No.	50 (cont)
LM End	9.70	Issue Type +	Ma	Location *	WS
Category	Earthen Levee			GPS Latitude/Longitude	
				Start	End
Item	Erosion / Bank Caving			39.505435 °	39.505435 °
				-121.984172 °	-121.984172 °
DWR ID	DWR_LD0003_01_f_2014_50				
Action/Comments					
Schedule repair of erosion site prior to the next inspection. Inspector Comments: Repair the erosion along the waterside toe.

View of the erosion along the waterside toe. Same site as the USACE erosion issue.

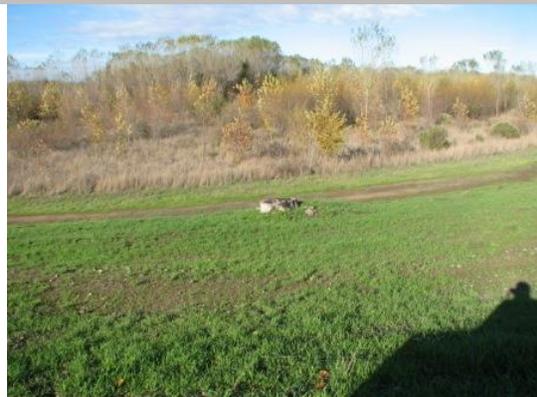
Photo 1 of 1 : FA_2015_LD0003_27_29_20150910_00016.jpg

View of the stump along the toe.

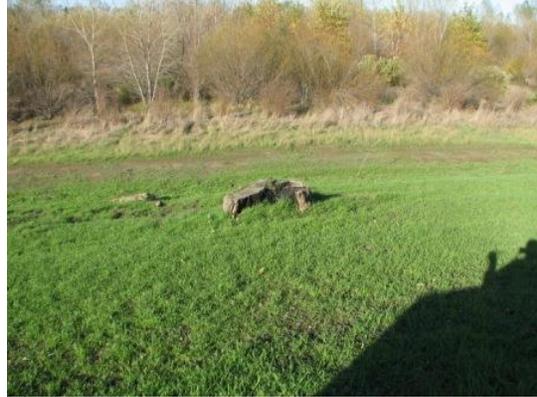
Photo 1 of 1 : FA_2015_LD0003_27_30_20150910_00017.jpg

View of the stump along the slope.

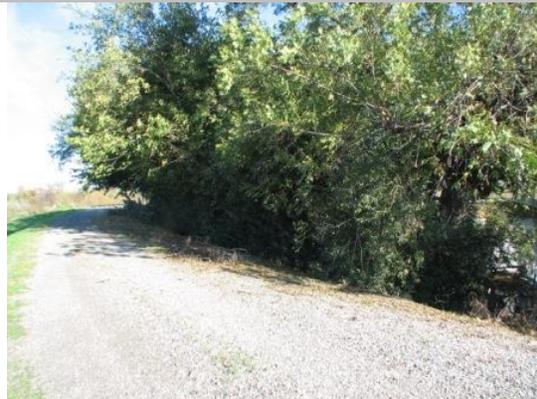
Photo 1 of 1 : FA_2015_LD0003_27_4_20150910_00003.jpg

View of the trees along the slope.
