**Flood Control Project Maintenance  
Levee Inspections**

**Fall 2010 Levee Maintenance Deficiency Summary Report**

**Levee District No. 0009 (Sutter County)**

**Levee Inspection Report By Mile - Fall 2010**

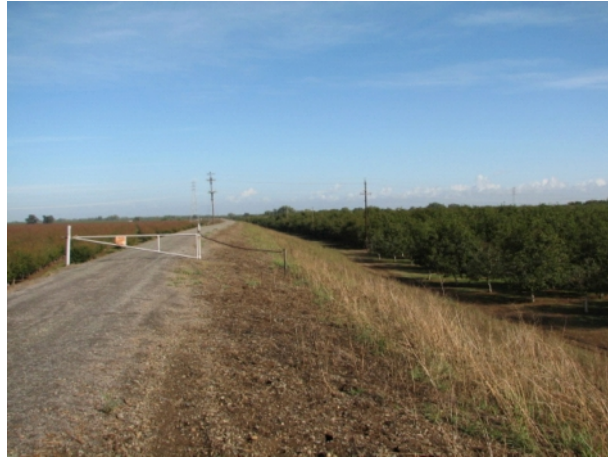
cathom\_f\_20101027\_176.jpg

Levee Mile Report Line	1
Start Levee Mile	0.00
End Levee Mile	6.24
Location	Water Side
Category	Earthen Levee
Item	Vegetation

Levee mile 0.00, water side slope.

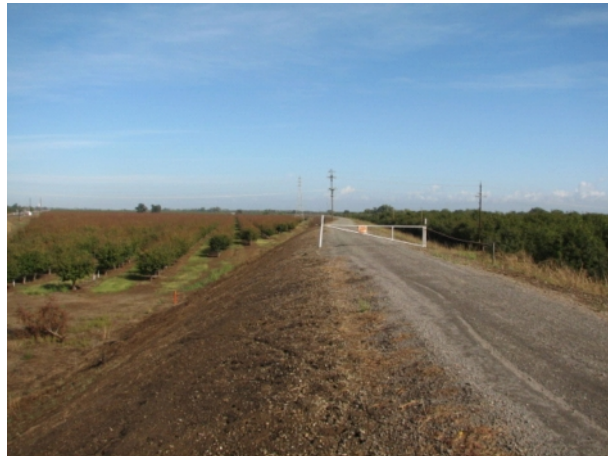
cathom\_f\_20101027\_175.jpg

Levee Mile Report Line	2
Start Levee Mile	0.00
End Levee Mile	6.24
Location	Land Side
Category	Earthen Levee
Item	Vegetation

Levee mile 0.00, land side slope.

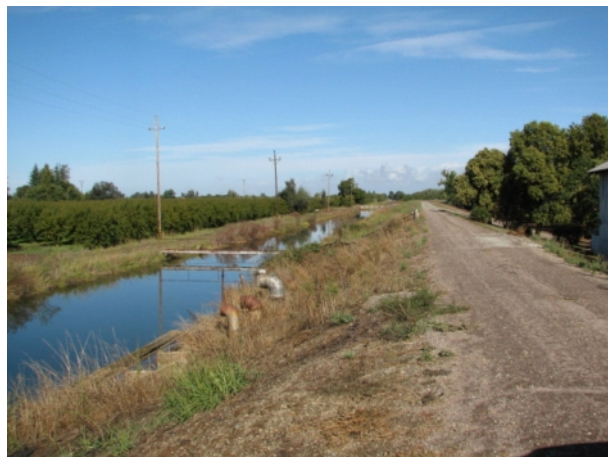
cathom\_f\_20101027\_177.jpg

Levee Mile Report Line	7
Start Levee Mile	5.68
End Levee Mile	6.02
Location	Land Side
Category	Earthen Levee
Item	Encroachments

AD at land side toe.

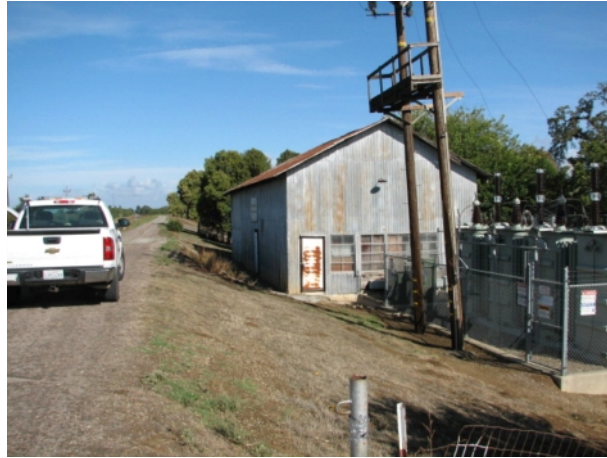
Levee Mile Report Line	8
Start Levee Mile	5.68
End Levee Mile	5.68
Location	Water Side
Category	Earthen Levee
Item	Encroachments
Building at the water side toe.	
cathom_f_20101027_178.jpg
