**Flood Control Project Maintenance  
Levee Inspections**

**Fall 2011 Levee Maintenance Deficiency Summary Report**

**Levee District No. 0009 (Sutter County)**

Waterway			Bank	Unit Miles
Unit No. 01 Sutter County, Feather River			Right	6.24
	Spring (March - May)	Summer (June - August)	(September - November) Fall	Winter (December - February)
Unit Maintenance Rating (Fall Only)			<b>A</b>	
Date of Inspection	3/15/2011 - 3/15/2011		10/5/2011 - 10/5/2011	
DWR Inspector	Clay Thomas		Clay Thomas	
Accompanied By	David Schmidl LD 9 Sutter		David Schmidl LD 9 Sutter

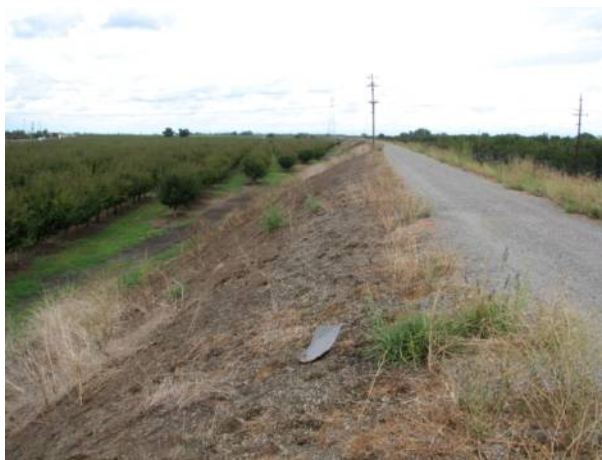
cathom\_f\_20111019\_949.jpg

Levee Mile Report Line	1
Start Levee Mile	0.00
End Levee Mile	6.20
Location	Land Side
Category	Earthen Levee
Item	Vegetation

This photo shows the landside vegetation looking upstream from levee mile 0.00.

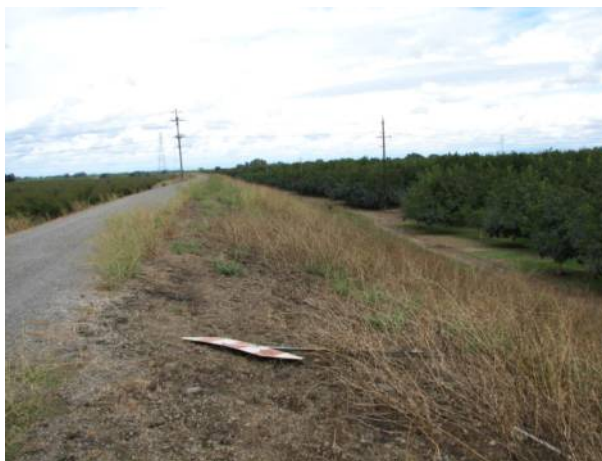
cathom\_f\_20111019\_950.jpg

Levee Mile Report Line	2
Start Levee Mile	0.00
End Levee Mile	6.20
Location	Water Side
Category	Earthen Levee
Item	Vegetation

This photo shows the waterside vegetation looking upstream from levee mile 0.00.

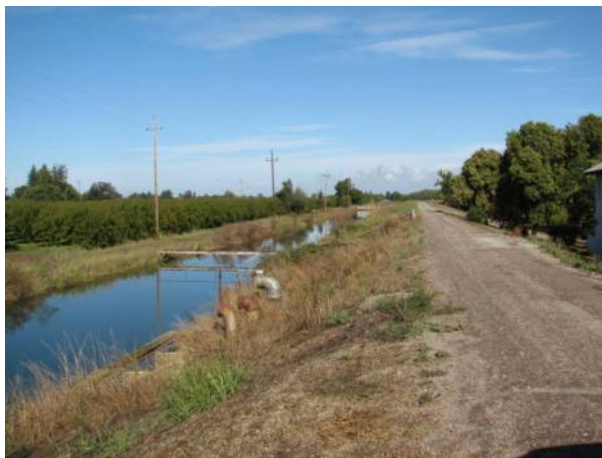
cathom\_f\_20110929\_247.jpg

Levee Mile Report Line	8
Start Levee Mile	5.68
End Levee Mile	6.02
Location	Land Side
Category	Earthen Levee
Item	Encroachments

AD at land side toe.

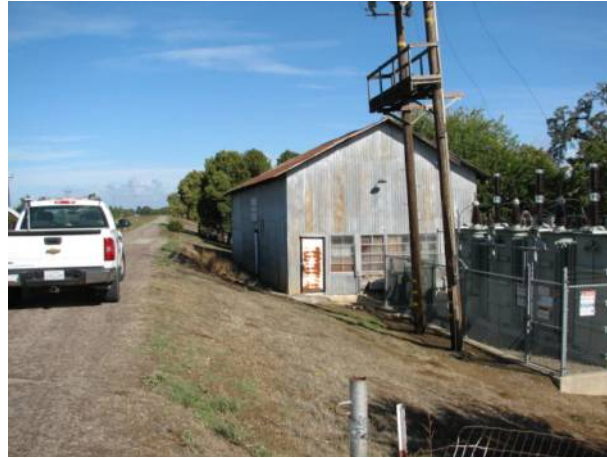
Levee Mile Report Line	9
Start Levee Mile	5.68
End Levee Mile	5.68
Location	Water Side
Category	Earthen Levee
Item	Encroachments
Building at the water side toe.	
cathom_f_20110929_246.jpg
