**Flood Control Project Maintenance
Levee Inspections**

Fall 2012 Levee Maintenance Deficiency Summary Report

Levee District No. 0009 (Sutter County)

Waterway			Bank	Unit Miles
Unit No. 01 Sutter County, Feather River			Right	6.24
	Spring (March - May)	Summer (June - August)	(September - November) Fall	Winter (December - February)
Unit Maintenance Rating (Fall Only)			A	
Date of Inspection	03/26/2012 - 03/26/2012		09/20/2012 - 09/20/2012	
DWR Inspector	Clay Thomas		Clay Thomas	
Accompanied By	David Schmidl LD 9 Sutter		David Schmidl LD 9 Sutter

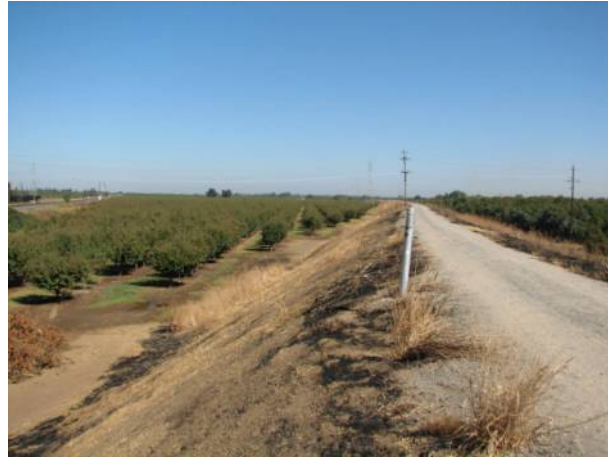
Levee Mile Report Line	4
Start Levee Mile	0.06
End Levee Mile	6.20
Location	Land Side
Category	Earthen Levee
Item	Vegetation

This photo is of the landside slope at levee mile 0.00.

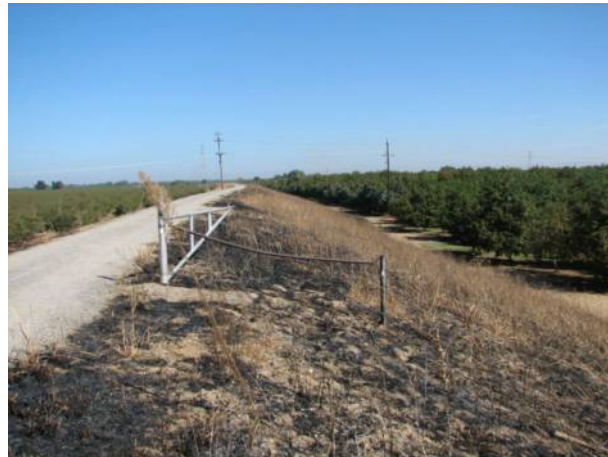
Levee Mile Report Line	5
Start Levee Mile	0.06
End Levee Mile	6.20
Location	Water Side
Category	Earthen Levee
Item	Vegetation

This photo is of the waterside slope at levee mile 0.00.

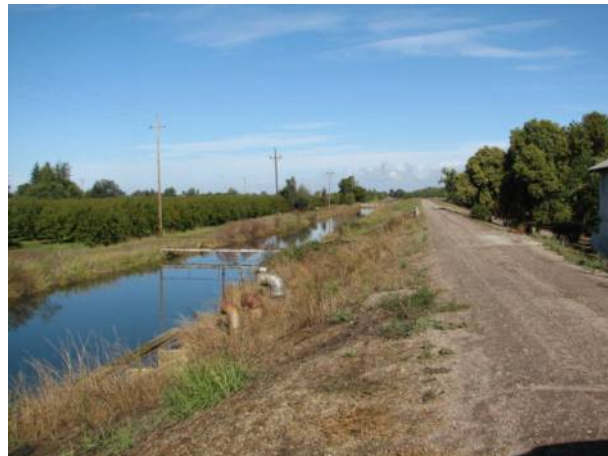
Levee Mile Report Line	13
Start Levee Mile	5.68
End Levee Mile	6.02
Location	Land Side
Category	Earthen Levee
Item	Encroachments

Agricultural ditch at land side toe.
