**Flood Control Project Maintenance
Levee Inspections**

Fall 2013 Levee Maintenance Deficiency Summary Report

Levee District No. 0009 (Sutter County)

Waterway			Bank	Unit Miles
Unit No. 01 Sutter County, Feather River			Right	6.24
	Spring (March - May)	Summer (June - August)	(September - November) Fall	Winter (December - February)
Unit Maintenance Rating (Fall Only)			M	
Date of Inspection	04/23/2013 - 04/23/2013		10/01/2013 - 10/01/2013	
DWR Inspector	Rick Burnett		Matthew Hoffman	
Accompanied By	David Schmidl LD 9 Sutter

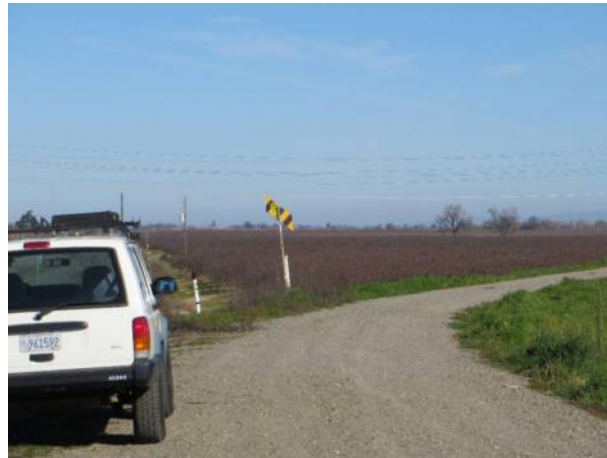
Levee Mile Report Line	4
Start Levee Mile	0.00
End Levee Mile	0.00
Location	Water Side
Category	Supplemental
Item	DWR UCIP Field Study

Marker on LS shoulder.

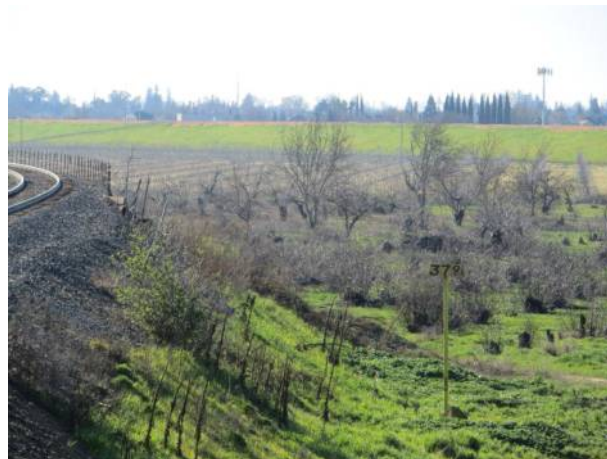
Levee Mile Report Line	5
Start Levee Mile	0.00
End Levee Mile	0.00
Location	Water Side
Category	Supplemental
Item	DWR UCIP Field Study

Sign between railroad and LD 1 puts alignment on west side of railroad tracks.

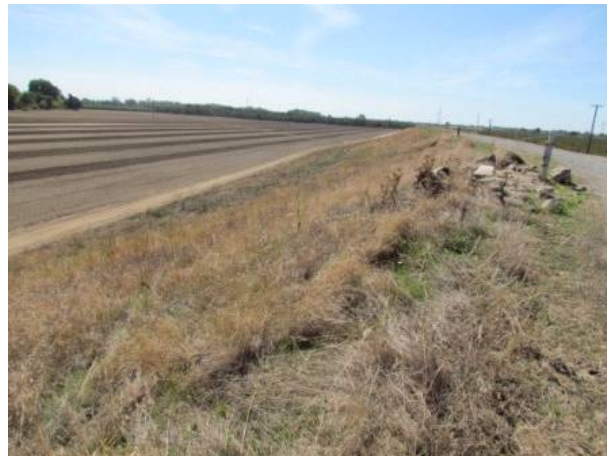
Levee Mile Report Line	6
Start Levee Mile	0.00
End Levee Mile	0.94
Location	Water Side
Category	Earthen Levee
Item	Vegetation

DWR ID: DWR_LD0009_01_f_2013_3									
6	0.00	0.94	Earthen Levee	Vegetation	WSA/W Ma	V2 : Remove the wild growth other than native grasses from the levee slopes. Inspector Comments: District has burned waterward side of levee but has yet to knock down the tall weeds/grass that was not taken care of by burning.	°	°	20 Y
DWR ID: DWR_LD0009_01_f_2013_20									
7	0.03	0.03	Supplemental	DWR UCIP Field Study	WS M En	Inspector Comments: FS_ID:9594 EP_NO: N/A Repair Type: Non-Urgent Crossing Status: Indicator Found UCIP Comments: gas lines need to be better marked in this area as they are only 2.6-feet below crown. FIELD_STRUCT_DESC: 8-5/8-inch diameter fuel line along the landward shoulder, 2.6 feet below the crown. FS Date: 3/1/2013	39.169339 °	-121.622616 °	8
DWR ID: DWR_LD0009_01_f_2013_8

Photo taken from the crown looking south at the vegetation on the waterward slope of the levee.

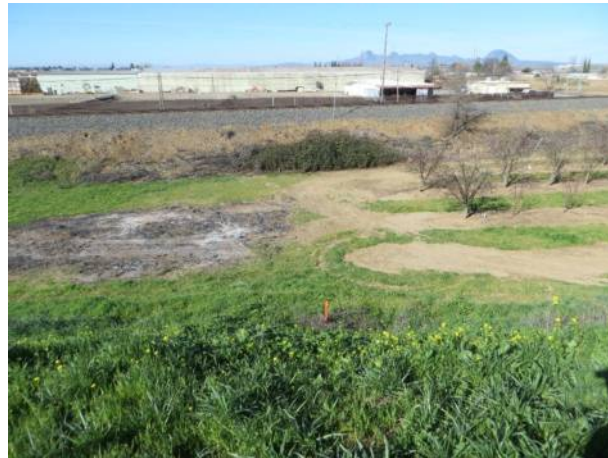
Levee Mile Report Line	8
Start Levee Mile	0.08
End Levee Mile	0.08
Location	Land Side
Category	Supplemental
Item	DWR UCIP Field Study

Gasline marker at LS toe.

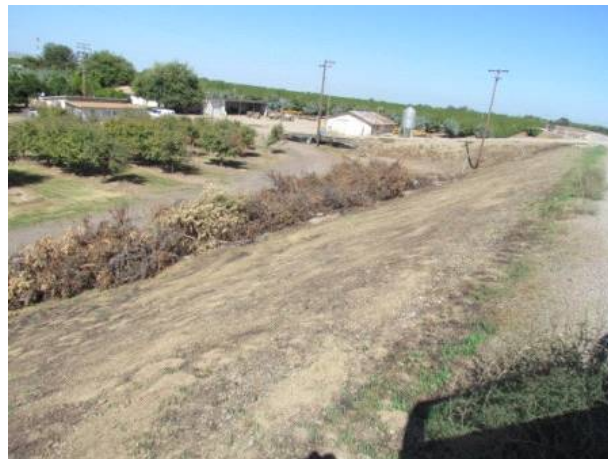
Levee Mile Report Line	9
Start Levee Mile	0.88
End Levee Mile	0.88
Location	Land Side
Category	Earthen Levee
Item	Encroachments

Photo taken looking north at a pruning pile stacked on the levee slope at the landward toe.

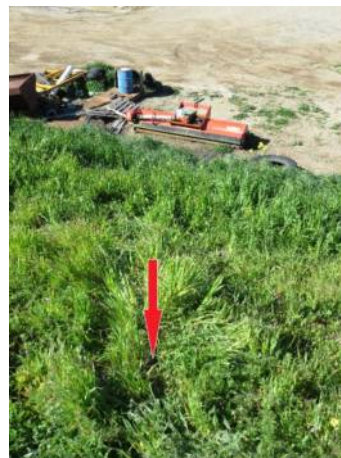
Levee Mile Report Line	10
Start Levee Mile	0.95
End Levee Mile	0.95
Location	Land Side
Category	Supplemental
Item	DWR UCIP Field Study

Pipe at crown on LS shoulder.

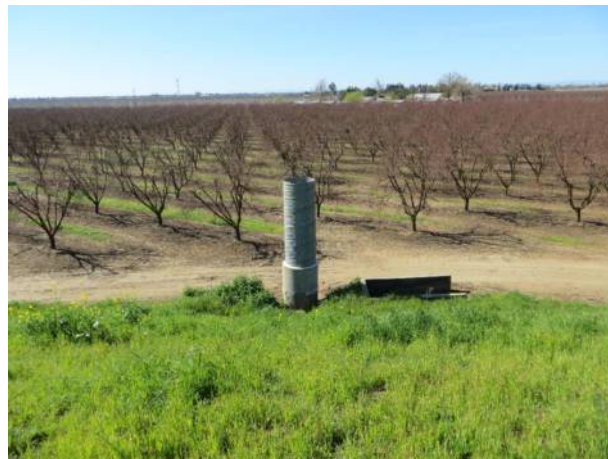
Levee Mile Report Line	12
Start Levee Mile	1.87
End Levee Mile	1.87
Location	Land Side
Category	Supplemental
Item	DWR UCIP Field Study

Concrete and CMP riser on LS toe.

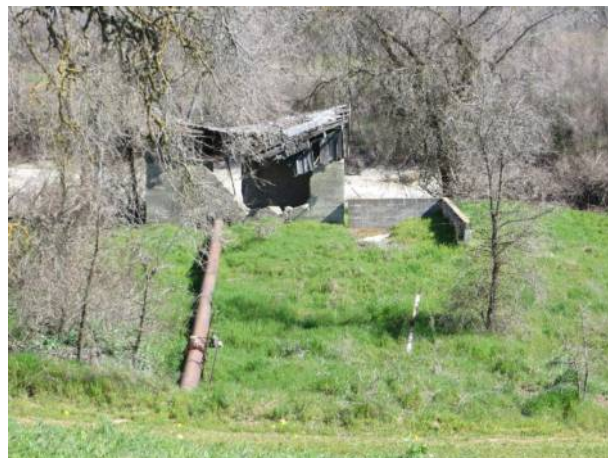
Levee Mile Report Line	13
Start Levee Mile	2.55
End Levee Mile	2.55
Location	Land Side
Category	Supplemental
Item	DWR UCIP Field Study

Pipe and pumphouse on WS toe/bench.

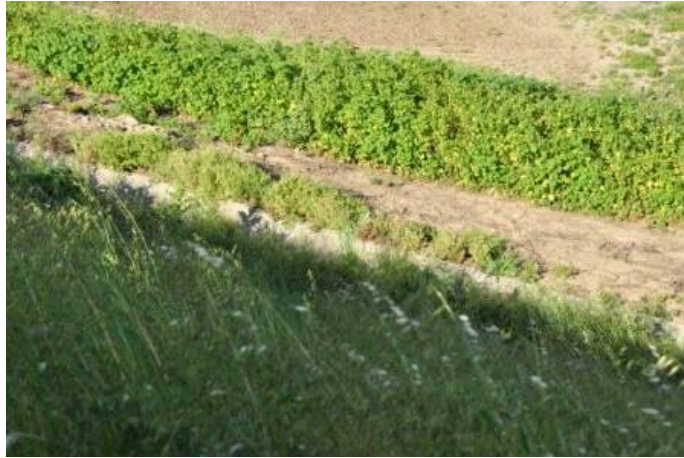
Levee Mile Report Line	15
Start Levee Mile	2.96
End Levee Mile	3.12
Location	Land Side
Category	Earthen Levee
Item	Encroachments

Concrete lined ditch at L/S levee toe.

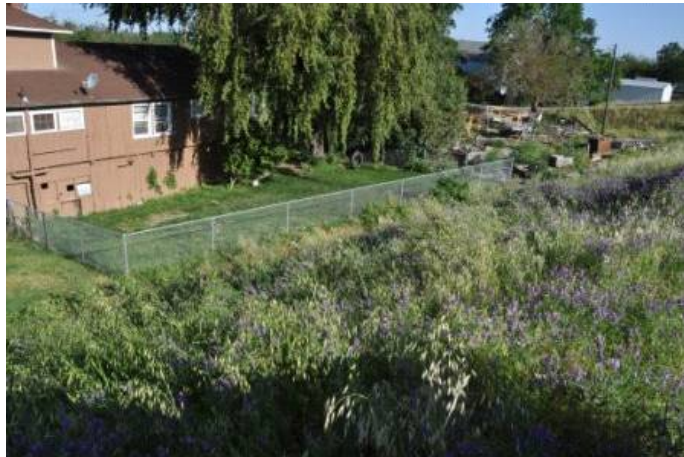
Levee Mile Report Line	16
Start Levee Mile	3.05
End Levee Mile	3.06
Location	Land Side
Category	Earthen Levee
Item	Encroachments

L/S fence along levee toe.

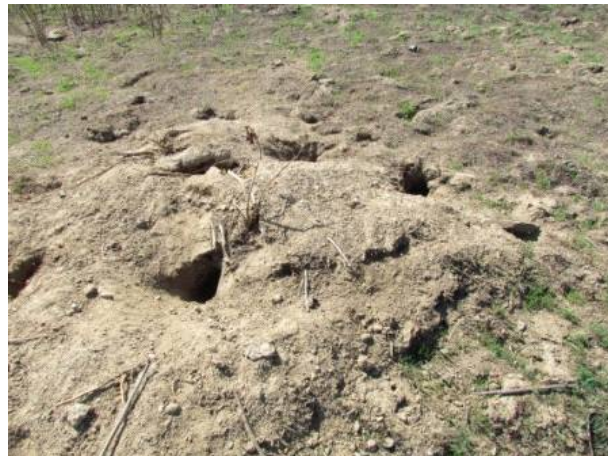
Levee Mile Report Line	17
Start Levee Mile	3.10
End Levee Mile	3.30
Location	Water Side
Category	Earthen Levee
Item	Animal Control

Photo taken looking south from the toe of the levee at rodent holes on the waterward slope.

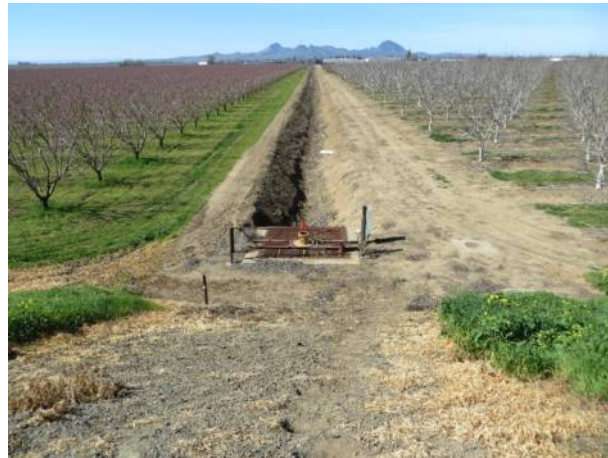
Levee Mile Report Line	18
Start Levee Mile	3.49
End Levee Mile	3.49
Location	Water Side
Category	Supplemental
Item	DWR UCIP Field Study

LS at trash rack and pumping plant.

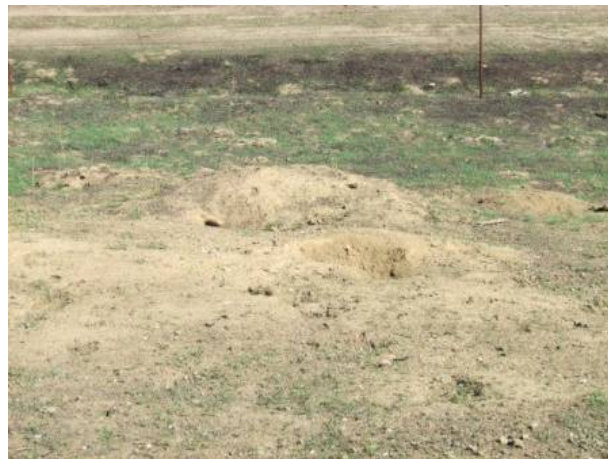
Levee Mile Report Line	21
Start Levee Mile	4.69
End Levee Mile	4.69
Location	Water Side
Category	Earthen Levee
Item	Animal Control

Photo taken from the levee crown looking east down the waterward slope at rodent holes.

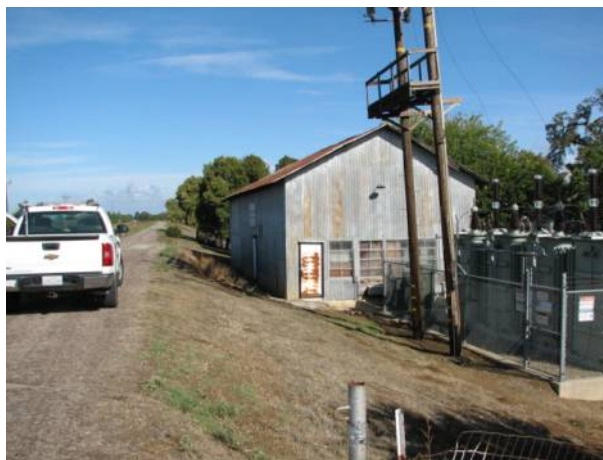
Levee Mile Report Line	23
Start Levee Mile	5.68
End Levee Mile	5.68
Location	Water Side
Category	Earthen Levee
Item	Encroachments

Building at the waterside toe.

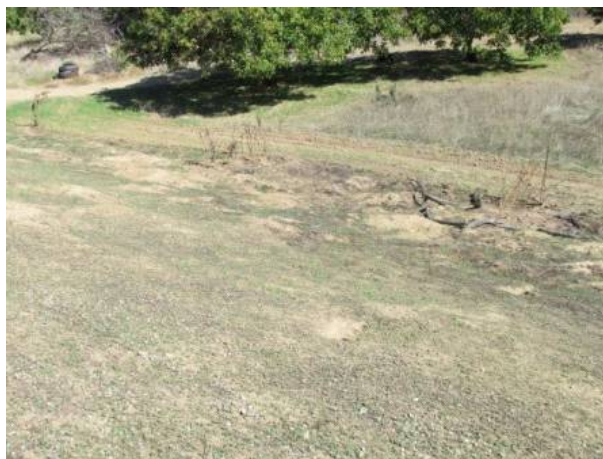
Levee Mile Report Line	24
Start Levee Mile	5.76
End Levee Mile	5.76
Location	Water Side
Category	Earthen Levee
Item	Animal Control

Photo taken from levee crown looking down waterward slope at rodent holes.

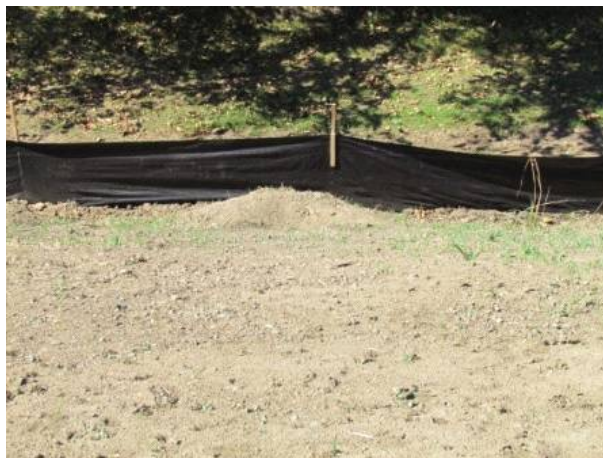
Levee Mile Report Line	25
Start Levee Mile	6.14
End Levee Mile	6.14
Location	Land Side
Category	Earthen Levee
Item	Animal Control

Photo taken from levee crown looking west down landward slope at rodent holes.
