**Flood Control Project Maintenance
Levee Inspections**

Fall 2014 Levee Maintenance Deficiency Summary Report

Levee District No. 0009 (Sutter County)

Waterway			Bank	Unit Miles
Unit No. 01 Sutter County, Feather River			Right	6.25
	Spring (March - May)	Summer (June - August)	(September - November) Fall	Winter (December - February)
Unit Maintenance Rating (Fall Only)			M	
Date of Inspection	03/12/2014 - 03/12/2014		11/13/2014 - 11/13/2014	
DWR Inspector	Matthew Hoffman		Matthew Hoffman	
Accompanied By	David Schmidl LD 9

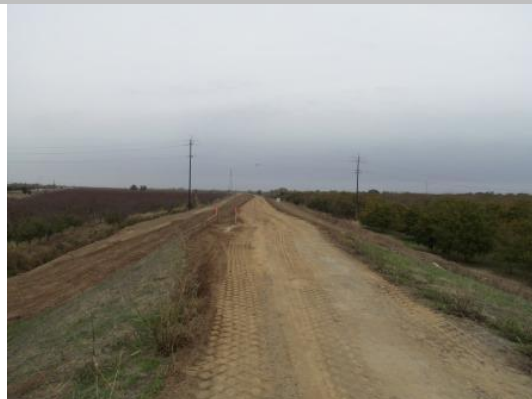
Photo 1 of 1 : FA_2014_LD0009_202_19_20141124_00018.jpg

LM Start	0.00	Rating **	A/W	Issue No.	19
LM End	6.24	Issue Type +	En	Location *	CR
Category	Earthen Levee			GPS Latitude/Longitude	
				Start	End
Item	Encroachments			39.168906 °	39.254369 °
				-121.622629 °	-121.636530 °
DWR ID	DWR_LD0009_01_f_2014_19				
Action/Comments					
Material					
Inspector Comments: The entire district is currently under construction and unable to inspect. Fall 2014

This photo was taken from the crown facing north looking at the levee currently under construction and unable to inspect. Fall 2014.

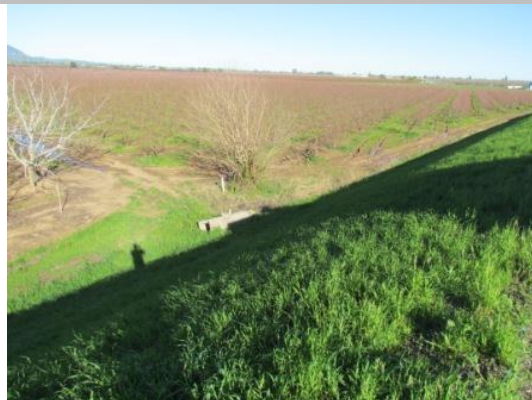
Photo 1 of 1 : FA_2014_LD0009_202_21_20141110_00005.jpg

LM Start	2.70	Rating **	M	Issue No.	21
LM End	2.70	Issue Type +	Ma	Location *	LS
Category	Earthen Levee			GPS Latitude/Longitude	
				Start	End
Item	Encroachments			39.206053 °	39.206053 °
				-121.629748 °	-121.629748 °
DWR ID	DWR_LD0009_01_f_2013_21				
Action/Comments					
Debris

This photo was taken from the crown facing north looking down the landward levee slope at concrete debris. Spring 2014.

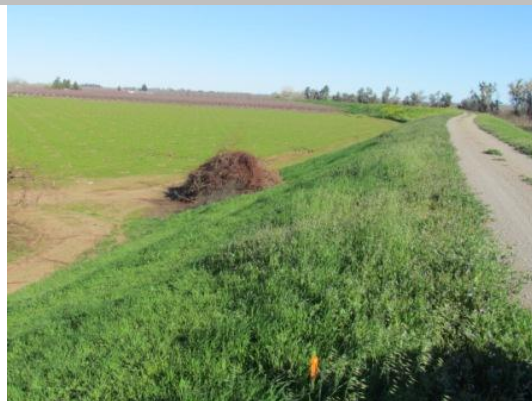
Photo 1 of 1 : FA_2014_LD0009_202_23_20141110_00007.jpg

LM Start	4.27	Rating **	M	Issue No.	23
LM End	4.27	Issue Type +	En	Location *	LS
Category	Earthen Levee			GPS Latitude/Longitude	
				Start	End
Item	Encroachments			39.228589 °	39.228589 °
				-121.629732 °	-121.629732 °
DWR ID	DWR_LD0009_01_f_2013_23				
Action/Comments					
Prunings

This photo was taken from the crown facing north looking down the landward levee slope at a pruning pile on at the toe. Spring 2014.

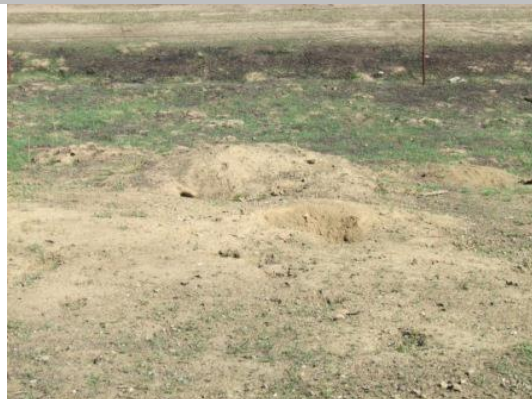
Photo 1 of 1 : FA_2014_LD0009_202_10_20141110_00002.jpg

LM Start	4.69	Rating **	U	Issue No.	10
LM End	4.69	Issue Type +	Ma	Location *	WS
Category	Earthen Levee			GPS Latitude/Longitude	
				Start	End
Item	Animal Control			39.234343 °	39.234343 °
				-121.632200 °	-121.632200 °
DWR ID	DWR_LD0009_01_f_2013_10				
Action/Comments					
No rodents visible, but rodent burrows visible; need to backfill and compact or grout burrows.

Photo taken from the levee crown looking east down the waterward slope at rodent holes.

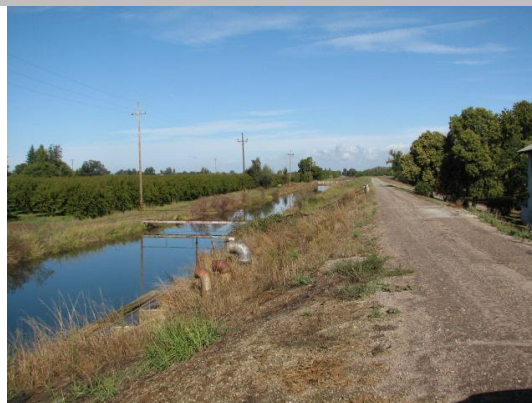
Photo 1 of 1 : FA_2014_LD0009_202_12_20141110_00004.jpg

LM Start	5.68	Rating **	M	Issue No.	12
LM End	6.02	Issue Type +	En	Location *	LS
Category	Earthen Levee			GPS Latitude/Longitude	
				Start	End
Item	Encroachments			39.247695 °	39.252631 °
				-121.637316 °	-121.636970 °
DWR ID	DWR_LD0009_01_s_2012_12				
Action/Comments					
Ditch

Agricultural ditch at landside toe.

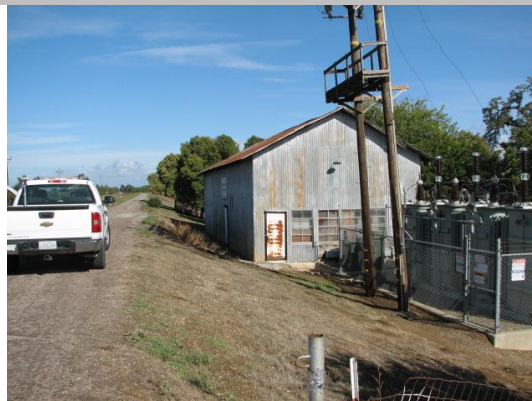
Photo 1 of 1 : FA_2014_LD0009_202_11_20141110_00003.jpg

LM Start	5.68	Rating **	U	Issue No.	11
LM End	5.68	Issue Type +	En	Location *	WS
Category	Earthen Levee			GPS Latitude/Longitude	
				Start	End
Item	Encroachments			39.247697 °	39.247697 °
				-121.637312 °	-121.637312 °
DWR ID	DWR_LD0009_01_s_2012_11				
Action/Comments					
Building

Building at the waterside toe.

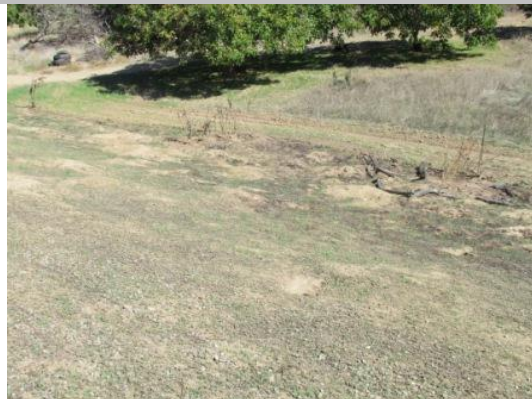
Photo 1 of 1 : FA_2014_LD0009_202_24_20141110_00008.jpg

LM Start	5.76	Rating **	U	Issue No.	24
LM End	5.76	Issue Type +	Ma	Location *	WS
Category	Earthen Levee			GPS Latitude/Longitude	
				Start	End
Item	Animal Control			39.248868 °	39.248868 °
				-121.637232 °	-121.637232 °
DWR ID	DWR_LD0009_01_f_2013_24				
Action/Comments					
No rodents visible, but rodent burrows visible; need to backfill and compact or grout burrows.

Photo taken from levee crown looking down waterward slope at rodent holes.

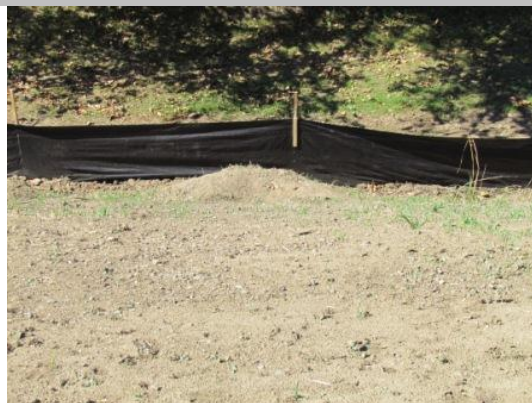
Photo 1 of 1 : FA_2014_LD0009_202_25_20141110_00009.jpg

LM Start	6.14	Rating **	U	Issue No.	25
LM End	6.14	Issue Type +	Ma	Location *	LS
Category	Earthen Levee			GPS Latitude/Longitude	
				Start	End
Item	Animal Control			39.254369 °	39.254369 °
				-121.636531 °	-121.636531 °
DWR ID	DWR_LD0009_01_f_2013_25				
Action/Comments					
No rodents visible, but rodent burrows visible; need to backfill and compact or grout burrows.

Photo taken from levee crown looking west down landward slope at rodent holes.
