**Flood Control Project Maintenance
Levee Inspections**

Fall 2015 Levee Maintenance Deficiency Summary Report

Levee District No. 0009 (Sutter County)

Levee Inspection Report By Mile - Fall 2015

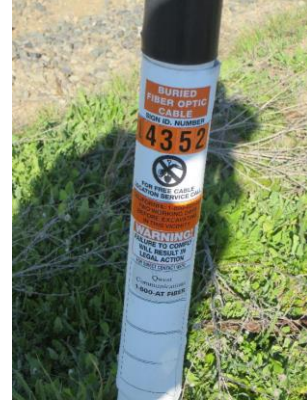
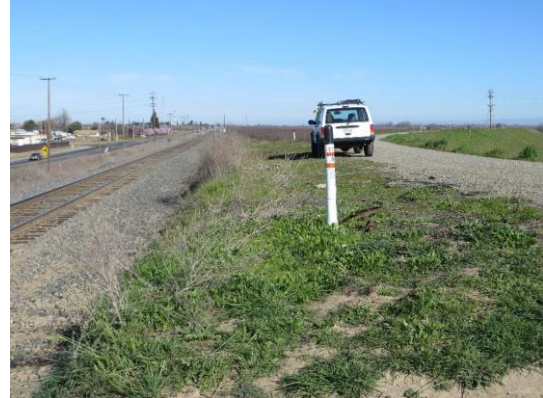
LM Start	0.00	Rating **	M	Issue No.	26
LM End	0.00	Issue Type +	En	Location *	LS
Category	Supplemental			GPS Latitude/Longitude	
				Start	End
Item	DWR UCIP Field Study			39.168829 °	39.168829 °
				-121.622643 °	-121.622643 °
DWR ID					
Action/Comments					
Inspector Comments: FS_ID:41944 DS_ID:22685 EP_NO: N/A FS_HLM: 0 Repair Type: Non-Urgent Crossing Status: Found UCIP Comments: No permit identified. FIELD_STRUCT_DESC: Fiber optic communication line at unknown depth below the crown. FS Date: 03/03/2013

Fiber optic line marker on LS shoulder.

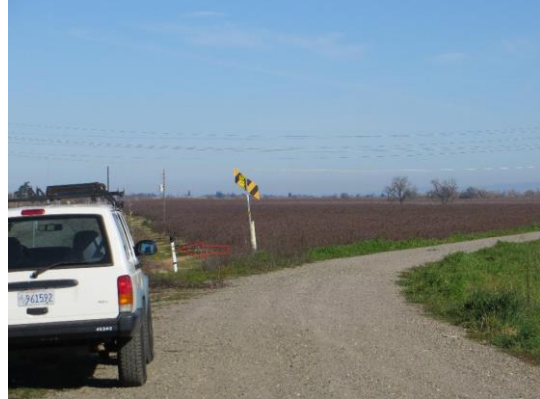
Photo 3 of 3 : UCIP_FA_2015_2195.jpg

LM Start	0.00	Rating **	M	Issue No.	26 (cont)
LM End	0.00	Issue Type +	En	Location *	LS
Category	Supplemental			GPS Latitude/Longitude	
				Start	End
Item	DWR UCIP Field Study			39.168829 °	39.168829 °
				-121.622643 °	-121.622643 °
DWR ID					
Action/Comments					
Inspector Comments: FS_ID:41944 DS_ID:22685 EP_NO: N/A FS_HLM: 0 Repair Type: Non-Urgent Crossing Status: Found

Fiber optic line marker on LS shoulder

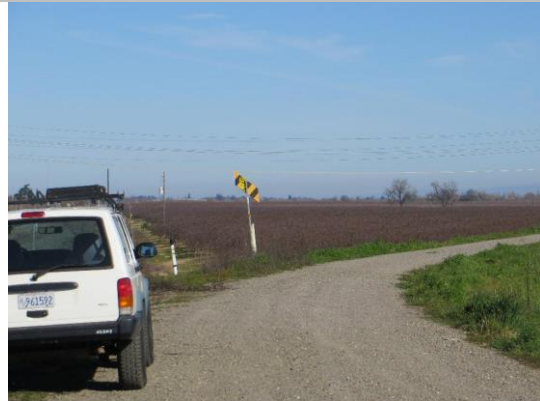
Photo 1 of 1 : UCIP_FA_2015_0472.jpg

LM Start	0.00	Rating **	M	Issue No.	27
LM End	0.00	Issue Type +	En	Location *	LS
Category	Supplemental			GPS Latitude/Longitude	
				Start	End
Item	DWR UCIP Field Study			39.168906 °	39.168906 °
				-121.622629 °	-121.622629 °
DWR ID					
Action/Comments					
Inspector Comments: FS_ID:9595					
DS_ID:17792					
EP_NO: 3823					
FS_HLM: 0					
Repair Type: Non-Urgent					
Crossing Status: Indicator Found					
UCIP Comments: Need better gas-line markings at levees.					
FIELD_STRUCT_DESC: 8-5/8-inch fuel line along the landward					
shoulder, 2.6 feet below the crown. Gasline marker on LS shoulder					
FS Date: 03/01/2013

Marker on LS shoulder.

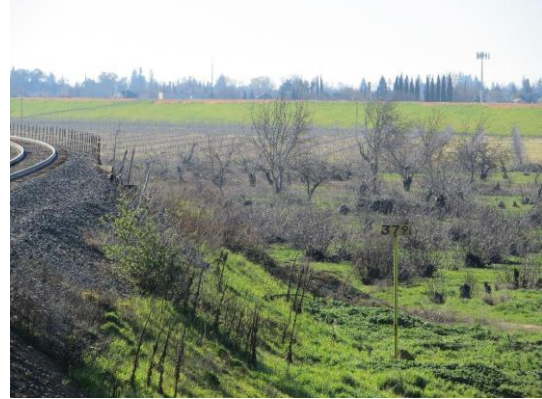
Photo 1 of 1 : UCIP_FA_2015_0471.jpg

LM Start	0.00	Rating **	M	Issue No.	28
LM End	0.00	Issue Type +	En	Location *	LS
Category	Supplemental			GPS Latitude/Longitude	
				Start	End
Item	DWR UCIP Field Study			39.168909 °	39.168909 °
				-121.622629 °	-121.622629 °
DWR ID

Inspector Comments: FS_ID:9592
 DS_ID:17793
 EP_NO: N/A
 FS_HLM: 0
 Repair Type: Non-Urgent
 Crossing Status: Indicator Found
 UCIP Comments: Need better gas-line markings at levees.
 FIELD_STRUCT_DESC: 8-5/8-inch fuel line through the levee. Sign on LS between railroad and end of LD1 puts alignment on west side of RR tracks.
 FS Date: 03/01/2013

Sign between railroad and LD 1 puts alignment on west side of railroad tracks.

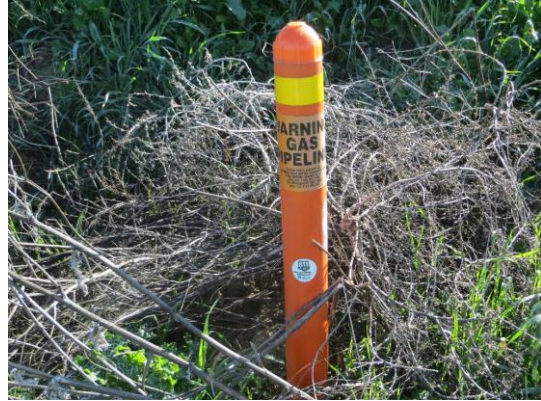
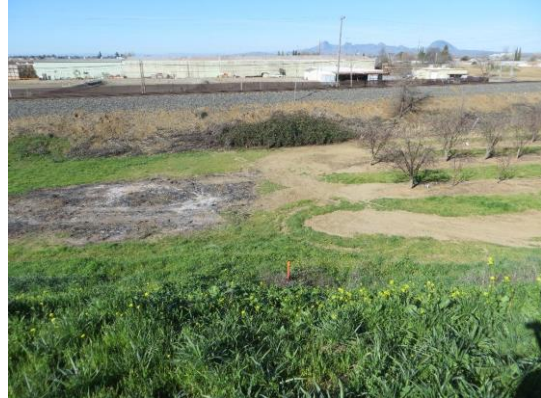
LM Start	0.10	Rating **	M	Issue No.	30
LM End	0.10	Issue Type +	En	Location *	LS
Category	Supplemental			GPS Latitude/Longitude	
				Start	End
Item	DWR UCIP Field Study			39.170153 °	39.170153 °
				-121.622546 °	-121.622546 °
DWR ID					
Action/Comments					
Inspector Comments: FS_ID:9596 DS_ID:17790 EP_NO: N/A FS_HLM: 0.08 Repair Type: Non-Urgent Crossing Status: Indicator Found UCIP Comments: Need better gas-line markings at levees. FIELD_STRUCT_DESC: 16-inch gas line through the levee, 3.5 feet below the crown. Marker on LS toe. Permit No. 1913, 1954, PG&E. FS Date: 03/01/2013

Close up of Gasline marker at LS toe.

Gasline marker at LS toe.

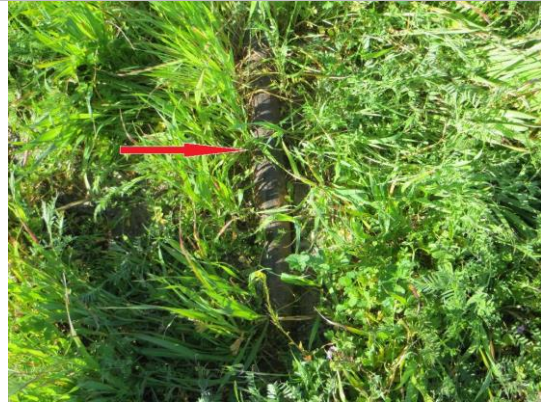
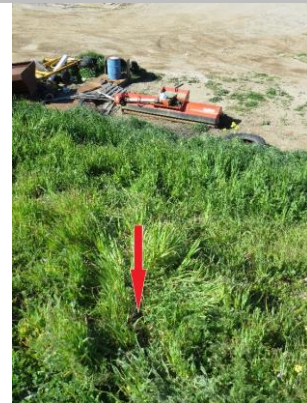
LM Start	0.96	Rating **	M	Issue No.	31
LM End	0.96	Issue Type +	En	Location *	LS
Category	Supplemental			GPS Latitude/Longitude	
				Start	End
Item	DWR UCIP Field Study			39.182607 °	39.182607 °
				-121.620775 °	-121.620775 °
DWR ID					
Action/Comments					
Inspector Comments: FS_ID:9598 DS_ID:17788 EP_NO: N/A FS_HLM: 0.951 Repair Type: Non-Urgent Crossing Status: Found

Pipe at crown on LS shoulder.

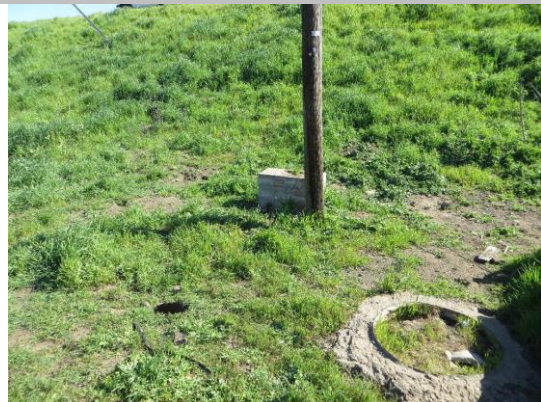
Photo 1 of 2 : UCIP_FA_2015_0477.jpg

LM Start	1.33	Rating **	M	Issue No.	32
LM End	1.33	Issue Type +	En	Location *	LS
Category	Supplemental			GPS Latitude/Longitude	
				Start	End
Item	DWR UCIP Field Study			39.187995 °	39.187995 °
				-121.620706 °	-121.620706 °
DWR ID					
Action/Comments					
Inspector Comments: FS_ID:9601 DS_ID:17785 EP_NO: N/A FS_HLM: 1.324 Repair Type: Non-Urgent Crossing Status: Indicator Found

JP at pump on LS toe.

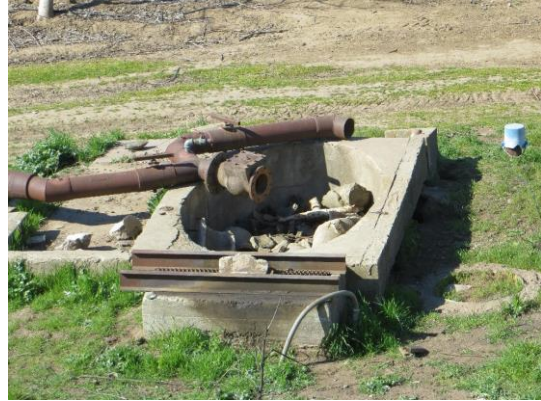
Photo 2 of 2 : UCIP_FA_2015_0478.jpg

LM Start	1.33	Rating **	M	Issue No.	32 (cont)	
LM End	1.33	Issue Type +	En	Location *	LS	
Category	Supplemental			GPS Latitude/Longitude		
				Start	End	
Item	DWR UCIP Field Study			39.187995 °	39.187995 °	
				-121.620706 °	-121.620706 °	
DWR ID						
Action/Comments						
Inspector Comments: FS_ID:9601						
DS_ID:17785						
EP_NO: N/A						
FS_HLM: 1.324						
Repair Type: Non-Urgent						
Crossing Status: Indicator Found						
UCIP Comments: Unable to determine type of abandonment.						
FIELD_STRUCT_DESC: *Abandoned* 10-inch steel pipe through the						
levee, 2.8 feet below the crown. Waterward end open. Steel plate						
welded on landward end. Pump and standpipe at the landward toe.						
Permit No. 1407, 1949.						
FS Date: 03/01/2013

Abandoned Pump platform on LS toe.

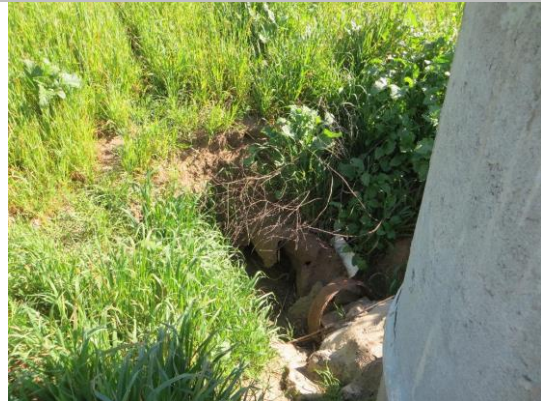
Photo 1 of 3 : UCIP_FA_2015_0479.jpg

LM Start	1.88	Rating **	M	Issue No.	33
LM End	1.88	Issue Type +	En	Location *	LS
Category	Supplemental			GPS Latitude/Longitude	
				Start	End
Item	DWR UCIP Field Study			39.195241 °	39.195241 °
				-121.624165 °	-121.624165 °
DWR ID					
Action/Comments					
Inspector Comments: FS_ID:41063 DS_ID:17784 EP_NO: 1119 FS_HLM: 1.87 Repair Type: Non-Urgent Crossing Status: Found UCIP Comments: Pipe needs to be repaired or properly abandoned. FIELD_STRUCT_DESC: 16-inch steel pipe through levee, 3.0 feet below crown. Pump in pump house on channel bank. Gate valve on the waterward end. Concrete standpipe and distribution box at the landward toe. (Permit No. 1119, 06/08/1946) FS Date: 03/01/2013

Corroded and damaged pipe at connection to concrete riser on LS toe.

Action/Comments					
Inspector Comments: FS_ID:41063 DS_ID:17784 EP_NO: 1119 FS_HLM: 1.87 Repair Type: Non-Urgent Crossing Status: Found UCIP Comments: Pipe needs to be repaired or properly abandoned. FIELD_STRUCT_DESC: 16-inch steel pipe through levee, 3.0 feet below crown. Pump in pump house on channel bank. Gate valve on the waterward end. Concrete standpipe and distribution box at the landward toe. (Permit No. 1119, 06/08/1946) FS Date: 03/01/2013

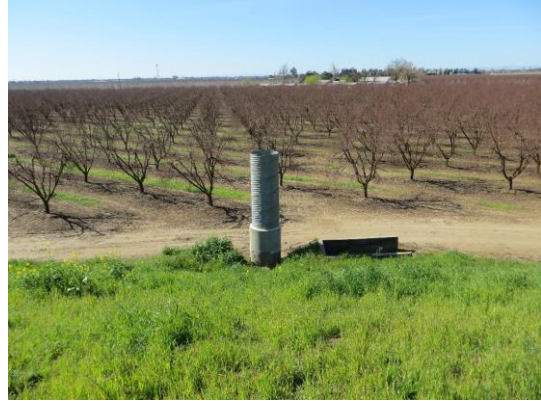
Photo 2 of 3 : UCIP_FA_2015_0480.jpg

Concrete and CMP riser on LS toe.

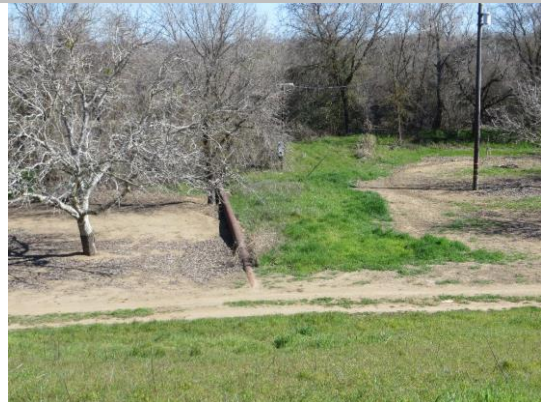
Photo 3 of 3 : UCIP_FA_2015_0481.jpg

Pipe on WS toe.

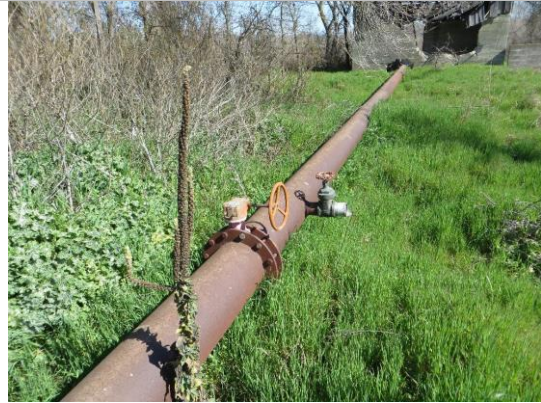
Photo 1 of 3 : UCIP_FA_2015_0482.jpg

LM Start	2.56	Rating **	U	Issue No.	34
LM End	2.56	Issue Type +	En	Location *	LS
Category	Supplemental			GPS Latitude/Longitude	
				Start	End
Item	DWR UCIP Field Study			39.203936 °	39.203936 °
				-121.629521 °	-121.629521 °
DWR ID					
Action/Comments					
Inspector Comments: FS_ID:9604 DS_ID:17783 EP_NO: N/A FS_HLM: 2.554 Repair Type: Urgent Crossing Status: Found

Pipe on WS toe at butterfly valve.

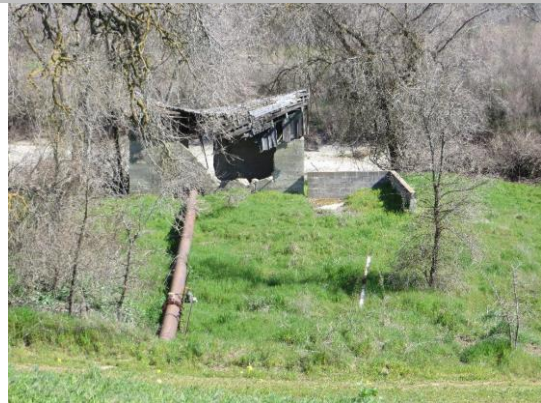
Photo 2 of 3 : UCIP_FA_2015_0483.jpg

Pipe and pumphouse on WS toe/bench.

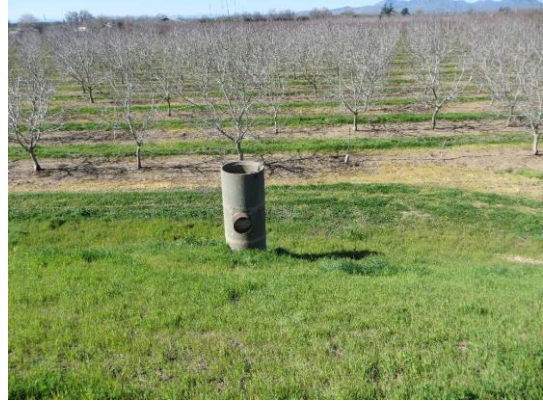
Photo 3 of 3 : UCIP_FA_2015_0484.jpg

LM Start	2.56	Rating **	U	Issue No.	34 (cont)
LM End	2.56	Issue Type +	En	Location *	LS
Category	Supplemental			GPS Latitude/Longitude	
				Start	End
Item	DWR UCIP Field Study			39.203936 °	39.203936 °
				-121.629521 °	-121.629521 °
DWR ID					
Action/Comments					
Inspector Comments: FS_ID:9604 DS_ID:17783 EP_NO: N/A FS_HLM: 2.554 Repair Type: Urgent Crossing Status: Found

CMP riser on LS toe.

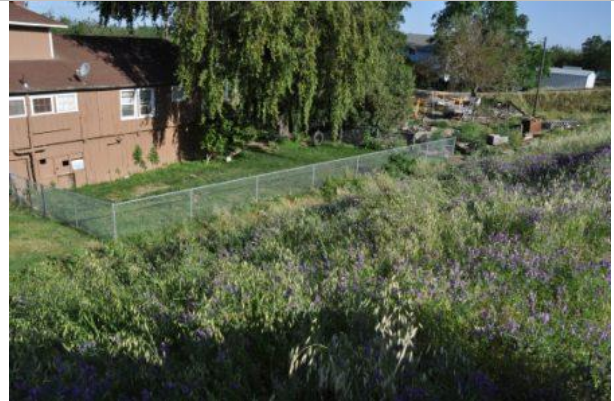
Photo 1 of 1 : FA_2015_LD0009_202_7_20151106_00001.jpg

LM Start	3.05	Rating **	M	Issue No.	7
LM End	3.06	Issue Type +	En	Location *	LS
Category	Earthen Levee			GPS Latitude/Longitude	
				Start	End
Item	Encroachments			39.211052 °	39.211228 °
				-121.628851 °	-121.628808 °
DWR ID	DWR_LD0009_01_s_2012_7				
Action/Comments					
Fence

L/S fence along levee toe.

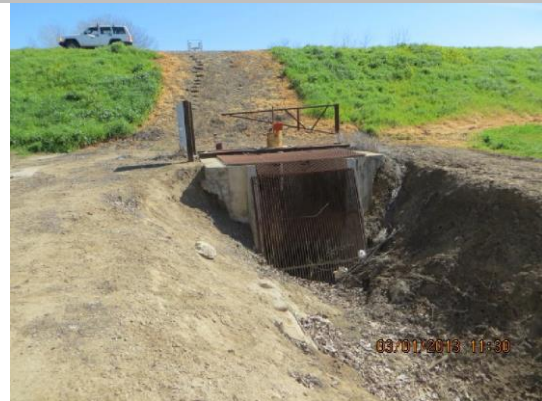
Photo 1 of 3 : UCIP_FA_2015_0485.jpg

LM Start	3.49	Rating **	U	Issue No.	35
LM End	3.49	Issue Type +	En	Location *	WS
Category	Supplemental			GPS Latitude/Longitude	
				Start	End
Item	DWR UCIP Field Study			39.217363 °	39.217363 °
				-121.628434 °	-121.628434 °
DWR ID					
Action/Comments					
Inspector Comments: FS_ID:41223 DS_ID:17782 EP_NO: 13657 FS_HLM: 3.488 Repair Type: Urgent Crossing Status: Found UCIP Comments: Needs flapgate on WS outlet. Pump is missing. FIELD_STRUCT_DESC: 20-inch pipe through levee, 2 feet below levee crown. Siphon breaker on waterward shoulder. Pump with trash rack at landward toe. (Permit No. 13657 - Micheli) FS Date: 10/15/2014

Trash rack on LS toe.

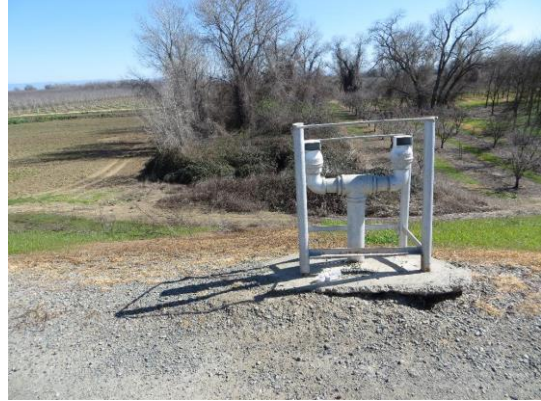
Photo 2 of 3 : UCIP_FA_2015_0486.jpg

LM Start	3.49	Rating **	U	Issue No.	35 (cont)	
LM End	3.49	Issue Type +	En	Location *	WS	
Category	Supplemental			GPS Latitude/Longitude		
				Start	End	
Item	DWR UCIP Field Study			39.217363 °	39.217363 °	
				-121.628434 °	-121.628434 °	
DWR ID						
Action/Comments						
Inspector Comments: FS_ID:41223						
DS_ID:17782						
EP_NO: 13657						
FS_HLM: 3.488						
Repair Type: Urgent						
Crossing Status: Found						
UCIP Comments: Needs flapgate on WS outlet. Pump is missing.						
FIELD_STRUCT_DESC: 20-inch pipe through levee, 2 feet below levee crown. Siphon breaker on waterward shoulder. Pump with trash rack at landward toe. (Permit No. 13657 - Micheli)						
FS Date: 10/15/2014

Siphon Breakers on WS shoulder.

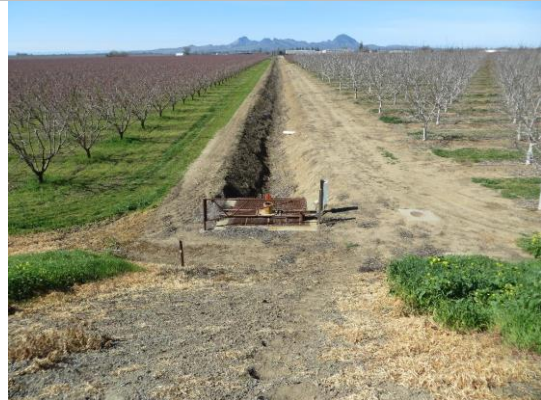
Photo 3 of 3 : UCIP_FA_2015_0496.jpg

LS at trash rack and pumping plant.

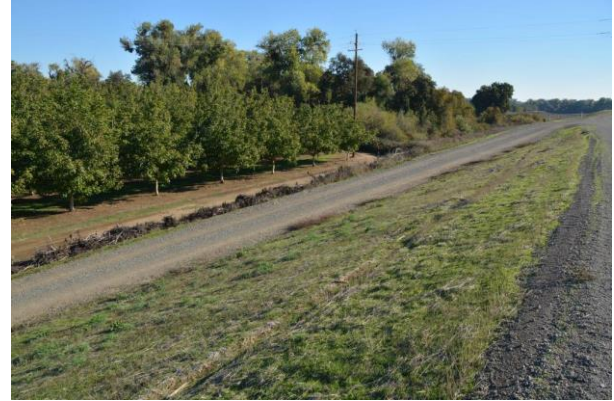
Photo 1 of 1 : FA_2015_LD0009_202_18_20151117_00015.jpg

LM Start	4.15	Rating **	M	Issue No.	18
LM End	4.15	Issue Type +	En	Location *	WS
Category	Earthen Levee			GPS Latitude/Longitude	
				Start	End
Item	Vegetation			39.226748 °	39.226748 °
				-121.629460 °	-121.629460 °
DWR ID	DWR_LD0009_01_f_2015_18				
Action/Comments					
Landscaping					
Inspector Comments: Pruning debris stacked along waterside toe/ access ramp.

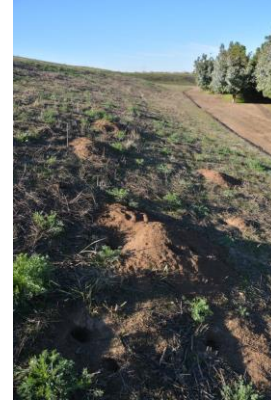
Photo 1 of 1 : FA_2015_LD0009_202_19_20151117_00016.jpg

LM Start	5.32	Rating **	U	Issue No.	19
LM End	5.32	Issue Type +	Ma	Location *	WS
Category	Earthen Levee			GPS Latitude/Longitude	
				Start	End
Item	Animal Control			39.242582 °	39.242582 °
				-121.637032 °	-121.637032 °
DWR ID	DWR_LD0009_01_f_2015_19				
Action/Comments					
No rodents visible, but rodent burrows visible; need to backfill and compact or grout burrows.

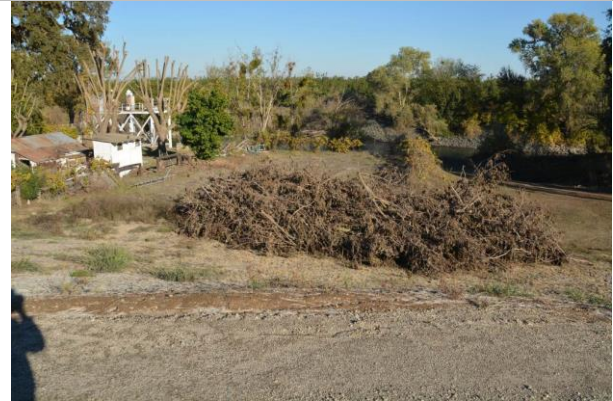
Photo 1 of 1 : FA_2015_LD0009_202_20_20151117_00017.jpg

LM Start	5.66	Rating **	M	Issue No.	20
LM End	5.66	Issue Type +	En	Location *	WS
Category	Earthen Levee			GPS Latitude/Longitude	
				Start	End
Item	Encroachments			39.247288 °	39.247288 °
				-121.637353 °	-121.637353 °
DWR ID	DWR_LD0009_01_f_2015_20				
Action/Comments					
Prunings					
Inspector Comments: Prunning debris stacked at toe of waterside levee.

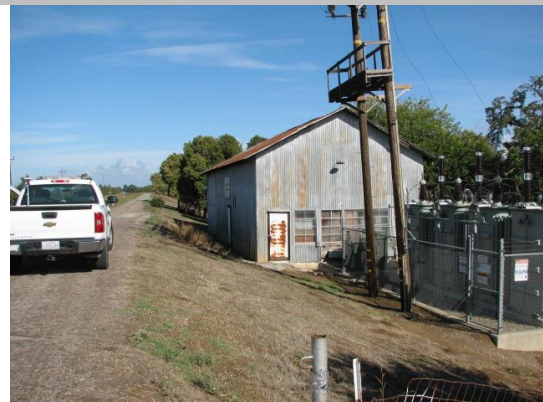
Photo 1 of 1 : FA_2015_LD0009_202_11_20151106_00003.jpg

LM Start	5.68	Rating **	U	Issue No.	11
LM End	5.68	Issue Type +	En	Location *	WS
Category	Earthen Levee			GPS Latitude/Longitude	
				Start	End
Item	Encroachments			39.247697 °	39.247697 °
				-121.637312 °	-121.637312 °
DWR ID	DWR_LD0009_01_s_2012_11				
Action/Comments					
Building

Building at the waterside toe.

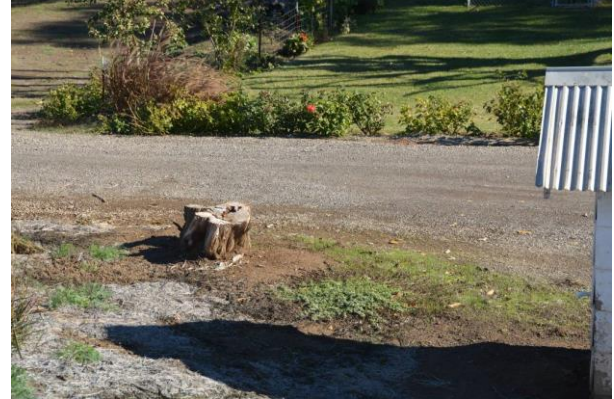
Photo 1 of 1 : FA_2015_LD0009_202_21_20151117_00018.jpg

LM Start	5.71	Rating **	N	Issue No.	21
LM End	5.71	Issue Type +	Ma	Location *	WS
Category	Earthen Levee			GPS Latitude/Longitude	
				Start	End
Item	Trim / Thin Trees			39.248009 °	39.248009
				-121.637306 °	-121.637306
DWR ID	DWR_LD0009_01_f_2015_21				
Action/Comments					
Tree stumps.					
Inspector Comments: Tree stump
