**Flood Control Project Maintenance
Levee Inspections**

Fall 2016 Levee Maintenance Deficiency Summary Report

Levee Inspection Report By Mile - Fall 2016

Levee District No. 0009 (Sutter County)

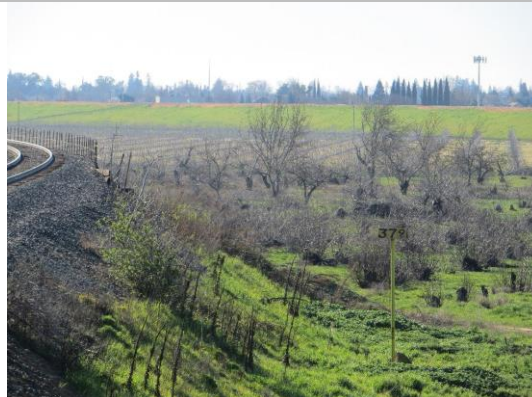
Photo 1 of 1 : UCIP_FA_2016_47098_16629.jpg

LM Start	0.00	Rating **	M	Issue No.	32
LM End	0.00	Issue Type +	En	Location *	WS
Category	Supplemental			GPS Latitude/Longitude	
				Start	End
Item	DWR UCIP Field Study			39.168909 °	39.168909 °
				-121.622629 °	-121.622629 °
DWR ID					
Comment Code					
Inspector Comment					
FS_ID:47098 DS_ID:17793 EP_NO: N/A Repair Type: Non-Urgent Crossing Status: Indicator Found UCIP Comments: Need better gas-line markings at levees. FIELD_STRUCT_DESC: 8-5/8-inch fuel line thru levee. Gasline marker found appr. 650 ft south of crossing on west side of RR. At location of sign, pipe assumed to run parrallel along west side of RR tracks before it crosses levee at LM 0, per Permit No. 3823. FS Date: 3/1/2013

Gasline marker found appr. 650 ft south of crossing at beginning of curve in RR bridge (west of RR).

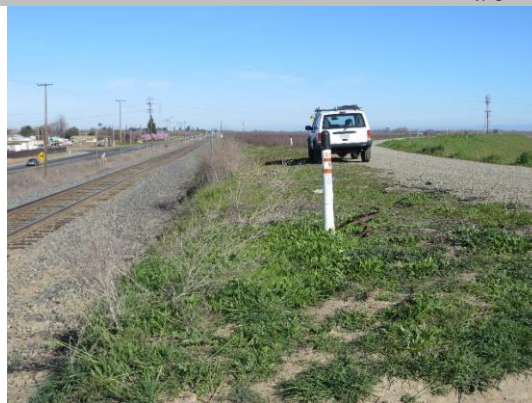
Photo 1 of 2 : UCIP_FA_2016_47090_40171.jpg

LM Start	0.01	Rating **	M	Issue No.	31
LM End	0.01	Issue Type +	En	Location *	WS
Category	Supplemental			GPS Latitude/Longitude	
				Start	End
Item	DWR UCIP Field Study			39.168871 °	39.168871 °
				-121.622514 °	-121.622514 °
DWR ID					
Comment Code					
Inspector Comment					
FS_ID:47090 DS_ID:22685 EP_NO: N/A Repair Type: Non-Urgent Crossing Status: Found UCIP Comments: No permit identified. FIELD_STRUCT_DESC: Fiber optic communication line at unknown depth below the crown. FS Date: 3/3/2013

Fiber optic line marker on LS shoulder.

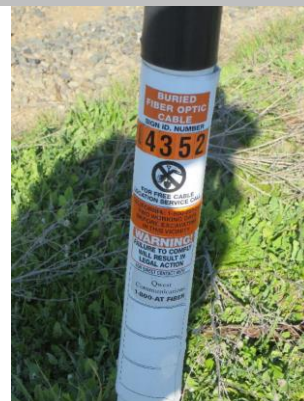
Photo 2 of 2 : UCIP_FA_2016_47090_40170.jpg

LM Start	0.01	Rating **	M	Issue No.	31 (cont)	
LM End	0.01	Issue Type +	En	Location *	WS	
Category	Supplemental			GPS Latitude/Longitude		
				Start		End
Item	DWR UCIP Field Study			39.168871 °		39.168871 °
				-121.622514 °		-121.622514 °
DWR ID						
Comment Code						
Inspector Comment						
FS_ID:47090 DS_ID:22685 EP_NO: N/A Repair Type: Non-Urgent Crossing Status: Found UCIP Comments: No permit identified. FIELD_STRUCT_DESC: Fiber optic communication line at unknown depth below the crown. FS Date: 3/3/2013

Fiber optic line marker on LS shoulder.

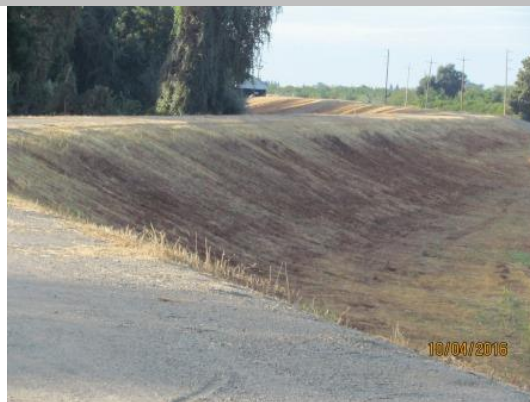
Photo 1 of 2 : FA_2016_LD0009_202_16_20161006_00026.jpg

LM Start	0.01	Rating **	A	Issue No.	16
LM End	6.24	Issue Type +	Ma	Location *	LS
Category	Earthen Levee			GPS Latitude/Longitude	
				Start	End
Item	Vegetation			39.168919 °	39.255752 °
				-121.622539 °	-121.636363 °
DWR ID	DWR_LD0009_01_f_2016_16				
Comment Code					
V1 : Control annual grass and weeds on the levee slopes and easements.					
Inspector Comment					
Well maintained annual vegetation. Fall 2016.

View of well maintained annual vegetation that is mowed on the landside looking downstream. Fall 2016.

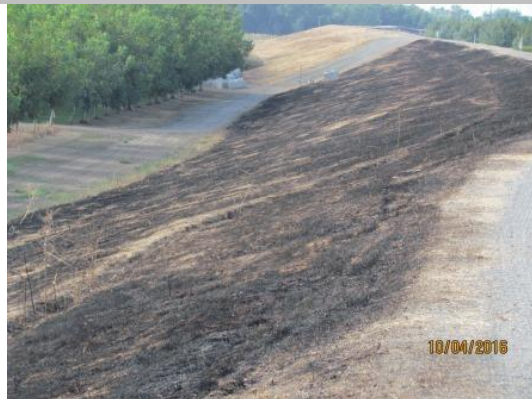
Photo 2 of 2 : FA_2016_LD0009_202_17_20161006_00034.jpg

LM Start	0.01	Rating **	A	Issue No.	17 (cont)	
LM End	6.24	Issue Type +	Ma	Location *	WS	
Category	Earthen Levee			GPS Latitude/Longitude		
				Start		End
Item	Vegetation			39.168919 °		39.255752 °
				-121.622540 °		-121.636363 °
DWR ID	DWR_LD0009_01_f_2016_17					
Comment Code						
V1 : Control annual grass and weeds on the levee slopes and easements.						
Inspector Comment						
Well maintained annual vegetation. Fall 2016.

View of well maintained annual vegetation that was burned on the waterside looking downstream. Fall 2016.

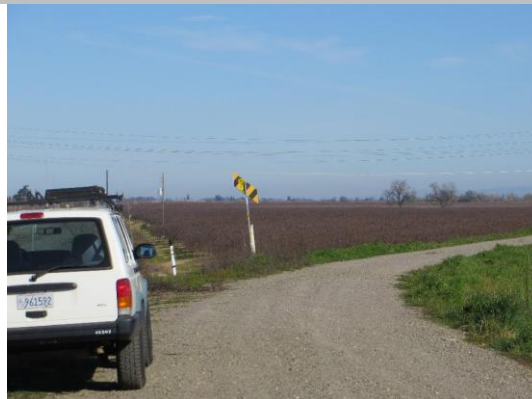
Photo 1 of 2 : UCIP_FA_2016_47099_16631.jpg

LM Start	0.05	Rating **	M	Issue No.	33
LM End	0.05	Issue Type +	En	Location *	WS
Category	Supplemental			GPS Latitude/Longitude	
				Start	End
Item	DWR UCIP Field Study			39.169419 °	39.169419 °
				-121.622631 °	-121.622631 °
DWR ID					
Comment Code					
Inspector Comment					
FS_ID:47099 DS_ID:17792 EP_NO: 3823 Repair Type: Non-Urgent Crossing Status: Indicator Found UCIP Comments: Need better gas-line markings at levees. FIELD_STRUCT_DESC: 8-5/8-inch fuel line along the landward shoulder, 2.6 feet below the crown. Gasline marker found on LS shoulder indicating location of crossing. Gasline marker also found apprx. 650 ft south of crossing on west side of RR tracks at beginning of curve in RR bridge, indicating location where pipe runs parrallel to RR before it crosses levee at this location. FS Date: 3/1/2013

Gasline marker found on LS shoulder.

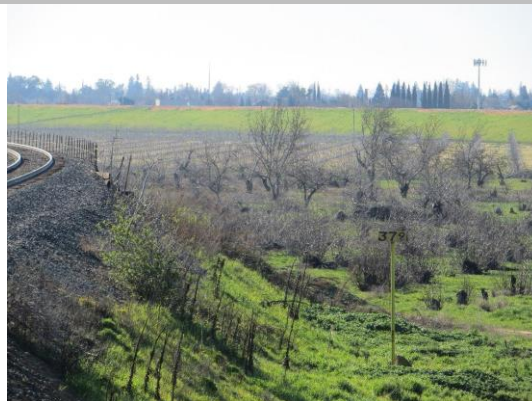
Photo 2 of 2 : UCIP_FA_2016_47099_74900.jpg

Gasline marker found apprx. 650 ft south of crossing on west side of RR.

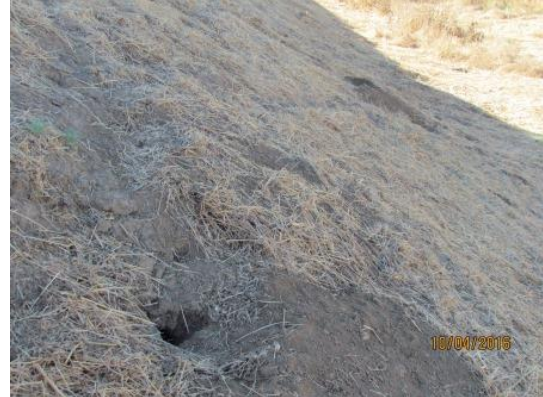
Photo 1 of 1 : FA_2016_LD0009_202_18_20161006_00042.jpg

LM Start	0.09	Rating **	M	Issue No.	18
LM End	0.09	Issue Type +	Ma	Location *	LS
Category	Earthen Levee			GPS Latitude/Longitude	
				Start	End
Item	Animal Control			39.170064 °	39.170064 °
				-121.622563 °	-121.622563 °
DWR ID	DWR_LD0009_01_f_2016_18				
Comment Code					
A3 : No rodents visible, but rodent burrows visible; need to backfill and compact or grout burrows.					
Inspector Comment					
Rodent holes that need to be backfilled.

View of rodent holes that need to be backfilled, no sign of rodents at time of inspection. Fall 2016.

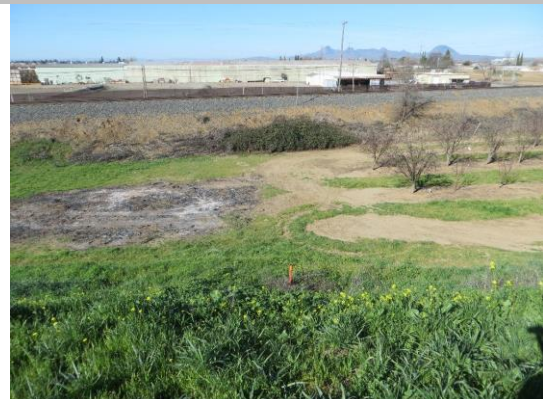
Photo 1 of 2 : UCIP_FA_2016_9596_16633.jpg

LM Start	0.10	Rating **	M	Issue No.	24
LM End	0.10	Issue Type +	En	Location *	LS
Category	Supplemental			GPS Latitude/Longitude	
				Start	End
Item	DWR UCIP Field Study			39.170153 °	39.170153 °
				-121.622546 °	-121.622546 °
DWR ID					
Comment Code					
Inspector Comment					
FS_ID:9596 DS_ID:17790 EP_NO: N/A Repair Type: Non-Urgent Crossing Status: Indicator Found UCIP Comments: Need better gas-line markings at levees. FIELD_STRUCT_DESC: 16-inch gas line through the levee, 3.5 feet below the crown. Marker on LS toe. Permit No. 1913, 1954, PG&E. FS Date: 3/1/2013

Gasline marker at LS toe.

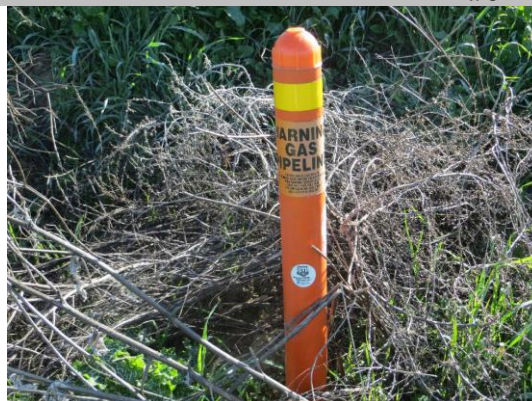
Photo 2 of 2 : UCIP_FA_2016_9596_16632.jpg

LM Start	0.10	Rating **	M	Issue No.	24 (cont)	
LM End	0.10	Issue Type +	En	Location *	LS	
Category	Supplemental			GPS Latitude/Longitude		
				Start		End
Item	DWR UCIP Field Study			39.170153 °		39.170153 °
				-121.622546 °		-121.622546 °
DWR ID						
Comment Code						
Inspector Comment						
FS_ID:9596 DS_ID:17790 EP_NO: N/A Repair Type: Non-Urgent Crossing Status: Indicator Found UCIP Comments: Need better gas-line markings at levees. FIELD_STRUCT_DESC: 16-inch gas line through the levee, 3.5 feet below the crown. Marker on LS toe. Permit No. 1913, 1954, PG&E. FS Date: 3/1/2013

Close up of Gasline marker at LS toe.

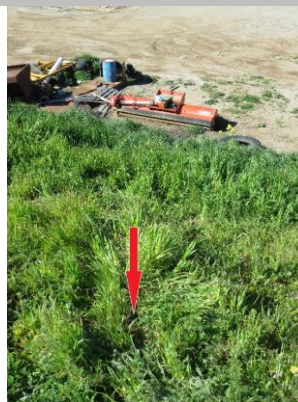
Photo 1 of 2 : UCIP_FA_2016_9598_16635.jpg

LM Start	0.96	Rating **	M	Issue No.	25
LM End	0.96	Issue Type +	En	Location *	LS
Category	Supplemental			GPS Latitude/Longitude	
				Start	End
Item	DWR UCIP Field Study			39.182607 °	39.182607 °
				-121.620775 °	-121.620775 °
DWR ID					
Comment Code					
Inspector Comment					
FS_ID:9598 DS_ID:17788 EP_NO: N/A Repair Type: Non-Urgent Crossing Status: Found UCIP Comments: Pipe needs to be removed from levee crown. FIELD_STRUCT_DESC: 3-inch steel pipe of an unknown type through the levee at the crown. [Additional Reference(s): DWR Levee Logs, 2005]. FS Date: 3/1/2013

Pipe at crown on LS shoulder.

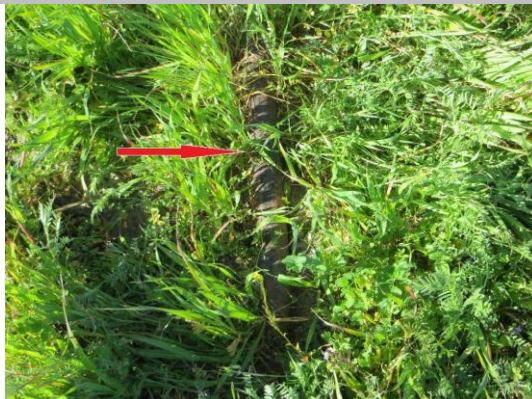
Photo 2 of 2 : UCIP_FA_2016_9598_16634.jpg

LM Start	0.96	Rating **	M	Issue No.	25 (cont)
LM End	0.96	Issue Type +	En	Location *	LS
Category	Supplemental			GPS Latitude/Longitude	
				Start	End
Item	DWR UCIP Field Study			39.182607 °	39.182607 °
				-121.620775 °	-121.620775 °
DWR ID					
Comment Code					
Inspector Comment					
FS_ID:9598 DS_ID:17788 EP_NO: N/A Repair Type: Non-Urgent Crossing Status: Found UCIP Comments: Pipe needs to be removed from levee crown. FIELD_STRUCT_DESC: 3-inch steel pipe of an unknown type through the levee at the crown. [Additional Reference(s): DWR Levee Logs, 2005]. FS Date: 3/1/2013

Pipe at crown on LS shoulder.

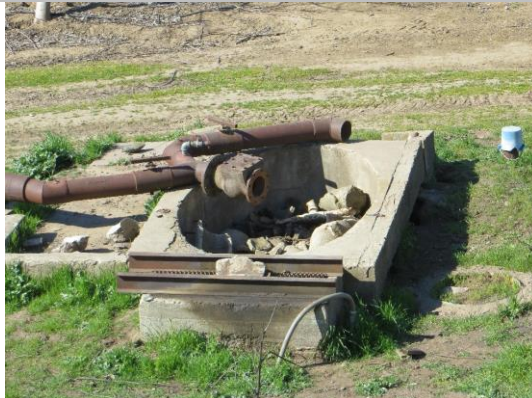
Photo 1 of 2 : UCIP_FA_2016_9601_16637.jpg

LM Start	1.33	Rating **	M	Issue No.	26
LM End	1.33	Issue Type +	En	Location *	LS
Category	Supplemental			GPS Latitude/Longitude	
				Start	End
Item	DWR UCIP Field Study			39.187995 °	39.187995 °
				-121.620706 °	-121.620706 °
DWR ID					
Comment Code					
Inspector Comment					
FS_ID:9601 DS_ID:17785 EP_NO: N/A Repair Type: Non-Urgent Crossing Status: Indicator Found UCIP Comments: Unable to determine type of abandonment. FIELD_STRUCT_DESC: *ABANDONED* 10-inch steel pipe through the levee, 2.8 feet below the crown. Waterward end open. Steel plate welded on landward end. Pump and standpipe at the landward toe. Permit No. 1407, 1949. FS Date: 3/1/2013

Abandoned Pump platform on LS toe.

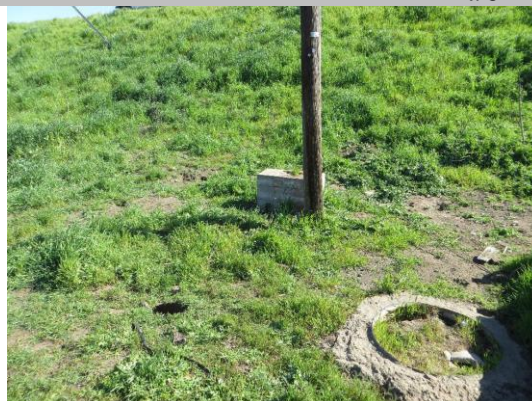
Photo 2 of 2 : UCIP_FA_2016_9601_16636.jpg

LM Start	1.33	Rating **	M	Issue No.	26 (cont)	
LM End	1.33	Issue Type +	En	Location *	LS	
Category	Supplemental			GPS Latitude/Longitude		
				Start	End	
Item	DWR UCIP Field Study			39.187995 °	39.187995 °	
				-121.620706 °	-121.620706 °	
DWR ID						
Comment Code						
Inspector Comment						
FS_ID:9601 DS_ID:17785 EP_NO: N/A Repair Type: Non-Urgent Crossing Status: Indicator Found UCIP Comments: Unable to determine type of abandonment. FIELD_STRUCT_DESC: *ABANDONED* 10-inch steel pipe through the levee, 2.8 feet below the crown. Waterward end open. Steel plate welded on landward end. Pump and standpipe at the landward toe. Permit No. 1407, 1949. FS Date: 3/1/2013

JP at pump on LS toe.

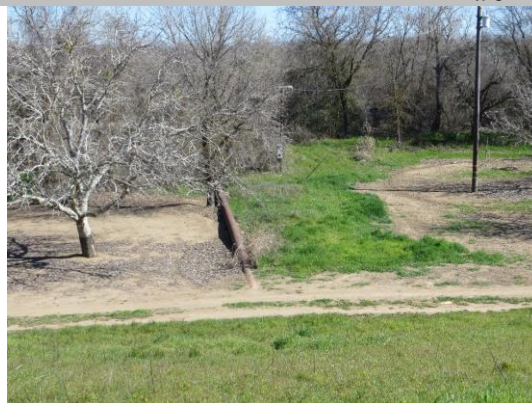
Photo 1 of 2 : UCIP_FA_2016_41063_16640.jpg

LM Start	1.88	Rating **	M	Issue No.	29
LM End	1.88	Issue Type +	En	Location *	LS
Category	Supplemental			GPS Latitude/Longitude	
				Start	End
Item	DWR UCIP Field Study			39.195241 °	39.195241 °
				-121.624165 °	-121.624165 °
DWR ID					
Comment Code					
Inspector Comment					
FS_ID:41063 DS_ID:17784 EP_NO: 1119 Repair Type: Non-Urgent Crossing Status: Found UCIP Comments: Pipe needs to be repaired or properly abandoned. FIELD_STRUCT_DESC: 16-inch steel pipe through levee, 3.0 feet below crown. Pump in pump house on channel bank. Gate valve on the waterward end. Concrete standpipe and distribution box at the landward toe. (Permit No. 1119, 06/08/1946) FS Date: 3/1/2013

Pipe on WS toe.

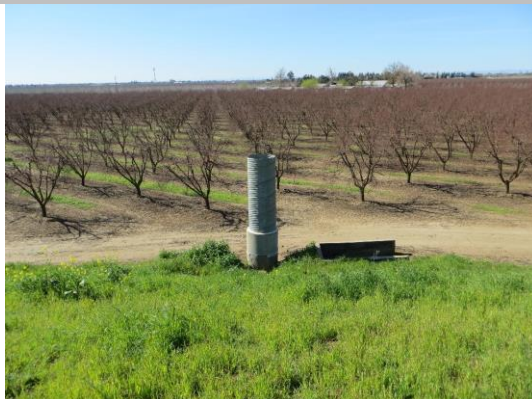
Photo 2 of 2 : UCIP_FA_2016_41063_16639.jpg

LM Start	1.88	Rating **	M	Issue No.	29 (cont)
LM End	1.88	Issue Type +	En	Location *	LS
Category	Supplemental			GPS Latitude/Longitude	
				Start	End
Item	DWR UCIP Field Study			39.195241 °	39.195241 °
				-121.624165 °	-121.624165 °
DWR ID					
Comment Code					
Inspector Comment					
FS_ID:41063 DS_ID:17784 EP_NO: 1119 Repair Type: Non-Urgent Crossing Status: Found UCIP Comments: Pipe needs to be repaired or properly abandoned. FIELD_STRUCT_DESC: 16-inch steel pipe through levee, 3.0 feet below crown. Pump in pump house on channel bank. Gate valve on the waterward end. Concrete standpipe and distribution box at the landward toe. (Permit No. 1119, 06/08/1946) FS Date: 3/1/2013

Concrete and CMP riser on LS toe.

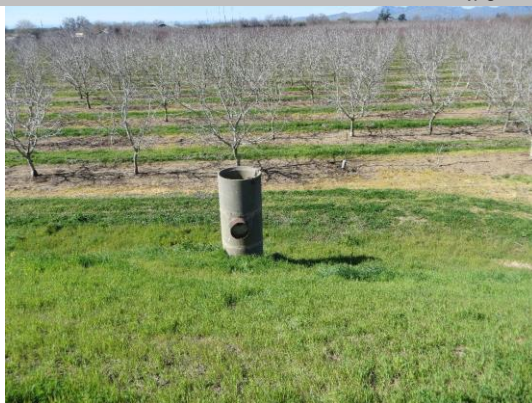
Photo 1 of 2 : UCIP_FA_2016_9604_16649.jpg

LM Start	2.56	Rating **	U	Issue No.	27
LM End	2.56	Issue Type +	En	Location *	LS
Category	Supplemental			GPS Latitude/Longitude	
				Start	End
Item	DWR UCIP Field Study			39.203936 °	39.203936 °
				-121.629521 °	-121.629521 °
DWR ID					
Comment Code					
Inspector Comment					
FS_ID:9604 DS_ID:17783 EP_NO: N/A Repair Type: Urgent Crossing Status: Found UCIP Comments: Pipe appears abandoned as pump is dosconnected and open on waterside. Pipe should be properly abandoned. FIELD_STRUCT_DESC: 18-inch steel pipe through levee, 8 feet below crown Pump and gate valve in pump house on channel bank. Concrete well on the bank. Siphon breaker in CMP riser on landward slope. (O+M 1955) FS Date: 3/1/2013

CMP riser on LS toe.

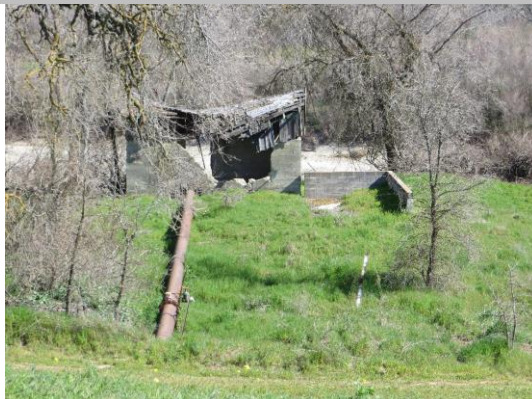
Photo 2 of 2 : UCIP_FA_2016_9604_16648.jpg

LM Start	2.56	Rating **	U	Issue No.	27 (cont)
LM End	2.56	Issue Type +	En	Location *	LS
Category	Supplemental			GPS Latitude/Longitude	
				Start	End
Item	DWR UCIP Field Study			39.203936 °	39.203936 °
				-121.629521 °	-121.629521 °
DWR ID					
Comment Code					
Inspector Comment					
FS_ID:9604					
DS_ID:17783					
EP_NO: N/A					
Repair Type: Urgent					
Crossing Status: Found					
UCIP Comments: Pipe appears abandoned as pump is dosconnected and open on waterside. Pipe should be properly abandoned.					
FIELD_STRUCT_DESC: 18-inch steel pipe through levee, 8 feet below crown Pump and gate valve in pump house on channel bank. Concrete well on the bank. Siphon breaker in CMP riser on landward slope. (O+M 1955)					
FS Date: 3/1/2013

Pipe and pumphouse on WS toe/bench.

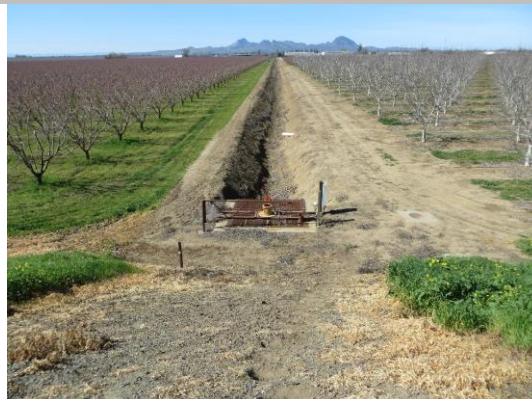
Photo 1 of 2 : UCIP_FA_2016_41223_16653.jpg

LM Start	3.49	Rating **	U	Issue No.	28
LM End	3.49	Issue Type +	En	Location *	LS
Category	Supplemental			GPS Latitude/Longitude	
				Start	End
Item	DWR UCIP Field Study			39.217363 °	39.217363 °
				-121.628434 °	-121.628434 °
DWR ID					
Comment Code					
Inspector Comment					
FS_ID:41223					
DS_ID:17782					
EP_NO: 13657					
Repair Type: Urgent					
Crossing Status: Found					
UCIP Comments: Needs flapgate on WS outlet. Pump is missing.					
FIELD_STRUCT_DESC: 20-inch interior and exterior coated steel					
drainage pipe through the levee, 2 feet below the crown. Siphon					
breaker on the waterside (WS) shoulder. Pump with a trash rack is					
located at the landside (LS) toe, not found. (Permit No. 13657, 1983 -					
Micheli). [Additional Reference(s): DWR Levee Logs, 2005].					
FS Date: 10/15/2014

LS at trash rack and pumping plant.

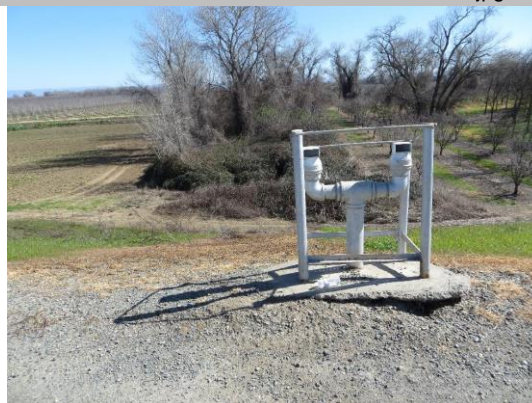
Photo 2 of 2 : UCIP_FA_2016_41223_16652.jpg

Siphon Breakers on WS shoulder.

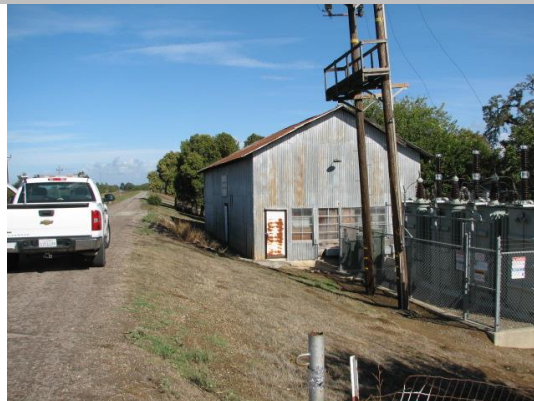
Photo 1 of 2 : FA_2016_LD0009_202_11_20160906_00001.jpg

LM Start	5.68	Rating **	M	Issue No.	11
LM End	5.68	Issue Type +	En	Location *	WS
Category	Earthen Levee			GPS Latitude/Longitude	
				Start	End
Item	Encroachments			39.247697 °	39.247697 °
				-121.637312 °	-121.637312 °
DWR ID	DWR_LD0009_01_s _ 2012_11				
Comment Code					
BU : Building					
Inspector Comment

Building at the waterside toe. Spring 2016.

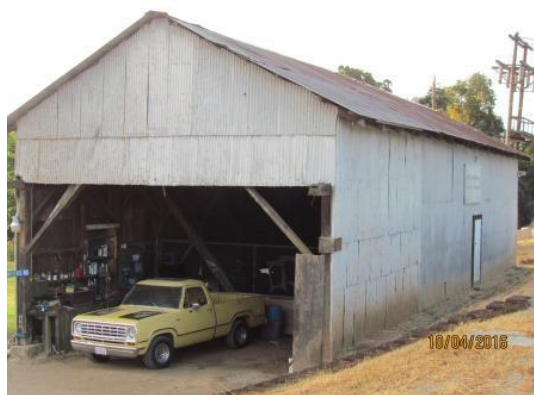
Photo 2 of 2 : FA_2016_LD0009_202_11_20161006_00039.jpg

Building at the waterside toe looking downstream. Fall 2016
