**Flood Control Project Maintenance
Levee Inspections**

Fall 2017 Levee Maintenance Deficiency Summary Report

Levee District No. 0009 (Sutter County)

Levee Inspection Report By Mile - Fall 2017

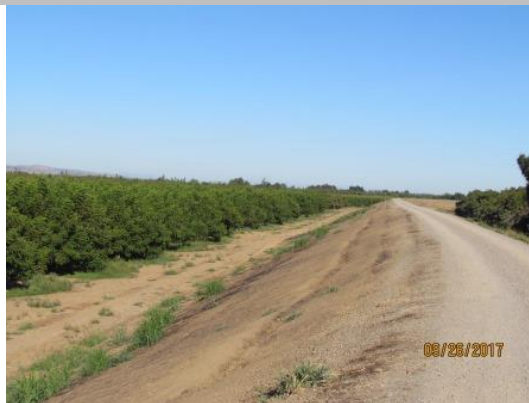
Photo 1 of 2 : FA_2017_LD0009_202_1_20170929_00006.jpg

LM Start	0.09	Rating **	A	Issue No.	1
LM End	6.24	Issue Type +	Ma	Location *	LS
Category	Earthen Levee			GPS Latitude/Longitude	
				Start	End
Item	Vegetation			39.170037 °	39.255775 °
				-121.622573 °	-121.636385 °
DWR ID	DWR_LD0009_01_f_2017_1				
Comment Code					
V1 : Control annual grass and weeds on the levee slopes and easements.					
Inspector Comment					
Well maintained annual vegetation, Fall 2017.

View looking upstream on the landside of the well maintained annual vegetation, Fall 2017.

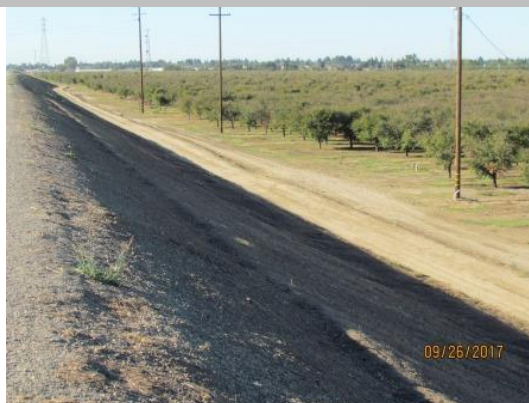
Photo 2 of 2 : FA_2017_LD0009_202_1_20170929_00007.jpg

View looking downstream on the landside of the well maintained annual vegetation, Fall 2017.

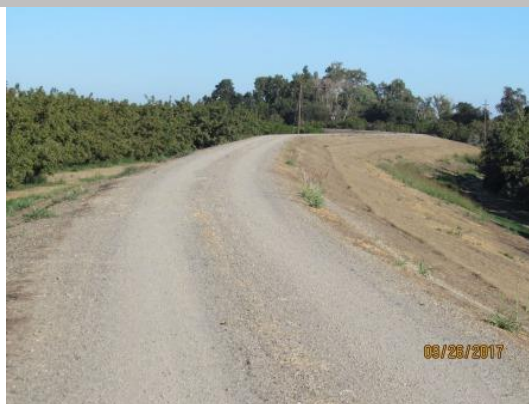
Photo 1 of 2 : FA_2017_LD0009_202_2_20170929_00009.jpg

LM Start	0.09	Rating **	A	Issue No.	2
LM End	6.24	Issue Type +	Ma	Location *	WS
Category	Earthen Levee			GPS Latitude/Longitude	
				Start	End
Item	Vegetation			39.170037 °	39.255775 °
				-121.622573 °	-121.636385 °
DWR ID	DWR_LD0009_01_f_2017_2				
Comment Code					
V1 : Control annual grass and weeds on the levee slopes and easements.					
Inspector Comment					
Well maintained annual vegetation, Fall 2017.

View looking upstream on the waterside of the well maintained annual vegetation, Fall 2017.

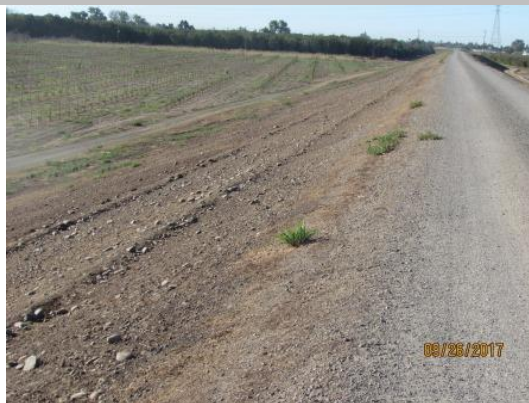
Photo 2 of 2 : FA_2017_LD0009_202_2_20170929_00008.jpg

LM Start	0.09	Rating **	A	Issue No.	2 (cont)	
LM End	6.24	Issue Type +	Ma	Location *	WS	
Category	Earthen Levee			GPS Latitude/Longitude		
				Start		End
Item	Vegetation			39.170037 °		39.255775 °
				-121.622573 °		-121.636385 °
DWR ID	DWR_LD0009_01_f_2017_2					
Comment Code						
V1 : Control annual grass and weeds on the levee slopes and easements.						
Inspector Comment						
Well maintained annual vegetation, Fall 2017.

View looking downstream on the waterside of the well maintained annual vegetation, Fall 2017.

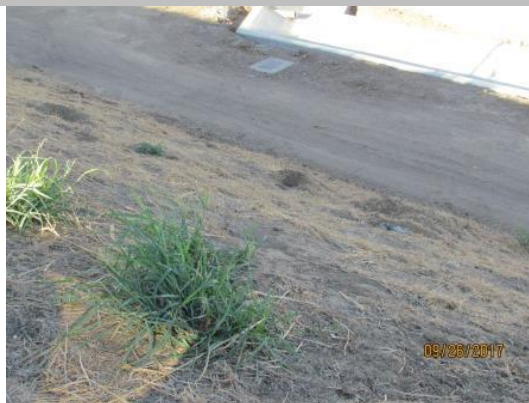
Photo 1 of 1 : FA_2017_LD0009_202_18_20170929_00010.jpg

LM Start	0.09	Rating **	M	Issue No.	18
LM End	0.09	Issue Type +	Ma	Location *	LS
Category	Earthen Levee			GPS Latitude/Longitude	
				Start	End
Item	Animal Control			39.170064 °	39.170064 °
				-121.622563 °	-121.622563 °
DWR ID	DWR_LD0009_01_f_2016_18				
Comment Code					
A3 : No rodents visible, but rodent burrows visible; need to backfill and compact or grout burrows.					
Inspector Comment					
Rodent activity was observed, holes need to be backfilled. Fall 2017.

View on landside of rodent activity and holes, Fall 2017.

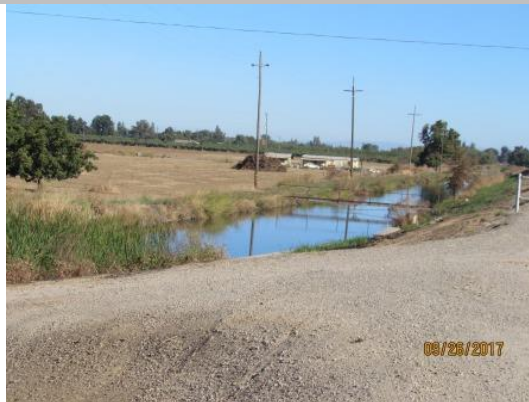
Photo 1 of 2 : FA_2017_LD0009_202_20_20170929_00011.jpg

LM Start	5.66	Rating **	M	Issue No.	20
LM End	6.00	Issue Type +	En	Location *	LS
Category	Earthen Levee			GPS Latitude/Longitude	
				Start	End
Item	Encroachments			39.247349 °	39.252258 °
				-121.637341 °	-121.637077 °
DWR ID	DWR_LD0009_01_f_2016_20				
Comment Code					
DT : Ditch					
Inspector Comment

View of ditch at the toe of the landside, looking upstream, Fall 2017.

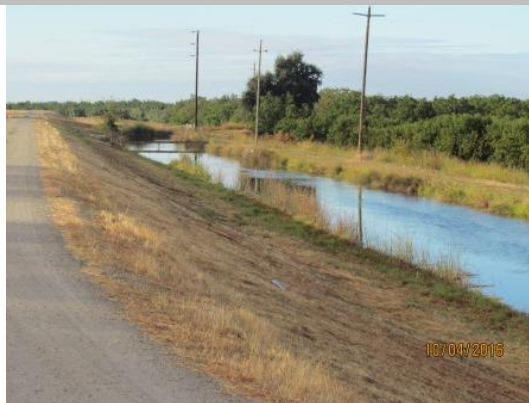
Photo 2 of 2 : FA_2017_LD0009_202_20_20170911_00004.jpg

View of ditch at the toe of the landside, looking downstream.

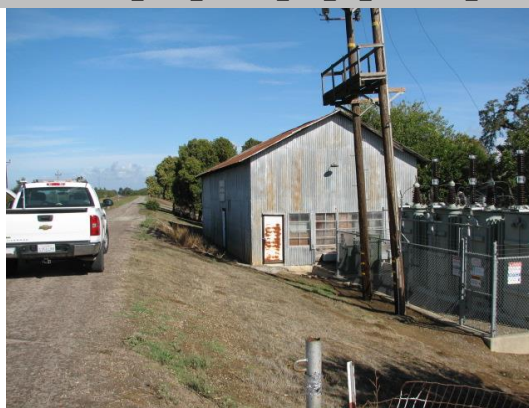
Photo 1 of 2 : FA_2017_LD0009_202_11_20170911_00001.jpg

LM Start	5.68	Rating **	M	Issue No.	11
LM End	5.68	Issue Type +	En	Location *	WS
Category	Earthen Levee			GPS Latitude/Longitude	
				Start	End
Item	Encroachments			39.247697 °	39.247697 °
				-121.637312 °	-121.637312 °
DWR ID	DWR_LD0009_01_s_2012_11				
Comment Code					
BU : Building					
Inspector Comment

Building at the waterside toe.

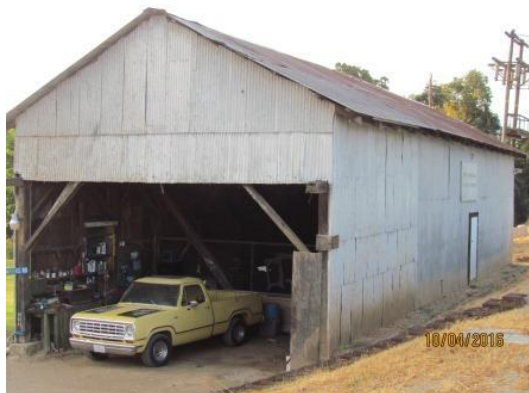
Photo 2 of 2 : FA_2017_LD0009_202_11_20170911_00002.jpg

Building at the waterside toe looking downstream.
