## Flood Control Project Maintenance Levee Inspections

### Fall 2020 Levee Maintenance Deficiency Summary Report

**Levee District No. 0009 (Sutter County)**

Waterway	Bank	Unit Miles	Inspection Start/End	Inspector
Unit No. 01 Sutter County, Feather River	Right	6.25	10/13/2020 10/13/2020	Brooks Weisser

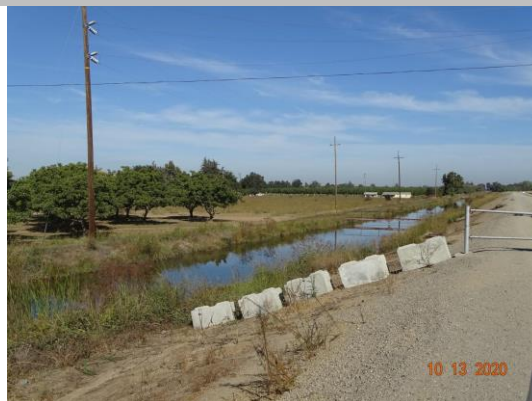
Photo 1 of 1 : FA\_2020\_LD0009\_202\_20\_20201019\_00003.jpg

LM Start	5.66	Rating **	M	Issue No.	20
LM End	6.00	Issue Type +	En	Location *	LS
Category	Earthen Levee			GPS Latitude/Longitude	
				Start	End
Item	Encroachments			39.247349 °	39.252258 °
				-121.637341 °	-121.637077 °
DWR ID	DWR_LD0009_01_f_2016_20				
Comment Code					
DT : Ditch					
Inspector Comment					
A ditch is located at the toe of the levee on the landside.

View looking upstream of ditch at the toe of the levee on the landside, Fall 2020.
