**Flood Control Project Maintenance
Levee Inspections**

Fall 2021 Levee Maintenance Deficiency Summary Report

Levee District No. 0009 (Sutter County)

Levee Inspection Report By Mile - Fall 2021

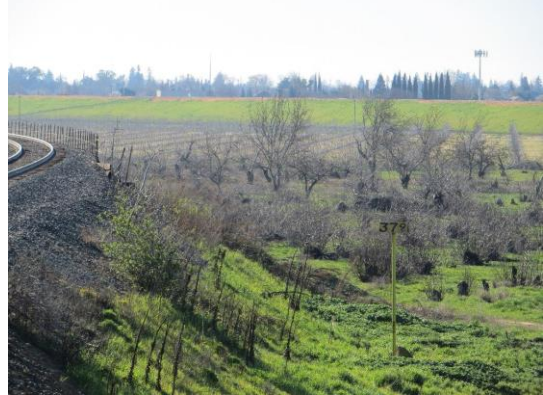
Photo 2 of 3 : UCIP_FA_2021_65983_74900.jpg

Gasline marker found appr. 650 ft south of crossing on west side of RR.

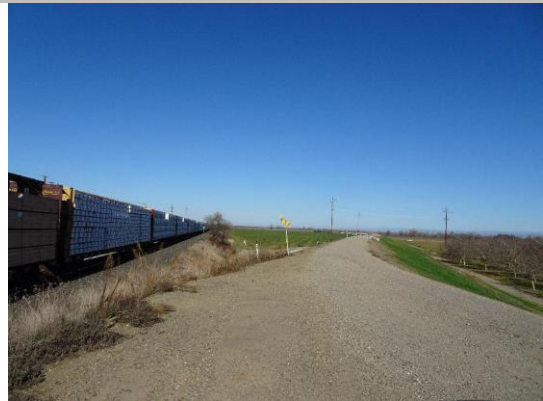
Photo 3 of 3 : UCIP_FA_2021_65983_98248.jpg

Overview of levee crown looking upstream towards pipe crossing.

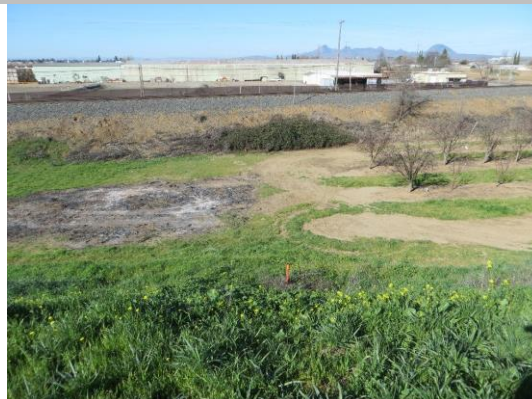
Photo 1 of 3 : UCIP_FA_2021_65984_16633.jpg

DS_ID:17790
FS_ID:65984
EP_NO: 1913
Repair Type: Non-Urgent
EVAL Issue: Safety Issue
Crossing Status: Found
UCIP Comments: 01/20/2021 Record has been updated from No Action Needed to Non-Urgent. No maintenance or inspection records were made available to confirm line integrity through the levee. Multiple markers visible on LS shoulder and toe. Need to contact owner to obtain as-builts to determine alignment, maintenance and inspection records. (O. Magana - DWR UCIP)09/05/2017 Need to coordinate with LMA to determine if work has been completed through this section of the levee. Record drawings show 16-inch line present above the 200-year water surface elevation (WSE). Feather River Project Improvements began at Station (Sta) 844+75 (LD0001S about LM 10.70) to Sta 1433+83 (LD0009 about LM 5.74), refer to record drawings for the Feather River West Levee Improvement Plans Station 844+75 to 1433+83, Volume 3 project details. Project details include levee degrade and reconstruction with cutoff wall and existing cutoff wall sections throughout project limits. (DWR UCIP – O. Magana)12/01/2016 Small section at the beginning of the levee segment is still under construction and should be completed by 2017 according to LMA's contact Mike Morris and David Schmidl. Crossing is scheduled to be protected-in-place as referenced in the Feather River West Levee Improvements. (DWR UCIP – O. Magana)03/01/2013 Need better gas-line markings at levees. (W. Wylie - DWR UCIP) FIELD_STRUCT_DESC: 16-inch steel gas line through the levee, 3.5 feet below the crown. Marker is visible on the landside (LS) toe. (16-inch pipe authorized under Permit No. 1913, 1954 – Pacific Gas and Electric Company [PG&E]; related 16-inch pipe installed approximately one mile upstream from the State Highway No. 20 bridge at Yuba City in LD0001S authorized under Permit No. 1924, 1954 – PG&E) [Additional Reference(s): DWR Levee Logs, 1993 and 2005] [Additional Reference(s): DWR Levee Logs, 1993 and 2005. Sutter Butte Flood Control Agency (SBFCA) Feather River West Levee Project, Volume 3 of 6 Feather River West Levee Improvement Plans STA 844+75 to 1433+83, 2016, Record Drawings, CoNo 01-2013C_Vol3_Full-Size_Record Drawings, Sta 1135+35, Drawing No. G-111, Sheet 27, and C-130, Sheet 68]

Gasline marker at LS toe.

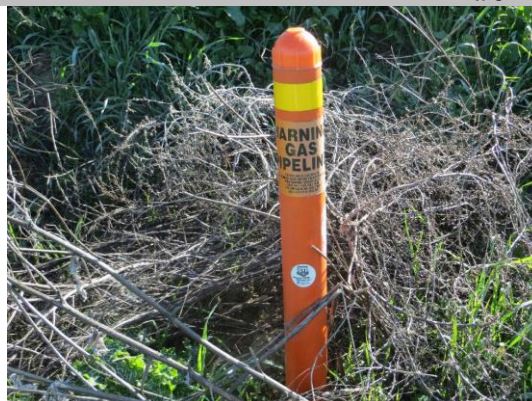
Photo 2 of 3 : UCIP_FA_2021_65984_16632.jpg

Close up of Gasline marker at LS toe.

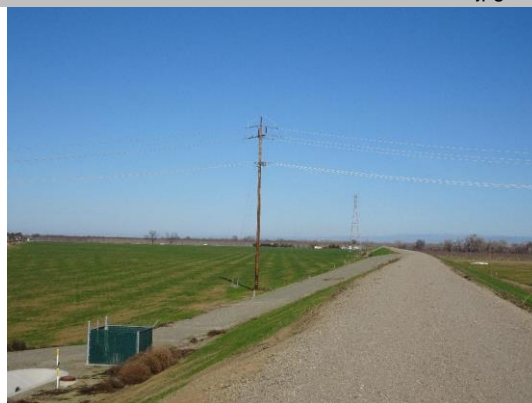
Photo 3 of 3 : UCIP_FA_2021_65984_98256.jpg

Overview of levee crown looking upstream towards pipe crossing.

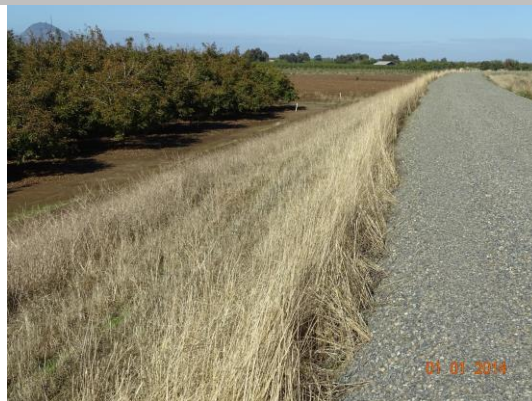
Photo 1 of 1 : FA_2021_LD0009_202_7_20211028_00011.jpg

LM Start	2.01	Rating **	M	Issue No.	7
LM End	2.17	Issue Type +	Ma	Location *	LS
Category	Earthen Levee			GPS Latitude/Longitude	
				Start	End
Item	Vegetation			39.196541 °	39.198458 °
				-121.625912 °	-121.627612 °
DWR ID	DWR_LD0009_01_f_2021_7				
Comment Code					
V1 : Control annual grass and weeds on the levee slopes and easements.					
Inspector Comment					
Control the annual vegetation, Fall 2021.

Control the annual vegetation, Fall 2021.

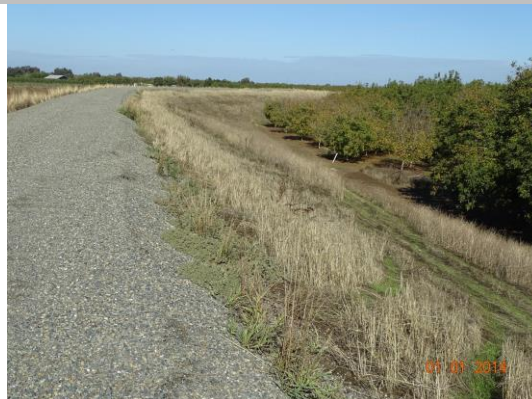
Photo 1 of 1 : FA_2021_LD0009_202_8_20211028_00012.jpg

LM Start	2.01	Rating **	M	Issue No.	8
LM End	2.17	Issue Type +	Ma	Location *	WS
Category	Earthen Levee			GPS Latitude/Longitude	
				Start	End
Item	Vegetation			39.196547 °	39.198468 °
				-121.625911 °	-121.627619 °
DWR ID	DWR_LD0009_01_f_2021_8				
Comment Code					
V1 : Control annual grass and weeds on the levee slopes and easements.					
Inspector Comment					
Control the annual vegetation, Fall 2021.

Control the annual vegetation, Fall 2021.

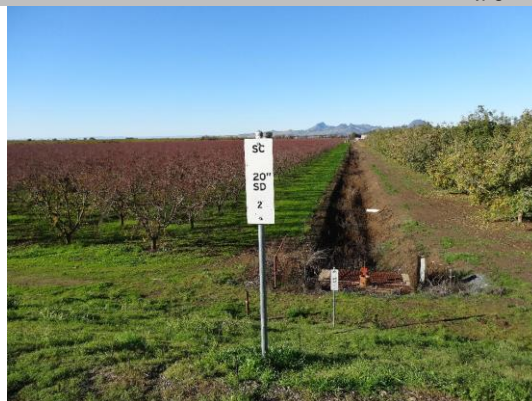
Photo 1 of 3 : UCIP_FA_2021_66015_77453.jpg

Comment Code					
Inspector Comment					
DS_ID:25521 FS_ID:66015 EP_NO: N/A Repair Type: Non-Urgent EVAL Issue: Levee Improvement Project Crossing Status: Found UCIP Comments: 01/20/2021 Record has been updated from No Action Needed to Non-Urgent. No permit was found authorizing the installation of this structure. CVFPB will need to review crossing to determine owner. (O. Magana - DWR UCIP)12/01/2016 New pipe section through the levee installed, pipe upgraded as part of the SBFCA Feather River West Levee Project. Need to coordinate with the CVFPB to identify the new permit issued for pipe upgrade. (DWR UCIP – O. Magana) FIELD_STRUCT_DESC: 20-inch cement mortar lined and coated steel drainage pipe through the levee, about 2 feet below the crown. Valve utility box (5-foot by 5-foot by 4-foot) with cover located on the waterside (WS) shoulder. Siphon breaker and air relief valve located inside utility box. 20-inch pipe ties to existing 20-inch pressure pipe on the LS. Paddle markers visible on landside (LS) near shoulder and toe. Existing storm drain pump station located on the LS toe at storm drain canal. Concrete headwall with guardrail and rip rap located at WS outlet. Paddle marker visible on WS toe. Flap gate located on the WS outlet. (new 20-inch pipe installed in 2015, no updated permit has been issued, owner of new pipe is Micheli Farms; existing 20-inch pipe was authorized under Permit No. 13657, 1983 - Justin Micheli, pipe through the levee was removed and replaced in 2015). [Additional Reference(s): DWR Levee Logs, 1993 and 2005. Sutter Butte Flood Control Agency (SBFCA) Feather River West Levee Project, Volume 3 of 6 Feather River West Levee Improvement Plans STA 844+75 to 1433+83, 2016, Record Drawings, CoNo 01-2013C_Vol3_Full-Size_Record Drawings, Sta 1314+80, Drawing No. G-117, Sheet 33, C-148, Sheet 86, and C-535, Sheet 235. SBFCA FRWLP improvements for the following Local Maintaining Agencies (LMAs) include ST0005, MA0007, MA0016, LD0009, and LD0001S work authorized under Permit No(s). 18793, 18793-1, 18793-2, 18793-3, 18793-4, 18793-5, 18793-6]. FS Date: 1/20/2021

LS view: paddle markers located on LS shoulder and LS toe. Pump and concrete box located inside canal.

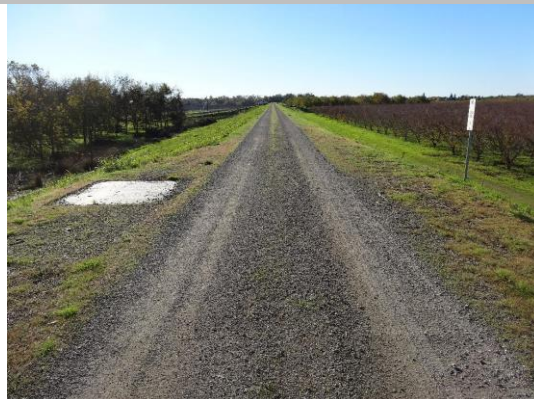
Photo 2 of 3 : UCIP_FA_2021_66015_77459.jpg

Overview of levee crown looking downstream at crossing.

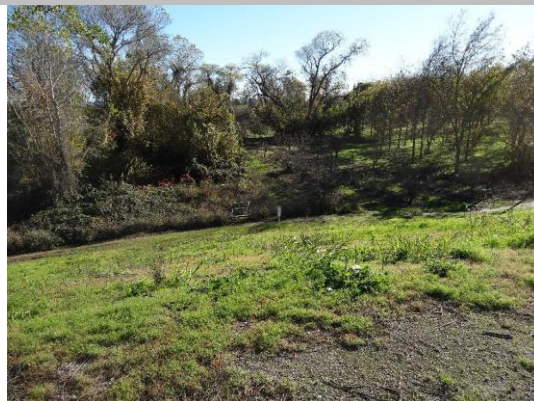
Photo 3 of 3 : UCIP_FA_2021_66015_77456.jpg

WS view: overview of WS slope and berm.

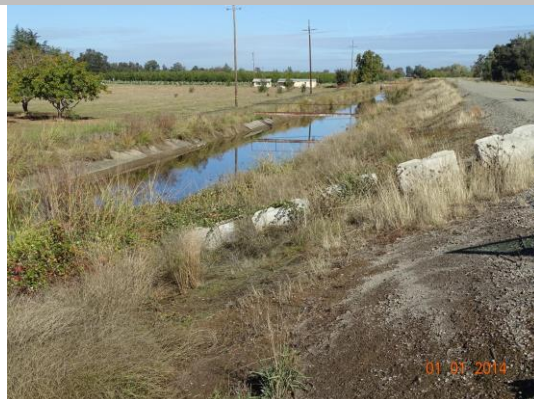
Photo 1 of 1 : FA_2021_LD0009_202_20_20211028_00013.jpg

LM Start	5.66	Rating **	M	Issue No.	20
LM End	6.00	Issue Type +	En	Location *	LS
Category	Earthen Levee			GPS Latitude/Longitude	
				Start	End
Item	Encroachments			39.247349 °	39.252258 °
				-121.637341 °	-121.637077 °
DWR ID	DWR_LD0009_01_f_2016_20				
Comment Code					
DT : Ditch					
Inspector Comment					
A ditch is located at the toe of the levee on the landside.

View looking upstream of ditch at the toe of the levee on the landside, Fall 2021.
