**Flood Control Project Maintenance
Levee Inspections
Fall 2022 Levee Maintenance Deficiency Summary Report**

Sacramento River Basin

Levee District No. 0009 (Sutter County)

Levee Inspection Report By Mile - Fall 2022

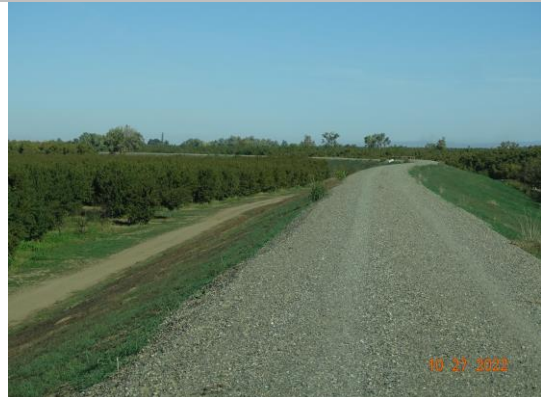
Photo 1 of 1 : FA_2022_LD0009_202_7_20221028_00011.jpg

LM Start	0.01	Rating **	A	Issue No.	7
LM End	5.66	Issue Type +	Ma	Location *	LS
Category	Earthen Levee			GPS Latitude/Longitude	
				Start	End
Item	Vegetation			39.168920 °	39.247377 °
				-121.622509 °	-121.637351 °
DWR ID	DWR_LD0009_01_f_2022_7				
Comment Code					
V1 : Control annual grass and weeds on the levee slopes and easements.					
Inspector Comment					
Annual vegetation is well maintained, Fall 2022.

View of annual vegetation on the landside slope, Fall 2022.

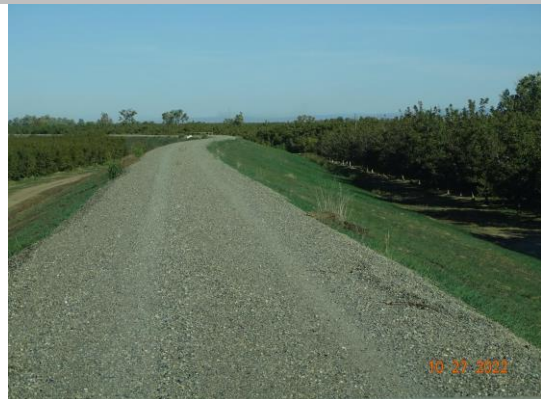
Photo 1 of 1 : FA_2022_LD0009_202_8_20221028_00012.jpg

LM Start	0.01	Rating **	A	Issue No.	8
LM End	5.67	Issue Type +	Ma	Location *	WS
Category	Earthen Levee			GPS Latitude/Longitude	
				Start	End
Item	Vegetation			39.168920 °	39.247560 °
				-121.622509 °	-121.637326 °
DWR ID	DWR_LD0009_01_f_2022_8				
Comment Code					
V1 : Control annual grass and weeds on the levee slopes and easements.					
Inspector Comment					
Annual vegetation is well maintained, Fall 2022.

View of annual vegetation on the waterside slope, Fall 2022.

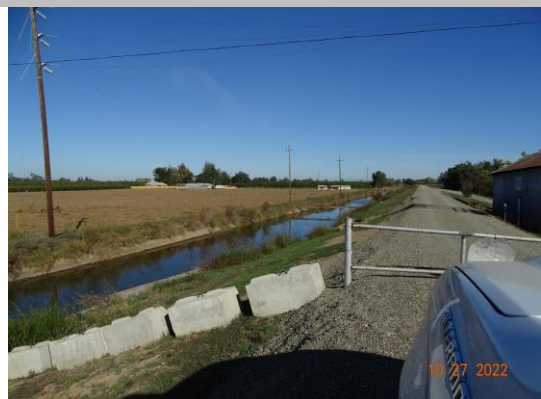
Photo 1 of 1 : FA_2022_LD0009_202_20_20221028_00013.jpg

LM Start	5.66	Rating **	M	Issue No.	20
LM End	6.00	Issue Type +	En	Location *	LS
Category	Earthen Levee			GPS Latitude/Longitude	
				Start	End
Item	Encroachments			39.247349 °	39.252258 °
				-121.637341 °	-121.637077 °
DWR ID	DWR_LD0009_01_f_2016_20				
Comment Code					
DT : Ditch					
Inspector Comment					
A ditch is located at the toe of the levee on the landside.

View looking upstream of ditch at the toe of the levee on the landside, Fall 2022.
