**Flood Control Project Maintenance
Levee Inspections
Fall 2023 Levee Maintenance Deficiency Summary Report**

Sacramento River Basin

Levee District No. 0009 (Sutter County)

Levee Inspection Report By Mile - Fall 2023

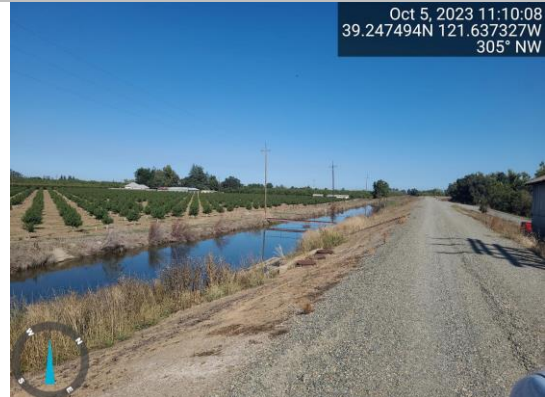
Photo 1 of 1 : FA_2023_LD0009_202_20_20231010_00002.jpg

LM Start	5.66	Rating **	M	Issue No.	20
LM End	6.00	Issue Type +	En	Location *	LS
Category	Earthen Levee			GPS Latitude/Longitude	
				Start	End
Item	Encroachments			39.247349 °	39.252258 °
				-121.637341 °	-121.637077 °
DWR ID	DWR_LD0009_01_f_2016_20				
Comment Code					
DT : Ditch					
Inspector Comment					
A ditch is located at the toe of the levee on the landside.

View looking upstream of ditch at the toe of the levee on the landside, Fall 2023.
