**Flood Control Project Maintenance  
Levee Inspections  
Fall 2024 Levee Maintenance Deficiency Summary Report**

**Sacramento River Basin**

**Levee District No. 0009 (Sutter County)**

**Flood Control Project Maintenance  
Levee Inspections****Levee Inspection Report By Mile - Fall 2024****Levee District No. 0009 (Sutter County)**

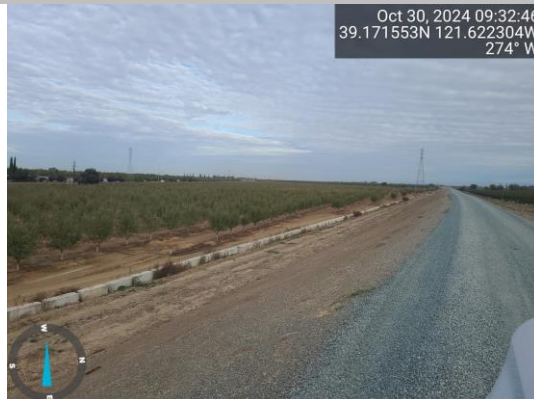
Photo 1 of 1 : FA\_2024\_LD0009\_202\_1\_20241031\_00003.jpg

LM Start	0.09	Rating **	A	Issue No.	1
LM End	6.25	Issue Type +	Ma	Location *	LS
Category	Earthen Levee			GPS Latitude/Longitude	
				Start	End
Item	Vegetation			39.170043 °	39.255811 °
				-121.622574 °	-121.636381 °
DWR ID	DWR_LD0009_01_f_2024_1				
Comment Code					
V1 : Control annual grass and weeds on the levee slopes and easements.					
Inspector Comment					
Annual vegetation is well maintained, Fall 2024.

View of maintained vegetation on the landside slope, Fall 2024.

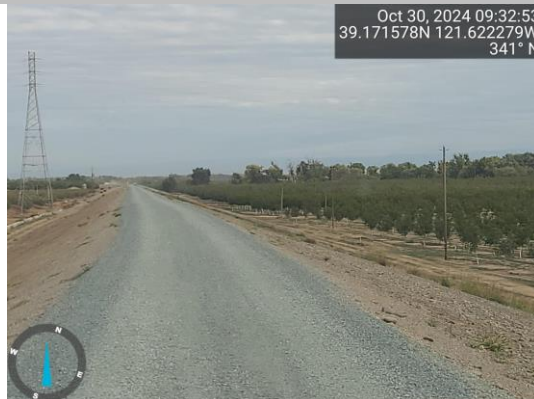
Photo 1 of 1 : FA\_2024\_LD0009\_202\_2\_20241031\_00004.jpg

LM Start	0.09	Rating **	A	Issue No.	2
LM End	6.25	Issue Type +	Ma	Location *	WS
Category	Earthen Levee			GPS Latitude/Longitude	
				Start	End
Item	Vegetation			39.170048 °	39.255814 °
				-121.622574 °	-121.636381 °
DWR ID	DWR_LD0009_01_f_2024_2				
Comment Code					
V1 : Control annual grass and weeds on the levee slopes and easements.					
Inspector Comment					
Annual vegetation is well maintained, Fall 2024.

View of maintained vegetation on the waterside slope, Fall 2024.

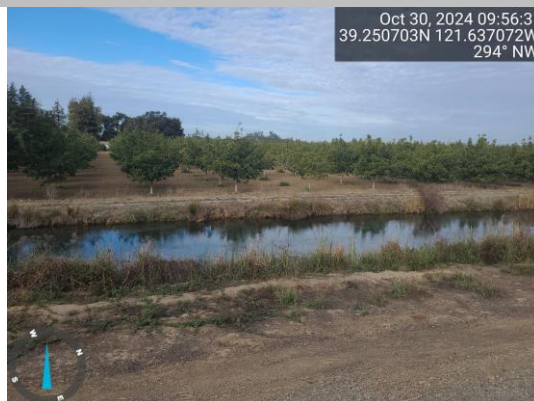
Photo 1 of 1 : FA\_2024\_LD0009\_202\_20\_20241031\_00002.jpg

LM Start	5.66	Rating **	M	Issue No.	20
LM End	6.00	Issue Type +	En	Location *	LS
Category	Earthen Levee			GPS Latitude/Longitude	
				Start	End
Item	Encroachments			39.247349 °	39.252258 °
				-121.637341 °	-121.637077 °
DWR ID	DWR_LD0009_01_f_2016_20				
Comment Code					
DT : Ditch					
Inspector Comment					
A ditch is located at the toe of the levee on the landside.

View looking upstream of ditch at the toe of the levee on the landside, Fall 2024.
